**ALBERTA TRANSPORTATION
GEOHAZARD ASSESSMENT PROGRAM
PEACE REGION (GRANDE PRAIRIE DISTRICT- NORTH)
2022 INSPECTION**

Site Number	Location	Name	Hwy	km
PH067	West of Fairview	East Hill Ditch Erosion Section	682:02	13.8-14.1
Legal Description		UTM Co-ordinates (NAD 83)		
Centre 36-81-5-W6		11 N 6214450	E 398000

PH067-1: HWY 682:02 - HINES CREEK
2022 INSPECTION PLAN

PEACE REGION (GRANDE PRAIRIE DISTRICT - NORTH)
PH067-1: HWY 682:02 km 11.6 TO 14.1
DITCH EROSION REPAIRS
SITE 3
DWG No. 32123-PH067-1-2

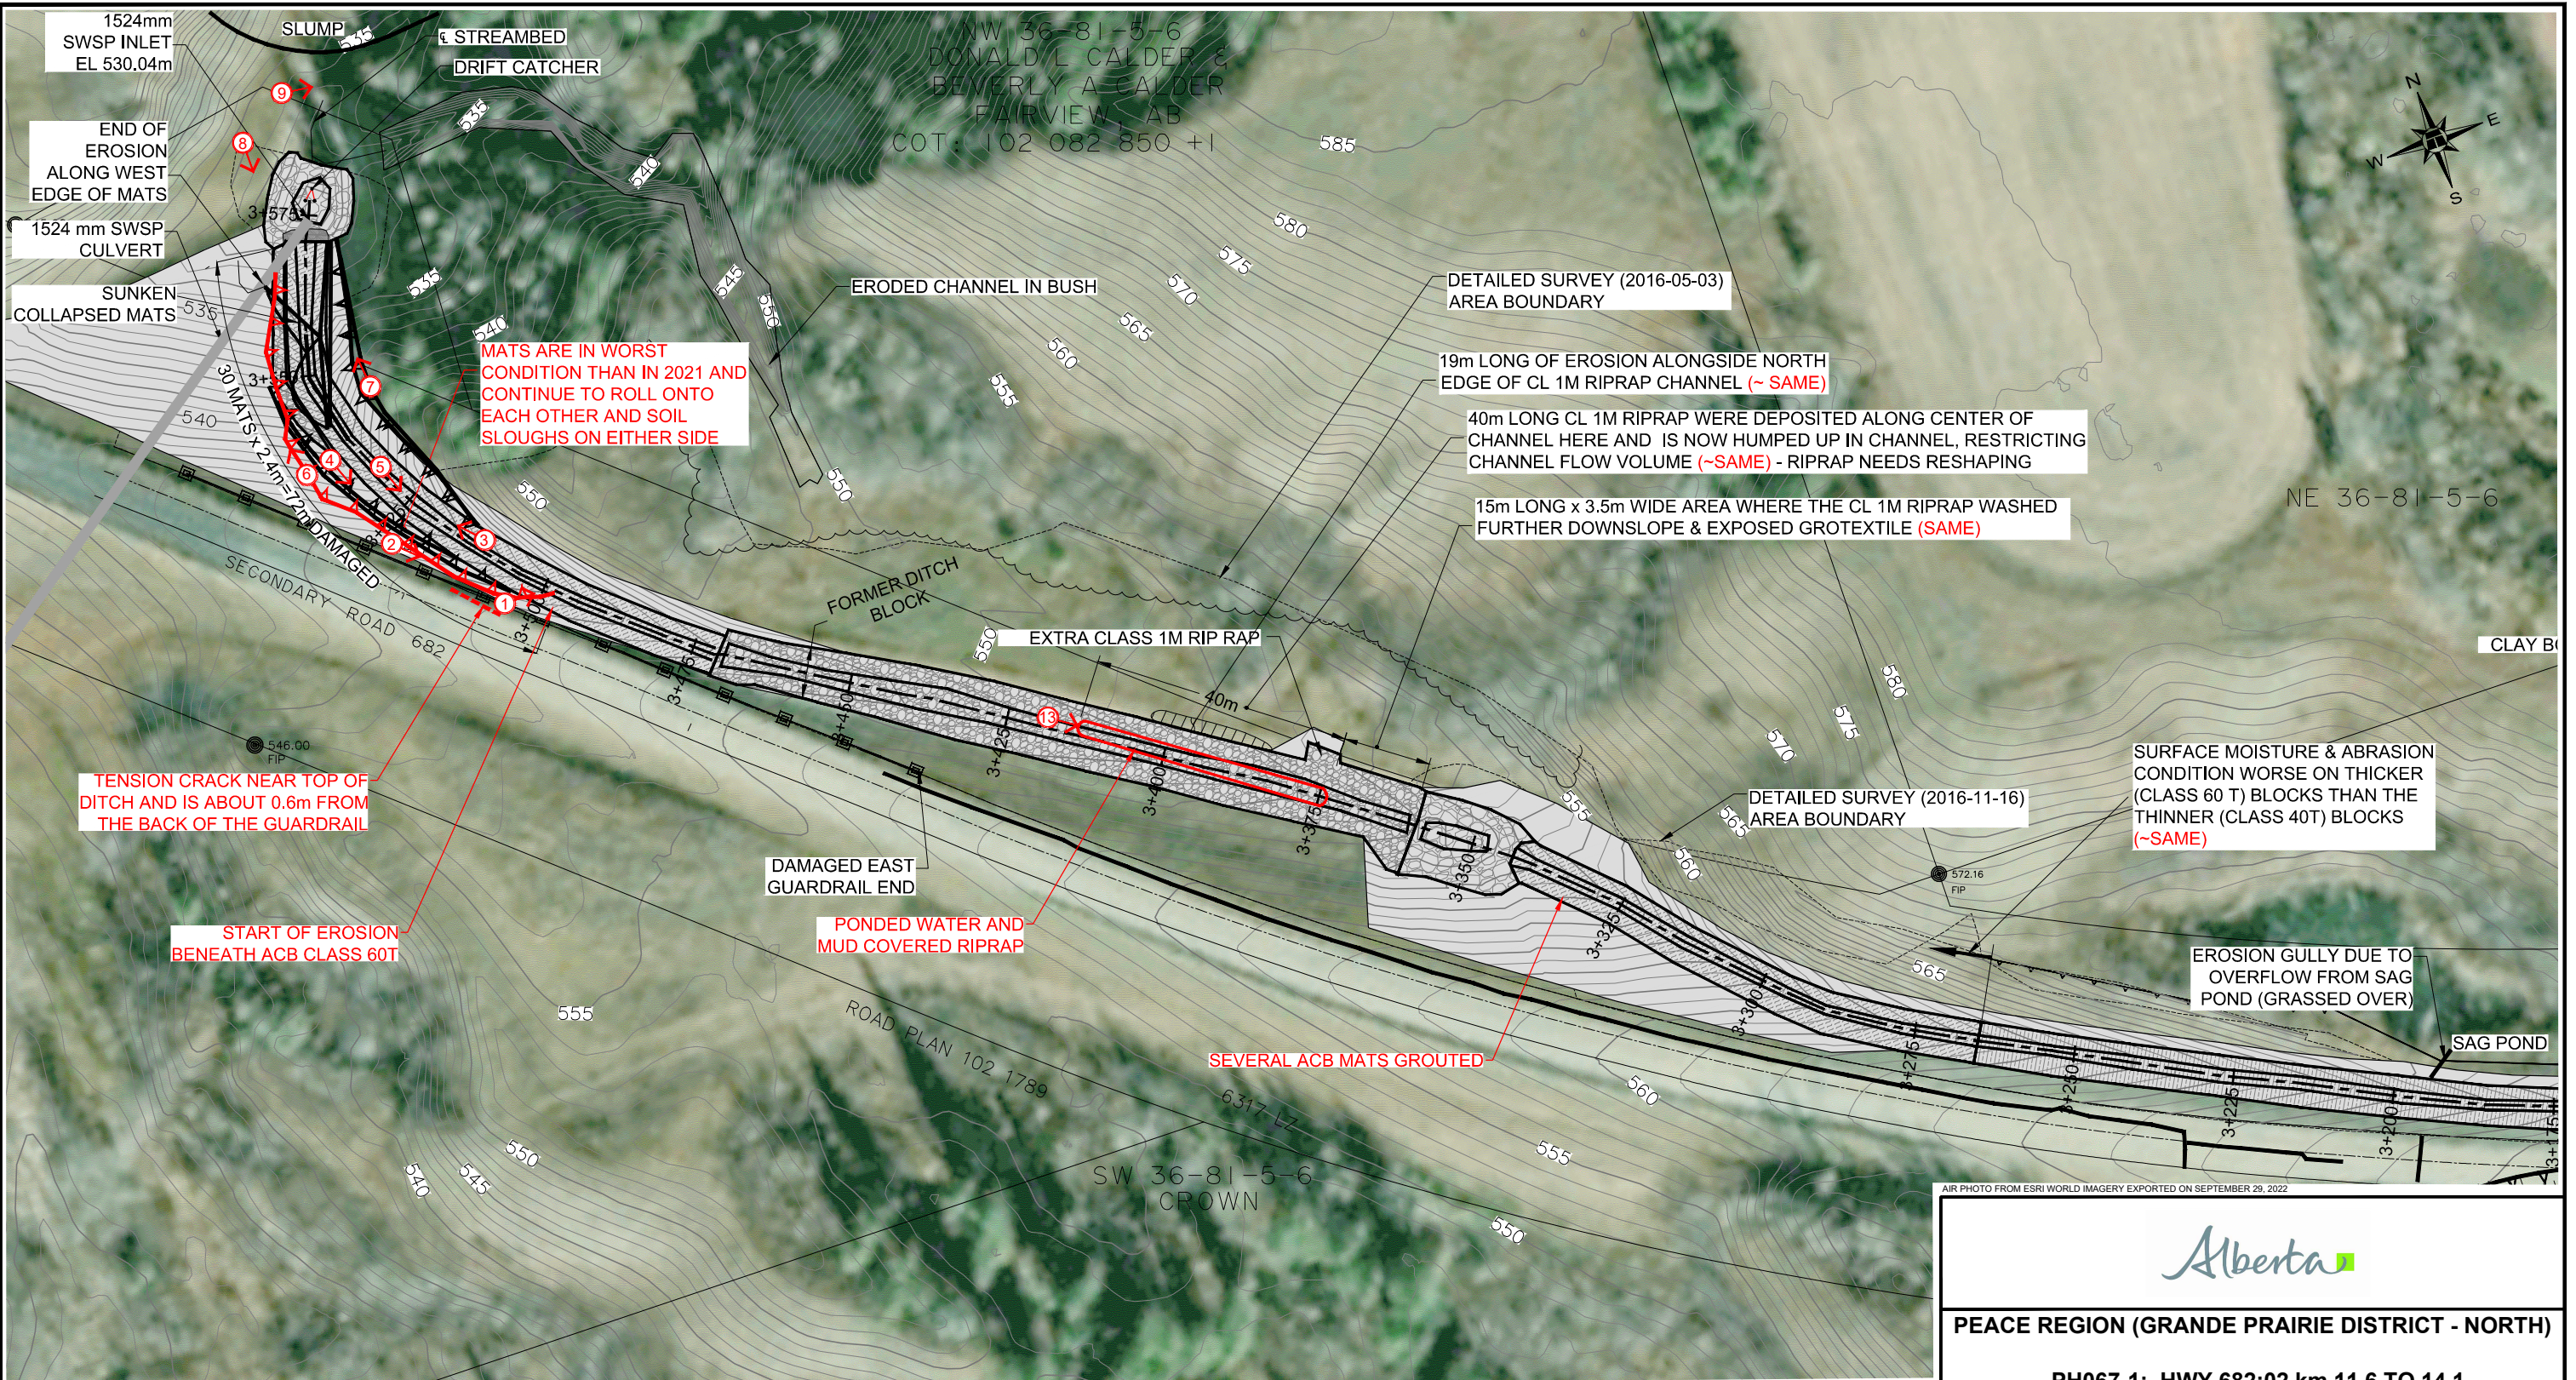
1. FEATURE LOCATIONS ARE APPROXIMATE
2. PREVIOUS OBSERVATIONS SHOWN IN BLACK
3. **MAY 17, 2022 FEATURES SHOWN IN RED**
4. ADVANCED ABRASION & SPALLING OF ACB MAT BLOCKS AND MANY BROKEN BLOCKS ALONG CENTER BASE OF CHANNEL; SOME MATS WORSE THAN OTHERS.
5. HIGHWAY SAND / SALT STAINING ALONG BASE & HIGHWAY SIDE OF ACB MATS IN CHANNEL.

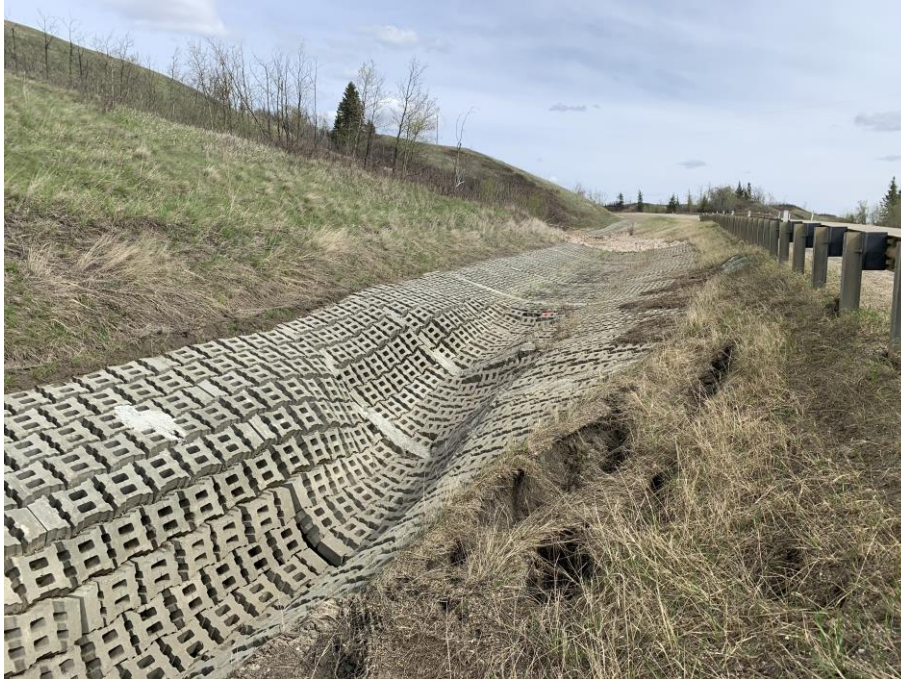
Photo 1 – Looking east along the beginning of the eroded ACB mat area north of the highway.

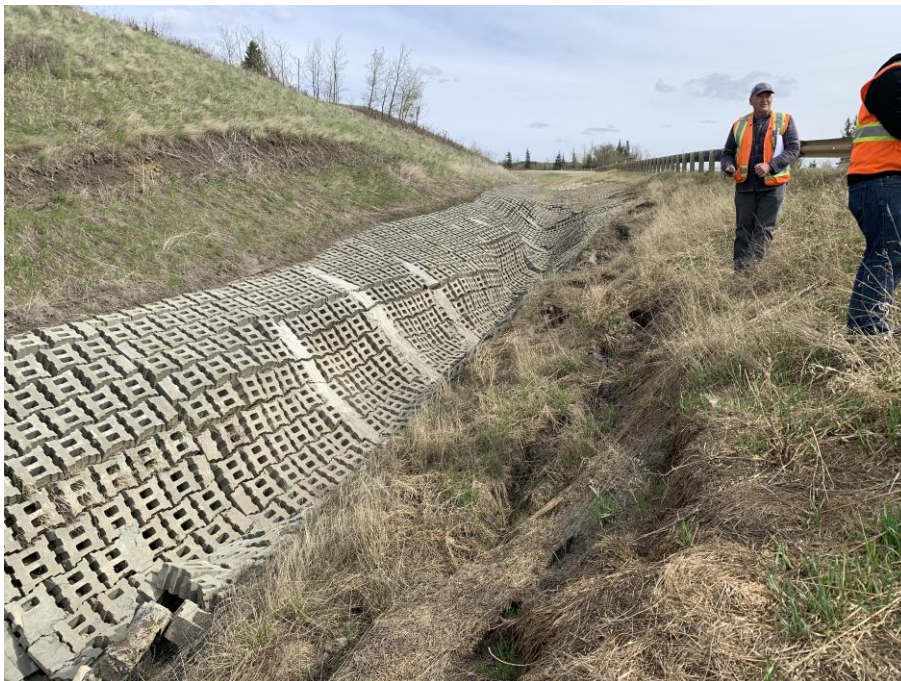
Photo 2 – Looking southeast along the edge of the eroded ACB mat area. Note the recent scarp extension along the south edge of the mats.

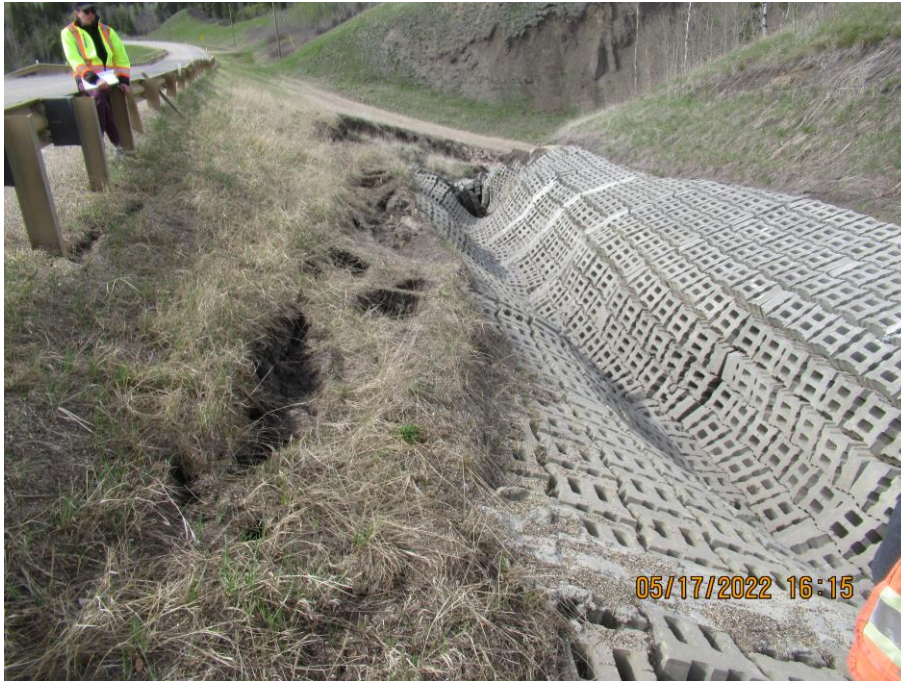
Photo 3 – Looking northwest along the severely damaged ACB mat area and enlarged slide scarp area.

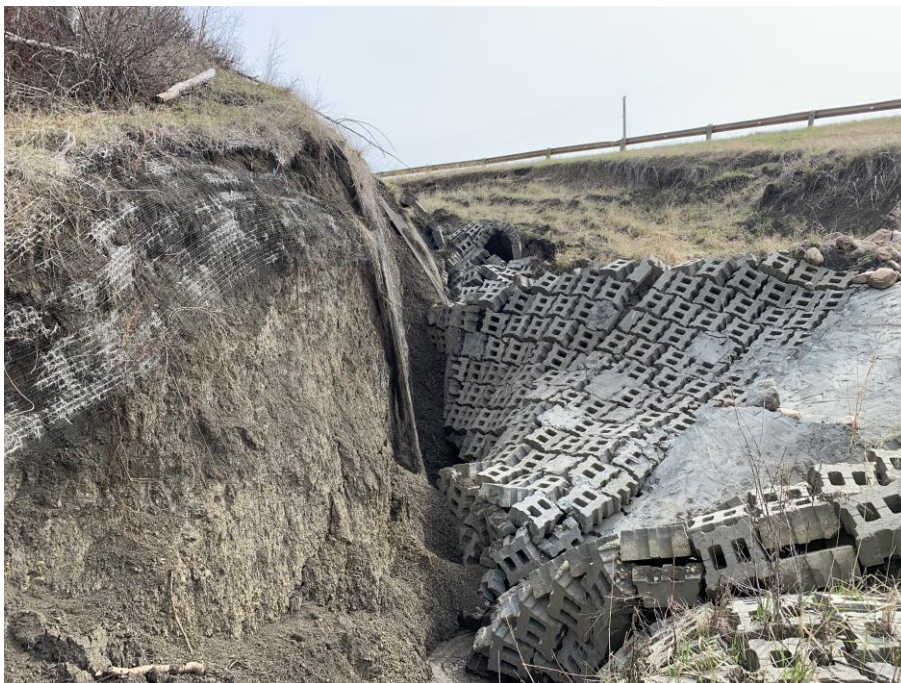
Photo 4 – Looking southeast at the severe erosion through the ACB mats. Note the enlarged erosion and slide developing south of the mats.

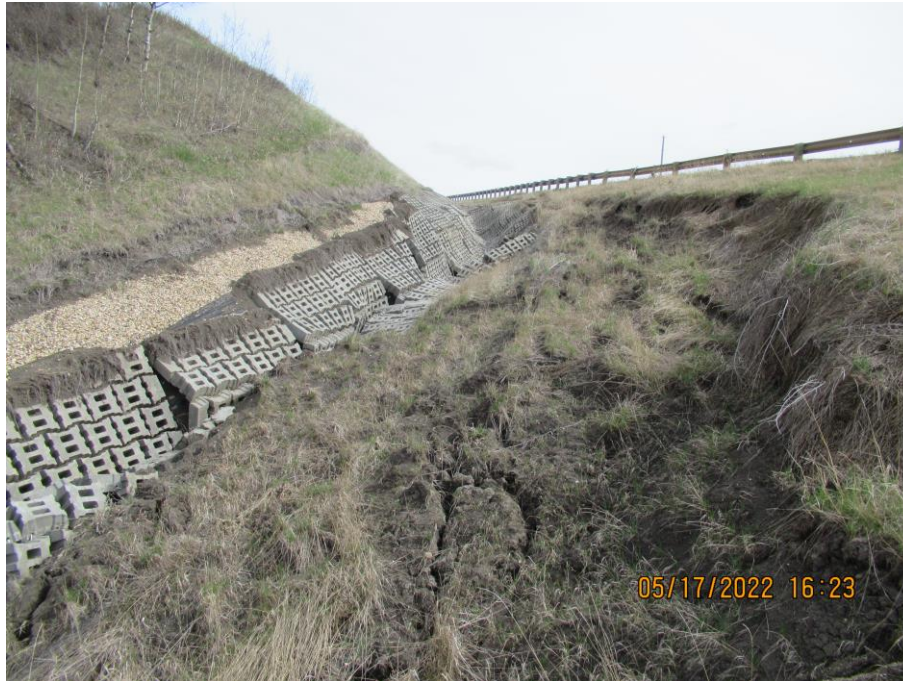
Photo 5 – Looking southeast along the north edge of the eroded ACB mats. Here the mats have slid down into the deeply eroded channel, exposing the underlying gravel.

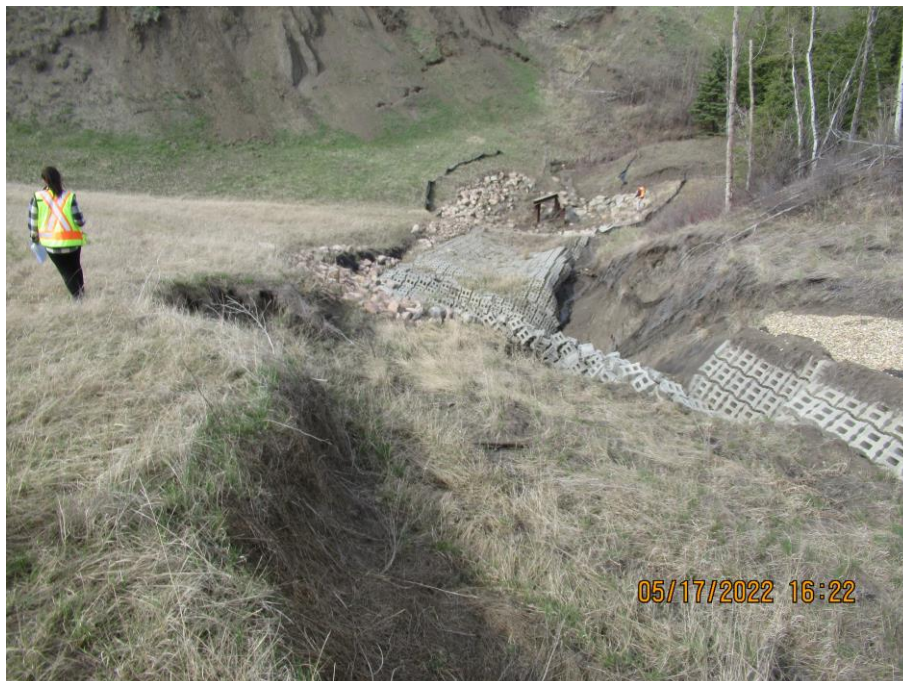
Photo 6 – Looking north along the southwest side of the damaged and eroded ACB mats.

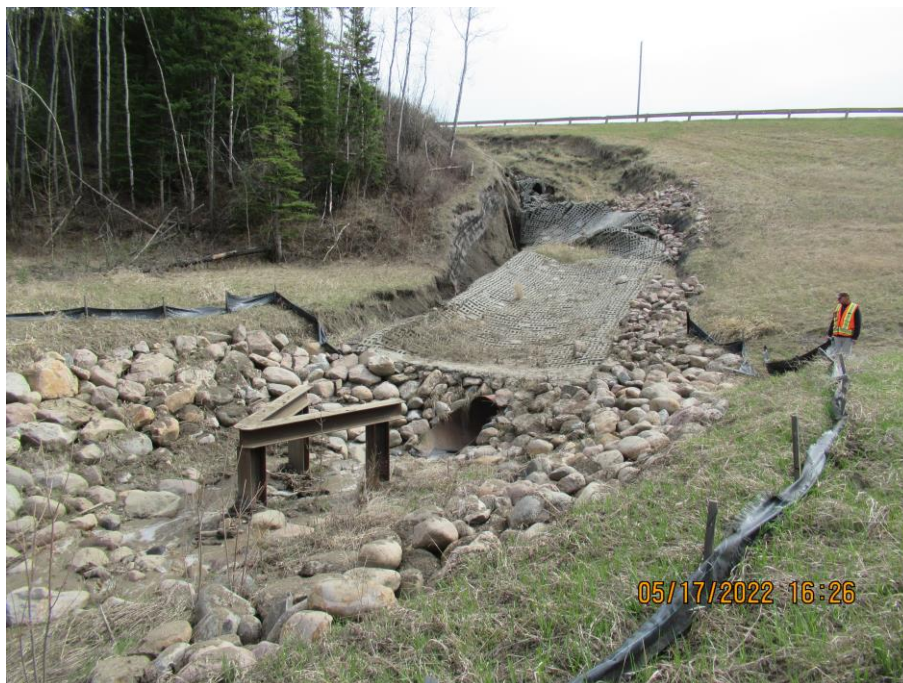
Photo 8 – Looking southeast at the culvert inlet and eroded ACB mat area leading to it.

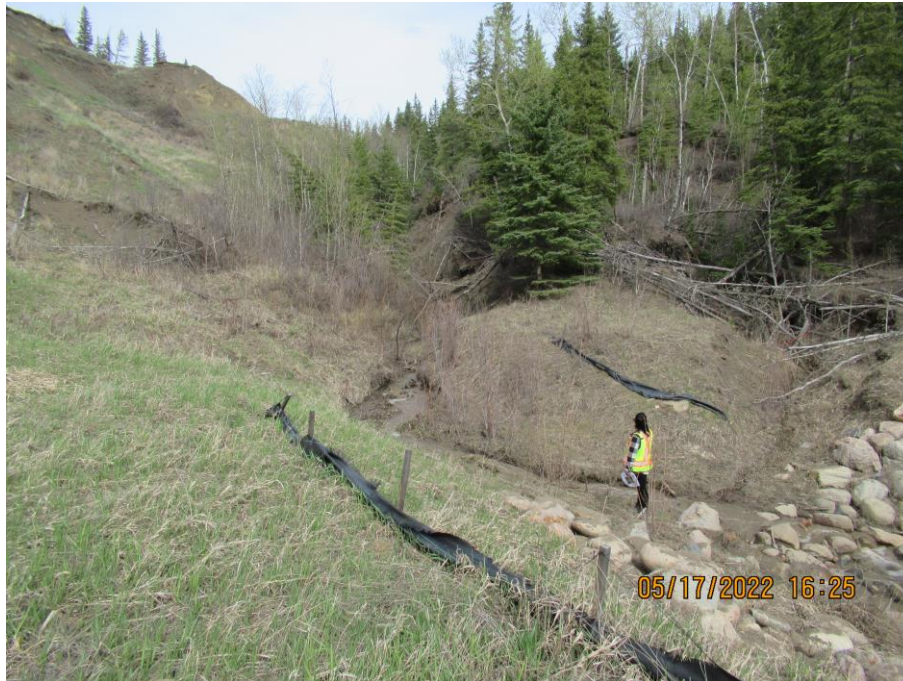
Photo 9 – Looking north at the slumping and infill occurring into the channel upstream of the 1524 SWSP culvert entrance.

Consider installing culverts (900 or 1200 mm diameter) in the slumping channel areas upstream of the existing 1524 mm diameter culvert inlet, to allow flow to the existing culvert while minimizing debris and potential blockage.

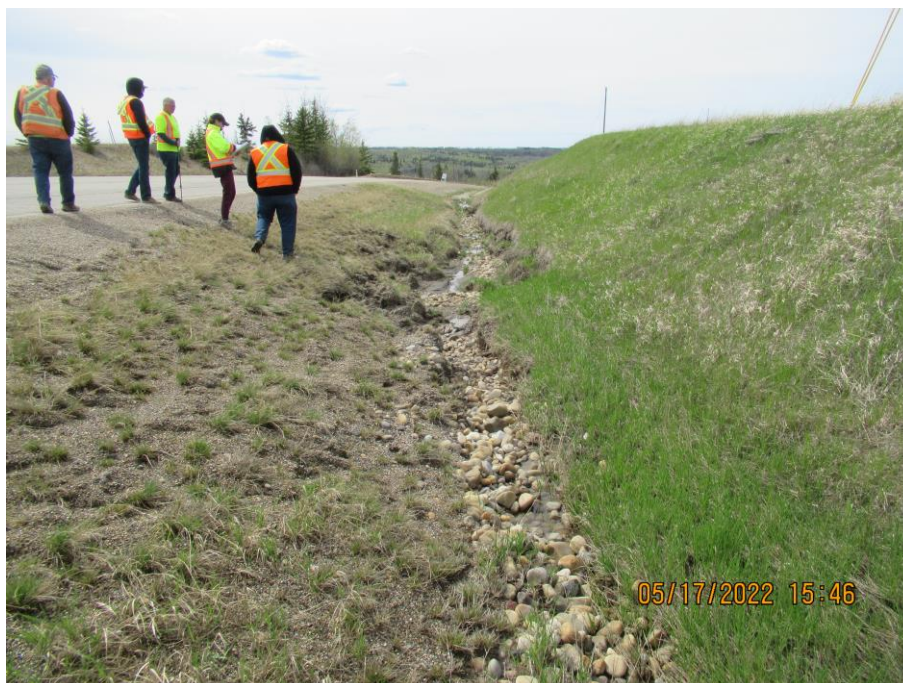
Photo 10 – Looking west at erosion that has formed uphill from the ACB matting.

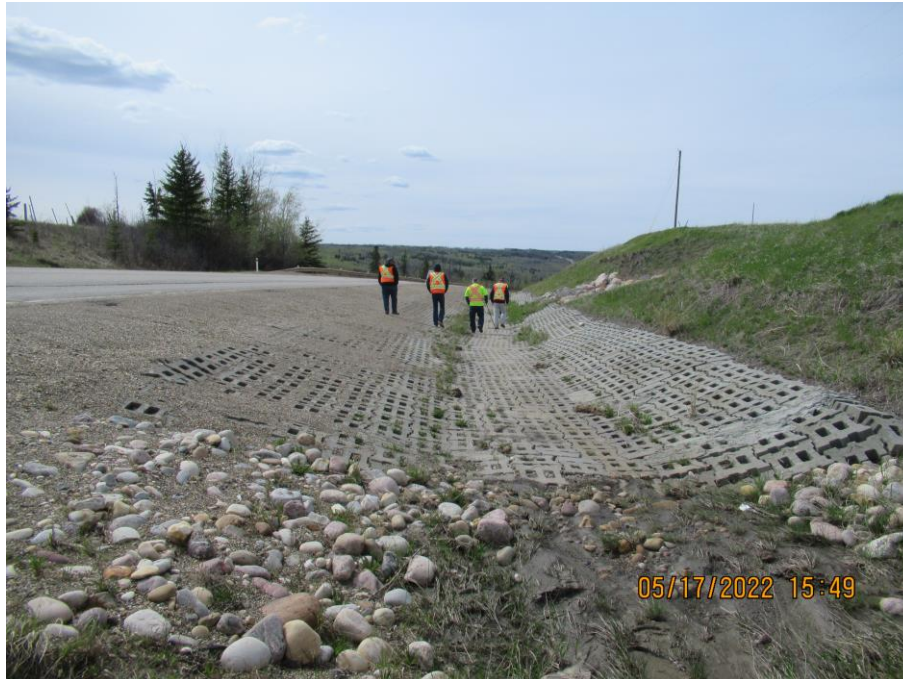
Photo 11 – Looking west at location where grass was flattened with mud and water.

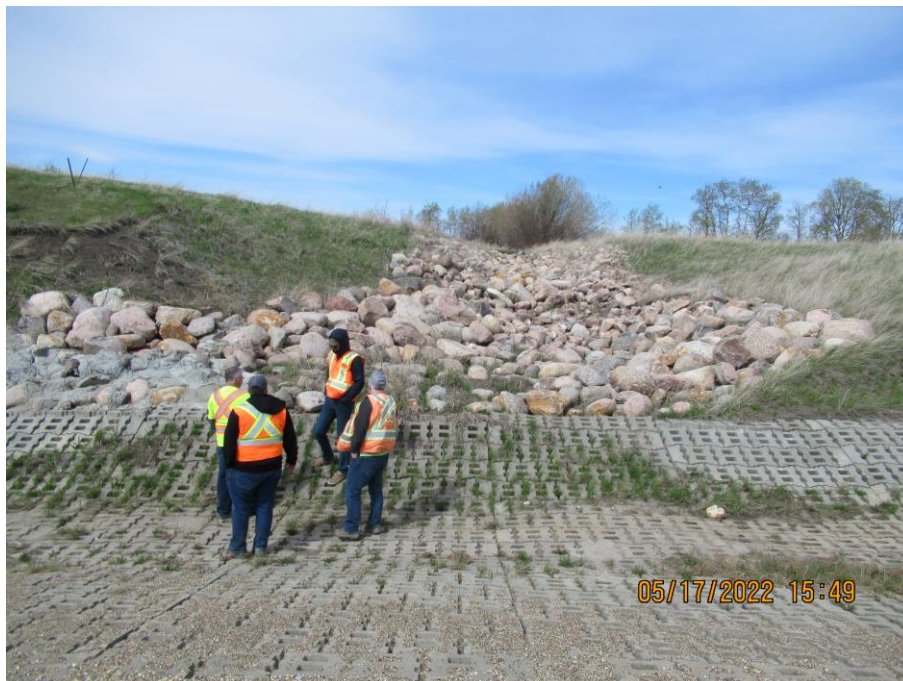
Photo 12 – Looking north at where riprap was previously placed, appears to be in good condition.

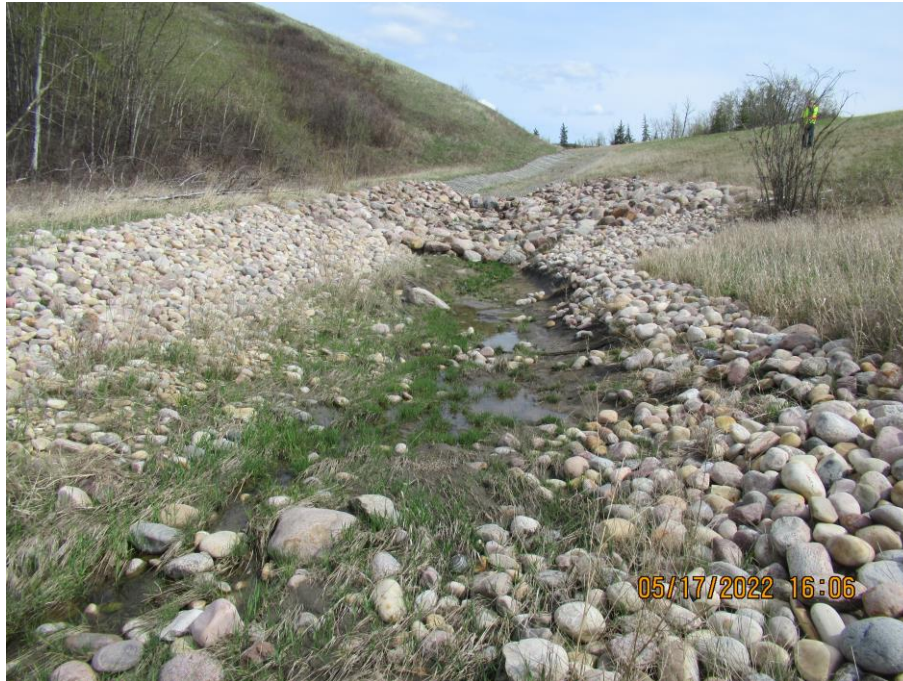
Photo 13 – Looking east at area within riprap that now has mud covering some of the riprap likely from high runoff flow events and ponding afterwards.

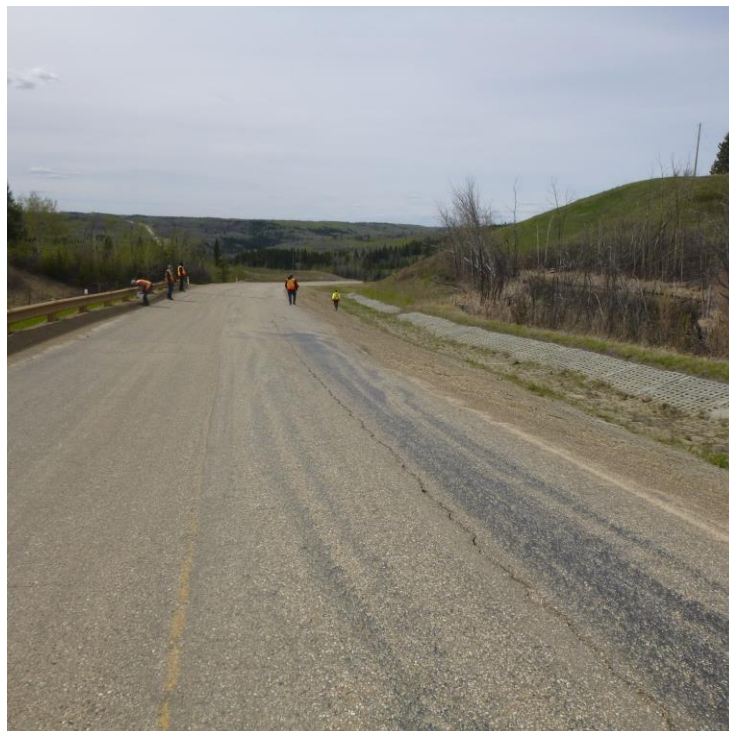
The dip across the highway near the sag pond (first noticed in 2014 ~Sta 3+200), has not gotten any worse this year, however new cracks appeared in 2020 and suggests that a landslide might be developing at this location, moving southward.

Photo 14 – Looking northwest at cracks in asphalt and dip in highway.

Continue monitoring the slide that appears to be developing across the highway near the sag pond.

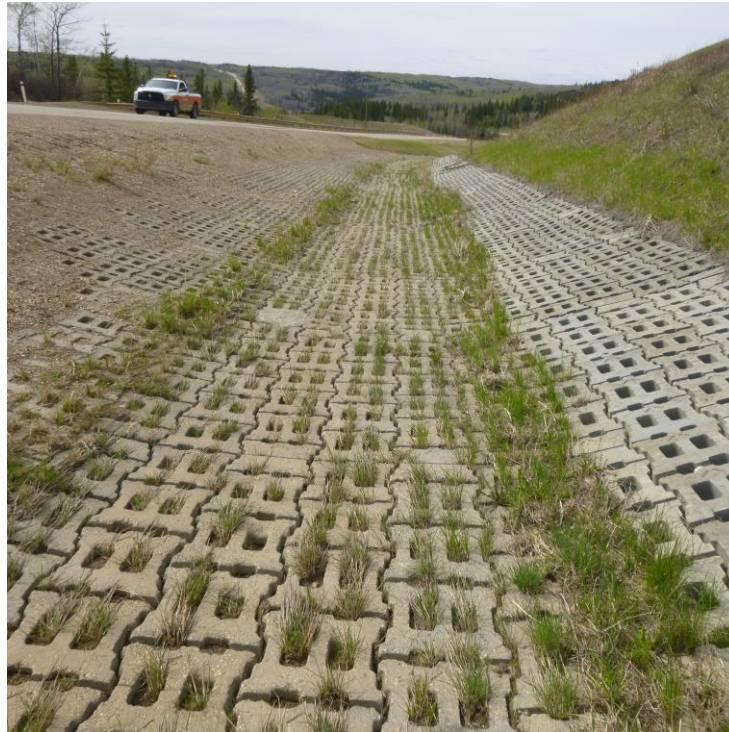
Photo 15 – Looking northwest at the ACB Matting performing well.
