**ALBERTA TRANSPORTATION AND  
ECONOMIC CORRIDORS  
GEOHAZARD ASSESSMENT PROGRAM  
PEACE REGION (GRANDE PRAIRIE DISTRICT– NORTH)  
2025 INSPECTION**

Site Number	Location	Name	Hwy	km
PH067	West of Fairview	East Hill Ditch Erosion Section	682:02	13.8-14.1
<b>Legal Description</b>		<b>UTM Co-ordinates (NAD 83)</b>		
Centre 36-81-5-W6		11 N 6214450	E 398000

PH067-1: HWY 682:02 - HINES CREEK  
2025 INSPECTION PLAN

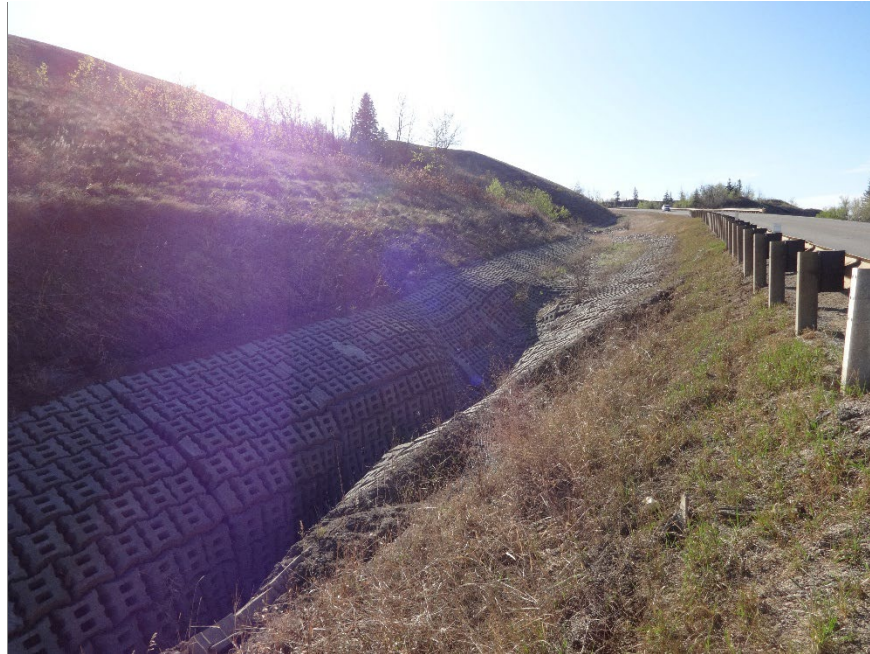
**Photo 1. Looking east along the beginning of the eroded ACB mat area north of the highway.**

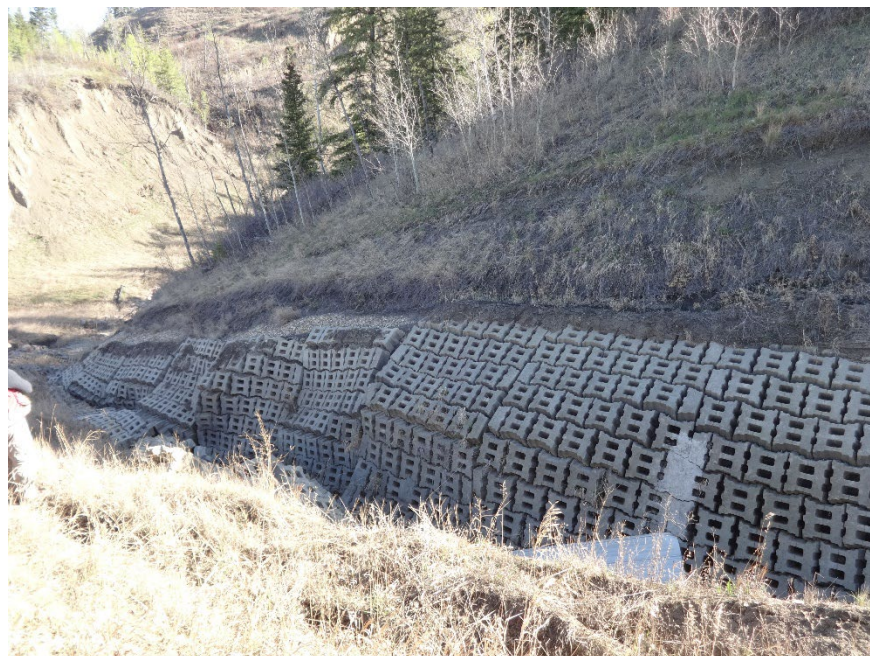
**Photo 2. Looking north along the edge of the eroded ACB mat area. Note the scarp extension along the north edge of the mats.**

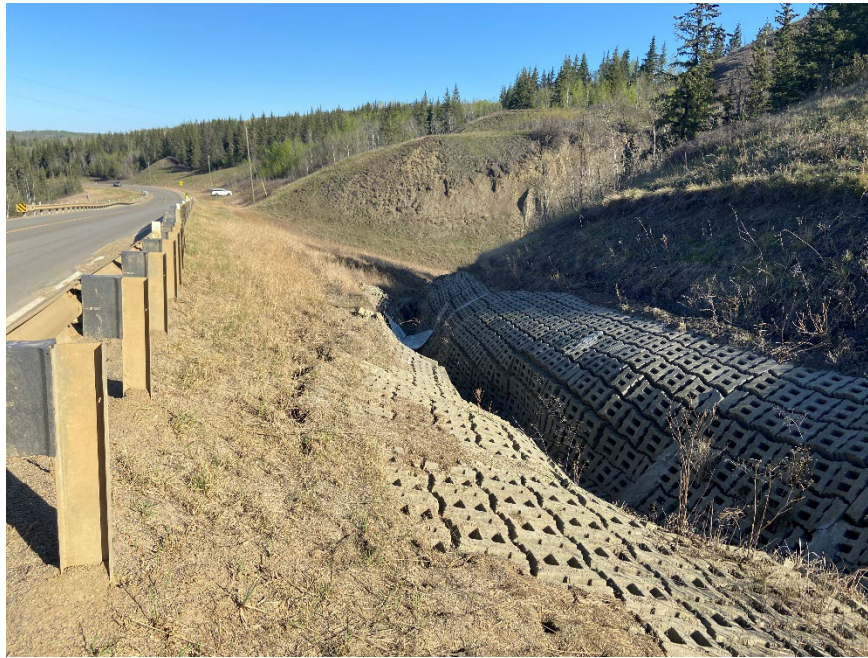
**Photo 3. Looking northwest along the severely damaged ACB mat area and enlarged slide scarp area.**

- 1) Sta 3+500 to Grimms Creek: Completely remove the damaged ACB block mats then fill/compact the eroded bottom with clay then repair with a stepped structure consisting of sheet piles and class 3 or grouted Class 2 riprap.
- 2) Extending the length of the CI 2 riprap dissipation bowl by at least 15 m (Sta 3+360 to 3+375), where flow scoured the existing CI 1M riprap and exposed the underlying non-woven geotextile and deepening the channel to accommodate the larger riprap. Then re-arranging the moved CI 1M riprap over the 40 m length of channel downstream of this.
- 3) Repairing the short erosion gully that outlets from the sag pond onto the ACB mats (Sta 3+195) and installing a CI 1 riprap channel with a compacted clay cut-off leading onto the top of the mats.

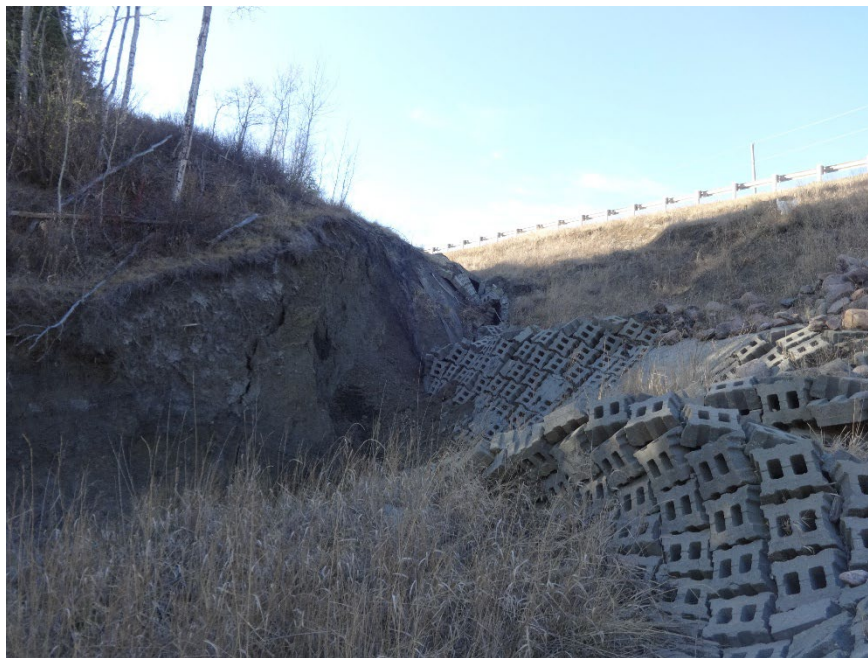
**Photo 4. Looking southeast at the severe erosion through the ACB mats. Note the enlarged erosion and slide developing south of the mats.**

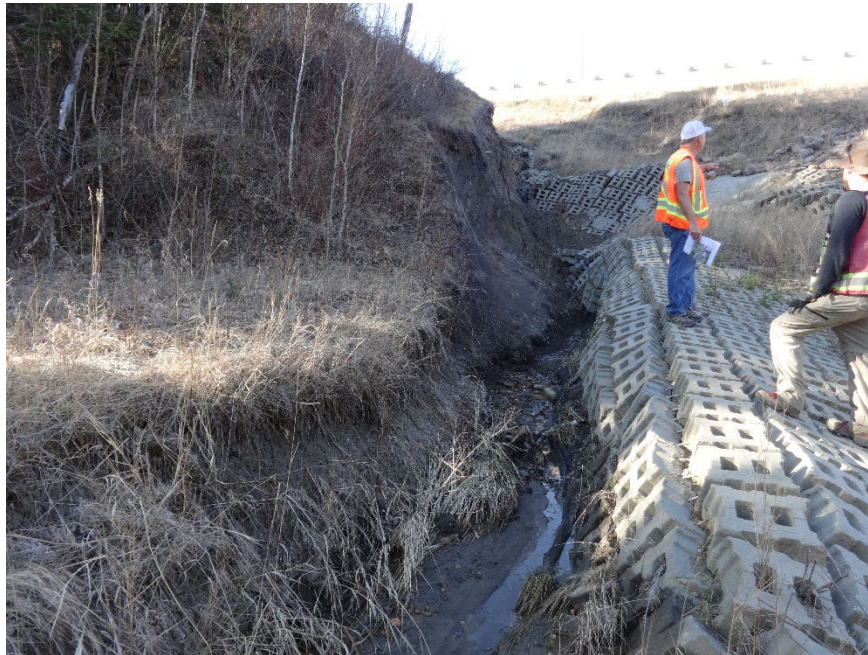
**Photo 5. Looking southeast along the east edge of the eroded ACB mats. Here the mats have slid down into the deeply eroded channel and water flows along here.**

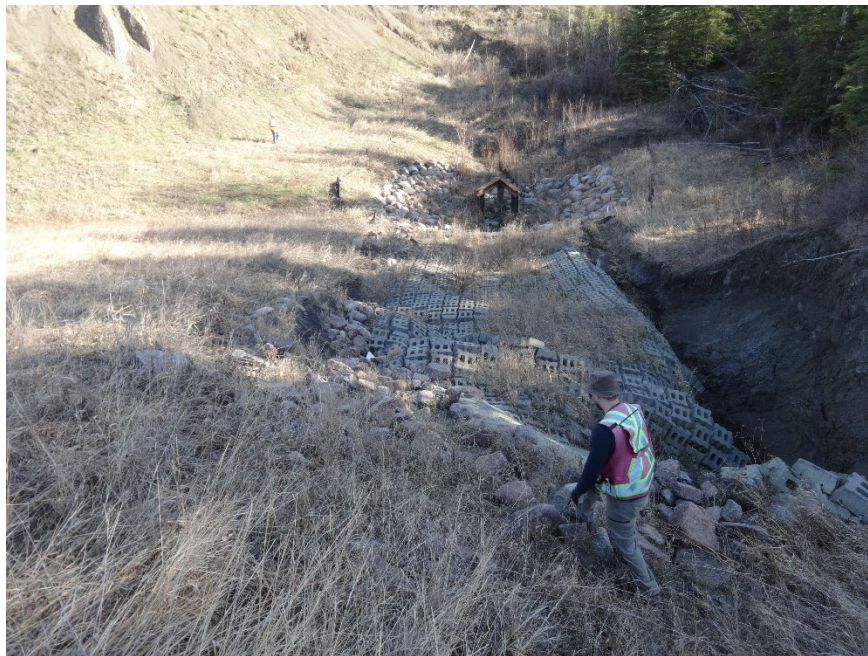
**Photo 6. Looking north along the southwest side of the damaged and eroded ACB mats.**

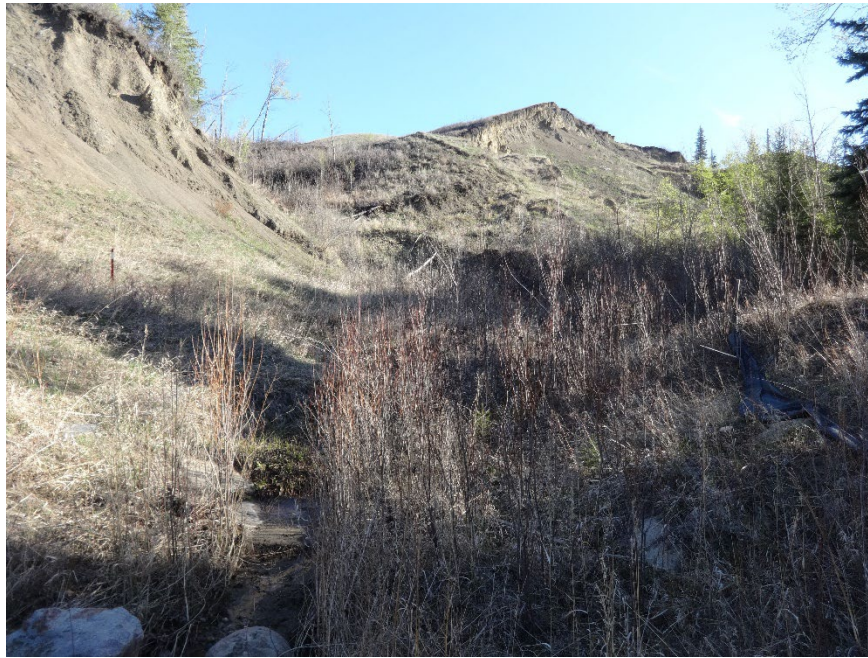
**Photo 7. Looking north at the slumping creek valley slopes upstream of the culvert.**

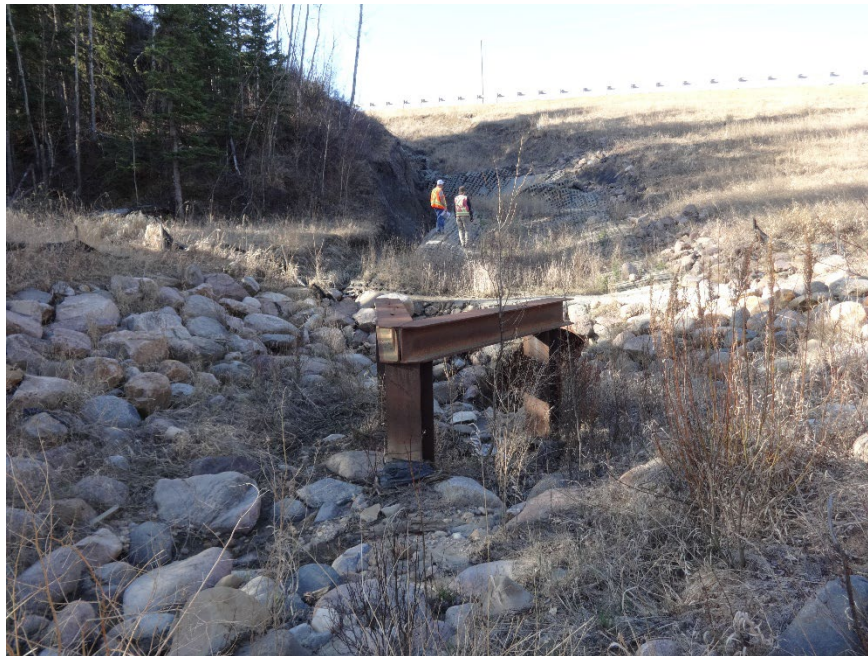
**Photo 8. Looking southeast at the culvert inlet, trash rack and eroded ACB mat area leading to it.**

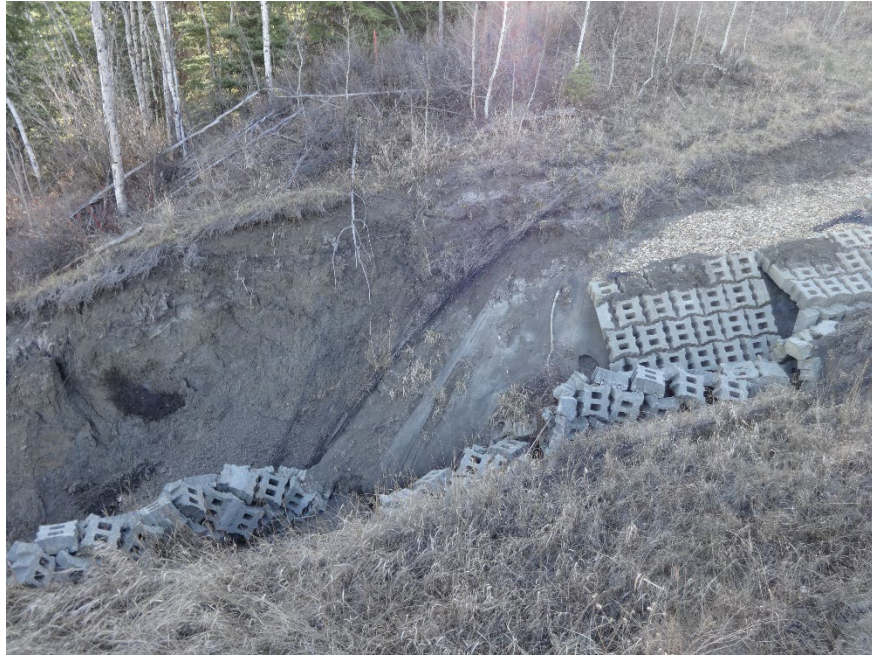
**Photo 9. Looking north at the slumping and infill occurring into the channel upstream of the 1524 mm SWSP culvert inlet.**

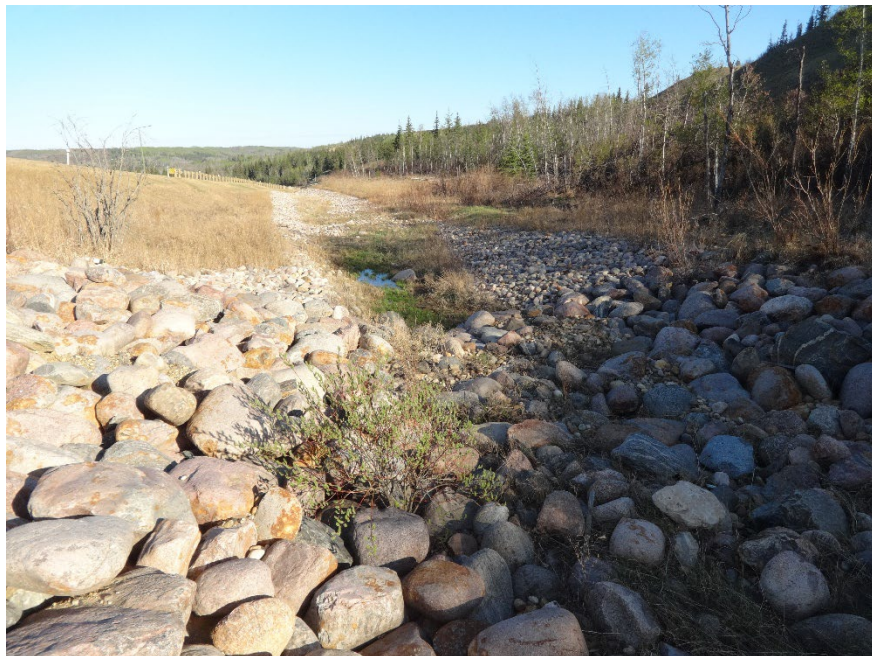
**Photo 10. Looking northwest at area within riprap that now has mud and grass covering some of the riprap likely from high runoff flow events and ponding afterwards.**

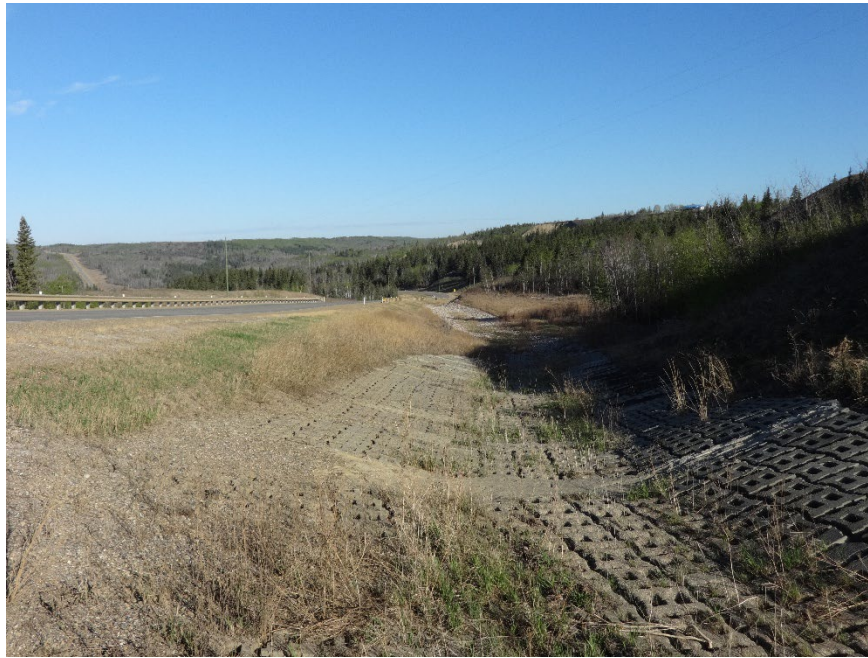
**Photo 11. Looking northwest at the ACB Matting that was previously grouted.**

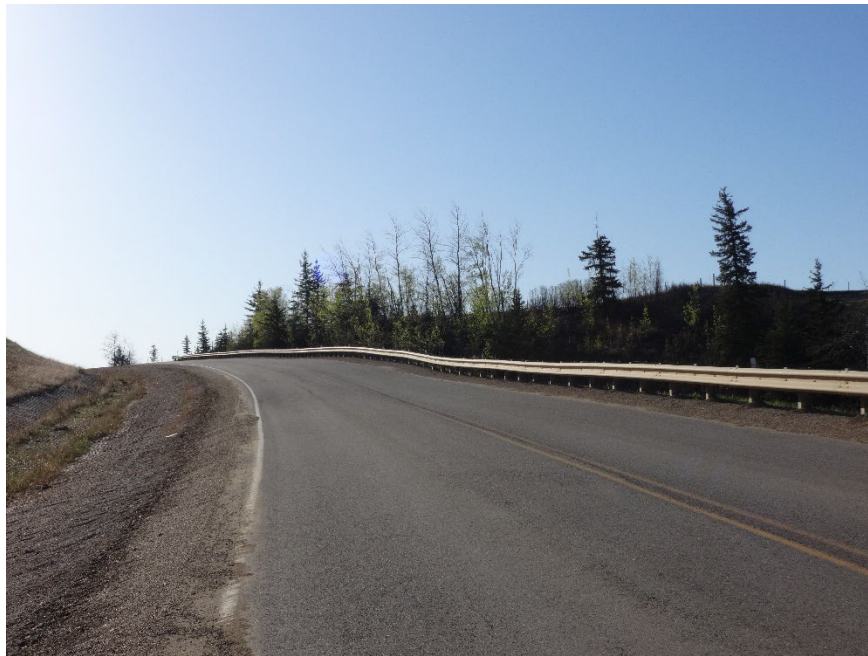
The dip across the highway near the sag pond (first noticed in 2014 ~Sta 3+200), has not gotten any worse this year, however cracks had appeared in 2020 before the 2023 overlay covered them and three cracks up to 30 mm wide have now shown through the new overlay and suggest that a landslide might be slowly developing at this location, moving southward.

**Photo 12. Looking southeast at the dip in the highway.**

Continue monitoring the slide that appears to be developing across the highway near the sag pond.

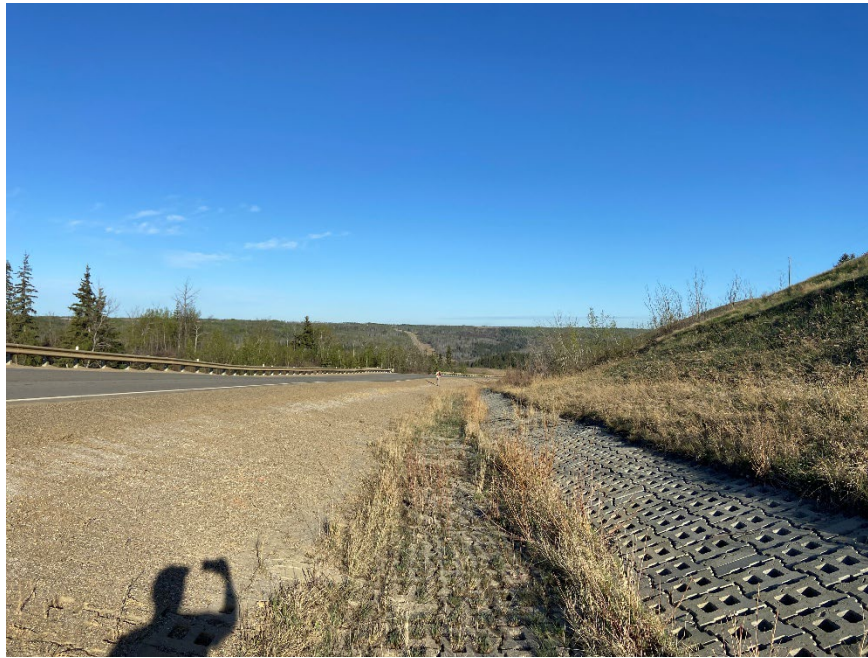
**Photo 13. Looking northwest at the ACB Matting performing well and previously had some willows growing out of them which were cut.**

Continue cutting or spraying the willows that grow in the lined channel with broadleaf pesticide to eliminate the trees from growing larger as their presence, if left unchecked, could impede drainage and cause high flows to erode outside the lined channel

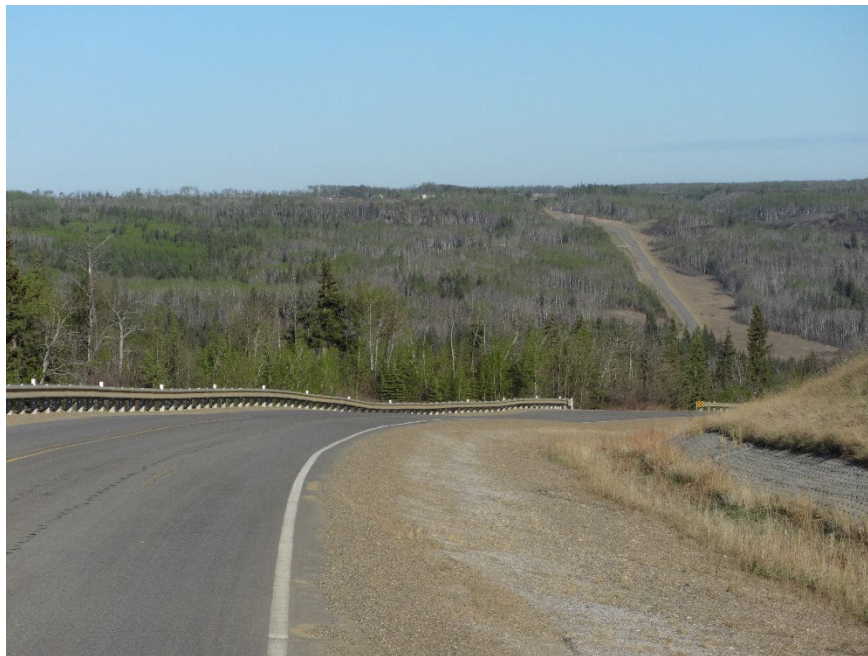
**Photo 14. Looking west at Grimms Creek valley and dip in the road.**

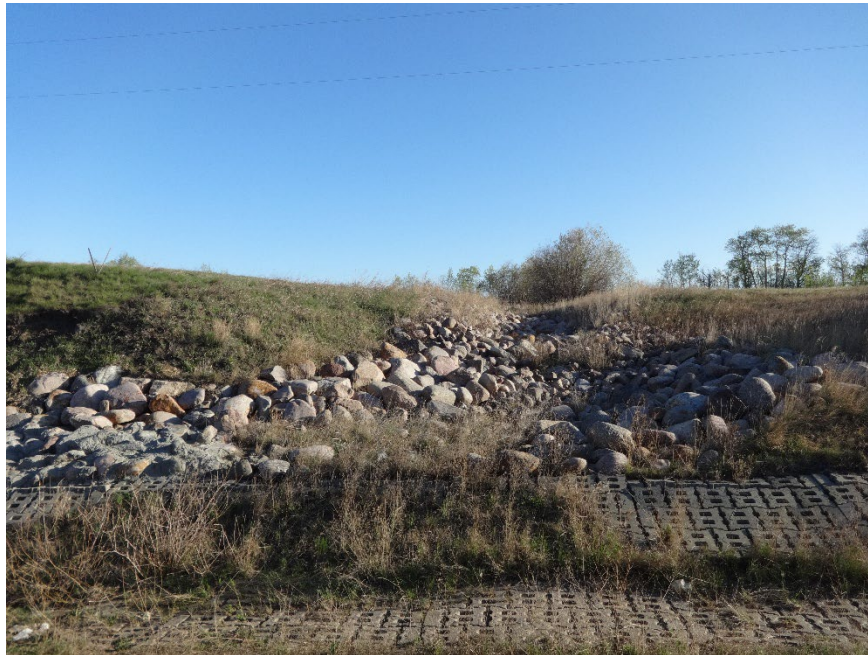
**Photo 15. Looking north at where riprap was previously placed, appears to be in good condition.**

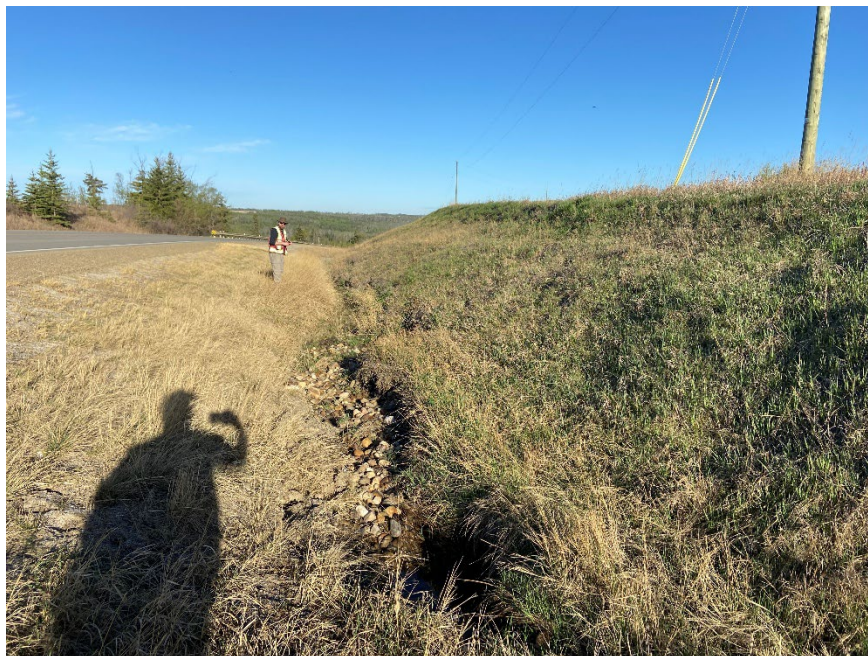
The newly eroded 120 m section of north ditch at the east end of the site that extends from the beginning of the 40T ACB mats at Sta 2+975 to the 500 mm dia. approach ditch culvert further east will eventually need to be repaired, using either Class 2 riprap, or gabion mattress.

**Photo 16. Looking northwest at the eastmost erosion in the ditch.**
