**ALBERTA TRANSPORTATION
GEOHAZARD ASSESSMENT PROGRAM
PEACE REGION – GRANDE PRAIRIE DISTRICT - NORTH
2021 INSPECTION**

Site Number	Location	Name	Hwy	km
PH077-1 and 77-2	West of Fairview	Sites E of Hines Creek Bridge	682:02	12.5-12.8
Legal Description		UTM Co-ordinates (NAD 83)		
NE35-81-5-W6		11V N 6215000	E 396650

Date	PF	CF	Total
Previous Inspection:	June 17, 2020	11	4	44 (PH077-1)
		13	4	52 (PH077-2)
Current Inspection:	July 13, 2021	13	4	52 (PH077-1)
		9	4	36 (PH077-2)
Road AADT:	160	Year:		2020
Inspected By:	Ed Szmata, AT Roger Skirrow, AT Rocky Wang, AT Max Shannon, AT Ken Szmata, AT		Barry Meays, Thurber Nicole Wilder Thurber	
Report Attachments:	<input checked="" type="checkbox"/> Photographs		<input checked="" type="checkbox"/> Plans	<input checked="" type="checkbox"/> Maintenance Items

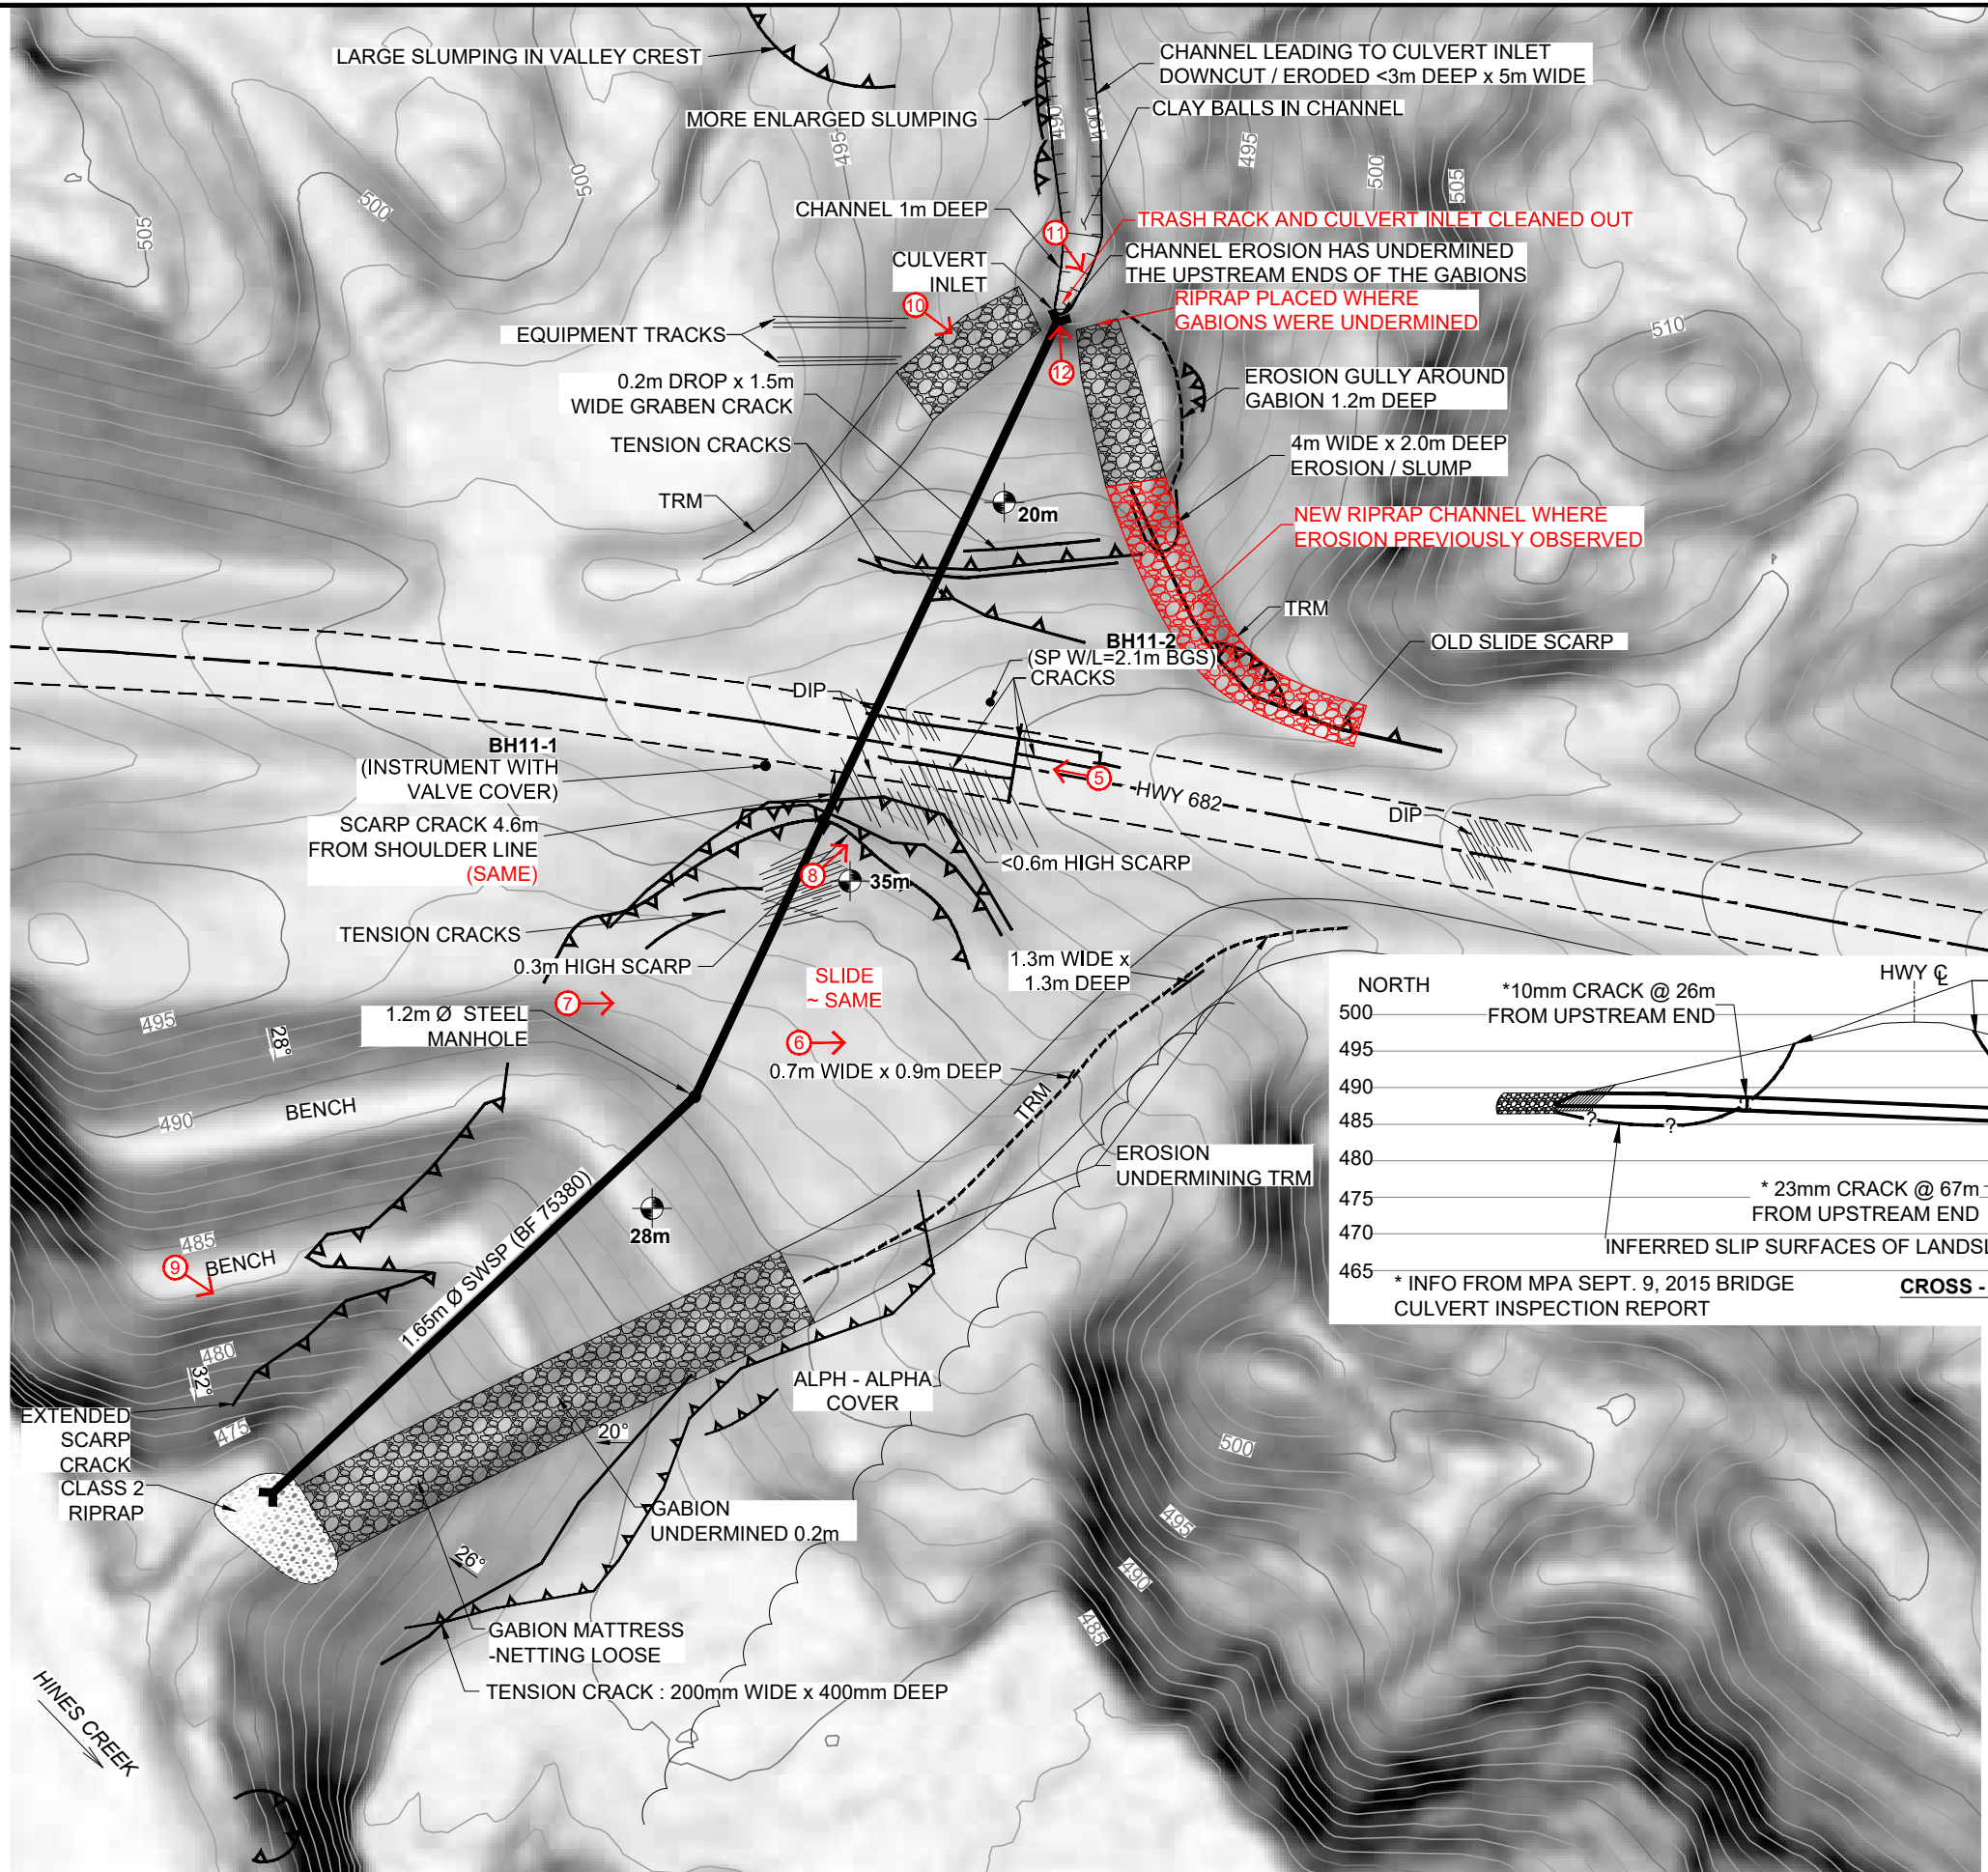
INSPECTION PLAN - SITE 2

1. SITE RELATIVELY UNCHANGED.
2. GABIONS LACKING INTERMEDIATE BAFFLES AND LIDS NOT ADEQUATELY TIED.
3. JULY 13, 2021 OBSERVATIONS SHOWN IN RED.

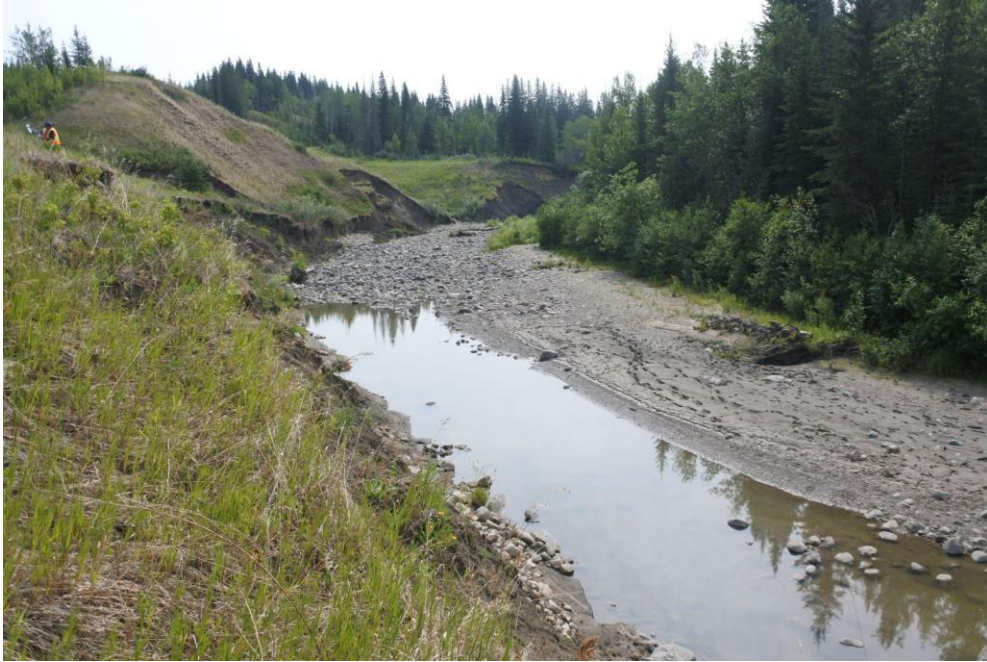
Photo 1 – Looking east at Slide PH077-1 at the erosion along the north side of the Creek.

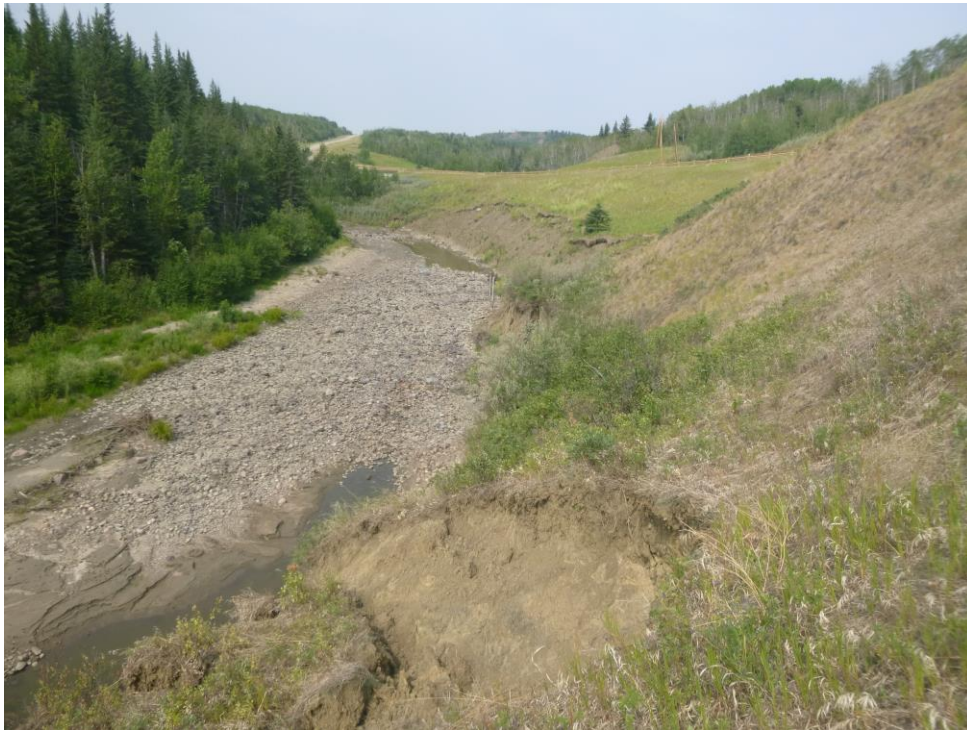
At PH077-1, the slide roughly paralleling the creek and highway is a direct result of erosion by Hines Creek and resulting soil loss along the toe of the embankment. The slope will tend to flatten with time due to loss of cohesion in the clay fill embankment material. Therefore, the slide could also gradually enlarge into the driving lanes of the highway surface, and there are already indications of this presumably starting to occur based on the existing cracks and dips in the highway. The smaller 15 m wide slide near the east end of this site may have been triggered by east ditch runoff erosion, and/or having a slope that is too steep for the composition material of the embankment. Ditch or surface erosion of the slope could also contribute to more rapid slope movements.

Photo 2 – Looking west at the fresh toe slumping above the creek at PH077-1 in the south highway embankment.

Medium Term: The recommended repair for only the small, shallower slide near the east end of the site is to subexcavate the failed slide mass down to intact clay and rebuild the slope with imported pitrun gravel. The new fill material should be placed and compacted in thin horizontal lifts, benched into the intact slope surface, possibly utilizing a gravel shear key to stabilize the slide area. Some of the more suitable excavated clay could be used to provide a covering layer overtop the gravel as the finished slope surface to shed runoff. A subdrain should be installed along the base of the slide excavation surface, to drain any surface/subsurface water that may enter the rehabilitated slide mass. The east ditch along the toe of this slide should be re-contoured and lined with either TRM or gabions. All existing topsoil should also be stripped and salvaged for replacement and seeded at completion of the repairs.

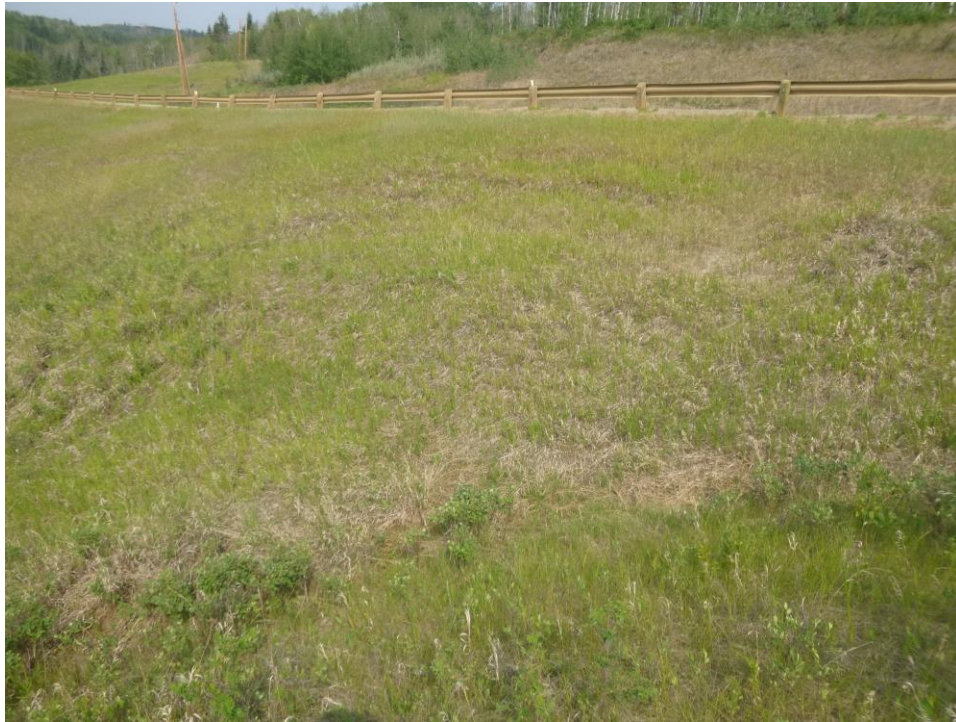
<input checked="" type="checkbox"/> Slope Movement	<p>At PH077-1: The Creek has eroded the toe of the south embankment, and a slide scarp has developed parallel to the highway and is as close as 8 m from the pavement. Additional fresh sloughing in same areas was observed in 2021. At the east end, the 15 m wide shallow sideslope slide has moved downslope and created a 0.4 m high scarp (at 3.6 m from the guardrail) and a 0.6 m high toe push.</p> <p>At PH077-2: A landslide has developed through the south embankment and has deformed the culvert. There is a 0.4 m high scarp located 4.6 m from the white shoulder line. North of the highway, a 1.5 m wide graben crack with a 0.2 m drop has developed above the erosion near the culvert inlet, and which has developed into a slide that has retrogressed back to near the highway.</p>	<input type="checkbox"/>	<input checked="" type="checkbox"/>
<input checked="" type="checkbox"/> Erosion	<p>At PH077-1, active erosion caused by the creek is occurring at the toe of the slope along the creek's edge. However, the river level was lower than normal at the time of the visit due to much drier weather in 2021.</p> <p>At PH077-2, the TRM south of the highway along the east runoff ditch where previously erosion was observed had been repaired with rip rap lining this ditch as well as placing riprap on the downstream end of the gabions.</p>	<input checked="" type="checkbox"/>	<input type="checkbox"/>

Photo 3 – Looking north upslope at the slide scarp adjacent to the highway at PH077-1.

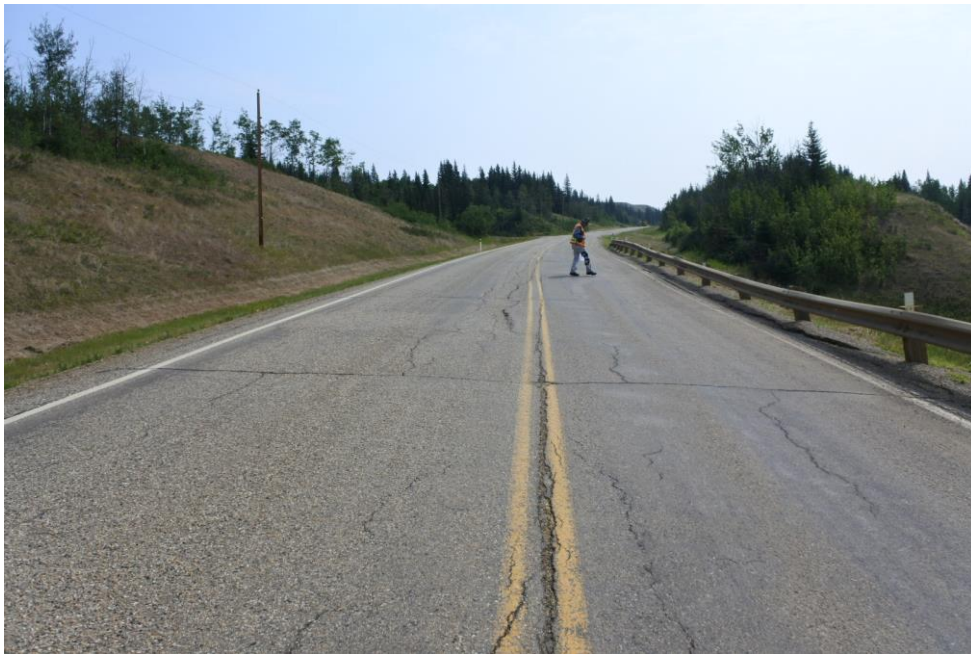
Maintenance:	Crack sealing.	Worsened?	
Observations:	Description	Yes	No
<input checked="" type="checkbox"/> Pavement Distress	<p>At PH077-1, a 40 m long (30 to 80mm wide) crack and a 15m long crack (near the east end) exist in the highway. A dip exists outside the longer crack extending across the highway. Appeared the same in 2021</p> <p>At PH077-2, cracks and a noticeable dip exist across a 40 m length of the highway overtop the SWSP culvert, with another dip existing further east. Same condition in 2021.</p>	<input type="checkbox"/>	<input checked="" type="checkbox"/>

Photo 4 - Looking east along the highway at the crack/dip in the highway above the Slide at PH077-1.

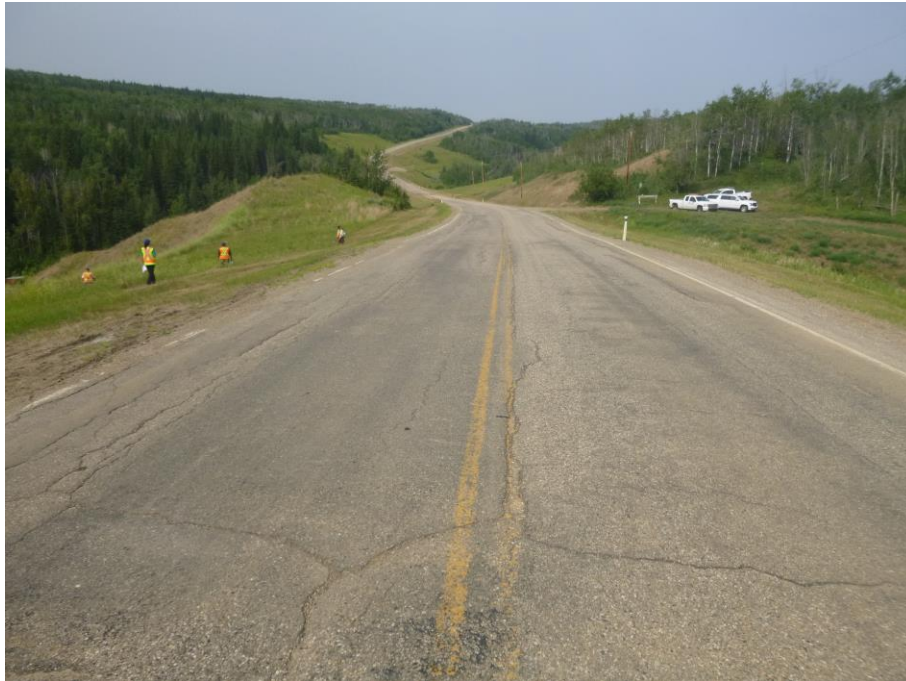
There is currently significant settlement observed overtop of the culvert at Site 2, in the form of dips and cracks in the highway. The subsidence and cracking could be the result of embankment fill settlement but might also be an indication that the slide movement will eventually retrogress towards the highway or has already.

Photo 5 - Looking east along the highway across PH077-2. Note the settlement and cracking in the highway.

Long Term: A potential long-term solution is a highway re-alignment to the north, done in conjunction with the re-alignment for Site 1, before meeting the existing bridge over Hines Creek. A re-alignment could allow some flattening of the south slope leading down to the creek. For this option, the top section of the culvert might need to be re-profiled to remain within the embankment fill and the inlet end of the pipe would need to be extended to allow a shift and flattening of the north embankment slope. The damaged pieces of the pipe will need to be repaired. Some shear piles might also be needed in the south slope.

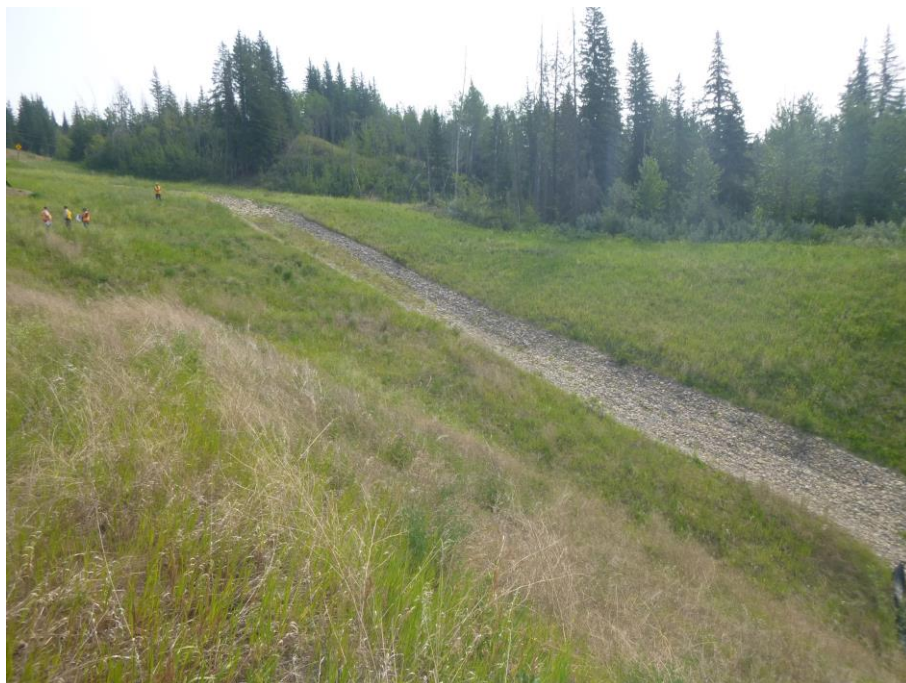
Photo 6 – Looking north along the TRM ditch channel of PH077-2.

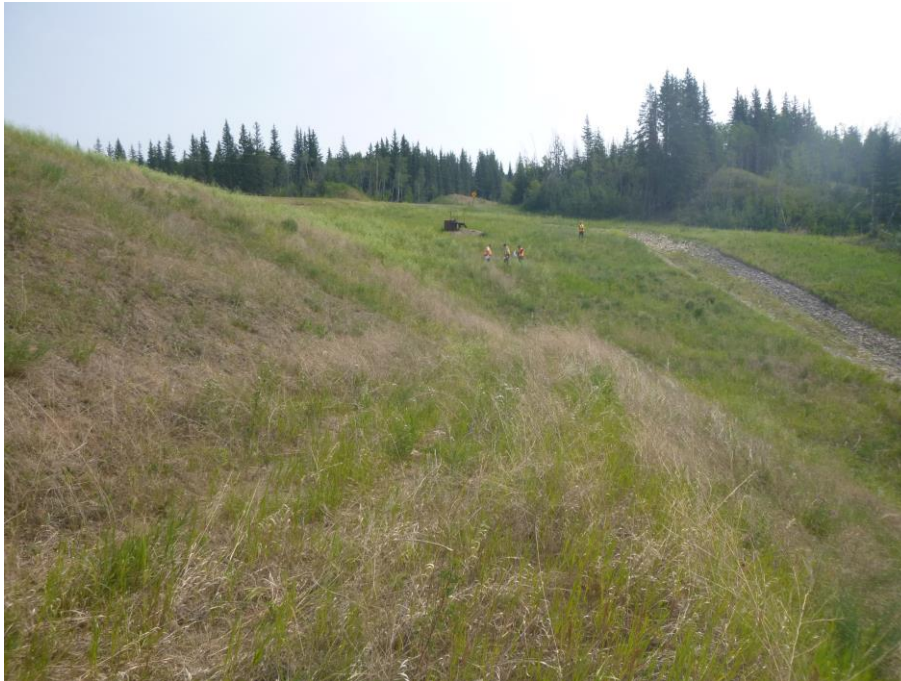
Photo 7 - Looking east along the south hwy embankment and southeast ditch drainage channel of PH077-2, Hines Creek.

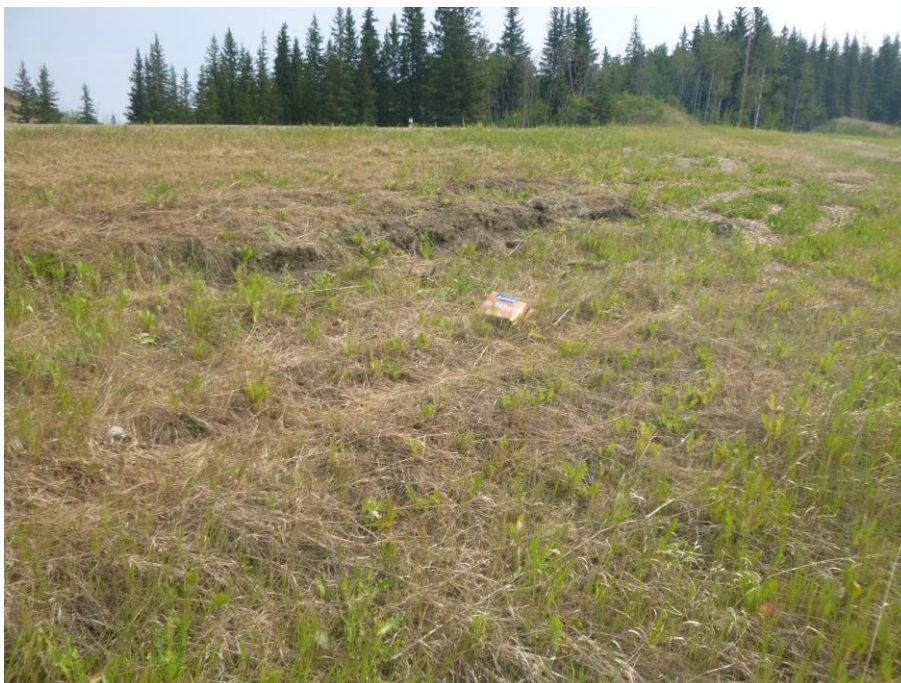
The cracks and subsidence in the south embankment slope are evidence that a landslide has formed in the slope at this location. This is supported by 2015 reports from AT that the culvert barrel had become distorted and separated, which indicate that the landslide is deep seated.

Photo 8 – Looking north towards the hwy from the south embankment of PH077-2, at the slide scarp in proximity to the highway.

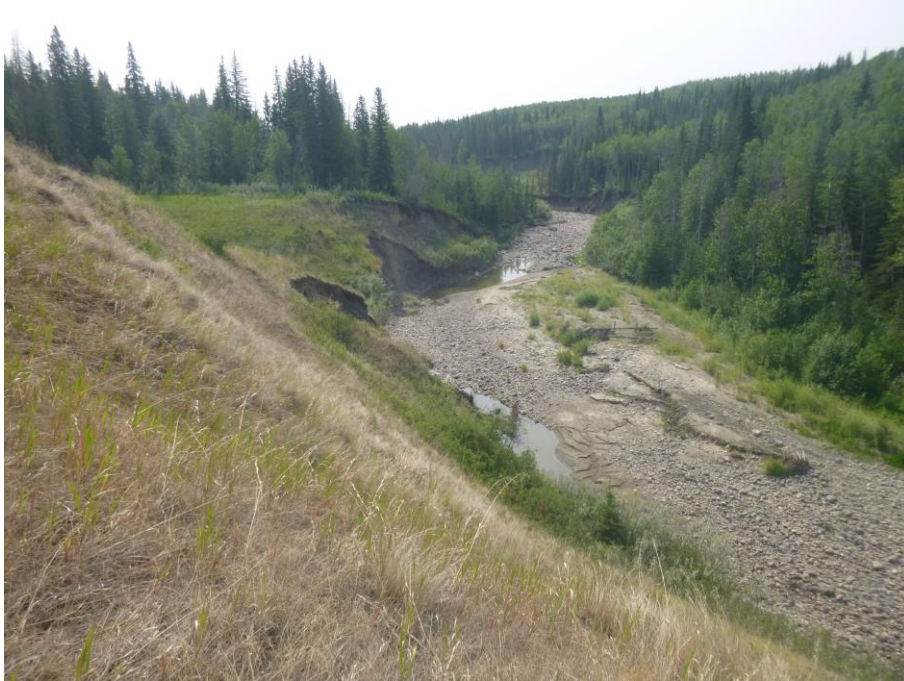
Photo 9 - Looking southeast at the culvert outlet area of PH077-2. Note the riverbank slumping east of the culvert outlet.

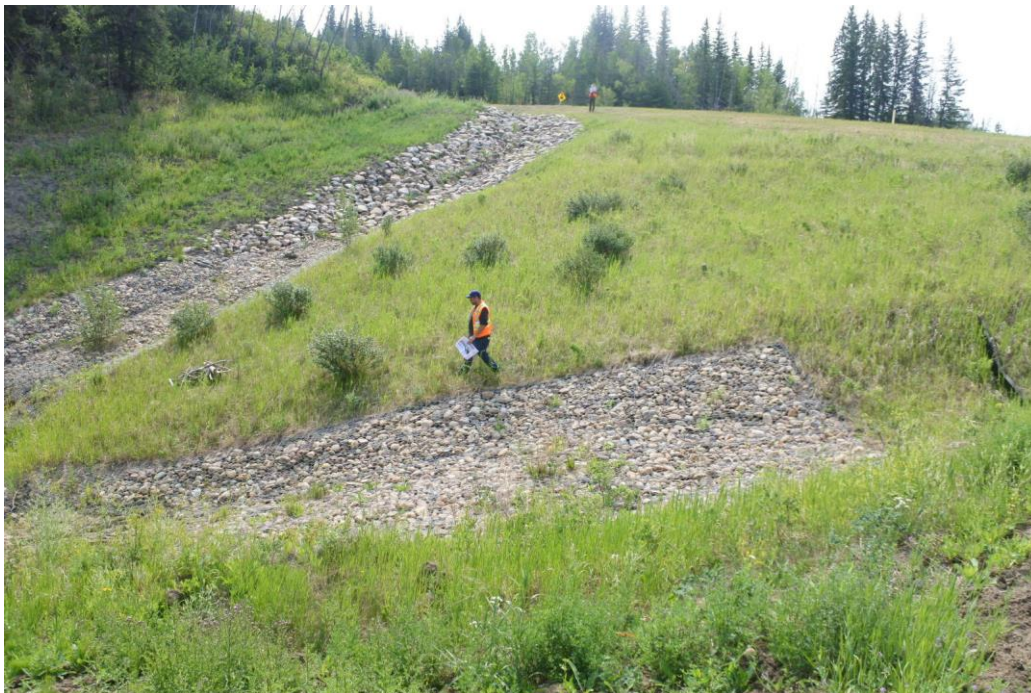
Photo 10 – Looking south at the erosion along the northeast ditch crotch leading to the culvert inlet area of the north embankment of PH077-2. The riprap protection has been extended further upslope on the east side since the 2020 inspection

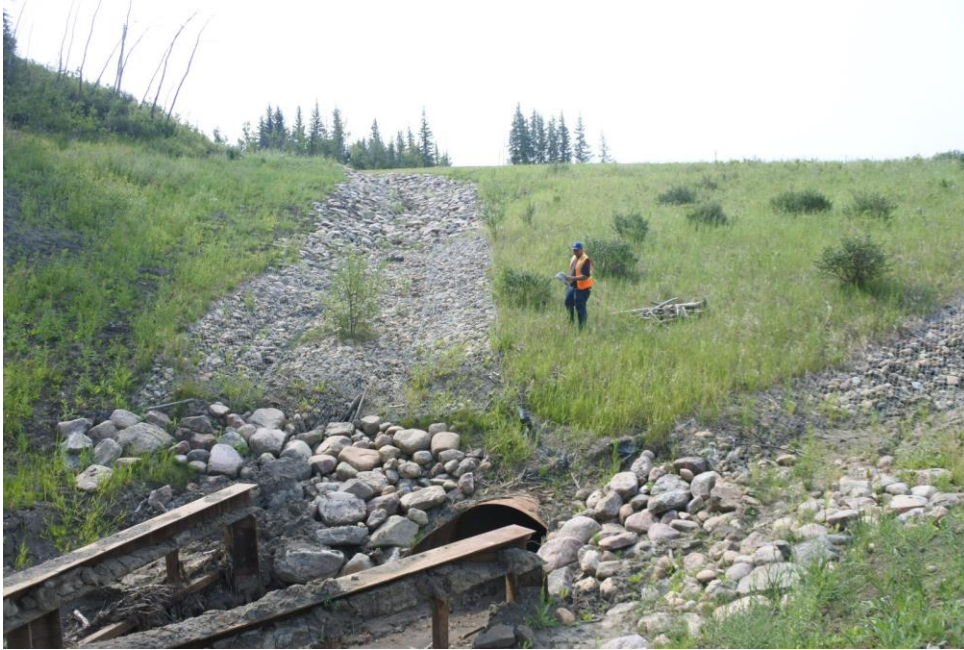
Photo 11 – Looking south at the culvert inlet area of the north embankment of PH077-2. The trash rack and culvert inlet were cleaned of debris since the 2020 inspection.

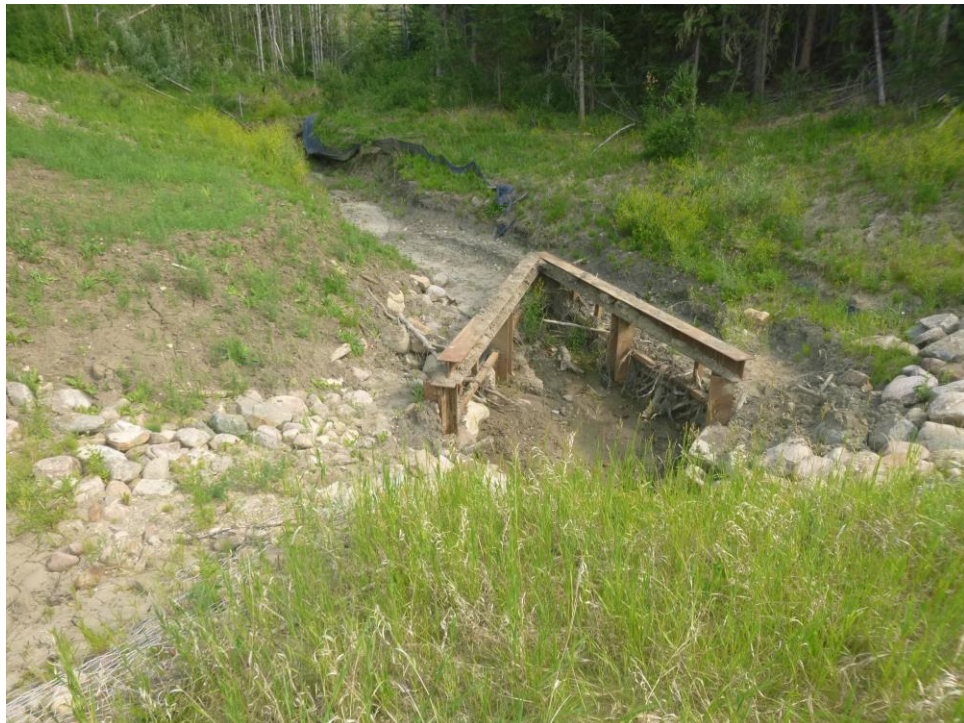
Photo 12 - Looking north along the infilled channel leading into the culvert inlet north of the highway at PH077-2.
