ALBERTA TRANSPORTATION AND ECONOMIC CORRIDORS GEOHAZARD ASSESSMENT PROGRAM PEACE REGION – GRANDE PRAIRIE DISTRICT - NORTH 2025 INSPECTION

Site Number	Location	Name	Hwy	km	
PH077-1 and 77-2	West of Fairview	Sites E of Hines Creek Bridge	682:02	12.5-12.8	
Legal Description		UTM Co-ordinates (NAD 83)			
NE35-81-5-W6		11V N 6215000	E 396650)

Client: Alberta Transportation and Economic Corridors File No.:32123

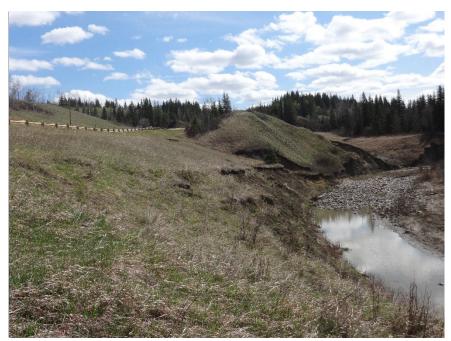
At PH077-1, the slide roughly paralleling the creek and highway is a direct result of erosion by Hines Creek and resulting soil loss along the toe of the embankment. The slope will tend to flatten with time due to loss of cohesion in the clay fill embankment material. Therefore, the slide could also gradually enlarge into the driving lanes of the highway surface, and there are already indications of this presumably starting to occur based on the cracks and dips in the highway. The smaller 15 m wide and larger 35 m wide slide near the east end of this site may have also been triggered by east ditch runoff erosion, and/or having a slope that is too steep for the composition material of the embankment. Ditch or surface erosion of the slope could also contribute to more rapid slope movements.

Photo 1. Looking east at Slide PH077-1 at the erosion along the north side of the Creek.

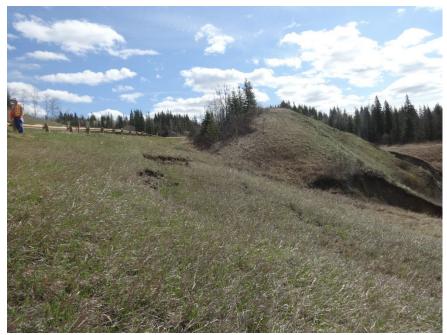
Photo 2. Looking east at the shallow slide in the south embankment slope at Site 1.

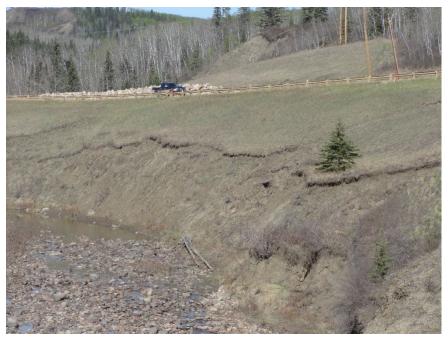
Photo 3. Looking west at the fresh toe slumping above the creek at PH077-1 in the south highway embankment.

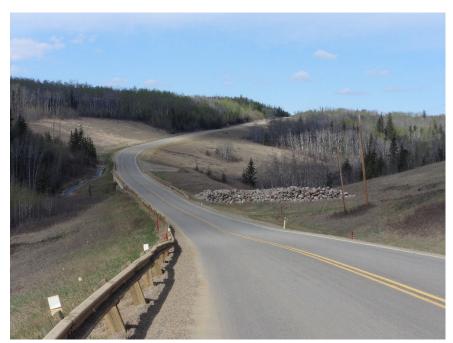
Observations:	Description	Worsened?	
Observations:	Description	Yes	No
☑ Pavement Distress	At PH077-1, a 40 m long crack and a 15m long crack (near the east end) had existed in the highway and are starting to show through the 2023 overlay. A noticeable dip exists across a 45 m length of the highway. At PH077-2, hairline cracks are starting to show through the 2023 overlay and a noticeable dip exists across a 40 m length of the highway overtop the SWSP culvert, with another dip existing further east.		
⊠ Slope Movement	At PH077-1: Towards the east a shallow 35 m wide south embankment slide developed and the backscarp is 6.2 m away from the guardrail with a 0.7 m high backscarp. Just east of this slide, there is an overgrown 15 m wide shallow side slope slide with a 0.4 m high scarp, 0.6 m high toe push that is 2.75 m away from the guardrail. The Creek has eroded the toe of the south embankment, and continued creek bank slumping is evident, with a 20 m wide area that slumped into the creek south of the 35 m wide slide, this appeared fairly similar in 2025. At PH077-2: A landslide has developed through the south embankment and has deformed the culvert. There is a 0.4 m high scarp located 4.9 m from the white shoulder line which appeared overgrown in 2025. North of the highway, a 1.5 m wide graben crack with a 0.25 m drop has developed above the erosion near the culvert inlet, and which has developed into a slide that previously retrogressed back towards the highway; this was unchanged in 2025. The riverbank is also locally slumping	\boxtimes

Photo 4. Looking west along the highway at where the cracks in the highway were (before overlay) above the Slide at PH077-1 The dip is still evident.

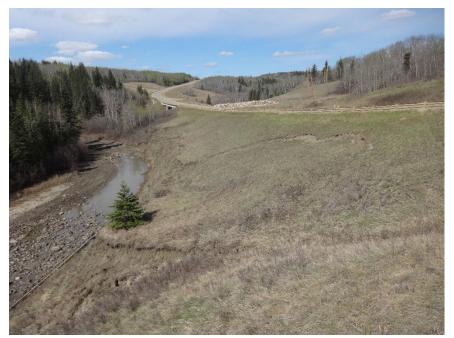
Photo 5. Looking west at newer slump that developed west of the knob hill.

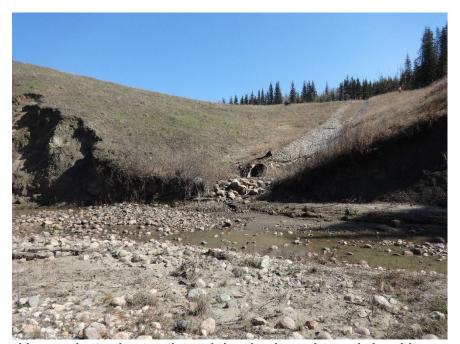
Photo 6. Looking north at culvert outlet and river bank erosion and sloughing on either side.

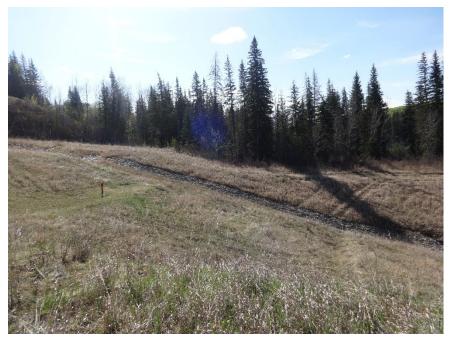
Photo 7. Looking east at riprap swale into the gabion mattress channel of PH077-2.

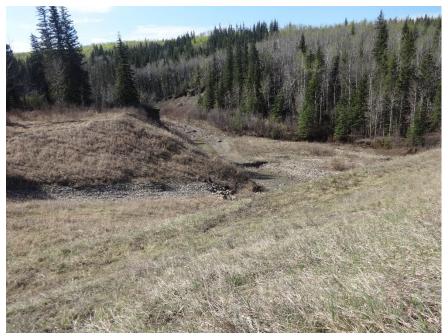
Photo 8. Looking southeast at the southeast ditch drainage channel of PH077-2, Hines Creek.

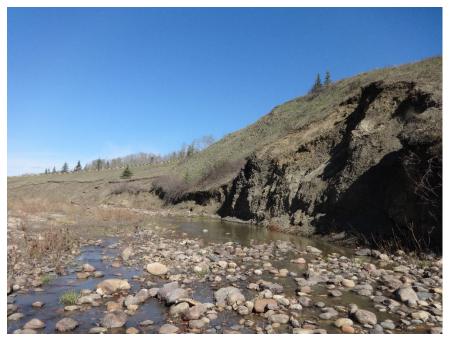
⊠ Erosion	upstream and downstream of the culvert outlet At PH077-1, active erosion caused by the creek is occurring at the toe of the slope along the creek's edge. At PH077-2, some of the riprap at the base of the south east riprap lined ditch was washed away by the creek.		
⊠ Seepage	At PH077-1 the soil within the tension crack within the 35 m wide slide was moist to wet.	\boxtimes	
□ Bridge/Culvert Distress	The upstream end of the 1.8 m diameter SWSP (BF75380) at PH077-2 was about 0.5 m buried with silt and debris at the drift catcher and the outlet did not appear to be visibly damaged at the time of our inspection but was somewhat buried in silt although the baffles were visible and had some ice inside. The 2025 bridge inspection noted that the vertical elbow was detaching from the pipe at 93 m from inlet and that below this there was no access due to silt. Baffles were tearing and there were distortions and cracks/separations within the culvert, which had a low rating advisory due to roof sag and sidewall deflections. The report also noted that drift and silt should be removed from pipe and drift catcher.

Photo 9. Looking west at river erosion adjacent to the culvert outlet area of PH077-2.

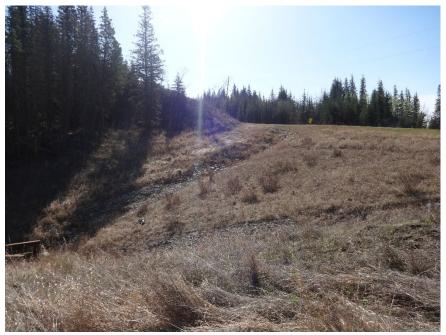
Photo 10. Looking southeast at the v-shaped ditches on the north side of the highway.

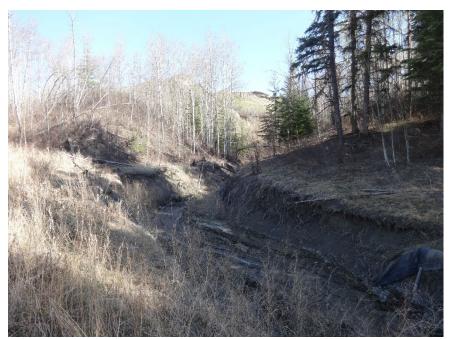
Similarly, cracks in the north embankment slope which previously retrogressed to near the highway also suggest a landslide has developed. This is also supported by a documented crack in the culvert. This landslide was likely triggered by loss of toe support due to erosion caused by the tributary creek. Highway ditch runoff erosion (at the TRM/gabion intersections) may have also been contributing factors.

Photo 11. Looking north at eroded tributary creek channel leading into the culvert inlet north of the highway at PH077-2.

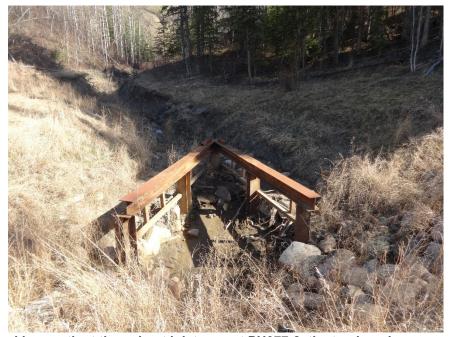
Photo 12. Looking north at the culvert inlet area at PH077-2, the trash rack appeared half full of debris.

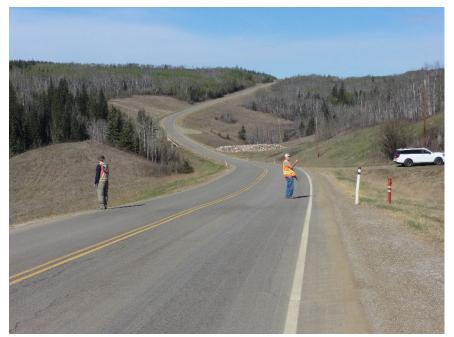
Settlement observed overtop of the culvert at Site 2, in the form of dips and cracks in the highway could be the result of embankment fill settlement but might also be an indication that the slide movement will eventually retrogress towards the highway or has already.

Photo 13. Looking west at the dip in the highway.

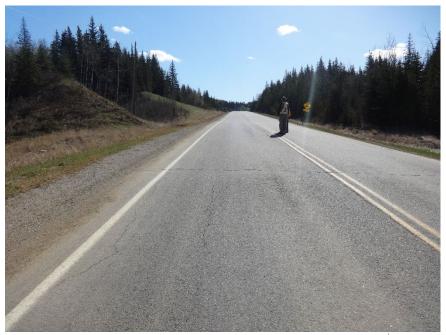
Photo 14. Looking east at the dip in the highway.
