**ALBERTA TRANSPORTATION  
GEOHAZARD ASSESSMENT PROGRAM  
PEACE REGION (GRANDE PRAIRIE DISTRICT - NORTH)  
2021 INSPECTION**

Site Number	Location	Name	Hwy	km
PH010	Eureka River South Hill	Sites 1, 2 and 4	726:02	9.8
Legal Description		UTM Co-ordinates (NAD 83)		
NW12/SW13-86-8-W6		11 N 6258319	E 368453

**2021 PH010-1 INSPECTION PLAN**

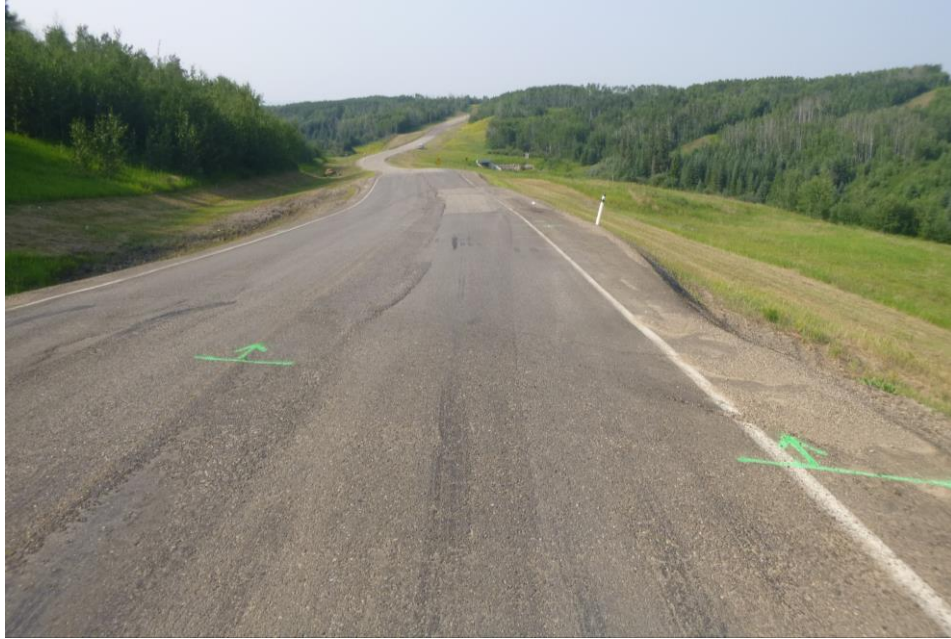
Photo 1 – Looking north from the south end of Slide Site 2 at the fresh milled/patched pavement. Note the more well-defined reflective south scarp crack extending into the east highway embankment.

Continue to patch and mill the highway at Sites 2 and 4 as required.

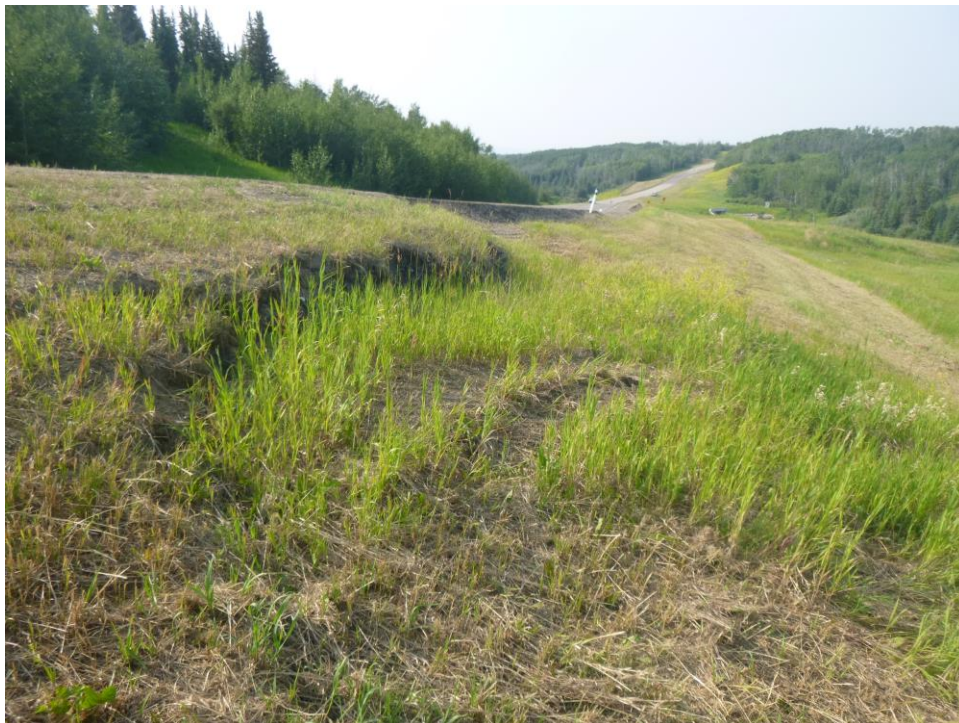
Photo 2 – Looking north across the south end of slide Site 2 and slide scarp extension along the east highway embankment.

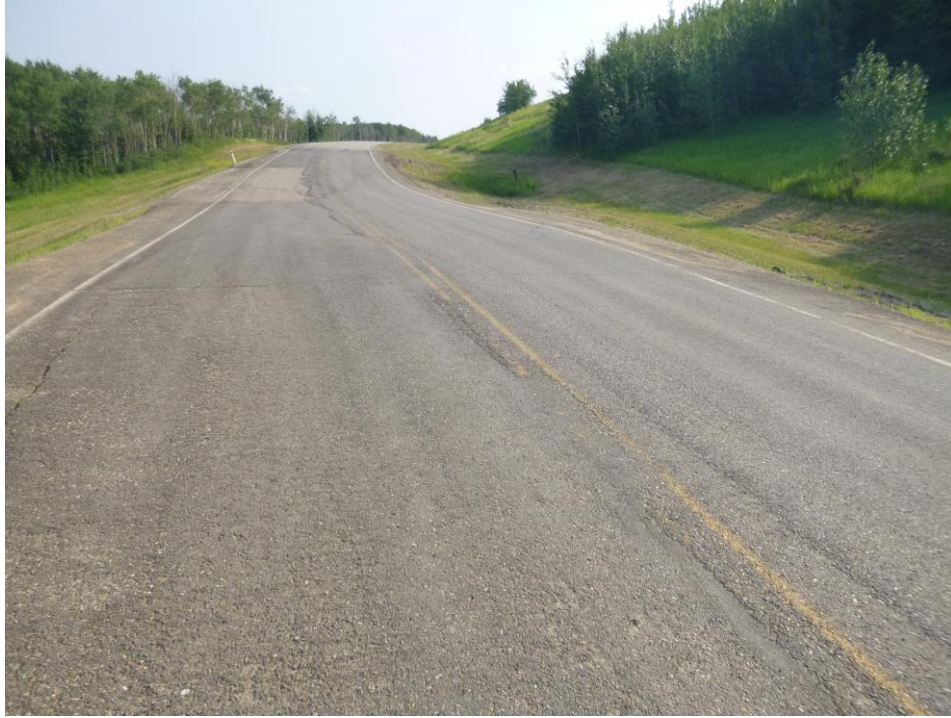
Photo 3 – Looking south at the slide scarp crossing the highway at Site 2. Note the dip in the highway, and the settled west ditch which was dry this year.

Periodically improve the drainage to eliminate intermittent water ponding in the west ditch at Site 2 by adding a small amount of fill as required. Also, re-grade the slope below Site 2 to seal the cracks and provide a smoother, more uniform slope from the broken, uneven, and crack infested slope that currently exists.

The dip in the highway at the Site 2 slide could be smoothed out by removing ACP which would reduce some driving weight, installing lightweight fill, and installing a new pavement structure. It will still likely creep, but patching could be performed more easily afterwards. A basic geotechnical investigation was performed in 2019 as part of Paving Contract #20531 to assess the asphalt thickness through the middle of this dip, and it was found that:

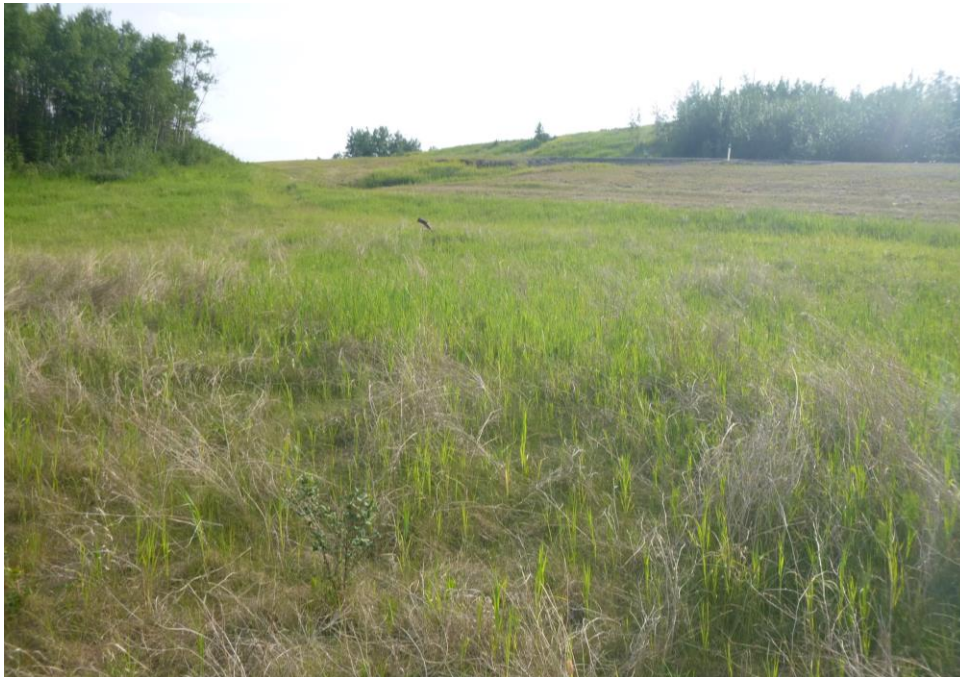
Photo 4 – Looking southwest towards the highway at the main body of the slide scarp at Site 2.

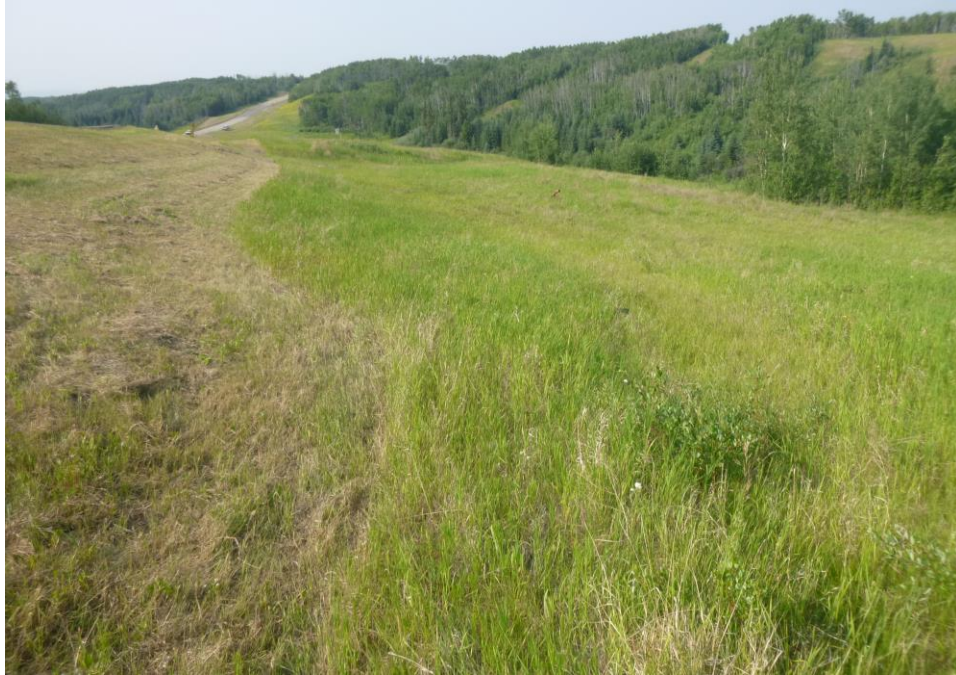
Photo 5 – Looking north along the east highway embankment from the south end of Slide Site 2.

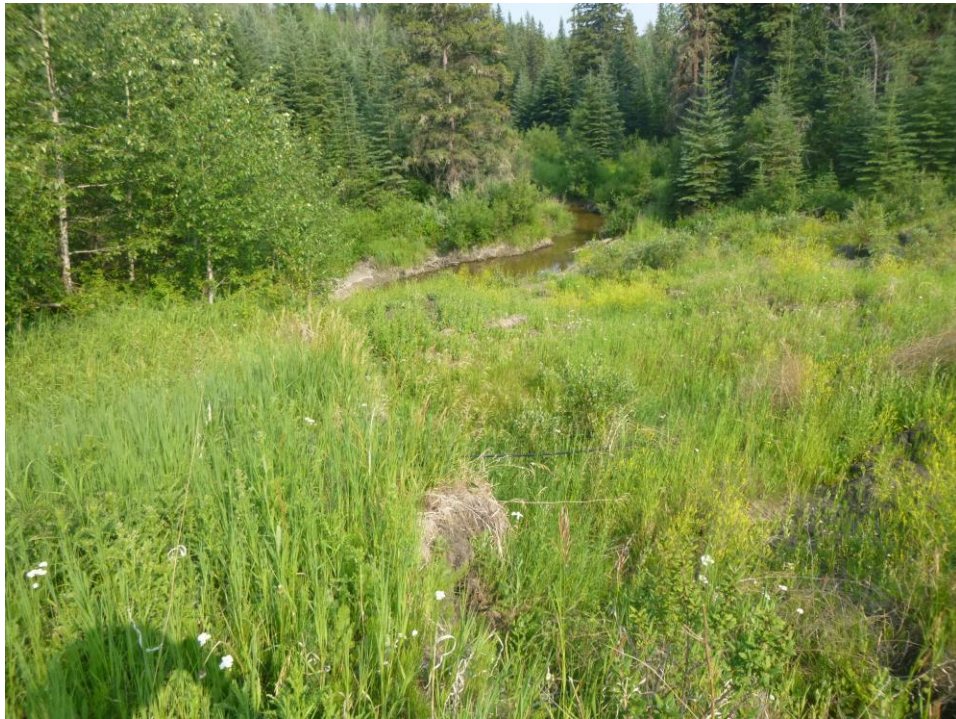
Photo 6 – Looking southeast at the outside bend of the river, which is causing the most active slumping area at Site 2.

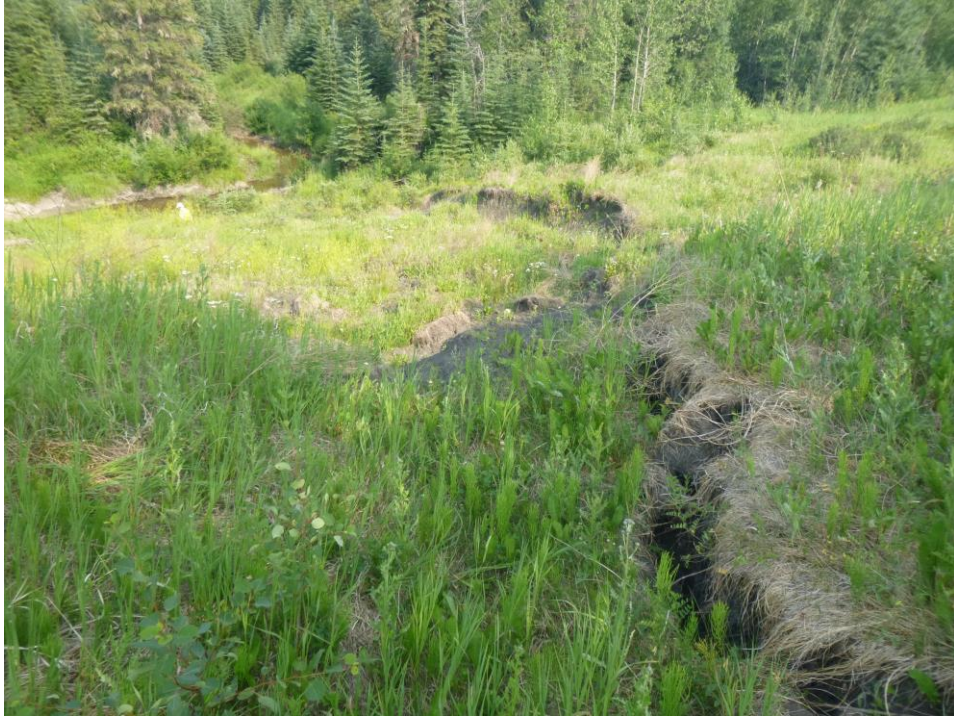
Photo 7 - Looking southeast across the most active portion of the slide block at Site 2 adjacent to the river, and the adjoining scarp extension northwards.

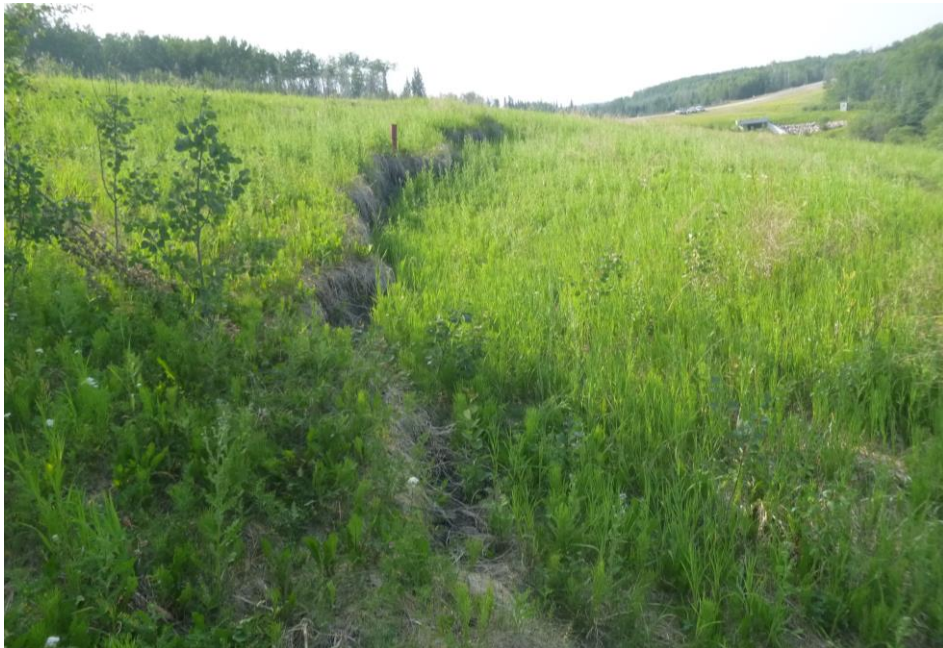
Photo 8 – Looking northwest along the fresh extended slide scarp/crack of Site 2, from just north of the most active portion of the slide.

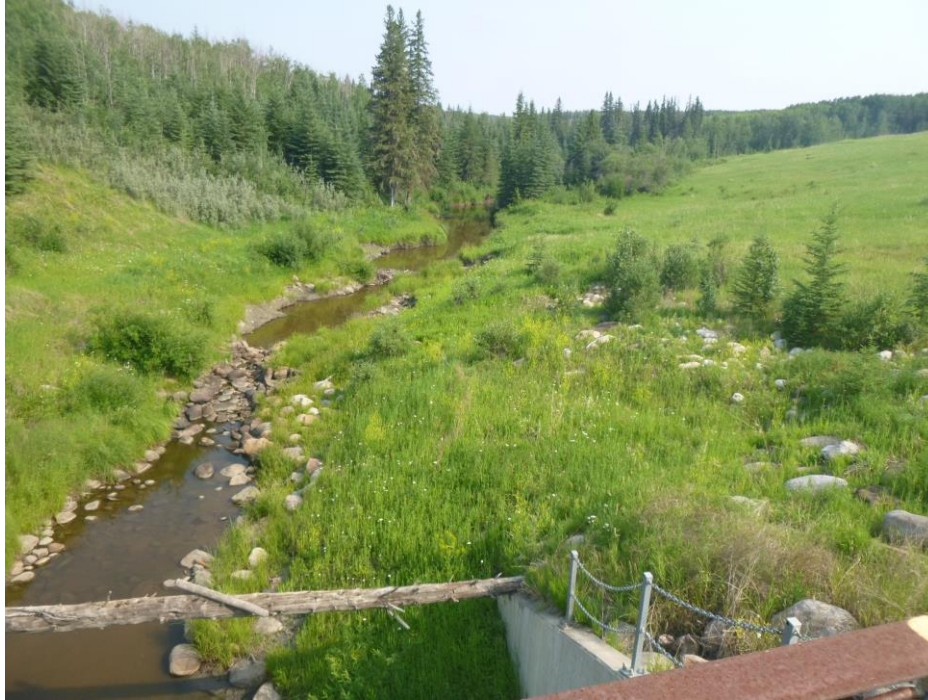
Photo 9 - Looking south along the River at the toe of Slide Site 1. Note in the background the piping erosion from the eroded gravel drain that has developed into a slump at the river toe.

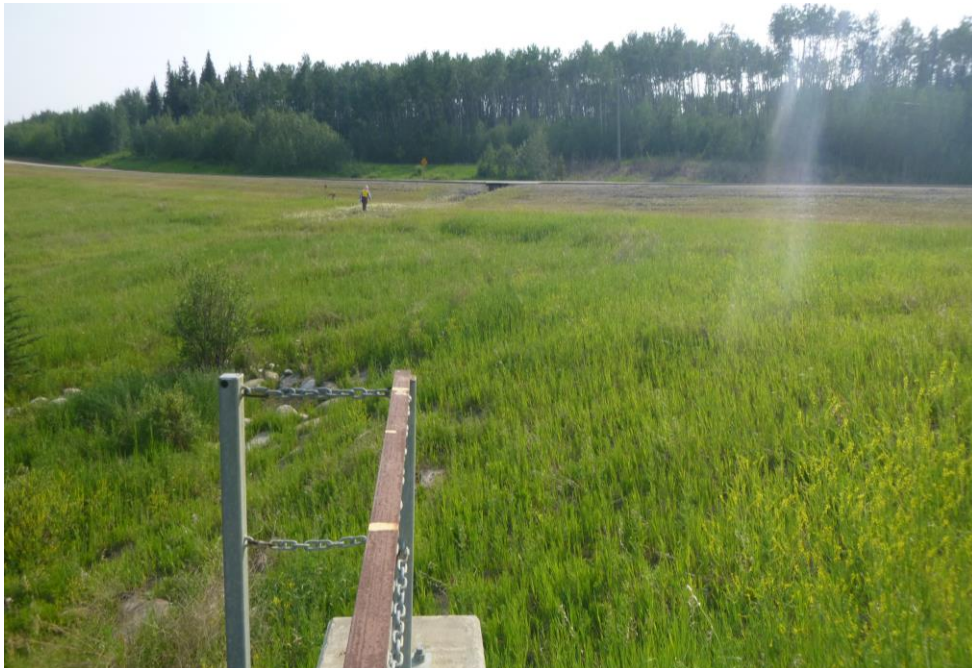
Site 1 was observed to be unchanged from last year. The scarp located 16 m from the highway was measured to have about a 0.7 m height this year, same as last year. Also, the 4 m long settled/separated SB lane pavement area observed directly above the embankment scarp was unchanged.

Photo 10 - Looking southwest across Slide Site 1 from northeast of the river (Site 4 is on the left-hand side). Note the grassed over slide scarp parallel to the highway.

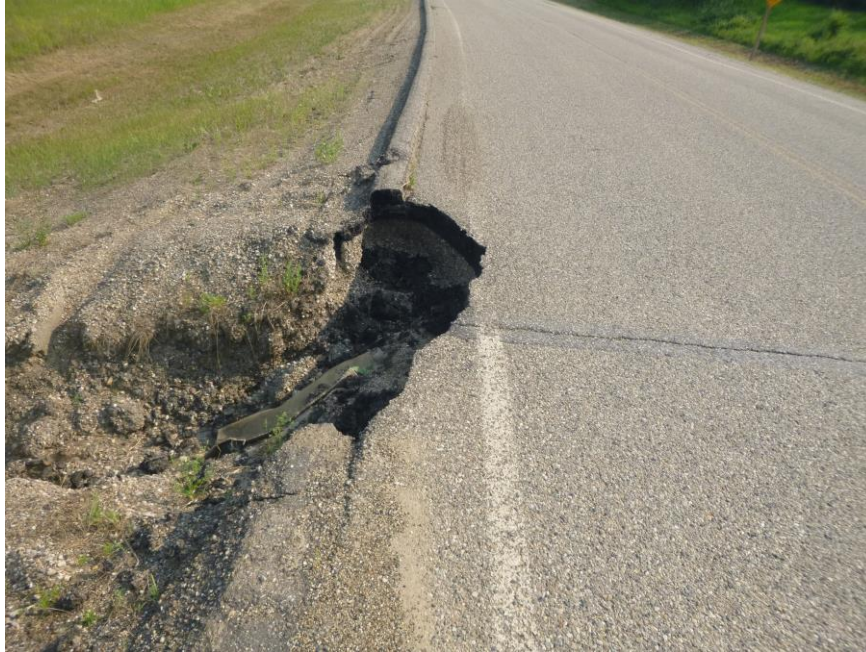
Photo 11 – Looking south along the east edge of the highway near the north end of Slide Site 1 where the AC curb has been breached, and runoff is causing erosion on the highway embankment and the edge of the pavement (it has extended to the white line this year).

Repair the AC curb that was breached along the east edge of the highway above Slide Site 1 to prevent channelized surface runoff. Repair the erosion rilling that formed below the breach on the highway embankment sideslope, and which now fully extends across the paved northbound shoulder, using compacted crushed gravel (and new ACP on the shoulder).

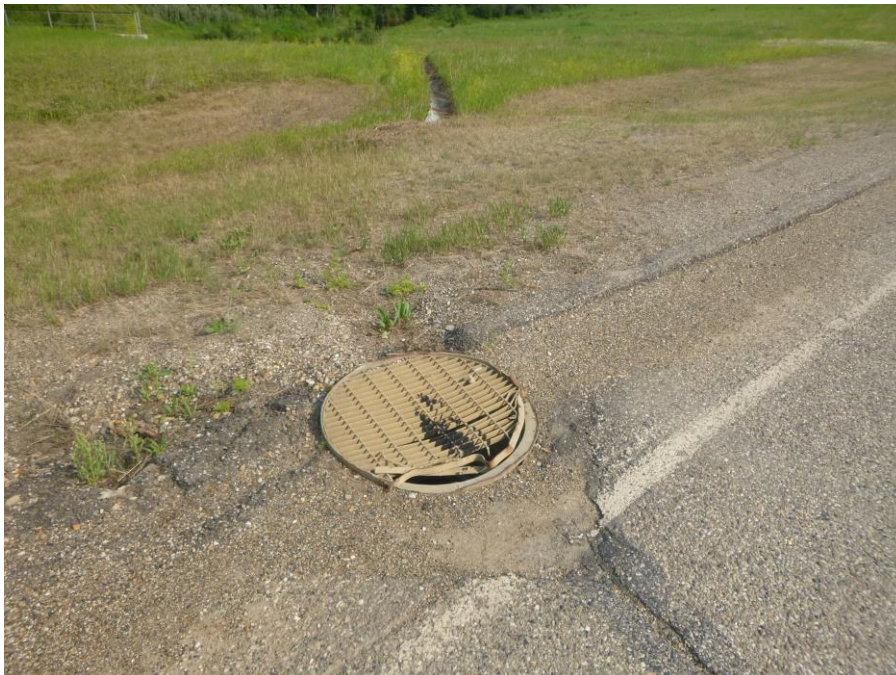
Photo 12 – Looking southeast at the damaged lid of the 800 mm diameter down drain along the east edge of the hwy that leads to the half culvert at Site 1.

Replace the damaged lid to the 800 mm drop manhole in the edge of the pavement (that leads to the half culvert).

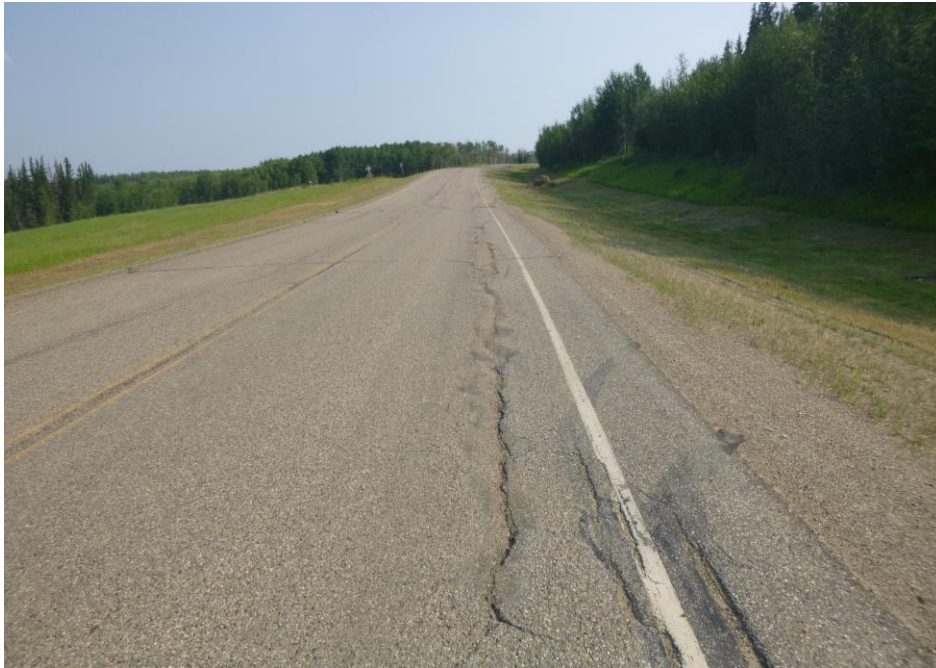
Photo 13 – Looking south towards Site 4 at the cracking/distortion along the highway directly above the Site 1 slide.

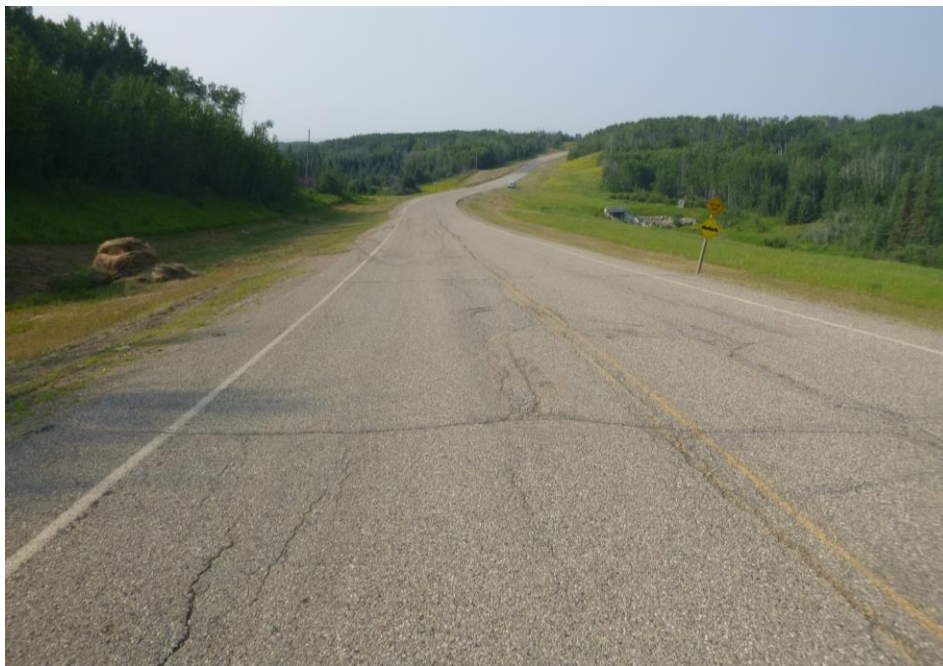
Photo 14 – Looking north along the highway at the pavement separation area across Site 4 and towards Site 1.
