September 21, 2021

**ALBERTA TRANSPORTATION GRMP (CON0022165)
PEACE REGION (GRANDE PRAIRIE DISTRICT – NORTH)
INSTRUMENTATION MONITORING RESULTS – SPRING 2021**

SITE PH010: HWY 726:02, EUREKA RIVER

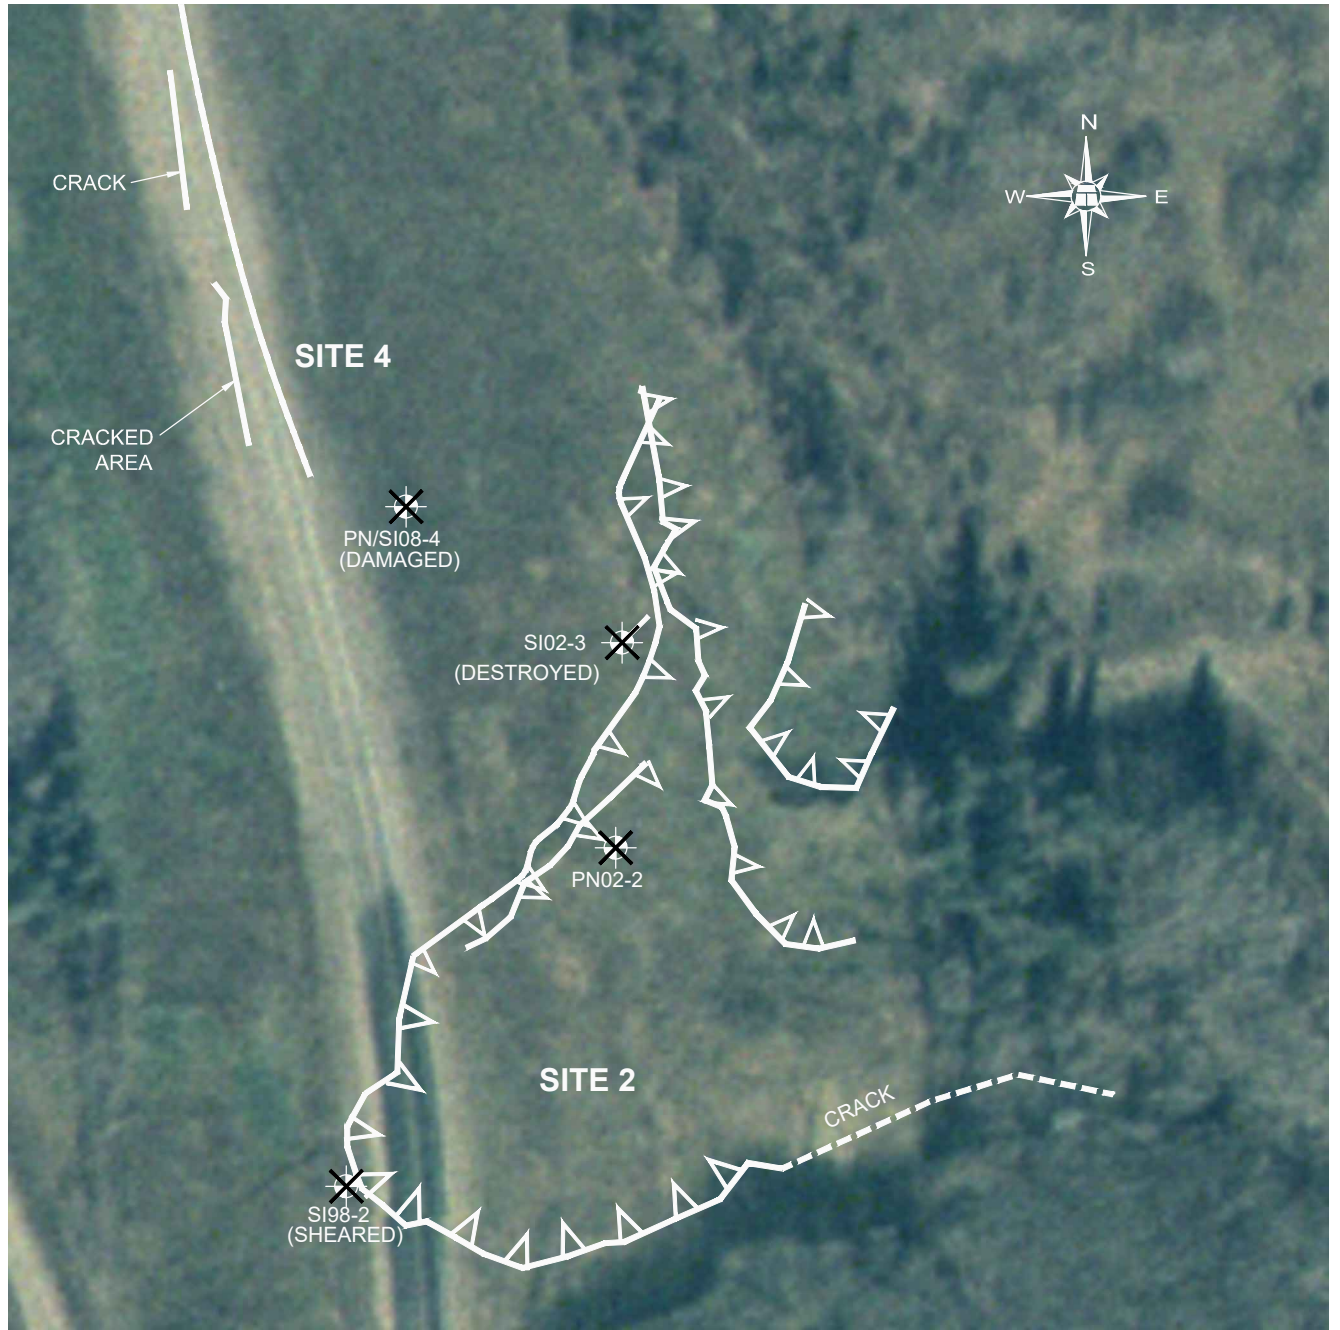
* Bent at ground level. Damaged by lawnmower. Stick up protector is sunk down 4 ft into the ground. If repair required, backhoe will be needed.
Hit by lawn mower again. PN airline pinched inside casing. No reading, see photograph

SI08-4 and PN08-4 should be repaired so that readings can resume. SI08-4 is damaged below the ground surface; thus, mechanical excavation will be required to repair it.

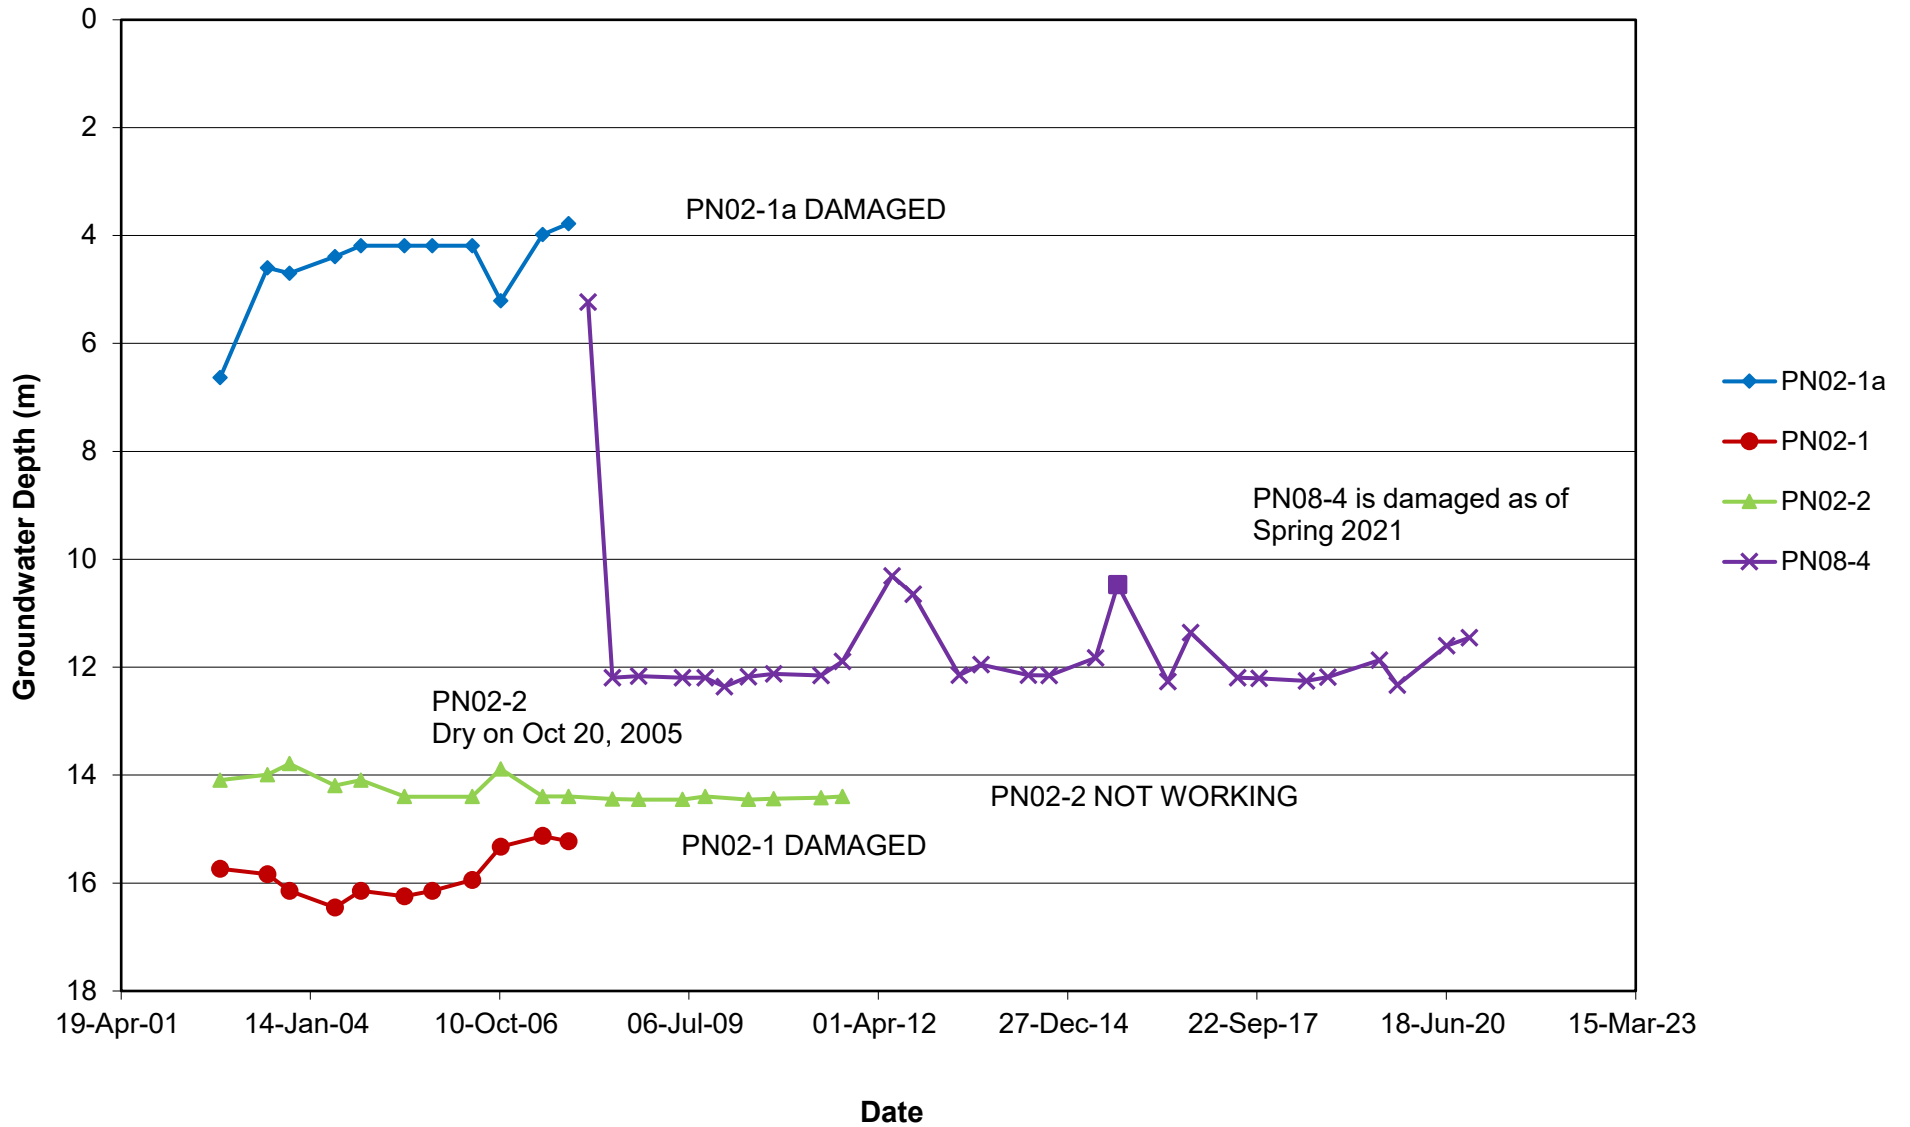
**FIGURE PH010-1
PIEZOMETER DATA FOR HWY 726:02, EUREKA RIVER**

PN02-2 had previously shown a groundwater level of 11.45 m below ground level when it was last read in the fall of 2020.
