**ALBERTA TRANSPORTATION
GEOHAZARD ASSESSMENT PROGRAM
PEACE REGION (GRANDE PRAIRIE DISTRICT - NORTH)
2022 INSPECTION**

| Site Number | Location | Name | Hwy | km |
|---|---|---|---|---|
| PH010 | Eureka River South Hill | Sites 1, 2 and 4 | 726:02 | 9.8 |

2022 PH010 INSPECTION PLAN

2022 PH010-1 INSPECTION PLAN

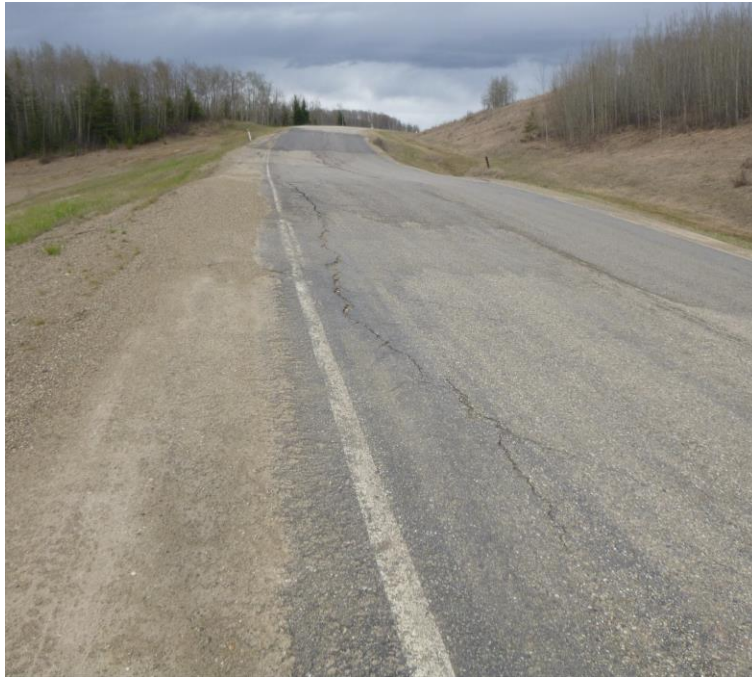
Photo 1 – Looking south at the slide scarp crossing the highway at Site 2. Note the dip in the highway, and the extended slide crack reflecting through the patch along edge of the NB driving lane.

A geotechnical investigation and preliminary design were completed by Thurber at the Site 2 slide (dated Nov 21, 2019) as part of Paving Contract #20531 to assess the asphalt thickness through the middle of this dip. AT selected the following repair option, for which a detailed design and tender input were performed by Thurber for McIntosh Perry as part of Contract 21542 (slated for construction in 2023):

- Excavate the highway to a 3.5 m depth across the dip to remove a 2m thickness of exist ACP and some underlying subgrade. Replace these excavated materials with 2m of Lightweight Fill + 1m Clay + 0.5m new pavement structure. This would smoothen out the slide area and reduce some driving weight by removal of the existing ACP. The drainage will also be improved to eliminate intermittent water ponding in the west ditch by the addition of a small amount of fill as required during final grading.

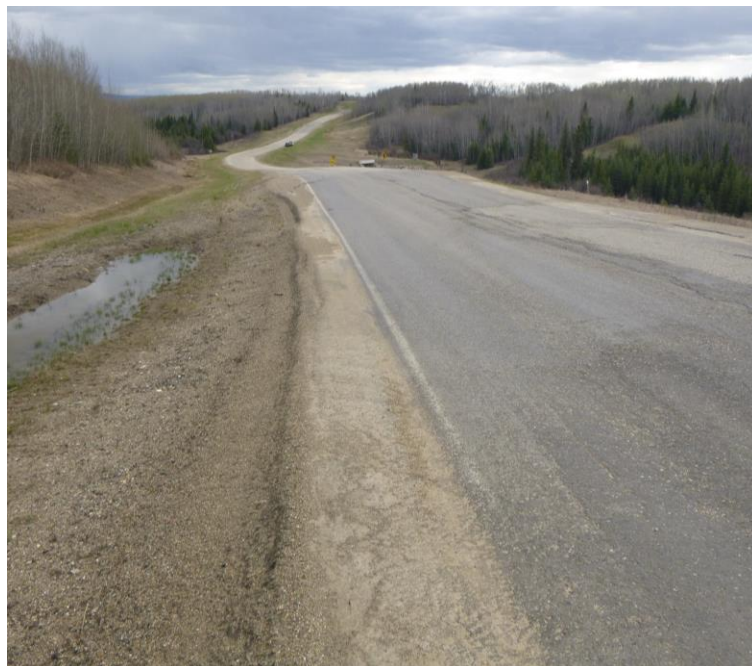
Photo 2 – Looking north from the Slide Site 2 at the fresh milled/patched pavement. Note the fresh, well-defined reflective north end scarp crack extending across the SB driving lane/shoulder.

Continue to patch and mill the highway at Sites 2 and 4 as required.

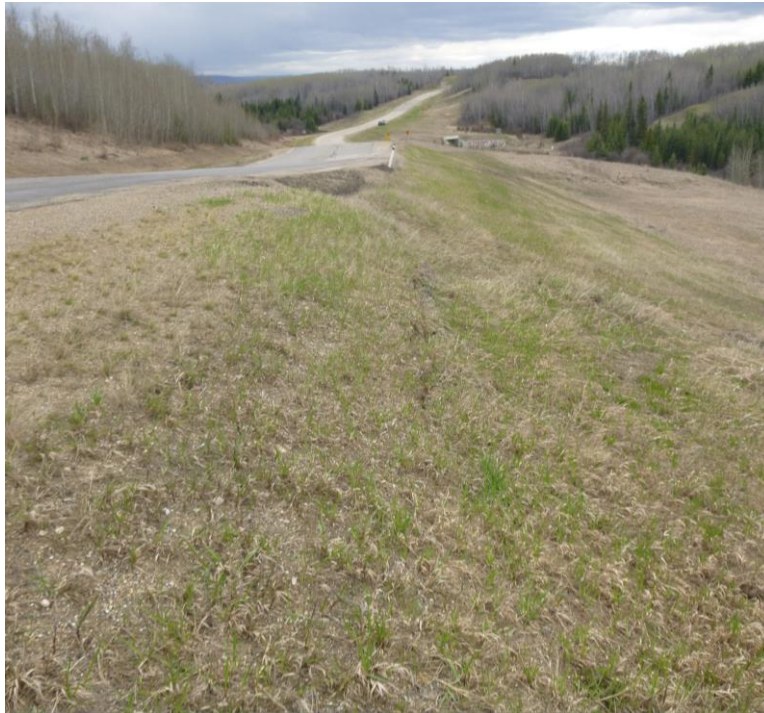
Photo 3 – Looking north across the south end of slide Site 2 and the slide scarp extension along the east highway embankment.

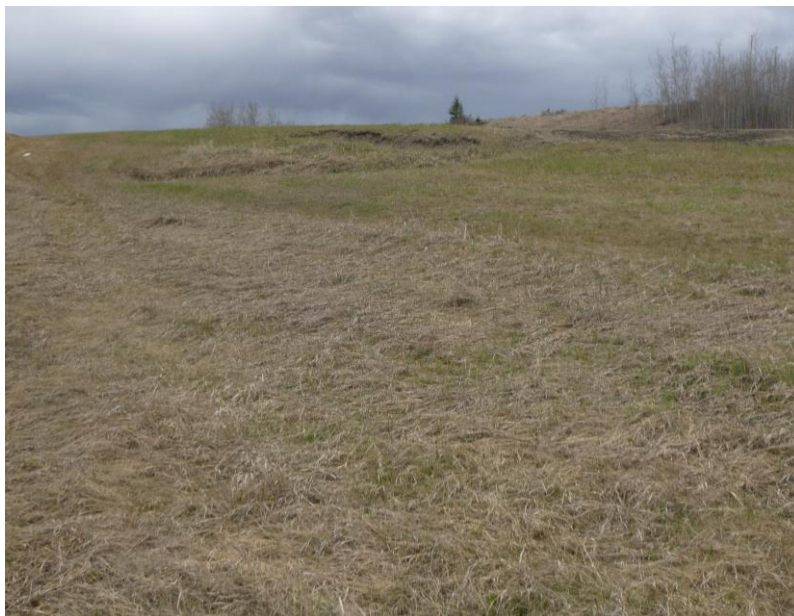
Photo 4 – Looking southwest towards the highway at the main body of the slide scarp at Site 2 where it crosses the hwy.

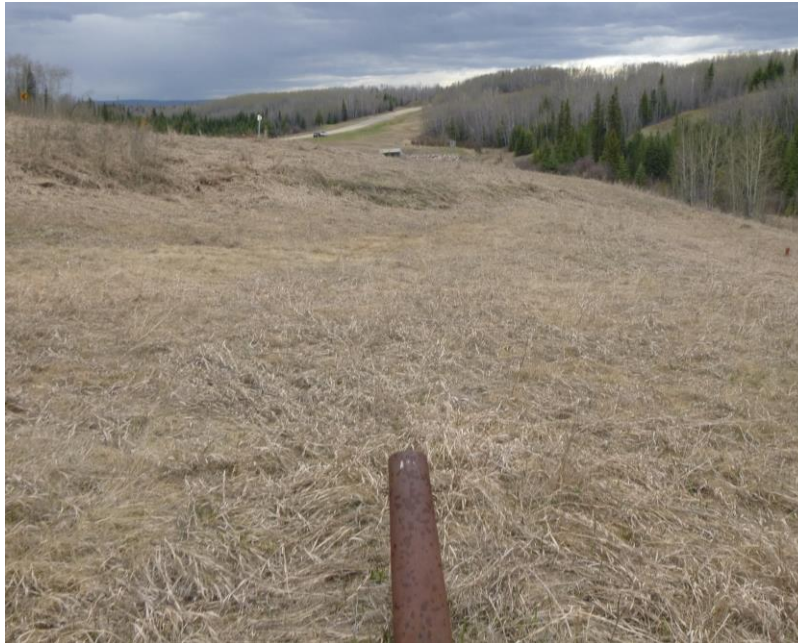
Photo 5 – Looking north along the east highway embankment from the south end of Slide Site 2.

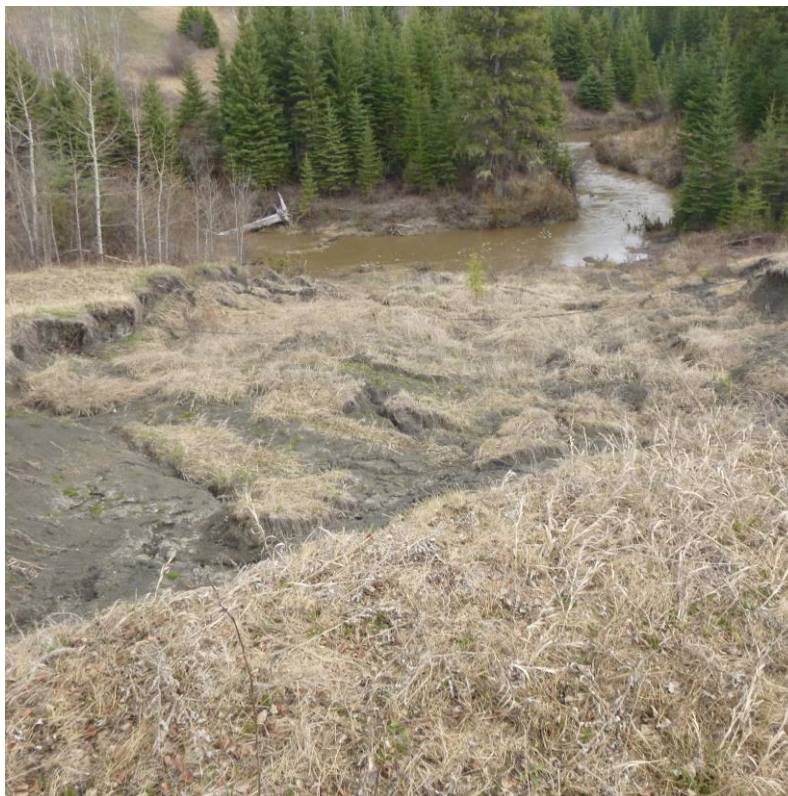
The landslides at the PH010 site were triggered by river erosion along the base of a river valley slope that has been subject to historic landslide movement. The slide movements are occurring in high plastic clay deposits. The landslide at Site 2 is more extensive and mobile than at Site 1, extending all the way up to and through the highway embankment. To date the movements at Site 2 have been dealt with by milling the pavement at the flanks of the slide and adding asphalt patches and small earth fills to smooth out dips in the road surface and the adjacent ditch. However, the additional weight of these fills and the ongoing river erosion at the toe of the slope keeps the landslide in motion. The movement at Site 1 has been slower and so far, the landslide has not retrogressed into the highway at that location.

Photo 6 – Looking southeast at the outside bend of the river, which is causing the most active slumping area at Site 2.

Periodically re-grade the slope below Site 2 to seal the cracks and provide a smoother, more uniform slope from the broken, uneven, and crack infested slope that currently exists.

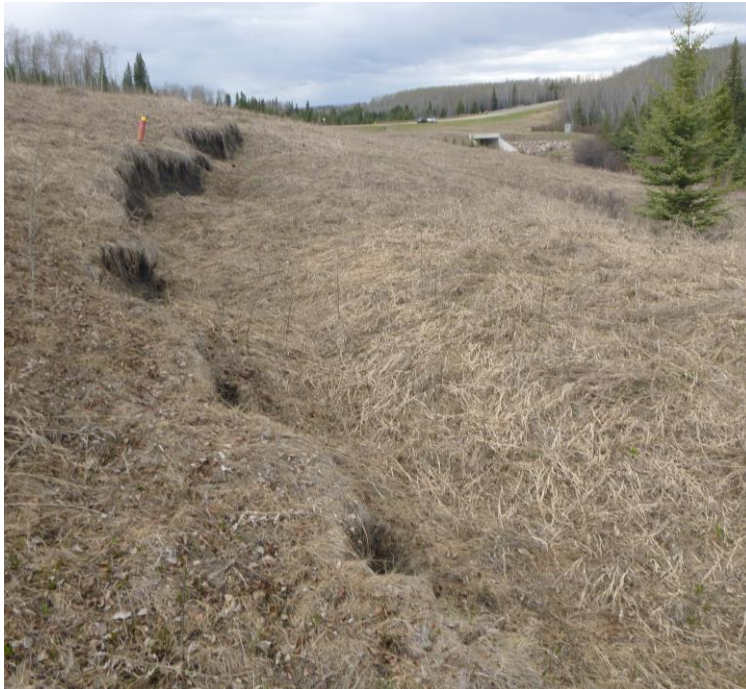
Photo 7 – Looking northwest along the fresh extended slide scarp/crack of Site 2, from just north of the most active portion of the slide.

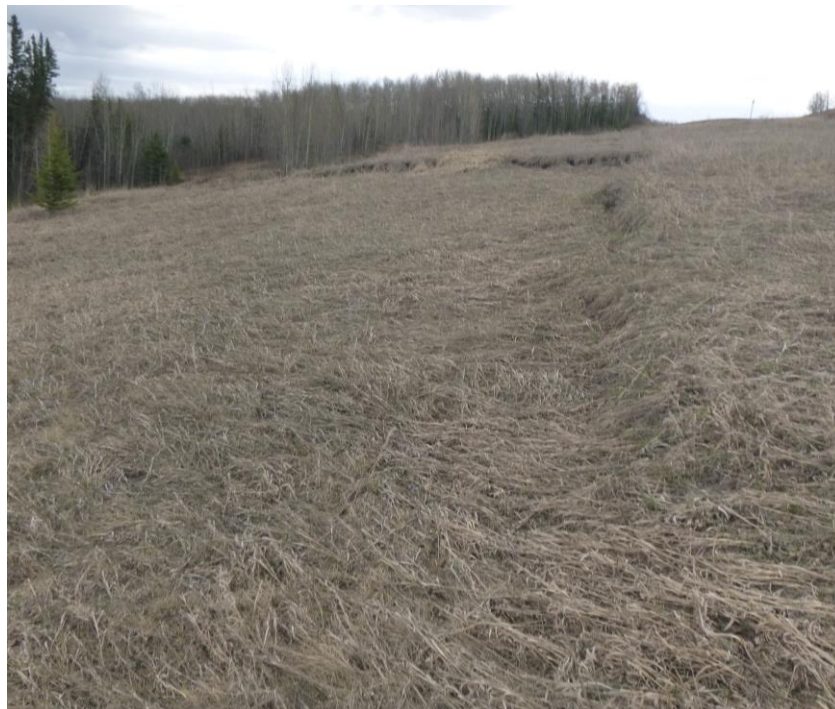
Inclinometer SI08-4 located between Sites 1 and 2 at Site 4 (damaged prior to 2020 readings) was indicating ongoing movements (latest ~8 mm/yr) at 7 to 9 m depth. Patching of the dip and cracks on the pavement in 2015, a more defined slide crack about 50 m long with a dip on the east side of it was observed in 2016, and visual observations indicating general crack widening, distortion, and on-going sealing in the last few years, suggests a larger slide is developing and moving towards the river. Based on the SI08-4 rate plot, the average rates of movement before and after the fall of 2016, were about 3 mm/year and 6 mm/year respectively, which suggests a slowly accelerating rate of movement from 2016 to 2020.

Photo 8 – Looking south along the north end of the slide scarp between Sites 2 and 4.

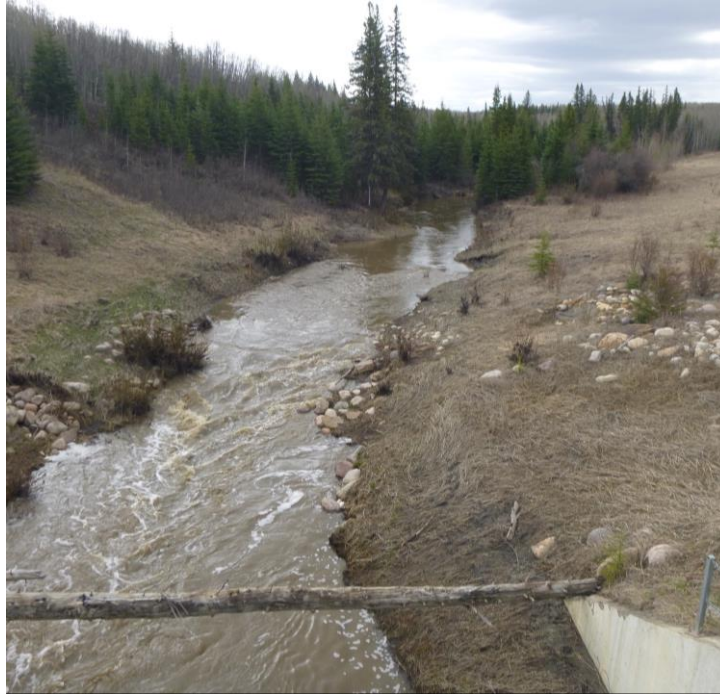
Photo 9 - Looking south along the River at the toe of Slide Site 1. Note in the background the piping erosion from the eroded gravel drain that has developed into a slump at the river toe.

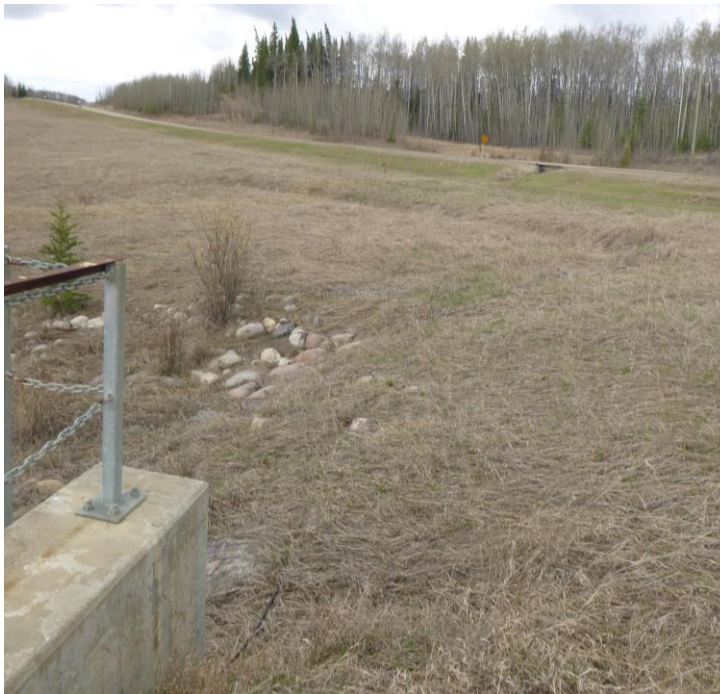
Photo 10 - Looking southwest across the Site 1 Slide from northeast of the river (Site 4 is on the left-hand side). Note the grassed over slide scarp parallel to the highway.

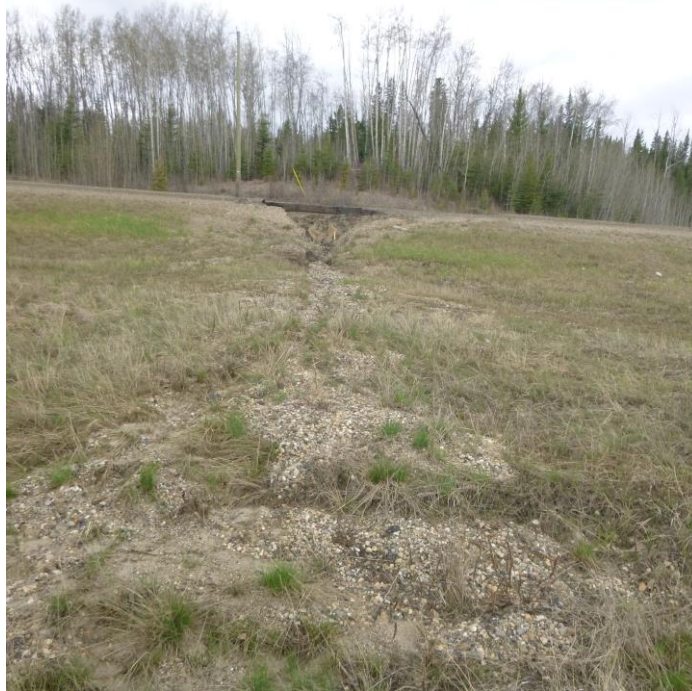
Photo 11 – Looking west towards the highway near the north end of Slide Site 1 where the AC curb has been breached, and runoff is causing erosion on the highway embankment and the edge of the pavement.

Repair the AC curb that was breached along the east edge of the highway above Slide Site 1 to prevent channelized surface runoff. Repair the erosion rilling that formed below the breach on the highway embankment sideslope, and which now fully extends across the paved northbound shoulder, using compacted crushed gravel (and new ACP on the shoulder).

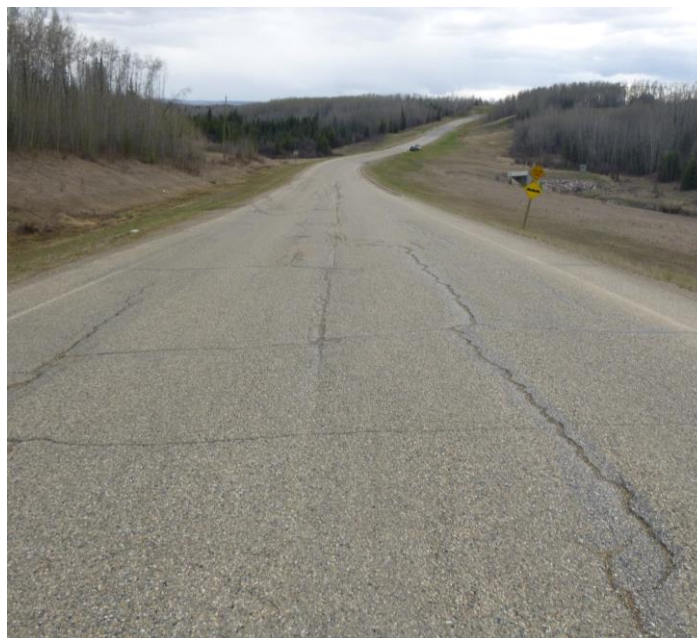
Photo 12 – Looking north from Site 4 at the cracking/distortion along the highway towards the Site 1 slide.
