**ALBERTA TRANSPORTATION AND
ECONOMIC CORRIDORS
GEOHAZARD ASSESSMENT PROGRAM
PEACE REGION (GRANDE PRAIRIE DISTRICT - NORTH)
2025 INSPECTION**

Site Number	Location	Name	Hwy	km
PH010	Eureka River South Hill	Sites 1, 2 and 4	726:02	9.8
Legal Description		UTM Co-ordinates (NAD 83)		
NW12/SW13-86-8-W6		11	N	6258319
		E	368453

2025 PH010 INSPECTION PLAN

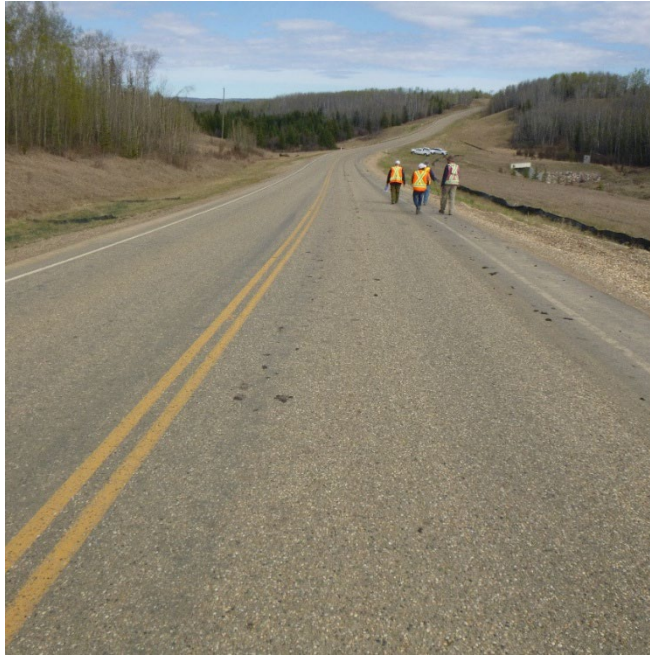
Inclinometer SI08-4 located between Sites 1 and 2 at Site 4 (damaged prior to 2020 readings) was indicating ongoing movements (latest ~8 mm/yr) at 7 to 9 m depth. After patching of the dip and cracks on the pavement in 2015, a more defined slide crack about 50 m long with a dip on the east side of it was observed in 2016, and past visual observations indicating general crack widening, distortion, and on-going sealing in the last few years prior to 2023, suggested a larger slide is developing and moving towards the river. However, there were no signs of distress in the new pavement overlay at Site 1 or 4 at the time of our spring 2025 inspection.

Photo 1 – Looking north along the hwy across Site 4 (PH010).

Continue to patch and mill the highway at Sites 2 and 4 as required.

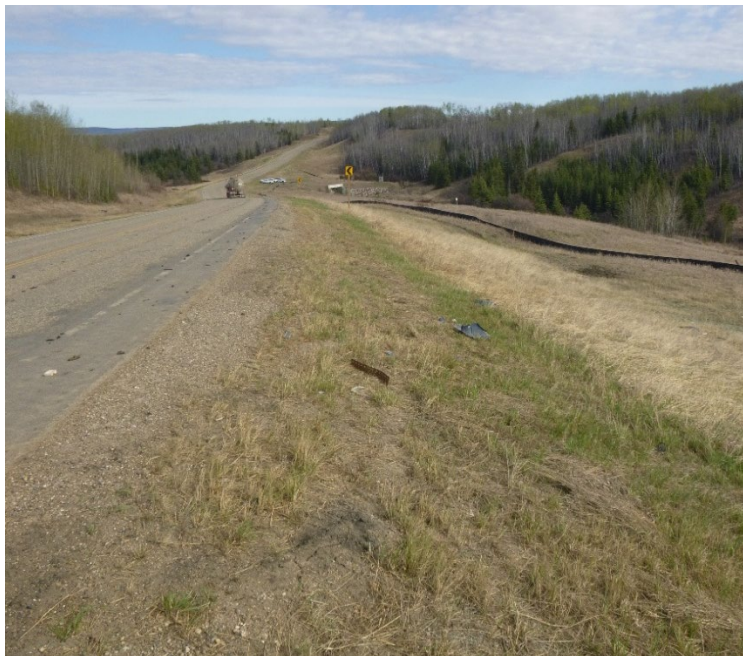
Photo 2 – Looking north along the hwy and east embankment at Site 2.

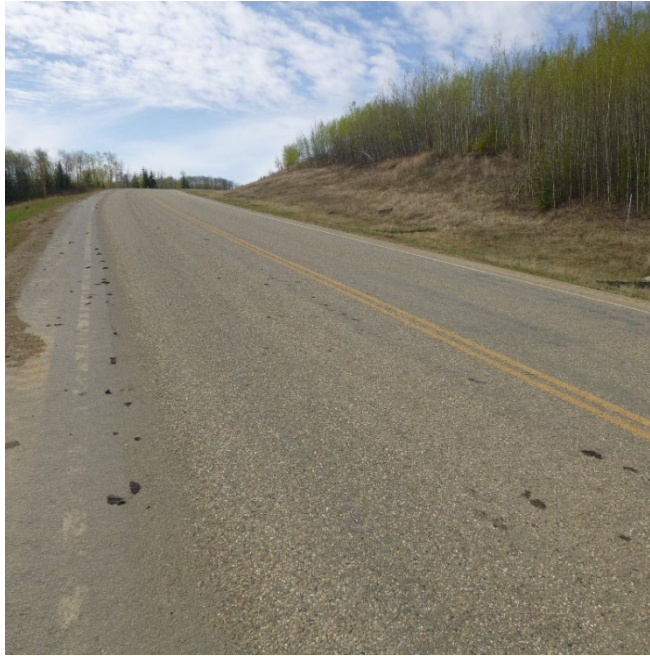
Photo 3 – Looking south along the hwy and west ditch of Site 2. Note the old, grassed-over backslope slumps, and a predominant ungrassed area where the 2023 construction detour existed.

At Site 2, one additional roll (30 m length) of TRM and ditch barriers should be extended northwards along the west ditch to protect it from erosion. Also, the TRM and ditch barriers along the north ditch should be extended a bit further up the west backslope, as bare soil and some erosion from the 2023 detour and recent surface flow was observed.

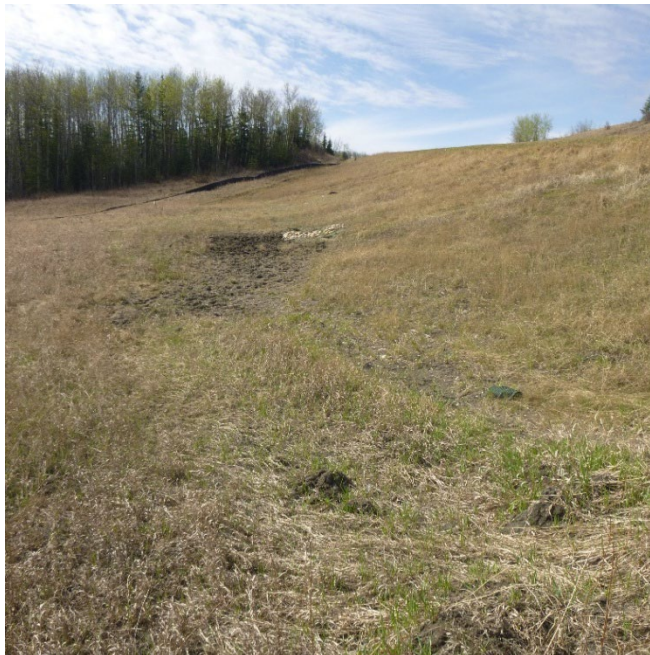
Photo 4 – Looking south along the east sideslope at steady slight seepage from the 2023 subdrain outlet constructed beneath the new Lightweight Geofoam fill at Site 2.

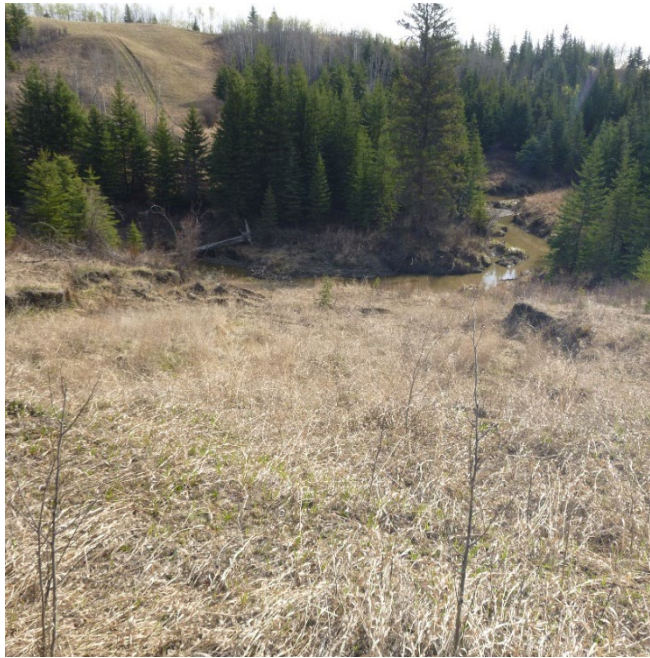
The landslides at the PH010 site were triggered by river erosion along the base of a river valley slope that has been subject to historic landslide movement. The slide movements are occurring in high plastic clay deposits.

Photo 5 – Looking east at the outside bend of the river, which is causing the most active slumping area at Site 2.

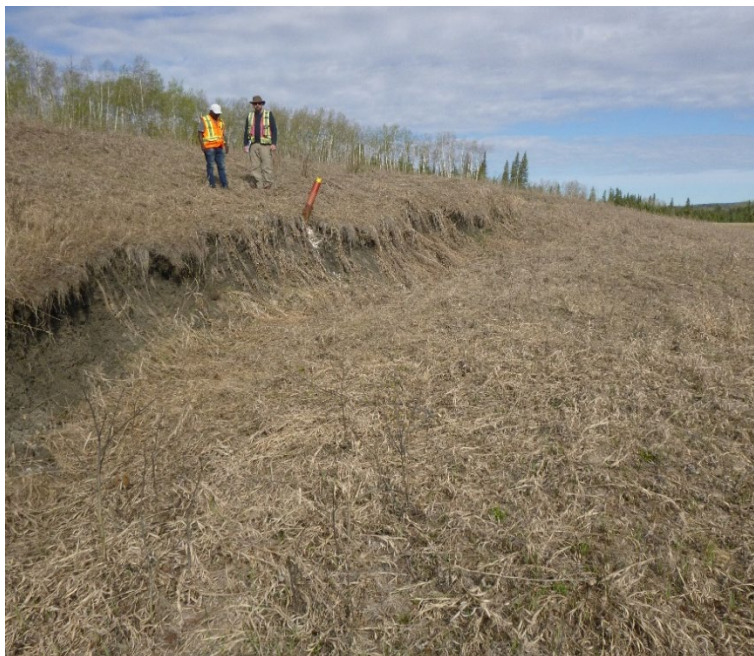
The landslide at Site 2 is extensive and very active, extending all the way up to and through the highway embankment. Prior to 2023 the movements at Site 2 have been dealt with by milling the pavement at the flanks of the slide and adding asphalt patches in the road surface and small earth fills to smooth out dips in the adjacent ditch. However, the additional weight of these fills and the ongoing river erosion at the toe of the slope kept the landslide in motion. In 2023 Hwy 726:02 was overlayed through the Eureka River valley, and as part of this Paving Contract #21542 that was managed by EGIS, TEC approved modest improvements to the Site 2 slide as was originally outlined in a geotechnical investigation and preliminary design completed by Thurber (dated Nov 21, 2019) consisting of: Excavation/removal to 4 m depth of the existing damaged 2m thickness of existing ACP/GBC and clay subgrade; Installation of a subdrain system draining towards the east; Re-construction of the hwy embankment with 3 layers of Geofoam lightweight fill blocks surrounded by sand then covered with 0.8 m of compacted clay; Installation of a new 0.52 m thick pavement structure reinforced with geogrid; Covering with the ACP overlay; and then completed with Topsoil Replacement, Seeding, and Soil Coverings. It should be noted that these improvements as discussed with TEC were intended to only slightly improve existing conditions by a Factor of Safety (FOS) of about 3% (due to the relative length of the landslide) by reducing some driving weight by removal of the existing ACP, and did not provide the customary minimum FOS of 1.3 requirement through this landslide area. The landslide will still likely creep, but patching could be performed more easily and less frequently afterwards.

Photo 6 – Looking northeast along the active slide scarp/crack of Site 2, from just north of the most active portion of the slide.

Periodically re-grade the slope below the highway at Site 2 to seal the cracks and provide a smoother, more uniform slope from the broken, uneven, and cracked slope that currently exists.

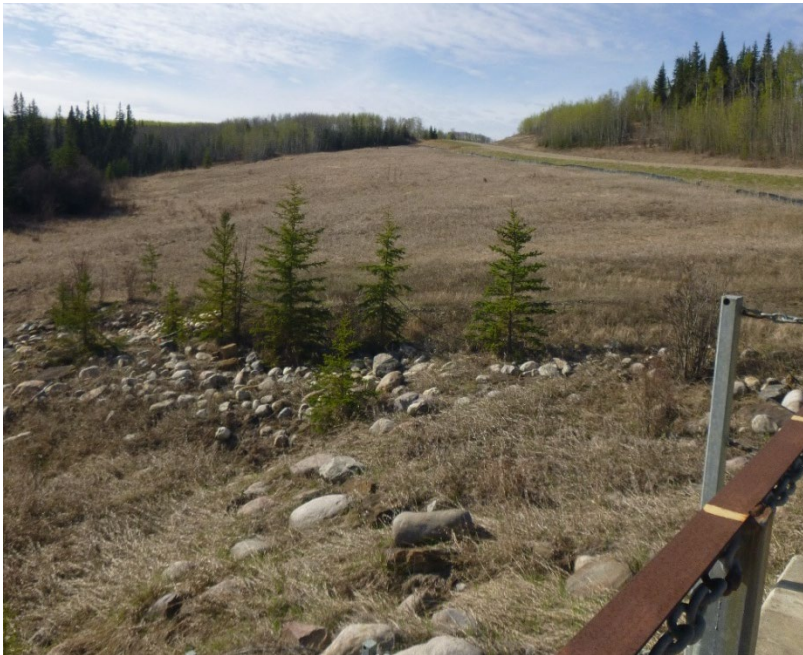
The movement at Site 1 has been slower and so far, the landslide has not retrogressed into the highway at that location. The 800 mm drop manhole, AC curb, and half culvert at Site 1 were removed as part of the above referenced paving contract, and replaced with a subdrain running alongside the east edge of the pavement that drains into a catch basin which in turn was connected to a 576 mm diameter SWSP that outlets at the river. These modifications have improved drainage control at this site.

Photo 7 – Looking south across the 2023 SWSP and outlet (Site 1). Note the dipped ground surface on the RHS of the photo overtop the Site 1 slide.

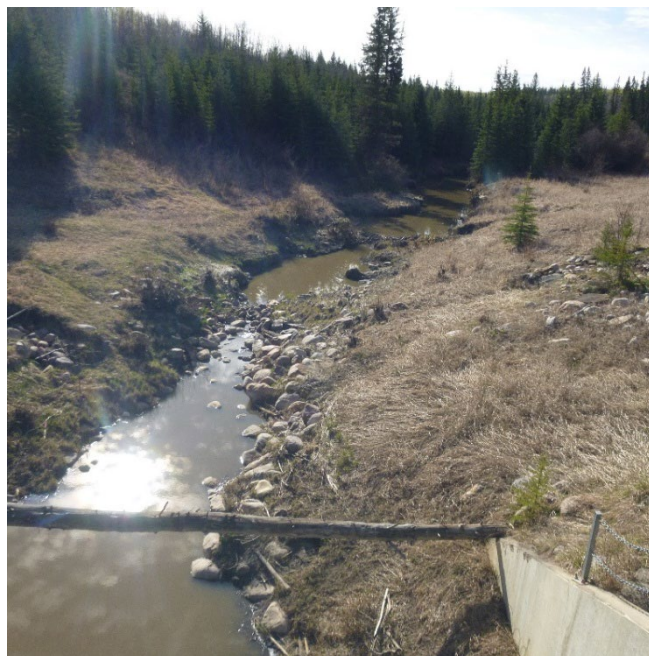
Photo 8 – Looking southeast along the Eureka River from the arch culvert inlet (Site 1).

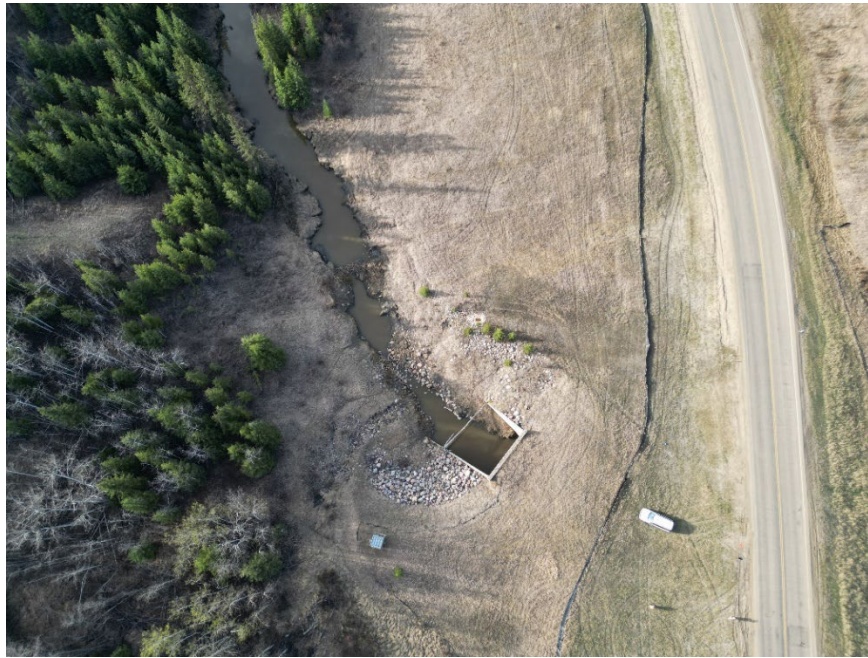
Photo 9 – Drone Photo looking south at Arch Culvert entrance and Site 1.

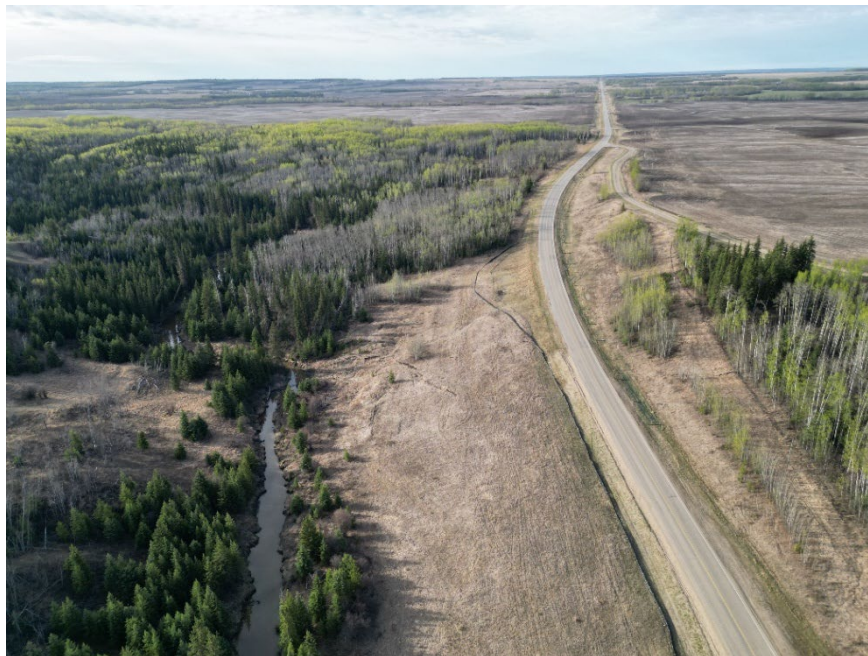
Photo 10 – Drone Photo looking south along the highway at Site 4 (foreground) and Site 2 (background).
