**ALBERTA TRANSPORTATION
GEOHAZARD ASSESSMENT PROGRAM
PEACE REGION (GRANDE PRAIRIE DISTRICT- NORTH)
2021 INSPECTION**

Site Number	Location	Name	Hwy	km
PH026	Eureka River North Hill	Sites #3, #5 and #6	726:02	10.1
Legal Description		UTM Co-ordinates (NAD83)		
SW13/SE14-86-8-W6		11 N 6258740	E 368408

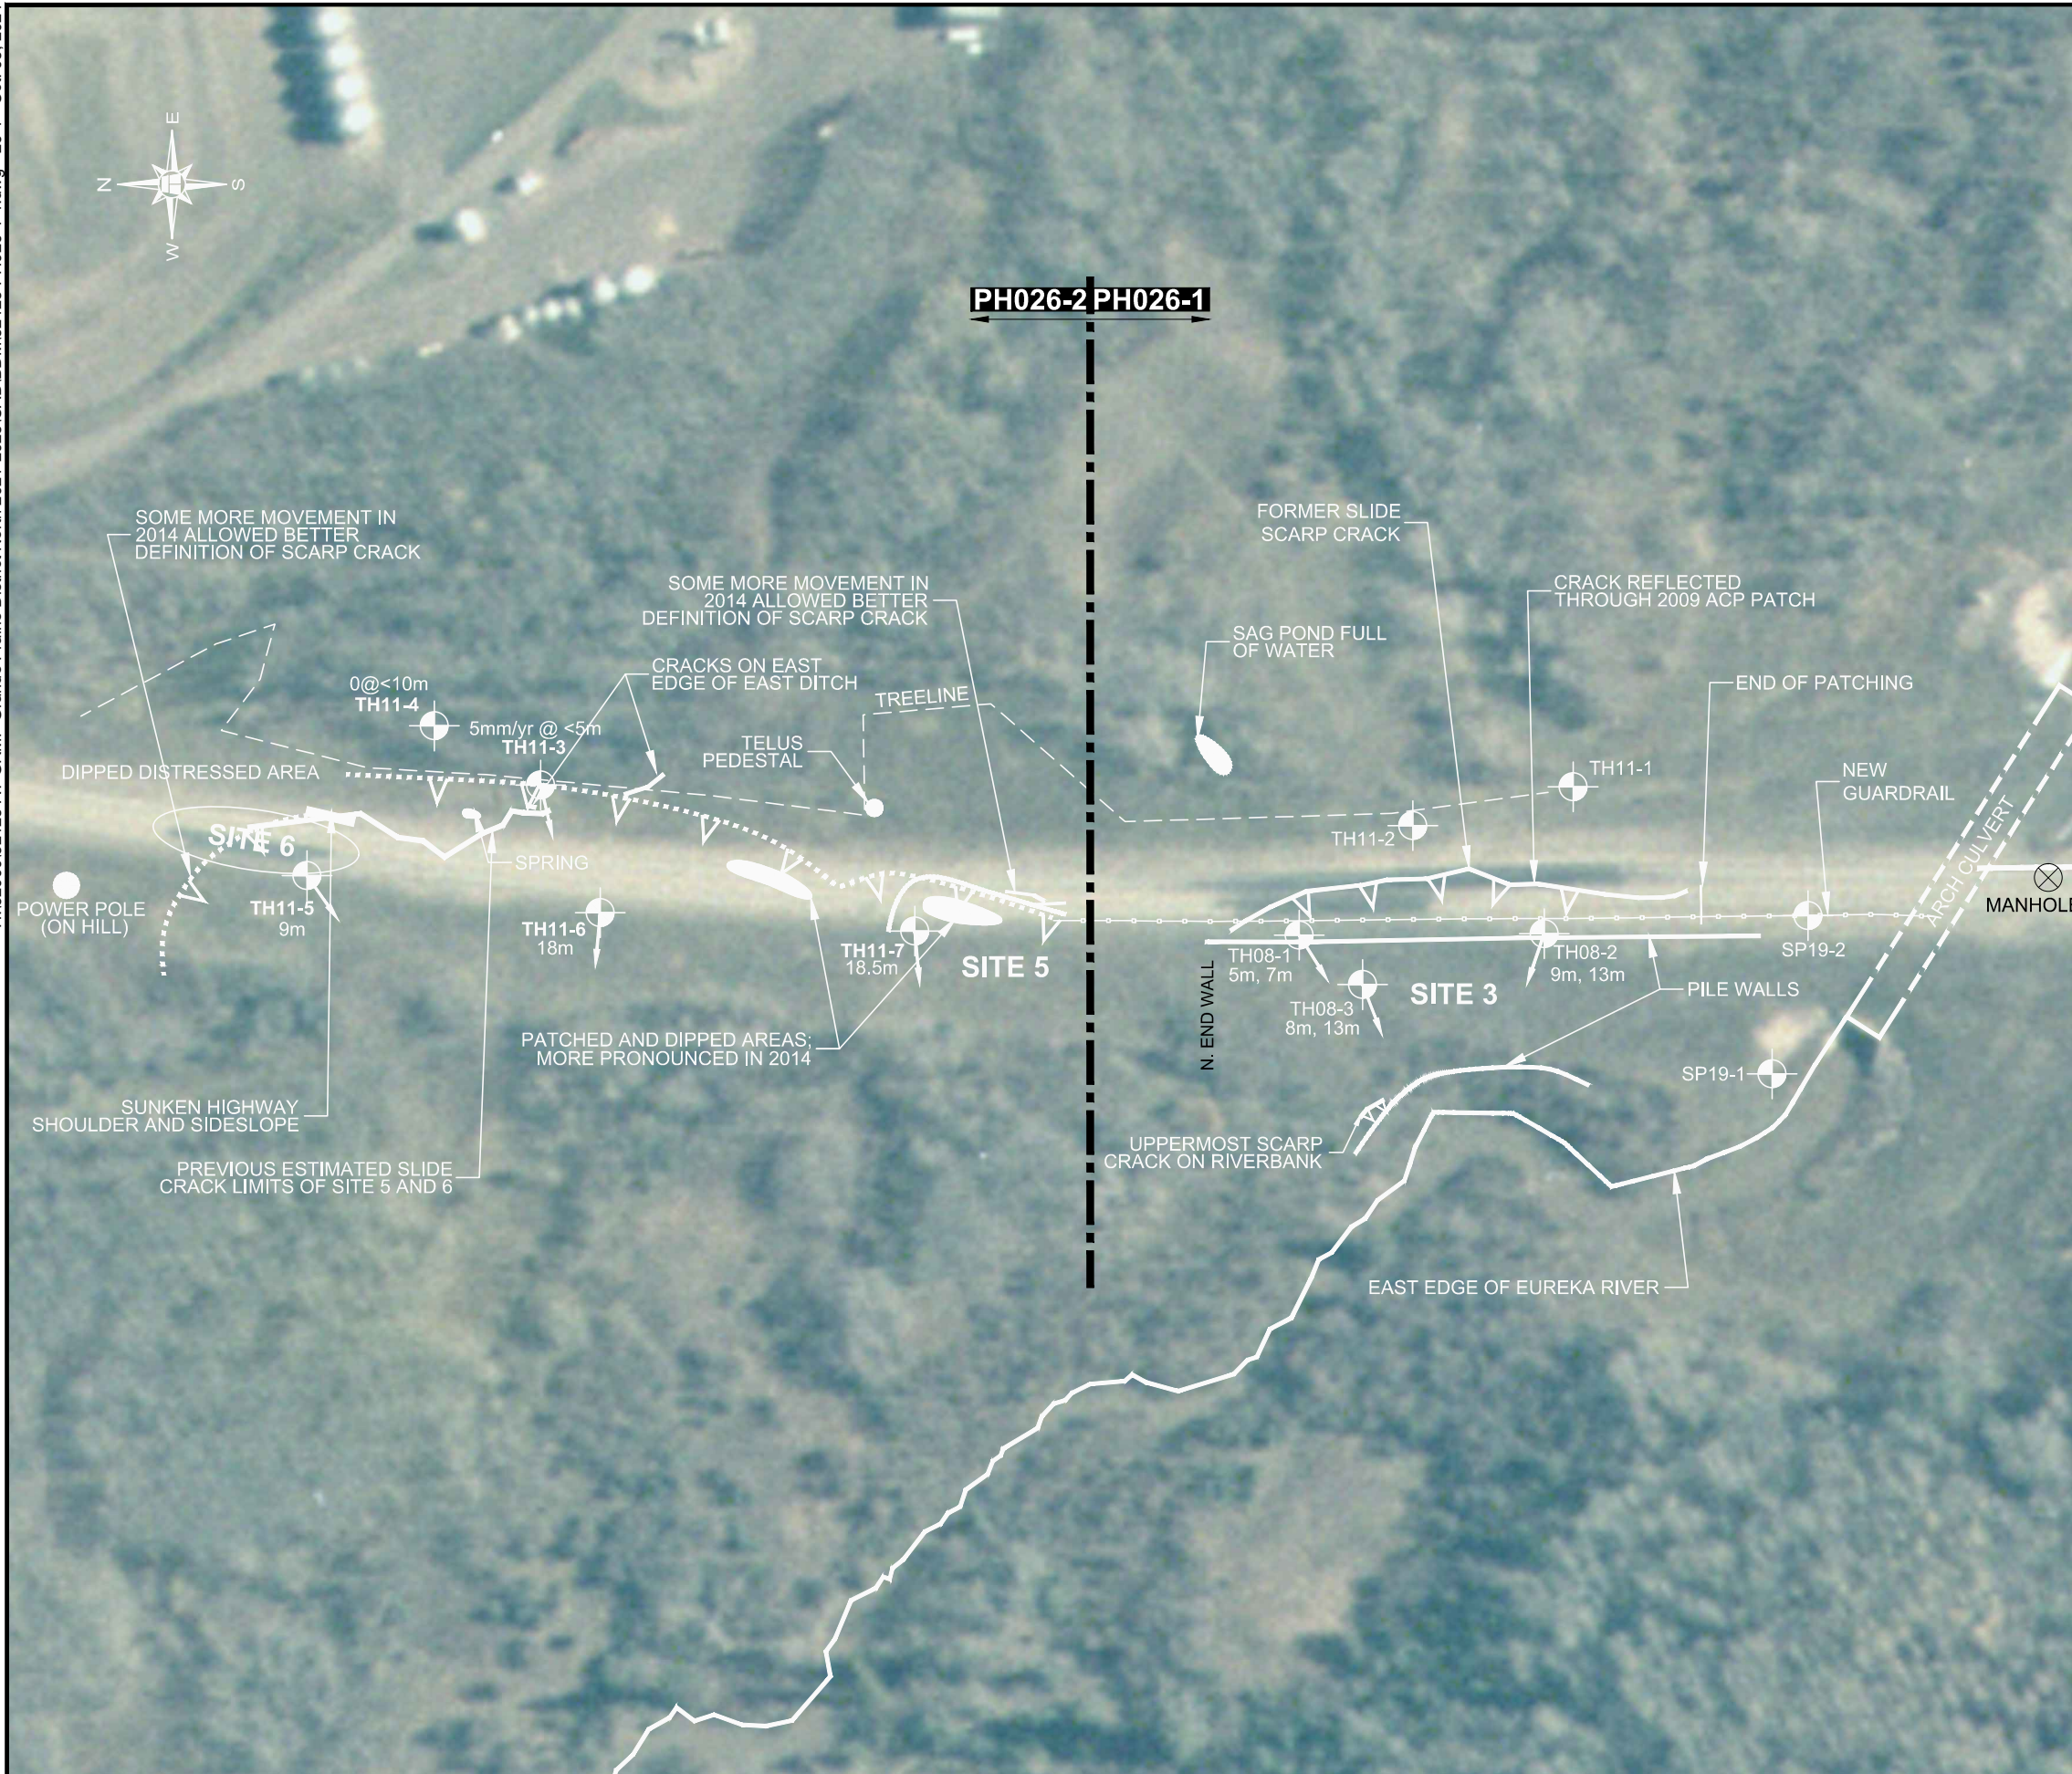
DWG No. 32123-PH026-1-1

1. SLIDE FEATURES RECORDED USING A HAND HELD GPS.
2. SITE 5 AND SITE 6 MAY OUTLINE THE EDGE OF A SINGLE SLIDE SPANNING BETWEEN THE TWO AREAS.
3. FOR UPDATED CRACKS / PATCHES, SEE DWG No. 32123-PH026-1-2 AND 32123-PH026-1-3.

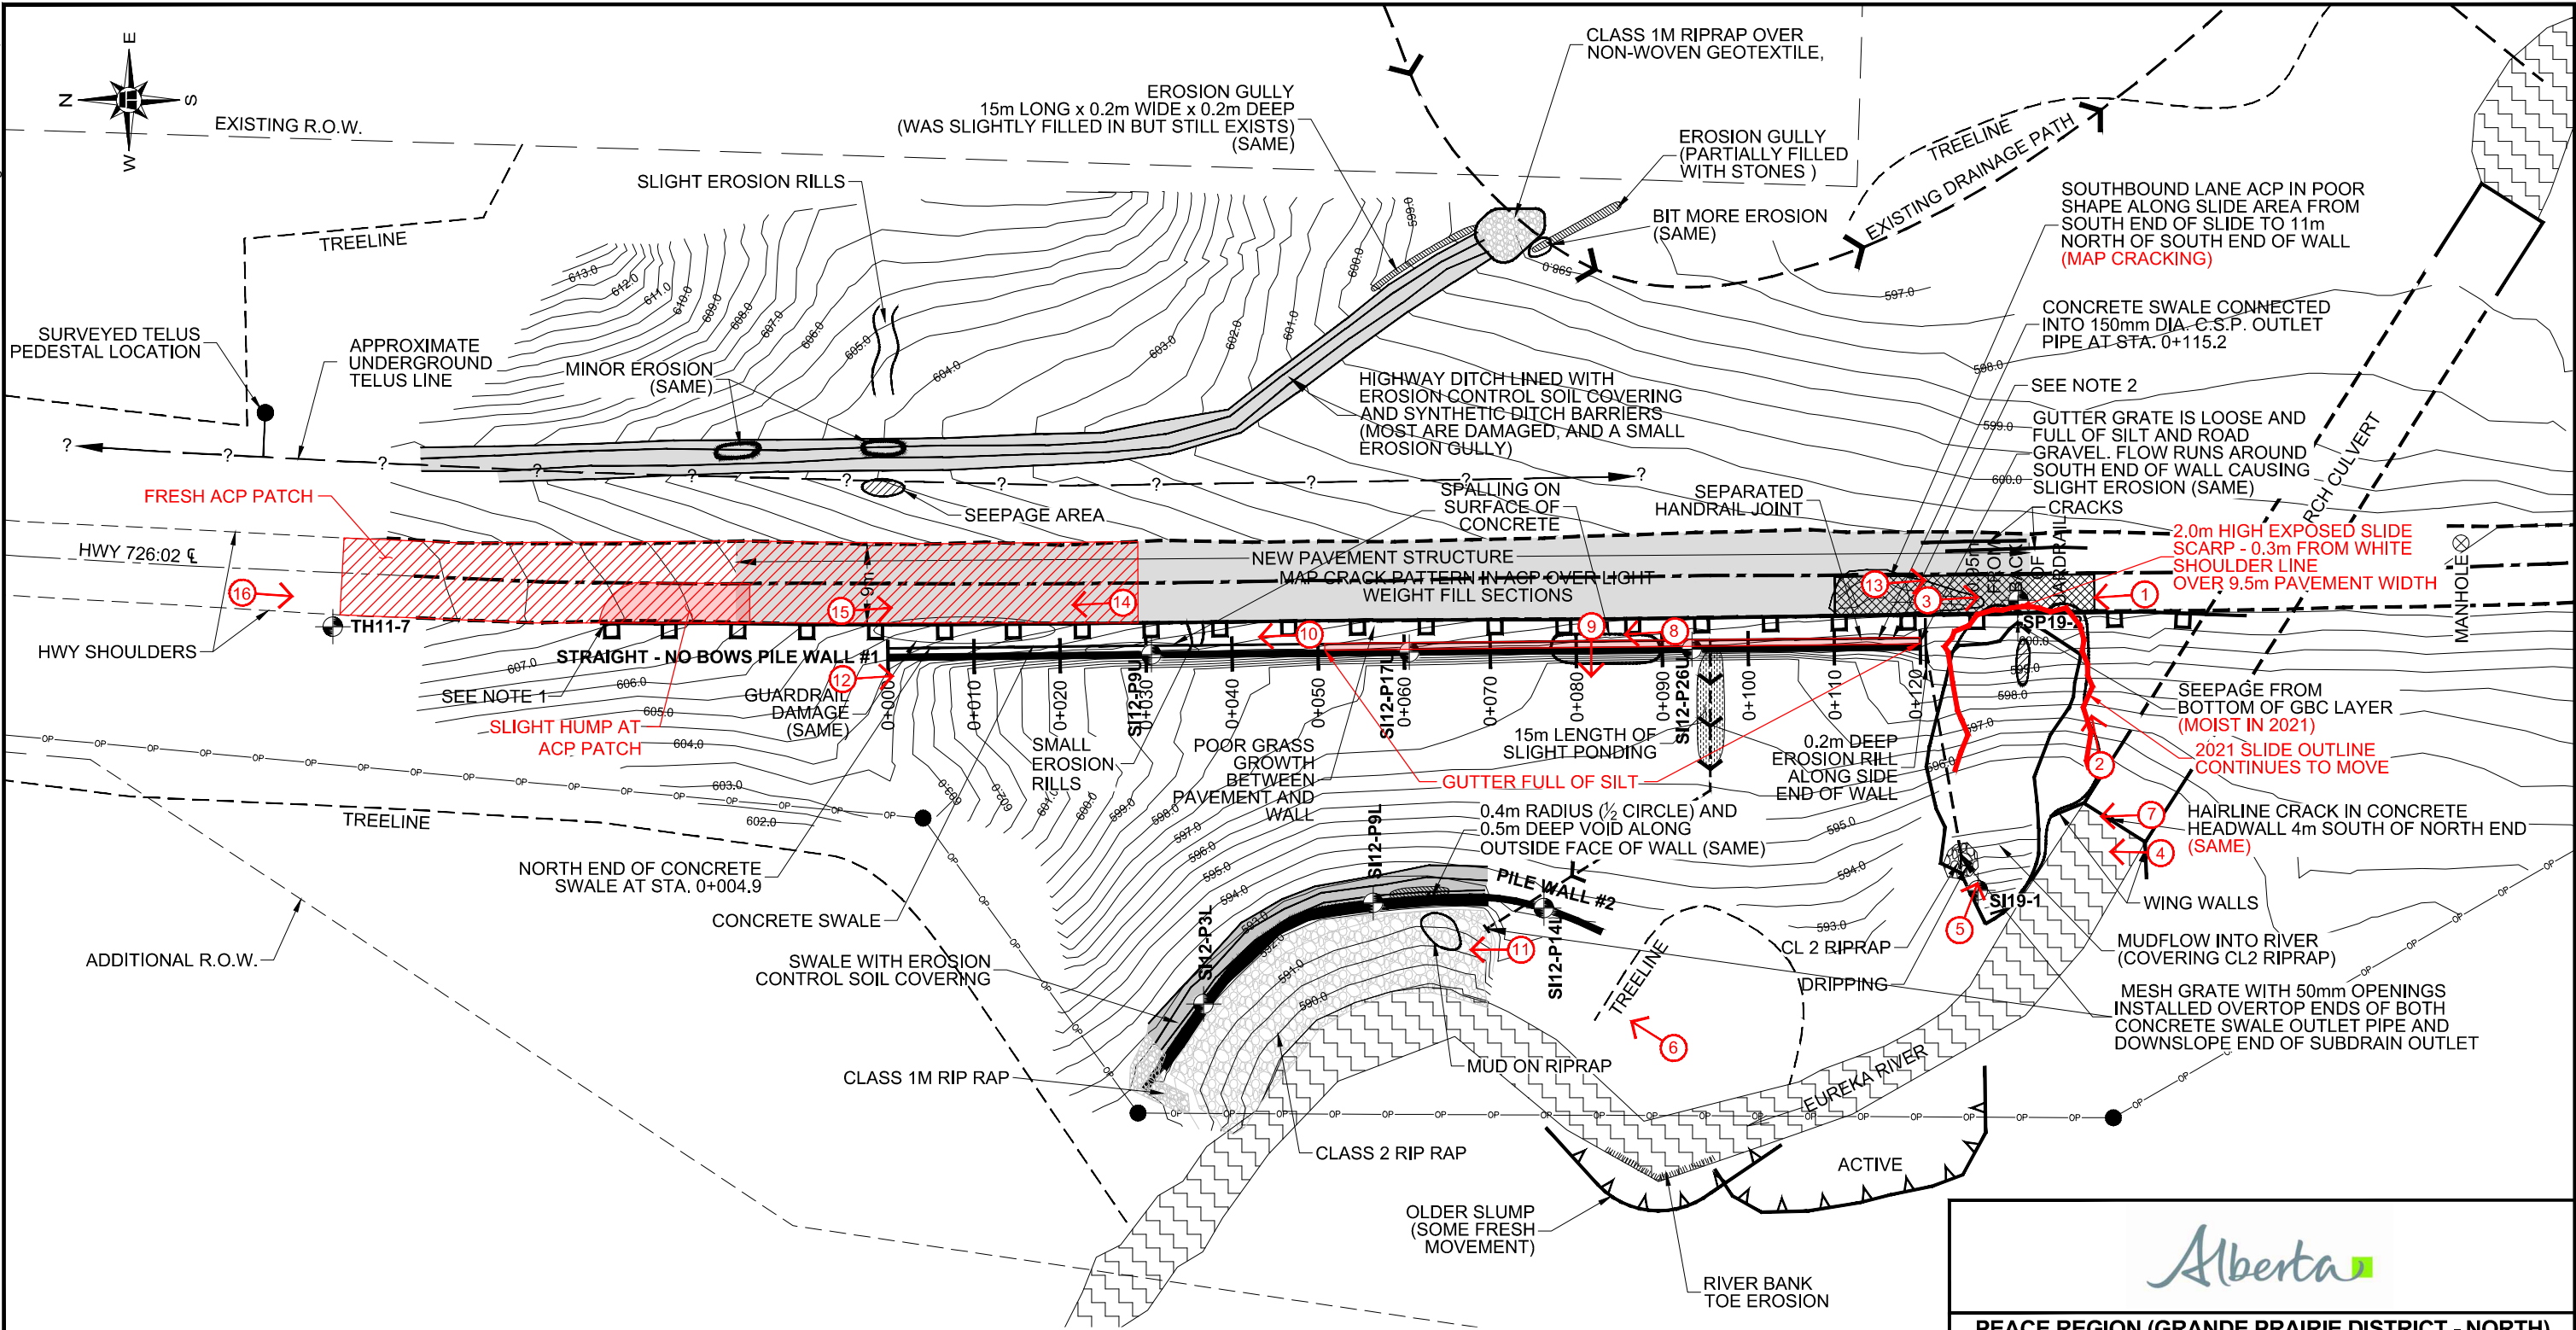
DWG No. 32123-PH026-1-3

- NOTES:**
1. END OF GUARDRAIL DAMAGED BY VEHICLE (AT MAINTENANCE). (SAME)
 2. GUTTER PLATE IS LOOSE AND GUTTER IS FULL OF DIRT AND NEEDS CLEANING (AT MAINTENANCE). (SAME)
 3. CONDITIONS ON JULY 13, 2021 SHOWN IN RED.
 4. REFER TO DWG NO. 32123 PH026-1-7 FOR LATEST SLIDE DETAILS.

- 1) Clean the gutter of soil/debris buildup under the handrail adjacent to the west side of the highway, and securely fasten the loose gutter grate.
- 2) Repair the damaged north collapsible guardrail end.
- 3) The spalled concrete on the surface of the upper pile wall should be repaired by placing a proper concrete sealant over the entire exposed surface to prevent any further degradation.
- 4) A steel sleeve could be installed over the gap in the handrail.

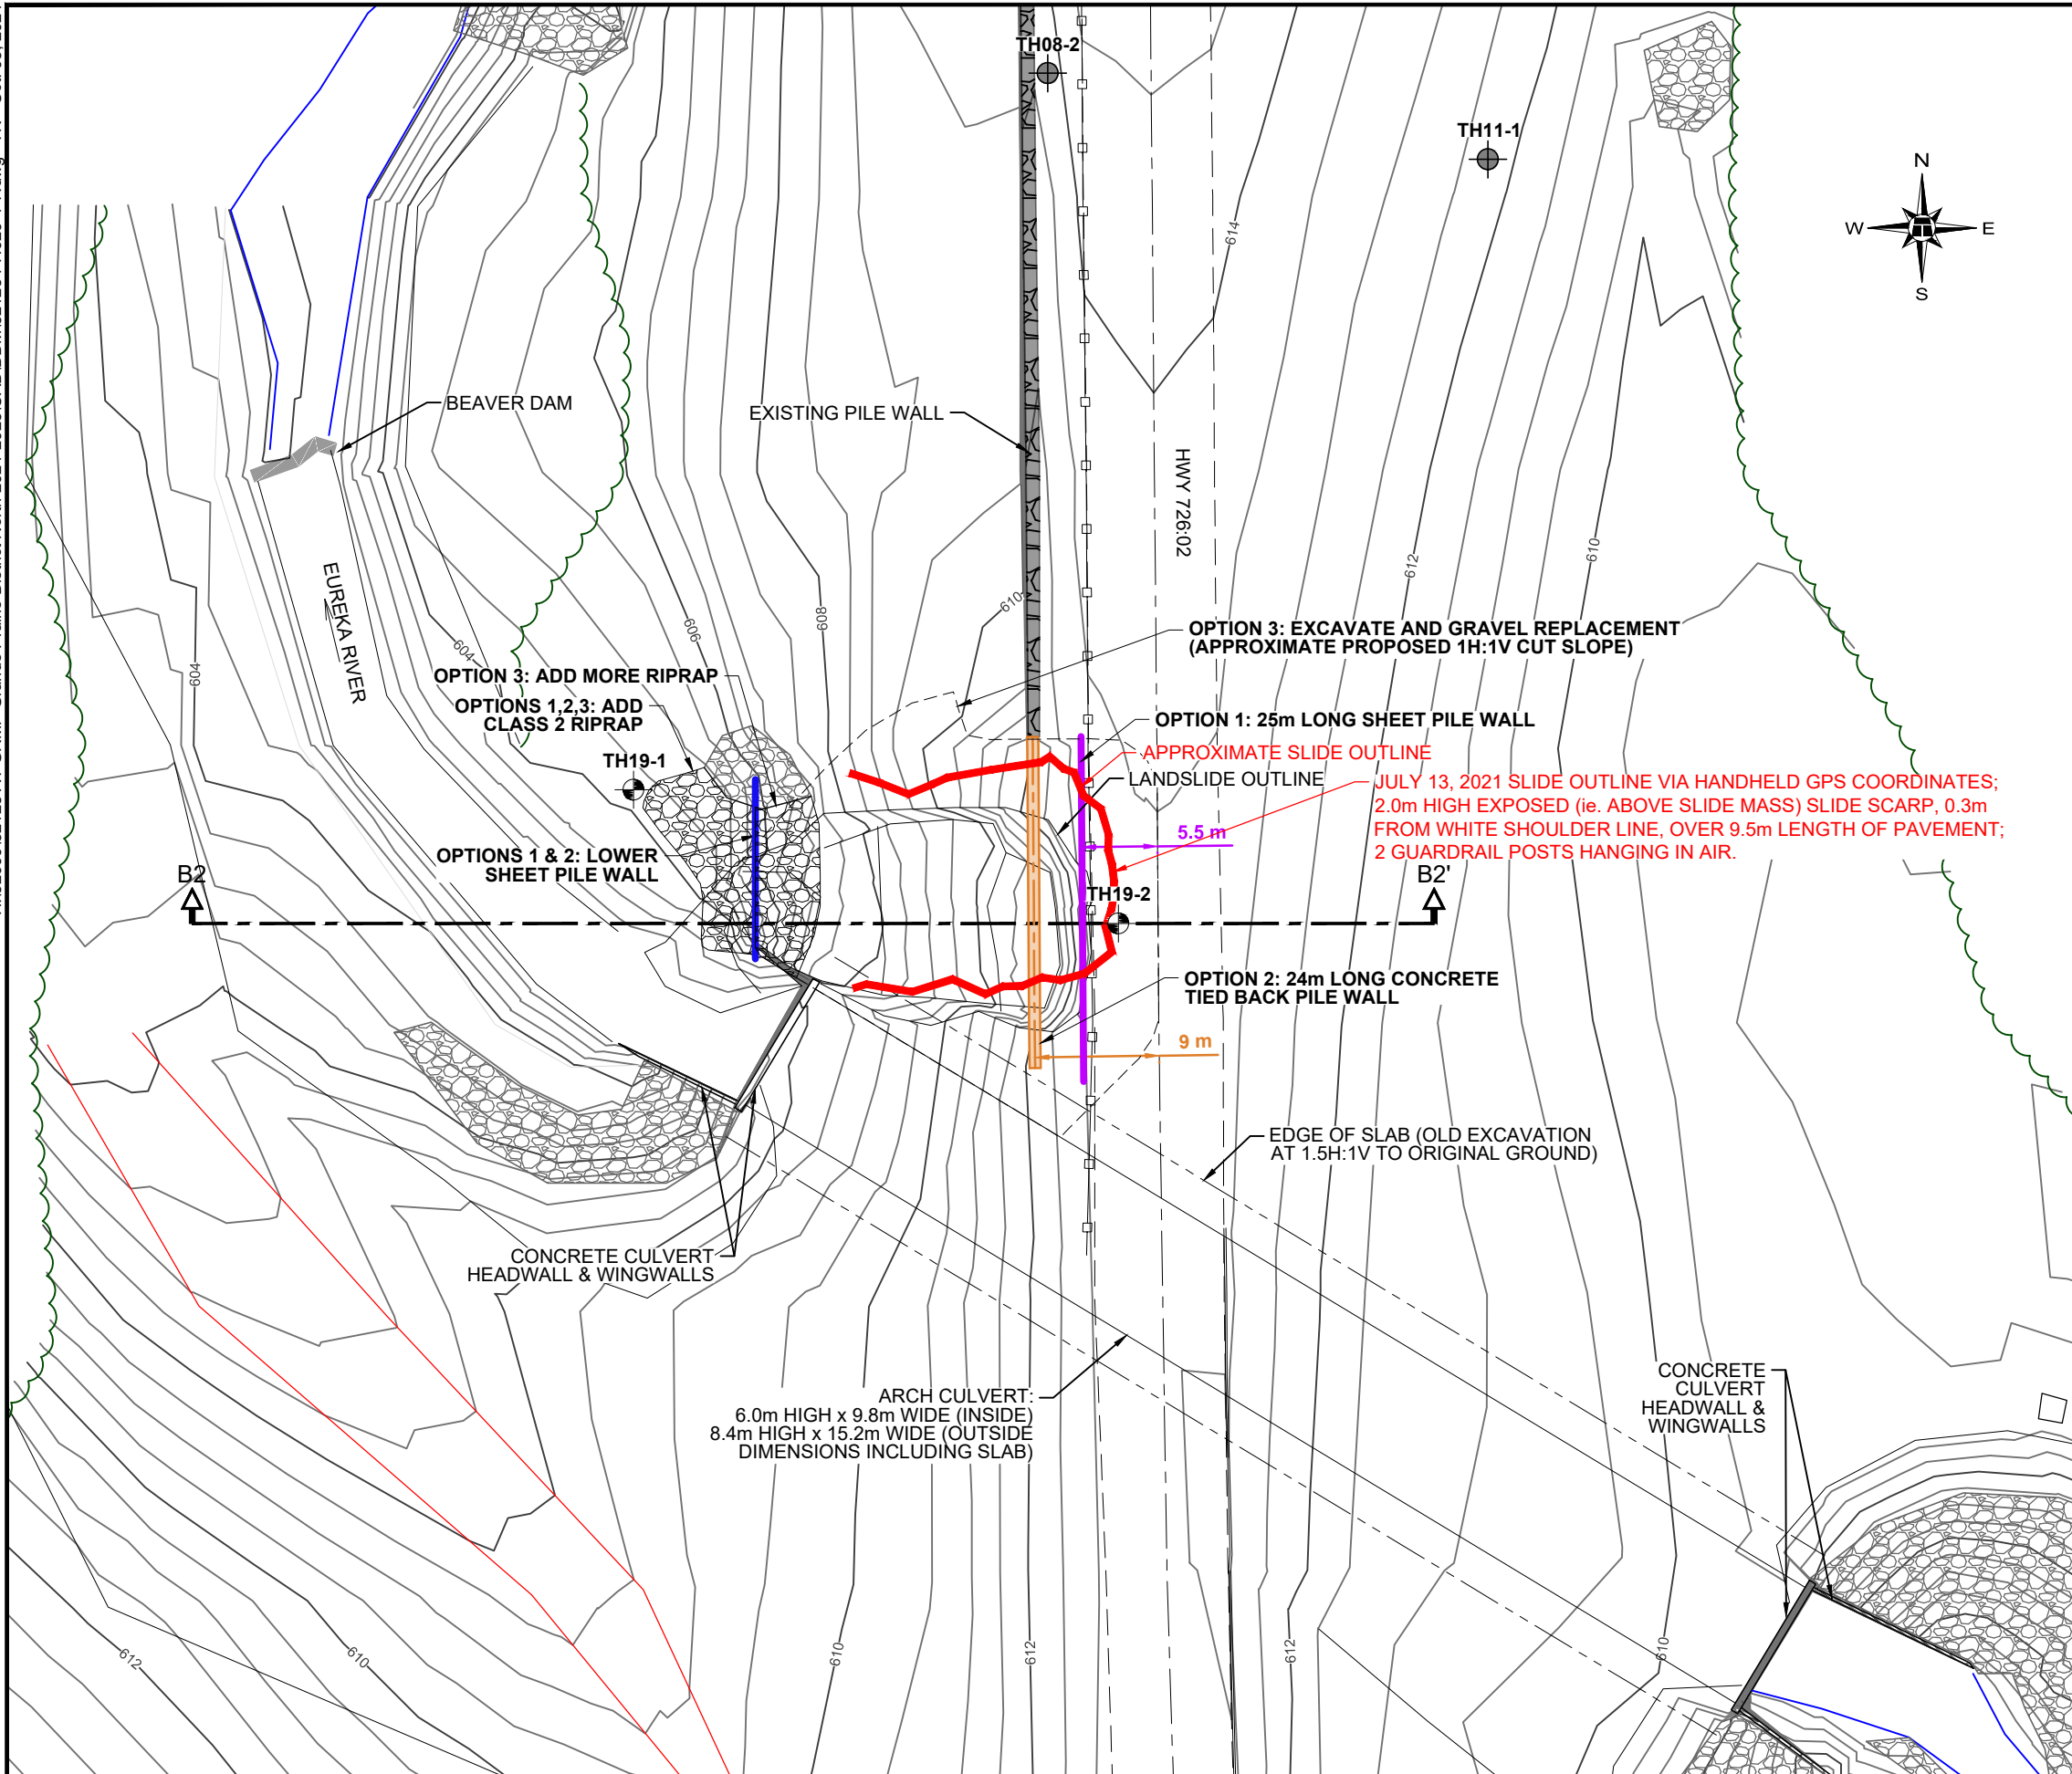
DWG No. 32123-PH026-1-7

- NOTES:**
1. END OF GUARDRAIL DAMAGED BY VEHICLE (AT MAINTENANCE). (SAME)
 2. GUTTER PLATE IS LOOSE AND GUTTER IS FULL OF DIRT AND NEEDS CLEANING (AT MAINTENANCE). (SAME)
 3. CONDITIONS ON JULY 13, 2021 SHOWN IN RED.

At Site 3, the slide that occurred due to seepage near the south end of the guardrail along the west highway embankment should be repaired. A geotechnical investigation and preliminary design were completed by Thurber (dated Nov 21, 2019) as part of Paving Contract #20531, that assessed and provided remedial cost alternatives. The following two most feasible alternative repair options were:

- 1) Excavate the slumped material in the west highway embankment, disposing of the material outside and away from the valley crests. Install non-woven geotextile and a subdrain system along the base of the excavated slump. Sheet piles will need to be installed along the slide toe

to minimize river inflow, and in conjunction with riprap to prevent future toe erosion. Re-build the new highway embankment using compacted gravel to re-establish the existing slope and to surround the subdrains. Extend the subdrains through the lower portion of the re-built slope to outlet on some Class 1M riprap above the river. Enhance the riprap along the toe of the repaired area.

- 2) Install two rows of sheet piles, one near the highway and one lower down the slope to retain the slide mass, and also install a subdrain system and enhance the riprap along the waters edge.

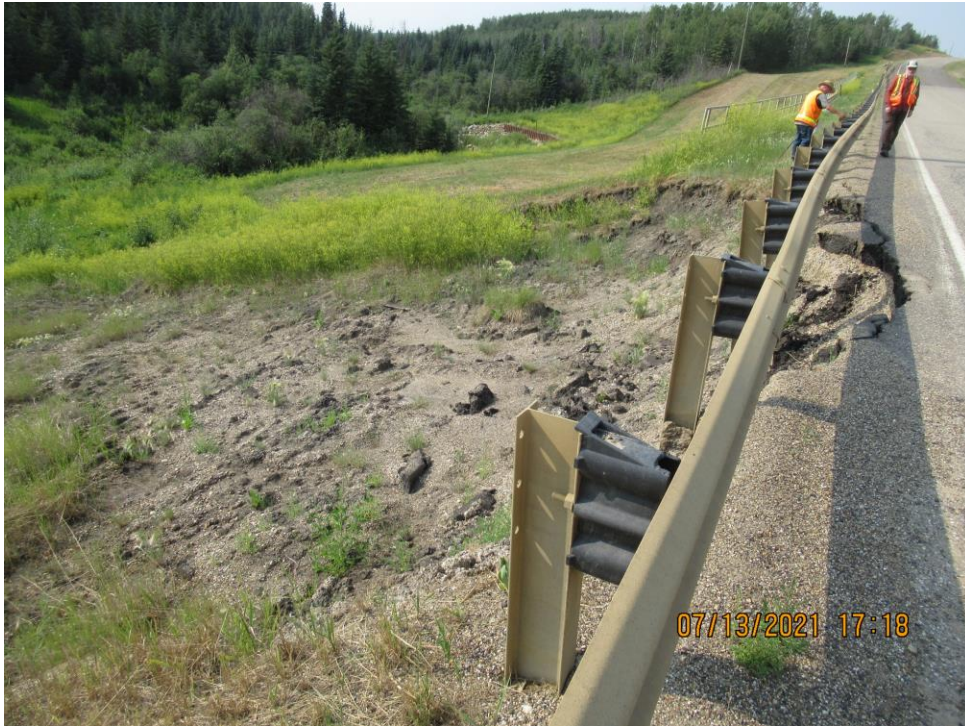
The seepage from the pavement GBC observed in 2016 south of the upper pile wall and ongoing weathering of the fill are the likely causes of the slide that occurred south of the upper pile wall in 2017. The seepage likely saturated the GBC and embankment fill with time, which created a weak soil mass that eventually failed, carrying the material down into the River.

Photo 1 – Looking north along the highway south of the upper pile wall at the landslide that developed at Site #3.

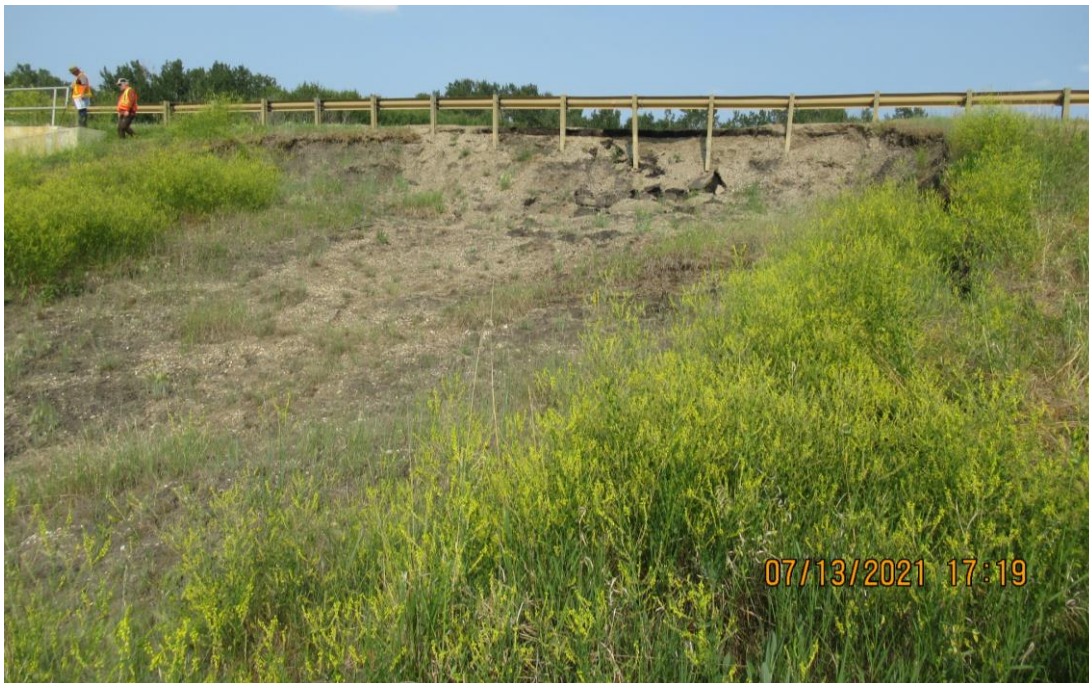
Photo 2 – Looking east at the body and scarp face of the slide at the south end of the pile wall at Site 3.

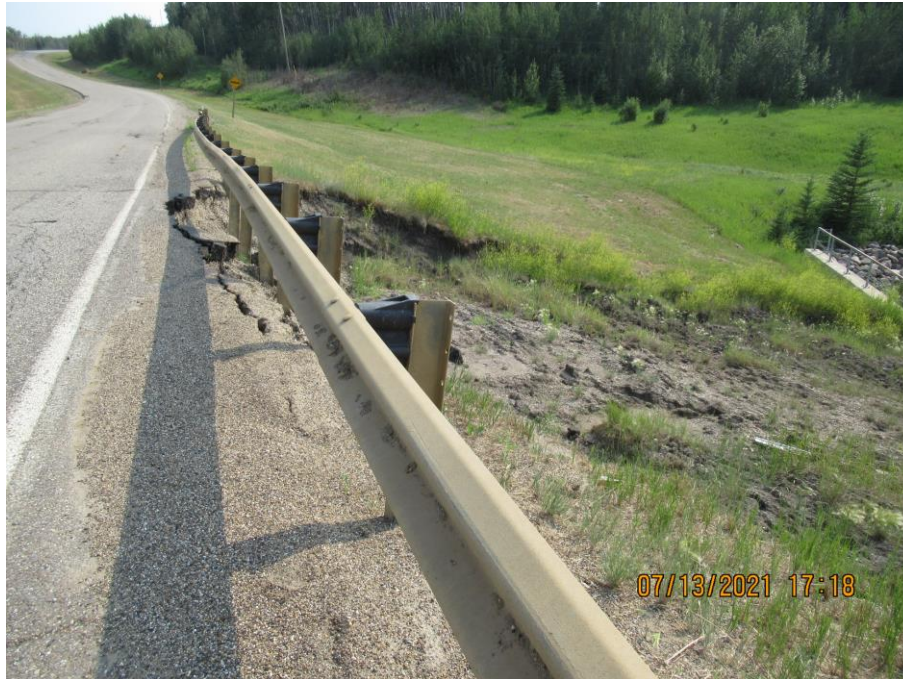
Primary Site Issue:	Slide scarp at Site #3 crossing highway at 2 locations was repaired in 2013. Two other slide areas developing further north, likely linked as one larger slide. A new landslide occurred in 2017 (Site #3) in the west sideslope between the upper pile wall and the bridge culvert.	
Dimensions:	Main slide at Site 3 was about 60 m long by 100 m wide. Slide Sites 5/6 are in the order of 200 m wide (along the highway) by 200 m long. The new slide is about 20 m wide along the highway and 35 m (avg. toward the river) in a 12 m high embankment slope.	
Date of any remediation:	Slide Site 3 was remediated in 2013 with 2 pile walls and riprap.	
Maintenance:	Semi-continuous patching and crack sealing at Sites 5/6.	
Observations:	Description	Worse?
<input checked="" type="checkbox"/> Pavement Distress	Cracks, differential settlement, subsidence, and dips in the pavement and shoulders at Sites 5/6. Also, at Site 3, alligator cracked area at the south end of the lightweight fill along with a hump near the north end, and map cracking is occurring over the majority of area where lightweight fill was placed. The new slide at Site 3 has extended into the paved shoulder of the highway.	<input checked="" type="checkbox"/>

Photo 3 – Looking S. along the hwy at the slide scarp that has extended into the SB shoulder to within 0.3 m of the white line beyond the south end of the upper pile wall at Site #3.

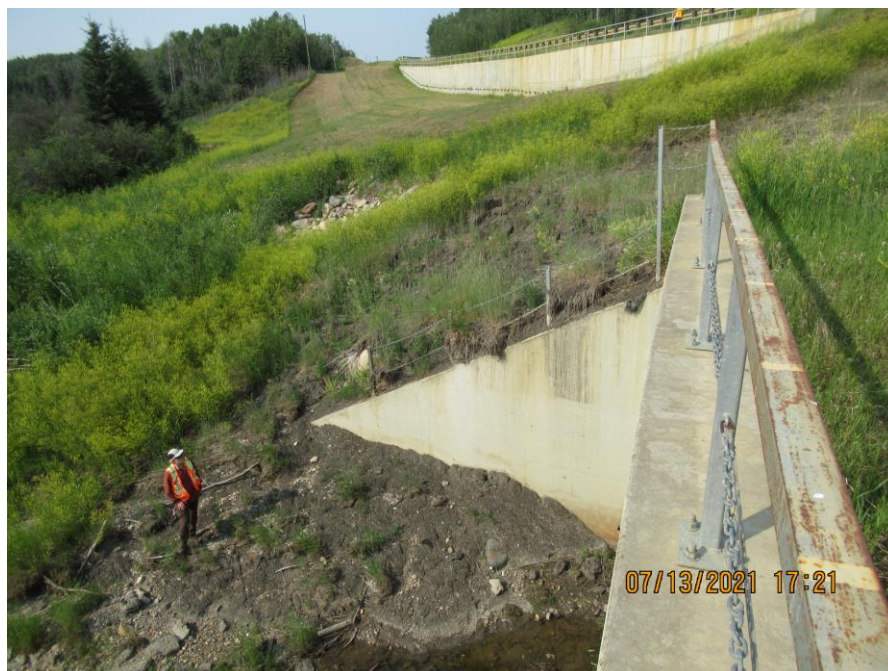
Photo 4 – Looking north at the toe of the slide that pushed debris against and around the arch culvert outlet headwall.

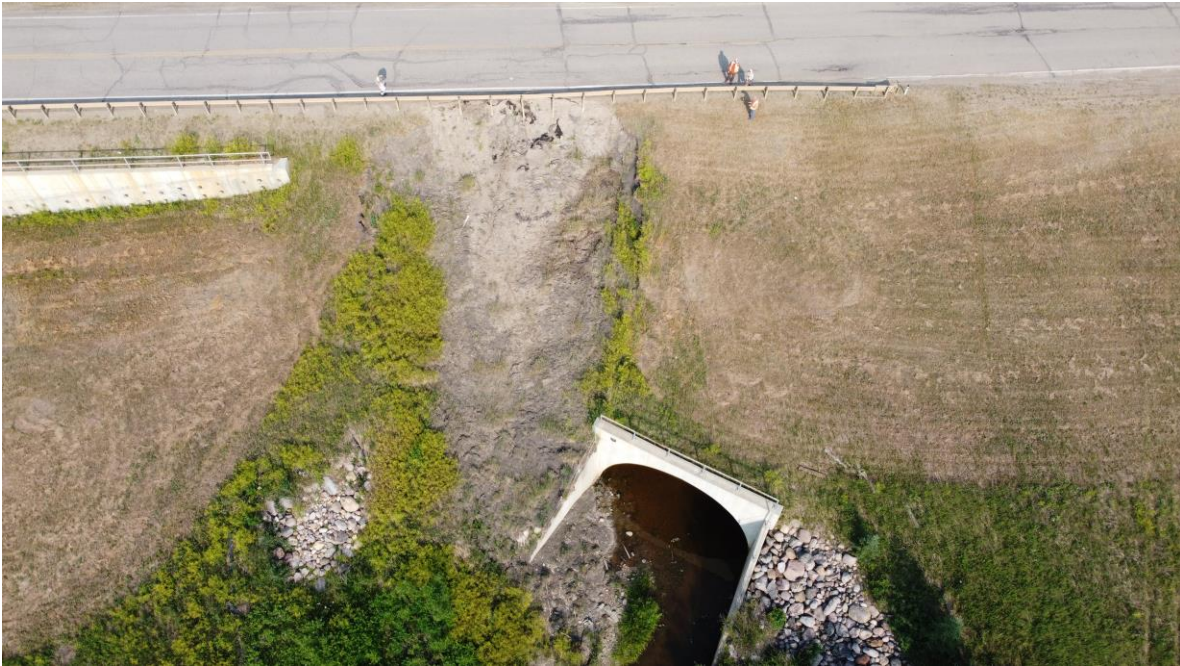
Photo 5 – Drone photo of the slide south of the pile wall at Site #3.

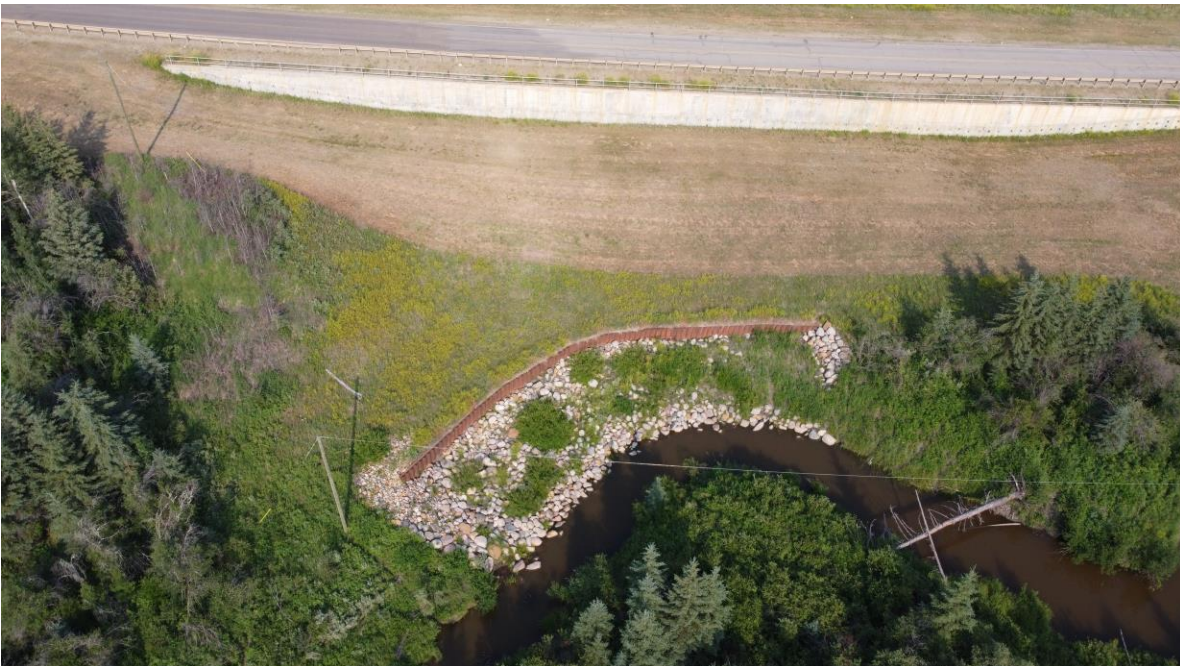
Based on these readings and site observations, the two walls, sheet piles, and riprap have effectively stabilized the original large landslide at Site 3.

Photo 6 – Drone photo of the upper and lower pile walls at Site 3.

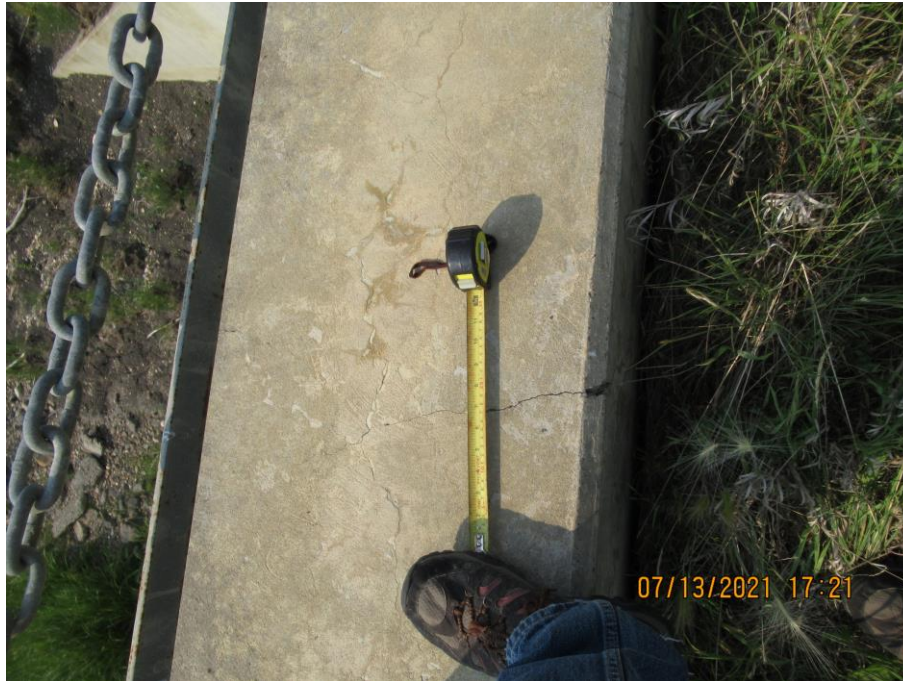
Photo 7 – Close up of a hairline crack in the arch culvert outlet headwall (4 m south of the north end).

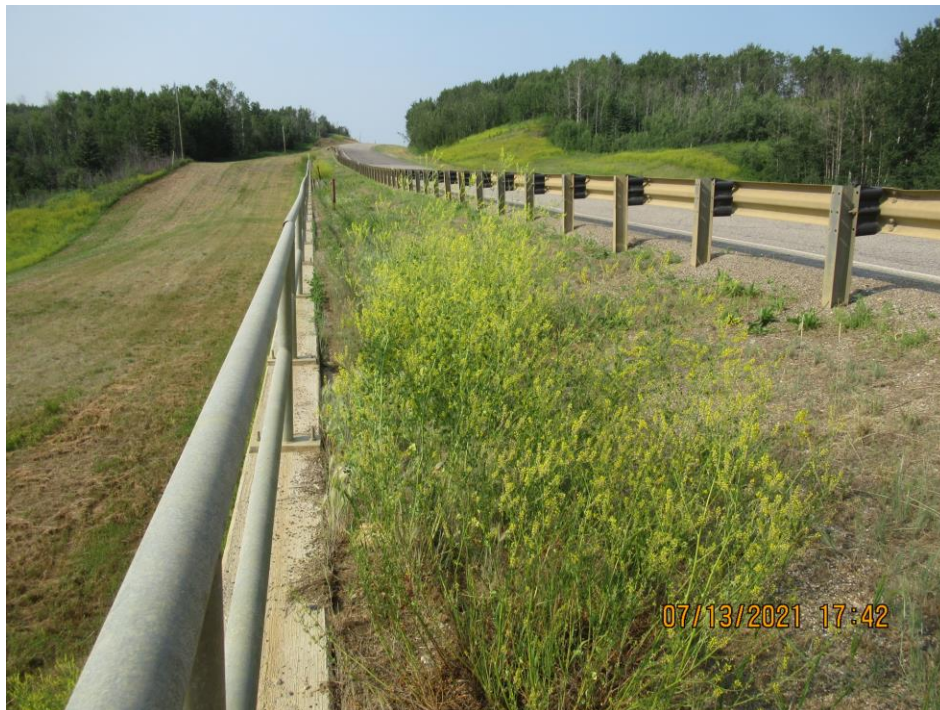
Photo 8 – Looking north along the top of the pile wall from near the south end. Note the gutter is filled with sand/debris, and the separated handrail.

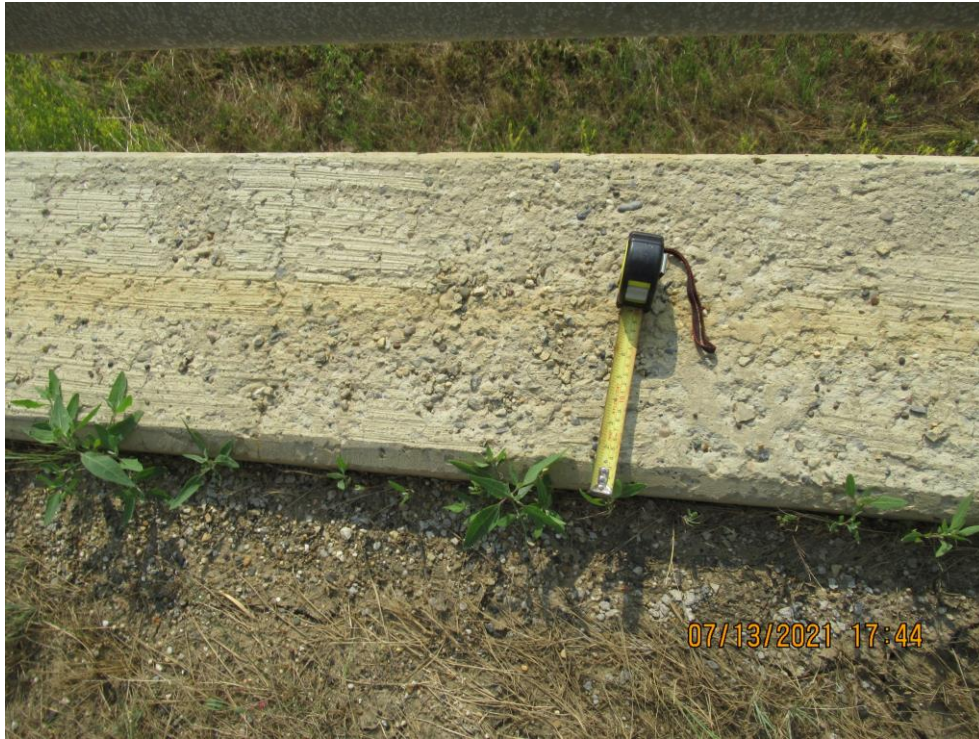
The exposed concrete along the top of the upper pile wall is spalling. This was attributed to weaker than design strengths on this material, for which the contractor was penalized for low strengths at that time.

Photo 9 – Looking at the spalling concrete on the top of the upper pile wall of Site 3.

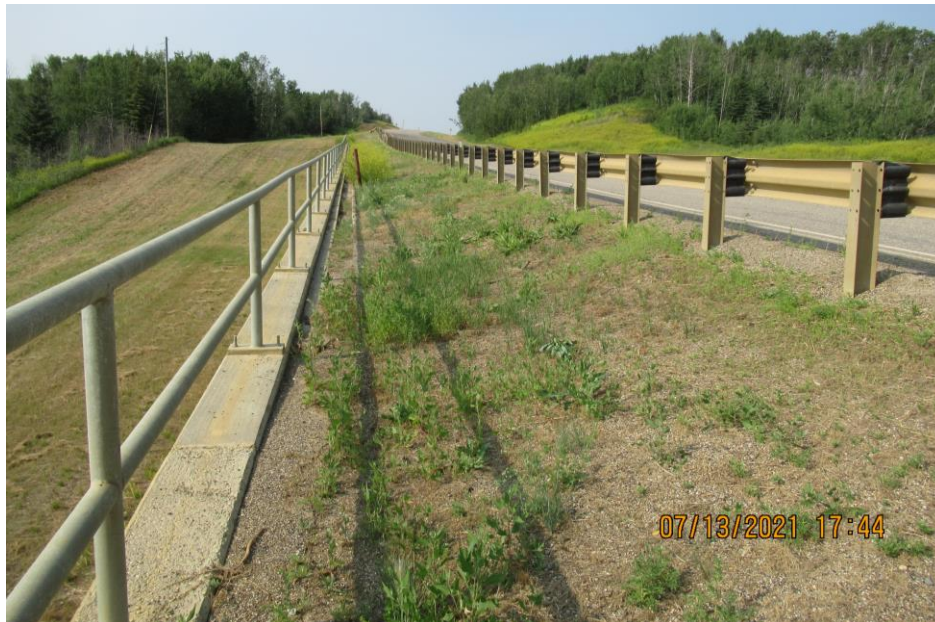
Photo 10 – Looking north along the area between the top of the pile wall and the guardrail. Note the infilled gutter.

Consider covering the slope in between the pavement and the upper wall with hand placed asphalt, as there is sparse grass growth here and some rilling has formed.

It was understood that the Site 3 pile wall should be added to the Bridge File yearly maintenance program, which would include gutter (concrete swale) cleaning at the same time as bridge deck cleaning occurs.

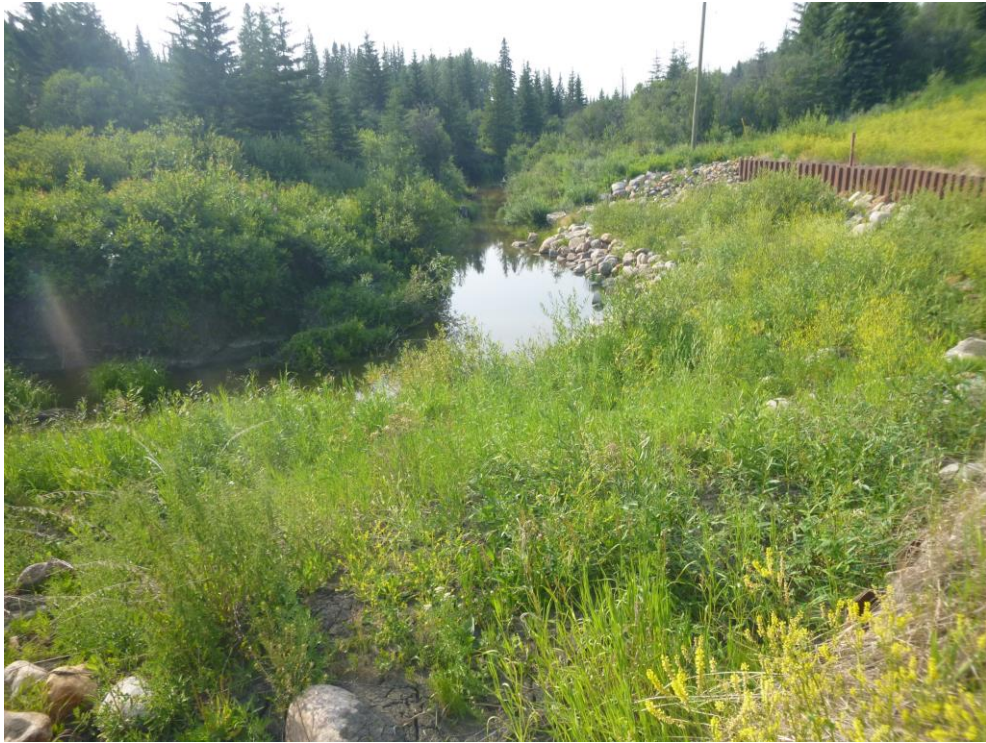
In the lower cantilever wall, all 3 SI's indicate negligible movements towards the River over the last year and appear to be stabilizing.

Photo 11 – Looking northwest at the lower pile wall area, Site 3.

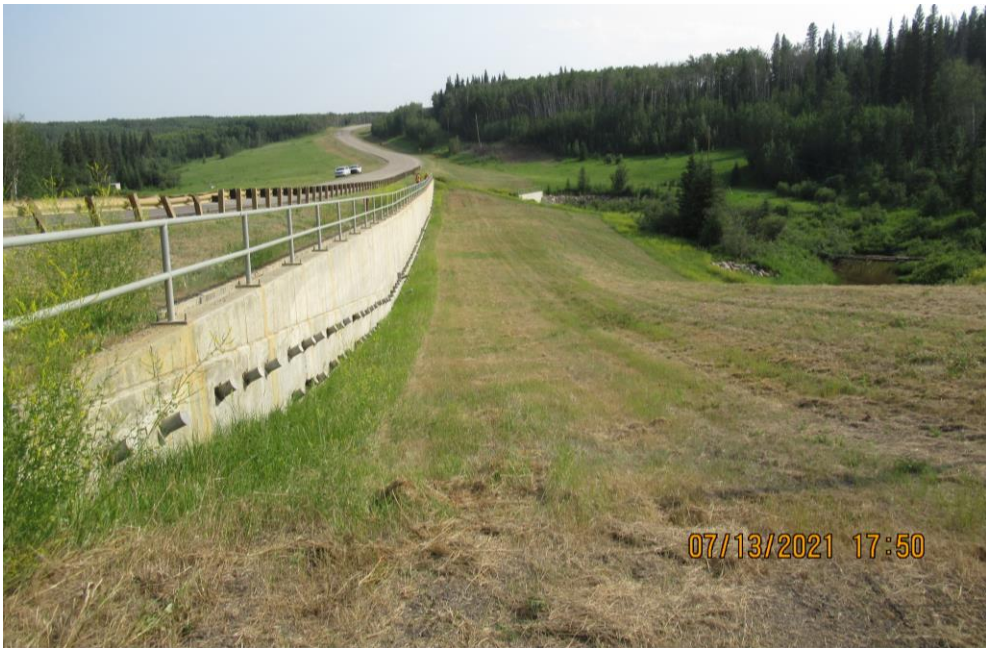
Photo 12 - Looking south along the upper pile wall and downslope embankment at Site 3.

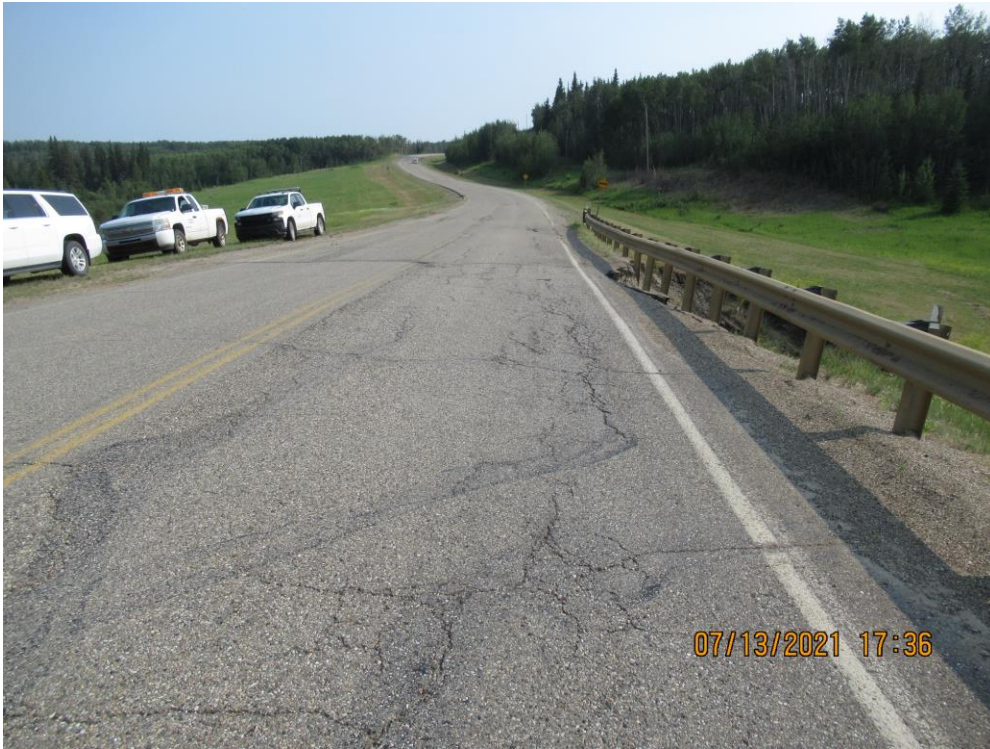
in poor shape from the south end of the slide area to about 11 m north of the south end of the wall. Also, map cracking exists quite extensively over the pavement adjacent to the upper pile wall. This is surmised to be due to flexing of the pavement structure overtop of the Geofam in response to heavy truck traffic, and also different thermal characteristics from freeze-thaw compared to total soil bedding. Some of the pavement distress was remediated by placing an asphalt patch at the north end of the wall in 2020.

Photo 13 – Looking south along the highway at the map cracking adjacent to the south end of the pile wall and the slide further south.

It is understood that AT is planning an overlay to be applied to the highway throughout the valley crossing section. Prior to placing the overlay, the design engineer should consider doing a full depth subgrade repair to improve the strength of the pavement and better bridge over the softer geofam zone, by: Excavating the majority of the 0.7 m of clay subgrade to near the surface of the geofam; Replacing the clay subgrade to compaction specifications; Installing geogrid in the compacted GBC; then Repaving these areas.

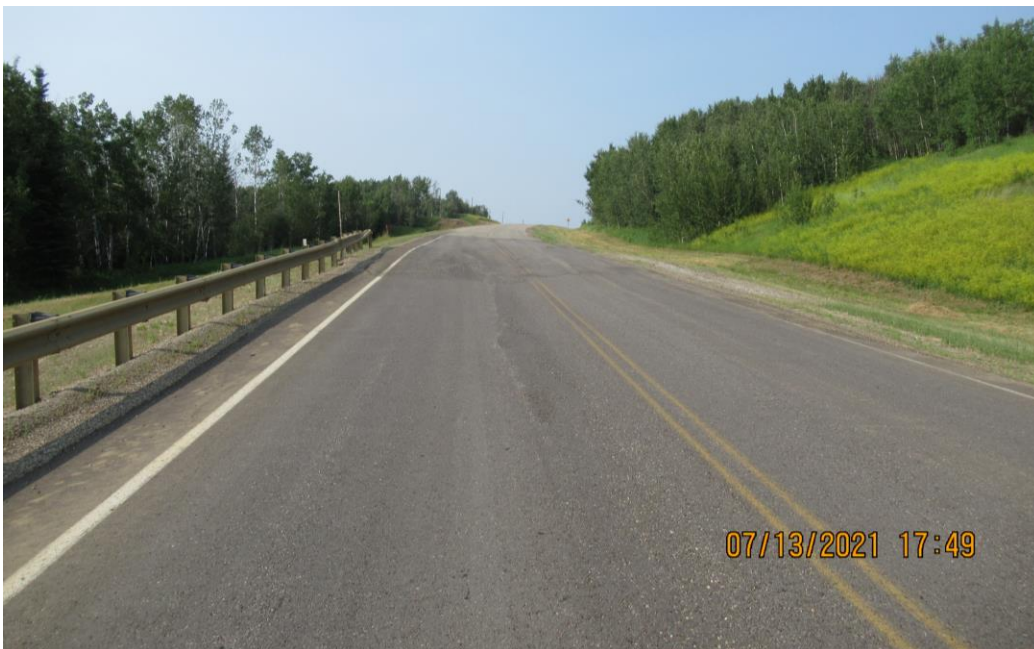
Pavement deflections and alligator cracks have showed up in both lanes (southbound lane worse) near each end of the upper pile wall where the lightweight (Geofoam) fill ends. The southbound lane ACP is

Photo 14 – Looking north along the highway at a fresh patch adjacent to the north end of the pile wall at Site 3. Note the hump near the north end of the Lightweight Fill.
