**ALBERTA TRANSPORTATION
GEOHAZARD ASSESSMENT PROGRAM
PEACE REGION (GRANDE PRAIRIE DISTRICT- NORTH)
2021 INSPECTION**

Site Number	Location	Name	Hwy	km
PH026	Eureka River North Hill	Sites #3, #5 and #6	726:02	10.1
Legal Description		UTM Co-ordinates (NAD83)		
SW13/SE14-86-8-W6		11 N 6258740	E 368408

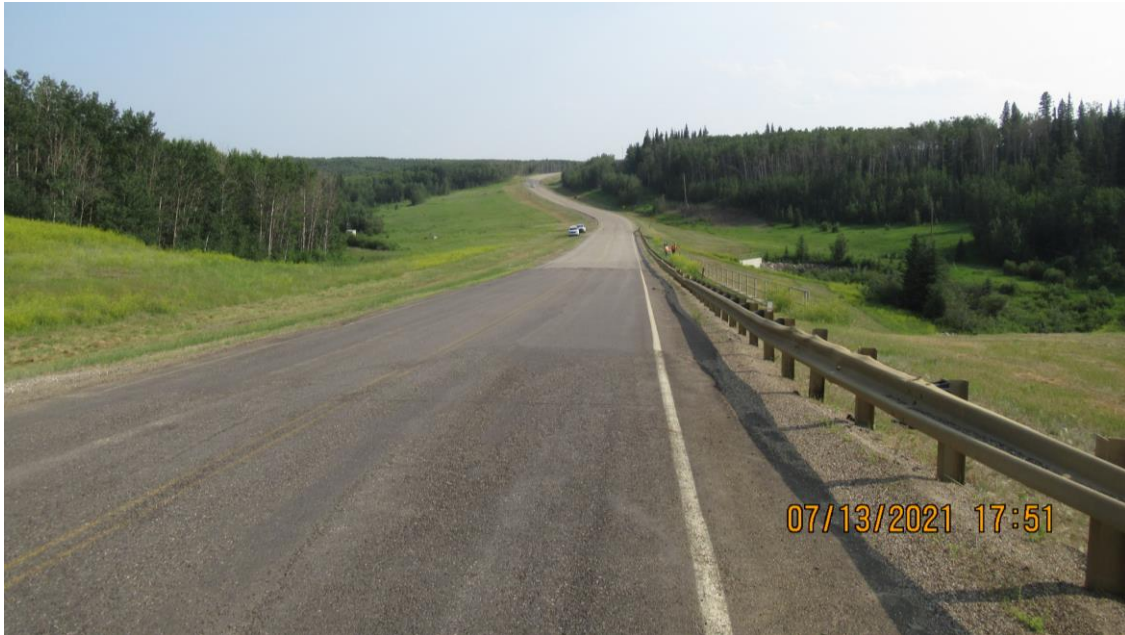
Photo 15 - Looking south along the highway from the hump in the fresh patch near the north end of the pile wall at Site 3.

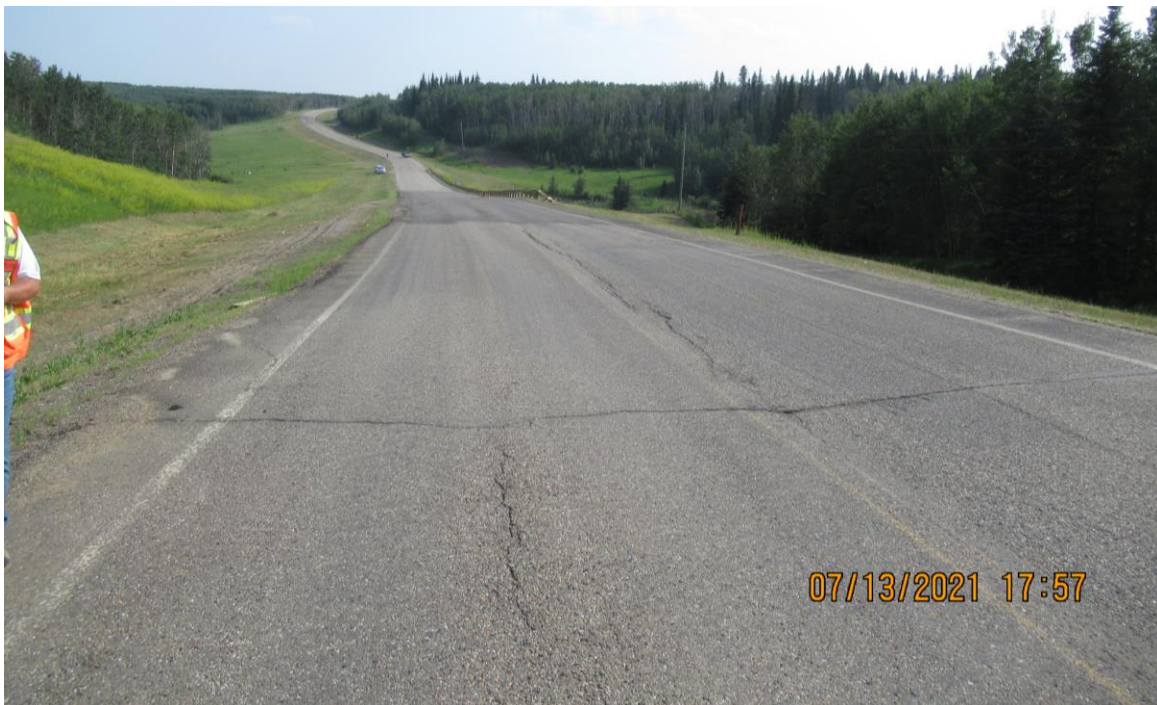
Photo 16 - Looking south along the highway at the distorted pavement and fresh patch further south, near the north end of Site 3/south end of Site 5. Note the broken Impact Attenuator on the north end of the guardrail.

- 1) Clean the gutter of soil/debris buildup under the handrail adjacent to the west side of the highway, and securely fasten the loose gutter grate.
- 2) Repair the damaged north collapsible guardrail end.
- 3) The spalled concrete on the surface of the upper pile wall should be repaired by placing a proper concrete sealant over the entire exposed surface to prevent any further degradation.
- 4) A steel sleeve could be installed over the gap in the handrail.

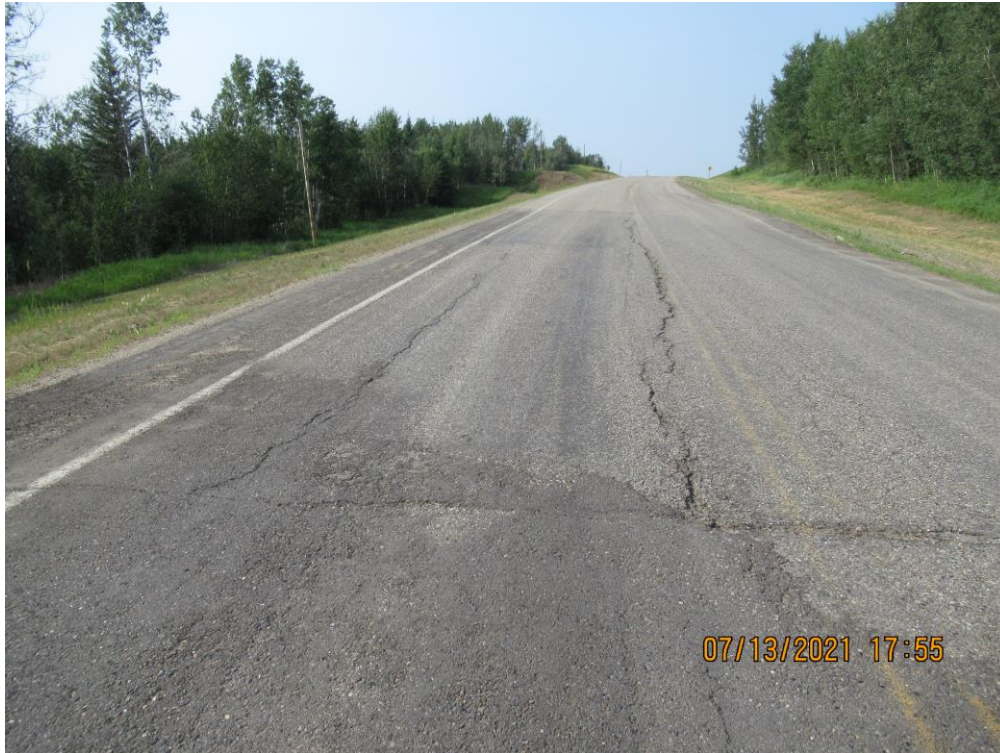
Slide features at/between the newer Sites 5 and 6 have not changed significantly over the last year, although a patch is proposed (and marked) at Site 6 for later this year. In previous years, more cracking, patching, distortion, and more pronounced subsidence over the dips had been noted. The cracks observed between the intermittent cracks previously found along the east ditch/backslope and the subsidence also were basically unchanged this year. The inclinometers installed in 2011 (SI's 11-3, -5, -6 and -7), which were previously showing movements in the order of 15 to 25 mm/year, have all sheared off within the last few years, except for SI's 11-3 and 11-4 which are located very near the top of the slide scarp. This indicates movements are occurring at both Sites 5 and 6, in addition to between them, at depths as deep as 18.5 m below ground surface. This more closely defines the slide boundary between Sites 5 and 6 and outlines the edge of a single larger slide moving towards the river.

Photo 17 - Looking north along the highway at the additional subsidence in the NBDL and shoulder at Site 5.

Continue to mill, patch, and crack seal the highway as required at Sites 5 and 6.

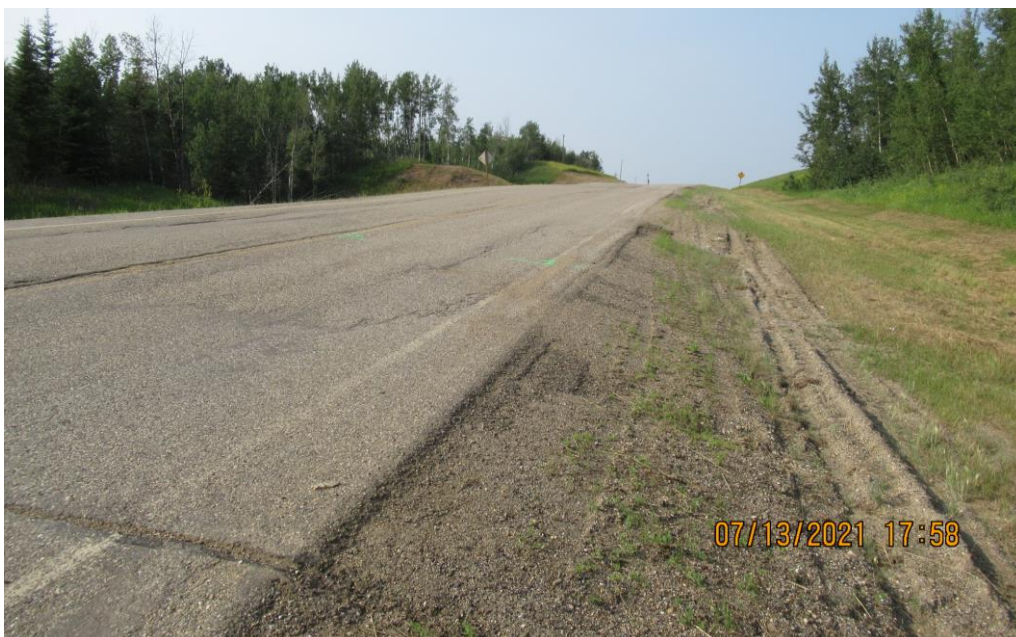
Photo 18 - Looking north along the east highway ditch and backslope slump at Site 5.

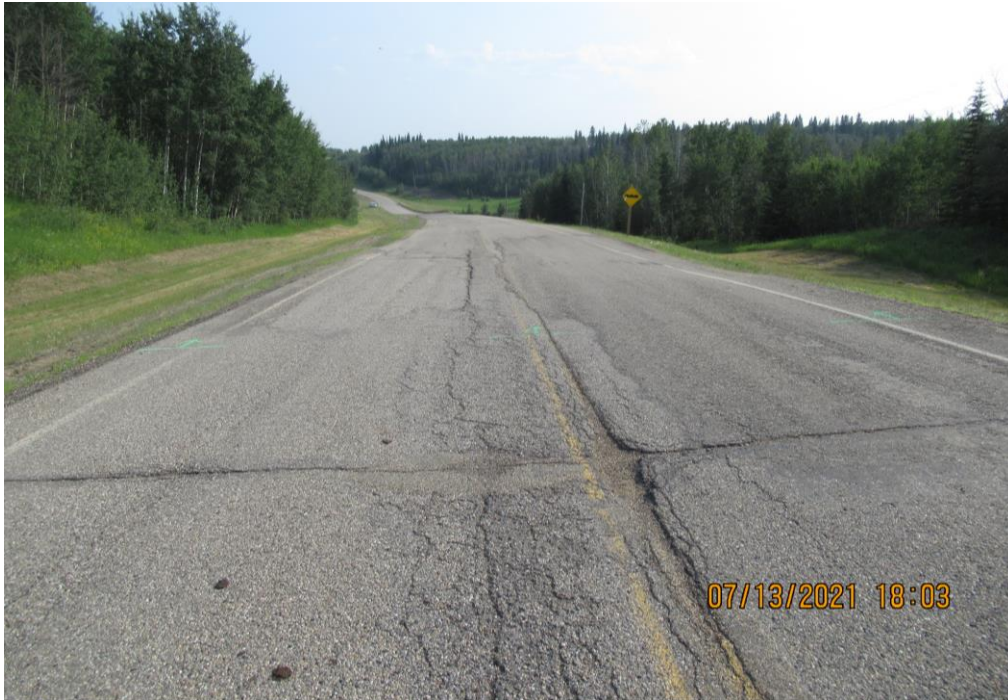
Photo 19 - Looking south along the highway at the fatigued pavement along the north end of Site 5. Note the settled east ditch and scarp that crosses the highway.

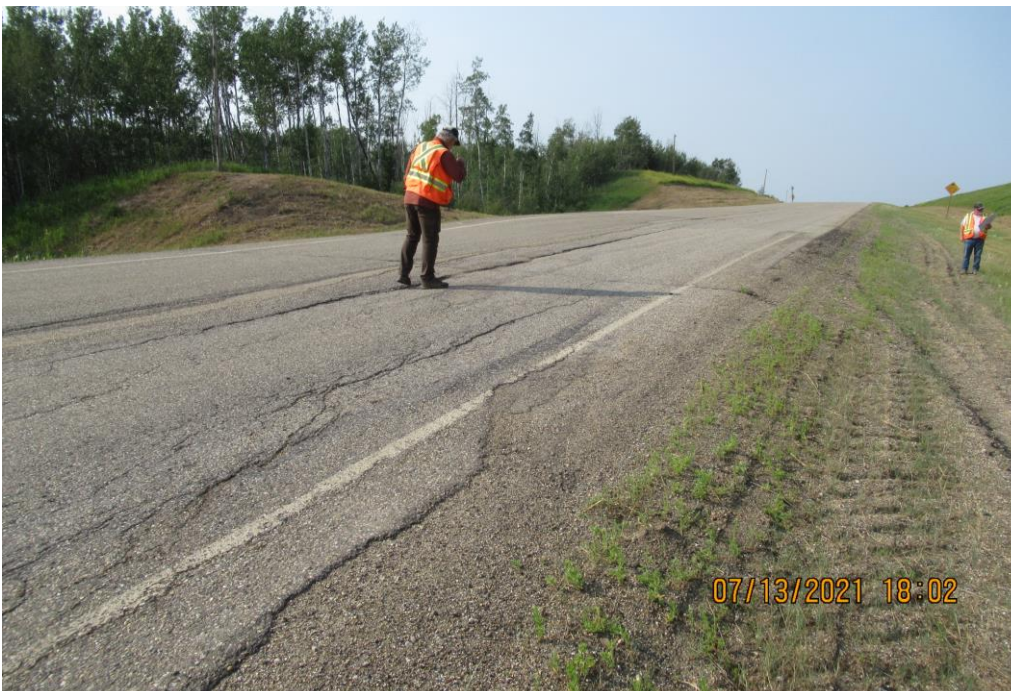
Photo 20 - Looking northwest from the east highway edge at where the slide scarp crosses the highway at the north end of Site 6.
