November 22, 2022

**ALBERTA TRANSPORTATION GRMP (CON0022165)
PEACE REGION (GRANDE PRAIRIE DISTRICT – NORTH)
INSTRUMENTATION MONITORING RESULTS – FALL 2022**

SITE PH026: HWY 726:02, EUREKA RIVER (SITES 3, 5 AND 6)

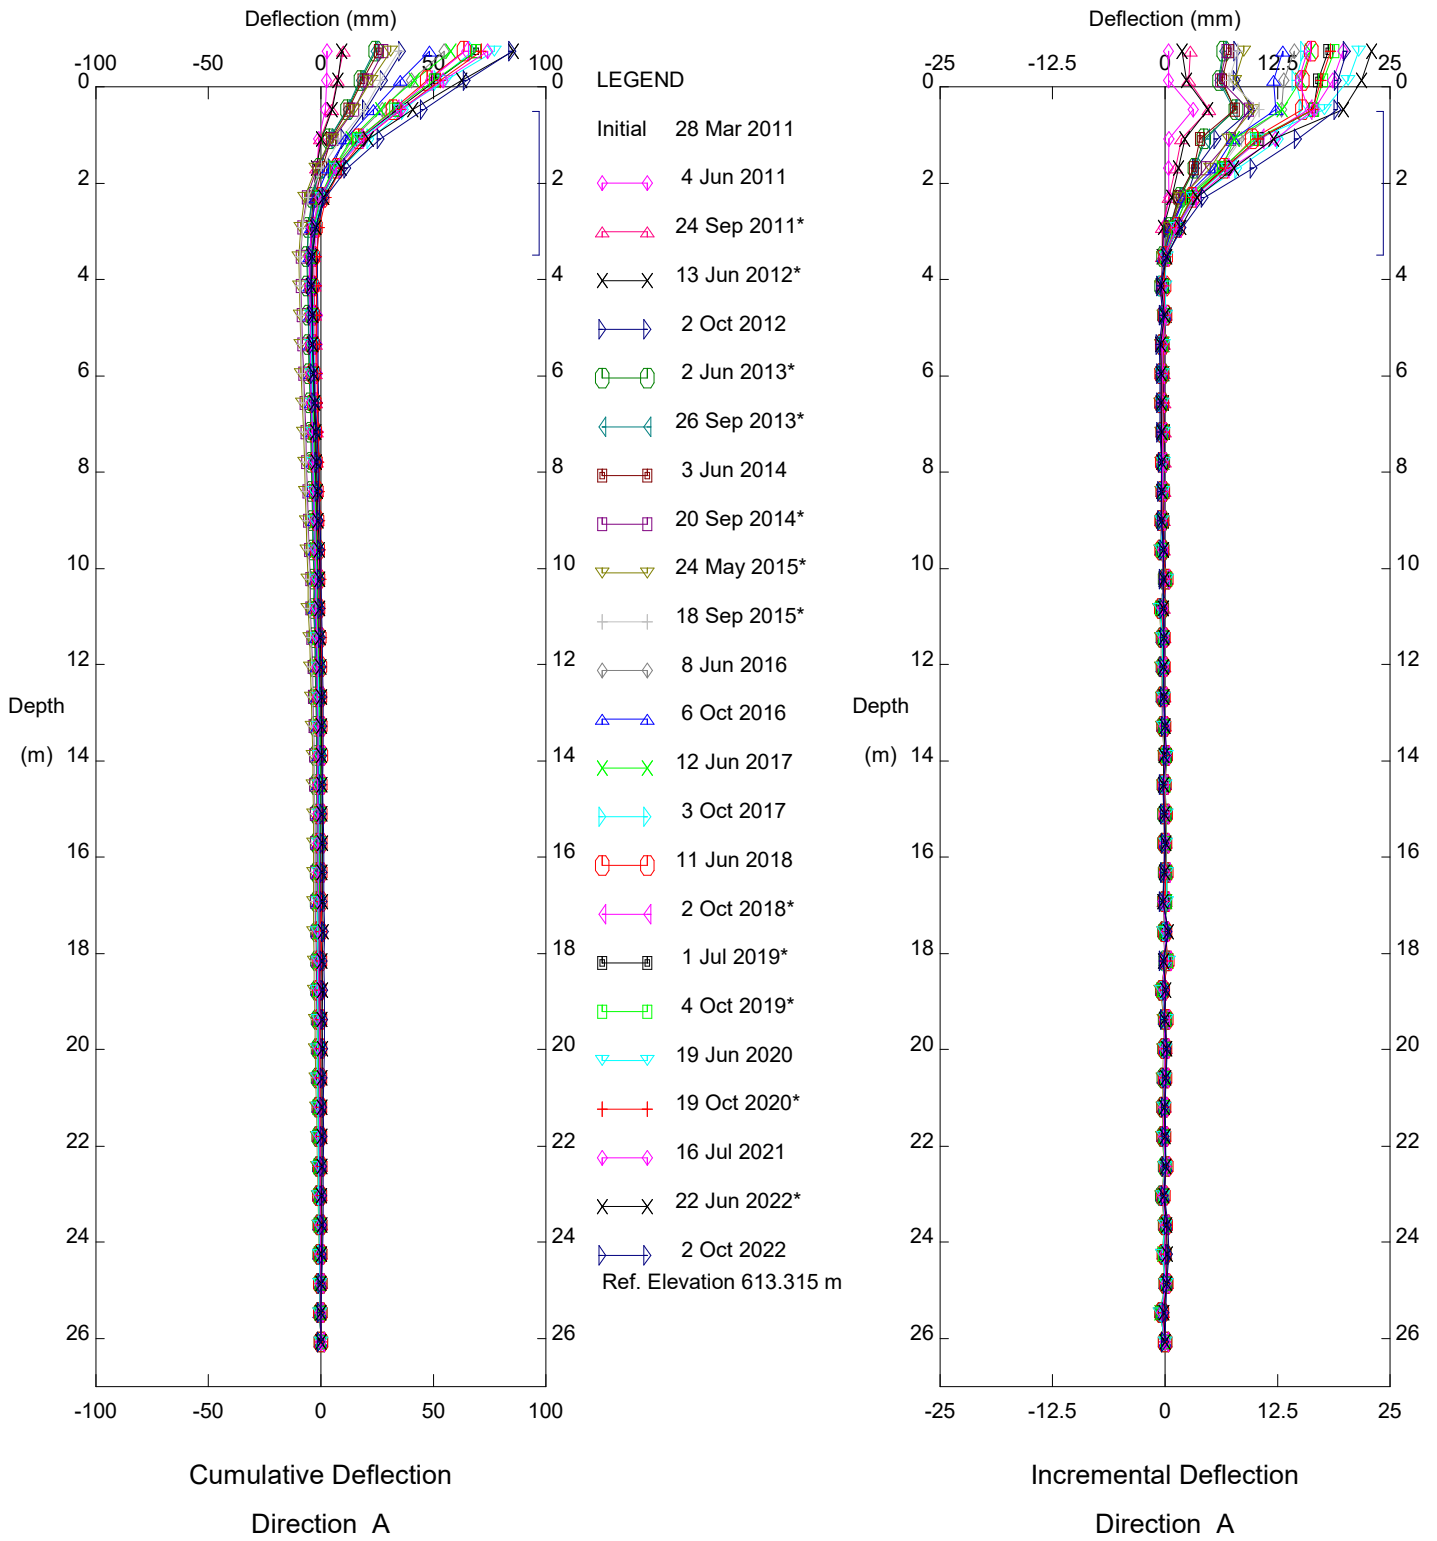
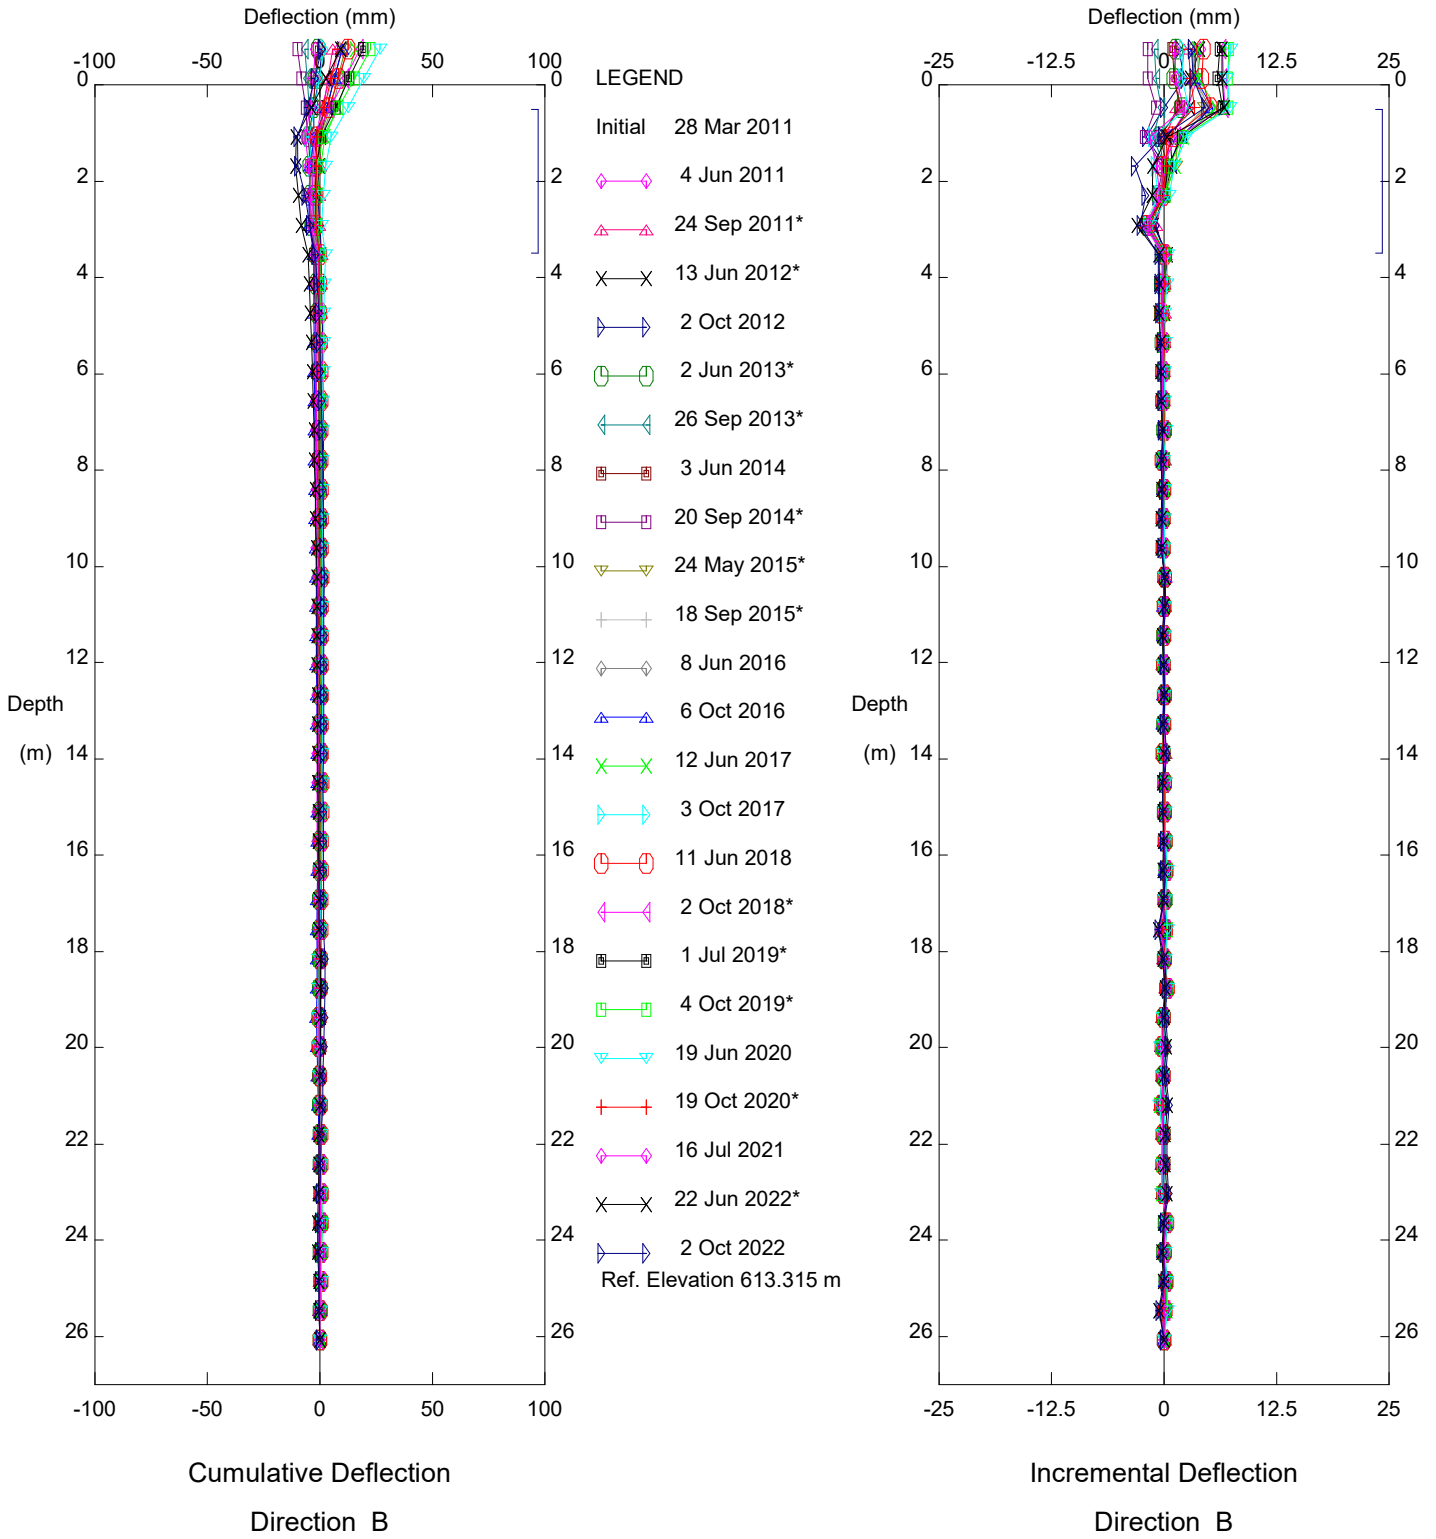
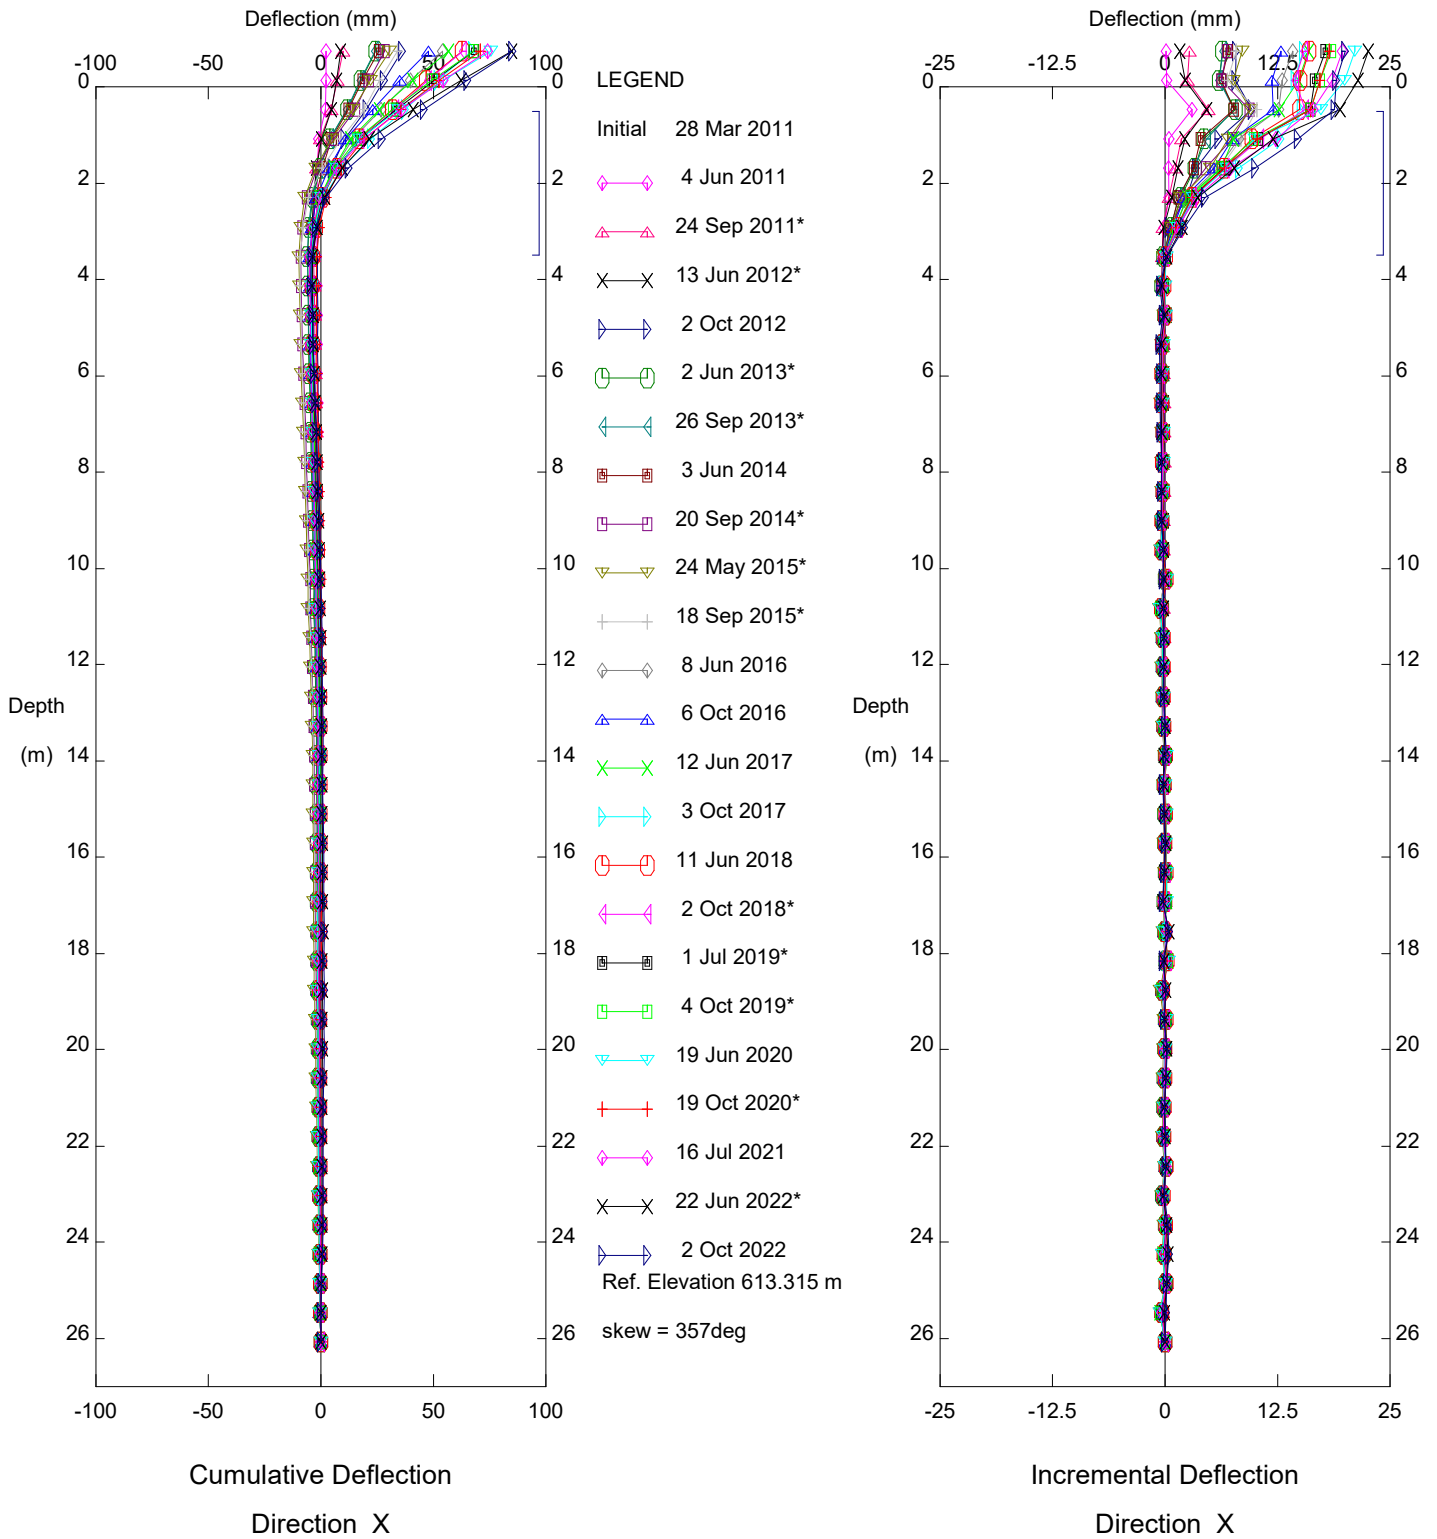
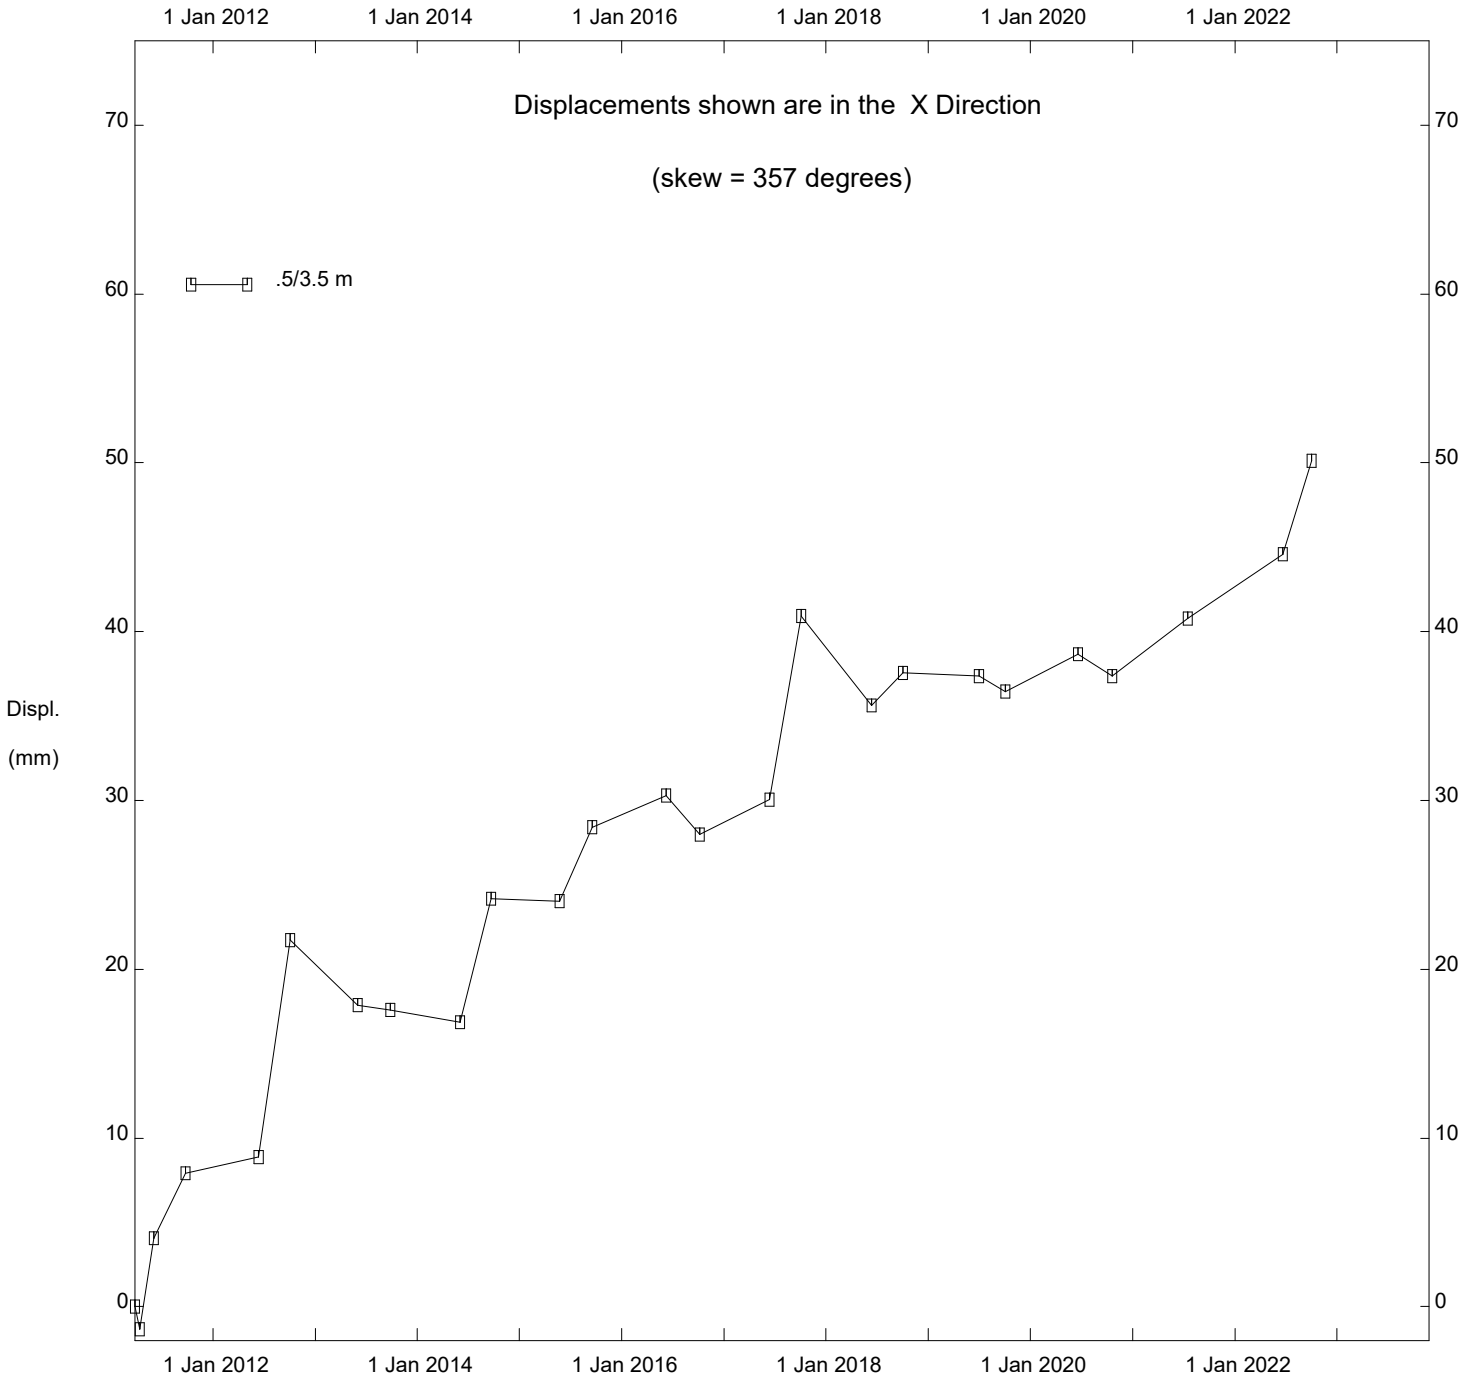
Hwy 726:02 Eureka River, PH026, Inclinometer SI11-3

43.7 mm over 8.1 m to 10.0 m depth in 260° direction	74.8 mm/yr between May and Oct. 2008			N/A	N/A	N/A
SI11-3	March 28, 2011	50.1 mm over 0.5 m to 3.5 m depth in 232° direction	42.3 mm/yr in October 2012	Active	June 22, 2022	5.5	19.7	15.6
SI11-4	March 27, 2011	No discernible movement	N/A	Active	June 22, 2022	N/A	N/A	N/A

The current rate of movement in SI11-3 is 19.7 mm/yr over 0.5 m to 3.5 m depth since the spring of 2022 readings. SI11-4 continued to show no discernible movement.

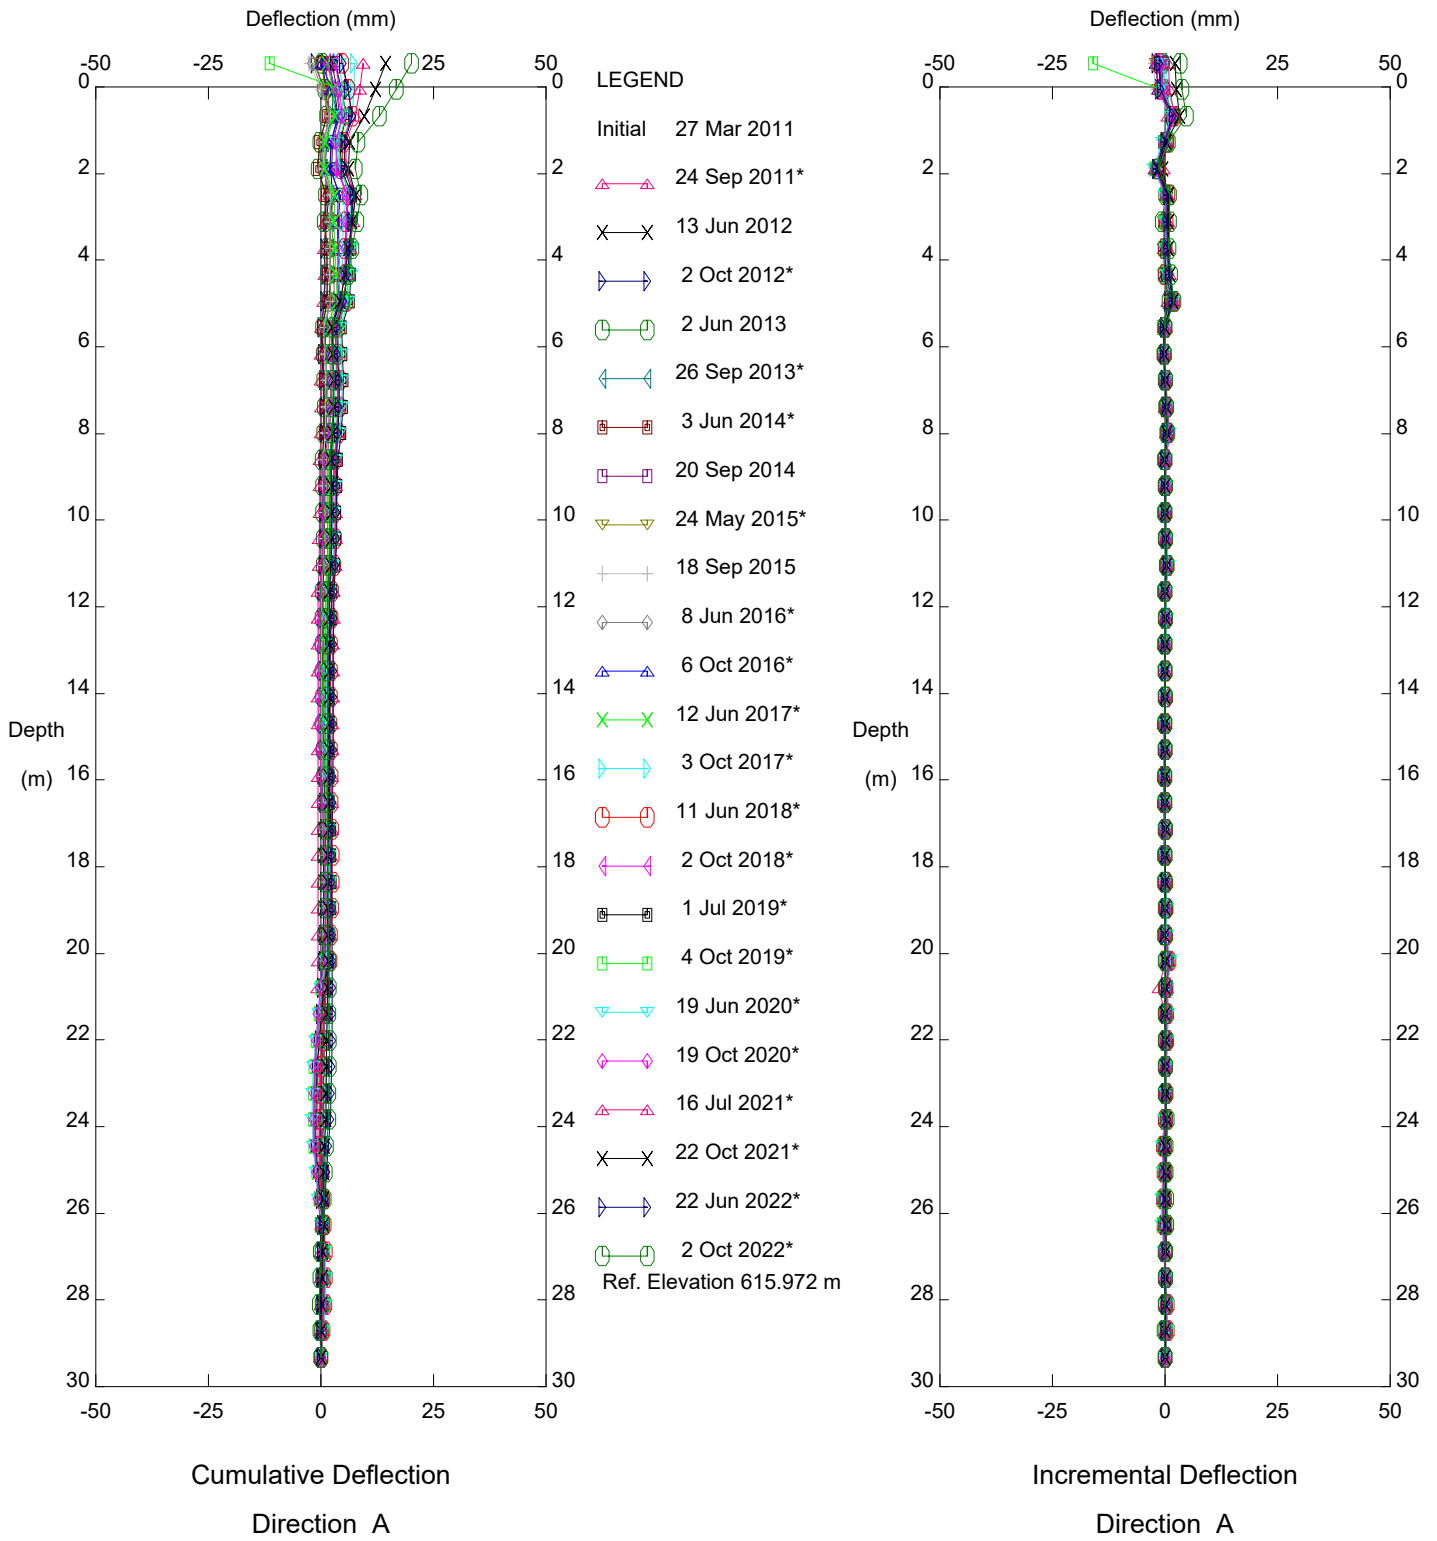
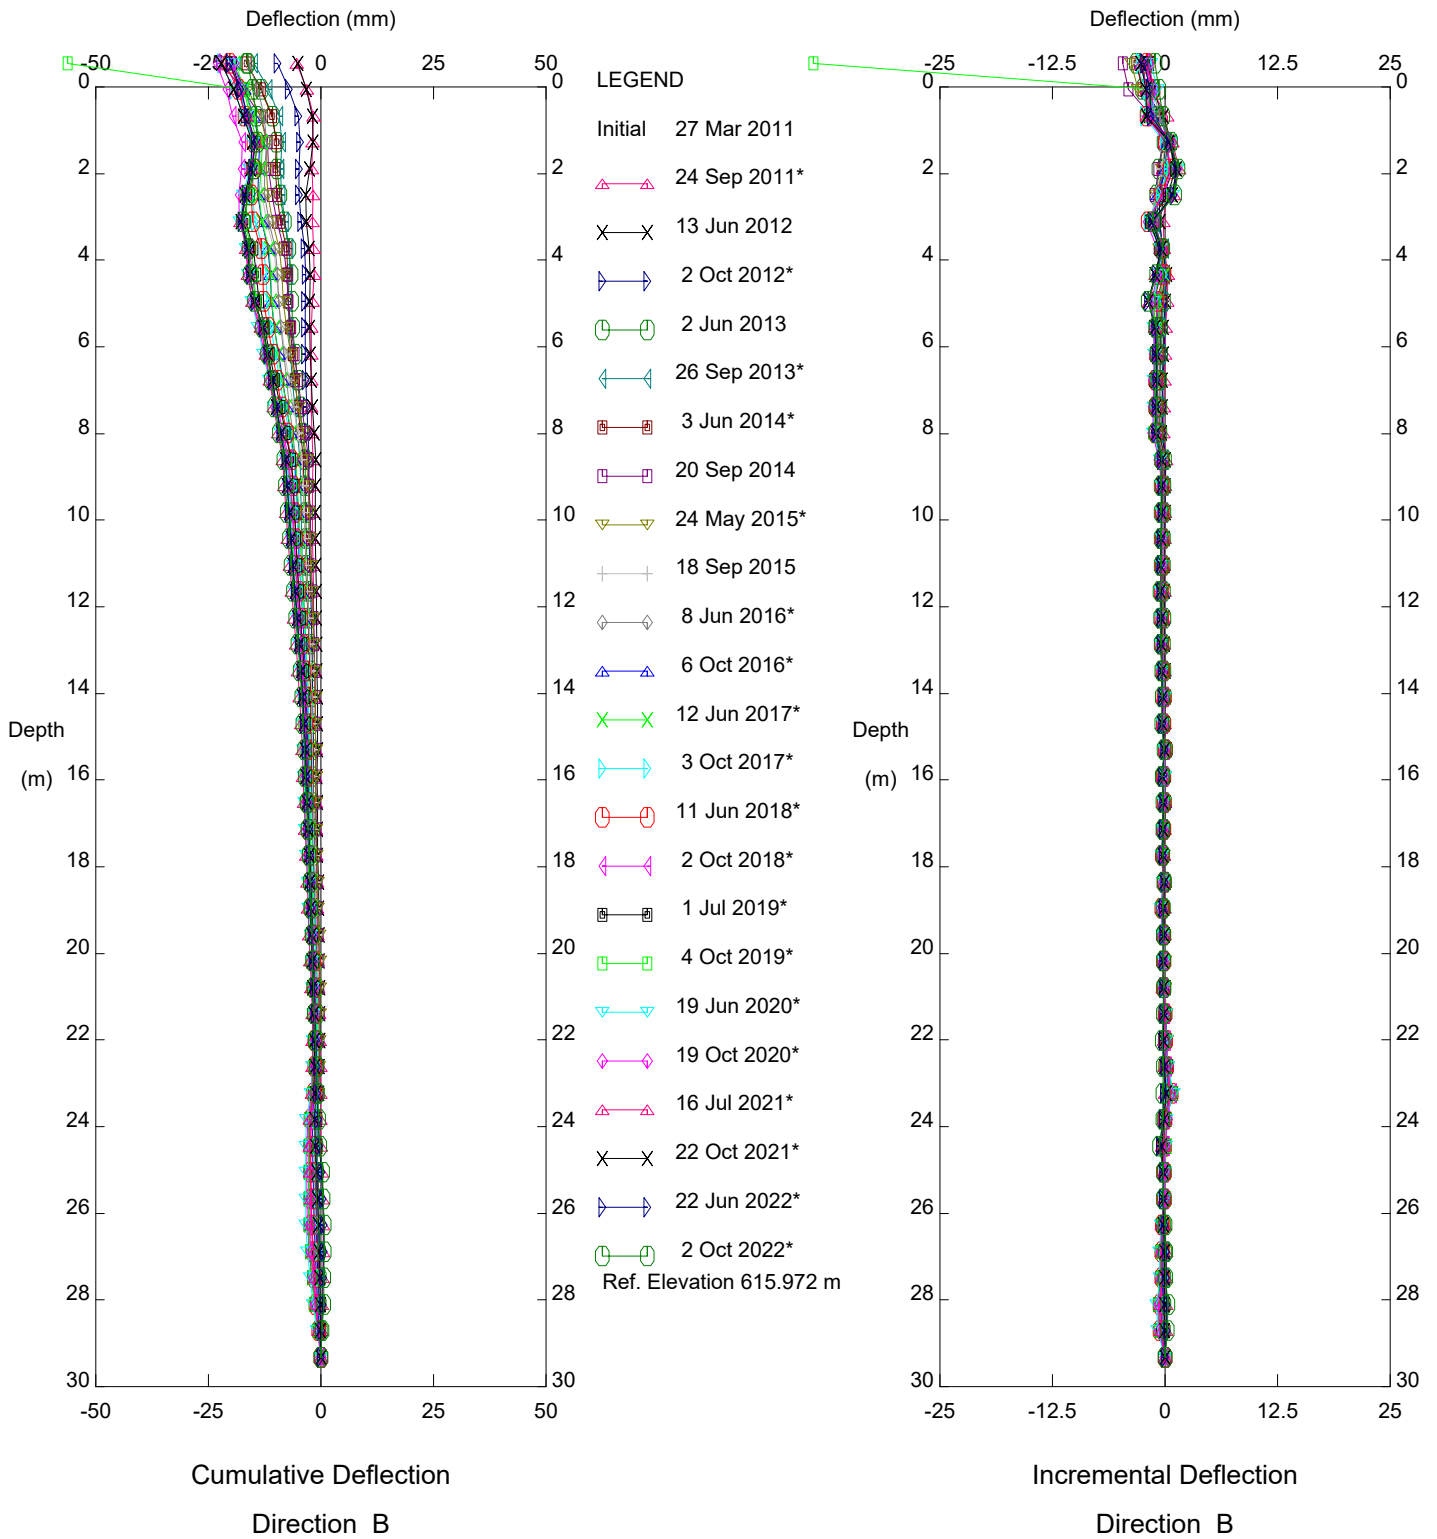
Hwy 726:02 Eureka River, PH026, Inclinometer SI11-4

A zone of movement was previously tracked in SI11-4 over 0.1 m to 9.8 m depth. However, this zone has not shown a consistent movement trend for several years and is also showing an apparent movement in the upslope direction, which is likely related to frost movement. Because of these factors, this movement zone will no longer be reported for this instrument.

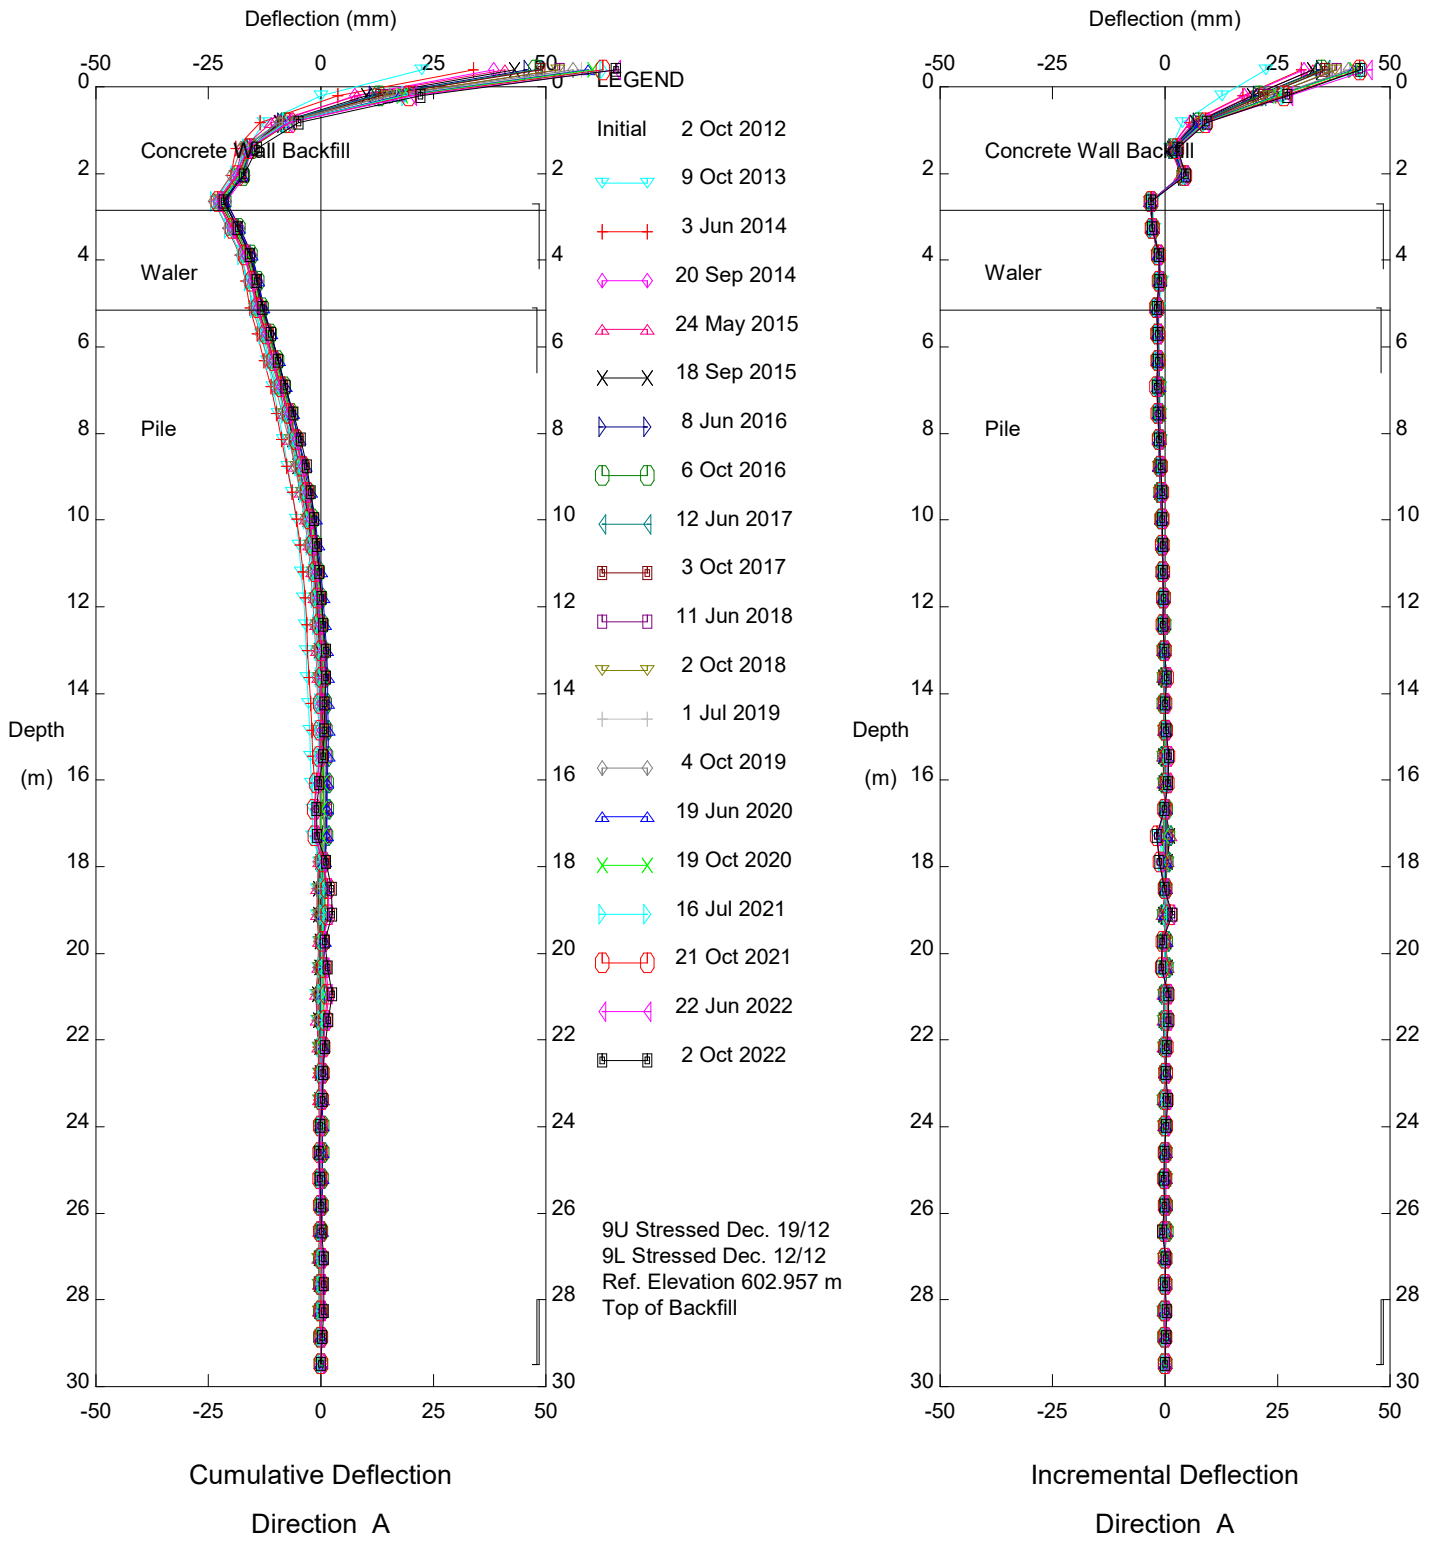
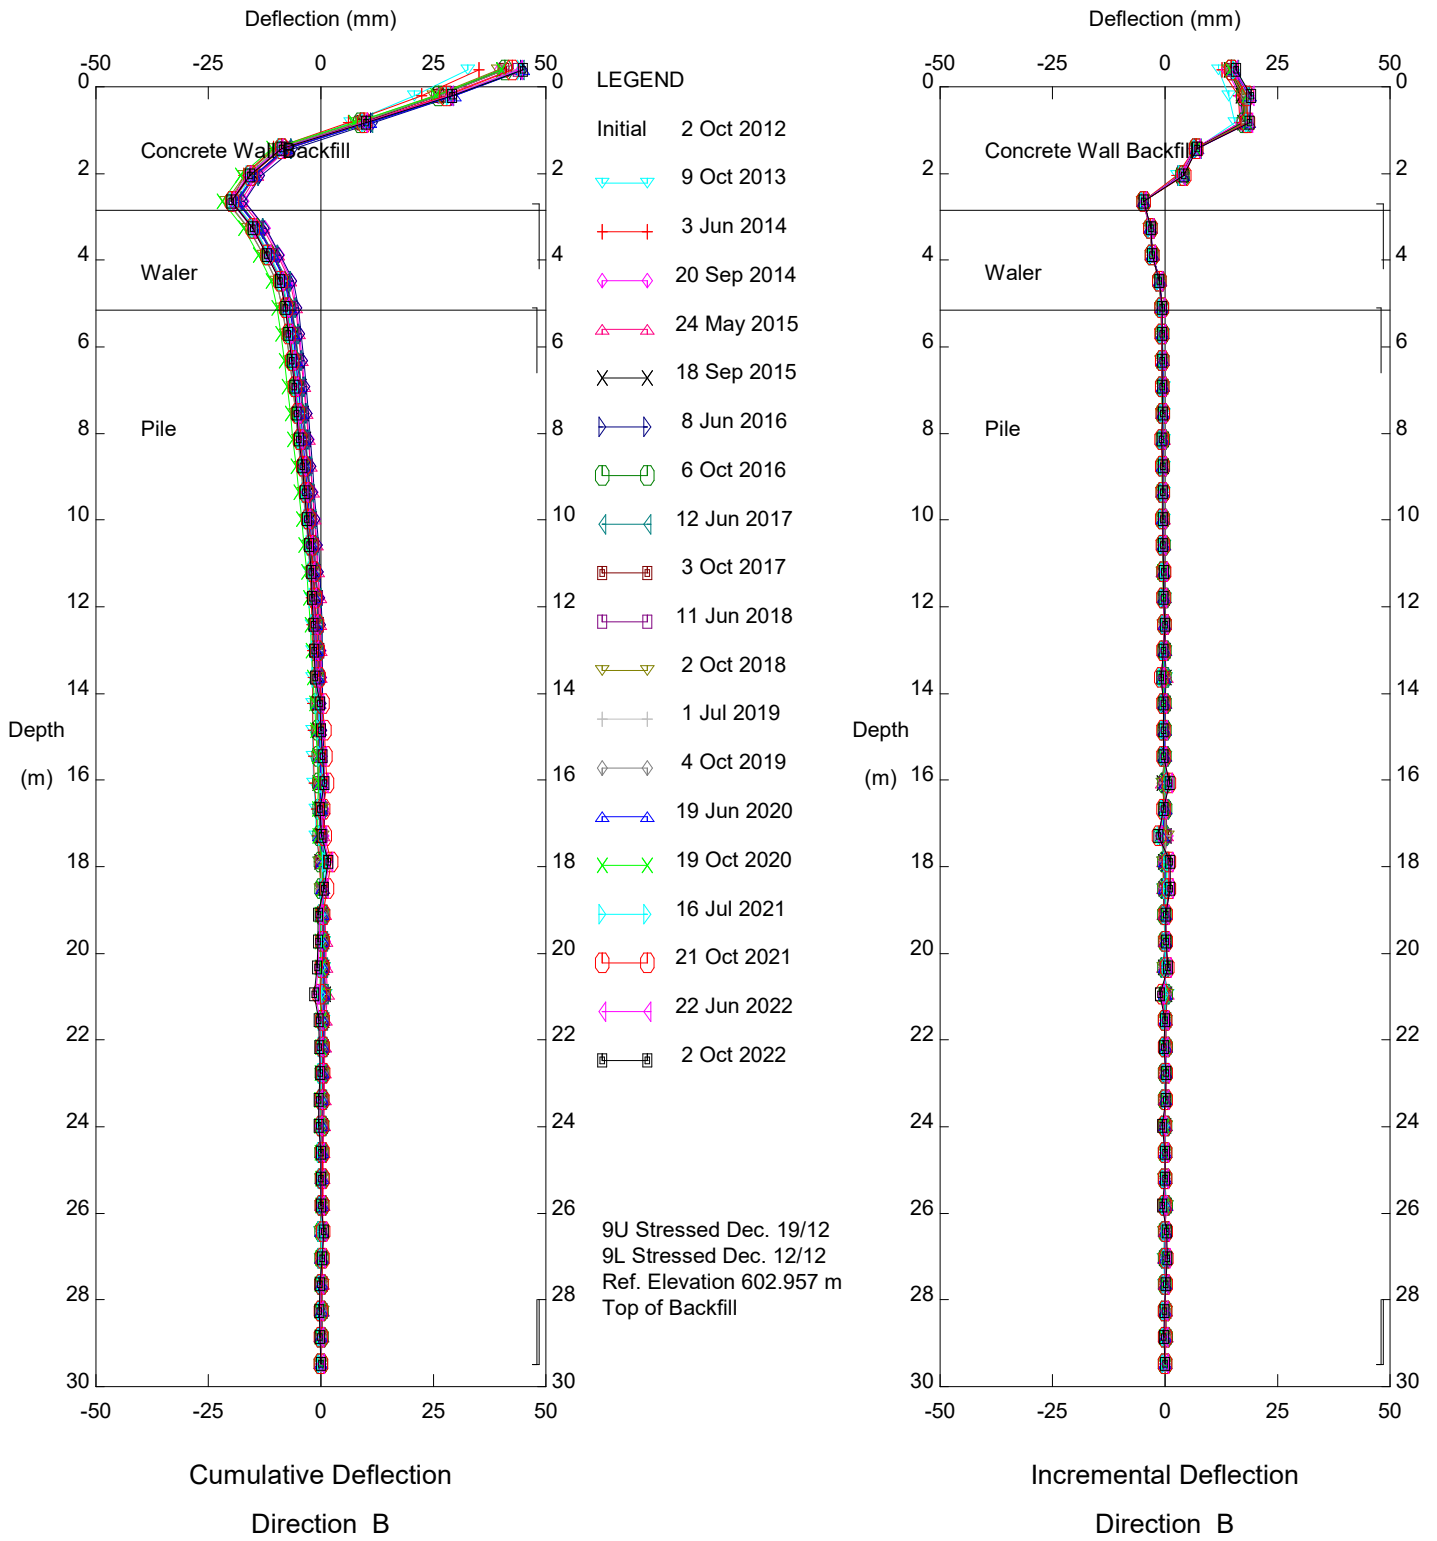
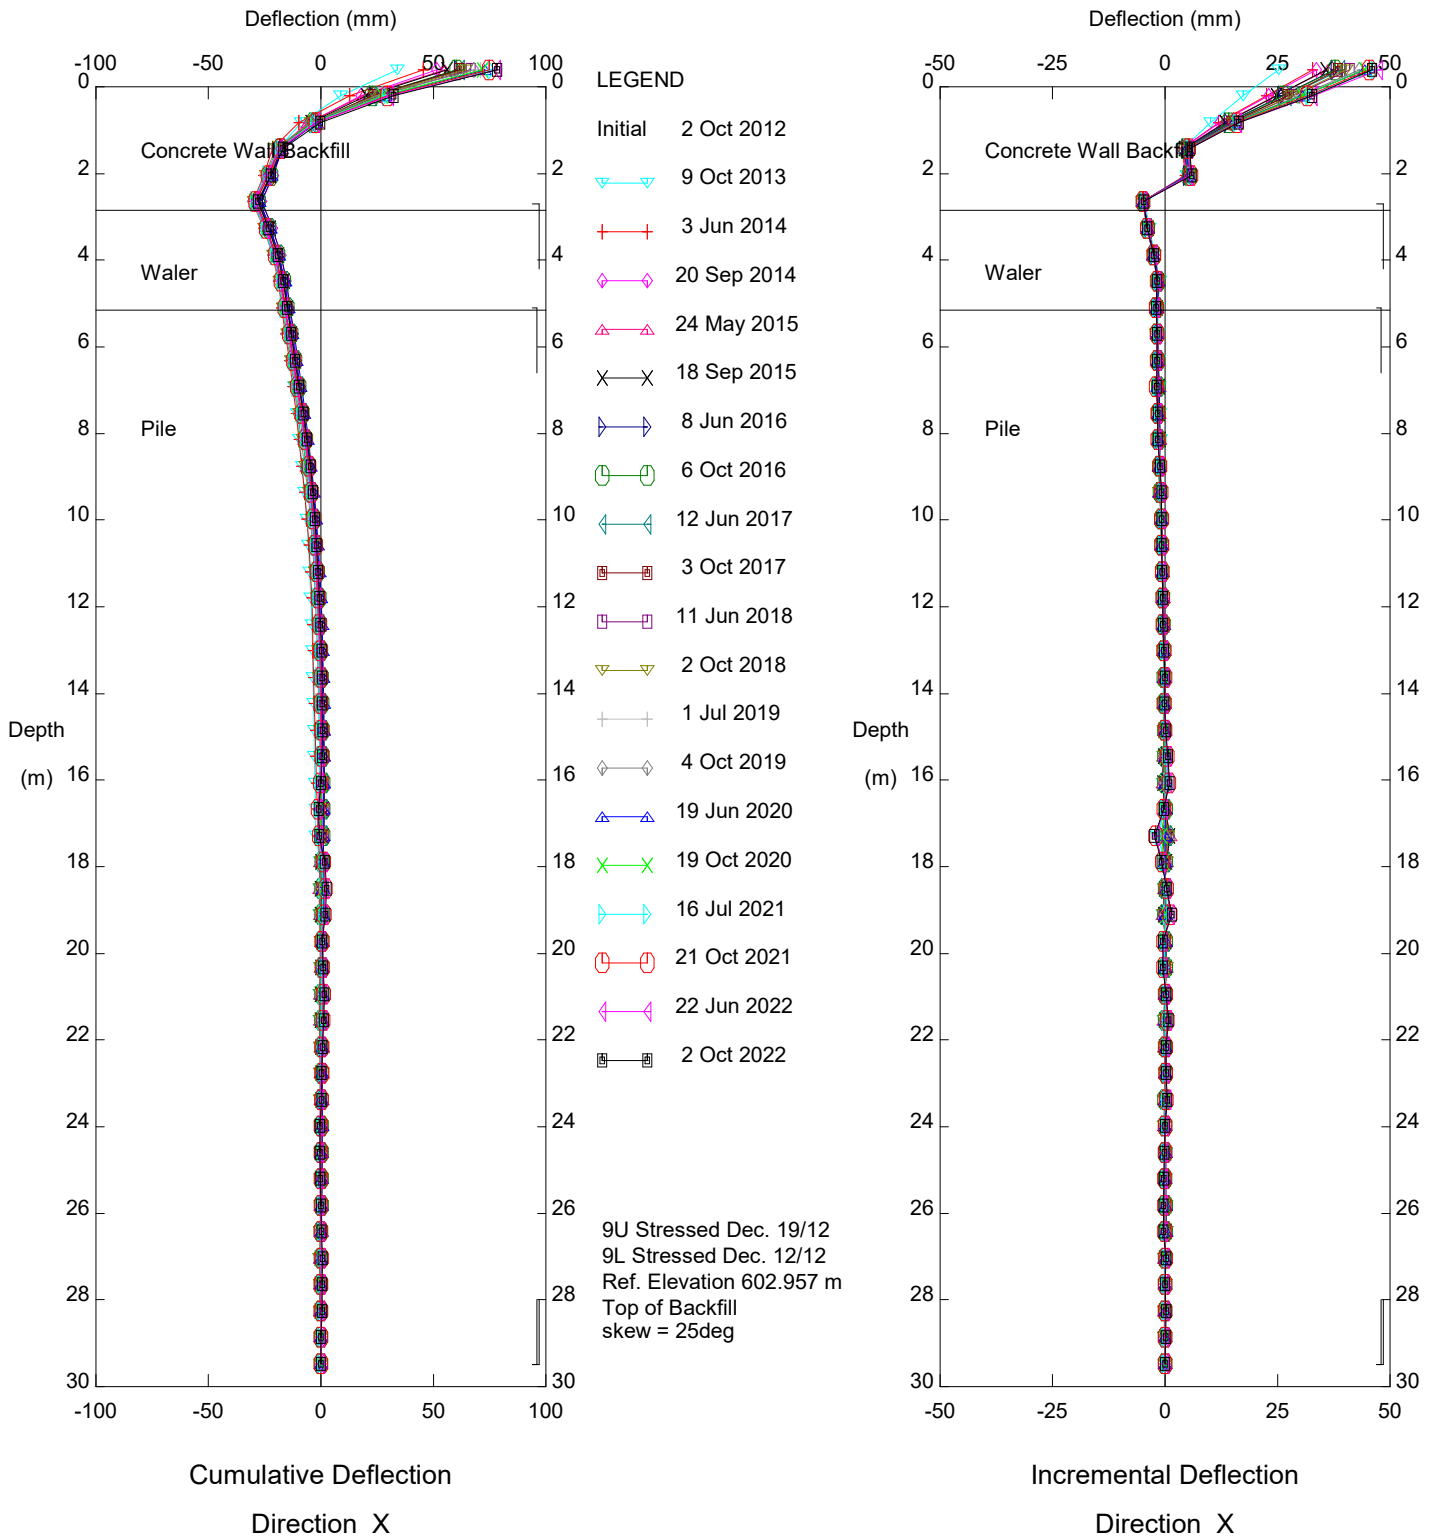
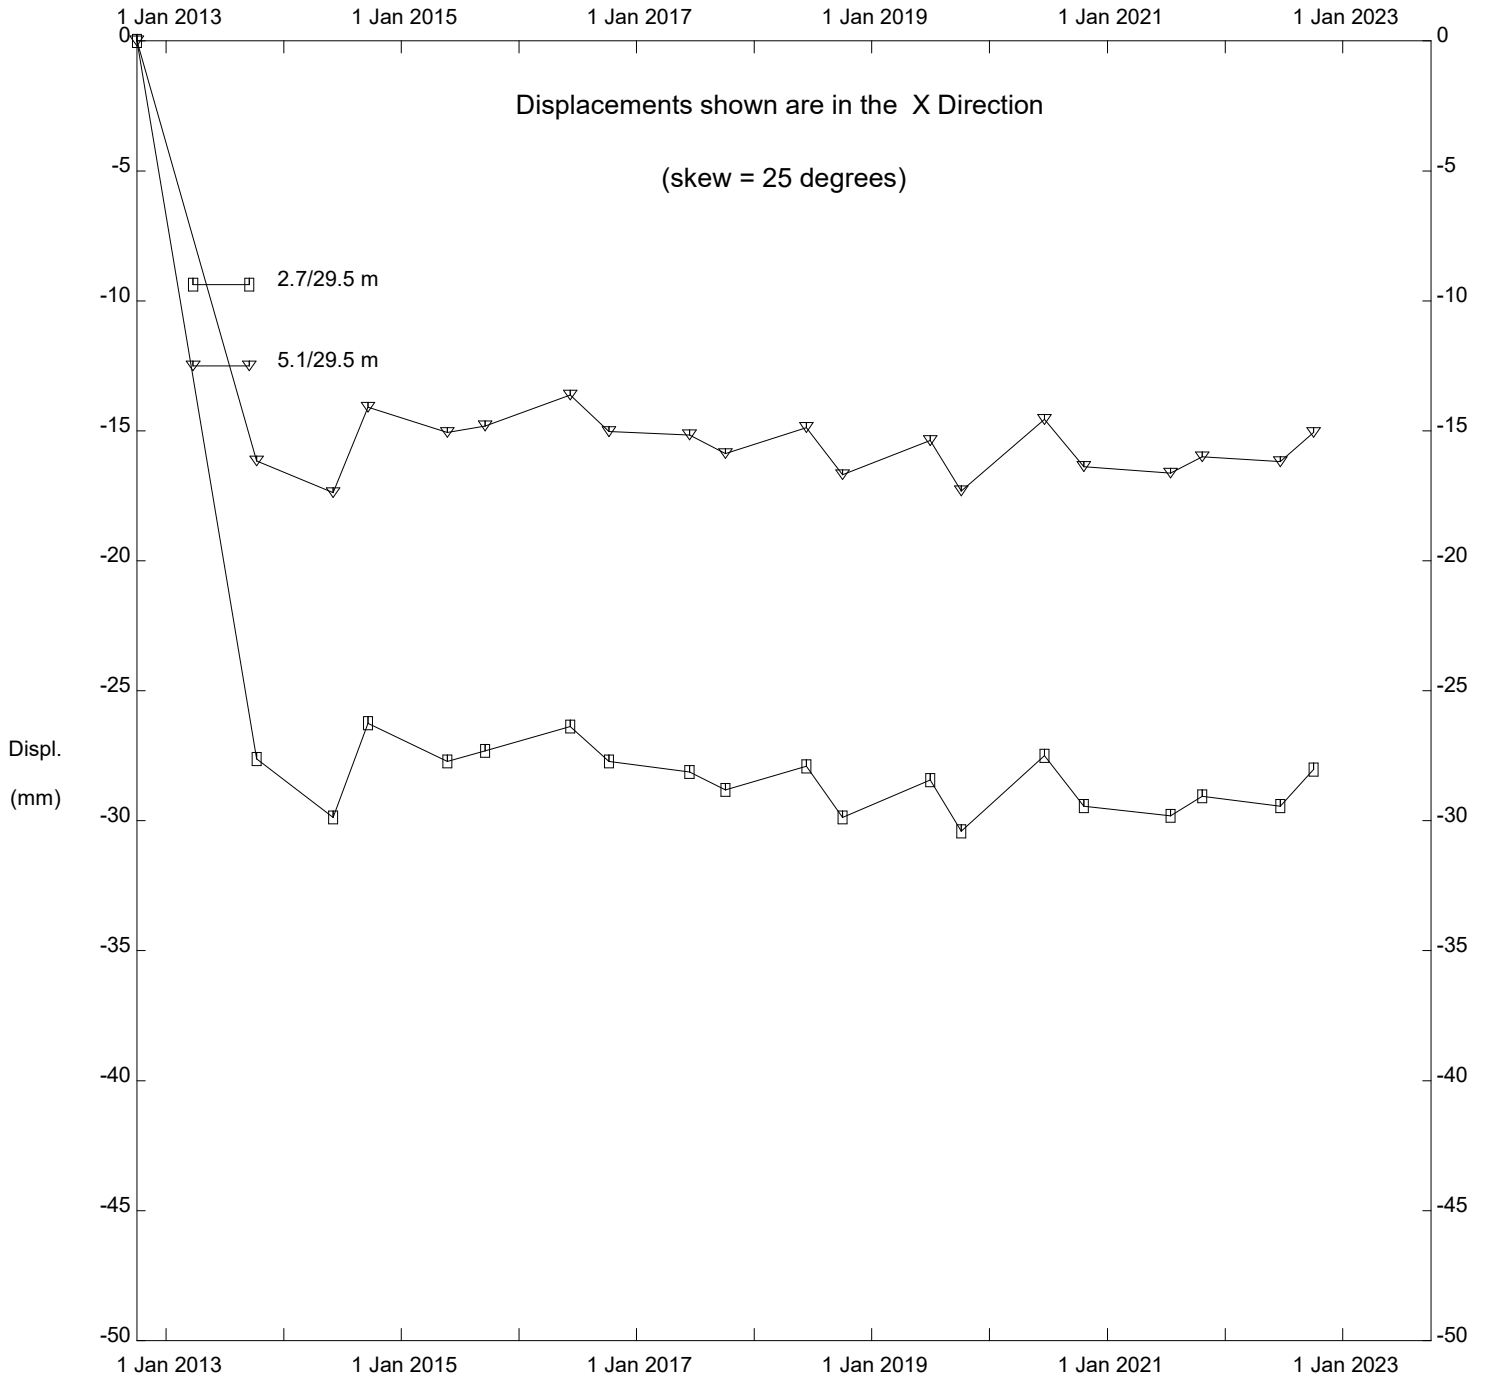
PH026 Eureka River Upper Wall, Inclinometer SI12-P9U

Since the fall of 2021, SI12-P9U showed a rate of movement of 5.0 mm/yr over the length of the waler and pile from 2.7 m to 29.5 m depth, and a rate of movement of 4.0 mm/yr over the length of the pile only from 5.1 m to 29.5 m depth. The total pile head movement to date has been 15.1 mm in the upslope direction.
