November 22, 2022

**ALBERTA TRANSPORTATION GRMP (CON0022165)
PEACE REGION (GRANDE PRAIRIE DISTRICT – NORTH)
INSTRUMENTATION MONITORING RESULTS – FALL 2022**

SITE PH026: HWY 726:02, EUREKA RIVER (SITES 3, 5 AND 6)

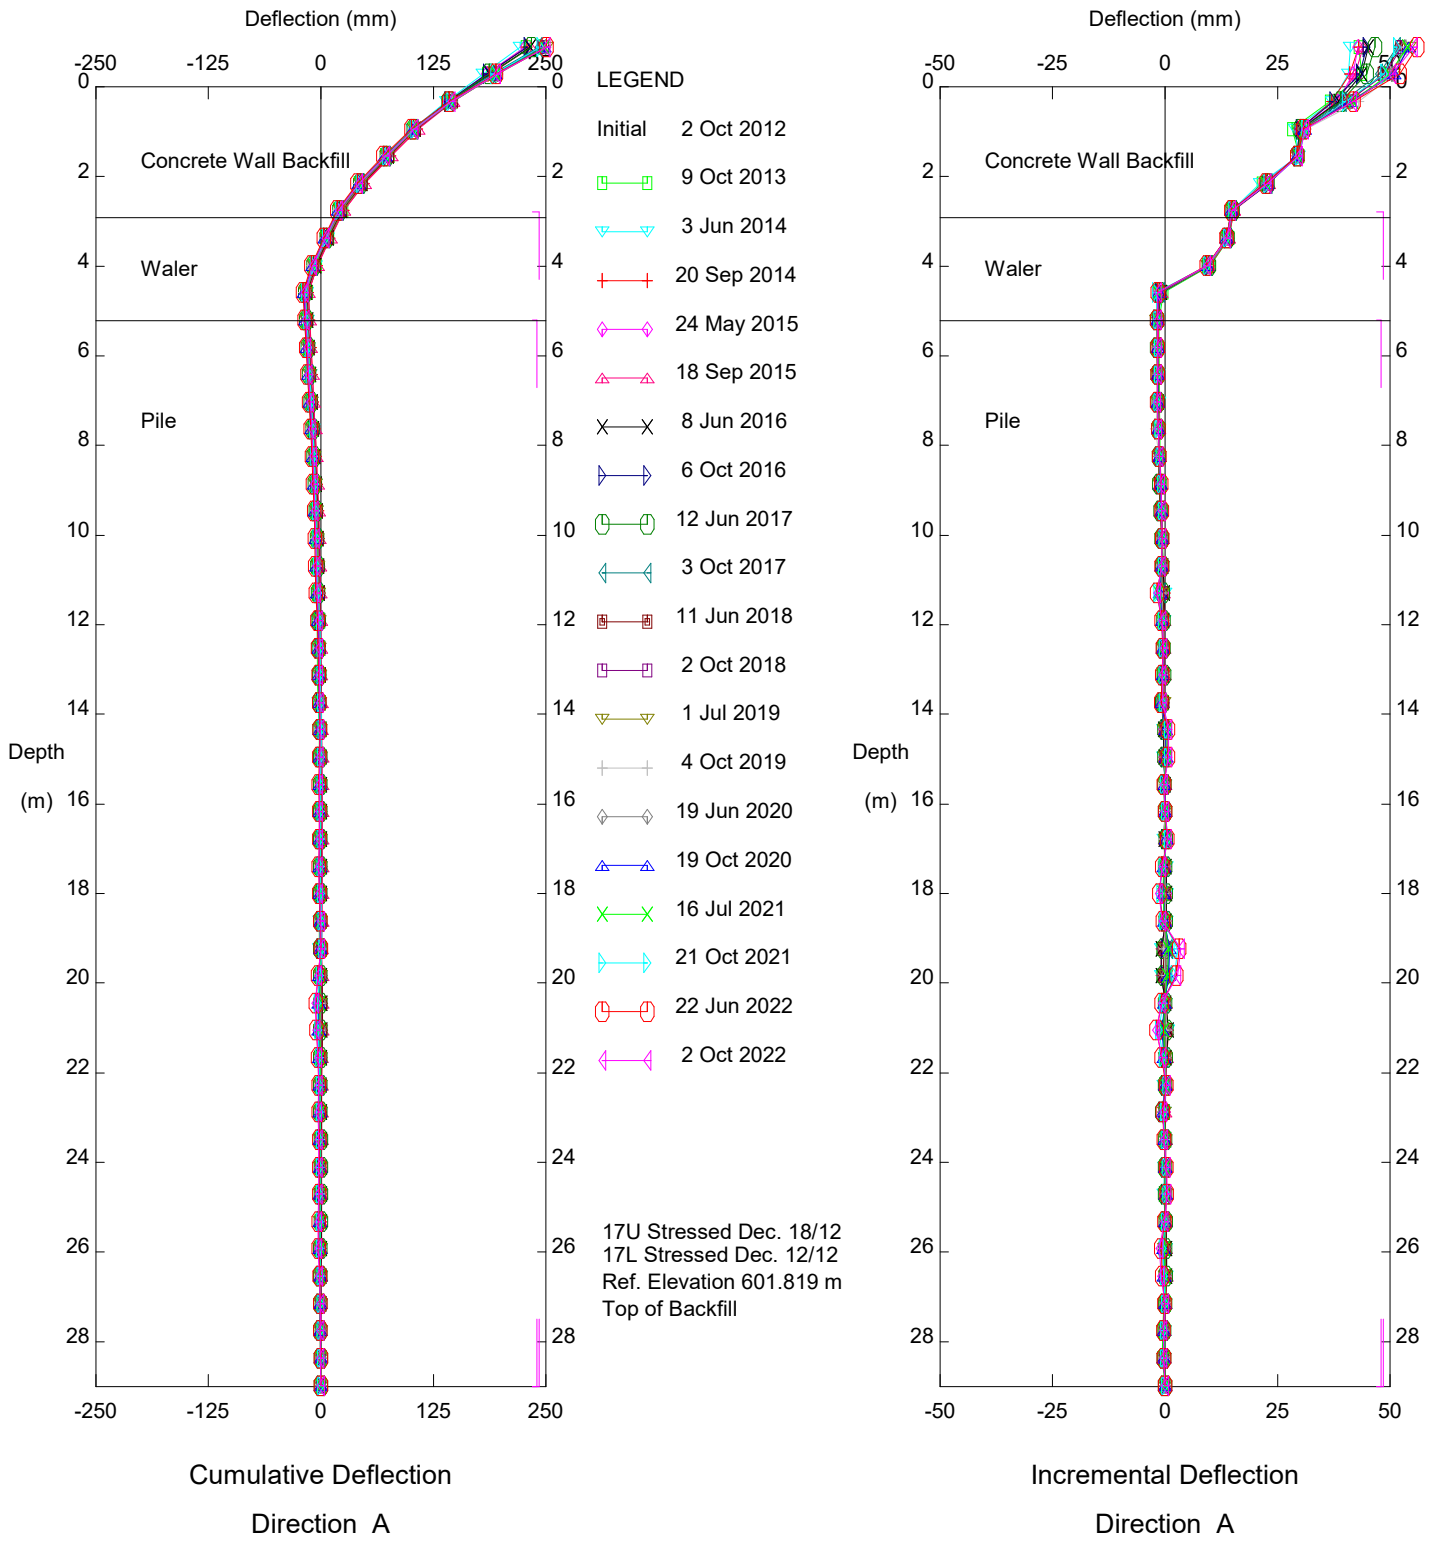
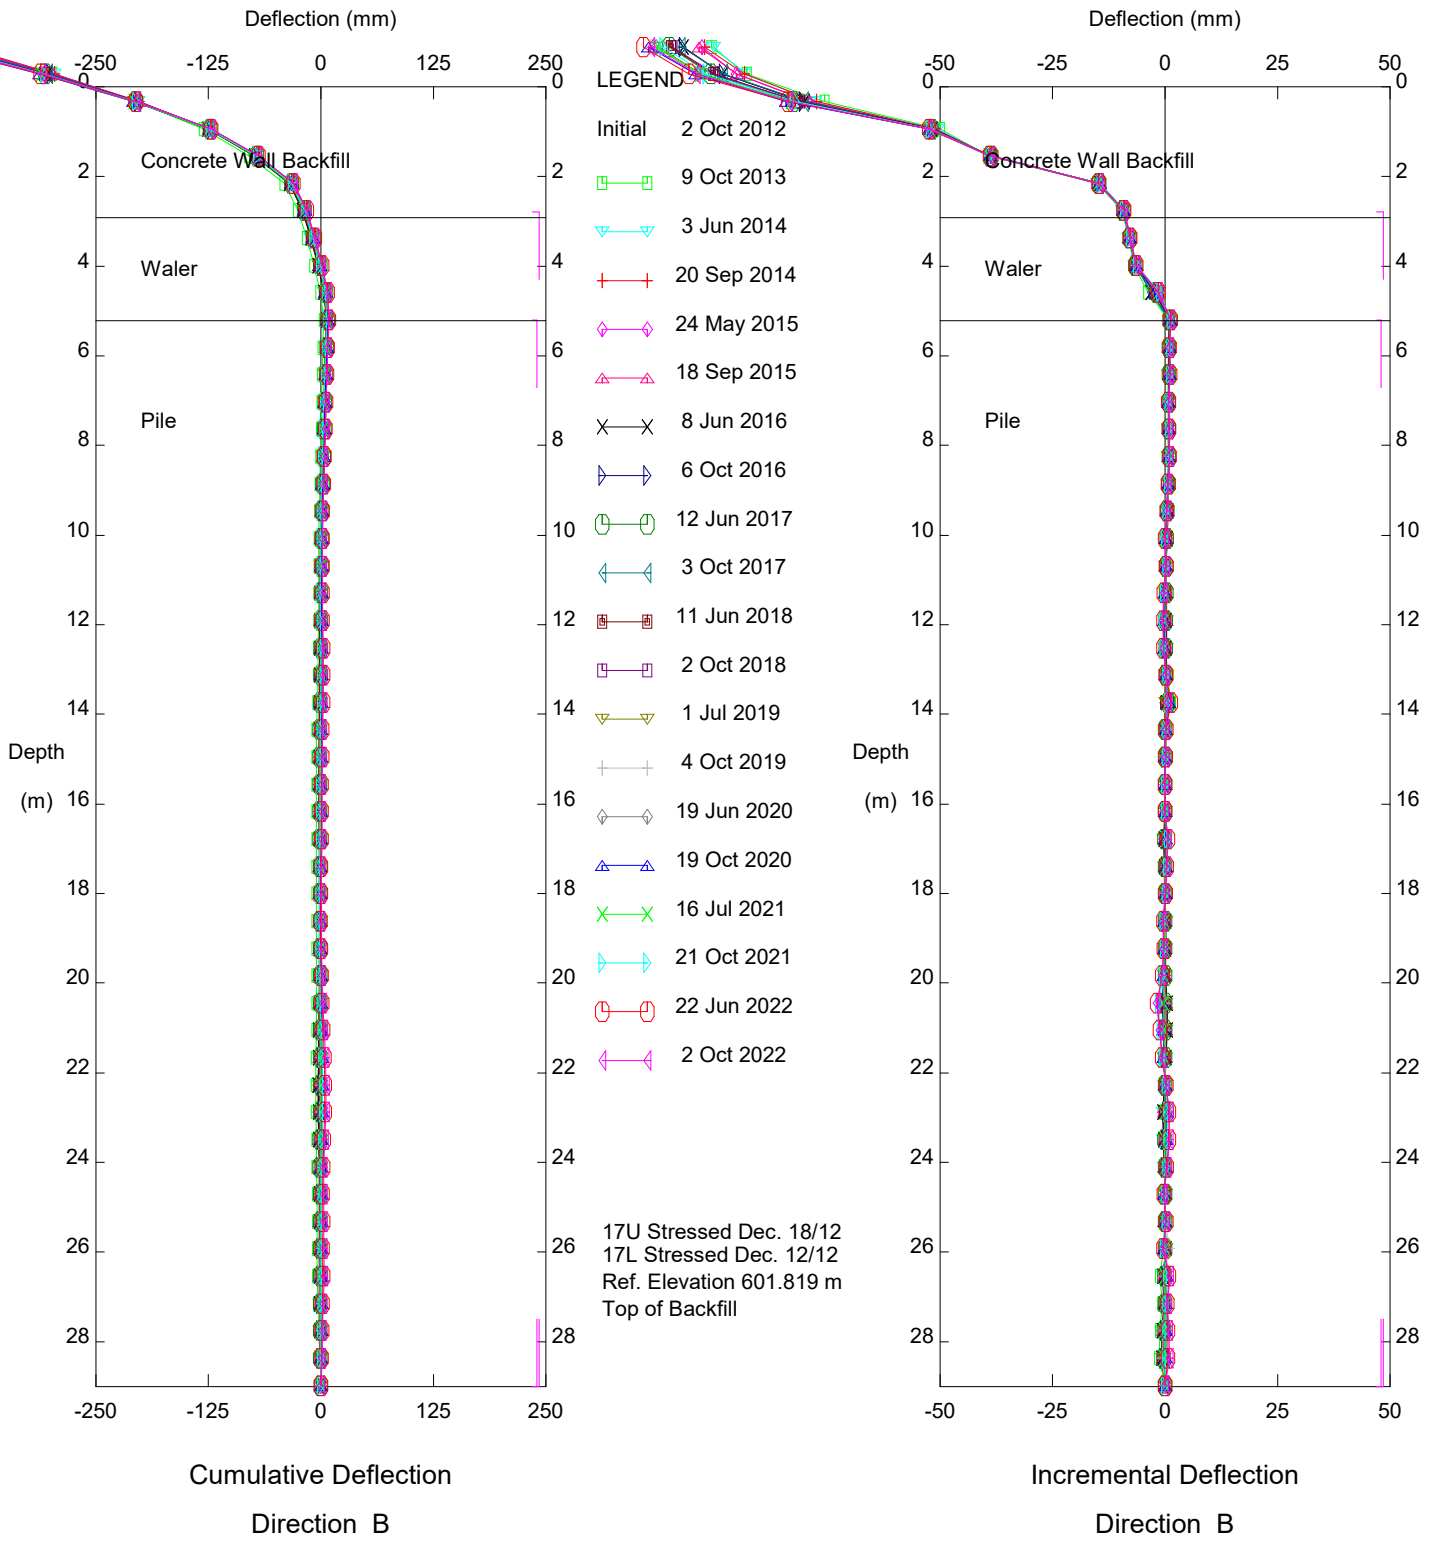
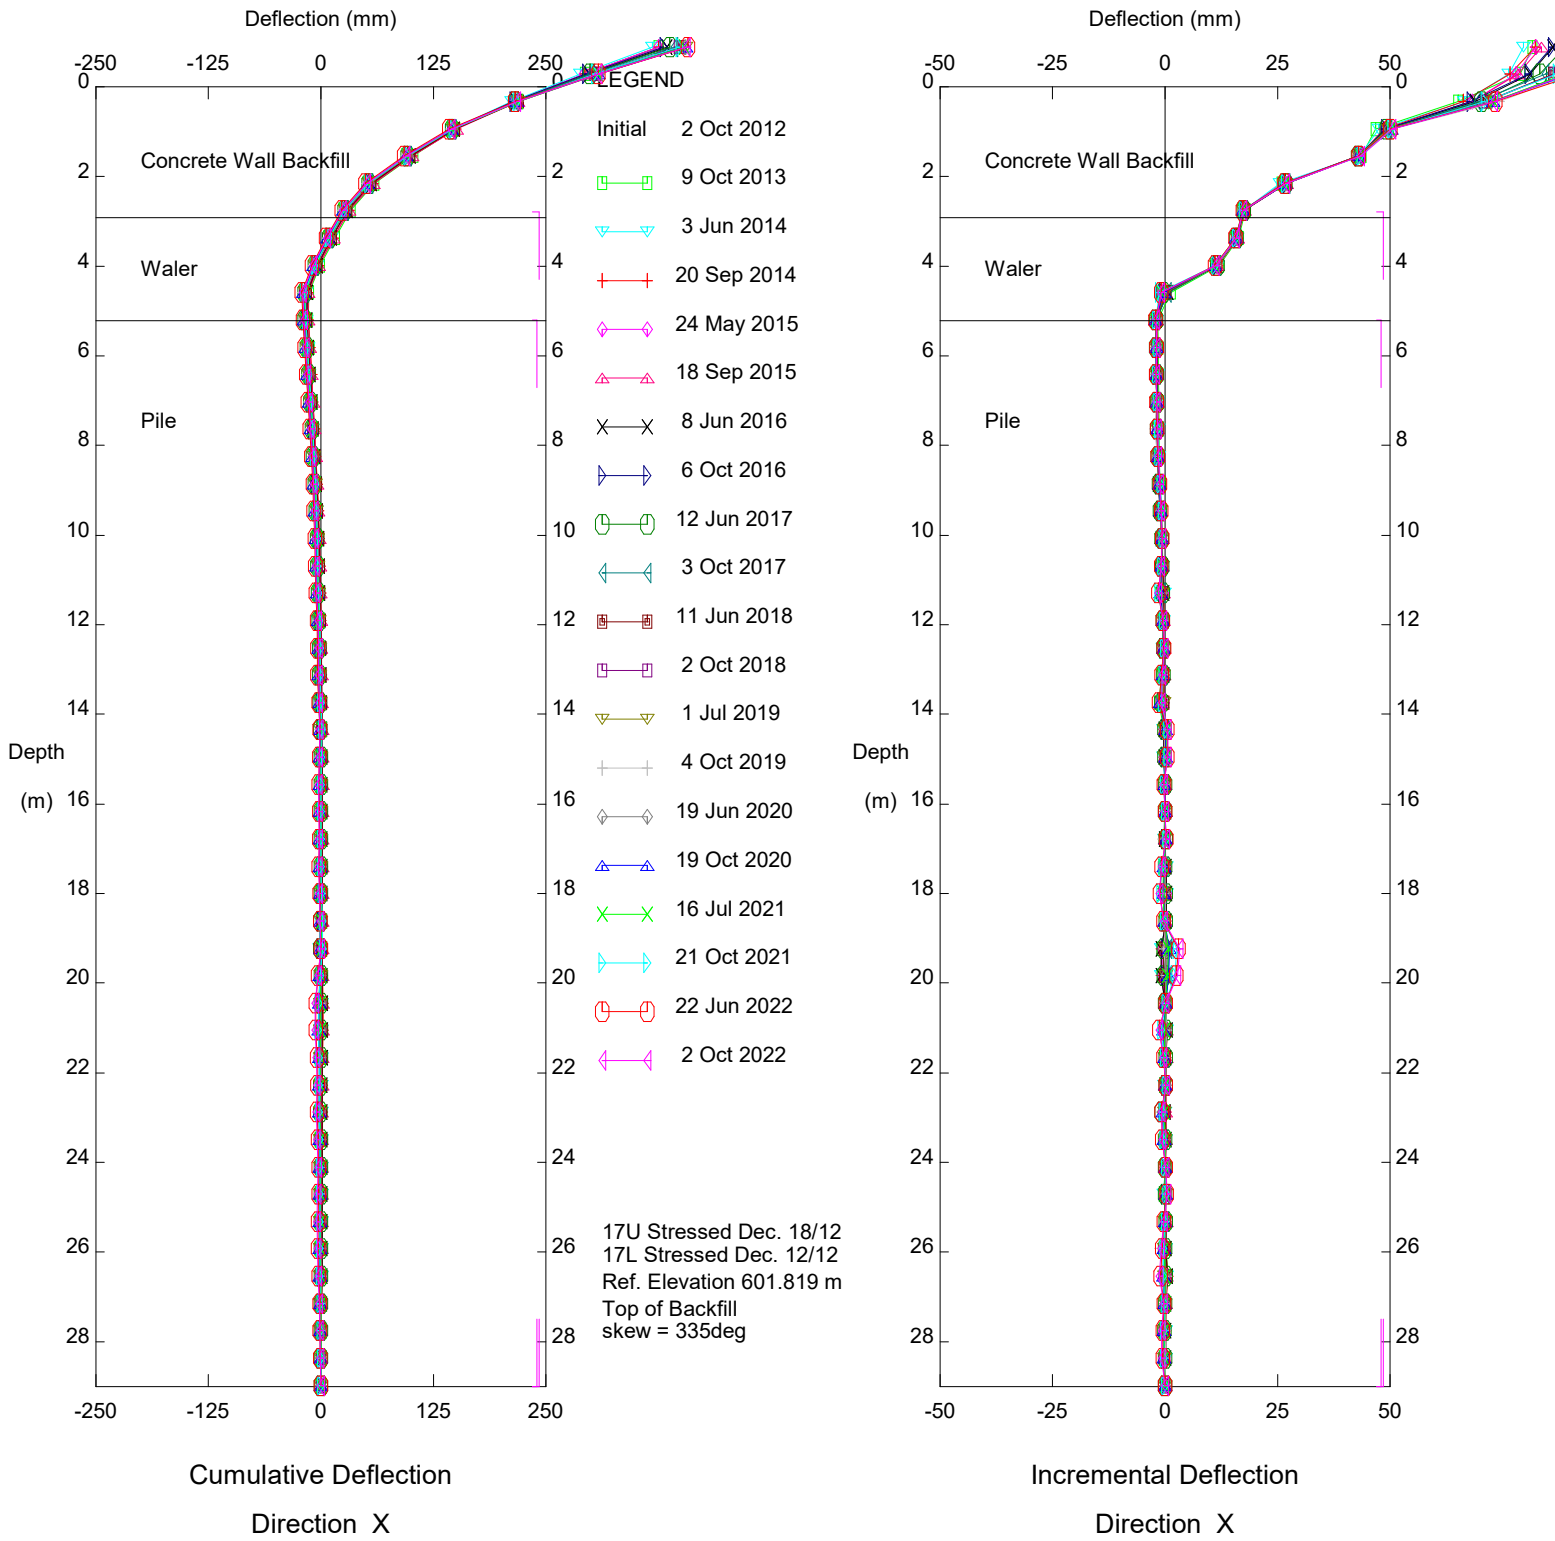
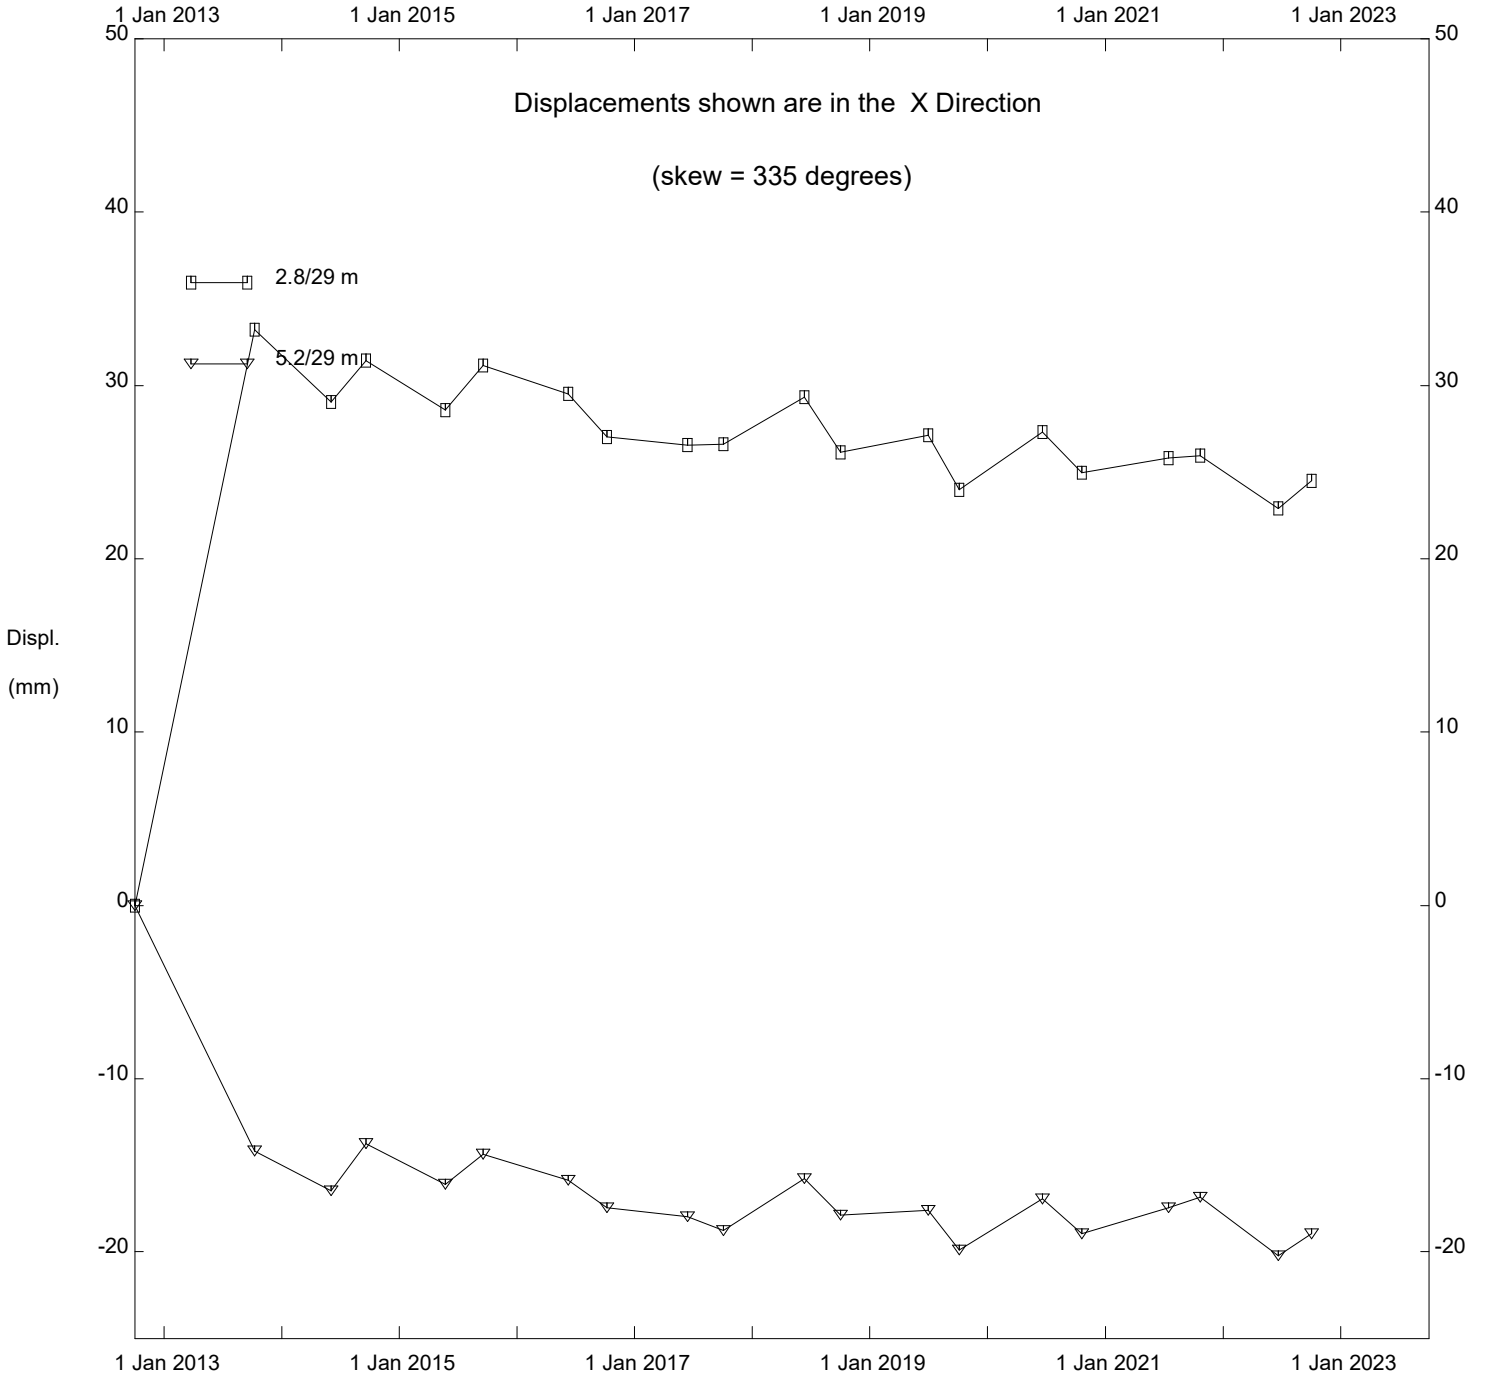
PH026 Eureka River Upper Wall, Inclinometer SI12-P17U

SI12-P17U showed a rate of movement of 5.5 mm/yr over the length of the pile and waler from 2.8 m to 29.0 m, and a rate of movement of 4.5 mm/yr over the length of the pile only from 5.2 m to 29.0 m depth. The total pile head movement to date has been 19.0 mm in the upslope direction.

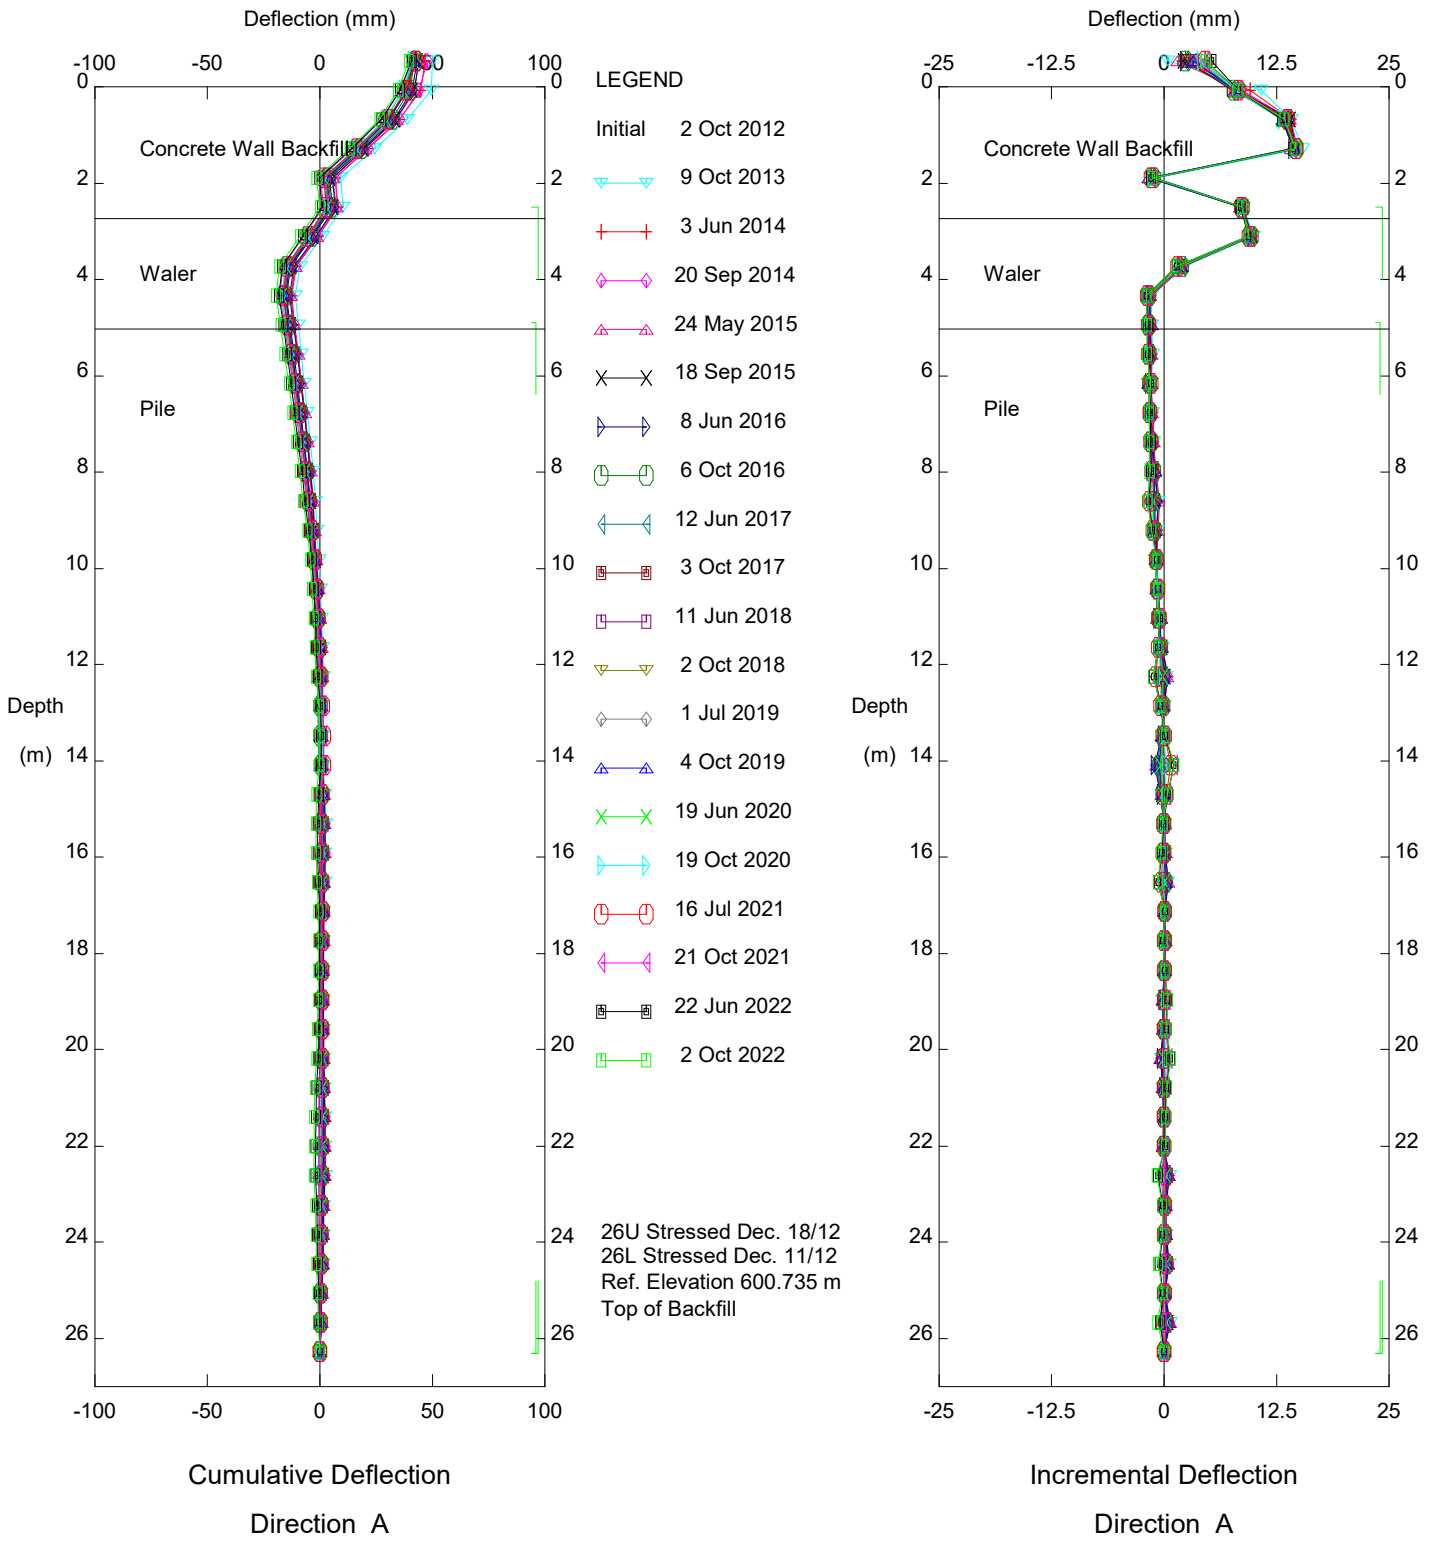
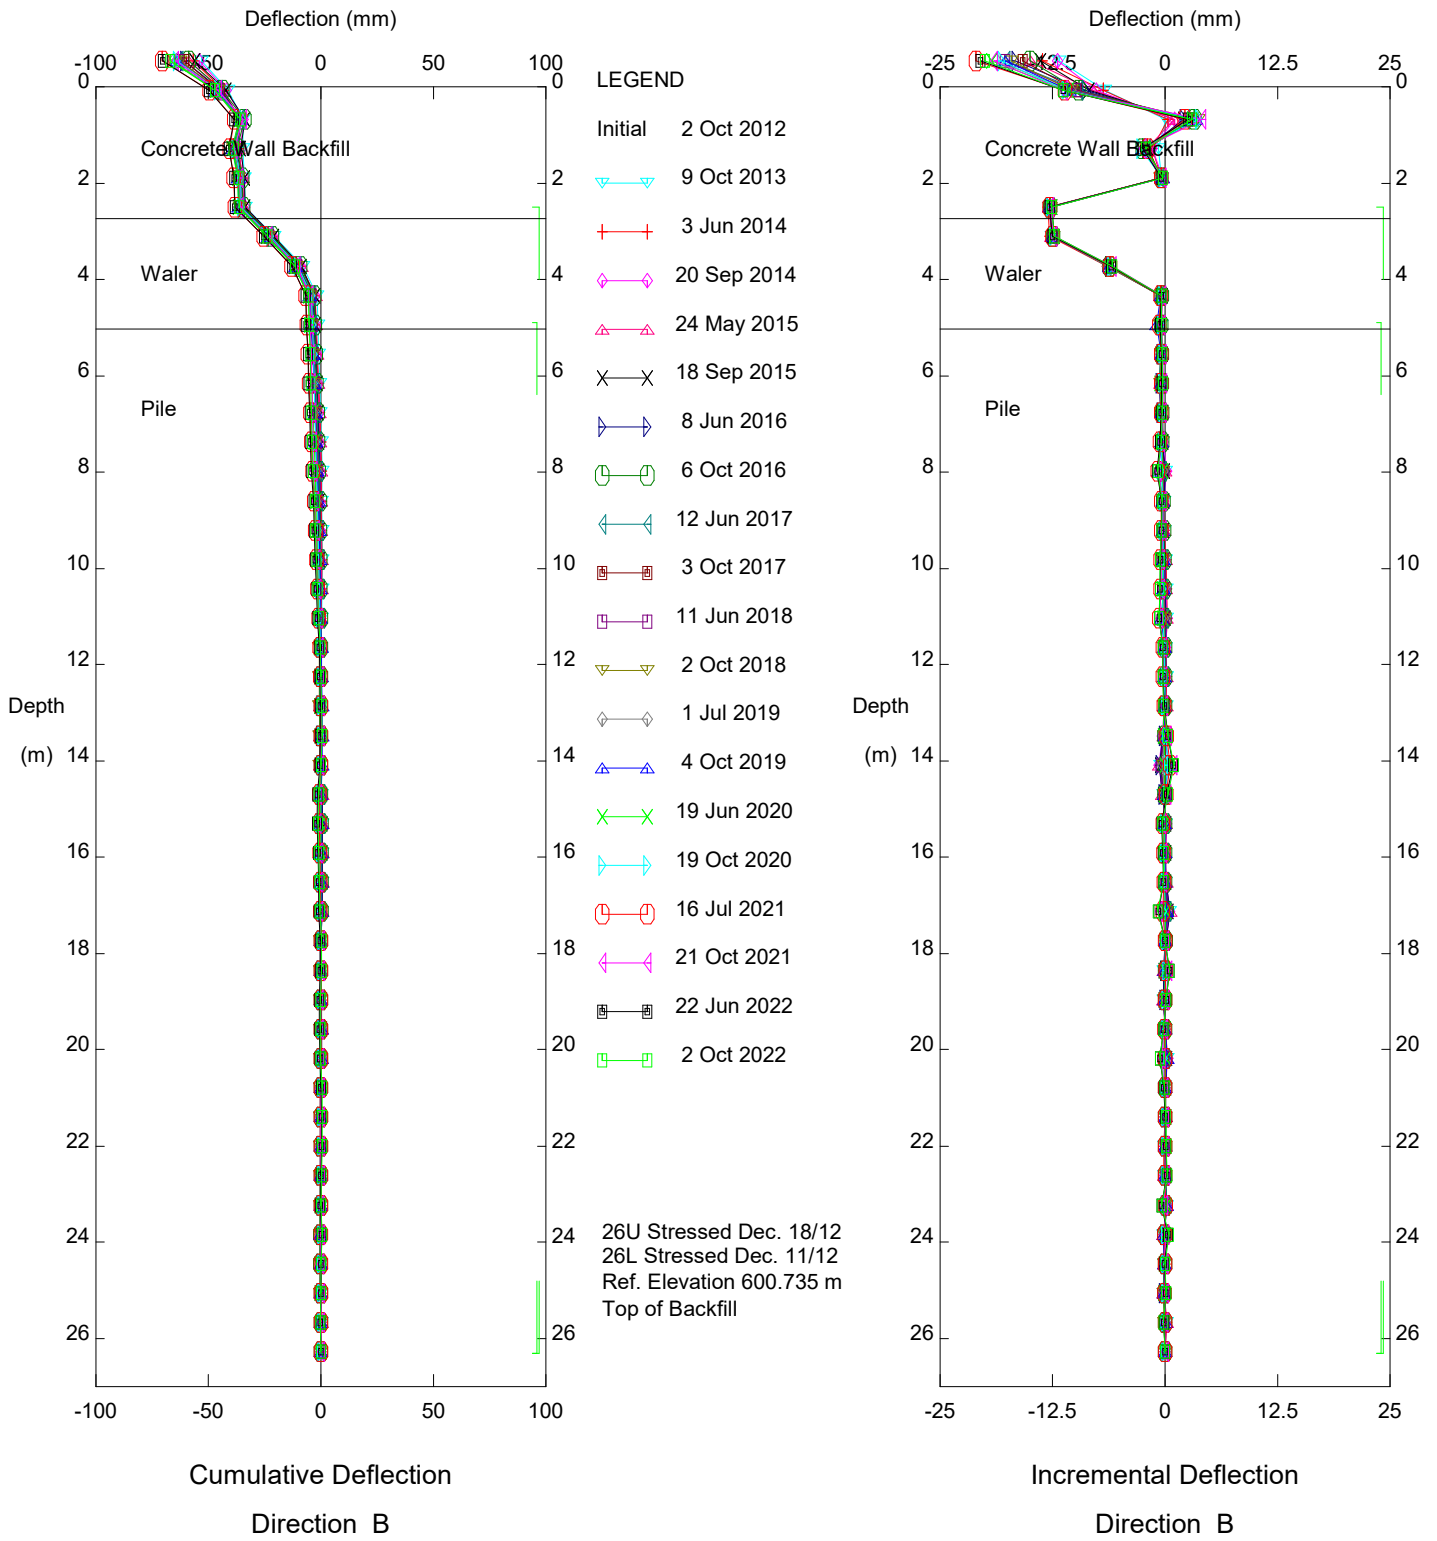
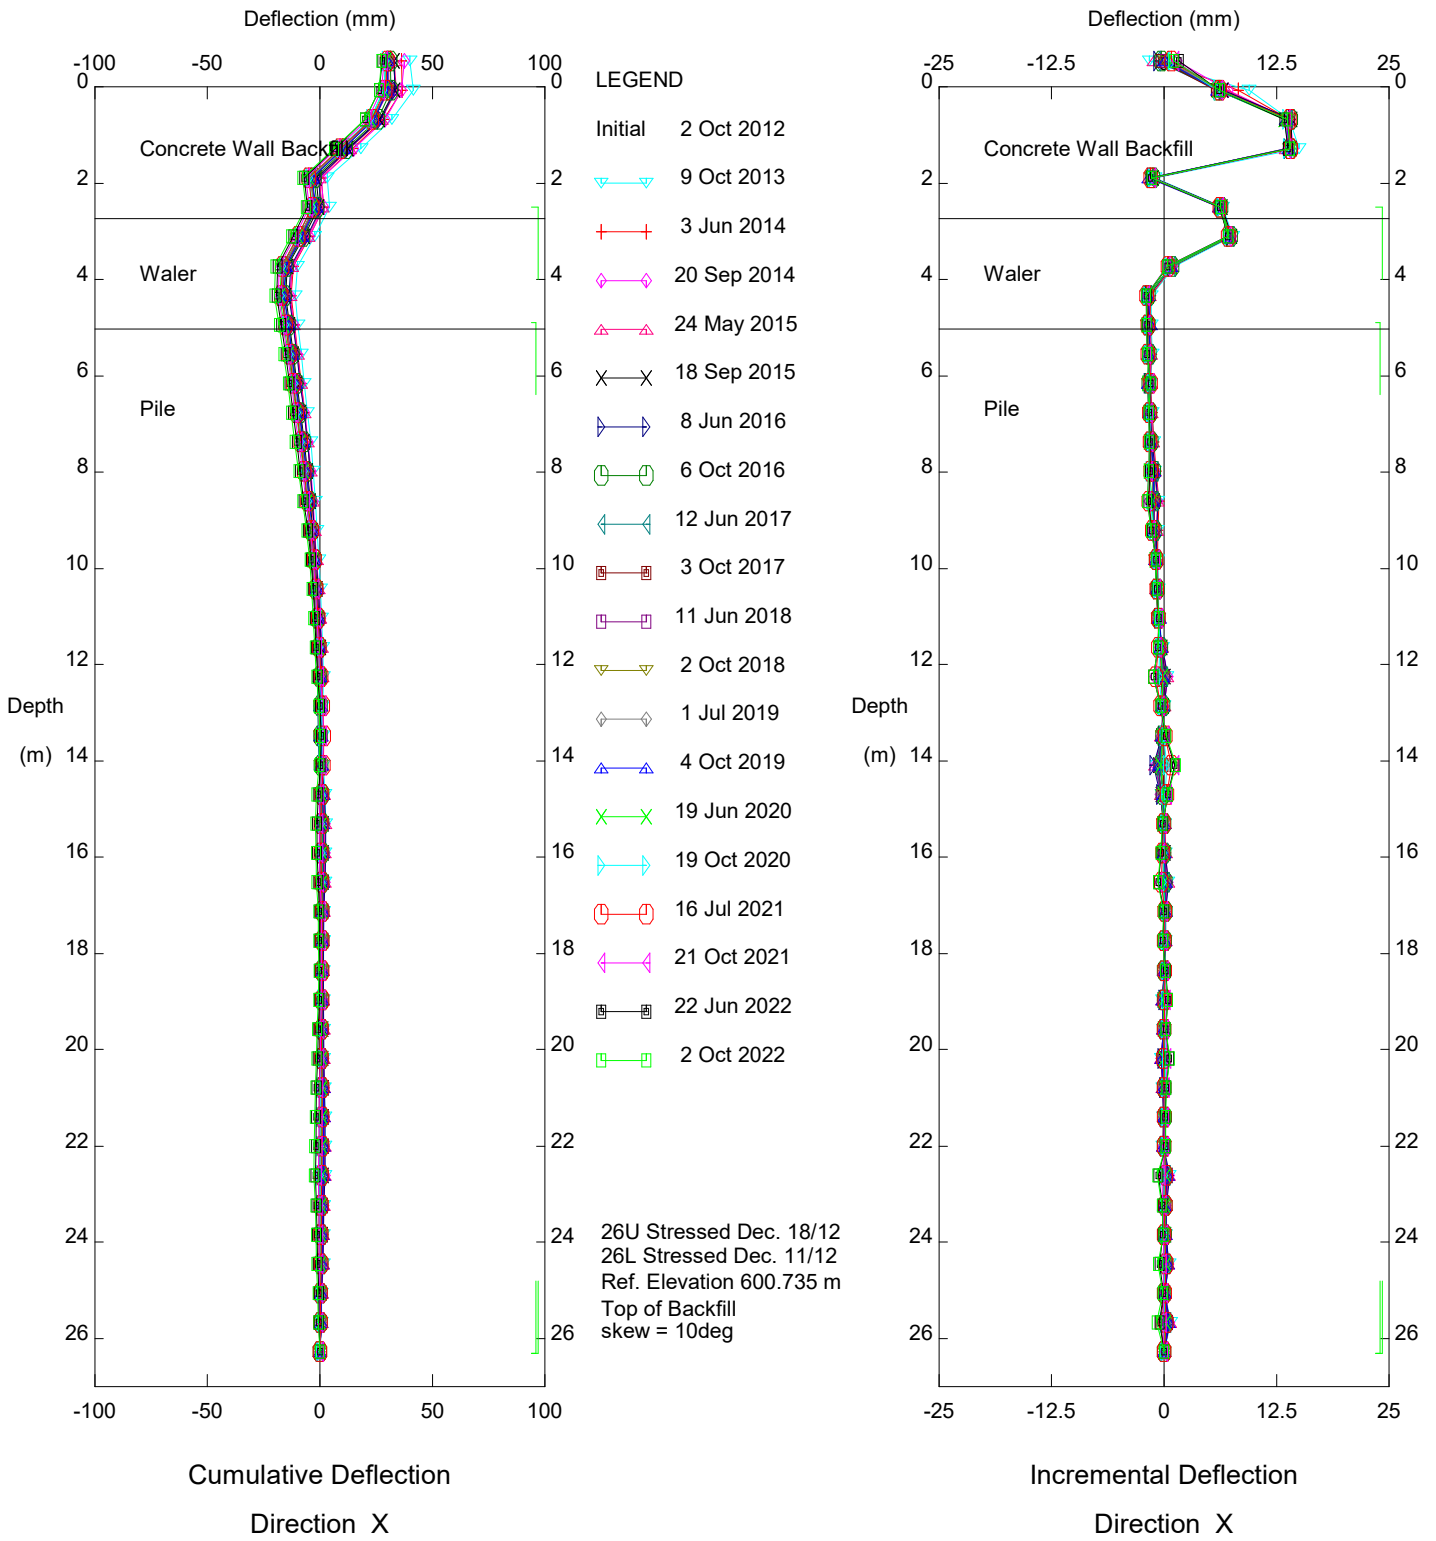
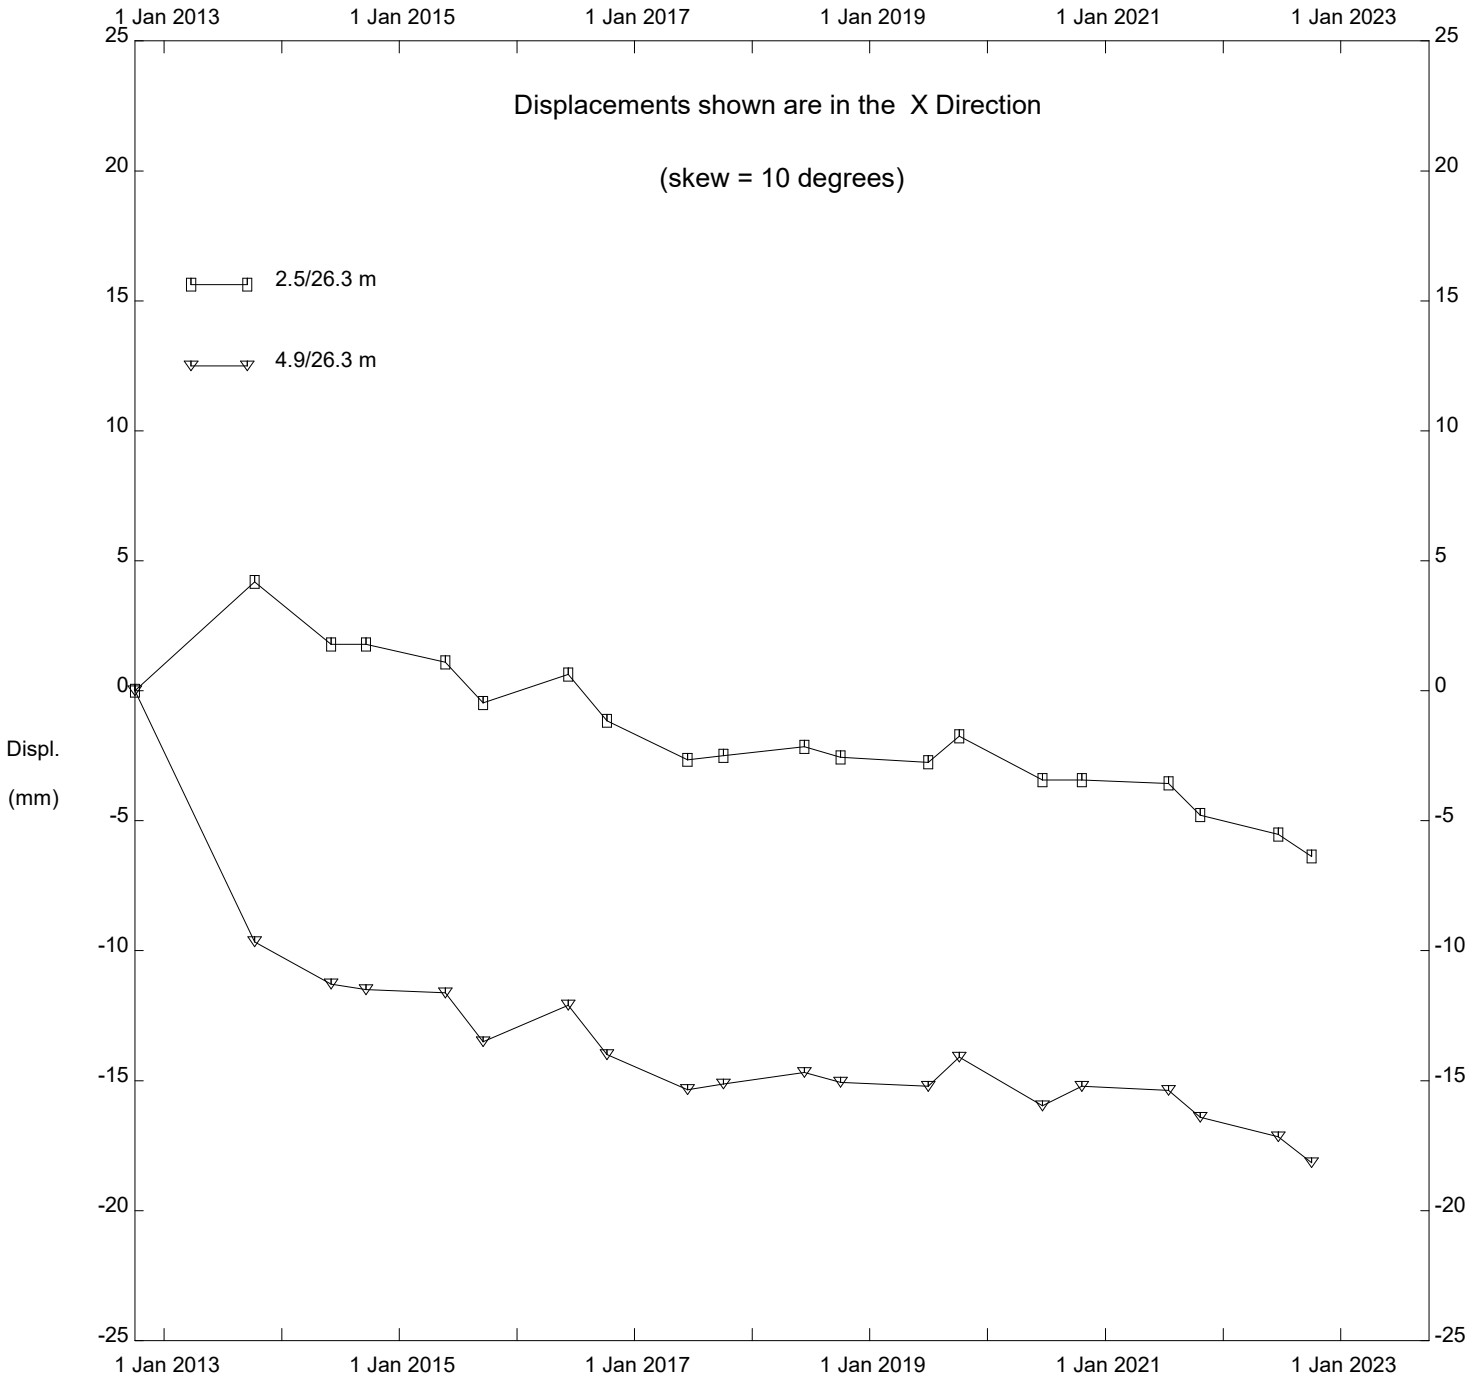
PH026 Eureka River Upper Wall, Inclinometer SI12-P26U

SI12-P26U showed a rate of movement of 3.0 mm/yr of uphill movement over the length of the pile and waler from 2.5 m to 26.3 m depth, and 3.5 mm/yr of uphill movement over the length of the pile only from 4.9 m to 26.3 m depth. The total pile head movement to date has been 18.1 mm in the upslope direction.
