November 22, 2022

**ALBERTA TRANSPORTATION GRMP (CON0022165)
PEACE REGION (GRANDE PRAIRIE DISTRICT – NORTH)
INSTRUMENTATION MONITORING RESULTS – FALL 2022**

SITE PH026: HWY 726:02, EUREKA RIVER (SITES 3, 5 AND 6)

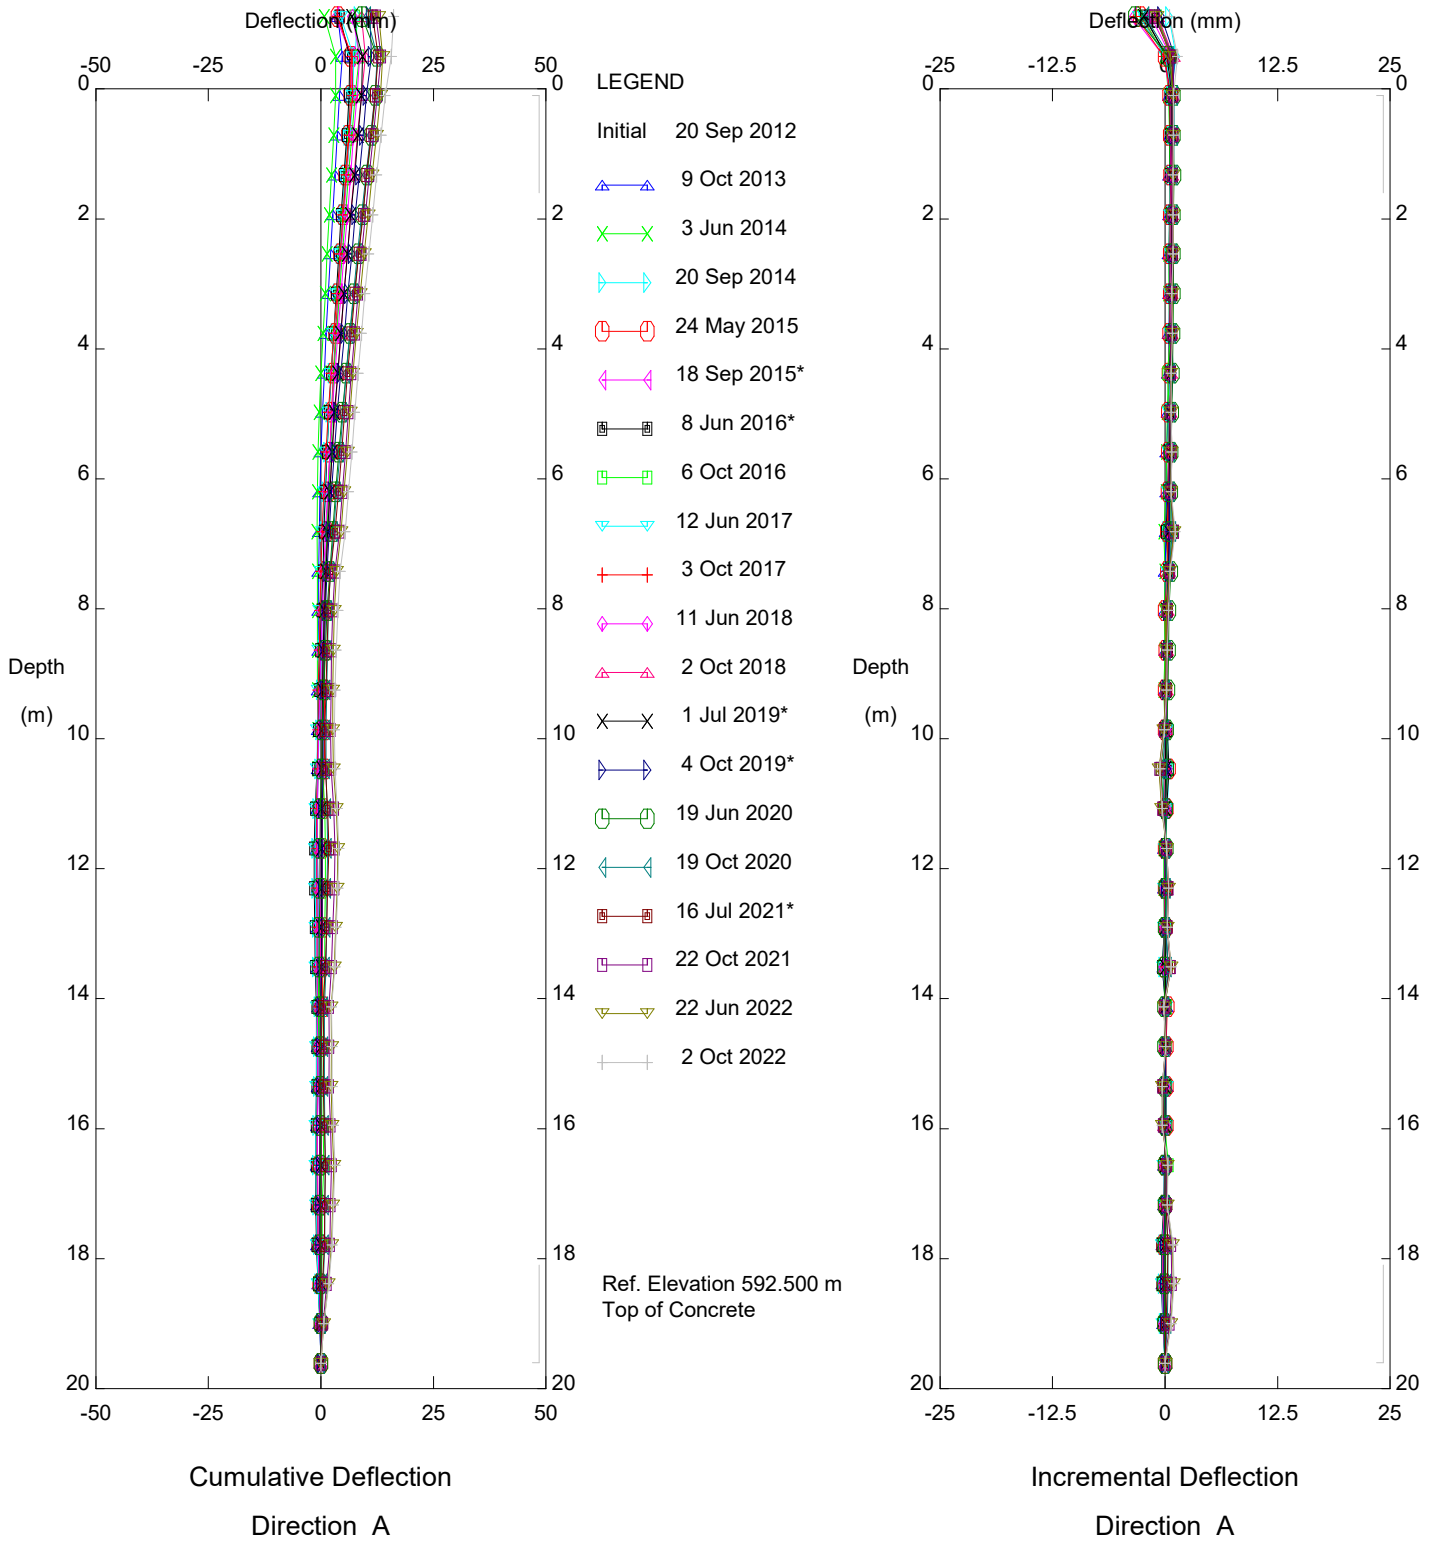
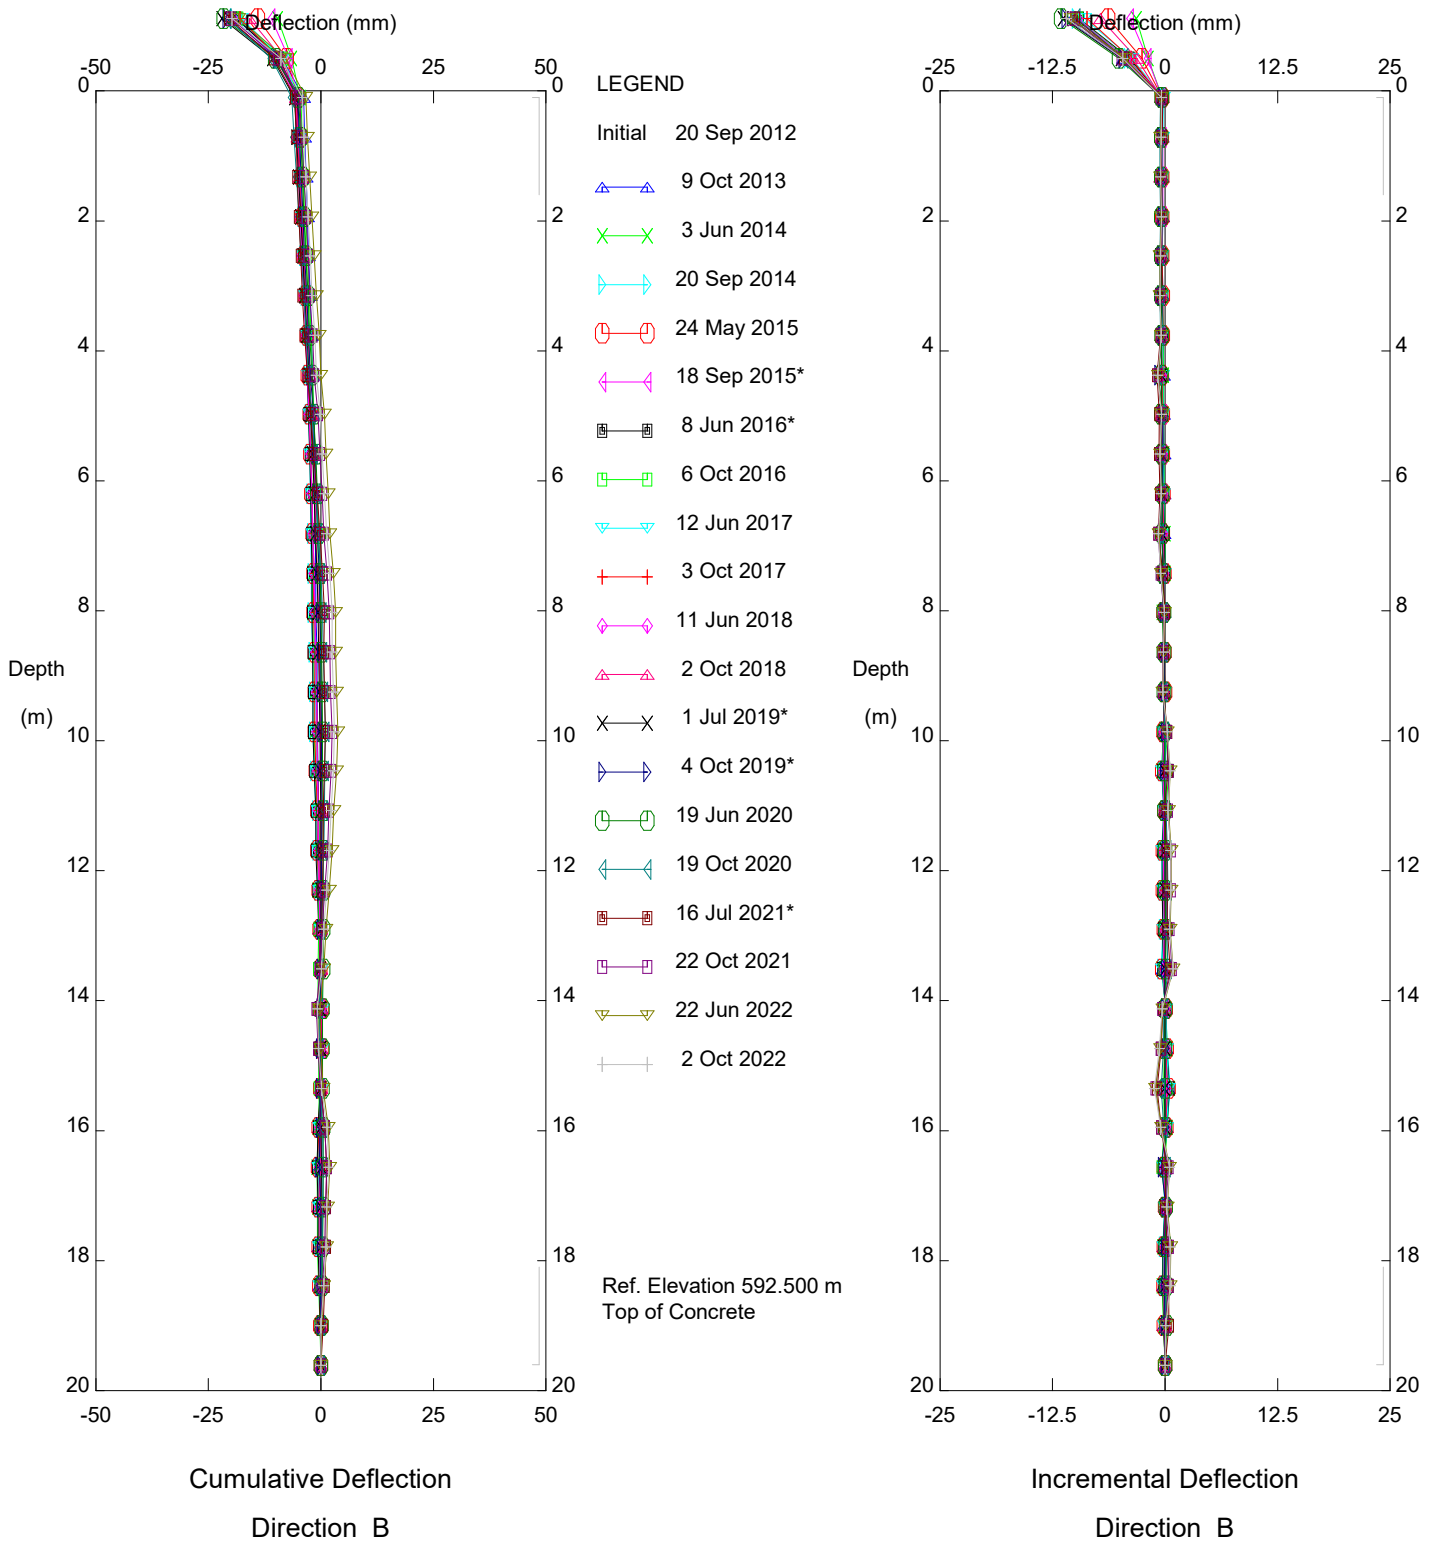
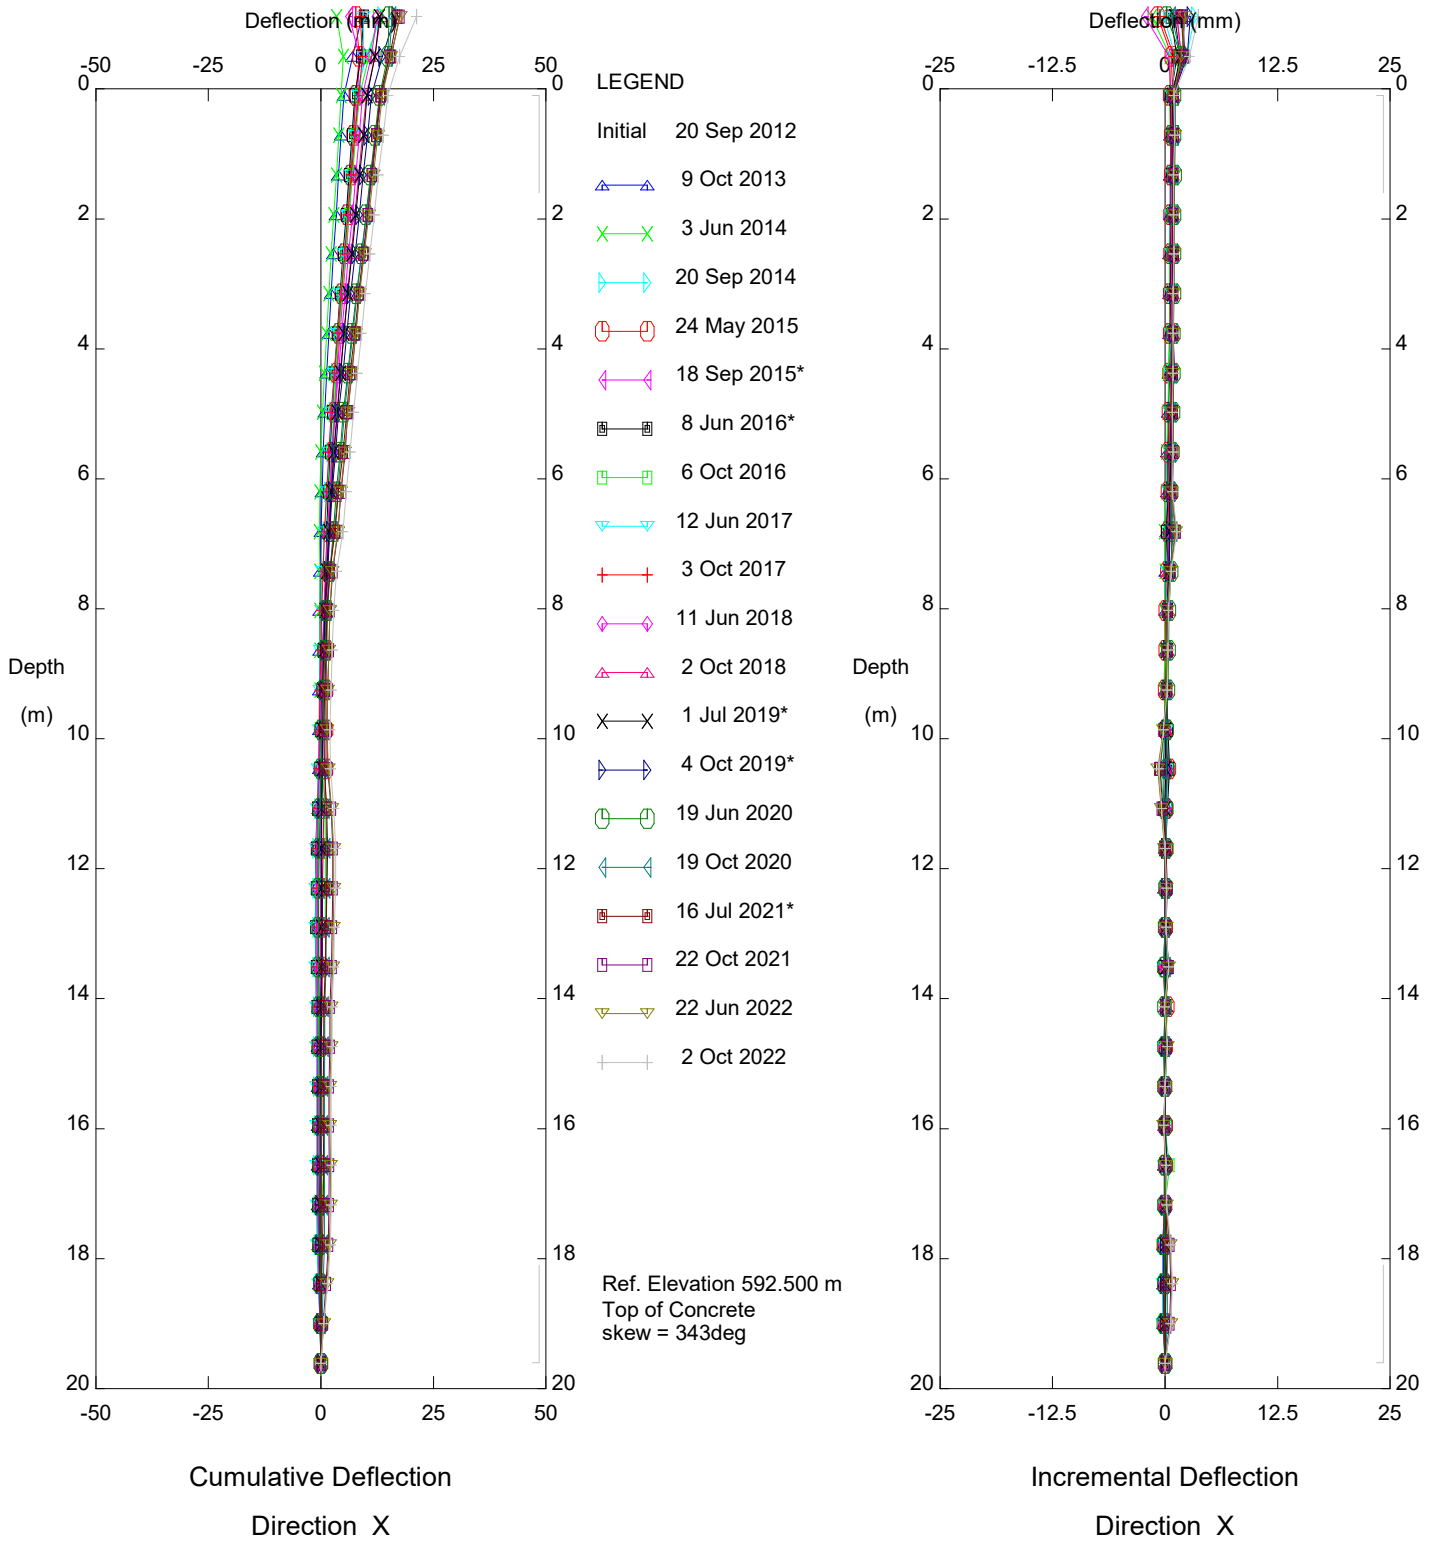
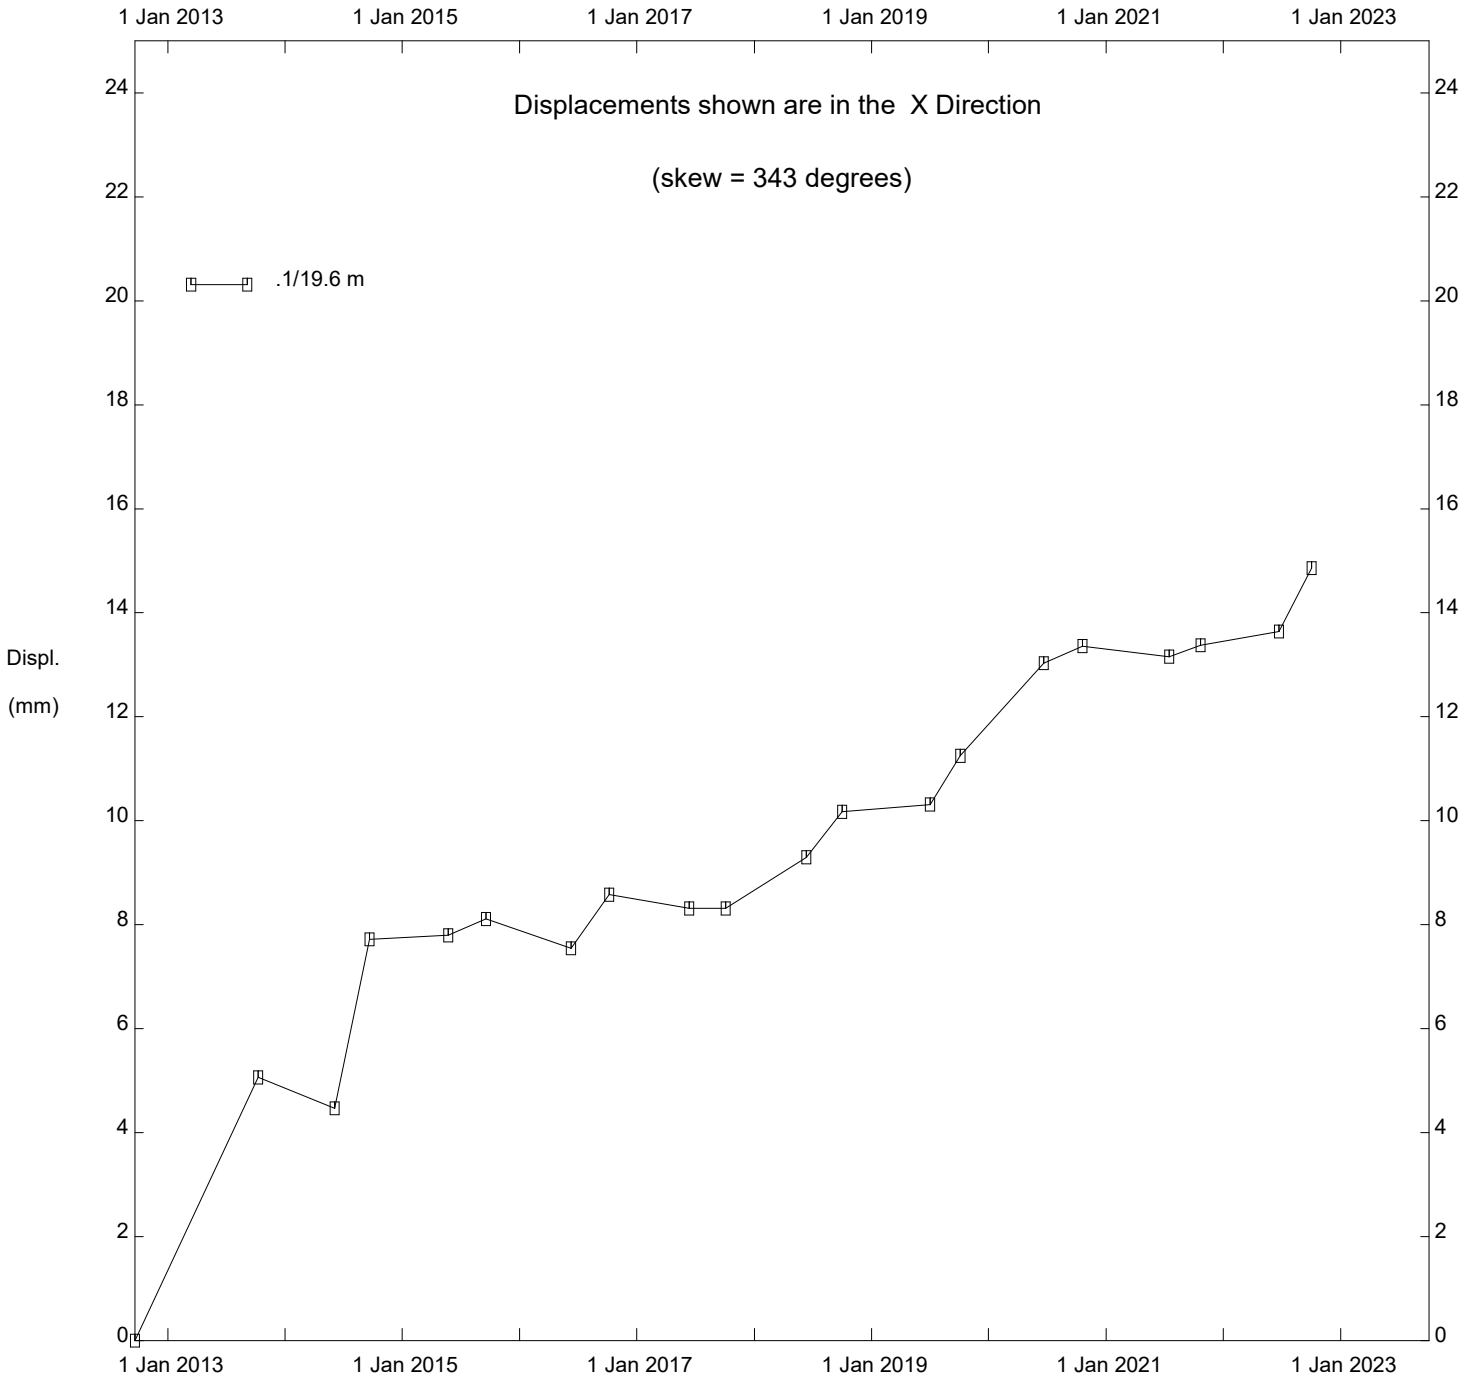
PH026 Eureka River Lower Wall, Inclinometer SI12-P3L

Slope inclinometers SI12-P3L, SI12-P9L and SI12-P14L were installed in the lower wall to monitor pile movements. SI12-P3L has shown a total pile head movement of 14.9 mm towards the river since installation, with a rate of movement of 4.4 mm/yr the length of the pile since the spring of 2022 readings. SI12-P9L has shown a total pile head movement of 20.3 mm in the downslope direction since installation, with a rate of movement of 0.2 mm/yr over the length of the pile since the spring of 2022 readings. SI12-P14L has shown a total pile head movement of 6.1 mm in the downslope direction since installation, with a rate of movement of 0.8 mm/yr since the spring of 2022.

The deflections of the piles in the lower pile wall were somewhat affected by the installation and backfilling of sheet piling on the downslope side of the piles between September 25 and October 30, 2013, after the inclinometers had been installed.

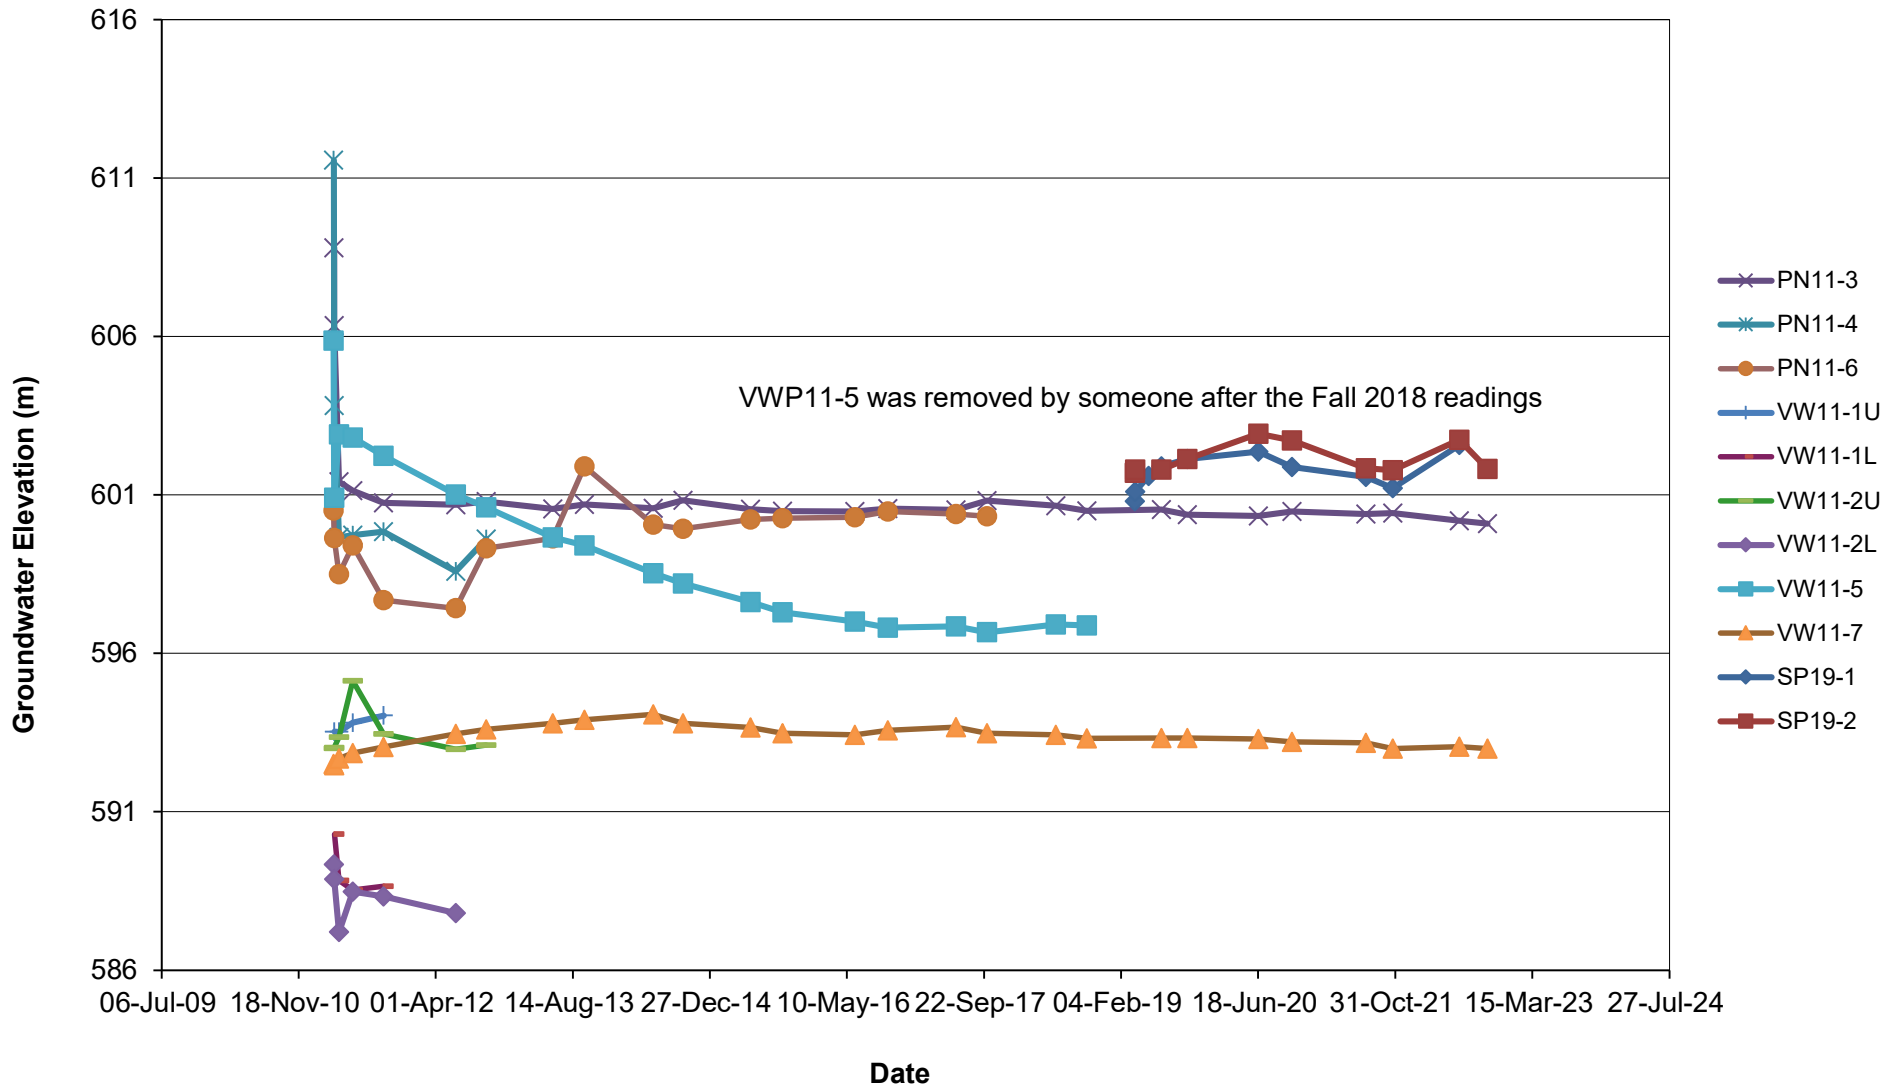
**FIGURE PH026-1
PIEZOMETRIC ELEVATIONS FOR HWY 726:02 EUREKA RIVER (SITE 3, 5 AND 6)**

Since the previous readings in the spring of 2022, the groundwater level decreased in pneumatic piezometer PN11-3 by 0.09 m. The groundwater level decreased in vibrating wire piezometer VW11-7 by 0.05 m since the spring of 2022 readings.

The groundwater levels decreased in standpipe piezometers SP19-1 and SP19-2 by 1.21 m and 0.92 m, respectively, since the spring of 2022 readings.

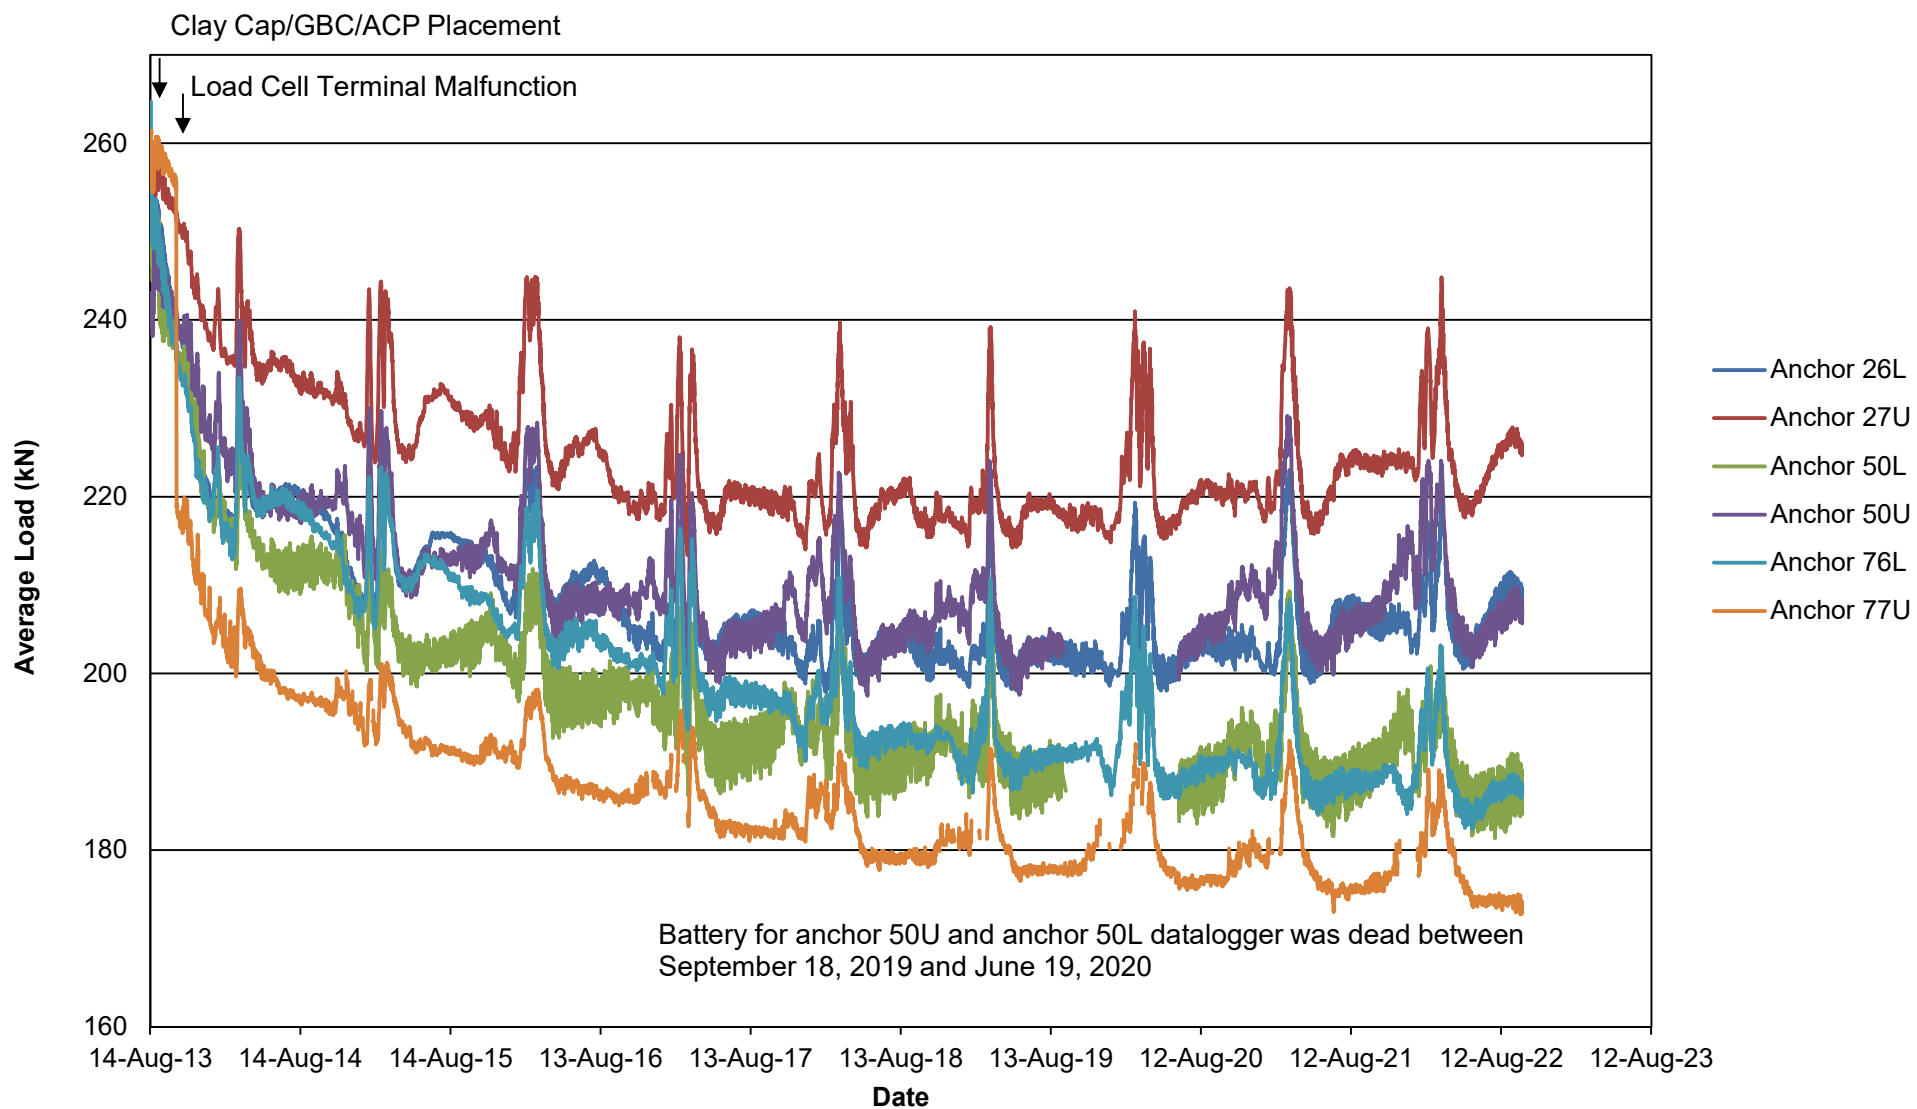
FIGURE PH026-3
LOAD CELL DATA FOR HWY 726:02 UPPER PILE WALL ANCHORS

Since the spring of 2022, all of the load cells except VC1762 (77U) showed increases in the measured load, ranging from 0.48 kN in VC1760 (anchor 50L) to 5.33 kN in VC1764 (anchor 27U). Load cell VC1762 (77U) showed a decrease in measured load of 0.43 kN since the spring of 2022 readings. The current readings on the load cells varied from 173.93 kN in VC1762 (anchor 77U) to 225.62 kN in VC1764 (anchor 27U). The anchor design load was 300 kN and the anchors were locked off at 240 kN. It should be noted that as of October 16, 2013 at 9:59 AM one of the vibrating wires in VC1762 (anchor 77U) has stopped working. The measured force in VC1762 is an average of two vibrating wires instead of three.

Initially, the load cells showed a gradual decrease in measured load since they were locked off. However, over the past several readings cycles, the load cell readings have been levelling off, indicating the pile wall may be reaching a point of equilibrium. Table PH026-5 summarizes the load cell readings. Plots of load cell load and temperature readings are plotted in Figures PH026-3 and PH026-4 in Appendix A.
