**ALBERTA TRANSPORTATION
GEOHAZARD ASSESSMENT PROGRAM
PEACE REGION (GRANDE PRAIRIE DISTRICT- NORTH)
2022 INSPECTION**

Site Number	Location	Name	Hwy	km
PH026	Eureka River North Hill	Sites #3, #5 and #6	726:02	10.1
Legal Description		UTM Co-ordinates (NAD83)		
SW13/SE14-86-8-W6		11 N 6258740	E 368408

2022 PH026-1 INSPECTION PLAN

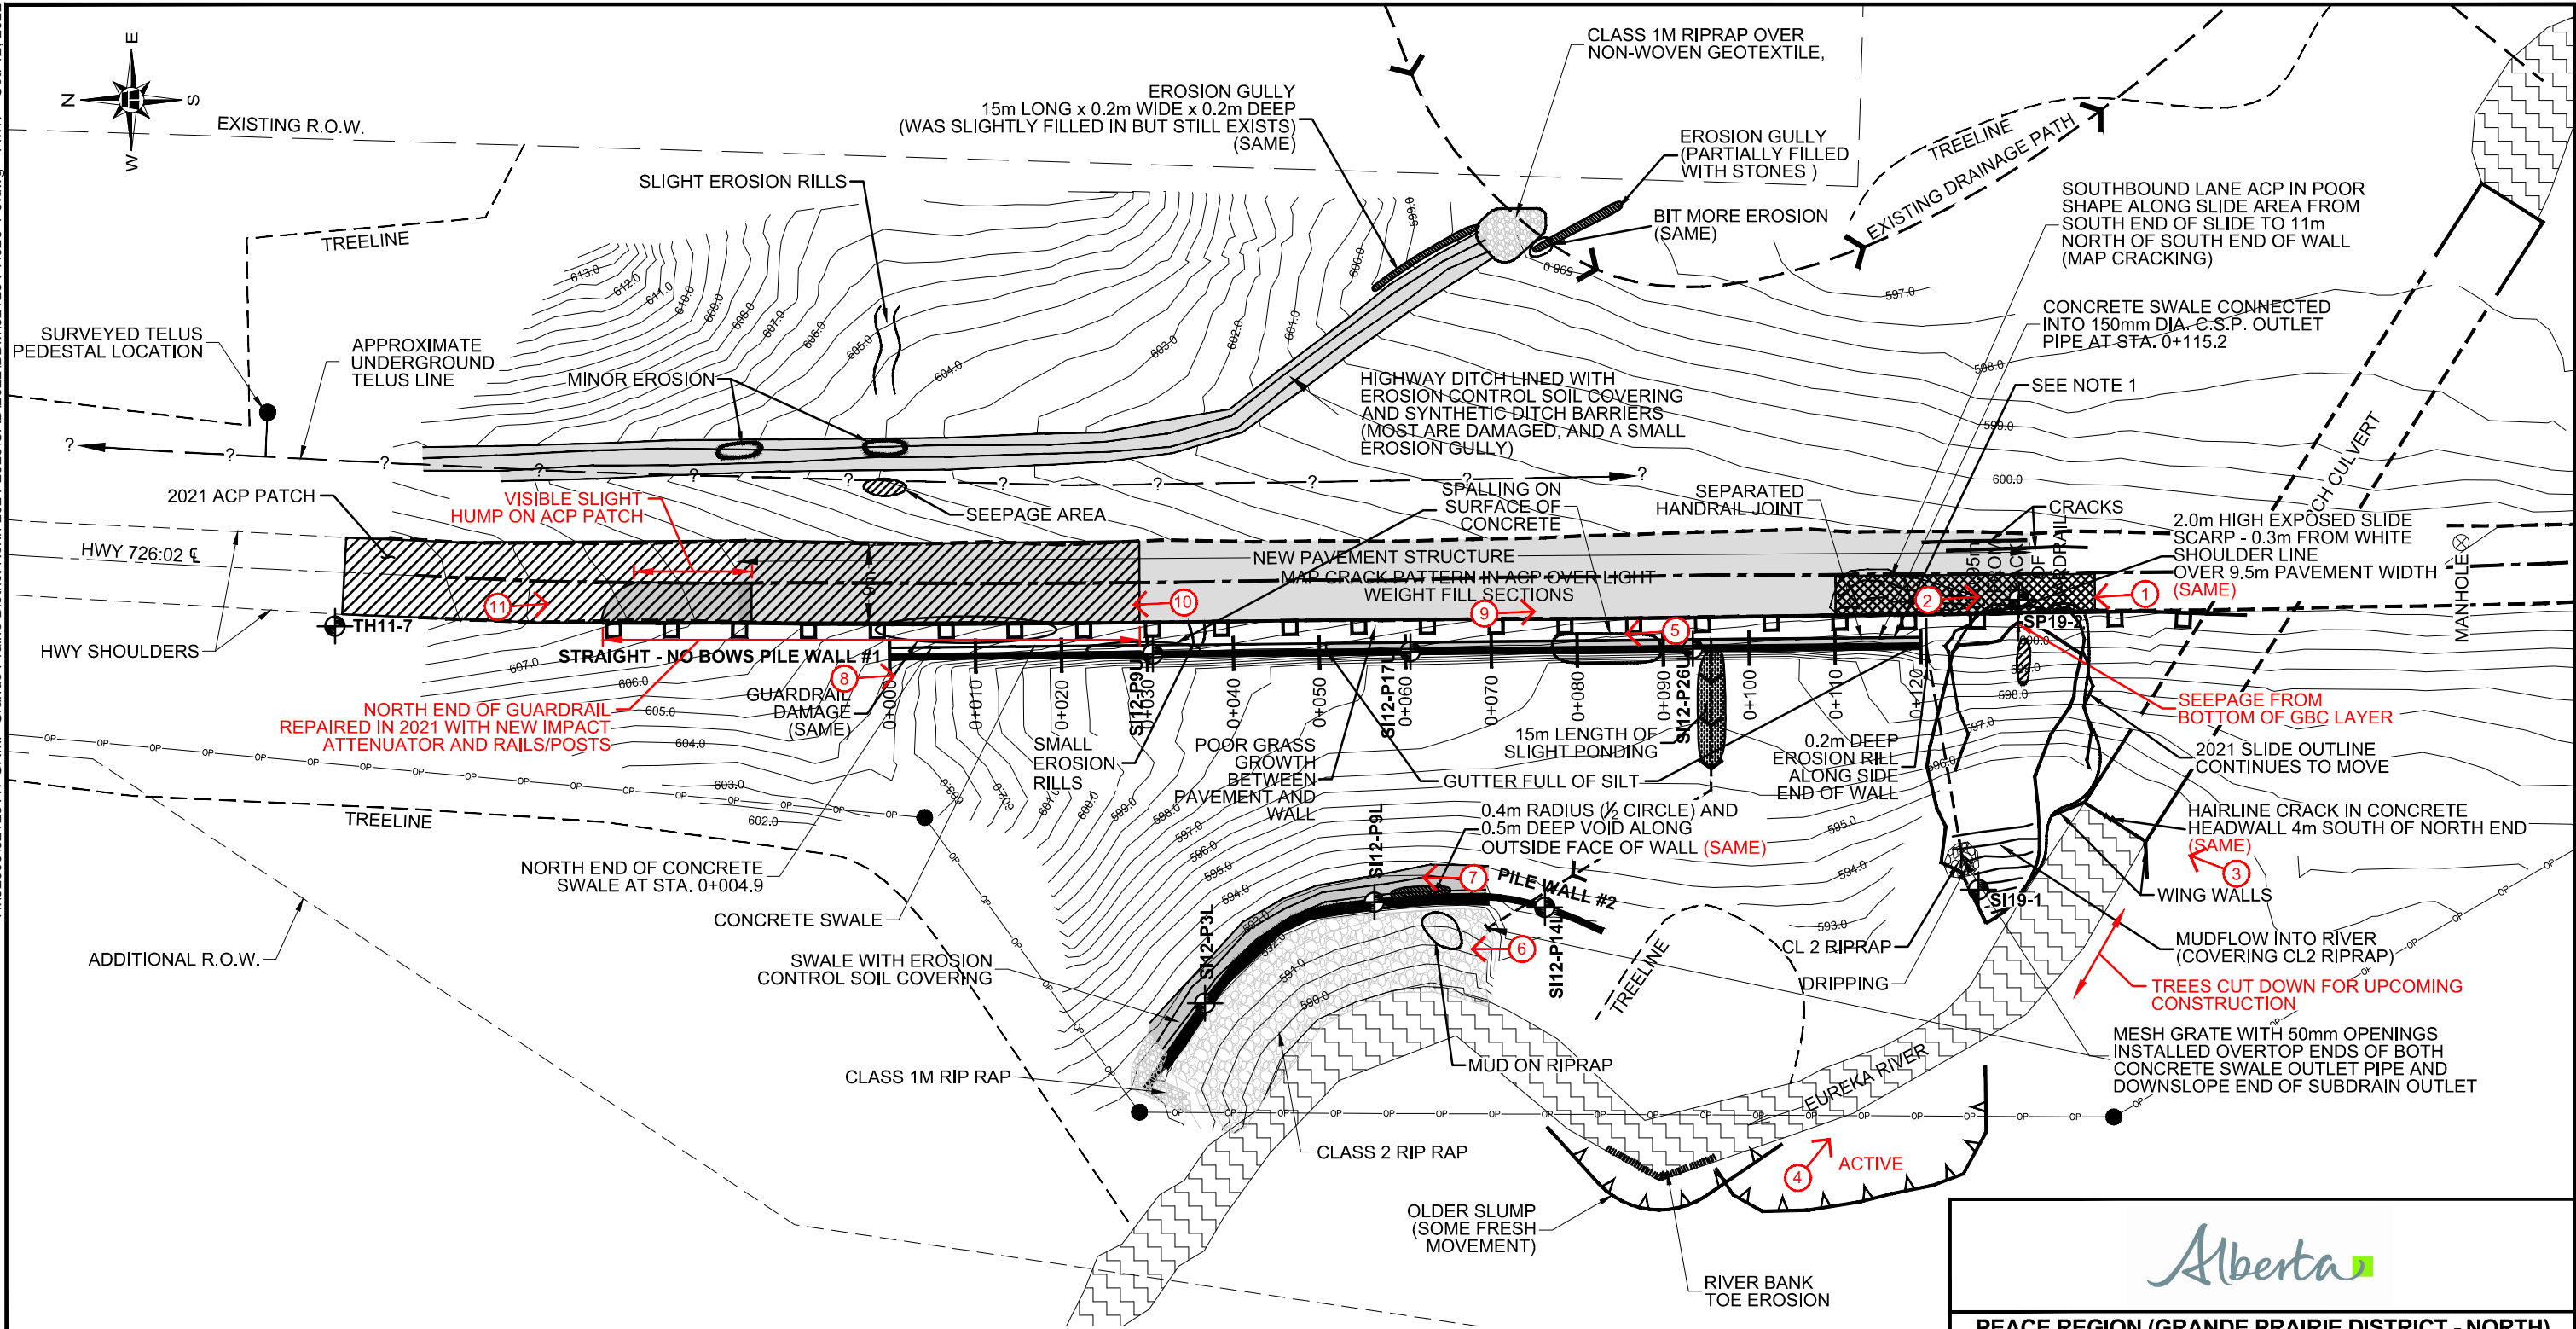
DWG No. 32123-PH026-1-3

- NOTES:**
- 1. GUTTER GRATE IS LOOSE AND GUTTER IS FULL OF DIRT AND NEEDS CLEANING (AT MAINTENANCE).
 - 2. CONDITIONS ON MAY 16, 2022 SHOWN IN RED.
 - 3. REFER TO DWG NO. 32123 PH026-1-7 AND -PH026-1-8 FOR LATEST SLIDE DETAILS.

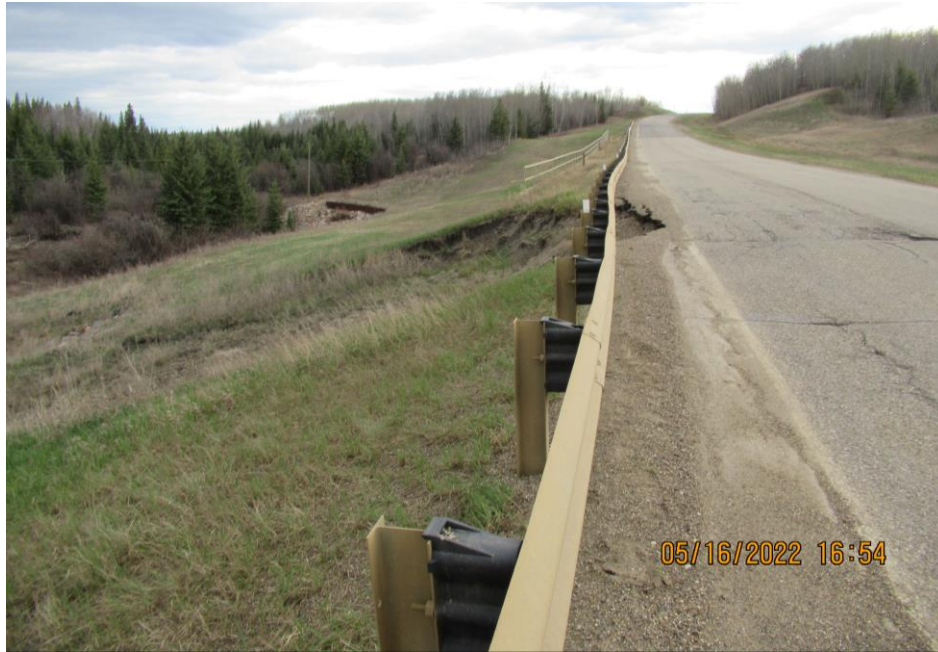
The seepage from the pavement GBC observed in 2016 south of the upper pile wall and ongoing weathering of the fill are the likely causes of the slide that occurred south of the upper pile wall in 2017. The seepage likely saturated the GBC and embankment fill with time, which created a weak soil mass that eventually failed, carrying the material down into the river.

Photo 1 – Looking north along the highway south of the upper pile wall at the landslide that developed at Site 3.

At Site 3, the slide that occurred between the upper pile wall and bridge culvert will be repaired as part of the above noted contract, as follows:

- Excavate the slumped material in the west highway embankment, disposing of the material outside and away from the valley crests. Install non-woven geotextile and a subdrain system along the base of the excavated slump. Sheet piles will need to be installed along the slide toe to minimize river inflow, adjacent to the arch culvert to provide support for excavation adjacent to it, and adjacent to the highway/pile wall for excavation support. Extend the subdrains through the lower portion of the re-built slope to outlet on the riprap adjacent to the river. Additional Class 2 riprap will be installed along the toe of the repaired area adjacent to the river to prevent future toe erosion. Re-build the new highway embankment using compacted gravel to re-establish the existing slope and to surround the subdrains.

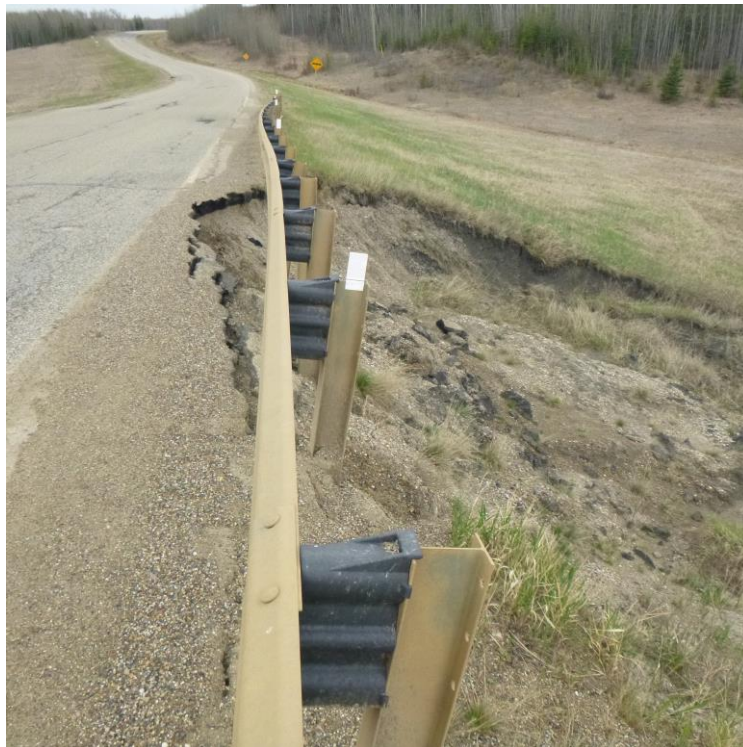
Photo 2 – Looking south at the slide scarp that has extended into the SB shoulder to within 0.3 m of the white line beyond the south end of the upper pile wall at Site 3.

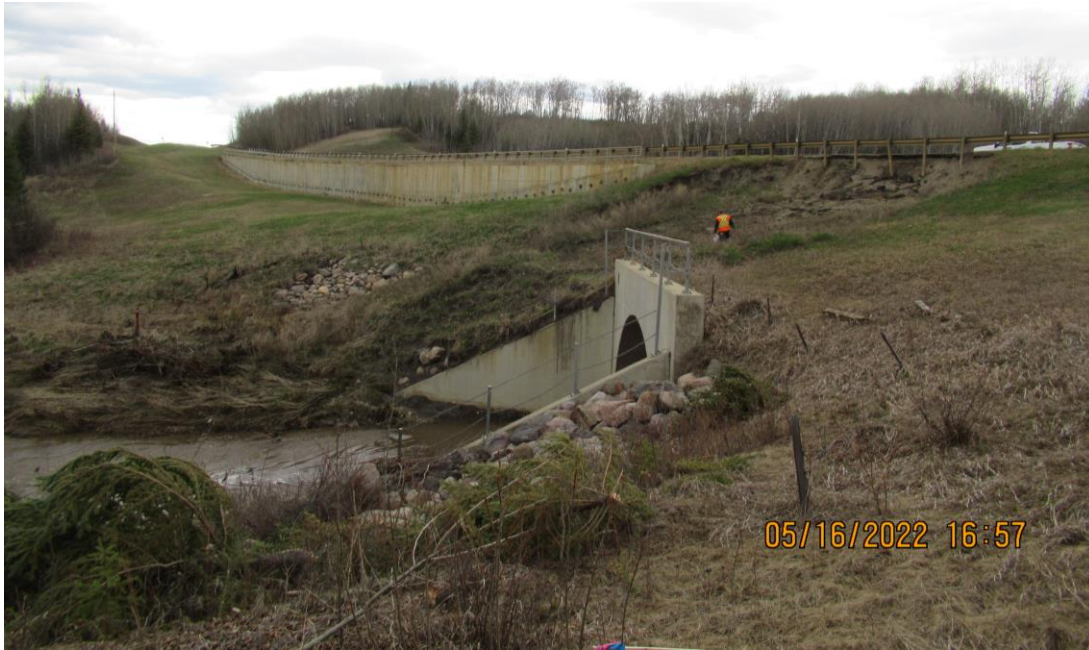
Photo 3 – Looking north at the toe of the slide that pushed debris against and around the arch culvert outlet headwall at Site 3. Note the cut trees on the south side of the arch culvert.

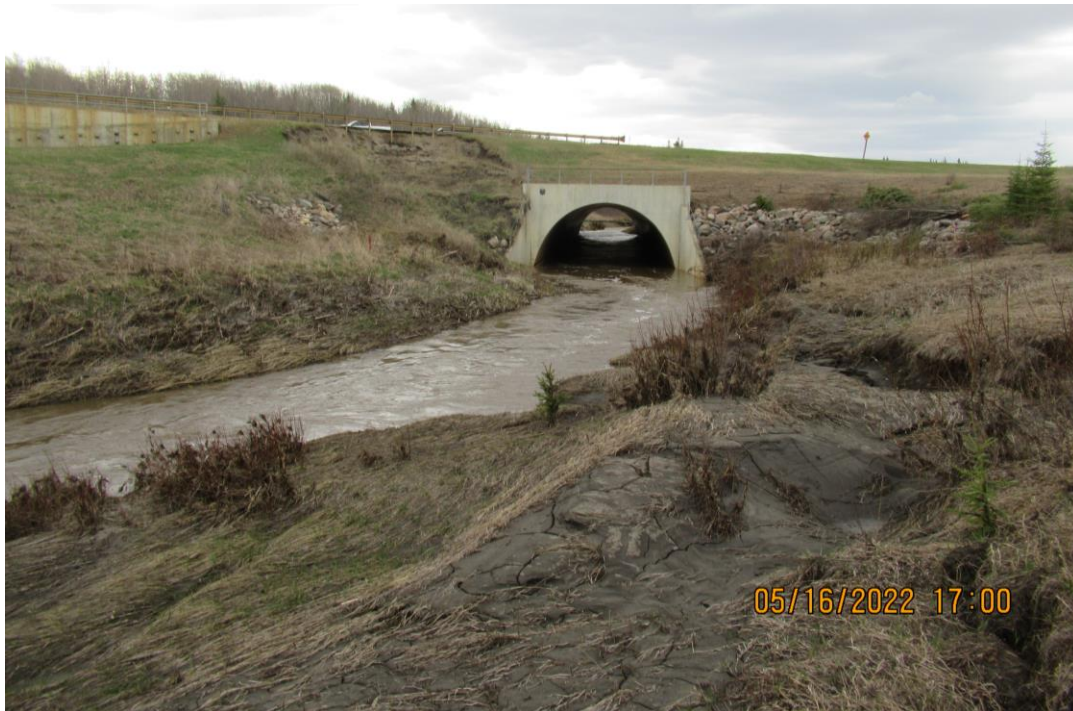
Photo 4 – Looking east at the body and scarp face of the slide between the south end of the pile wall and the arch culvert at Site 3.

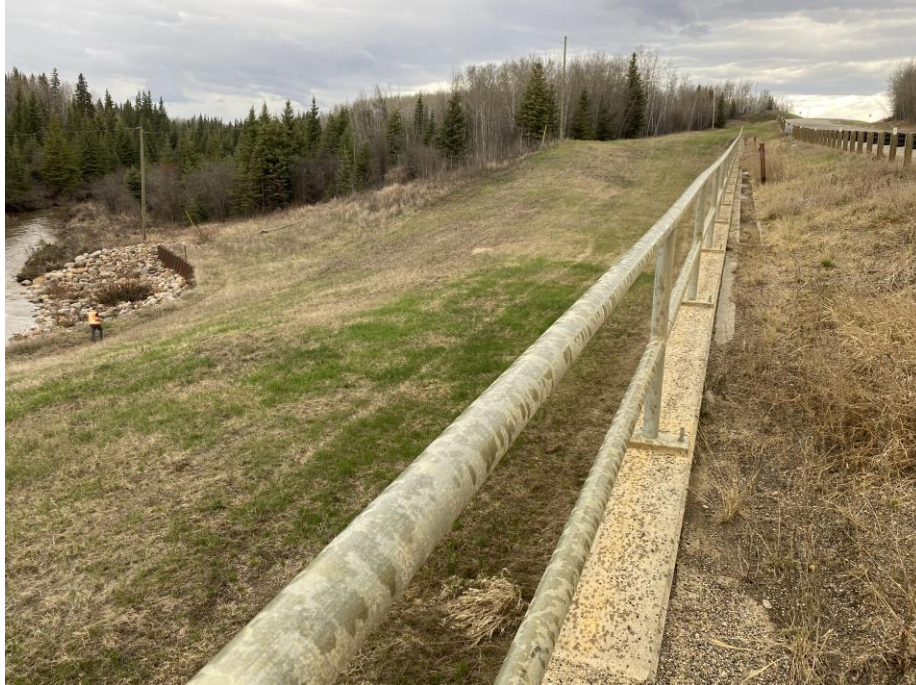
Photo 5 – Looking north along the top of the pile wall from near the south end at Site 3. Note the gutter is filled with sand/debris.

- 1) Clean the gutter of soil/debris buildup under the handrail adjacent to the west side of the highway, and securely fasten the loose gutter grate.
- 2) The spalled concrete on the surface of the upper pile wall should be repaired by placing a proper concrete sealant over the entire exposed surface to prevent any further degradation.
- 3) A steel sleeve could be installed over the gap in the handrail.

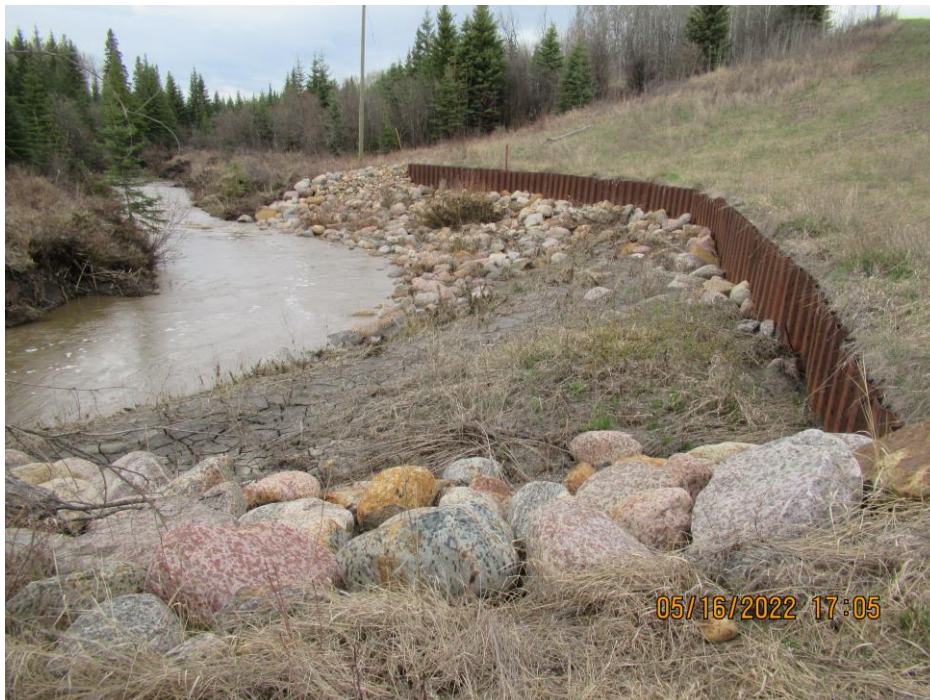
Photo 6 – Looking northwest at the lower pile wall area and riprap behind it at Site 3.

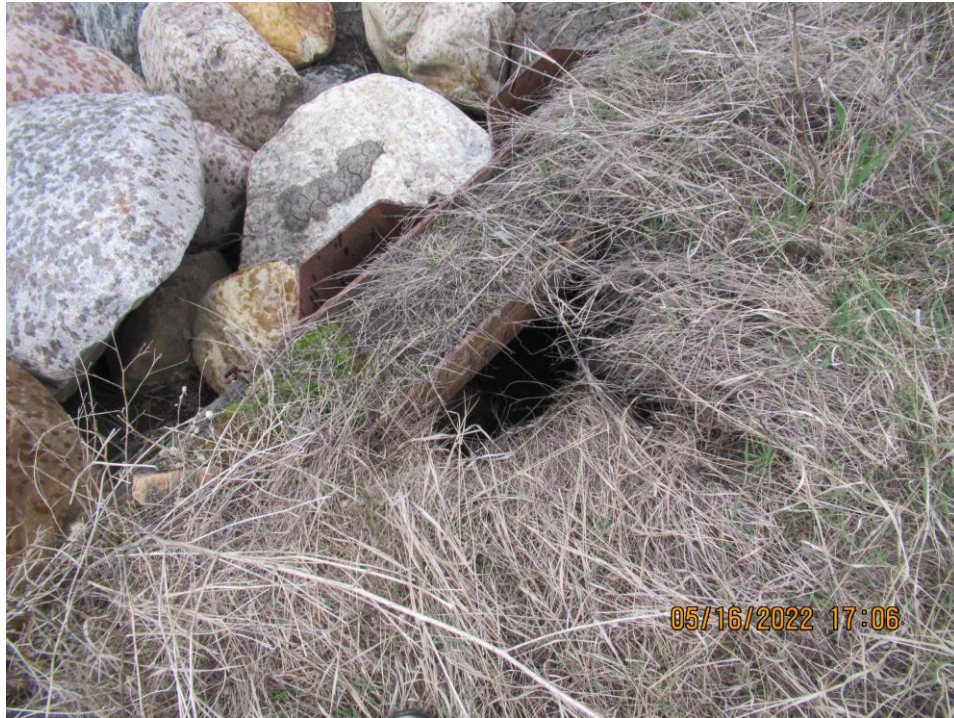
Photo 7 – Looking at the small void on the upslope side of the lower pile wall at Site 3.

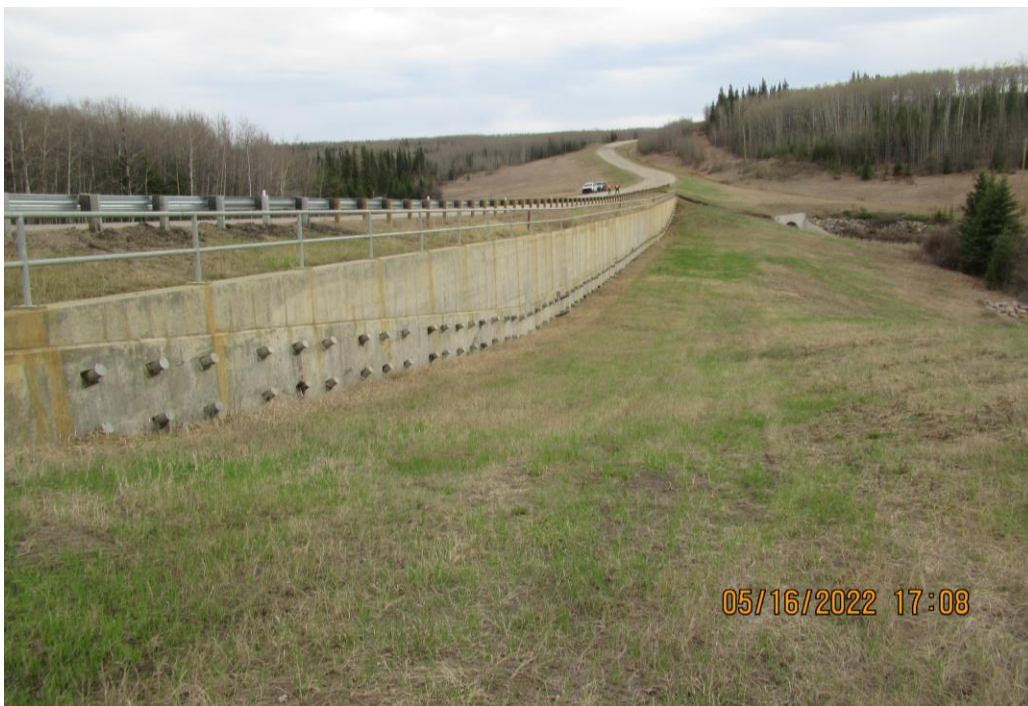
Photo 8 - Looking south along the upper pile wall and downslope embankment at Site 3.

Consider covering the slope in between the pavement and the upper wall with hand placed asphalt, as there is sparse grass growth here and some rilling has formed.

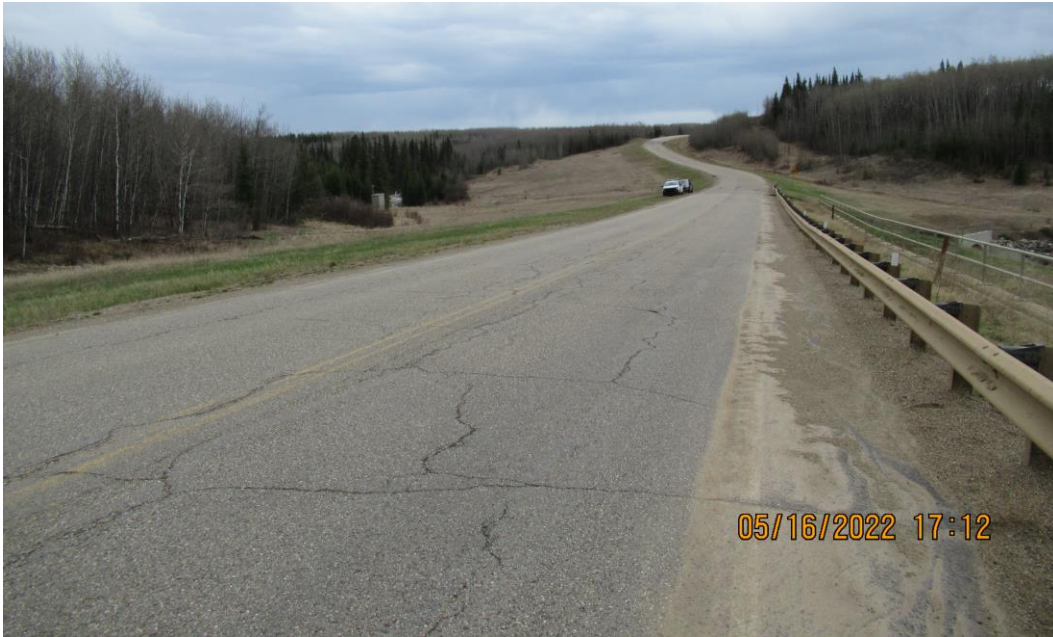
Pavement deflections and alligator cracks have showed up in both lanes (southbound lane worse) near each end of the upper pile wall where the lightweight (Geofoam) fill ends. The southbound lane ACP is in poor shape from the south end of the slide area to about 11 m north of the south end of the wall. Also, map cracking exists quite extensively over the pavement adjacent to the upper pile wall. This is surmised

to be due to flexing of the pavement structure overtop of the Geofam in response to heavy truck traffic, and different thermal characteristics from freeze-thaw compared to total soil bedding. Some of the pavement distress was remediated by placing asphalt patches at the north end of the wall in 2020 and 2021.

Photo 9 – Looking south along the highway at the highway map cracking adjacent to the south half of the pile wall at Site 3.

It is understood that AT has tendered an overlay to be applied to the highway throughout the valley crossing section (Paving Contract #21542), with construction slated for 2023. Prior to placing the overlay, the design engineer should consider doing a full depth subgrade repair to improve the strength of the pavement and better bridge over the softer geofam zone, by: Excavating the majority of the 0.7 m of clay subgrade to near the surface of the geofam; Replacing the clay subgrade to compaction specifications; Installing geogrid in the compacted GBC; then repaving these areas.

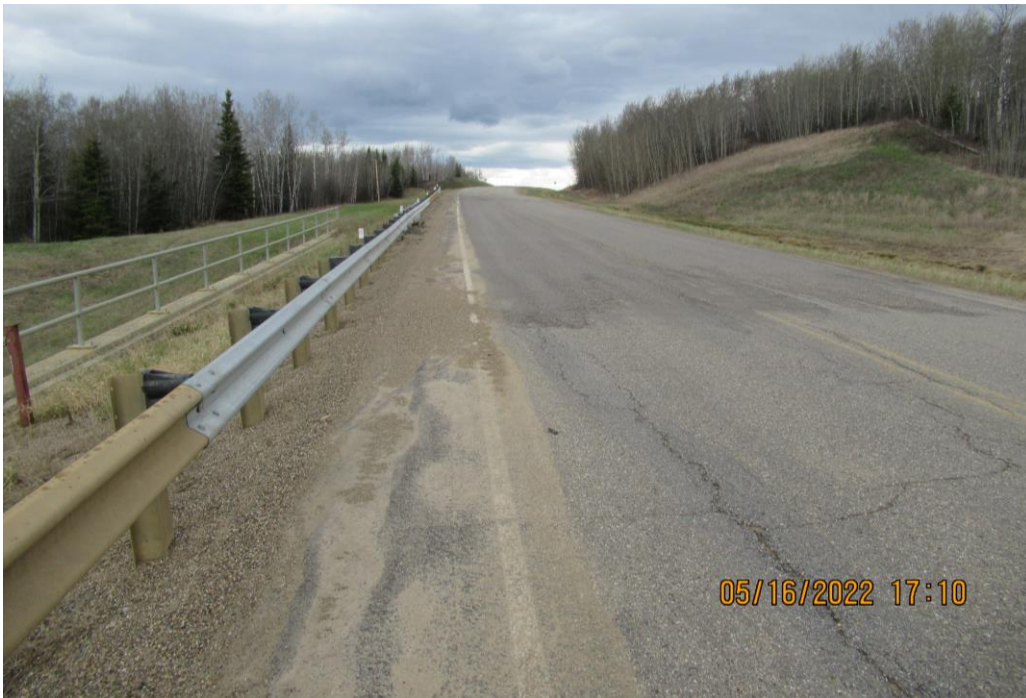
Photo 10 – Looking north along the highway at last year's patch adjacent to the north end of the pile wall at Site 3. Note the freshly placed guardrail, and the hump near the north end of the Lightweight Fill and guardrail.

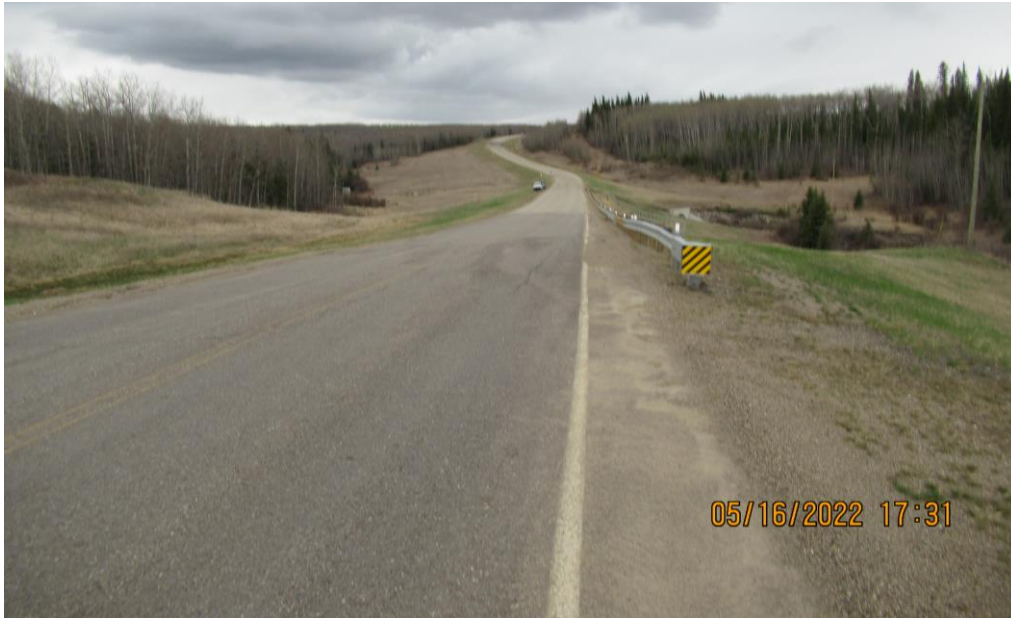
Photo 11 - Looking south along the highway from just north of the hump in the patch near the north end of the pile wall at Site 3. Note the new Impact Attenuator.

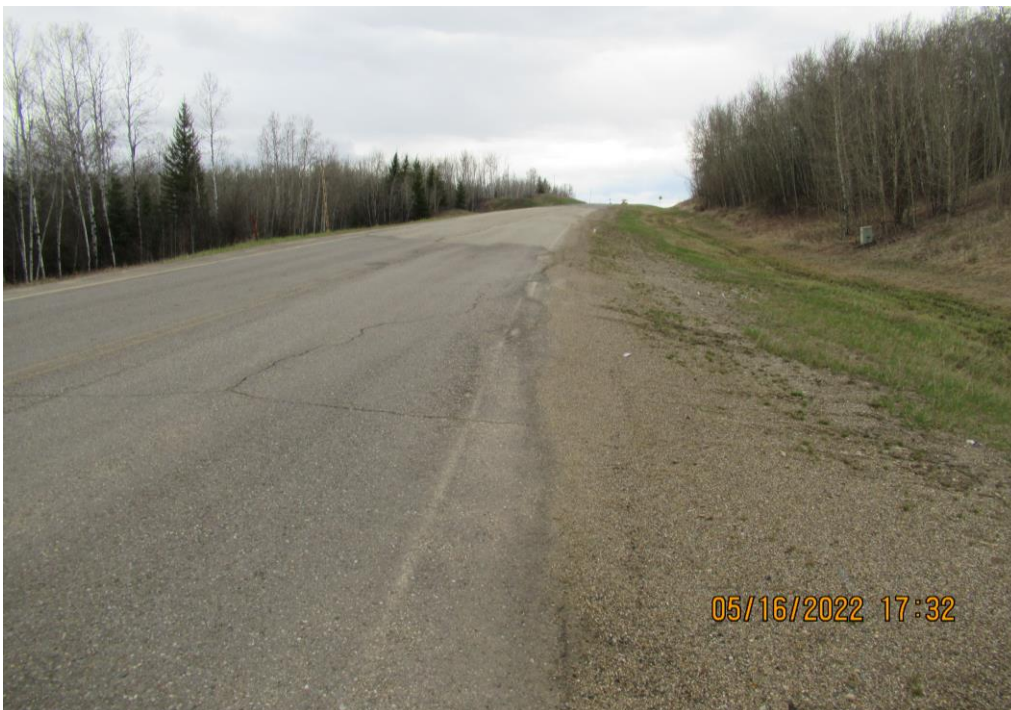
Photo 12 - Looking north along the highway at the distorted pavement and fresh patch, near the south end of Site 5.

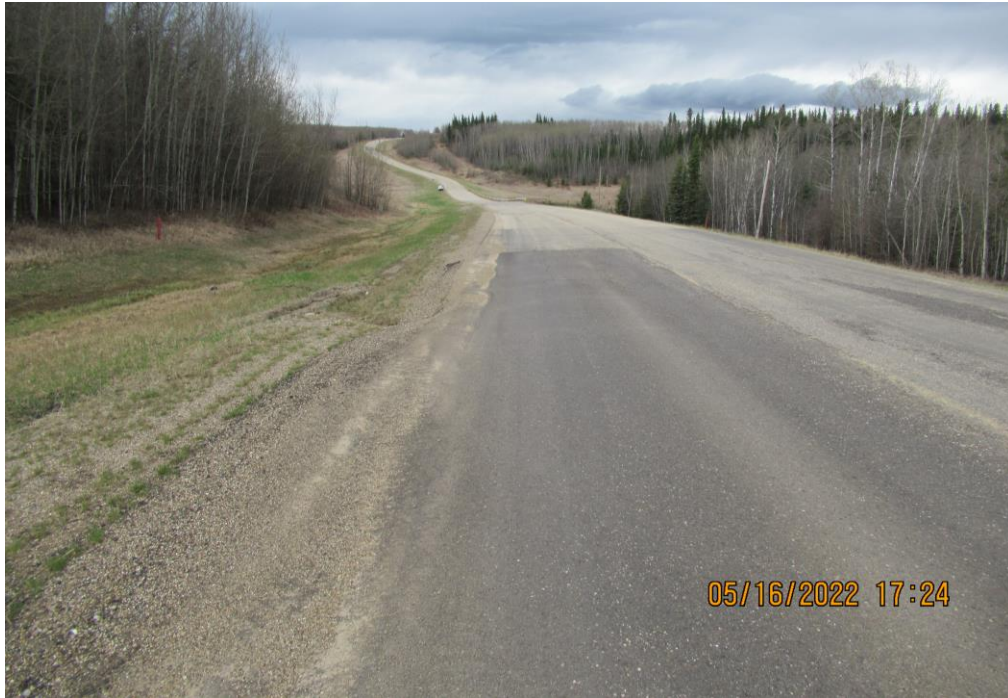
Photo 13 - Looking south along the highway at the subsidence in the NB driving lane and shoulder at Site 5.

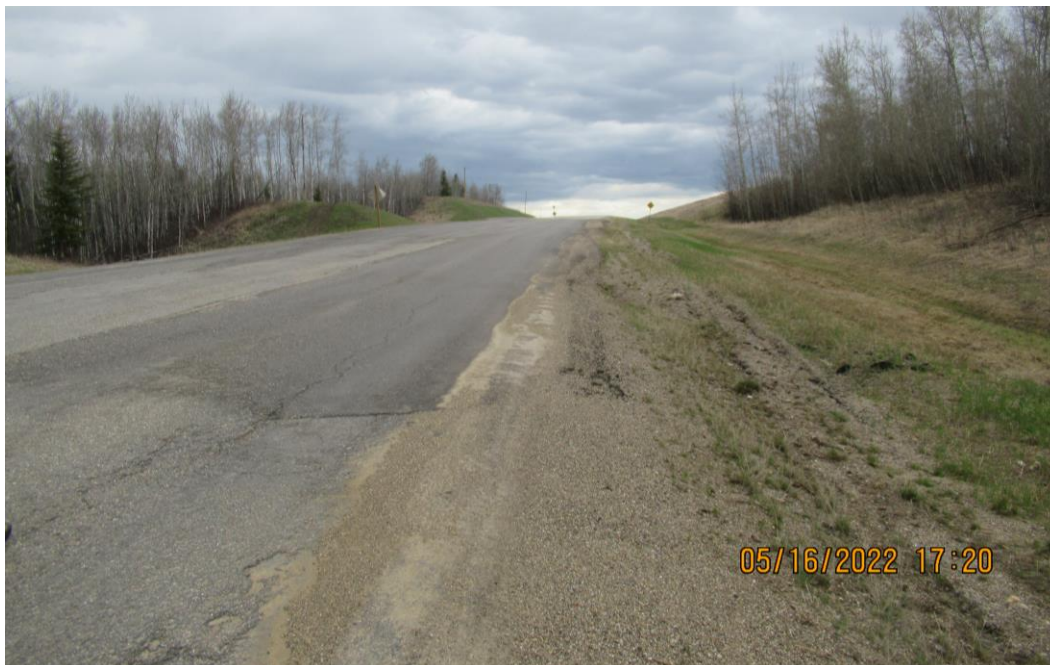
Slide features at/between Sites 5 and 6 have not changed significantly over the last couple of years. The inclinometers installed in 2011 (SI's 11-5, -6 and -7), which were previously showing movements in the order of 15 to 25 mm/year, had all sheared off by 2015, except for SI's 11-3 and 11-4 which are located very near the top of the slide scarp. This indicates movements are occurring at both Sites 5 and 6, in addition to between them, at depths as deep as 18.5 m below ground surface. This more closely defines the slide boundary between Sites 5 and 6 and outlines the edge of a single larger slide moving towards the river.

Photo 14 - Looking north along the east highway edge at where the slide scarp crosses the highway at Site 6.

The major highway re-alignment is still considered the best long-term recommendation, since the slip surfaces at Sites 5 and 6 are too deep to stabilize with a cost-effective pile wall.
