ALBERTA TRANSPORTATION AND
ECONOMIC CORRIDORS GRMP
PEACE REGION
(GRANDE PRAIRIE DISTRICT - NORTH)
INSTRUMENTATION MONITORING – FALL 2025

Site Number	Location	Name	Hwy	km
PH023	HWY 64:02 km 24.10	Clear River East Hill (Site 5- Twin Pipes Landslide)	64:02	Km 24.1
Legal Description: 12-27-84-11 W6		UTM Co-ordinates		
		11U E 335453	N	6244315

Current Monitoring:	29-Sept-2025	Previous Monitoring	15-June-2025
Instruments Read By:	Mr. Niraj Regmi, G.IT. and Mr. Angelo Castillo, of Thurber

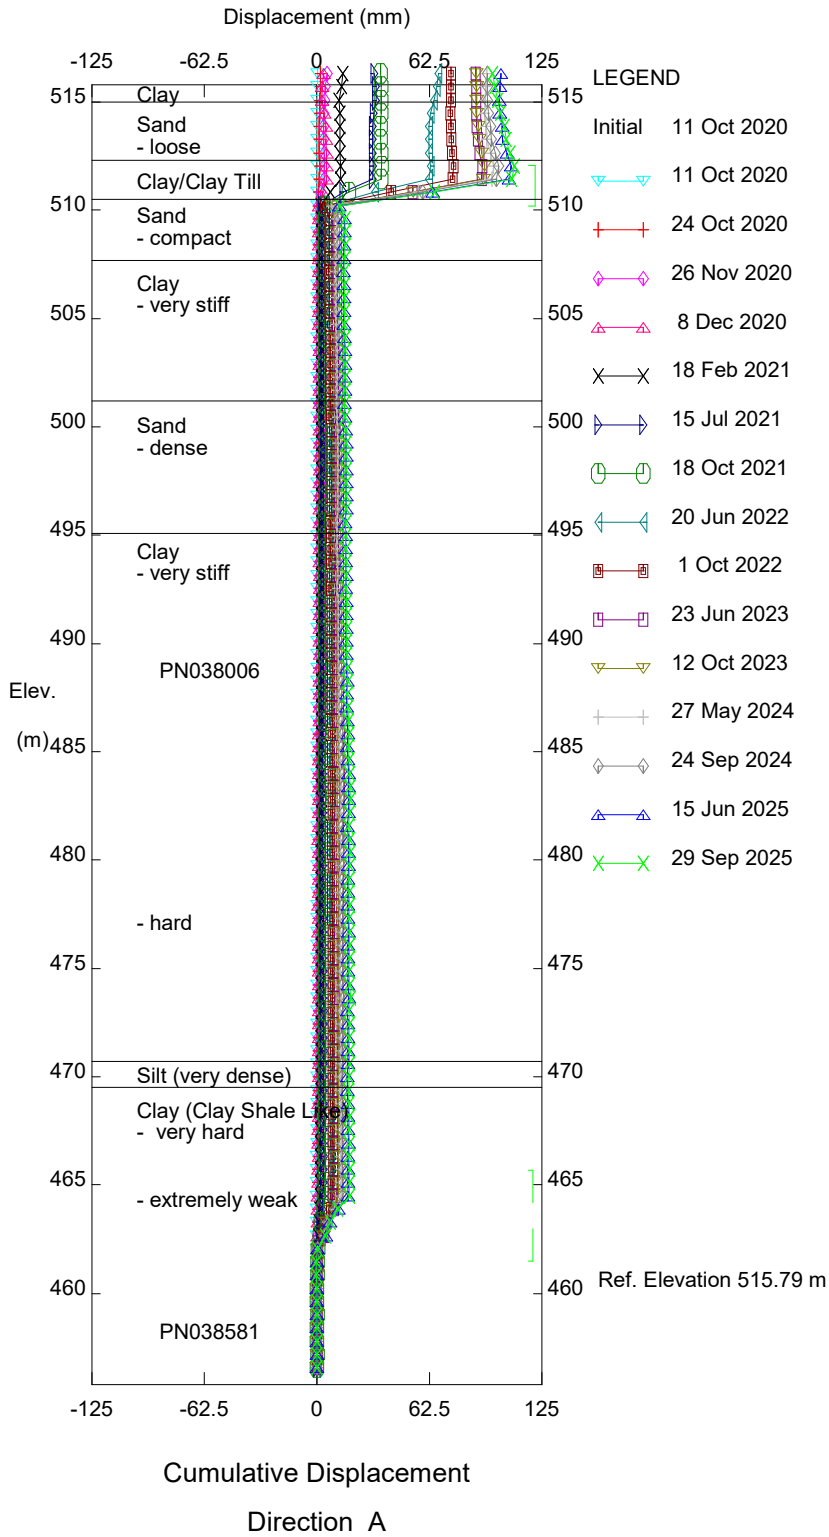
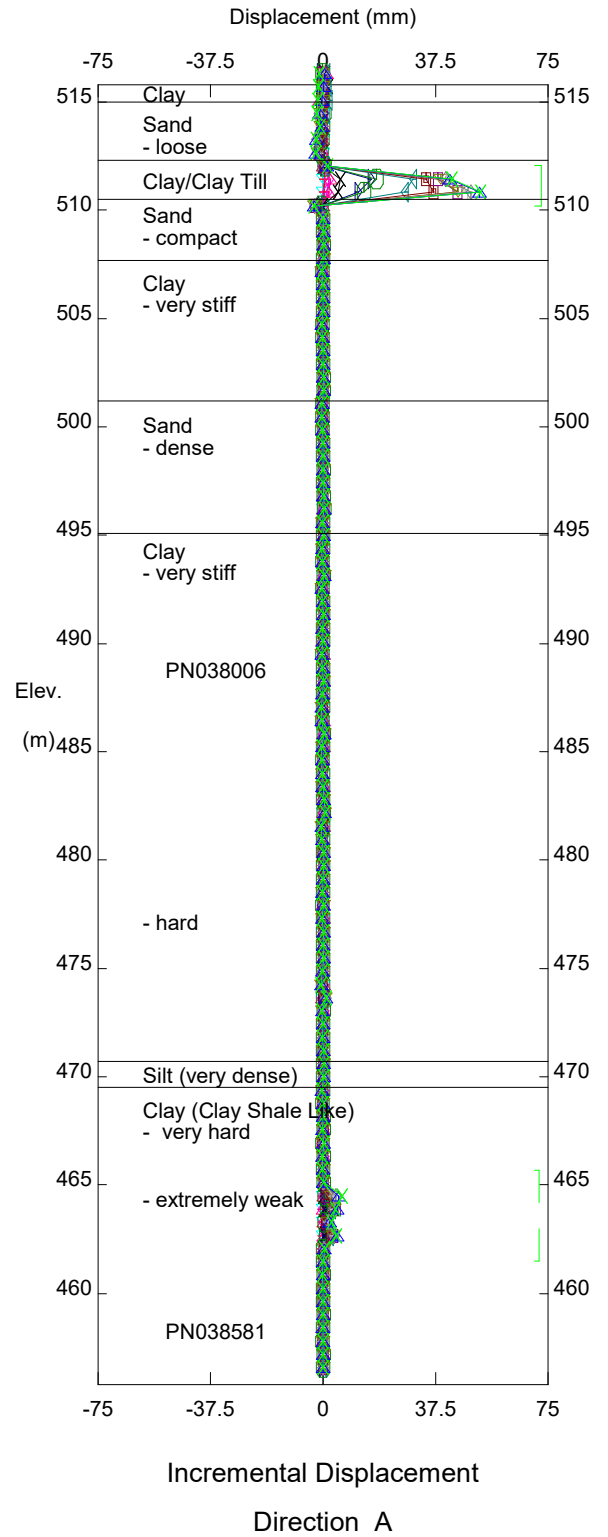
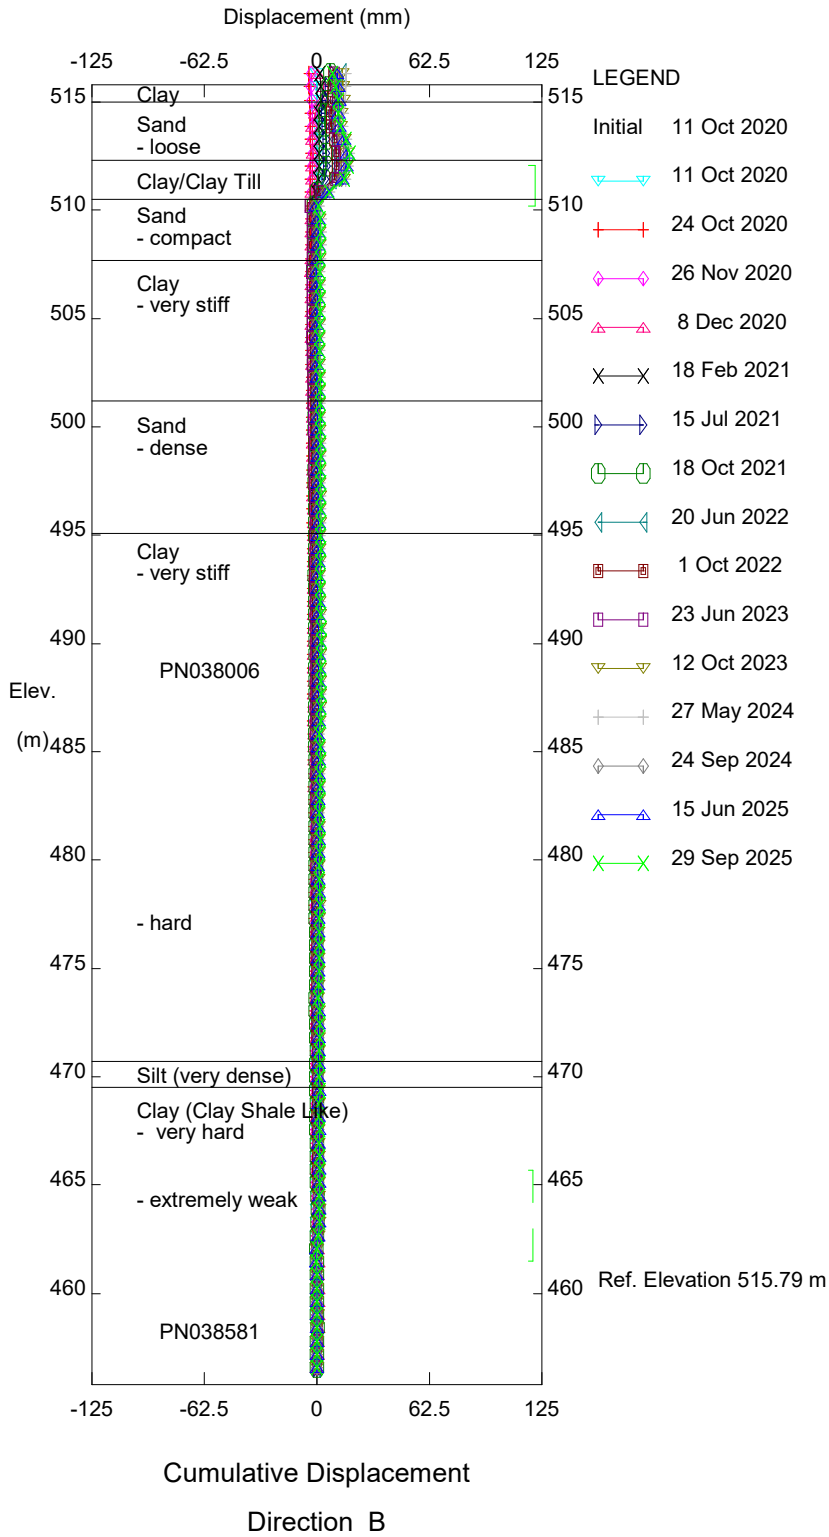
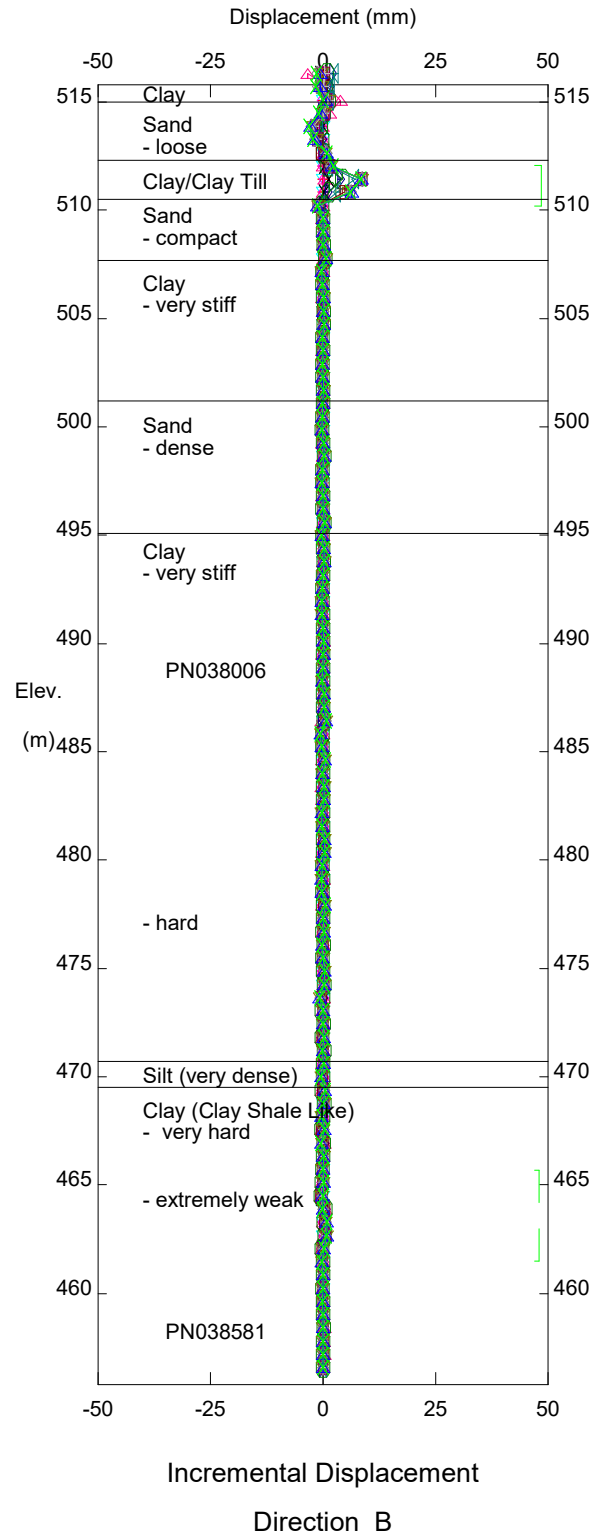
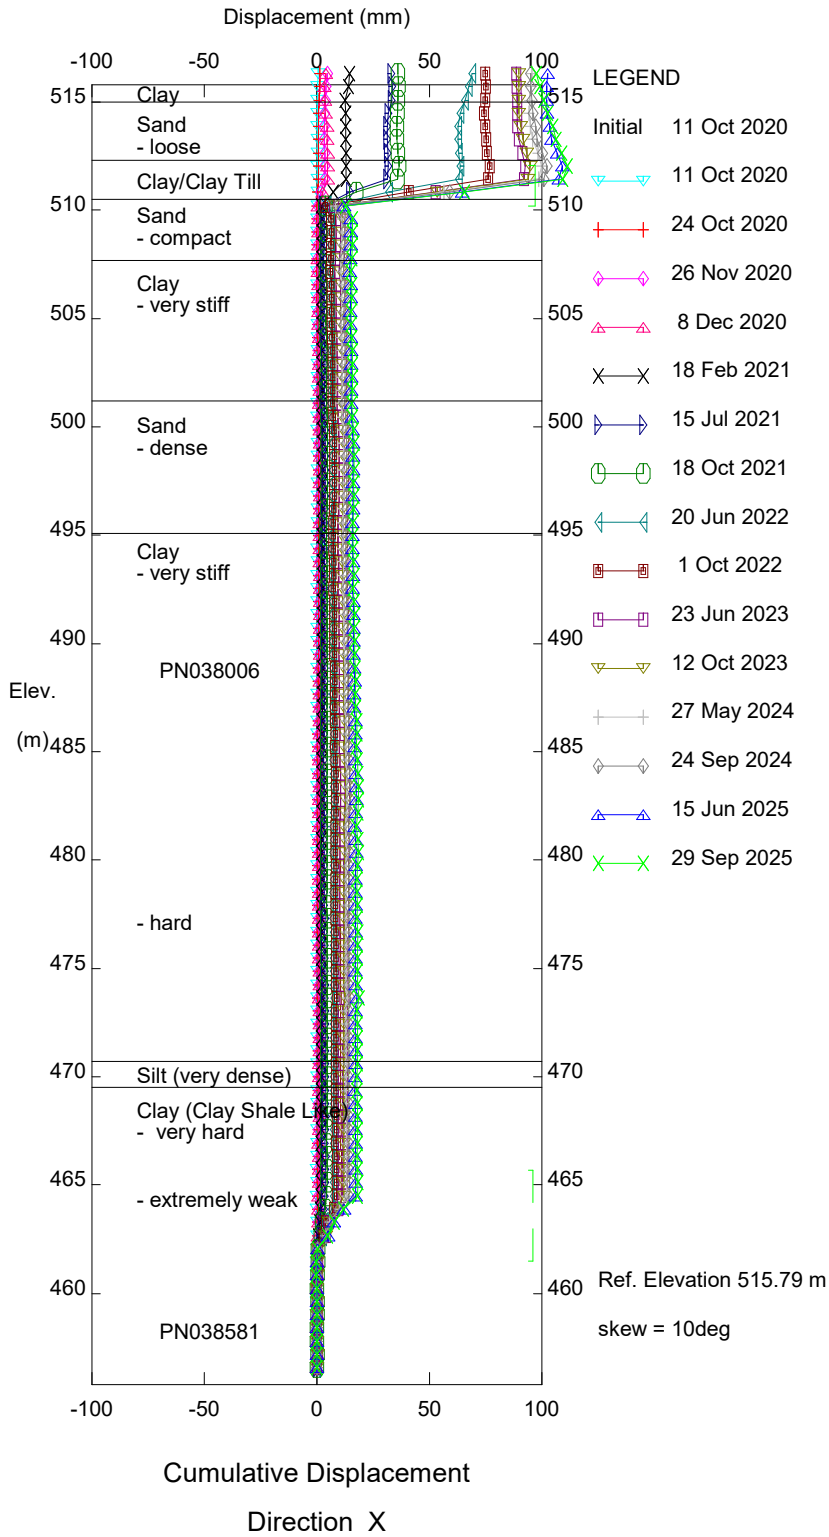
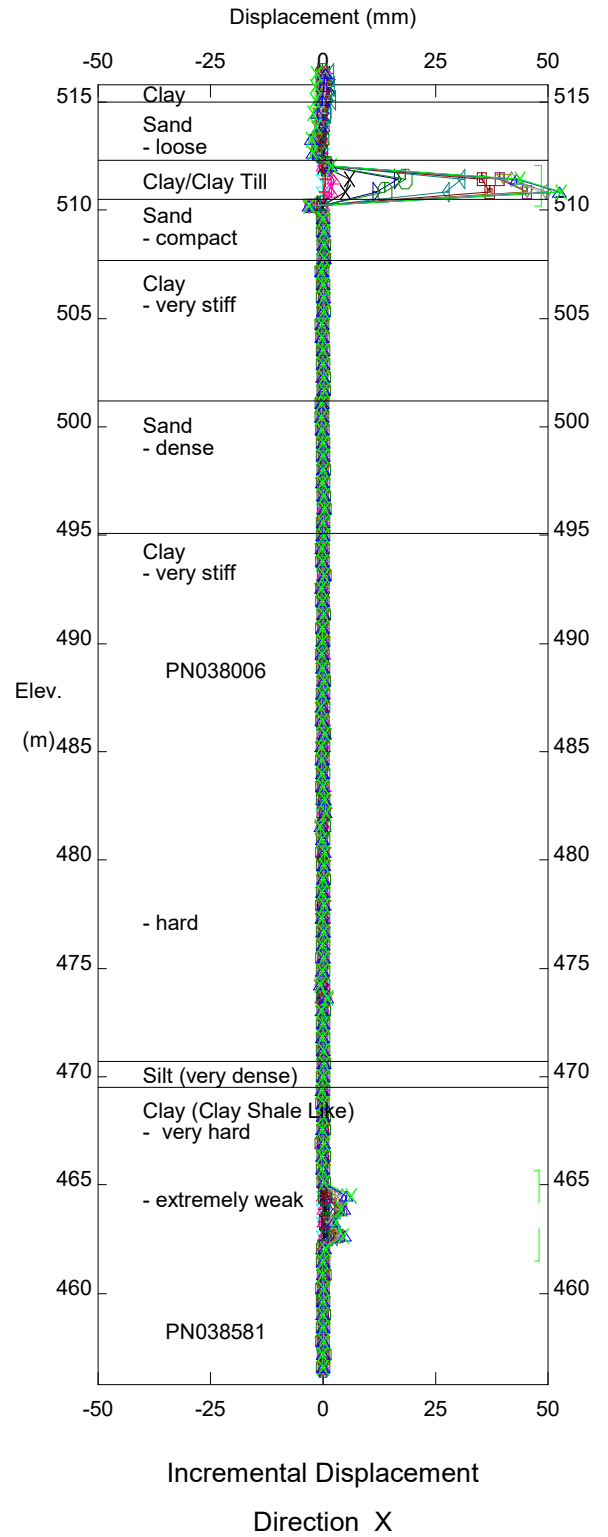
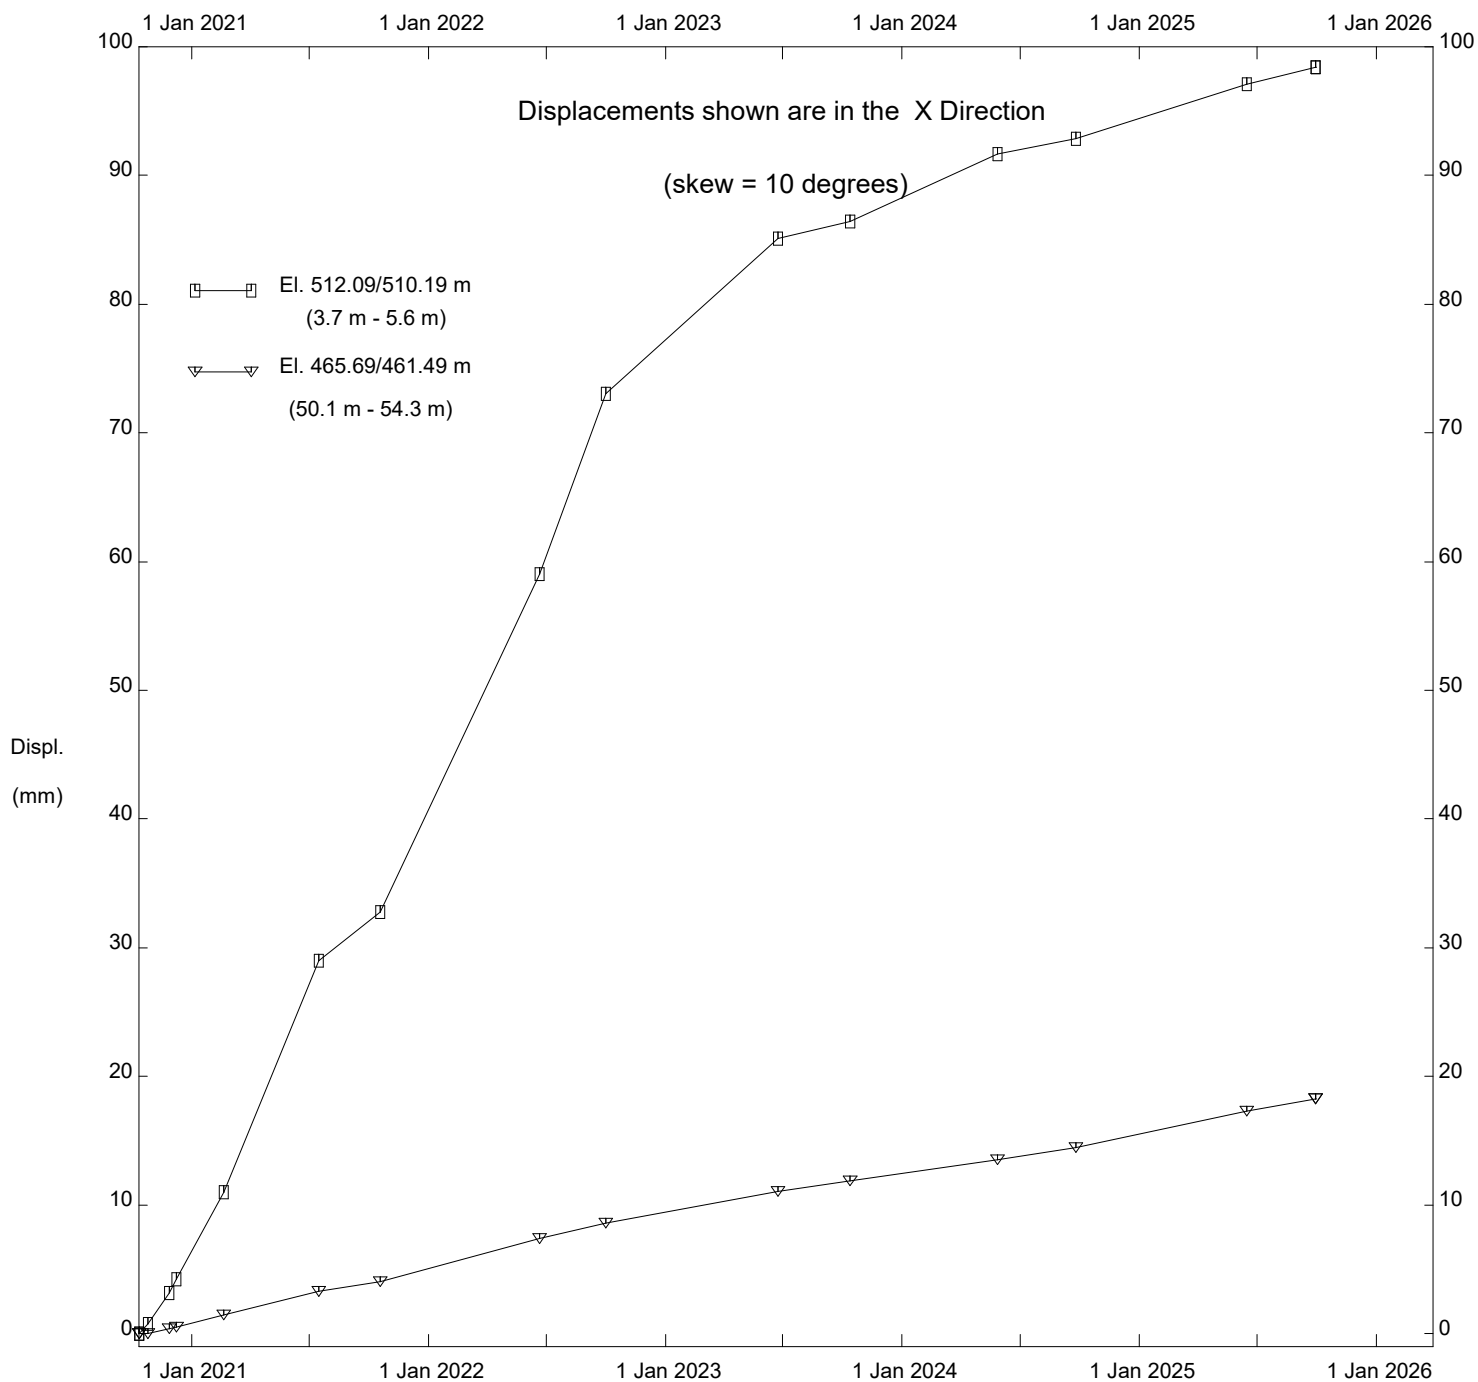
Hwy 64:02 Twin Pipes Landslide (PH023), Inclinator SI20-1

Discussion	
Zones of New Movement:	None
Interpretation of Monitoring Results:	<p>Overall, the SIs showed slightly slower rates of movement compared to the previous readings in the spring of 2025.</p> <p>SI20-1 showed current movement rates of 4.7 mm/yr over 3.7 m to 5.6 m depth and 3.2 mm/yr over 50.1 m to 54.3 m depth. SI20-7 showed rates of movement of 1.2 mm/yr over 17.8 m to 19.6 m and 2.5 mm/yr over 31.8 m to 33.6 m depth. SI 20-1 and 20-7 are about 600 m apart but both show comparable movement rates and elevation of the deeper movement zones (both SI are moving at about elevation 460 m in a weak clay strata) which is a confirmation of a very large and deeply seated movement mass.</p> <p>The groundwater levels in piezometers PN20-1A, PN20-1B, PN20-3B, PN20-8A, and showed decreases in groundwater levels of 0.07 m, 0.91 m, 0.07 m, and 0.07 m respectively, since the spring of 2025 readings. PN20-2A, PN20-7B (see comment below) and PN20-8B showed increases in groundwater level of 0.14 m, 1.33 m and 0.07 m, respectively, since the spring of 2025 readings. The groundwater levels in piezometers PN20-3A and PN20-7A remained the same since the spring of 2025 readings.</p>
