**ALBERTA TRANSPORTATION AND
ECONOMIC CORRIDORS
GEOHAZARD ASSESSMENT PROGRAM
PEACE REGION (GRANDE PRAIRIE DISTRICT - NORTH)
2025 INSPECTION**

Site Number	Location	Name	Hwy	km
PH026	Eureka River North Hill	Sites #3, #5 and #6	726:02	10.1
Legal Description		UTM Co-ordinates (NAD83)		
SW13/SE14-86-8-W6		11 N 6258740	E 368408

Date	PF	CF	Total
Previous Inspection:	May 8, 2024	3	4	12 (Site 3)
		9	5	45 (Sites 5 and 6)
Current Inspection:	May 8, 2025	3	4	12 (Site 3)
		7	6	42 (Sites 5 and 6)
Road AADT:	480		Year:	2024
Inspected By:	Barry Meays, Don Proudfoot (Thurber) Chris Newman, Ken Szmata, Babatunde Awokunle (TEC)			
Report Attachments:	<input checked="" type="checkbox"/> Photographs		<input checked="" type="checkbox"/> Plans	<input checked="" type="checkbox"/> Maintenance Items

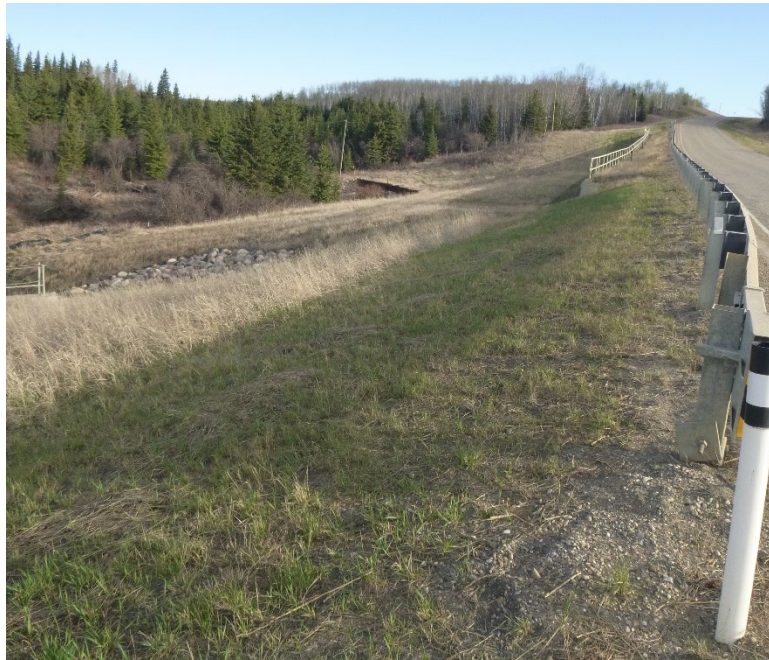
Photo 1 – Looking northwest at the 2023 slide repairs and arch culvert outlet from south of the upper pile wall at Site 3.

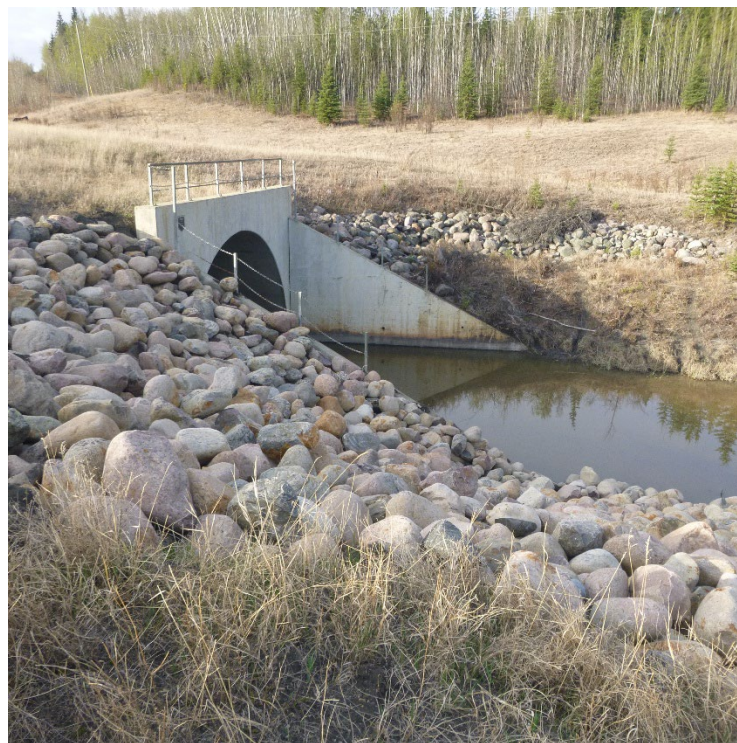
Photo 2 – Looking south at the lower slide repairs and arch culvert outlet at Site 3.

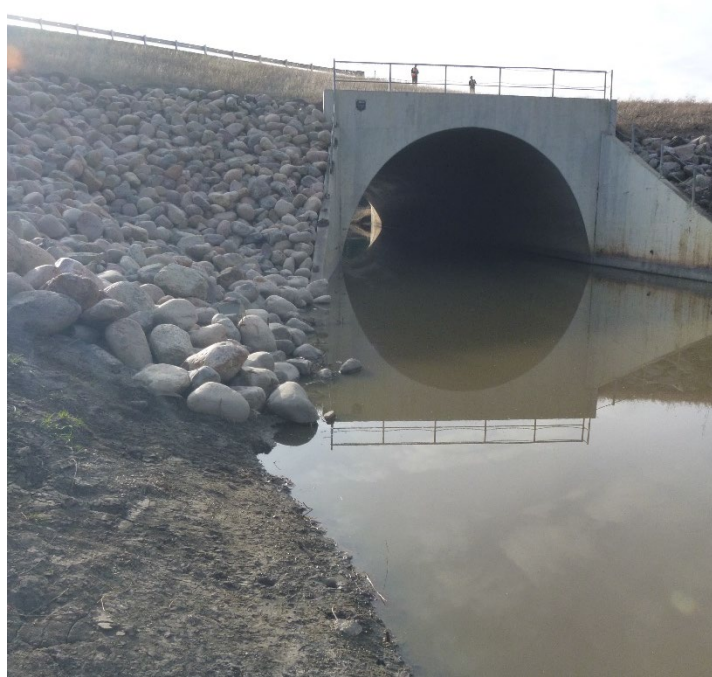
Photo 3 – Looking southeast at the slide repairs and the arch culvert outlet area at Site 3.

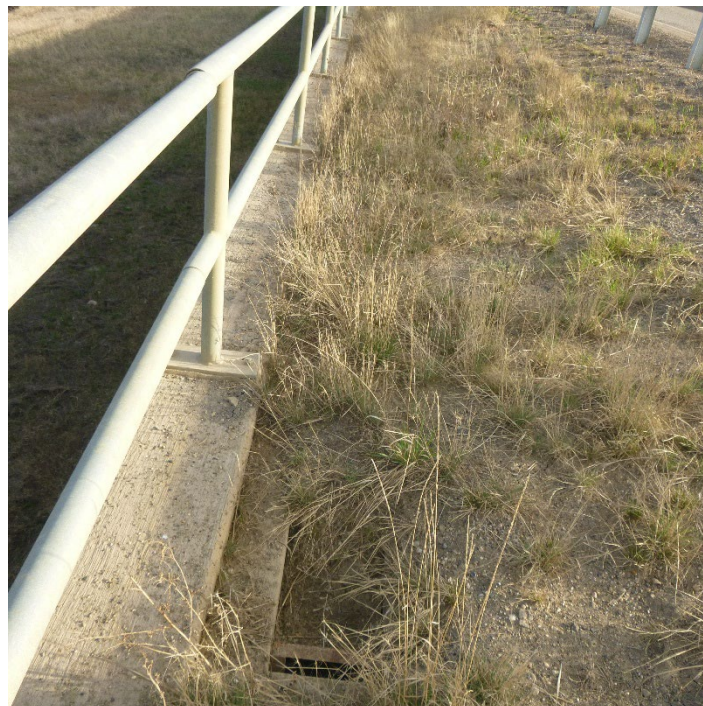
<input checked="" type="checkbox"/> Other	Maintenance issues that require attention: loose gutter grate and silt/debris filled concrete gutter. The exposed concrete on the top of the upper pile wall is spalling. The handrail was separated at one location on the pile wall. Also, there was minimal grass growth on the west embankment around the 2023 slide repair area.	<input checked="" type="checkbox"/>
---	---	-------------------------------------

Photo 4 – Looking north at the top of pile wall gutter drain and loose cover plate at site 3. This needs to be maintained.

- 1) Clean the gutter of soil/debris buildup under the handrail adjacent to the west side of the highway and securely fasten the loose gutter grate.
- 2) The spalled concrete on the surface of the upper pile wall should be repaired by chipping off the loose material and replacing it with approved grout and then placing a proper concrete sealant over the entire exposed surface to prevent any further degradation.
- 3) A steel sleeve could be installed over the gap in the handrail.
- 4) Install a grate that was missing on the subdrain outlet from the 2023 slide repairs performed between the pile wall and bridge culvert.

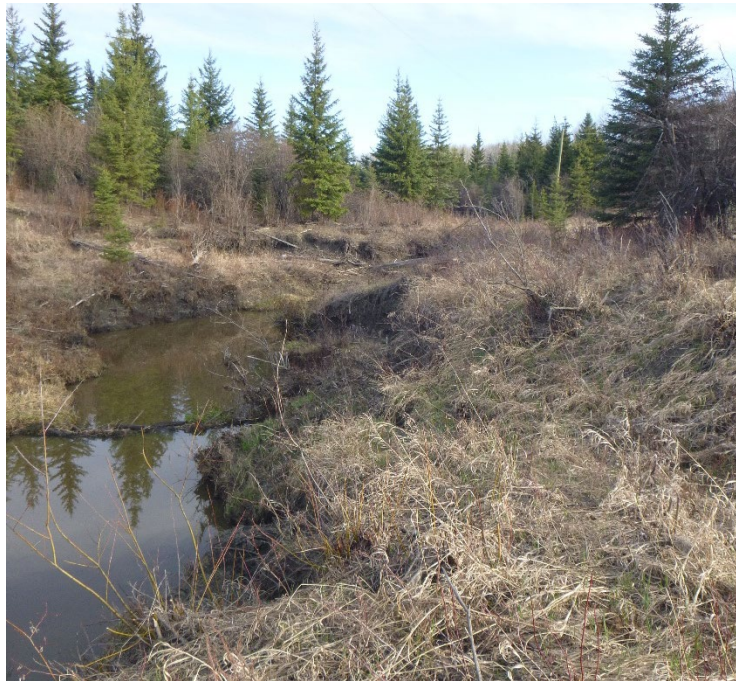
Photo 5 – Looking northwest along the river at the bank slumping, from just downstream of the arch culvert.

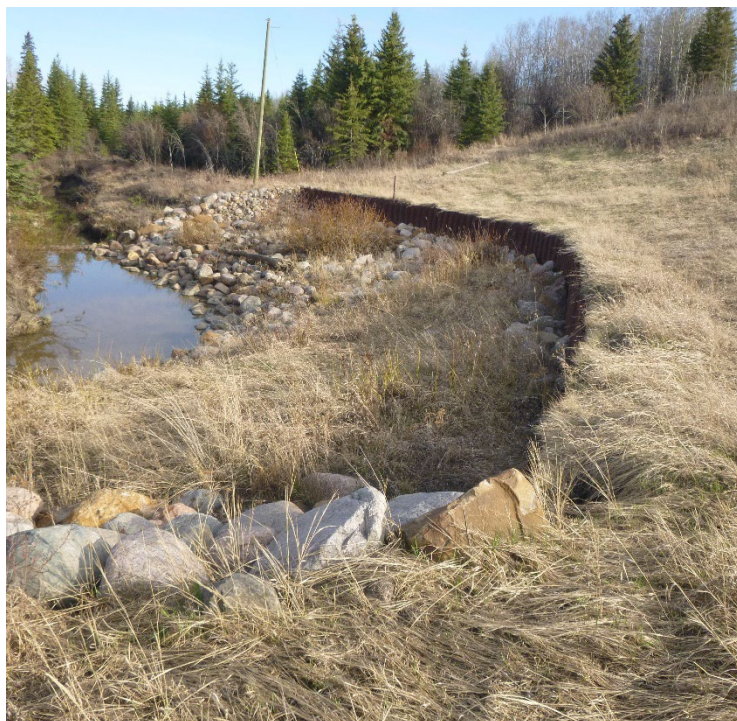
Photo 6 – Looking north at the lower pile wall area at Site 3, the riprap behind it, and the river.

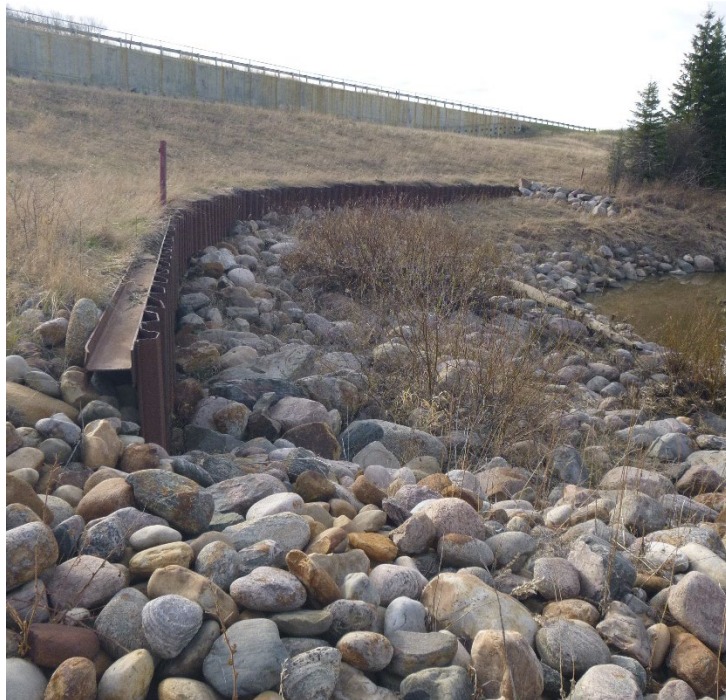
Photo 7 – Looking south along the lower pile wall, riprap, and river at Site 3.

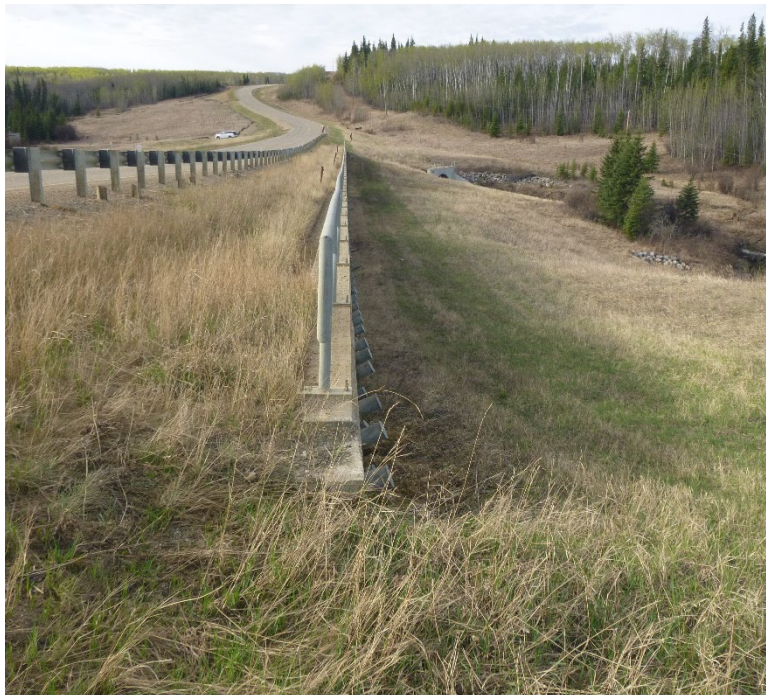
Photo 8 - Looking south along the upper pile wall and downslope embankment at Site 3.

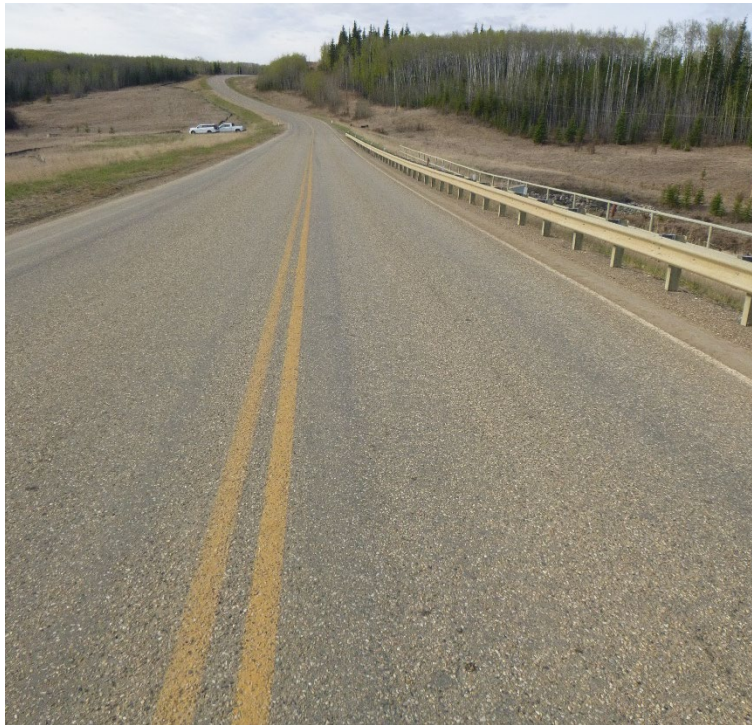
Photo 9 – Looking south along the highway from the midpoint of the upper pile wall of Site 3.

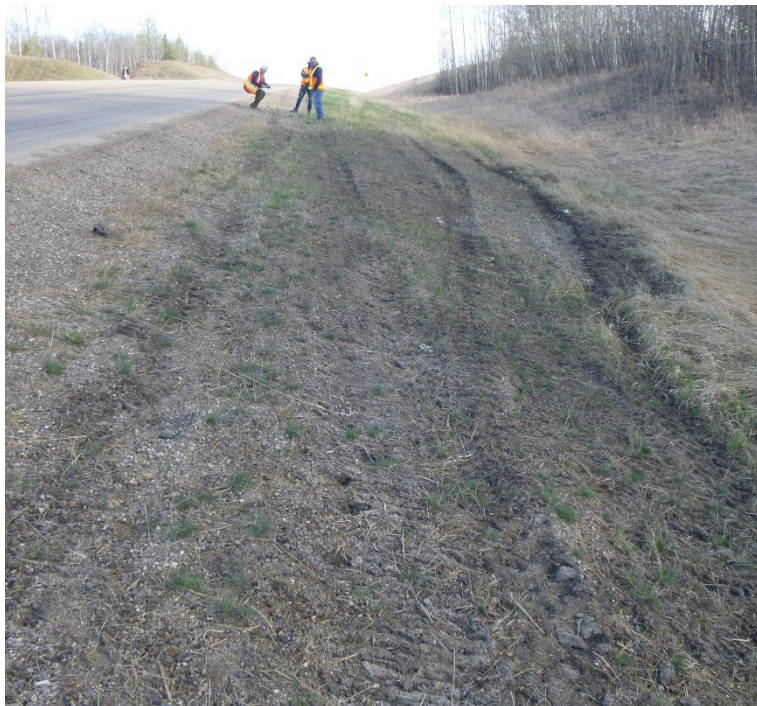
<input checked="" type="checkbox"/> Seepage	There is a seepage area in the east highway embankment and ditch north of the north end of the upper pile wall.	<input type="checkbox"/>	
<input type="checkbox"/> Bridge/Culvert Distress		<input type="checkbox"/>

Photo 10 - Looking north along the highway and east ditch from the Telus pedestal of Site 5. Note the slight seepage area.

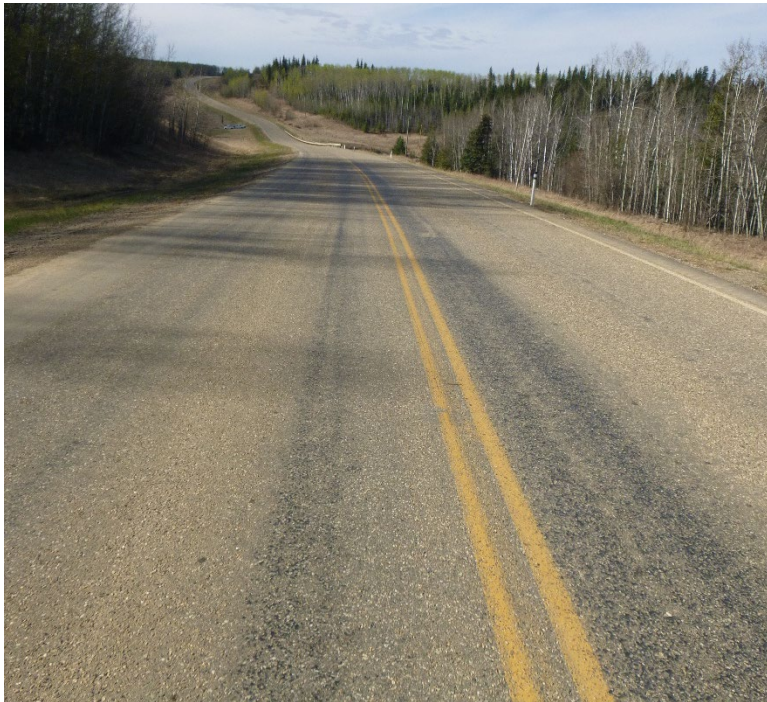
Photo 11 - Looking south along the highway between Sites 5 and 6.

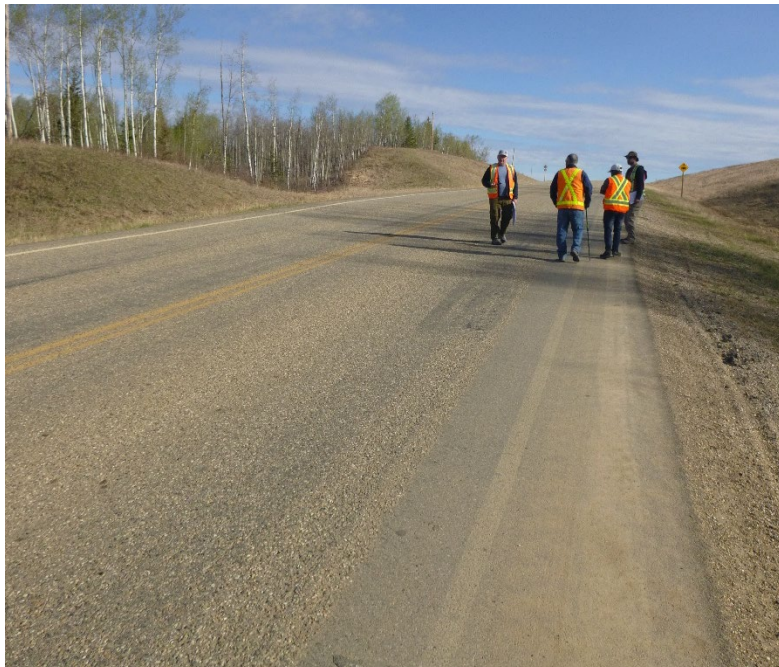
Photo 12 - Looking north along the east highway edge where the slide scarp crosses the highway at Site 6.

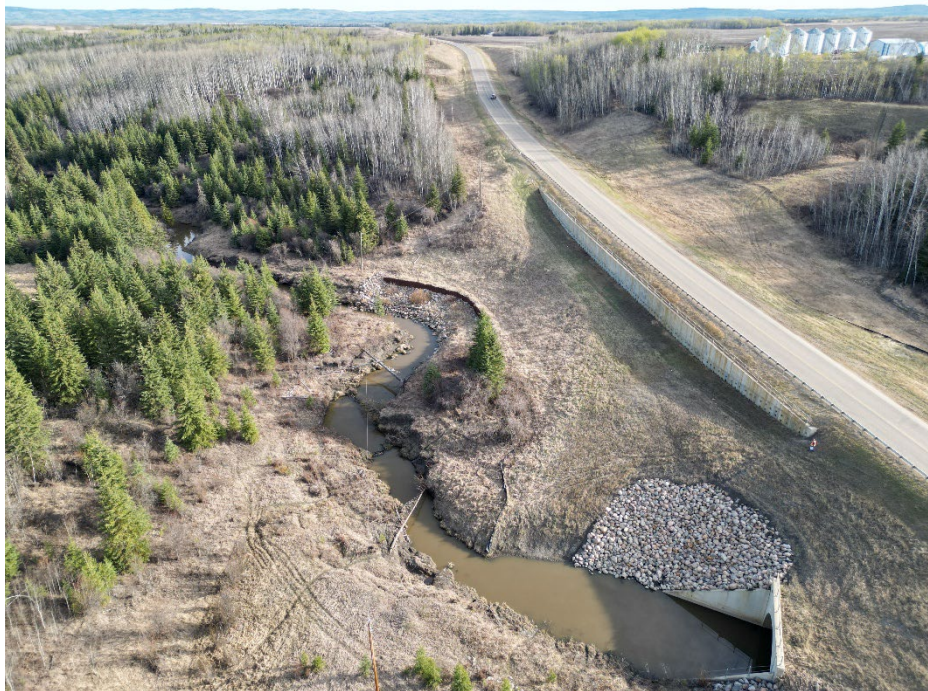
Photo 13 – Drone Photo looking north at the arch culvert outlet and Site 3, with Sites 5 and 6 in the background.

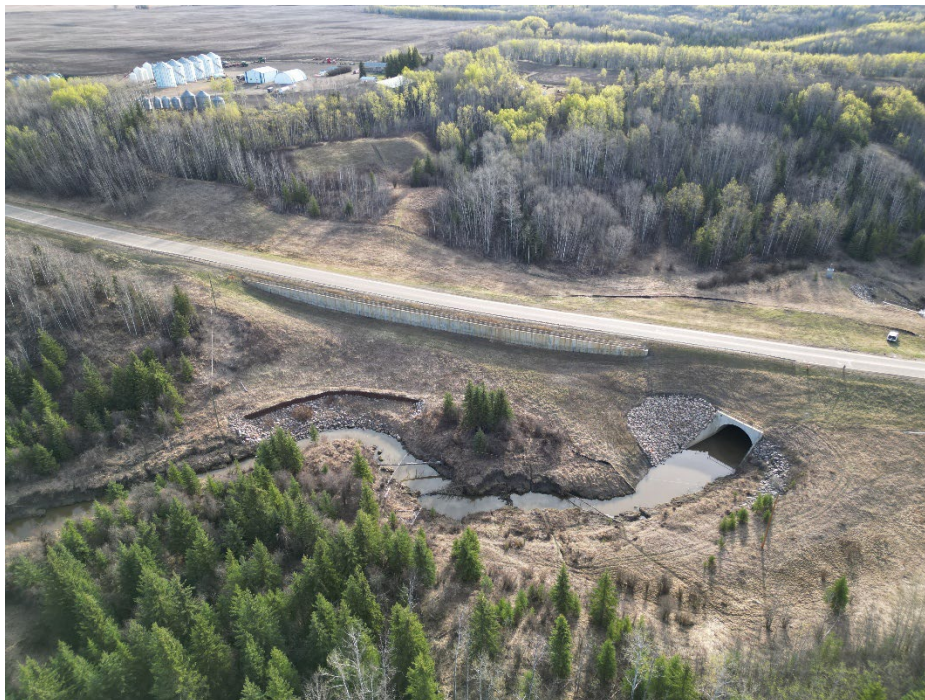
Photo 14 – Drone Photo looking northeast at Site 3.
