ALBERTA TRANSPORTATION AND
ECONOMIC CORRIDORS GRMP
PEACE REGION
(GRANDE PRAIRIE DISTRICT - NORTH)
INSTRUMENTATION MONITORING - SPRING 2025

Site Number	Location	Name	Hwy	km
PH026	HWY 726:02 km 9.91, 10.30	North Eureka River Slide	726:02	Km 9.9, 10.3
Legal Description: 8-14-86-8 W6		UTM Co-ordinates		
		11U E 368433	N	6258811

Current Monitoring:	15-June-2025	Previous Monitoring	27-May-2024
Instruments Read By:	Mr. Neil McDonald and Mr. Godfred Etiendem, of Thurber

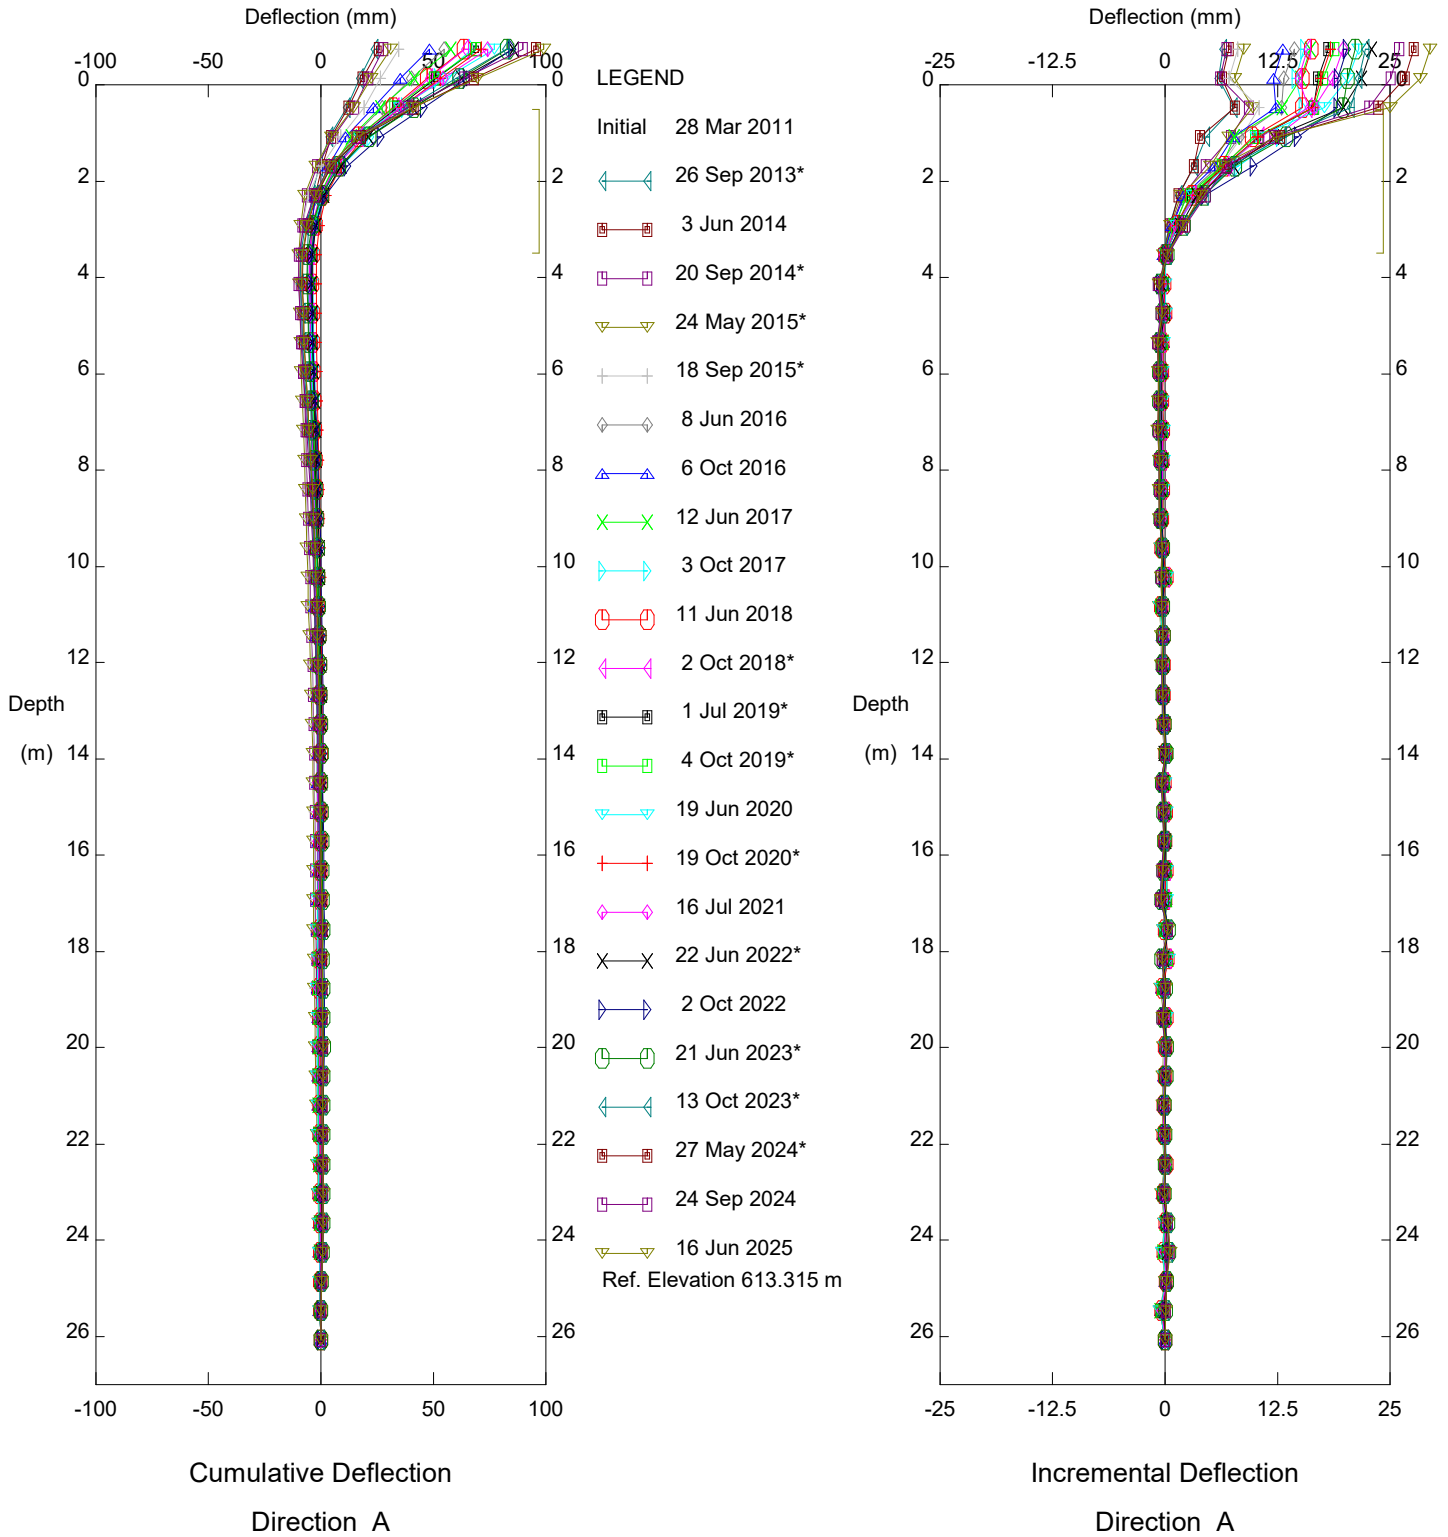
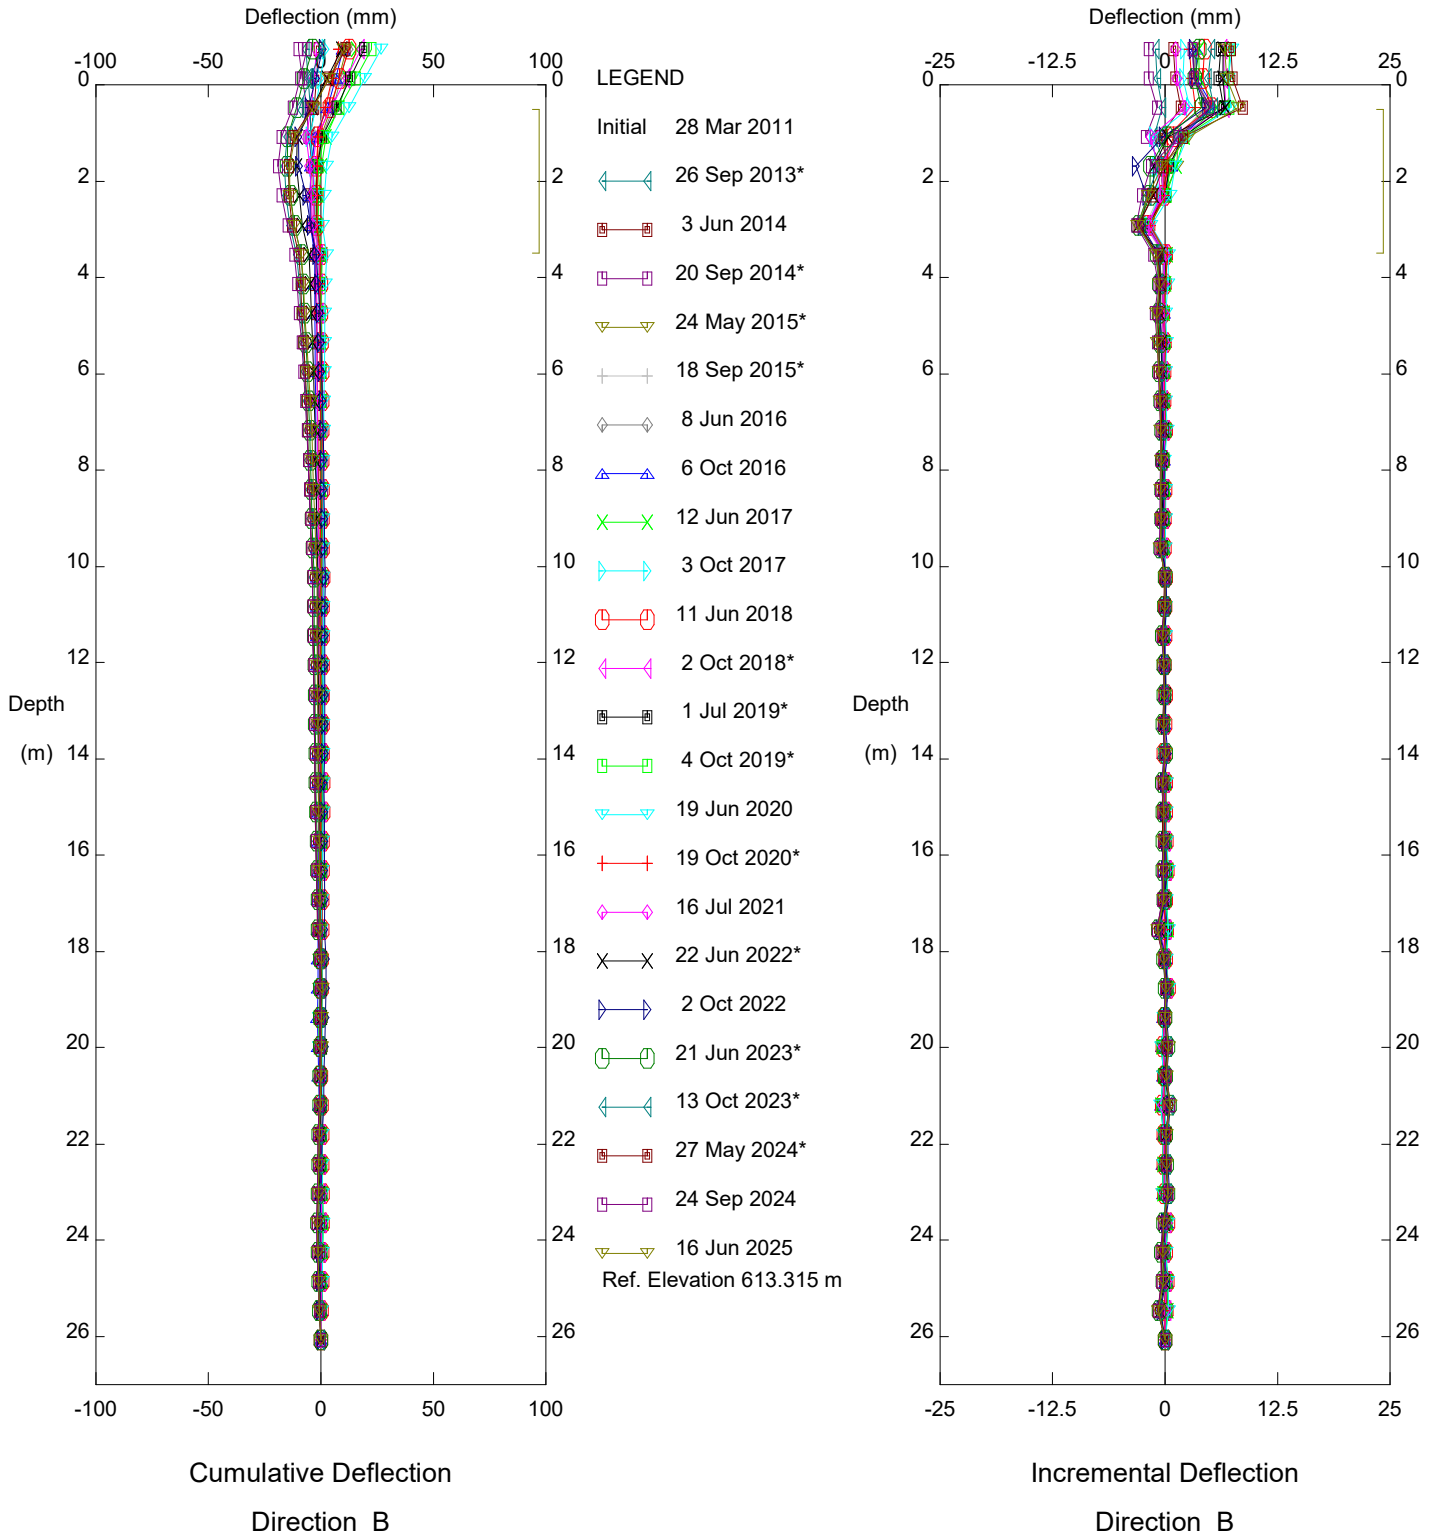
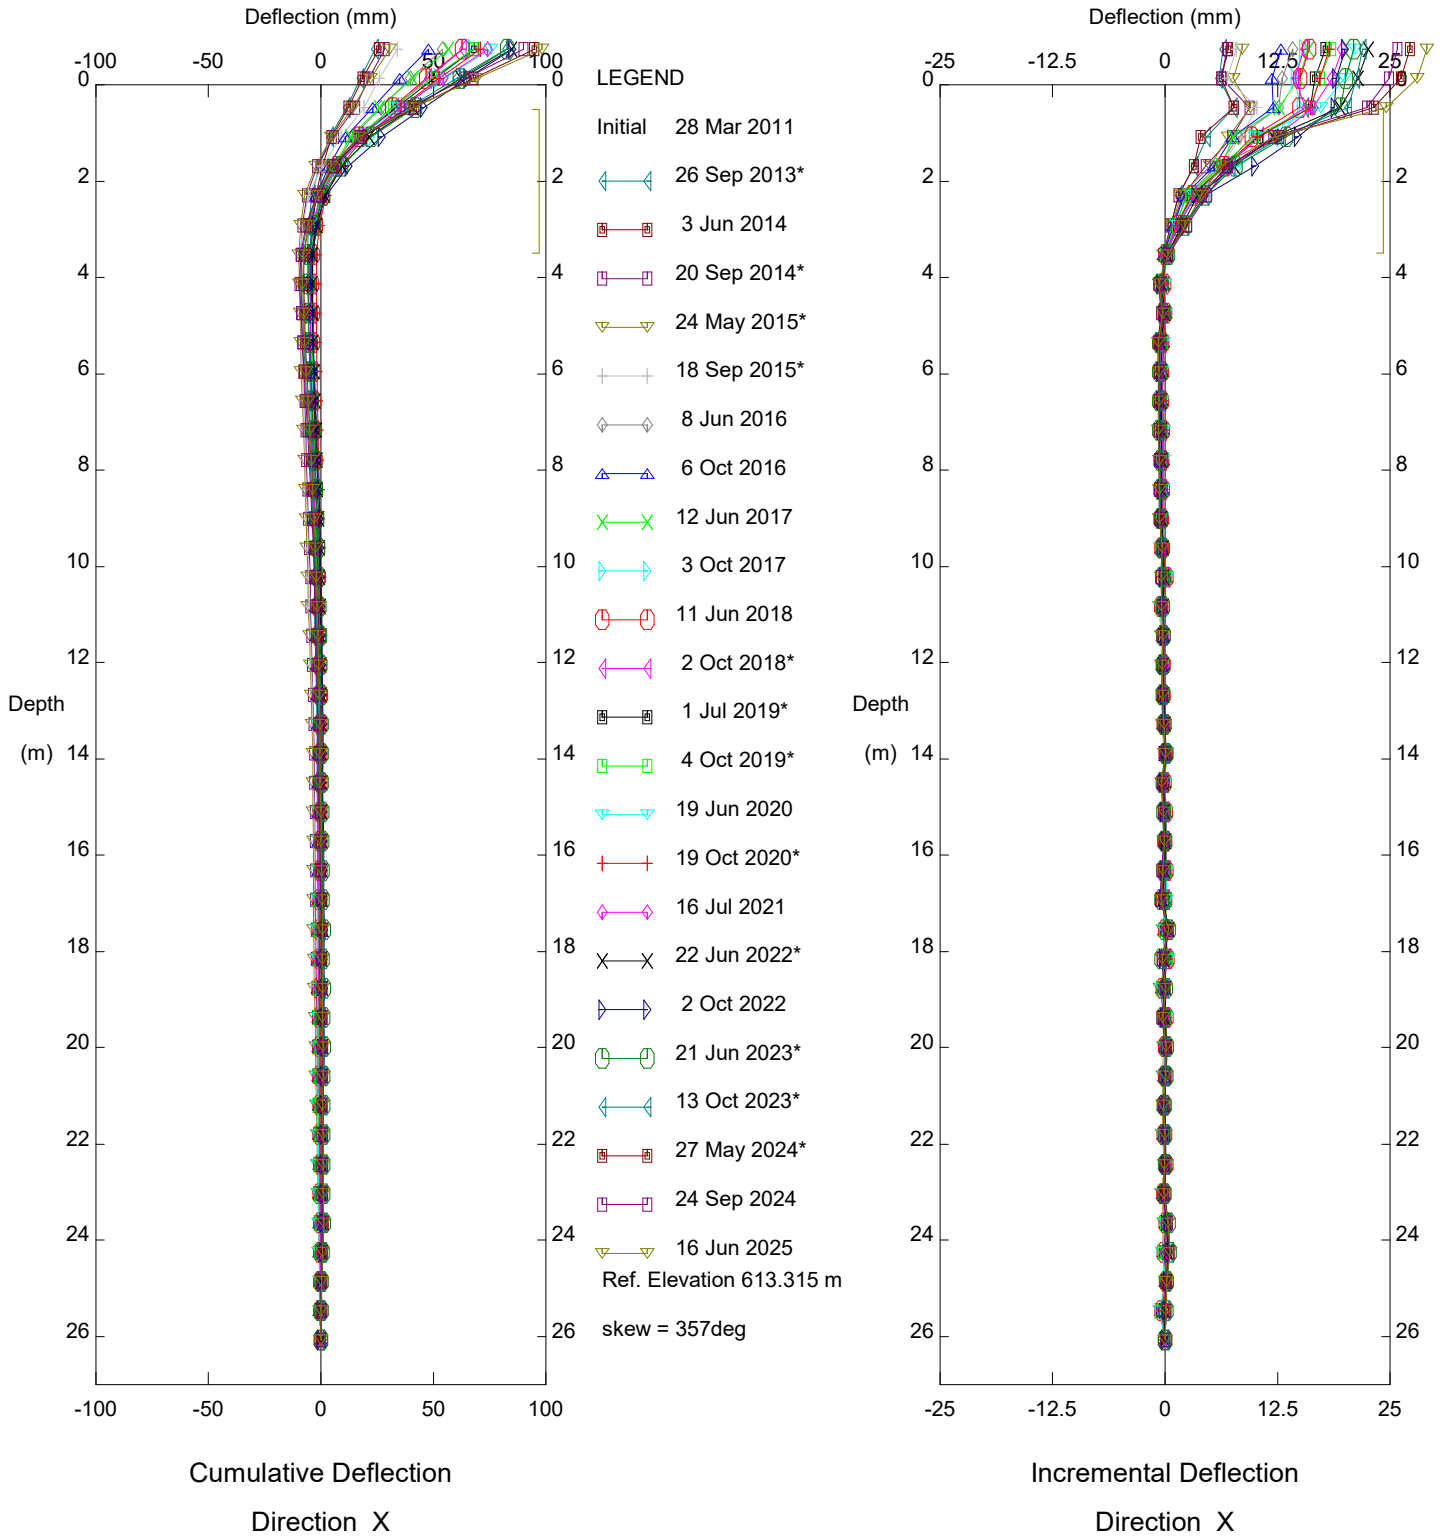
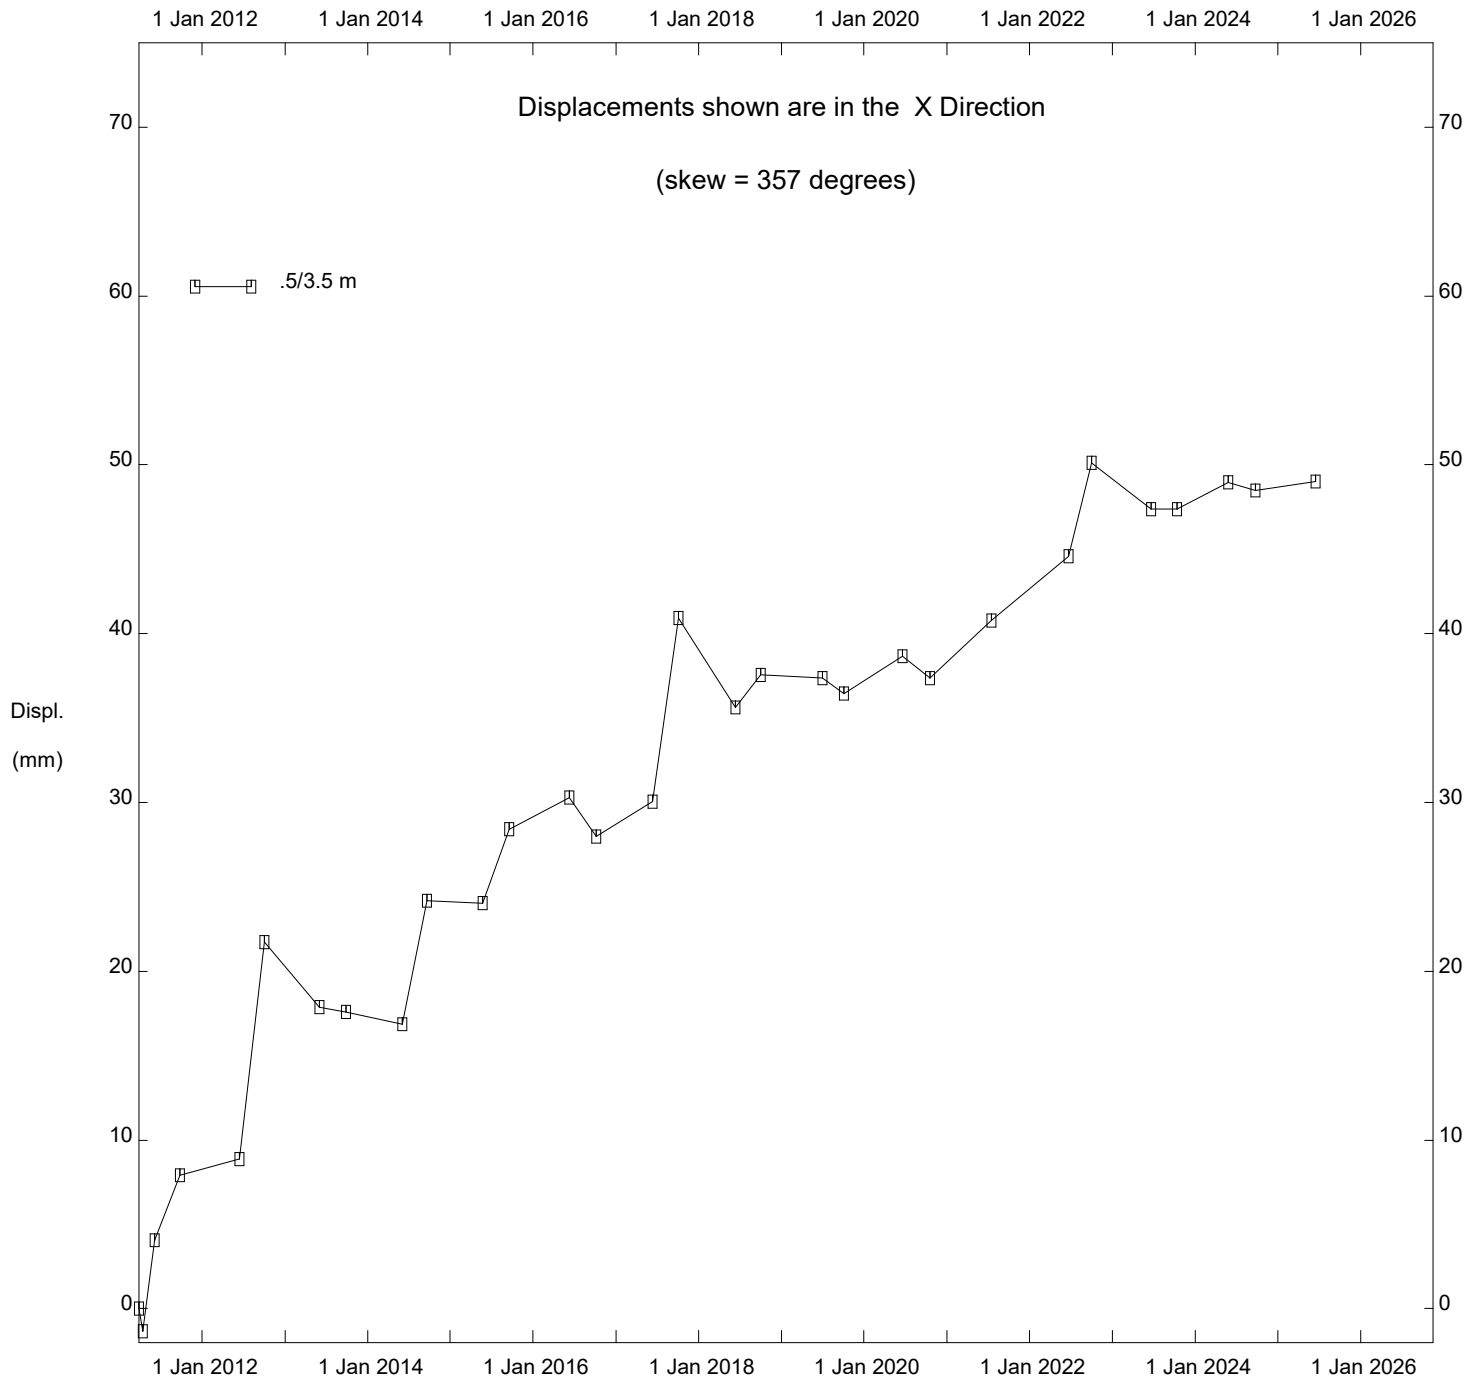
Hwy 726:02 Eureka River, PH026, Inclinometer SI11-3

Discussion	
Zones of New Movement:	None
Interpretation of Monitoring Results:	Slope Indicators Slope inclinometer SI11-3 showed a rate of movement of 0.8 mm/yr over 0.5 m to 3.5 m depth since the fall of 2024 readings. Since 2013 the rate of movement has fluctuated and shows an overall rate of about 2.5 mm per year. SI11-4 shows subtle indefinite movement zones. Slope inclinometers SI12-P9U, SI12-P17U, SI12-P26U were installed in the upper wall. All three SIs showed similar deflection profiles

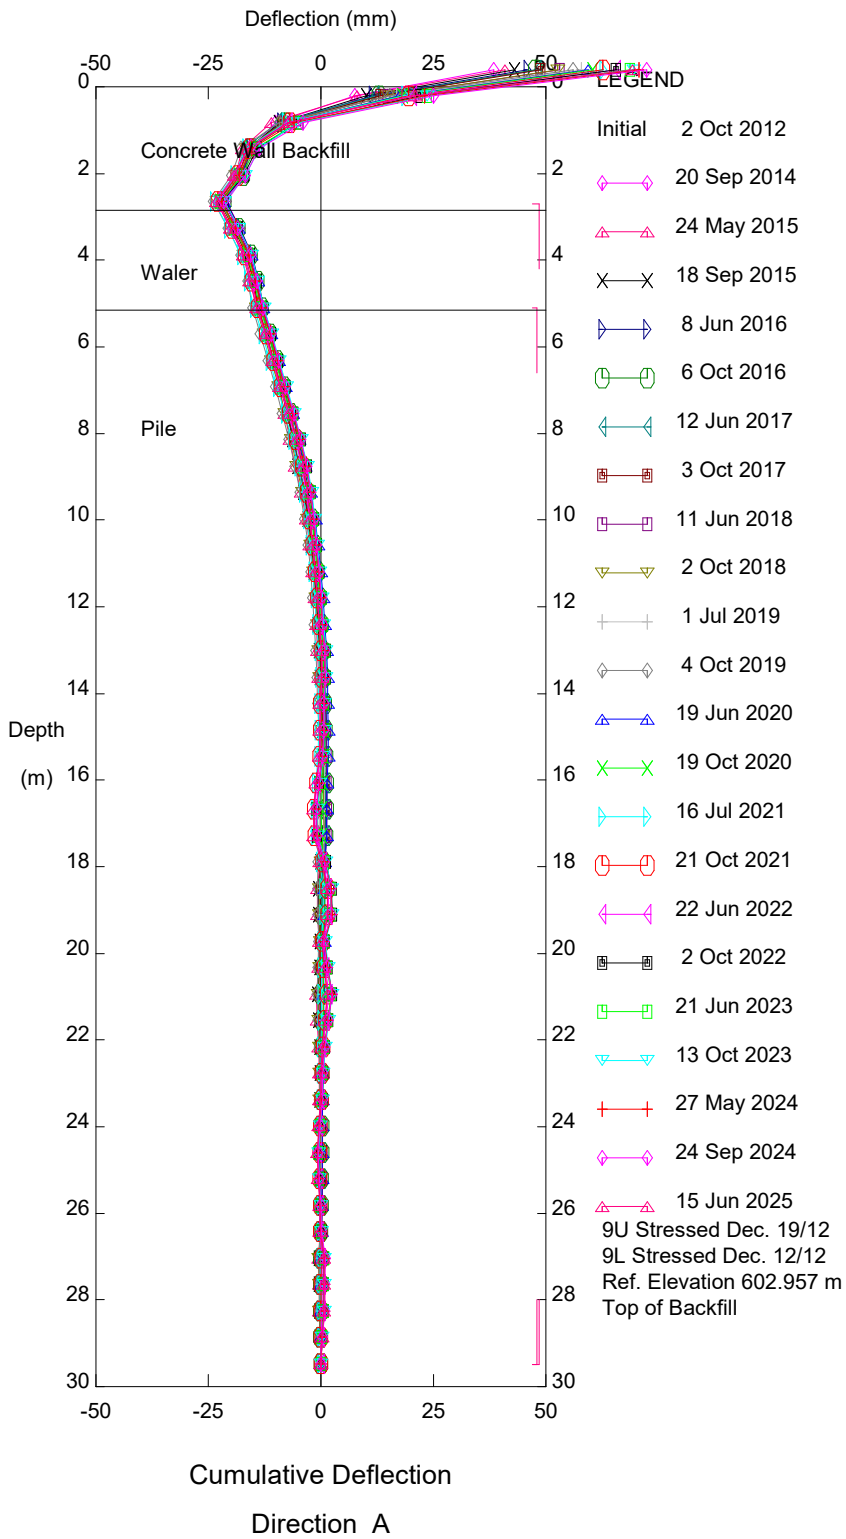
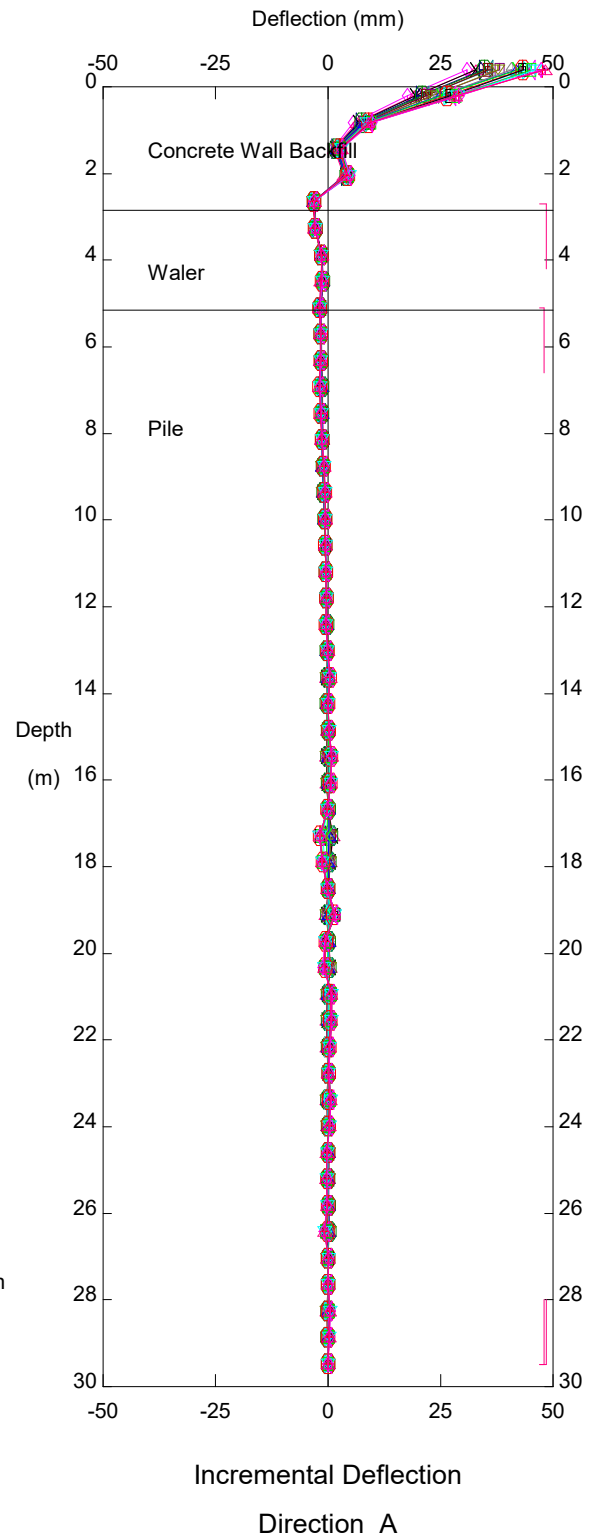
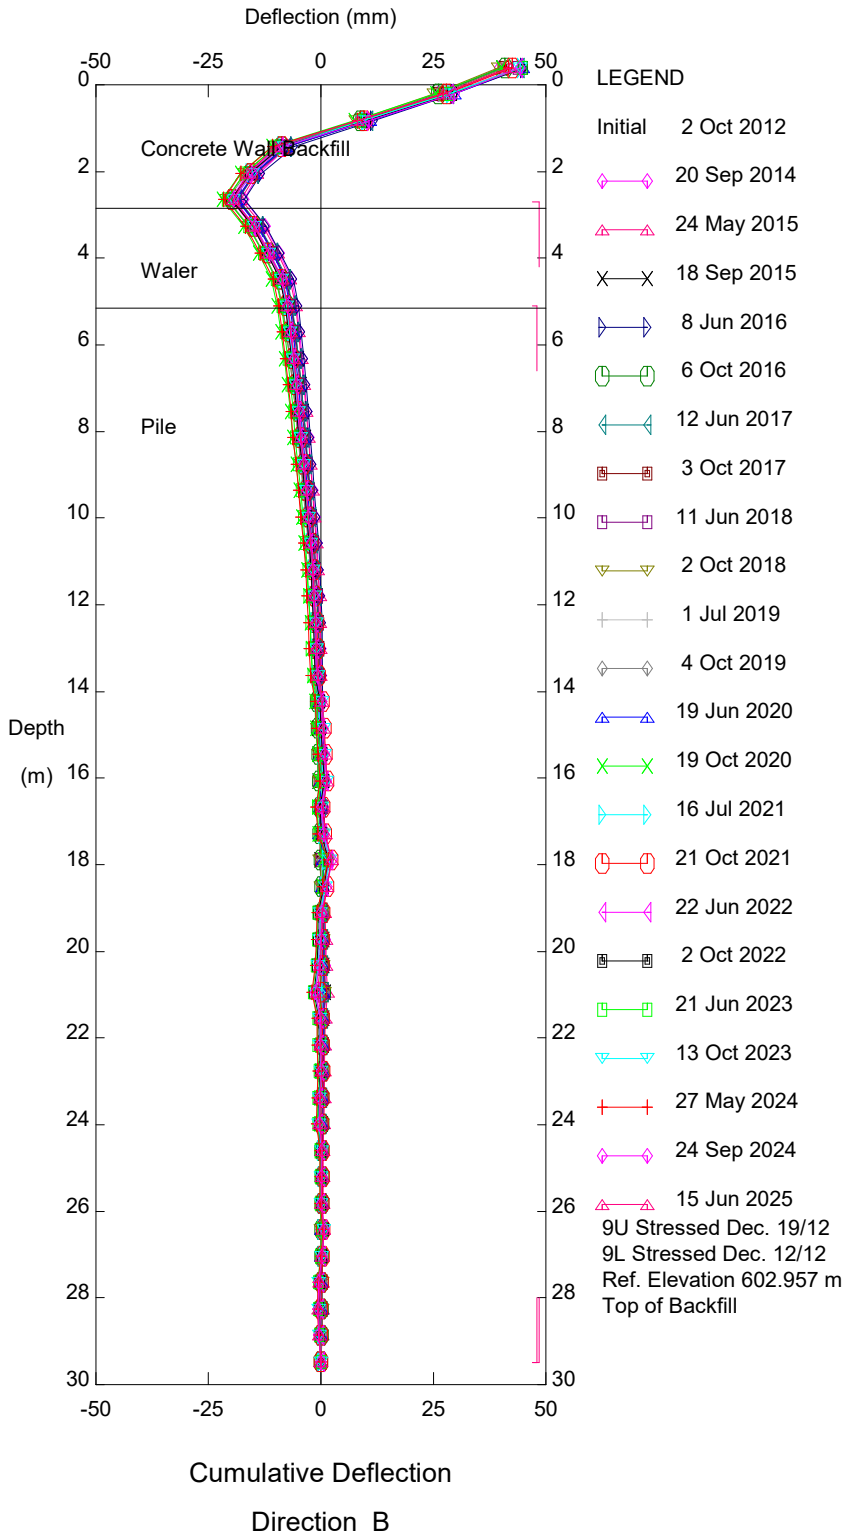
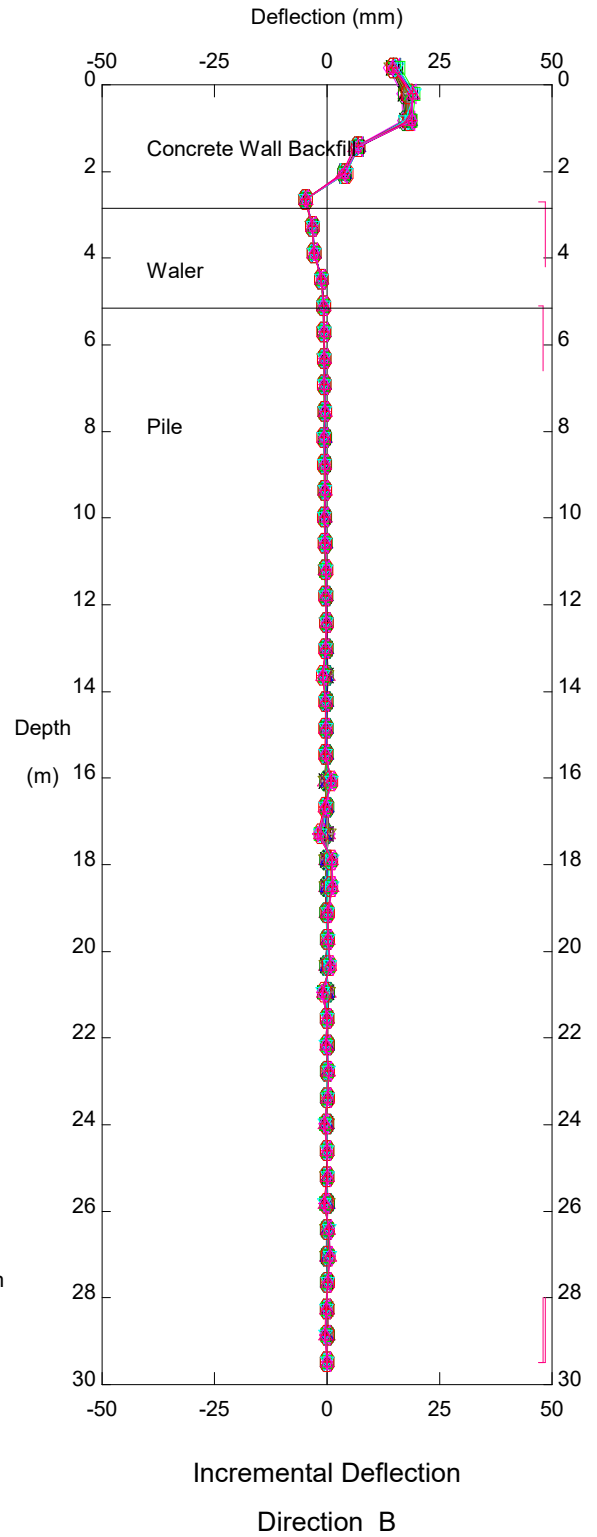
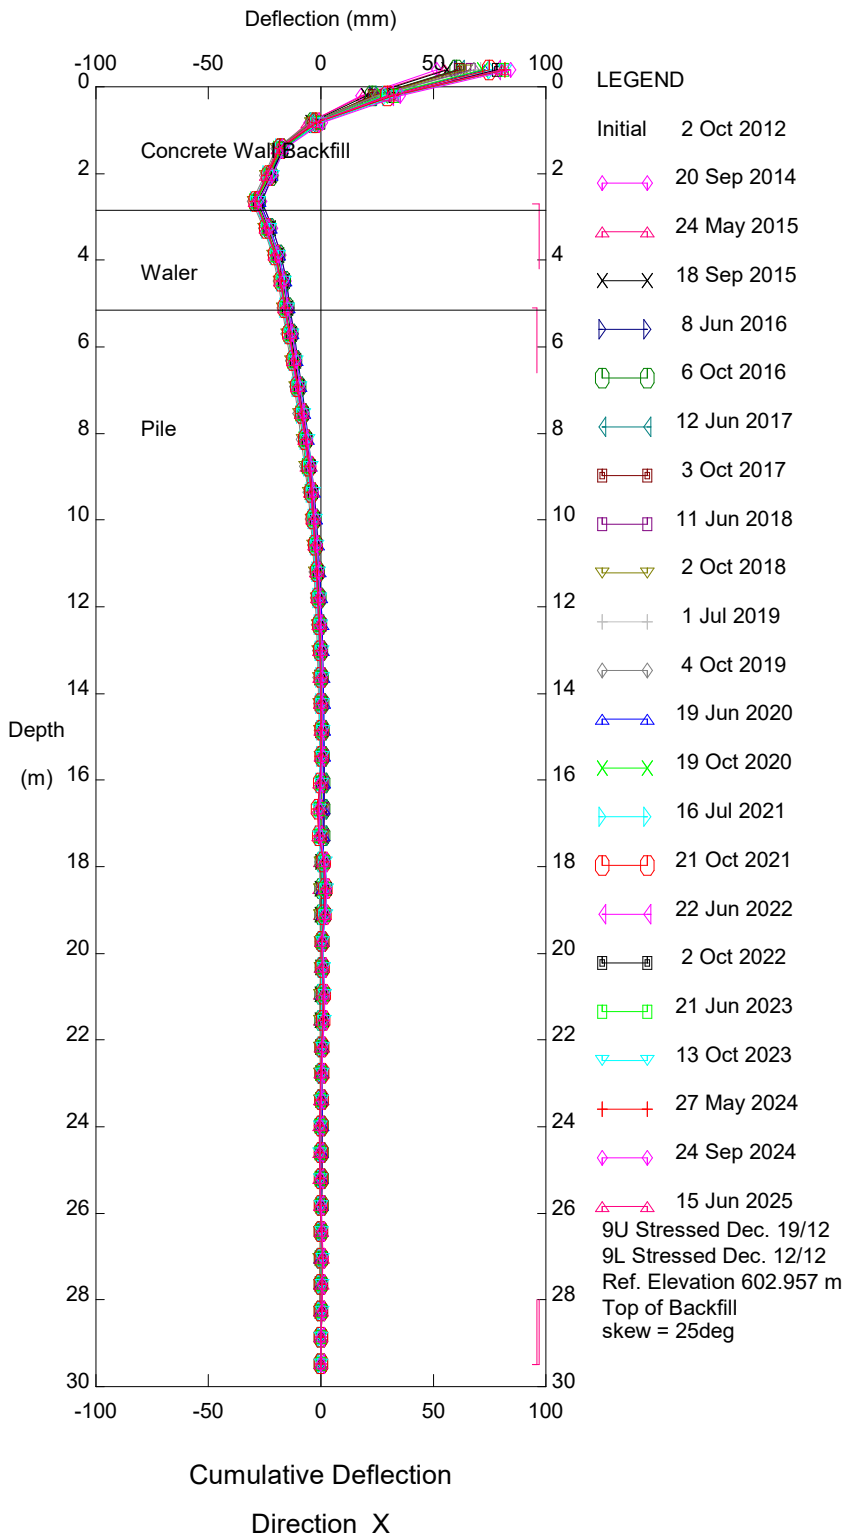
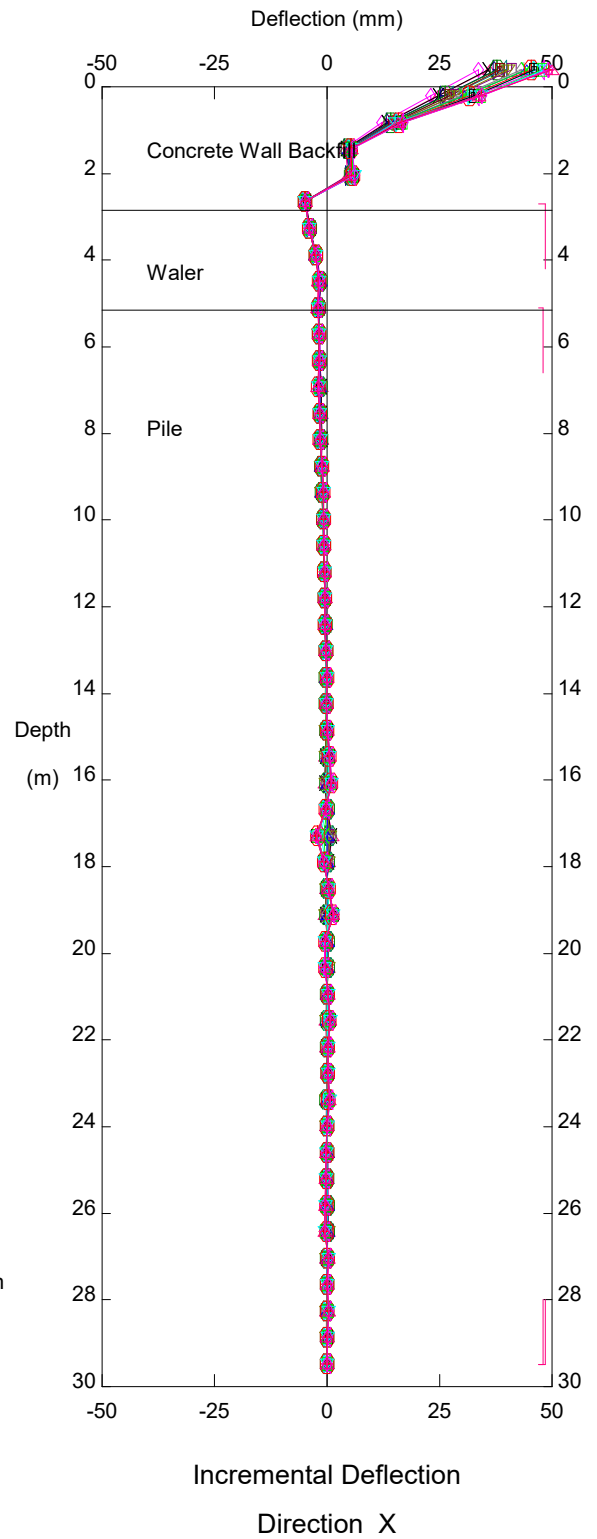
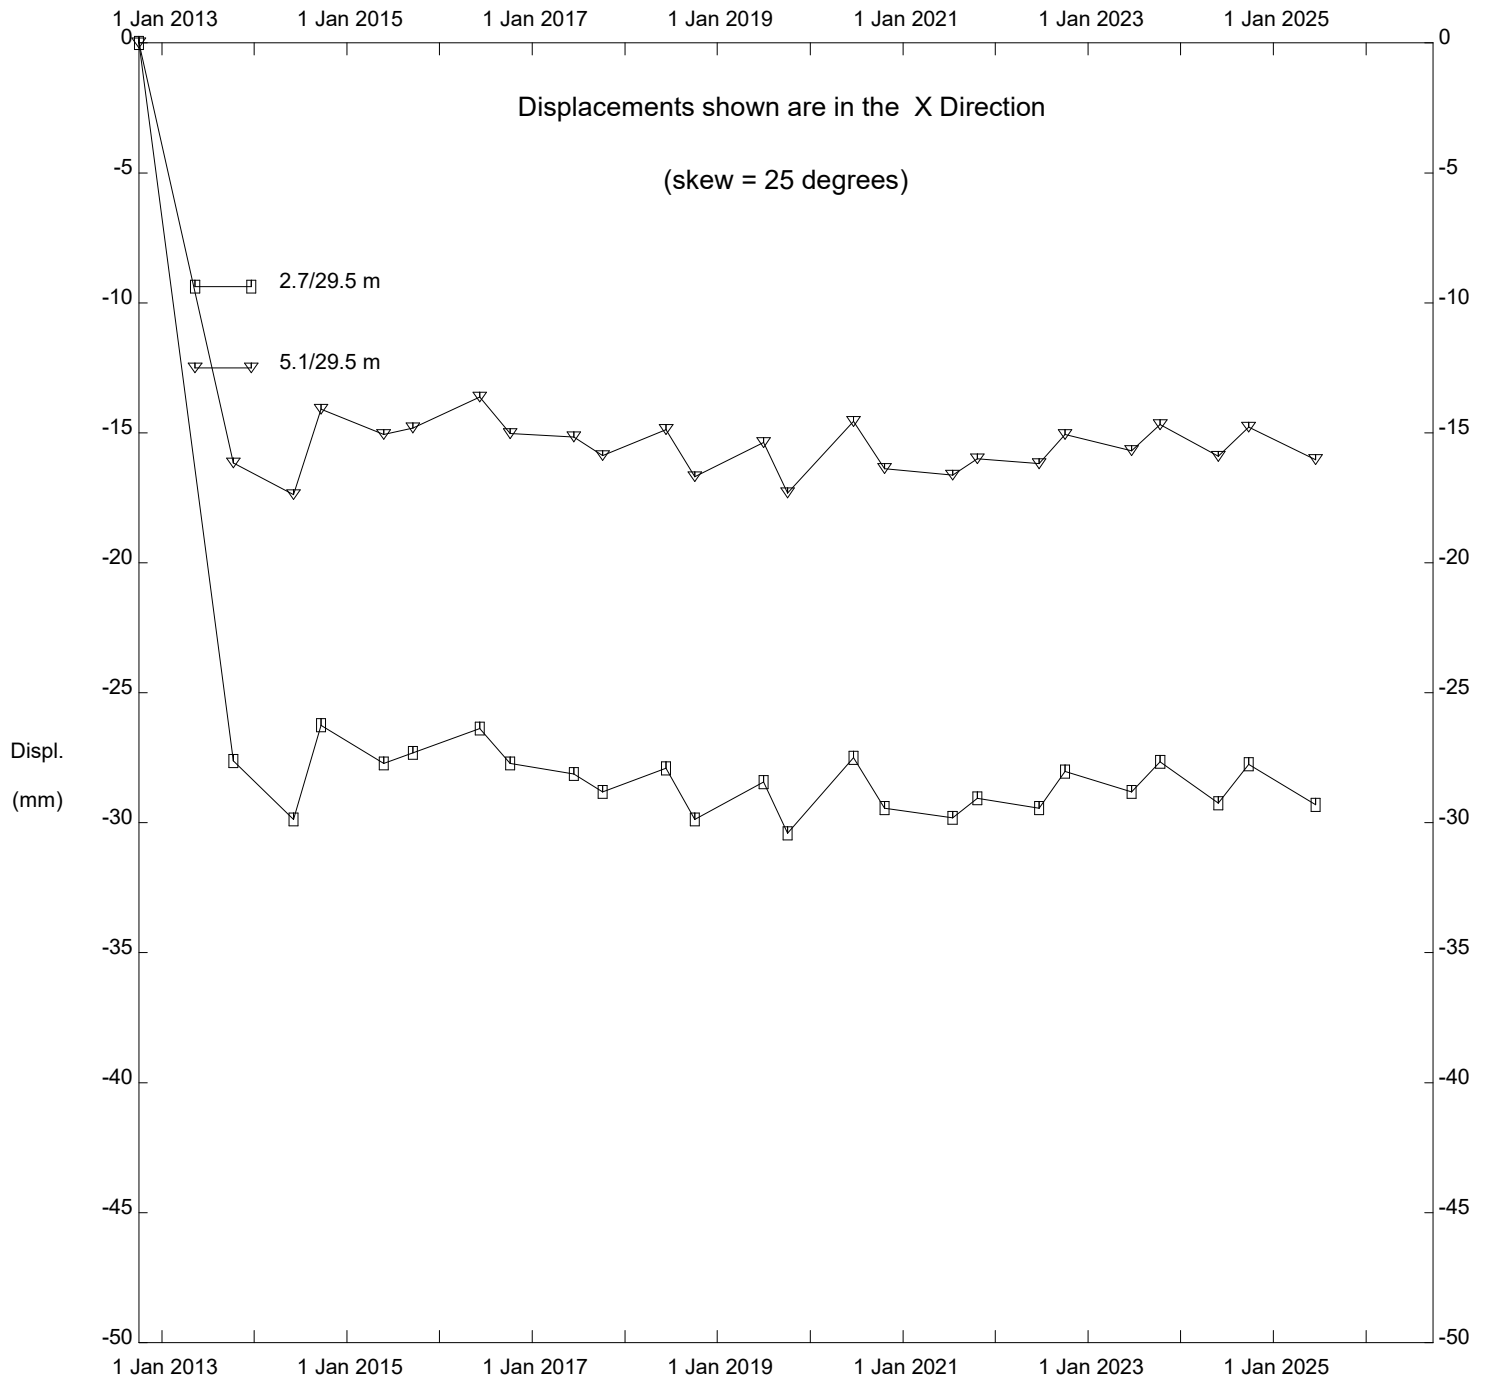
PH026 Eureka River Upper Wall, Inclinator SI12-P9U

<p>wherein the anchors pull the piles and waler into the uphill side and the cantilever supported backfill above the waler pushes the SIs downhill.</p> <p>SI12-P9U showed no discernible movement over the length of the pile and waler from 2.7 m to 29.5 m depth and over the length of the pile from 5.1 m to 29.0 m depth, since the fall of 2024 readings. The average rate of movement over the last 10 years has been near 0 mm/yr, excluding relative spring/fall oscillations. The total pile head movement to date has been 16.0 mm in the upslope direction of which about 2 mm of movement has occurred since 2014.</p> <p>SI12-P17U showed no discernible movement over the length of the pile and waler from 2.8 m to 29.0 m depth and over the length of the pile from 5.2 m to 29.0 m depth, since the fall of 2024 readings. The average rate of movement over the last 10 years has been in the order of <-1 mm/yr, (or in the uphill direction), excluding relative spring/fall oscillations. The total pile head movement to date has been 21.9 mm in the upslope direction of which about 5 mm of movement has occurred since 2014.</p> <p>SI12-P26U showed no discernible movement over the length of the pile and waler from 2.5 m to 26.3 m depth and a rate of movement of 0.5 mm/yr over the length of the pile only from 4.9 m to 26.3 m depth. The average rate of movement over the last 10 years has been in the order of <-1 mm/yr, (or in the uphill direction), excluding relative spring/fall oscillations, except that the readings since the fall of 2023 have shown a general trend reversal of about 0.5 mm/yr (or in the downhill direction), which may be attributed to the 2023 construction measures that occurred in this area. The total pile head movement to date has been 18.4 mm in the upslope direction of which about 7 mm has occurred since 2014.</p> <p>Slope inclinometers SI12-P3L, SI12-P9L and SI12-P14L were installed in the lower wall adjacent to Eureka River.</p> <p>SI12-P3L has shown a total pile head movement of 14.0 mm towards the river since installation, with no discernible movement over 0.1 m to 19.6 m since the fall of 2024 readings. SI12-P9L has shown a total pile head movement of 3.6 mm in the downslope direction since installation, with no discernible movement over the length of the pile since the fall of 2024 readings. Significant noise was detected in the current and previous readings of SI12-P9L, so the movement rate should be reevaluated during the next readings. SI12-P14L has shown a total pile head movement of 4.1 mm in the downslope direction since installation, with a rate of movement of 1.2 mm/yr (downhill) since the fall of 2024 readings. The average rate of movement over the last 2 to 3 years has been near 0 mm/yr in all three of these lower pile wall pile inclinometers, except that the readings in the last two years in SI12-P9L have shown a trend change to about -6 mm/yr (or in the uphill direction) which may be attributed to the 2023 construction measures that occurred in close vicinity to this area.</p> <p>Piezometers</p> <p>Since the previous readings in the fall of 2024, the groundwater level in pneumatic piezometer PN11-3 decreased by 0.22 m. Vibrating wire piezometer VW11-7 showed a decrease in groundwater level of 0.04 m since the fall of 2024 readings. Over the longer term, since about 2014, both of these piezometers have shown a slight decreasing trend in groundwater levels</p> <p>Load Cells</p> <p>Anchors 26L and 27U are installed at pile P9 towards the north end of the pile wall. Anchors G50U and G50L are installed at pile P17 in the</p>
