ALBERTA TRANSPORTATION AND
ECONOMIC CORRIDORS GRMP
PEACE REGION
(GRANDE PRAIRIE DISTRICT - NORTH)
INSTRUMENTATION MONITORING - SPRING 2025

Site Number	Location	Name	Hwy	km
PH026	HWY 726:02 km 9.91, 10.30	North Eureka River Slide	726:02	Km 9.9, 10.3
Legal Description: 8-14-86-8 W6		UTM Co-ordinates		
		11U E 368433	N	6258811

Current Monitoring:	15-June-2025	Previous Monitoring	27-May-2024
Instruments Read By:	Mr. Neil McDonald and Mr. Godfred Etiendem, of Thurber

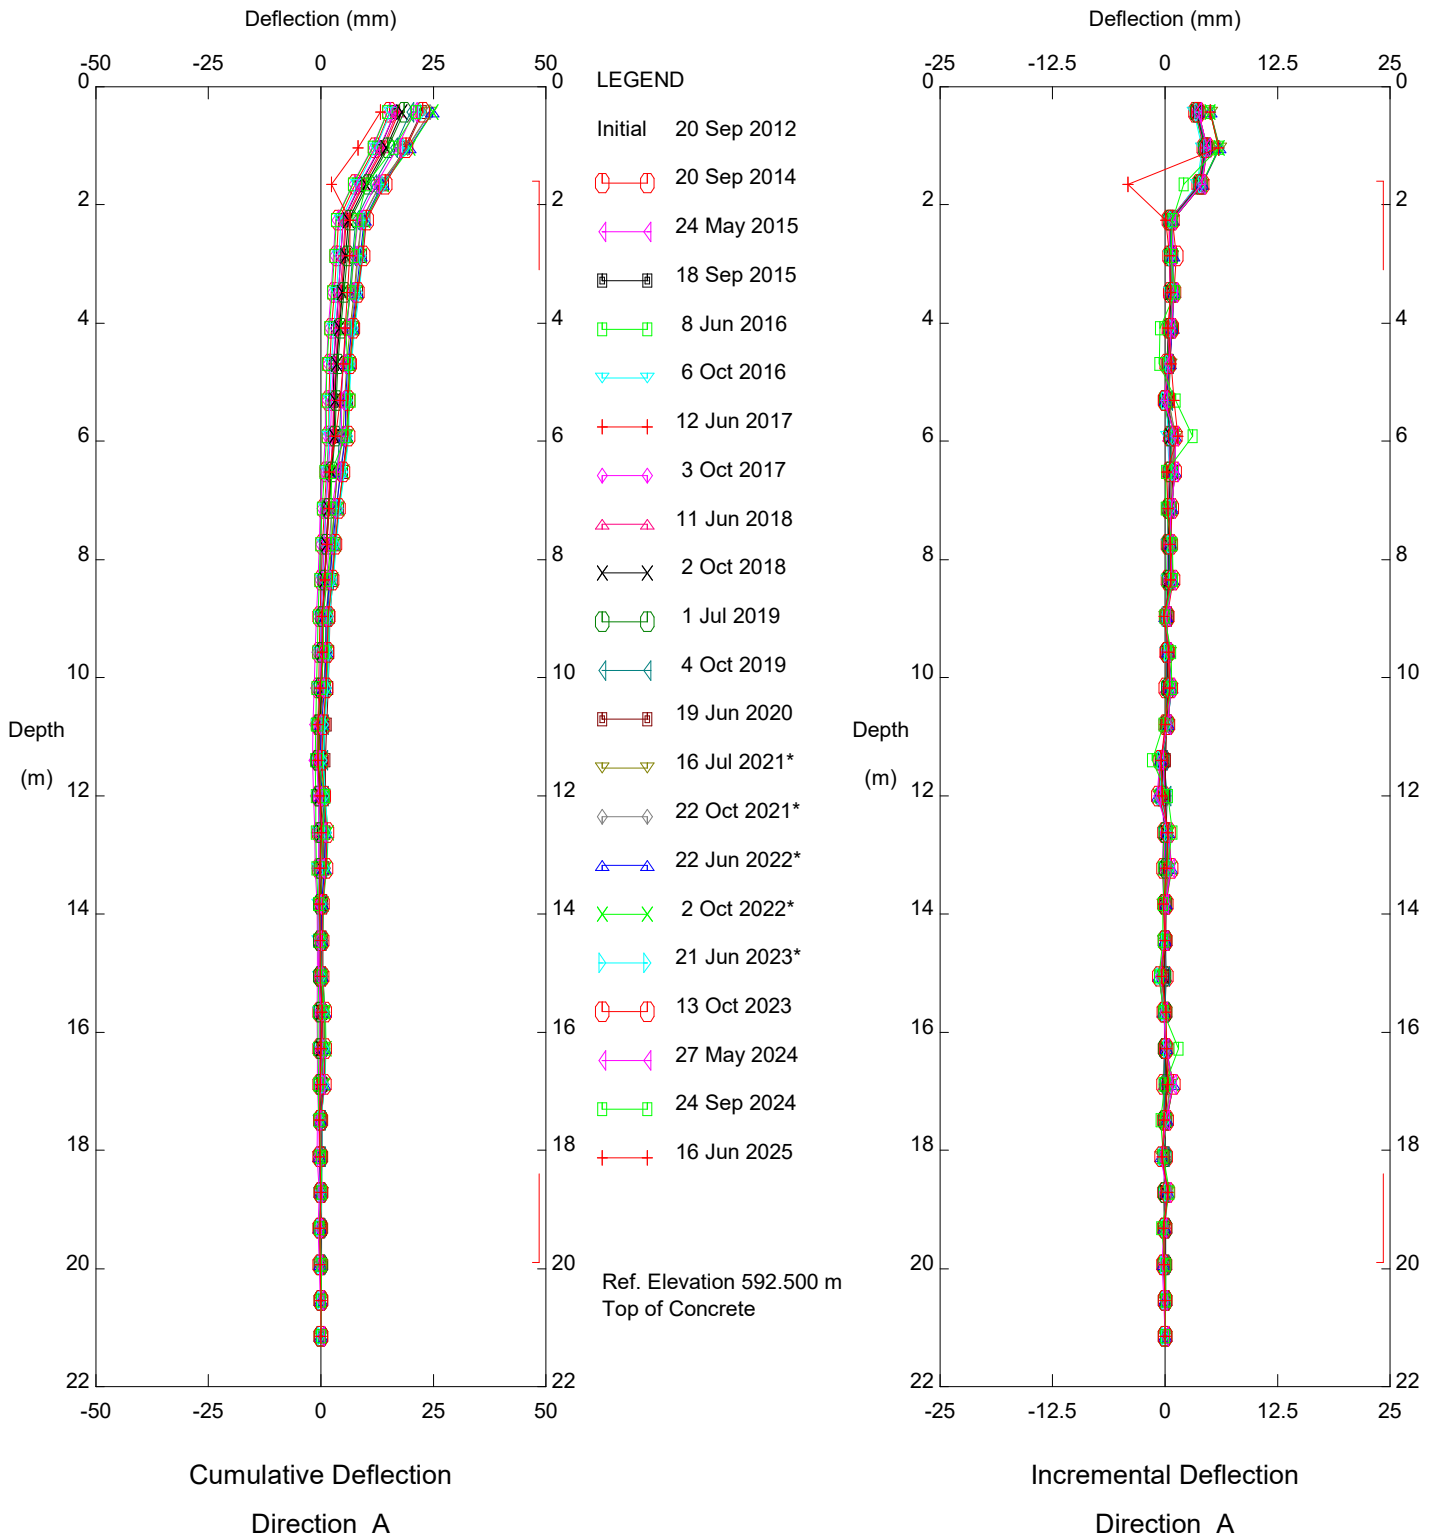
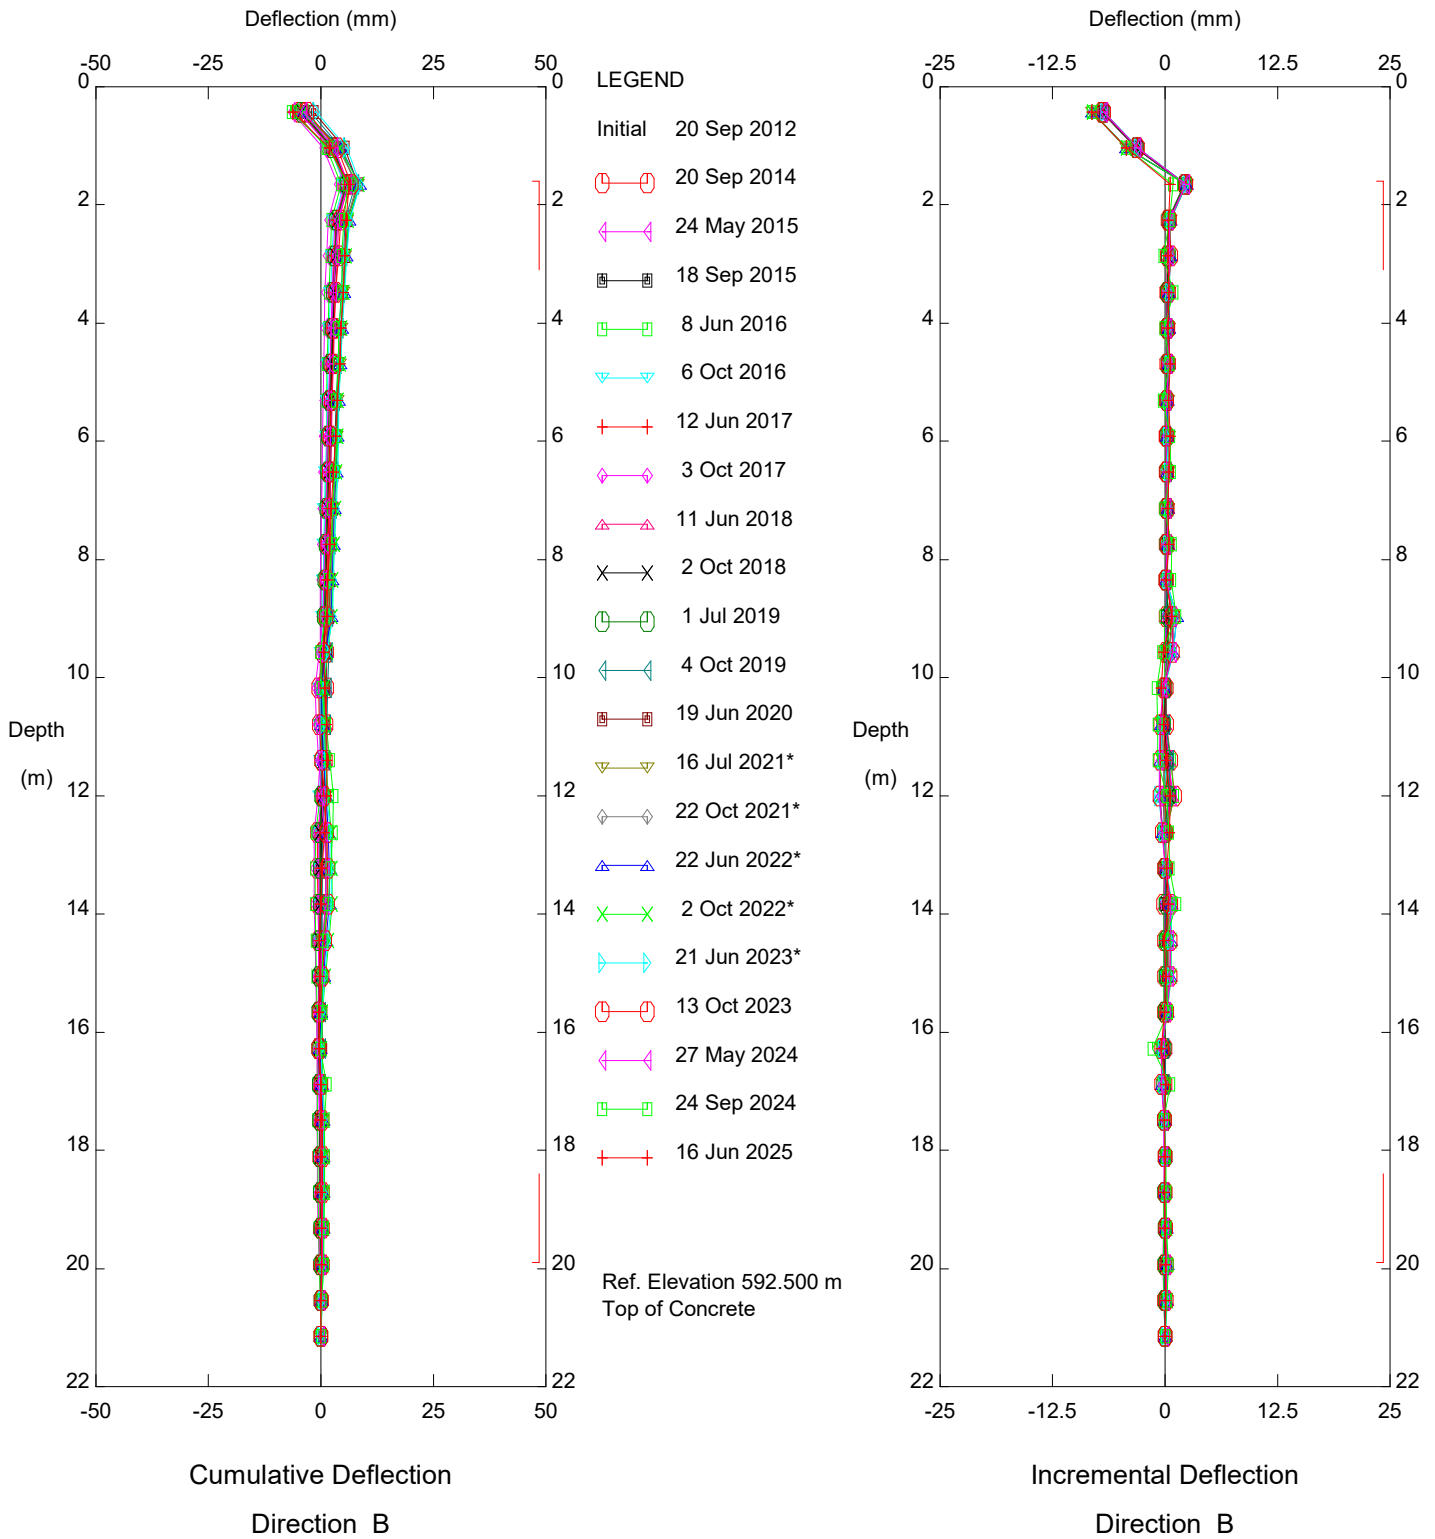
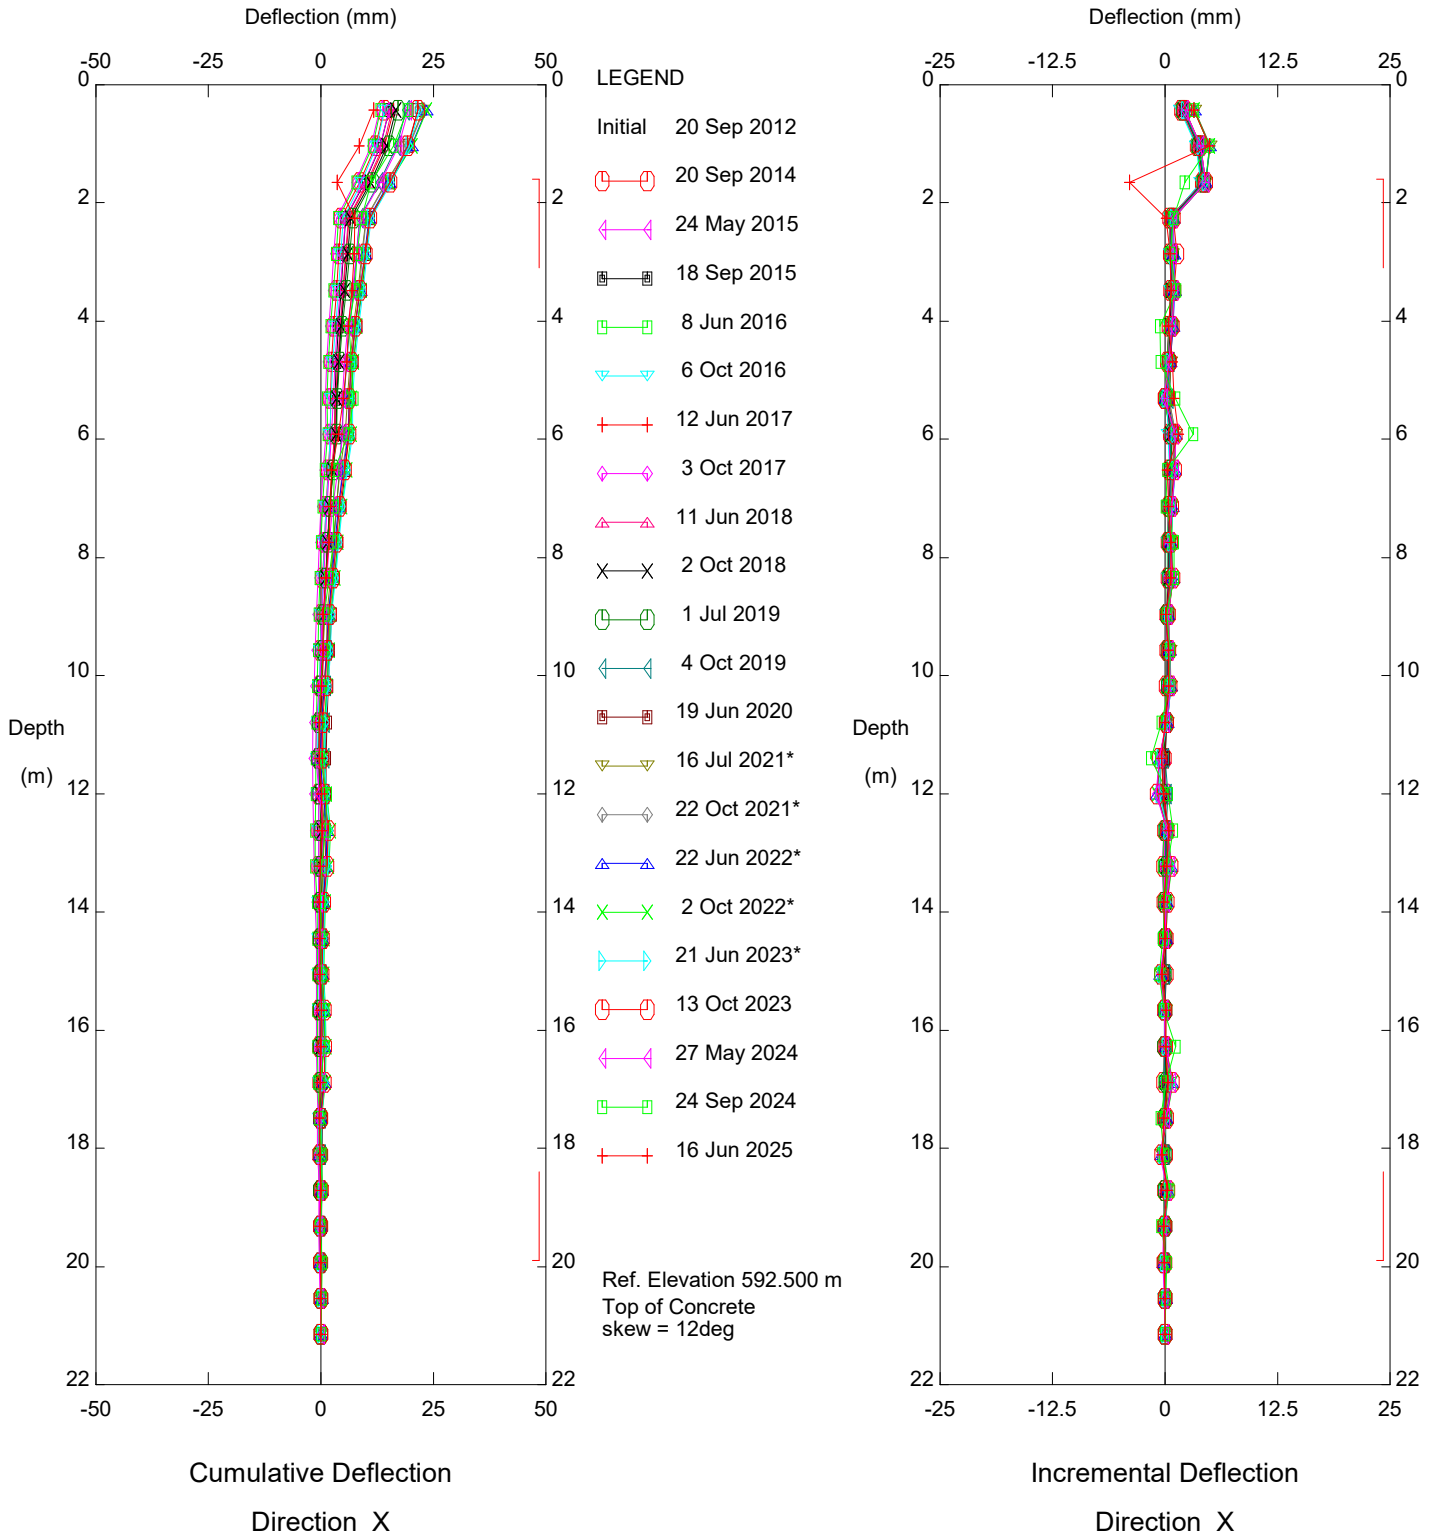
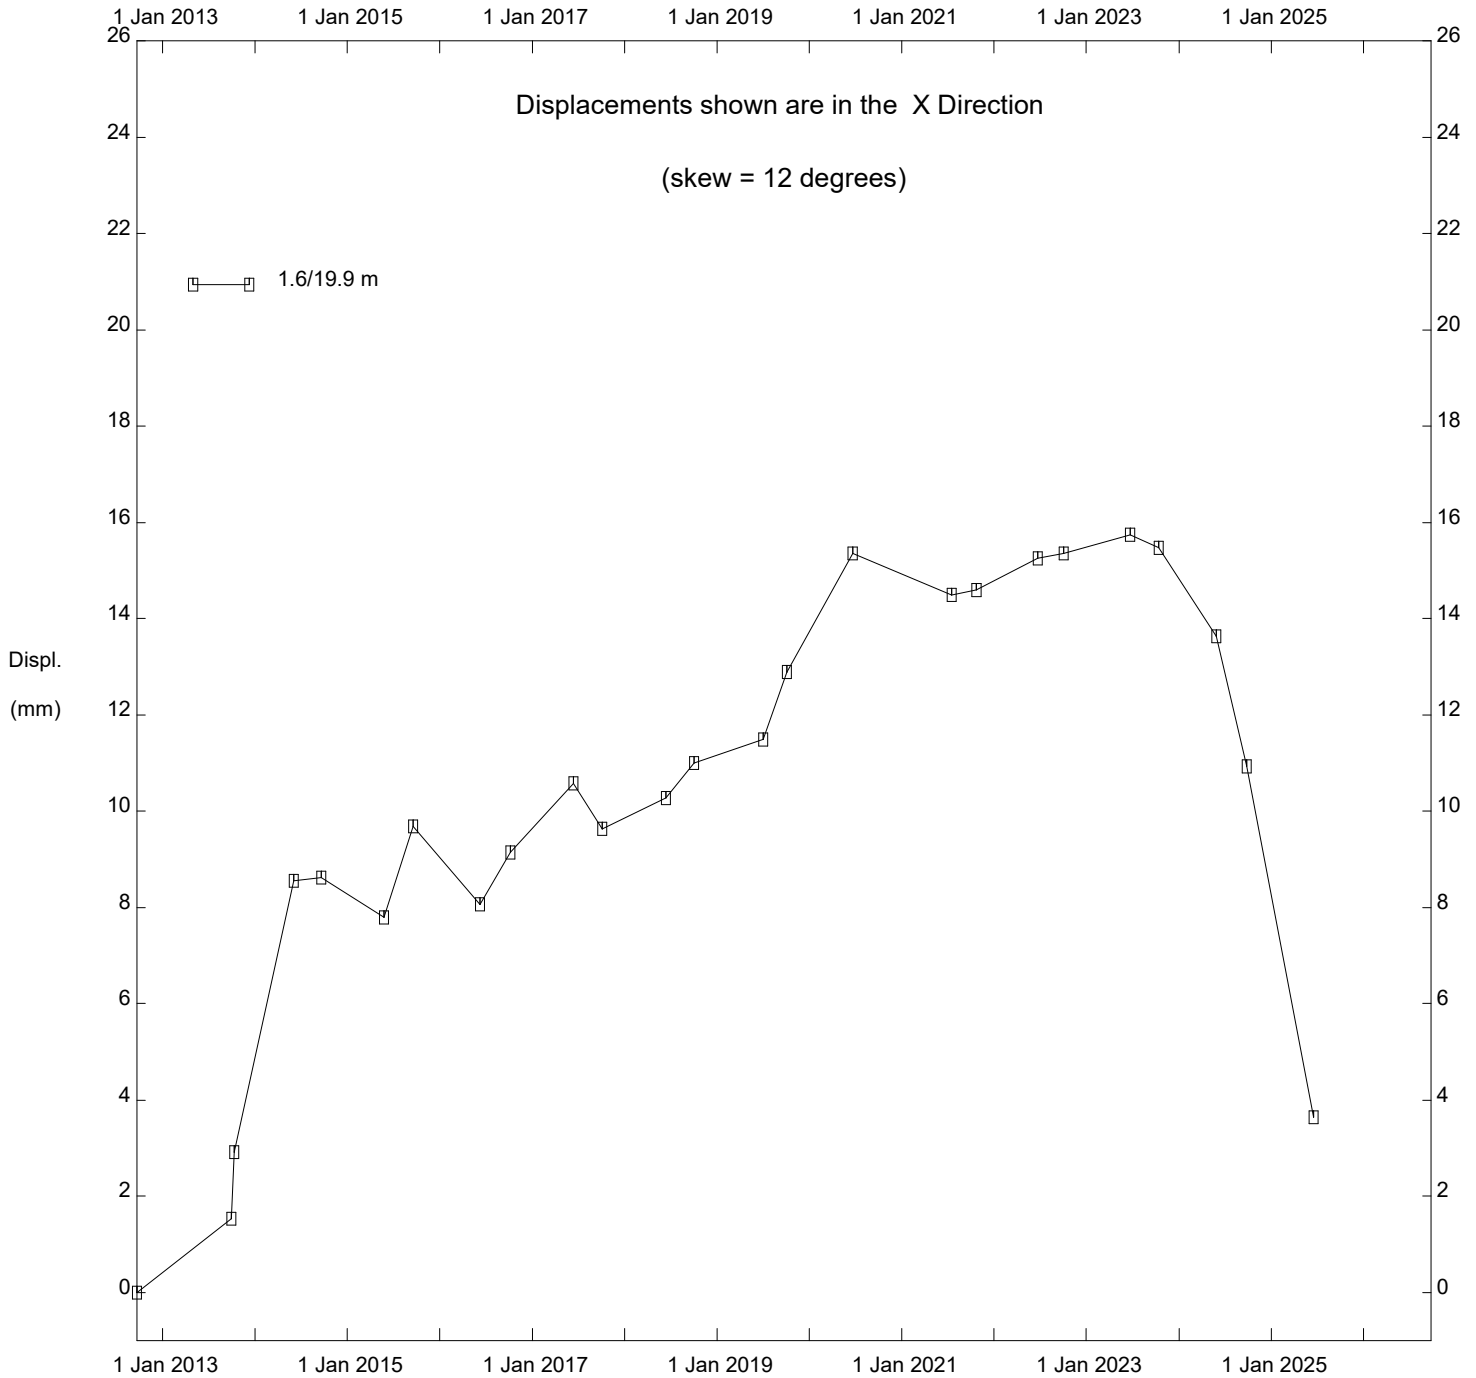
PH026 Eureka River Lower Wall, Inclinator SI12-P9L

Readout Equipment Used			
Slope Inclinometers: Two RST Digital Inclinator probes with 2 ft. wheelbases and RST Pocket PC readouts	Pneumatic Piezometers: RST C108 pneumatic piezometer readout	Vibrating Wire Piezometers: Geokon GK 404 vibrating wire readout	Standpipe Piezometers:
Load Cell: RST Multichannel DTLINK software	Strain Gauges:	SAA's:	Others:
Notes: Significant noise in the reading was detected near the top of SI12-P9L.

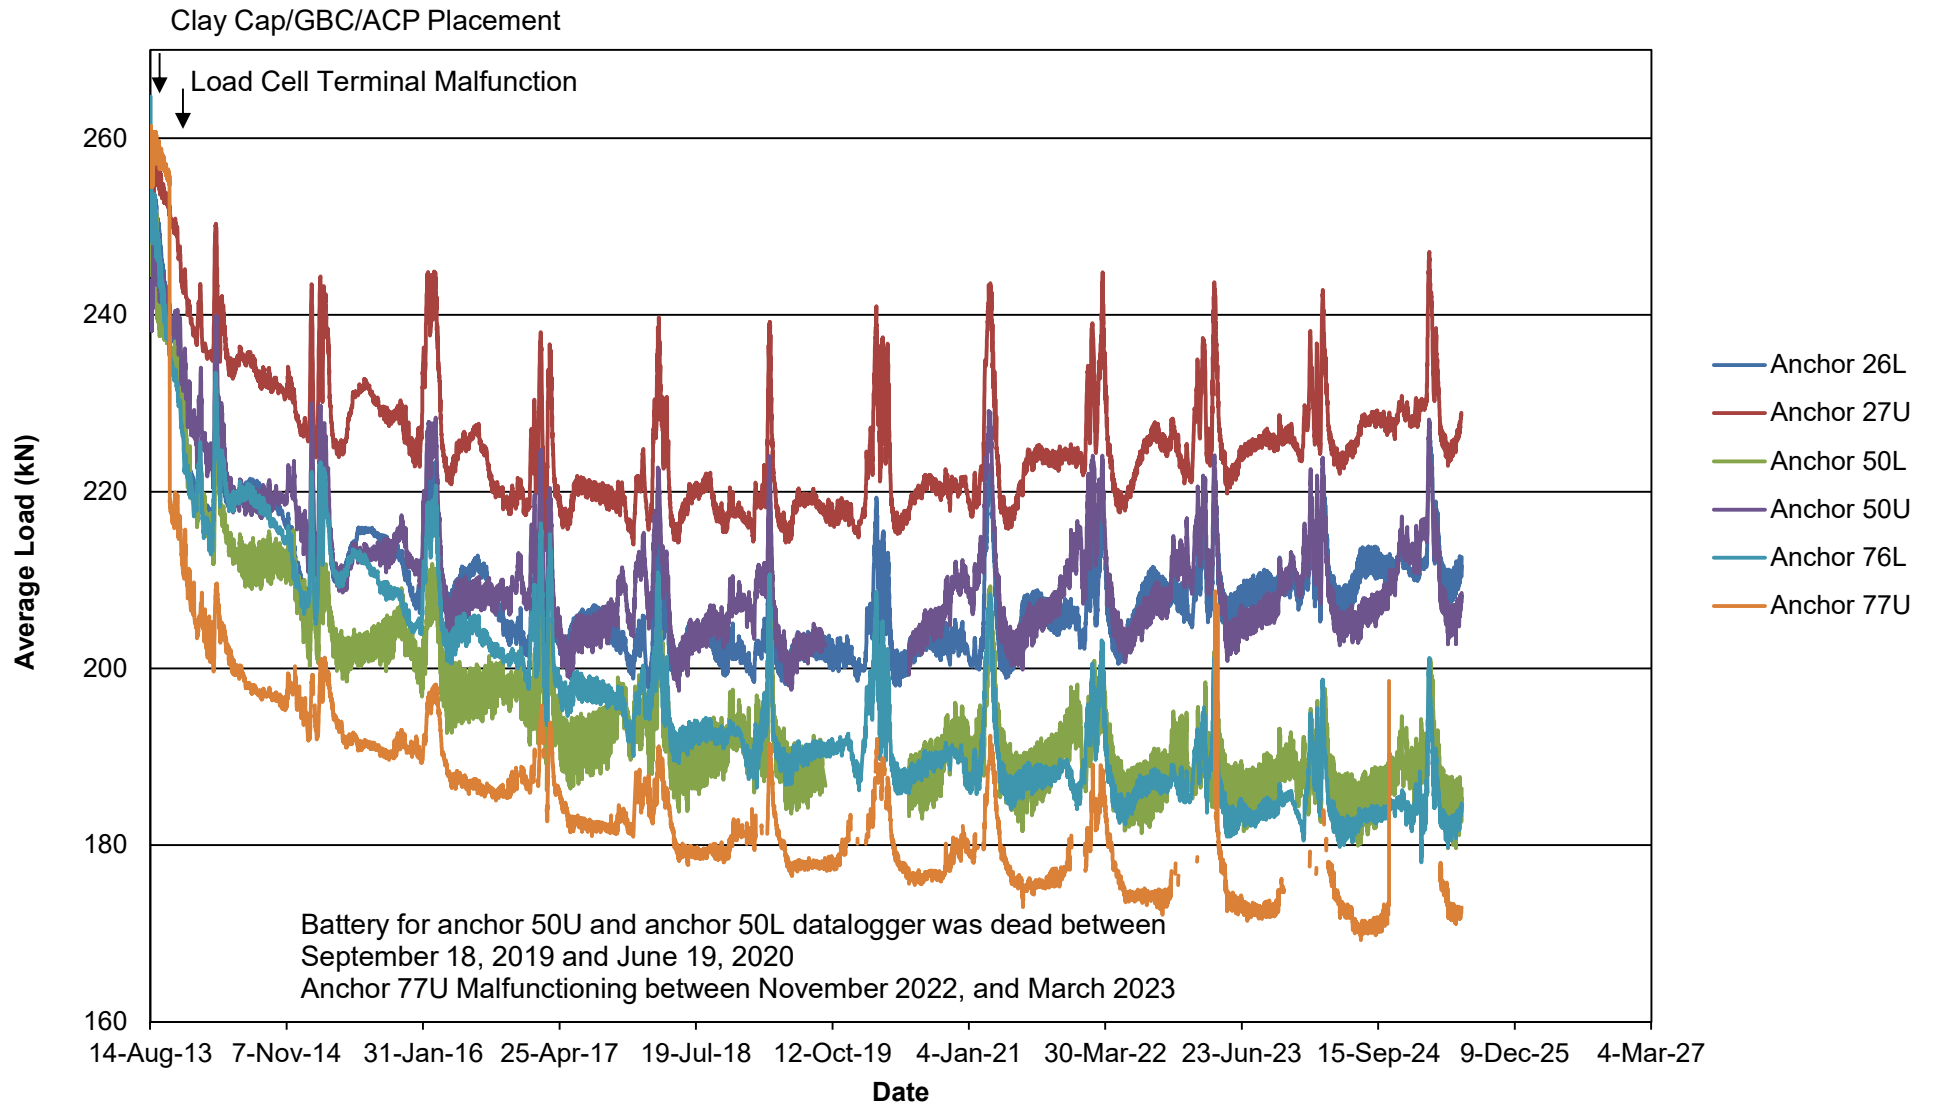
FIGURE PH026-3
LOAD CELL DATA FOR HWY 726:02 UPPER PILE WALL ANCHORS

<p>central portion of the wall. Anchors G76L and G77U are installed at P26 towards the south end of the wall.</p> <p>Since the fall of 2024, the load cells showed minor increases in measured load ranging from an increase of 0.15 kN in VC1762 (anchor 77U) to an increase of 1.57 kN in VC1761 (anchor 76L). The current readings on the load cells varied from 172.94 kN in VC1762 (anchor 77U) to 228.94 kN in VC1764 (anchor 27U). The anchor design load was 300 kN and the anchors were locked off at 240 kN.</p> <p>The load cells at P9 (anchors 26L and 27U) show an increasing load trend while the load cells at P26 (anchors G76L and G77U) show a decreasing load trend. The load cell readings at the middle pile, P17, are split with the lower anchor G50L showing a decreasing load pattern and the upper load cell, G50U, showing an increasing load pattern. This trend of diverging load trends is unlikely to be a concern for now, but if it continues there may be a concern for the load sharing of the wall structure, which could overstress the wall. All load cells readings are below the design load of 300 kN.</p> <p>The instrument readings at this site indicate that the landslide repairs at this site have been successful in stabilizing the slope movements.</p>
