**ALBERTA TRANSPORTATION
GEOHAZARD ASSESSMENT PROGRAM
PEACE REGION-GRANDE PRAIRIE
2017 INSPECTION REPORT**

Site Number	Location	Name	Hwy	km
GP14	Hwy 733:04	Bad Heart River South	733:04	8.938
Legal Description		UTM Co-ordinates (NAD 83)		
LSD-9-28-75-3 W6M		11U E 412076	N 6154417

**PEACE REGION (GRANDE PRAIRIE) 2017
GP014-1: HWY 733:04 BAD HEART RIVER SOUTH**

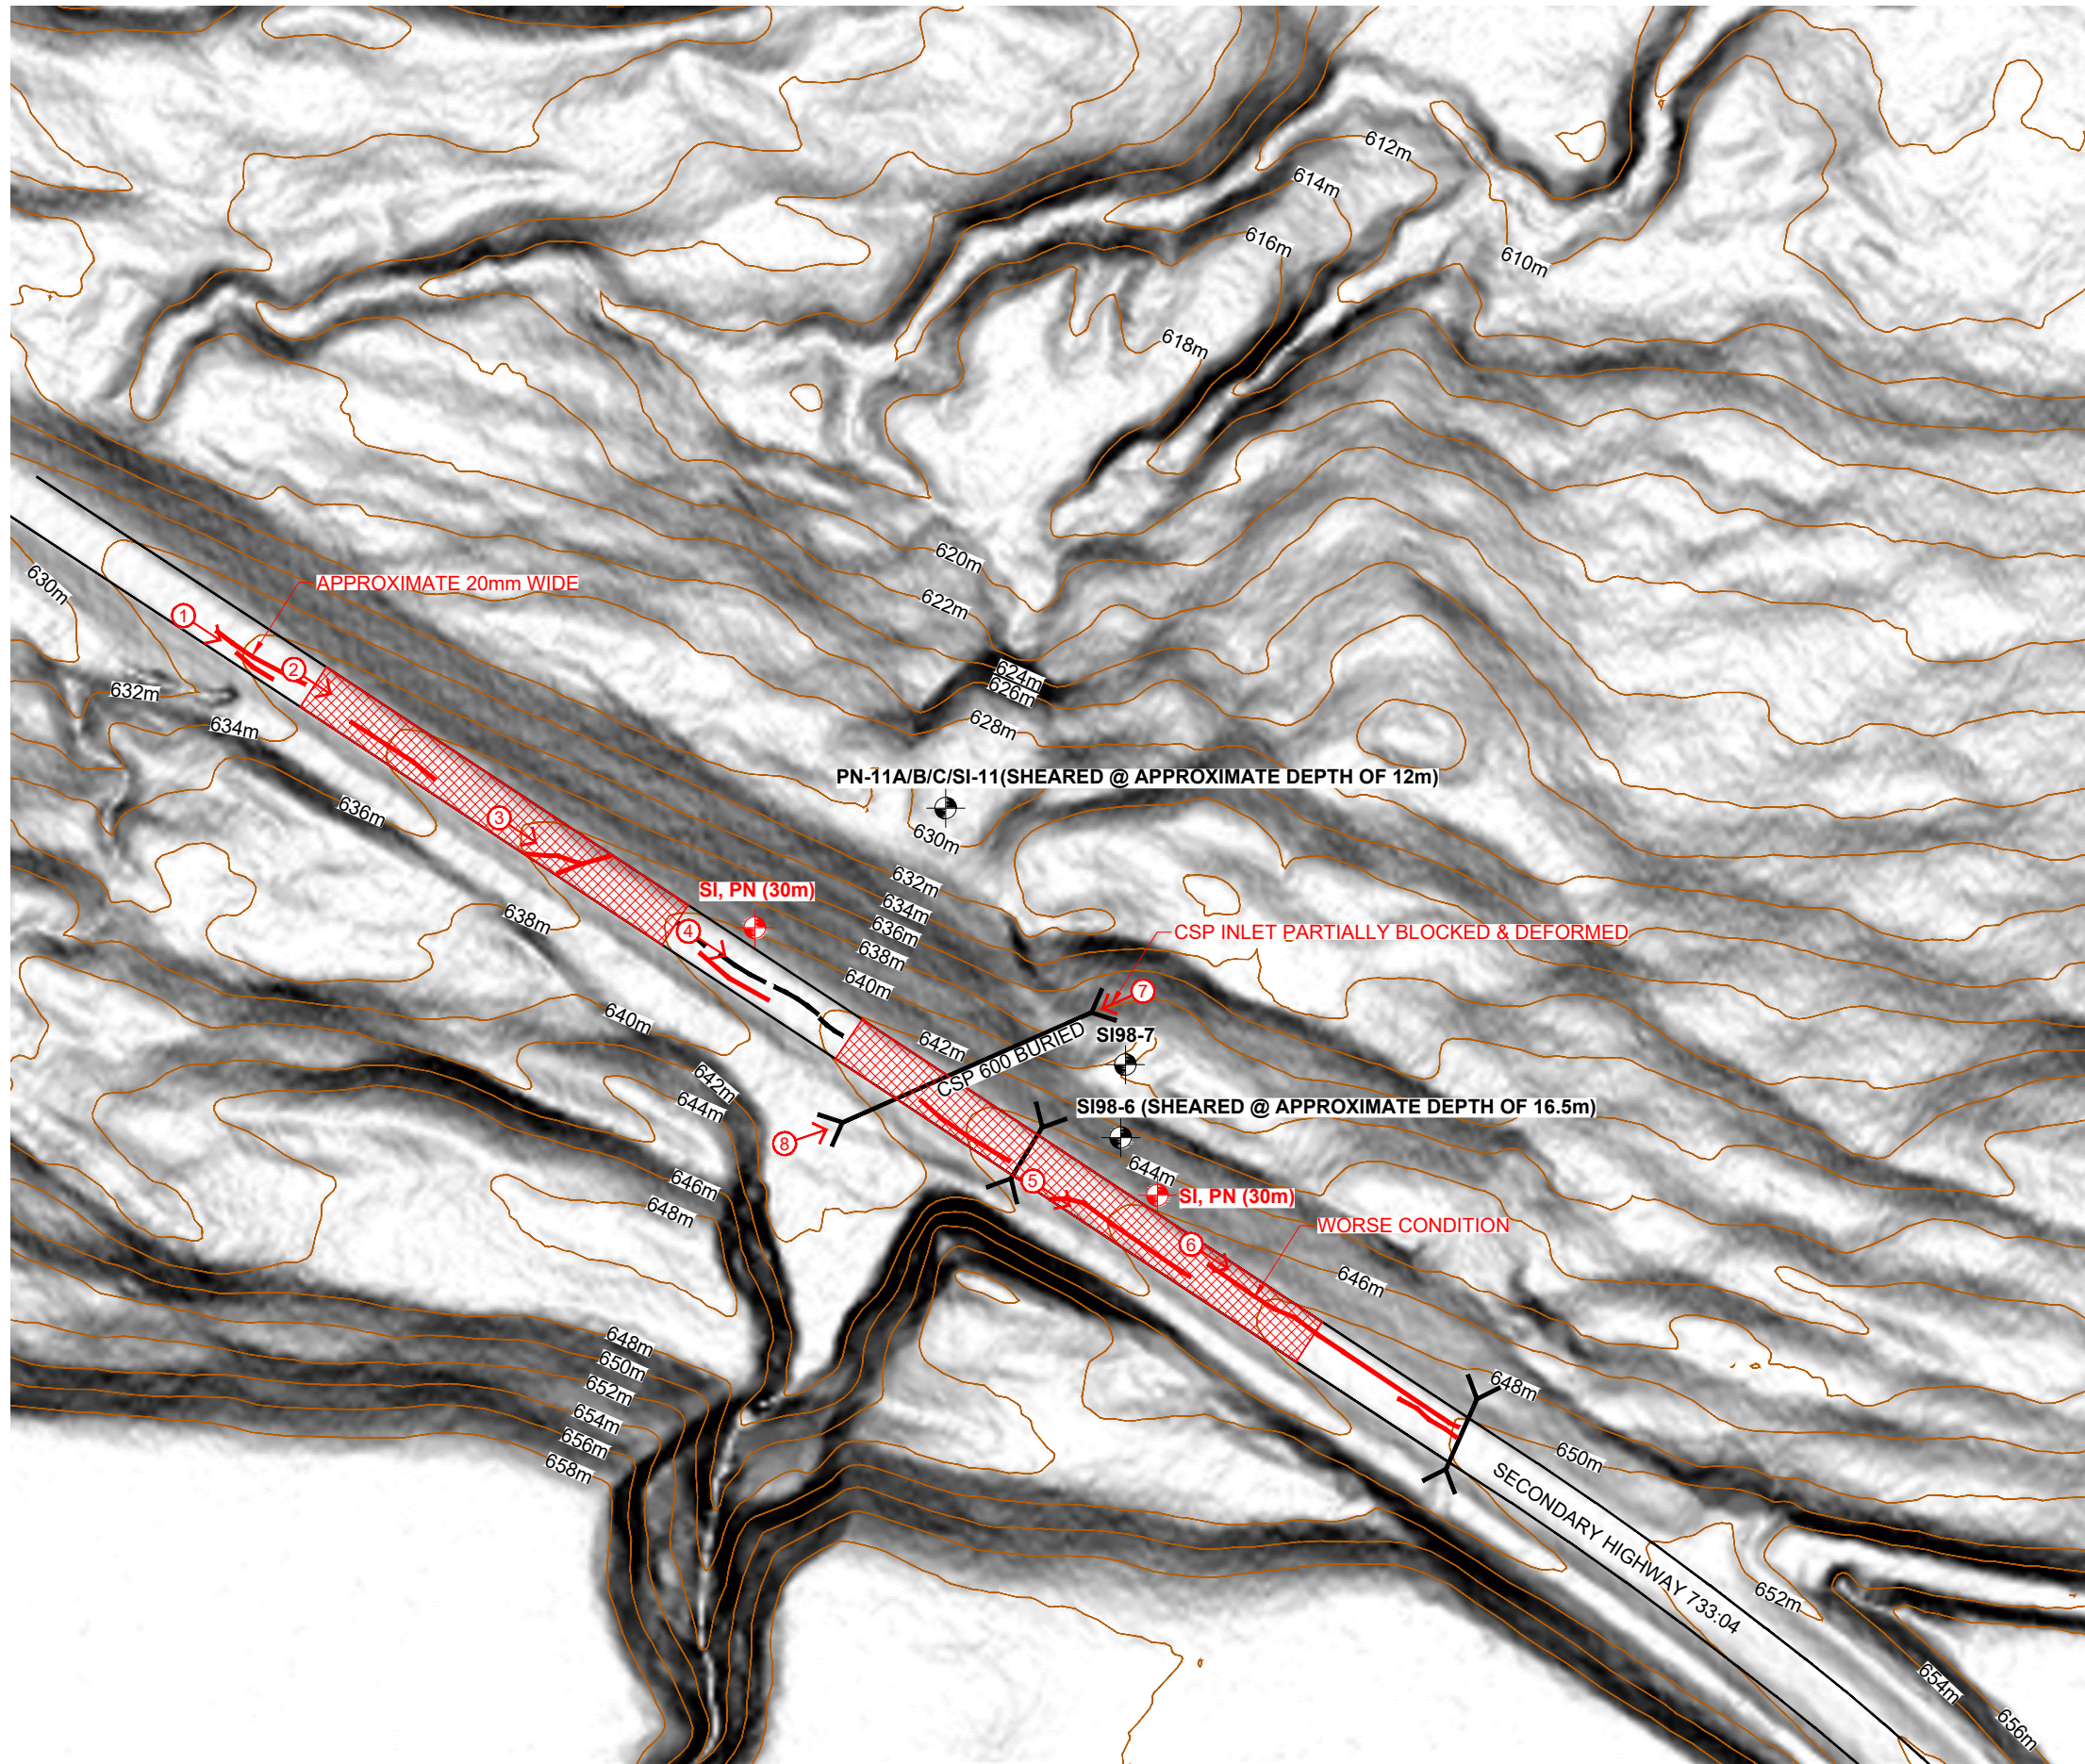
DWG No. 13353-GP014-1-1

Primary Site Issue:	<p>The roadway is located within an active landslide area on the Bad Heart River Valley south slope. The ongoing slope movements caused distress and cracking of pavement structure, requiring regular maintenance at a frequency of one to two years.</p> <p>The movement rate of the landslide appears to be slow based on site inspections during last several years.</p>	
Dimensions:	<p>The slide impact area is about 320 m long along the roadway alignment where cracks were observed on the pavement at the time of site inspection.</p> <p>Previous slope inclinometer (SI98-6 and SI-11) readings indicated that the slip surface was located at depths varying from 12 m to 17 m below the ground surface (approximate elevations from 618 m to 628 m).</p> <p>The extent and actual depths of the sliding zone perpendicular to the roadway alignment could not be defined from the existing information and require additional geotechnical instrumentation and monitoring to confirm.</p>

Assessment:		
No discernable slope movements were observed at this site during this inspection. Ongoing embankment creep was observed and appeared to account for the observed distress and cracking of the roadway pavement structure. Further details of the background information about this site can be obtained from the previous reports in the site Geohazard Binder and are not repeated herein.		
In order to keep the roadway surface in a suitable driving condition, TRANS has been sealing cracks and patching the pavement at a frequency of one to two years.		
Recommendations:		Ballpark Cost
In the short term, it is recommended that the cracks in the pavement be sealed or overlain with an asphalt patch as required. All observed drops along the landslide backscarp should also be milled and the area should be regularly monitored for signs of active slope movements.		Maintenance (\$60,000 every 2 years)

A geotechnical investigation is required to assess the mechanisms of the persistent embankment failure observed at this site and to design long term mitigation measures. The locations of the proposed new instruments are presented herein on the 2017 Geohazard Inspection Figure Drawing 13353-GP14-1.		\$30,000

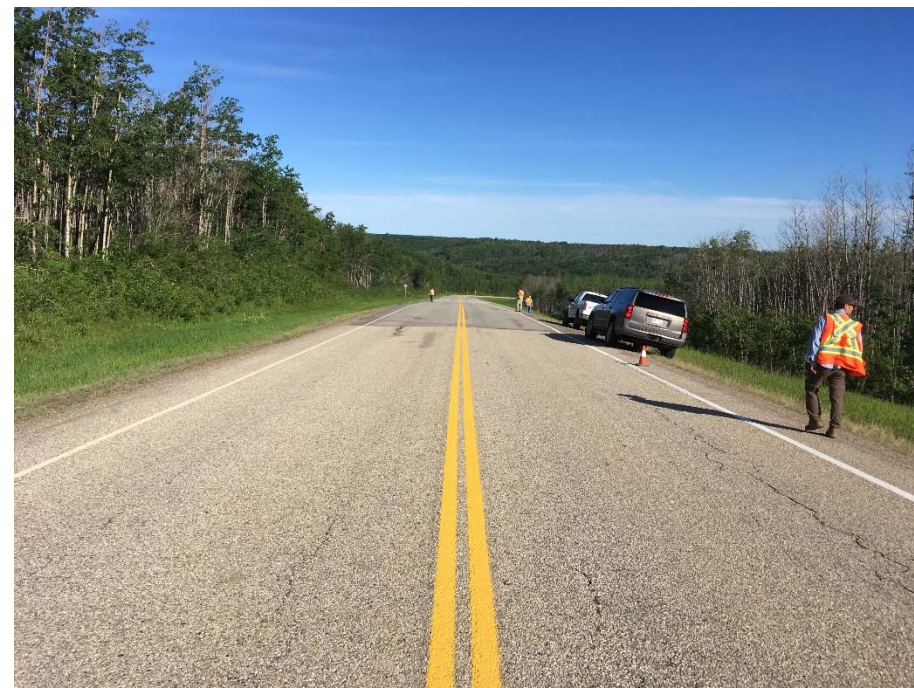
Photo 1.
Looking southeast
along Hwy 733.

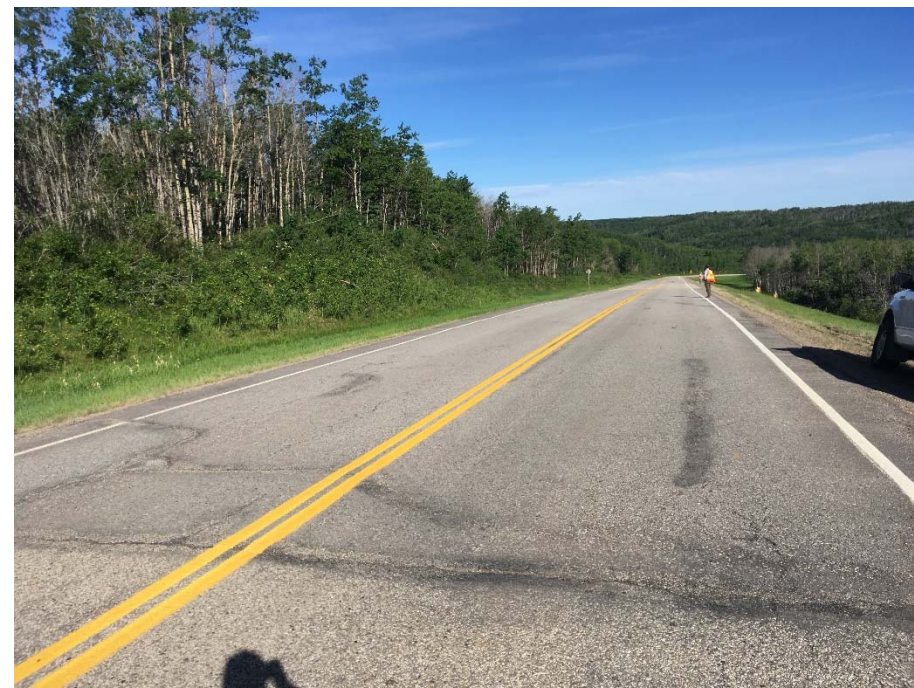
Photo 2.
Cracks reflecting
through patch in
pavement.

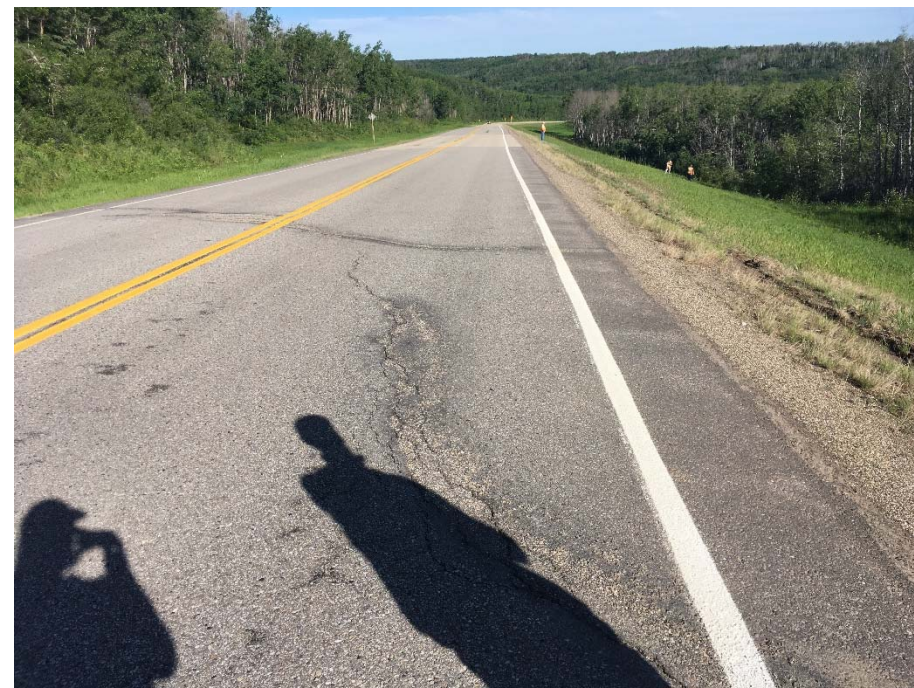
Photo 3.
Crack near middle
of northmost
asphalt patch.

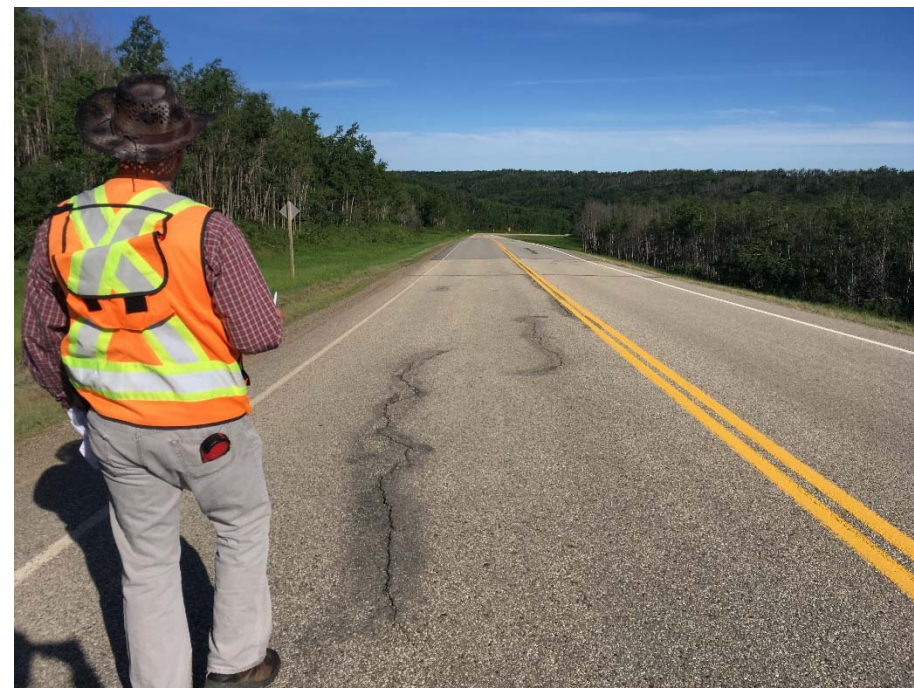
Photo 4.
Cracks on asphalt
in between the two
patches.

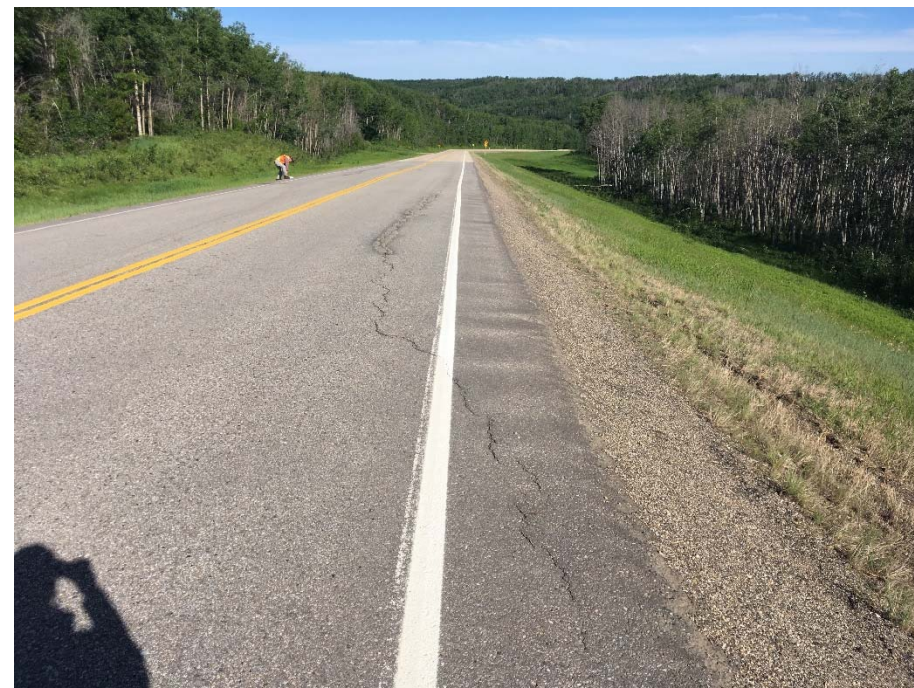
Photo 5.
Crack near middle of southmost patch which may be a scarp crack from arch shape.

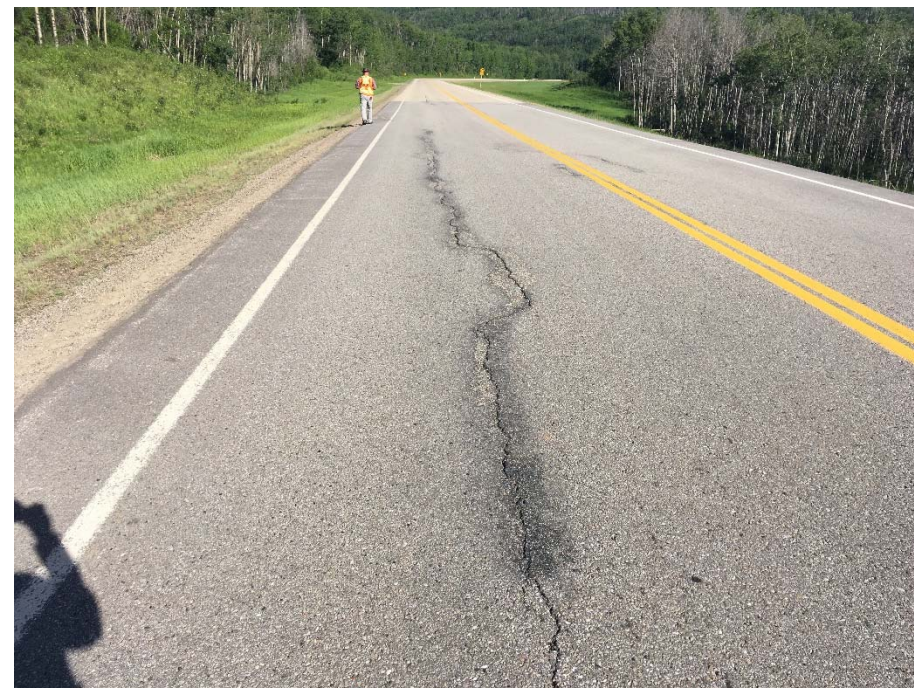
Photo 6.
Cracks on southern asphalt patch in northbound lane.

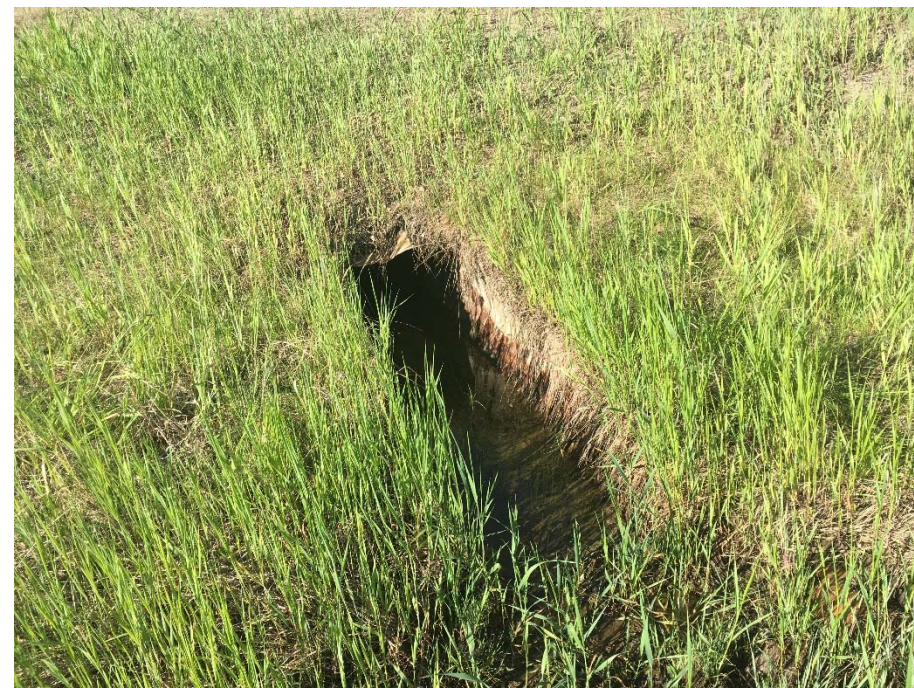
Photo 7.
600 mm CSP
culvert outlet with
water ponding
around outlet.

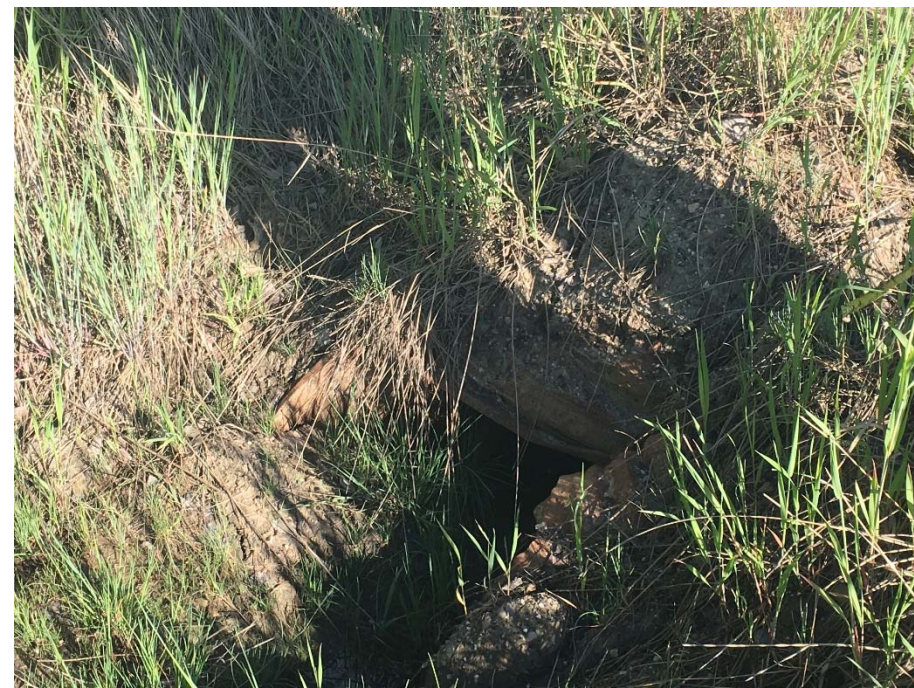
<input checked="" type="checkbox"/> Bridge/Culvert Distress	A centerline culvert was observed near the southern limits of the pavement cracks. The culvert appeared to be functioning well at the time of inspection; however, the culvert inlet is partially blocked and may back up during large precipitation events.	<input checked="" type="checkbox"/>
<input type="checkbox"/> Other		<input type="checkbox"/>
Instrumentation:		
One slope inclinometer (SI98-7) and three pneumatic piezometers (PN-11A, PN-11B, and PN-11C) have been monitored to date.		
SI98-7	This SI was accessible and located at toe of the embankment slope. The recent readings of this SI did not show any discernible movements.	
PN-11A PN-11B PN-11C	The readings from PN-11A and PN-11C pneumatic piezometers indicated an increase in the groundwater level of 0.03 m to 0.05 m respectively since the spring of 2016 instrument readings. PN-11B indicated a decrease in groundwater level of 0.25 m since the last readings in spring 2016.

Photo 8.
Culvert inlet patially
damaged and
blocked.
