ALBERTA TRANSPORTATION
 GEOHAZARD ASSESSMENT PROGRAM
 PEACE REGION-GRANDE PRAIRIE DISTRICT - NORTH
 2021 INSPECTION REPORT

Site Number	Location	Name	Hwy	km
GP014	Hwy 733:04	Bad Heart River South	733:04	8.938
Legal Description		UTM Co-ordinates (NAD 83)		
LSD-9-28-75-3 W6M		11U E 412076	N 6154417

**PEACE REGION (GRANDE PRAIRIE DISTRICT - NORTH)
GP014-1: HWY 733:04 BAD HEART RIVER SOUTH**

DWG No. 32123-GP014-1-1

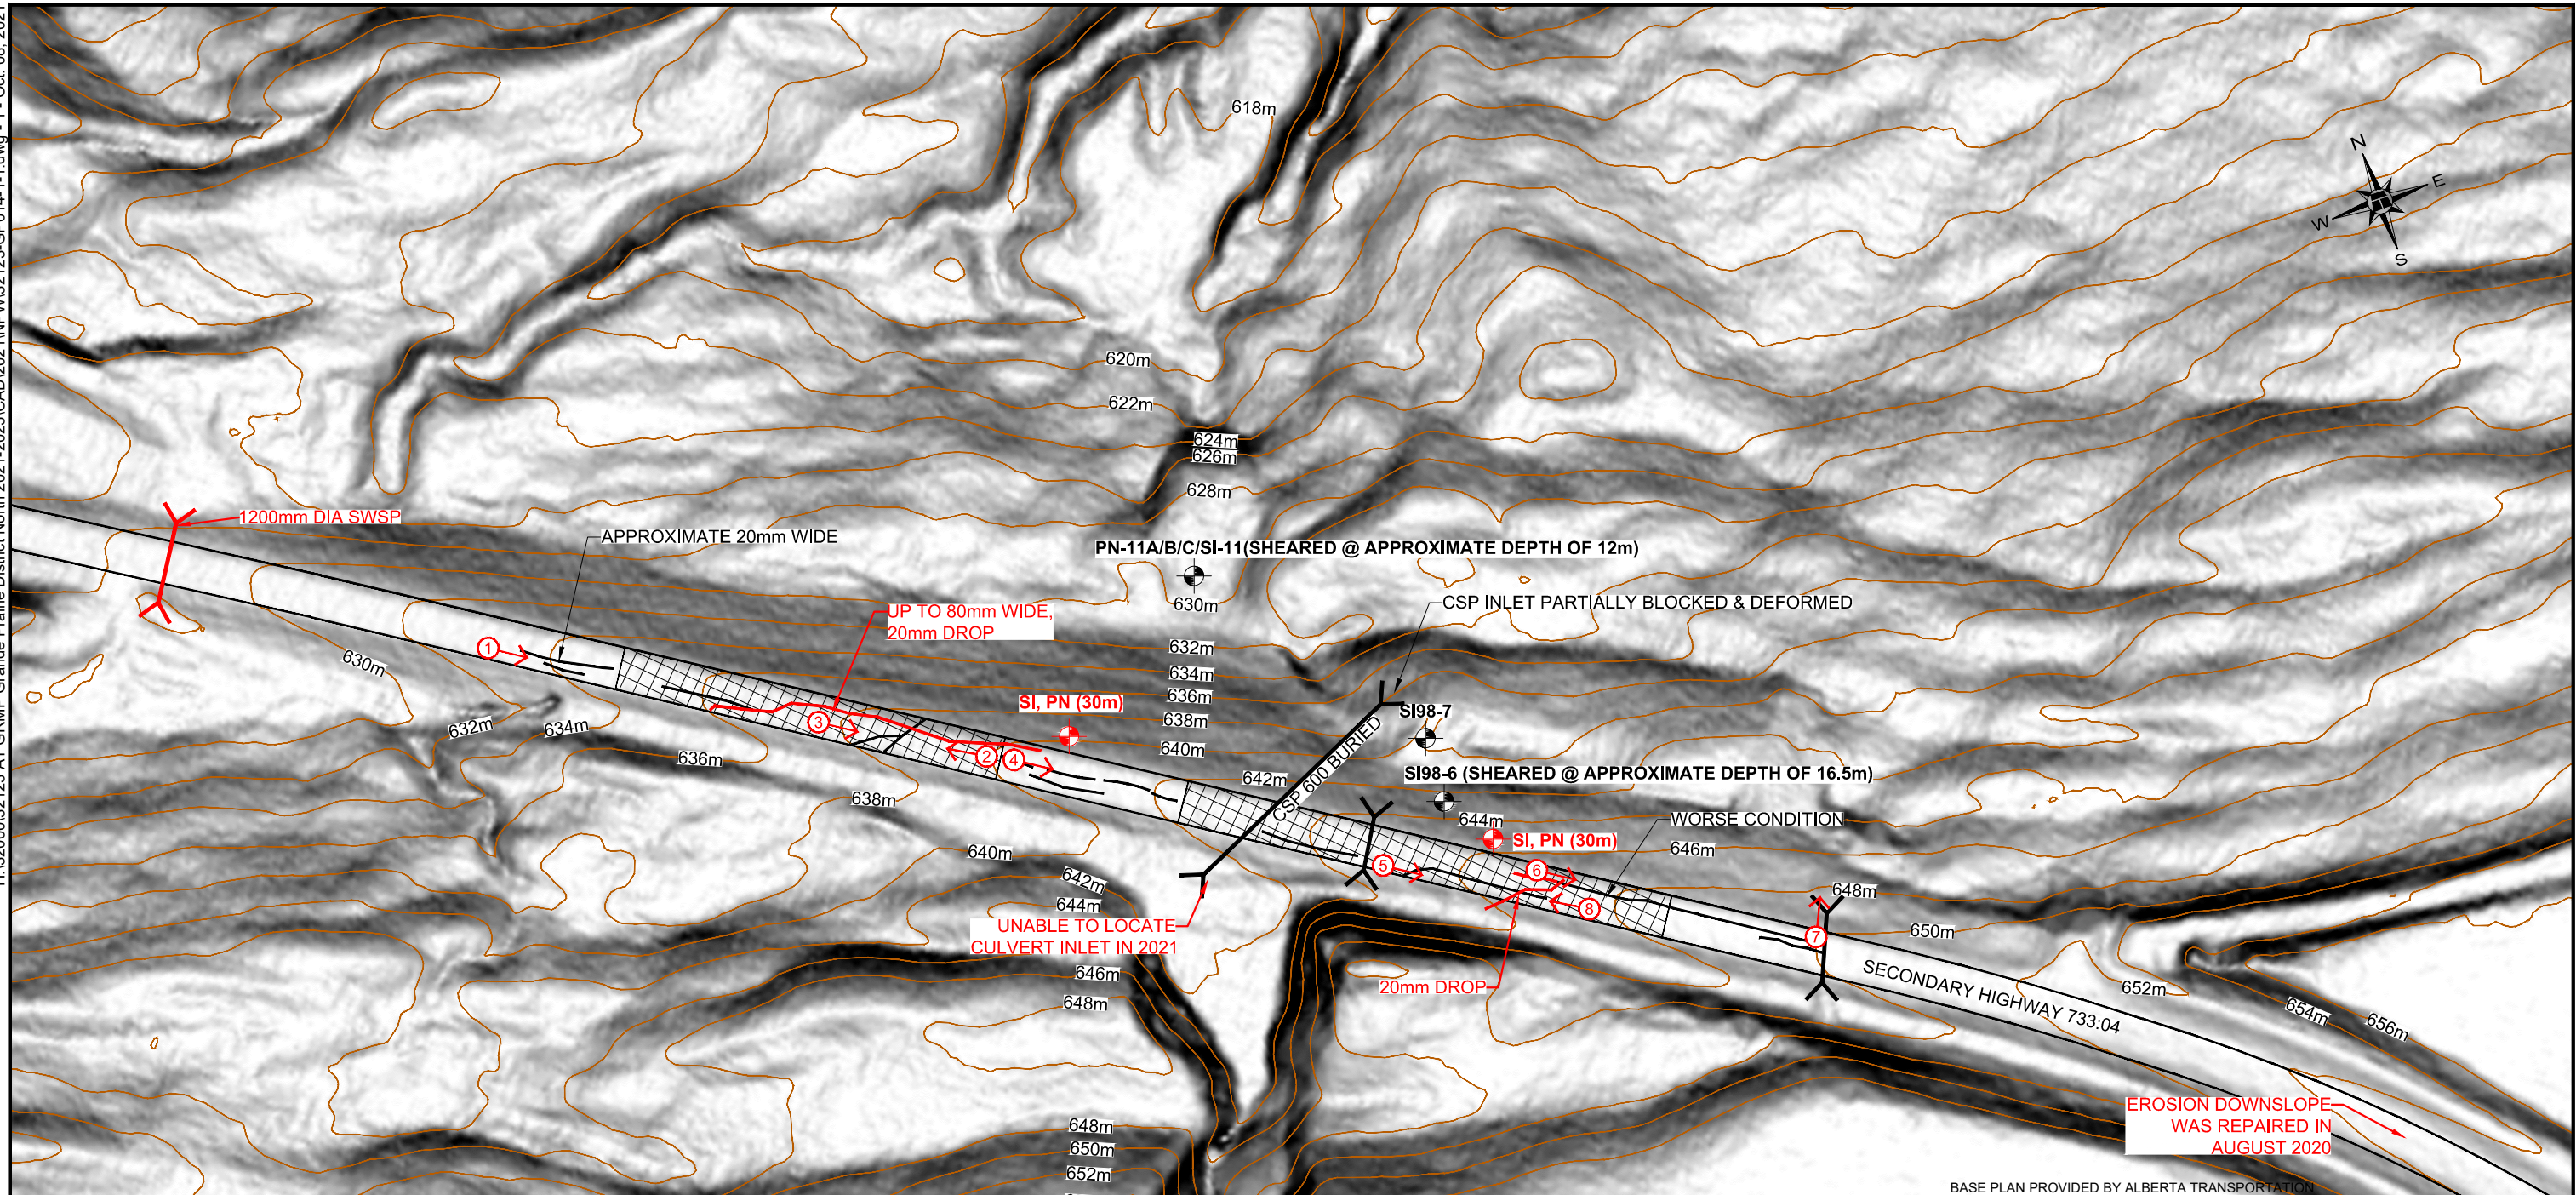
<p>Assessment:</p> <p>No discernable slope movements were observed at this site during this inspection. Ongoing embankment creep was observed and appeared to account for the observed distress and cracking of the roadway pavement structure. Further details of the background information about this site can be obtained from the previous reports in the site Geohazard Binder and are not repeated herein.</p> <p>In order to keep the roadway surface in a suitable driving condition, AT has been sealing cracks and patching the pavement at a frequency of one to two years.</p>		
<p>Recommendations:</p> <p>In the short term, it is recommended that the cracks in the pavement be sealed or overlain with an asphalt patch as required. All observed drops along the landslide backscarp should also be milled and the area should be regularly monitored for signs of active slope movements.</p> <p>A geotechnical investigation is required to assess the mechanisms of the persistent embankment failure observed at this site and to design long term mitigation measures. The locations of the proposed new instruments are presented herein on the 2021 Geohazard Inspection Figure Drawing 32123-GP014-1.</p>		<p>Ballpark Cost</p> <p>Maintenance (\$60,000 every 2 years)</p> <p>\$30,000</p>

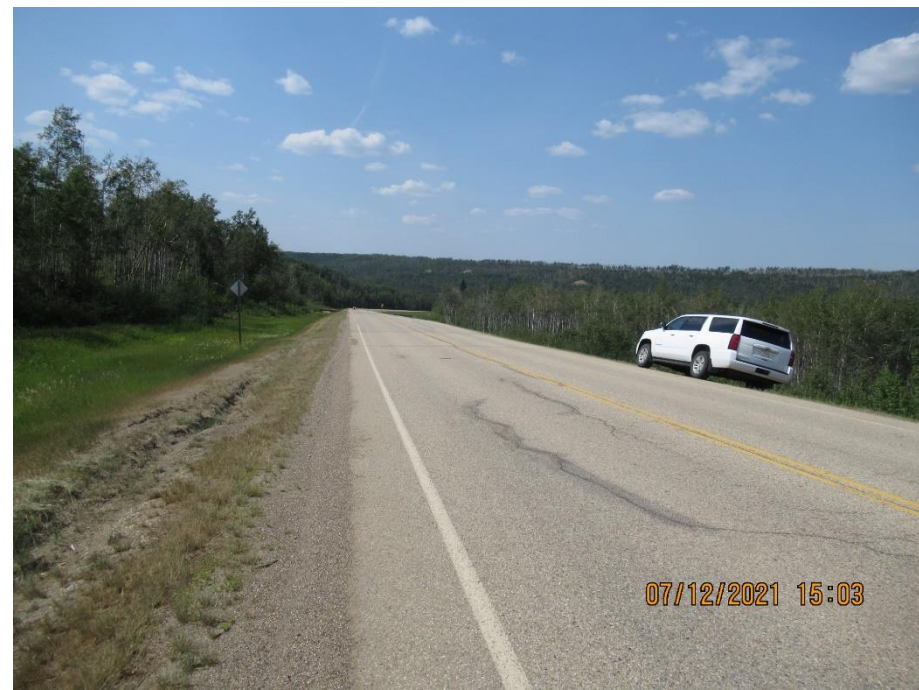
Photo 1.
Looking southeast
along Hwy 733.

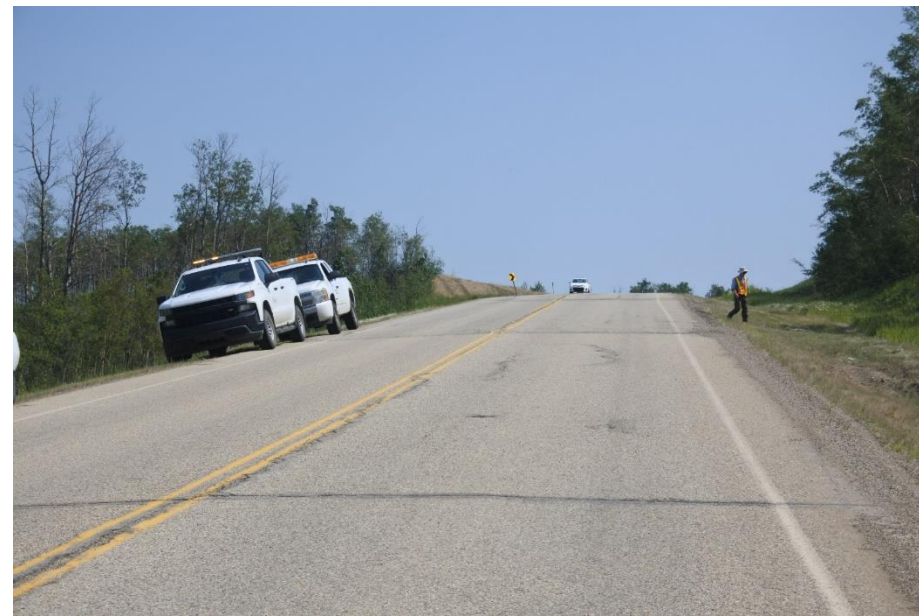
Photo 2.
Cracks reflecting
through patch in
pavement.

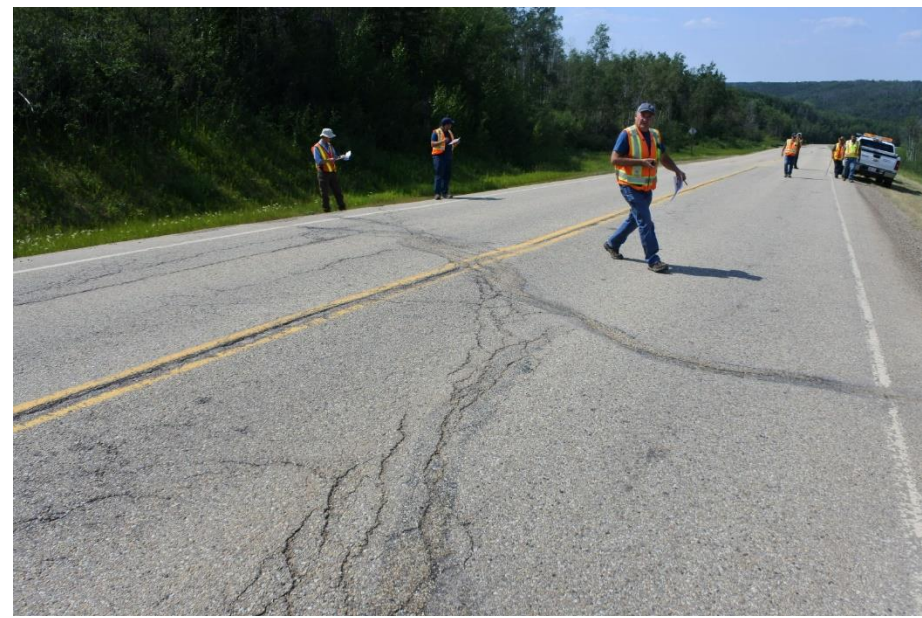
Photo 3.
Crack near middle
of northmost
asphalt patch.

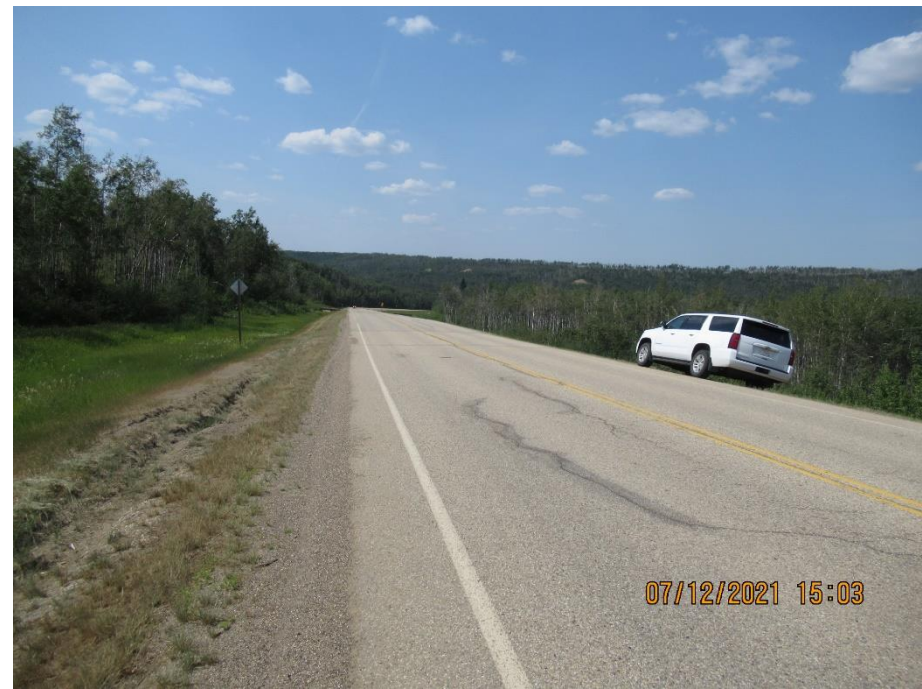
Photo 4.
Cracks on asphalt
in between the two
patches.

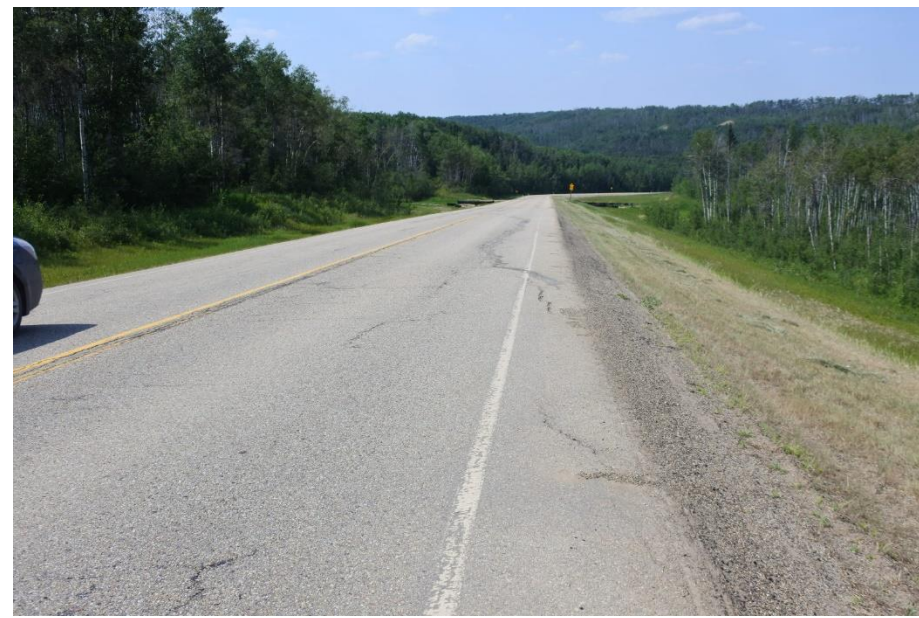
Photo 5.
Crack near middle
which may be a
scarp crack from
arch shape.

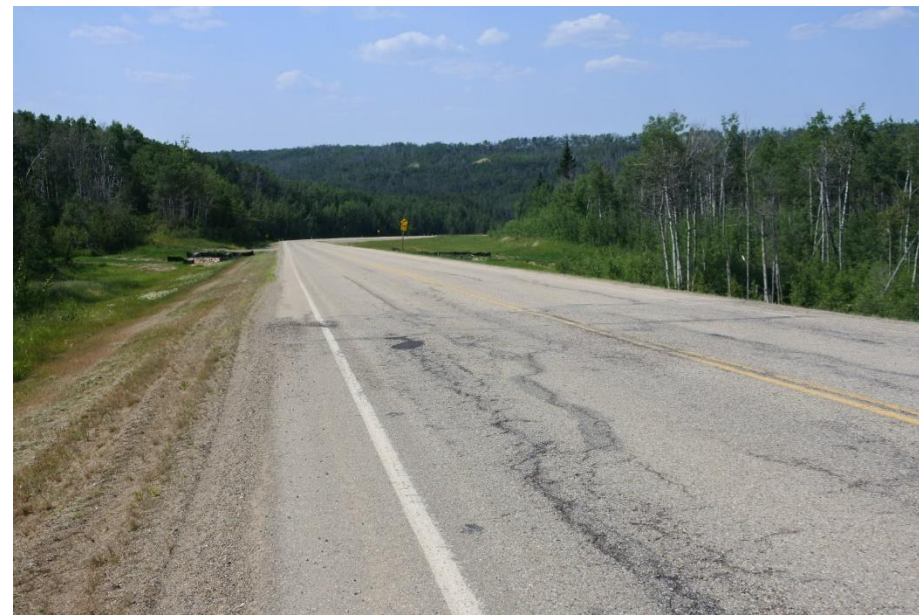
Photo 6.
Cracks on southern
asphalt patch in
northbound lane.

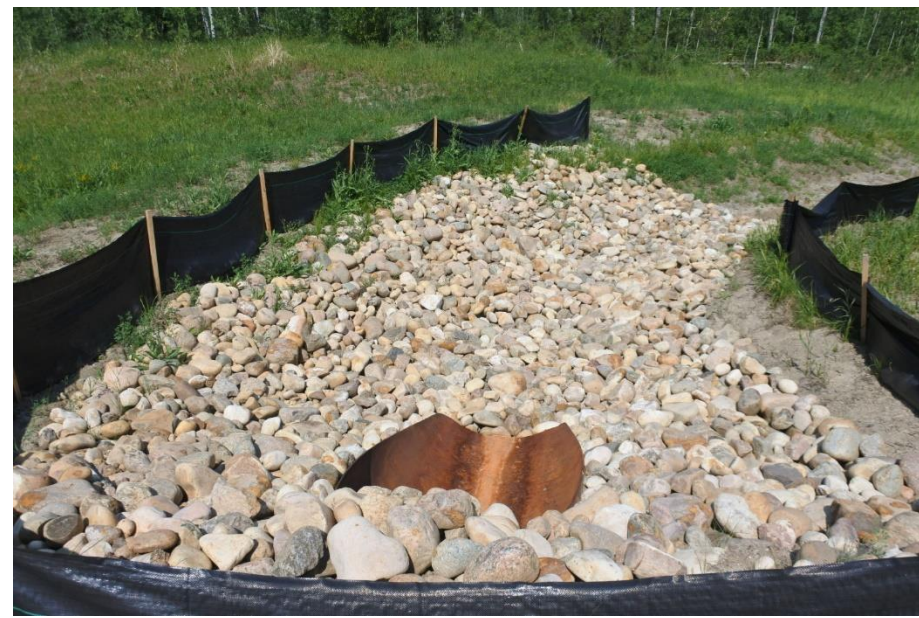
<input checked="" type="checkbox"/> Bridge/Culvert Distress	The previous centerline culvert that was partially blocked was not observed in 2021; however, a new 1200 mm diameter SWSP culvert was installed at the east end of the site in June 2020.	<input checked="" type="checkbox"/>
<input type="checkbox"/> Other		<input type="checkbox"/>
<p>Instrumentation:</p> <p>One slope inclinometer (SI98-7) and three pneumatic piezometers (PN-11A, PN-11B, and PN-11C) have been monitored to date.</p> <p>SI98-7 This SI was accessible and located at toe of the embankment slope. The recent readings of this SI did not show any discernible movements.</p> <p>PN-11A The readings from PN-11B and PN-11C pneumatic piezometers indicated a decrease in the groundwater level of 0.03 m to 0.23 m respectively since the spring of 2020 instrument readings. PN-11A showed no increase in water level since the last readings in spring 2020.</p> <p>PN-11B</p> <p>PN-11C</p>

Photo 7.
New 1200 mm
SWSP culvert
outlet installed in
June 2021.

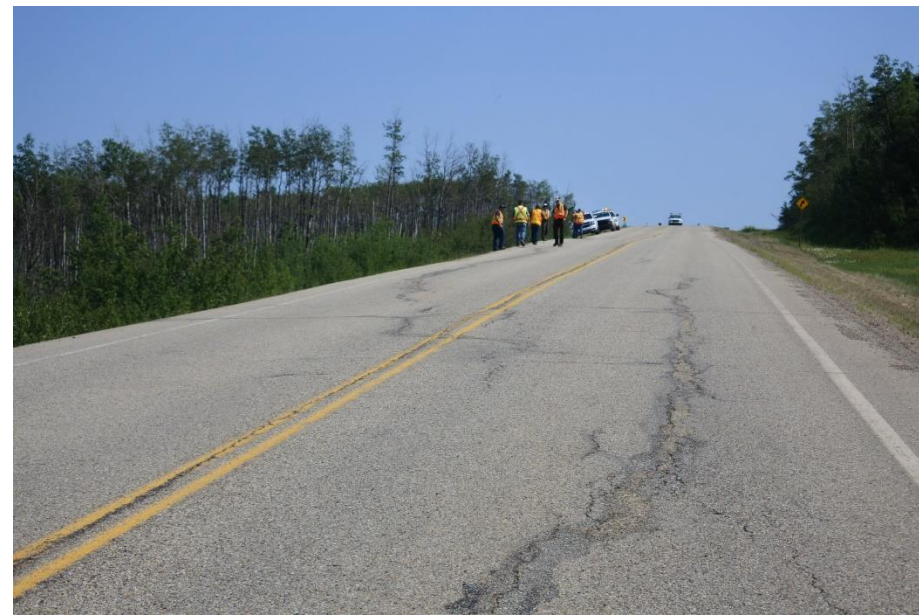
Photo 8.
Looking northwest
at cracks in
pavement on south
portion of the site.
