August 4, 2022 File No.: 32123

ALBERTA TRANSPORTATION GRMP (CON0022165) PEACE REGION (GRANDE PRAIRIE DISTRICT – NORTH) INSTRUMENTATION MONITORING RESULTS – SPRING 2022

SITE GP014: HWY 733:04, BAD HEART RIVER

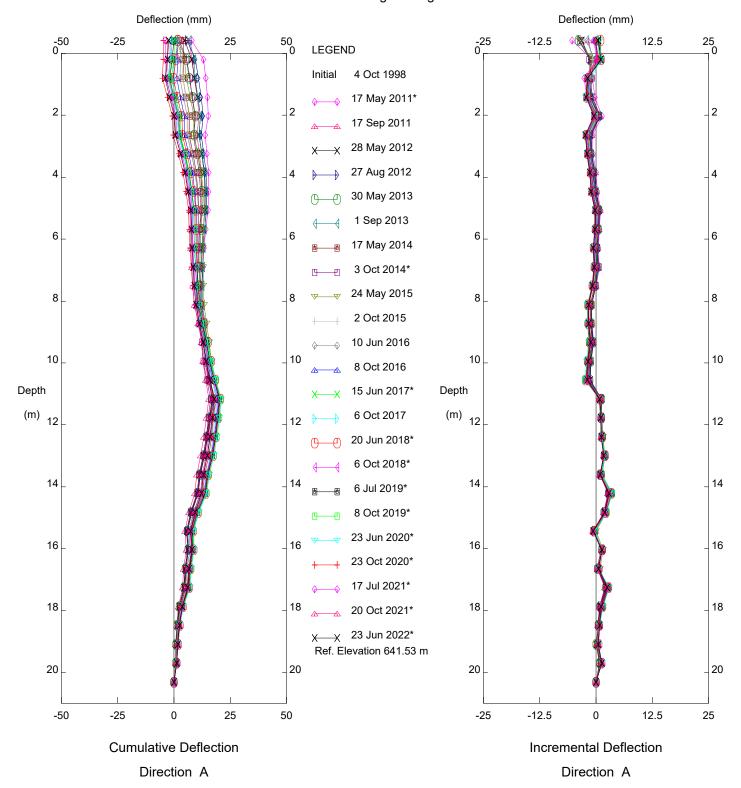
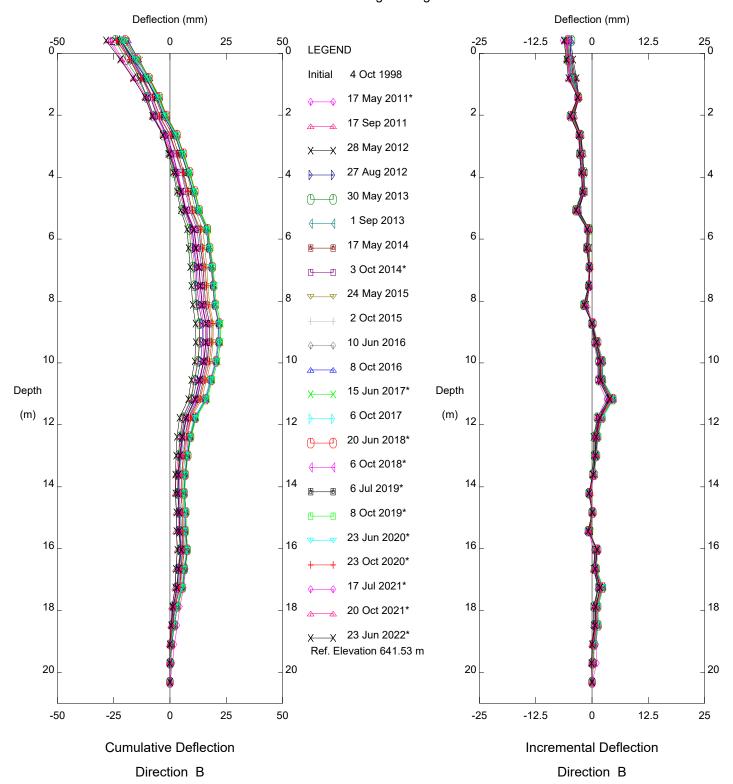
GP014 Bad Heart River South Slide, Inclinometer SI98-7

Zones of new movement were not observed in SI98-7 since the previous readings in the fall of 2021.

Slope inclinometer SI98-7 continued to show no discernible movement.

Since the instrumentation readings at this site show relatively minimum changes over several years of monitoring, we recommend reading the instrumentation at this site every two years; thus, the next set of readings should be in 2024.

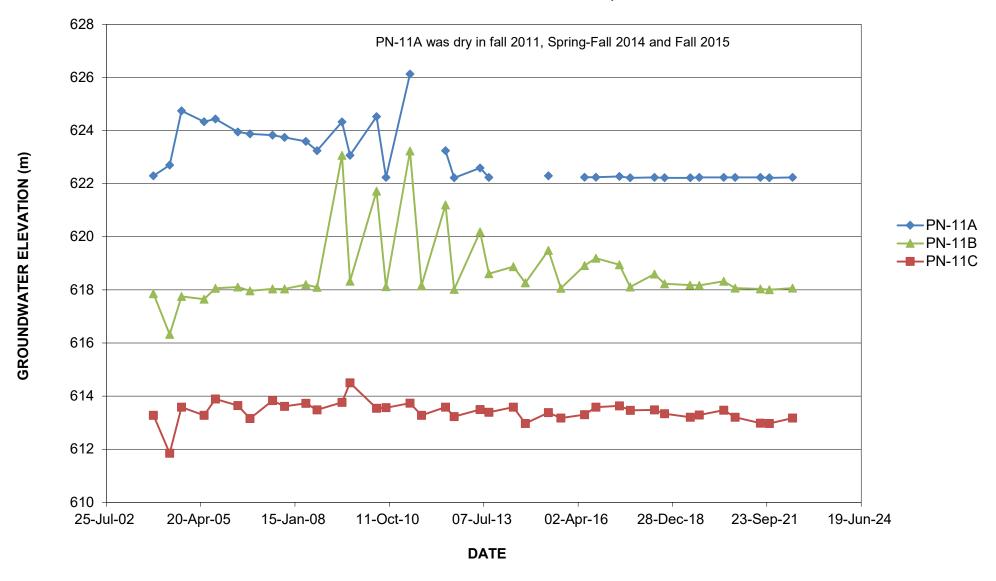
FIGURE GP014-1
PIEZOMETRIC ELEVATIONS FOR HWY 733:04, BAD HEART RIVER

Pneumatic piezometers PN-11A, PN-11B and PN-11C showed increases in groundwater levels of 0.01 m, 0.06 m, and 0.20 m, respectively, since the fall of 2021 readings. Pneumatic piezometer results are summarized in Table GP014-2 and are plotted in Figures GP014-1 (by elevation) and GP014-2 (by depth) in Appendix A.
