**ALBERTA TRANSPORTATION  
GEOHAZARD ASSESSMENT PROGRAM  
PEACE REGION–GRANDE PRAIRIE  
2020 INSPECTION REPORT**

Site Number	Location	Name	Hwy	km
GP35	Hwy 733:04	Bad Heart River North	733:04	8.938
Legal Description		UTM Coordinates (NAD 83)		
LSD-1-33-75-3 W6M		E 412,161 N 6,155,446

**GP035-1: HWY 733:04 BAD HEART RIVER NORTH  
2020 SITE INSPECTION**

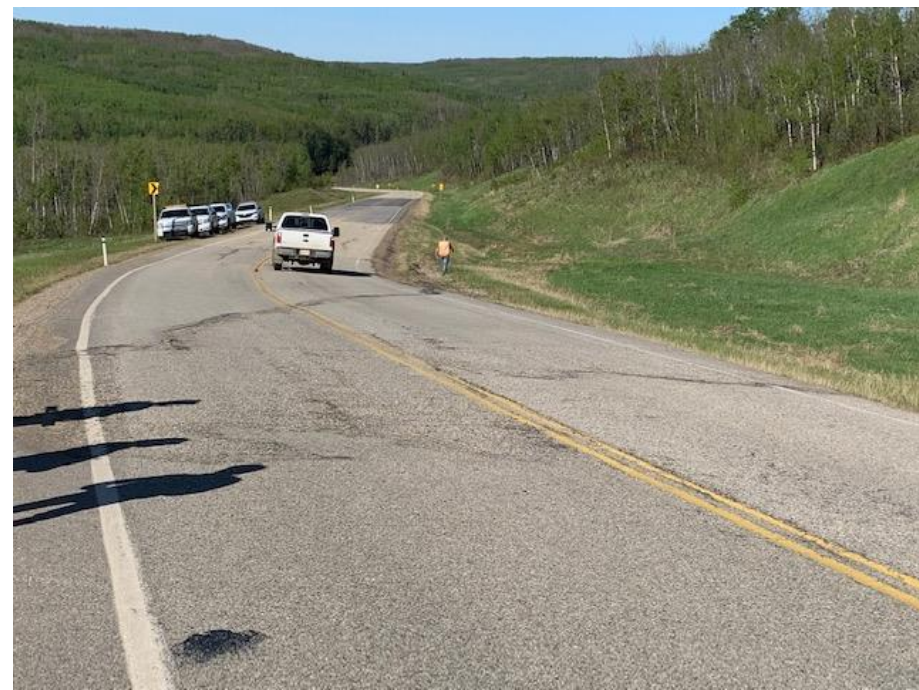
**Photo 1.**  
Looking southwest  
along Hwy (former  
north slide)

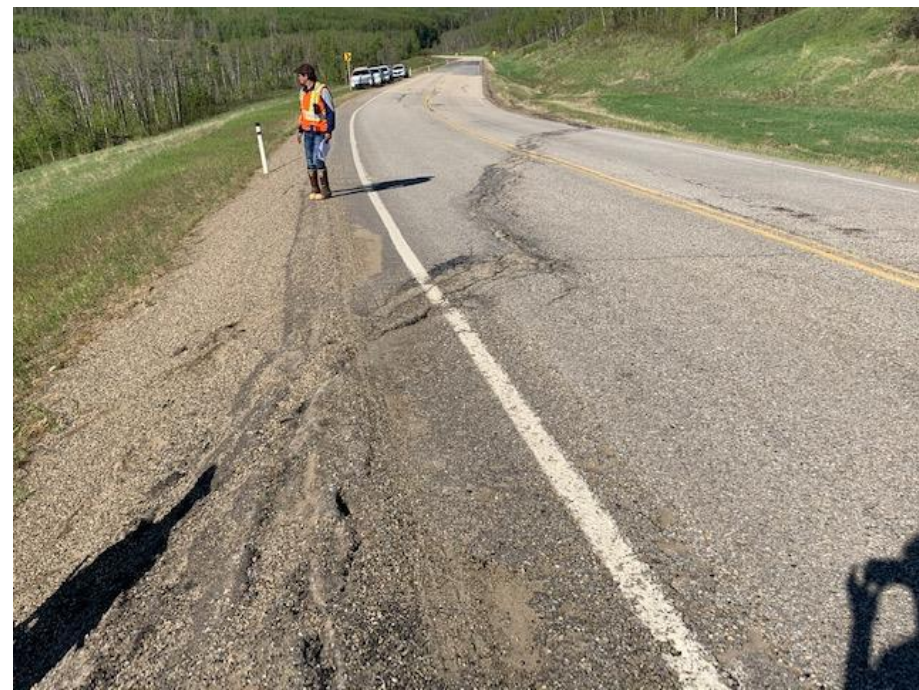
**Photo 2.**  
Looking southwest  
along Hwy 733 733  
at sharp shoulder  
from successive  
overlays (former  
north slide).

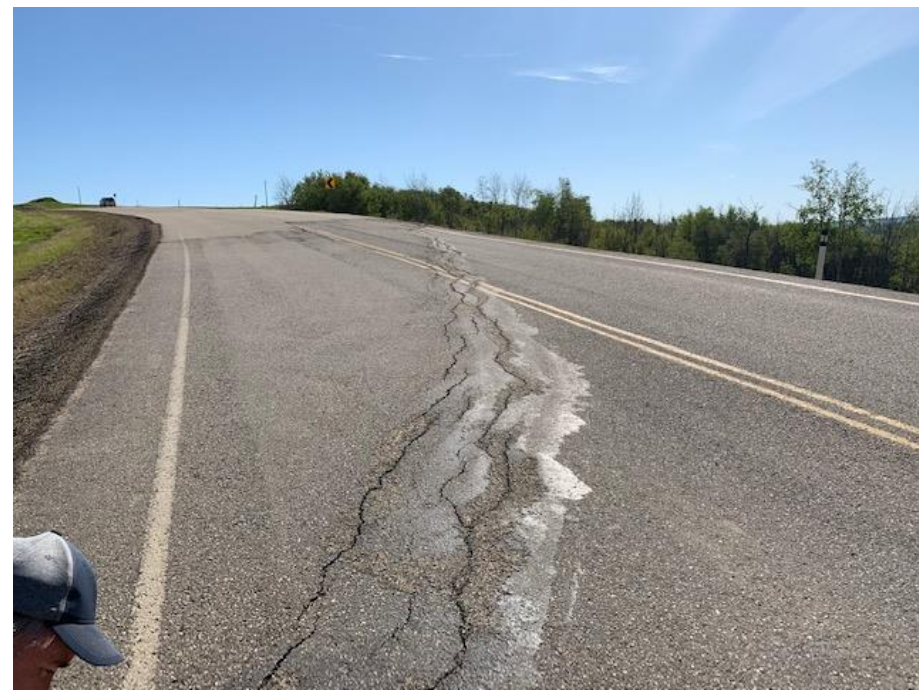
**Photo 3.**  
Looking northeast  
along Hwy 733 at  
scarp crack which  
extends into should  
and embankment  
(former north slide)

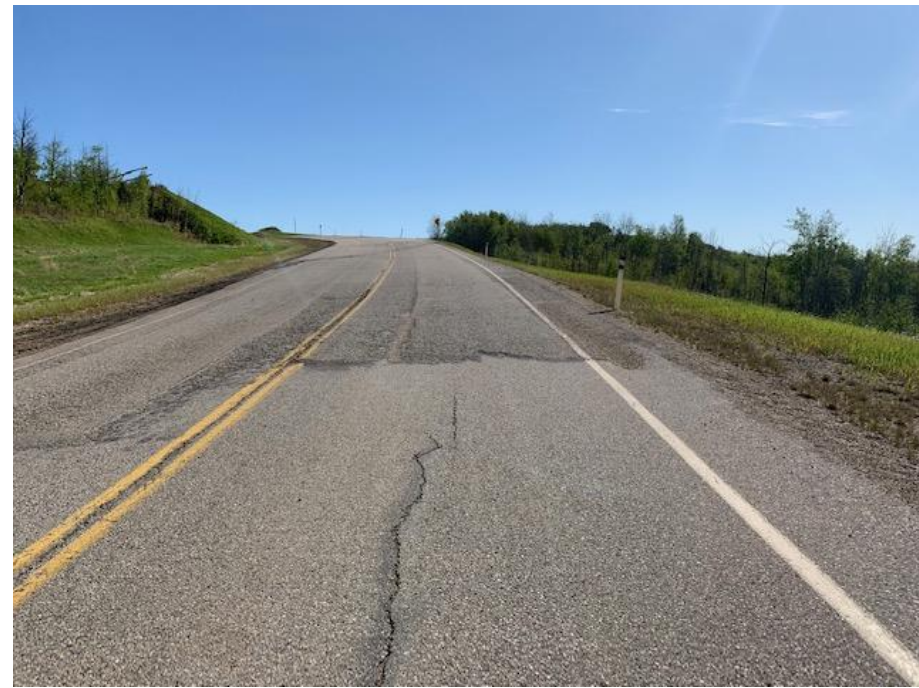
**Photo 4.**  
Looking northeast  
along Hwy 733  
(former north slide)  
Possible tension  
crack.

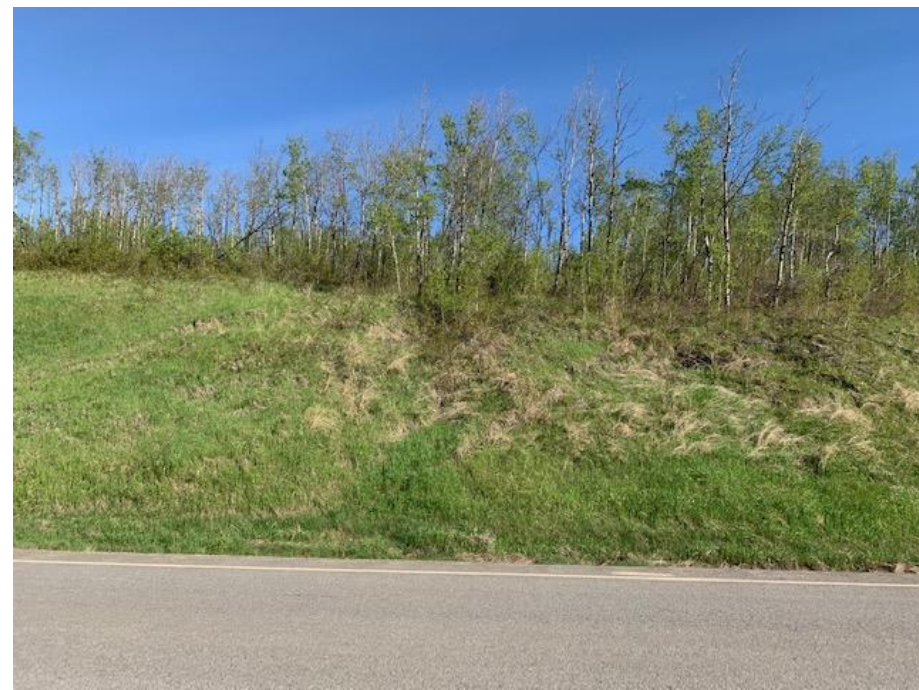
**Photo 5.**  
Looking northwest  
at backslope slump

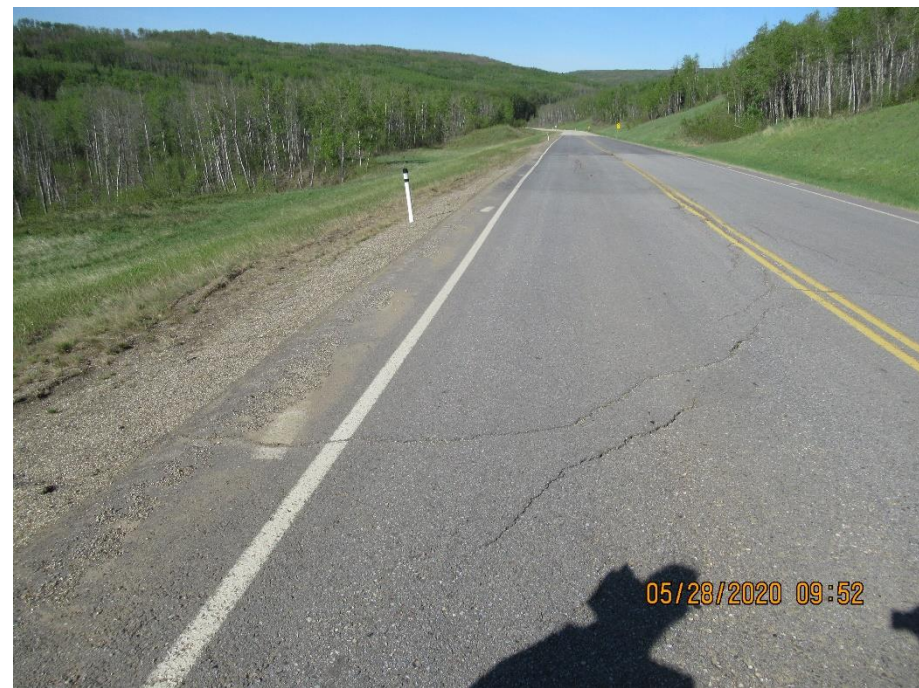
**Photo 6.**  
Looking southwest  
(former south  
slide).

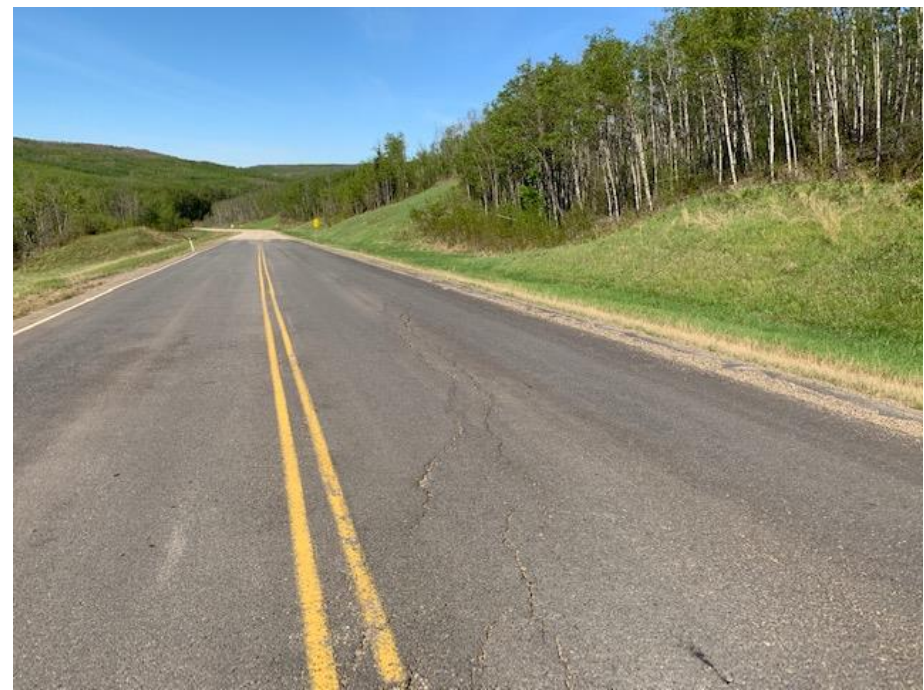
**Photo 7.**  
Looking southwest  
(end of the former  
south slide).

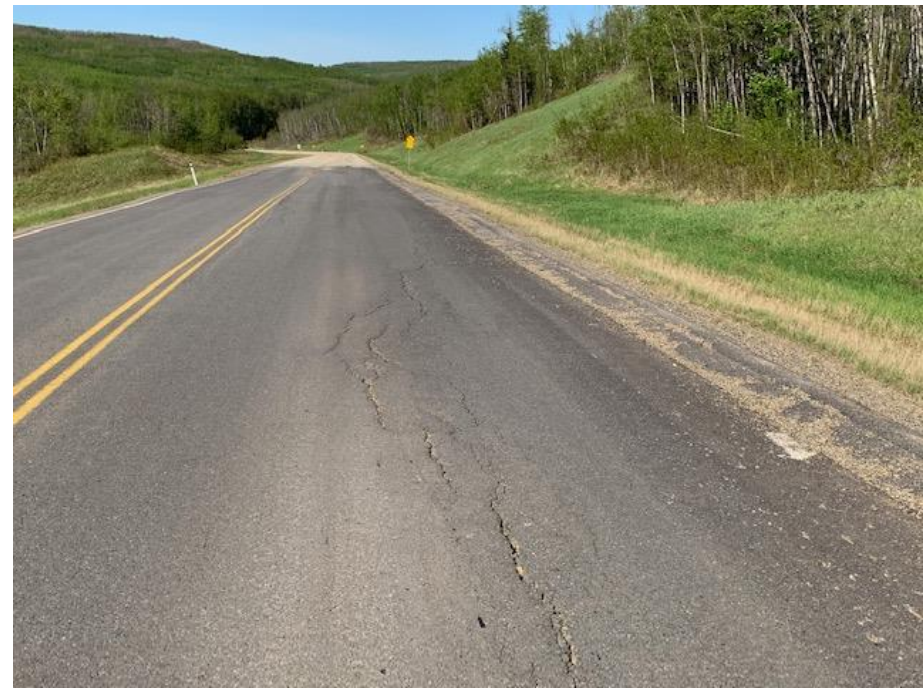
**Photo 8.**  
Looking southwest  
(end of the former  
south slide).

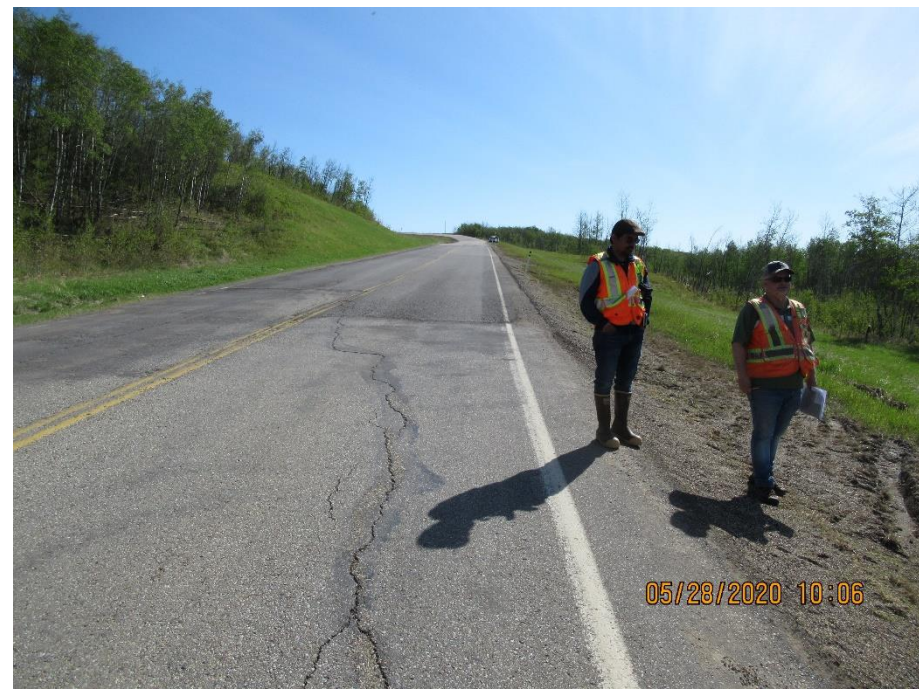
**Photo 9.**  
Looking northeast  
near the south end  
of the former south  
slide.

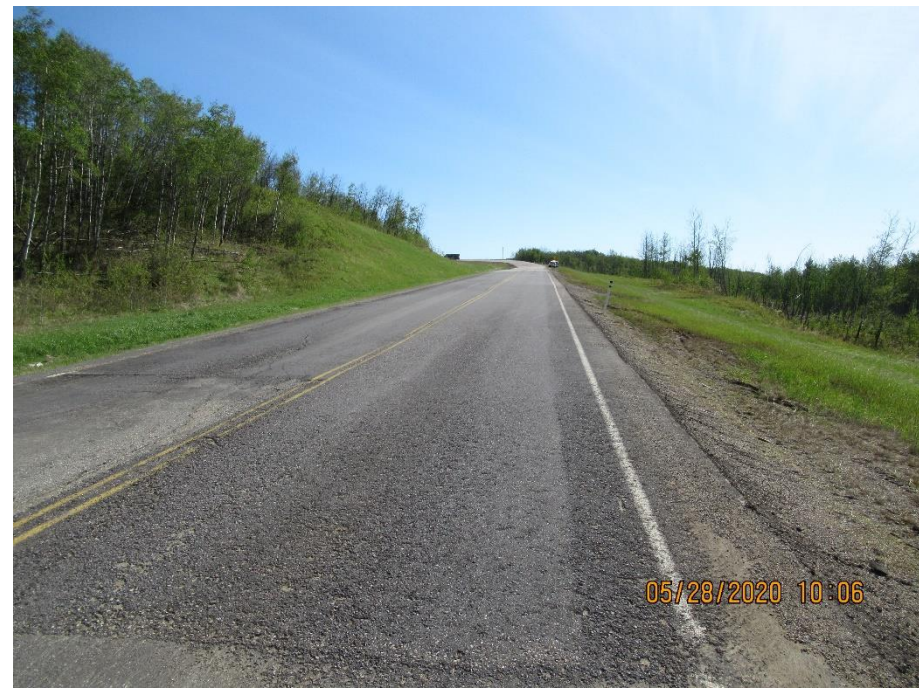
**Photo 10.**  
Looking northeast  
near the middle of  
the former south  
slide.

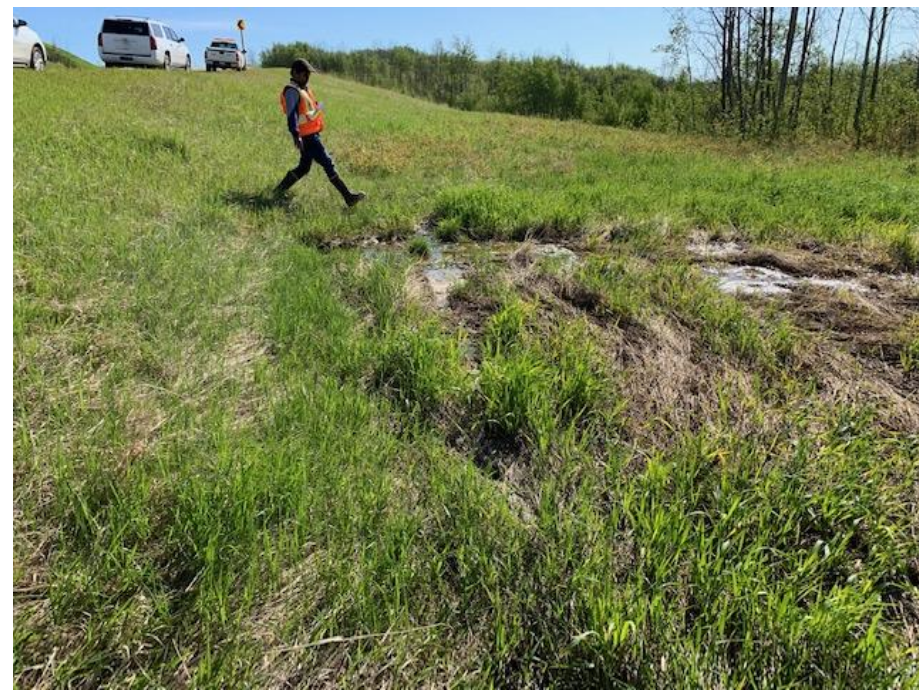
**Photo 11.**  
Looking east at  
ponded water in the  
south ditch.

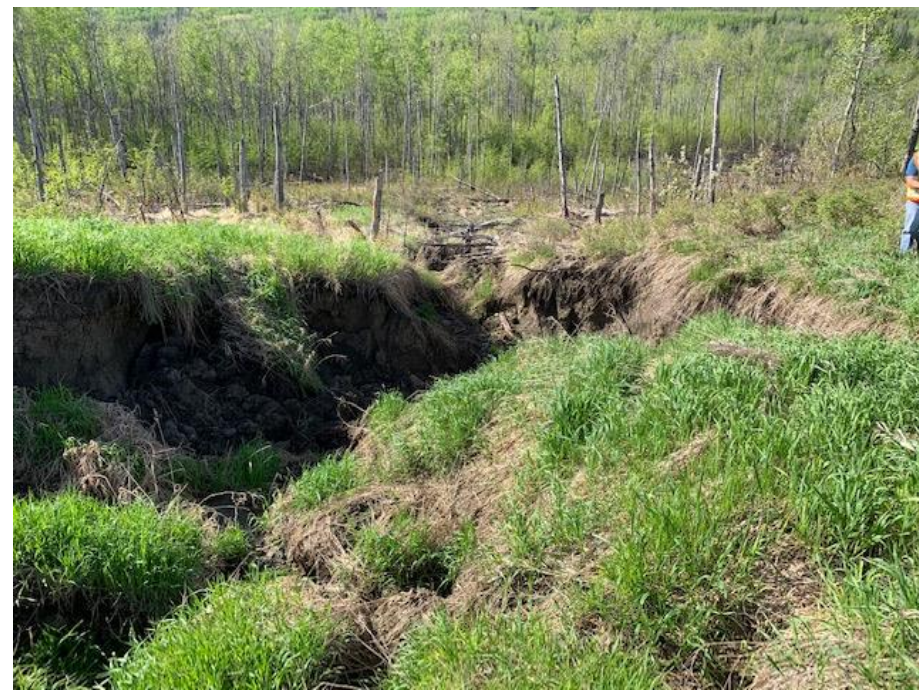
<input checked="" type="checkbox"/> Erosion	A drainage gully was observed just south of the 500 mm diameter CSP culvert during previous inspections and has worsened into an erosion gully in 2020. Which is now 6 m from the culvert outlet.	<input checked="" type="checkbox"/>
<input checked="" type="checkbox"/> Seepage	A gully which channels runoff flow from the farmland to the north to the slide area exists approximately 50 northeast of site. Some ponded water was observed at the base of the gully and seepage was previously observed along the west ditch and in a tension crack in the shoulder; seepage was present in 2020.	<input checked="" type="checkbox"/>
<input checked="" type="checkbox"/> Bridge/Culvert Distress	The existing centerline culvert (about 500 mm in diameter) appeared to be functioning well at the time of inspection; however, the culvert was partially obstructed by overgrown vegetation at inlet and outlet locations.	<input checked="" type="checkbox"/>

**Photo 12.**  
Looking south at  
erosion gully.

A mid to long term remediation measure could consist of realigning highway towards the backslope to minimize/avoid the impacts from the active landslide.		
<b>Recommendations:</b>		<b>Ballpark Cost</b>
As AT has been doing over the years, as a short-term mitigation measure, it is recommended that sealing of pavement cracks and patching of roadway be undertaken in the slide impacted area. The differential drops along the backscarps should be milled to improve driving conditions. The site should continue to be monitored to provide a history and trend of potential slide activity.		Maintenance (currently about \$100,000 every year)
Consideration should be given to install guard-rails (+/-150 m) along the northbound lane to eliminate the potential hazard of the sharp shoulder as a result of successive overlay patches. In addition, the inlet and outlet areas of the existing 500 mm centreline culvert should be cleared of vegetation and debris to improve its performance. The erosion gully should be monitored for retrogression. The possible tension crack and scour should be backfilled with clay material to minimize the surface water infiltration.		\$70,000
