**ALBERTA TRANSPORTATION
GEOHAZARD ASSESSMENT PROGRAM
PEACE REGION–GRANDE PRAIRIE
2021 INSPECTION REPORT**

Site Number	Location	Name	Hwy	km
GP35	Hwy 733:04	Bad Heart River North	733:04	8.938
Legal Description		UTM Coordinates (NAD 83)		
LSD-1-33-75-3 W6M		E 412,161	N 6,155,446

2021 SITE INSPECTION

DWG No. 32123-GP035-1

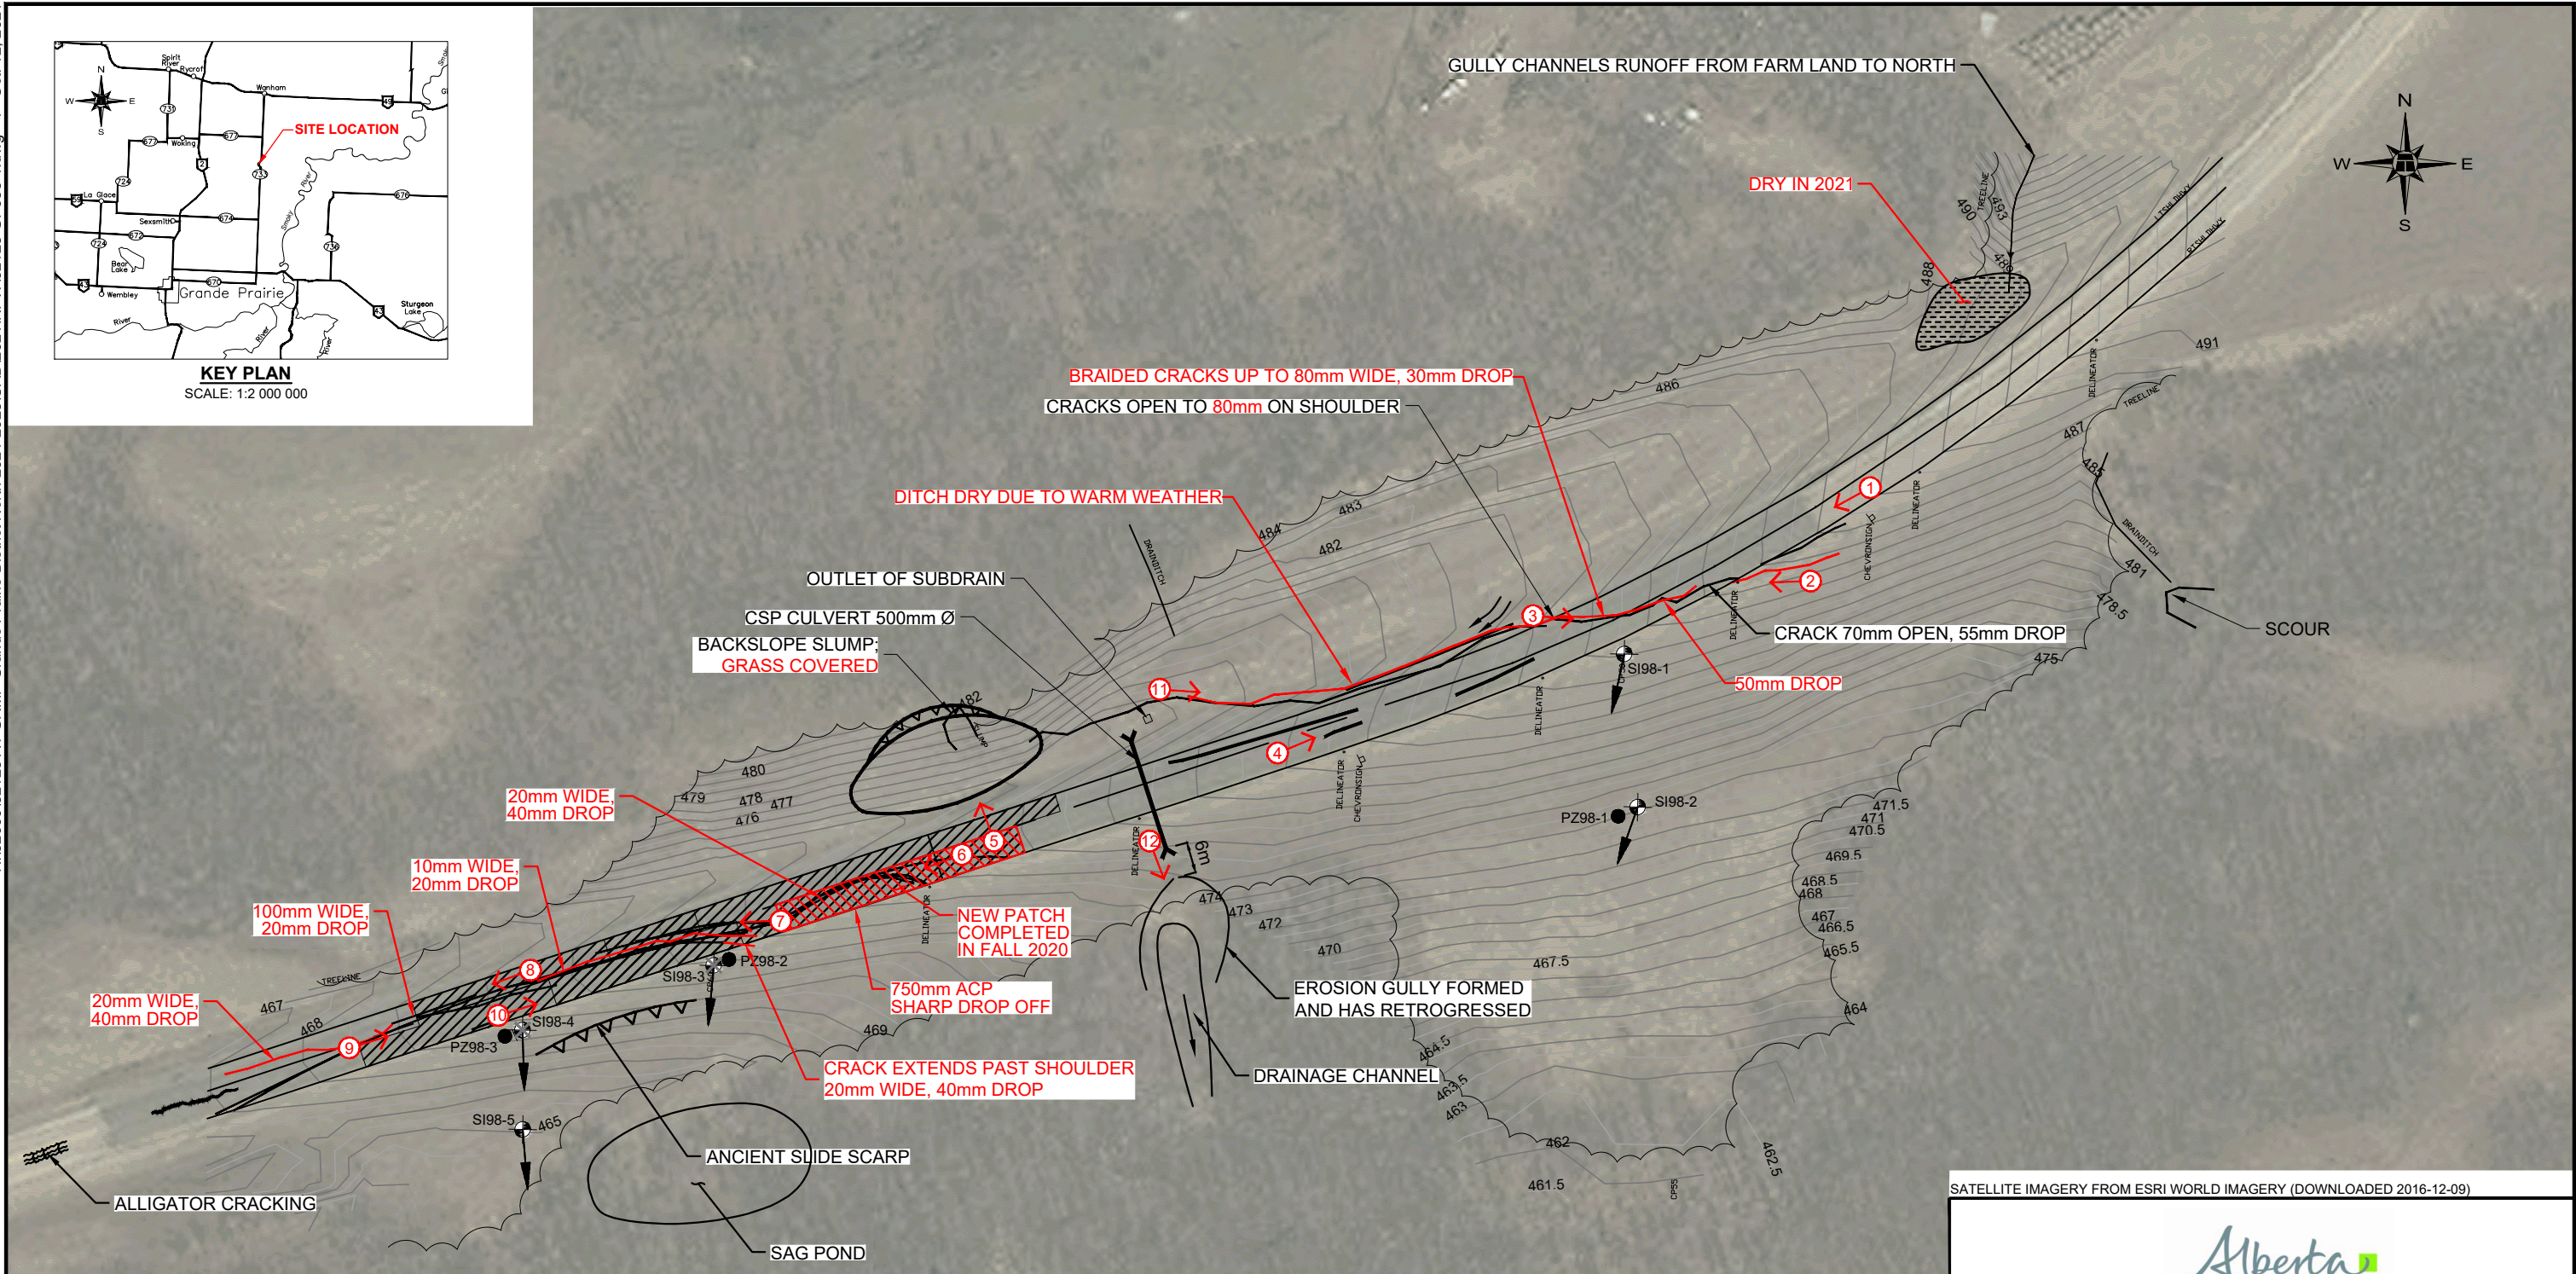
Primary Site Issue:	<p>Sliding movements of Hwy 733:04 along the north valley slope of Bad Heart River Valley. The roadway is located within an active landslide area and previously the site was identified by having an upper slide area and a lower slide area which were active since the early 1980's.</p> <p>Based on the recent observations of ground subsidence and head scarp cracking over the period between 2010 and 2020, it appears that the upper and lower slides have gradually coalesced into one major slide.</p> <p>Slide can be classified as slow movement based on the rate of movement.</p>
Dimensions:	<p>The upper slide was initially estimated to be about 80 m long and the lower slide was estimated to be about 150 m long along the roadway alignment. The extents along the valley slope for both could not be defined and require further investigation.</p> <p>The upper and lower slides appear to have merged and developed into a large slide about 380 m in length along roadway alignment.</p>

Observations:	Description	Worsened?
<input checked="" type="checkbox"/> Pavement Distress	Cracks and dips on the pavement within the landslide impact area with cracks open to 100 mm wide and differential drop up to 50 mm were observed during the 2021 inspection. The pavement was patched in summer 2019 and these same scarp cracks have reflected through the patch and some of the cracks have become braided.	<input checked="" type="checkbox"/>
<input type="checkbox"/> Slope Movement	The lower (south) and upper (north) slides have merged into a larger slide. Tension cracks up to 80 mm wide were observed extending along the west ditch near the northeast portion of the slide. The scarp was also more defined in the northwest ditch.	<input checked="" type="checkbox"/>
<input checked="" type="checkbox"/> Erosion	A drainage gully was observed just south of the 500 mm diameter CSP culvert during previous inspections and	<input checked="" type="checkbox"/>

Recommendations:		Ballpark Cost
<p>As AT has been doing over the years, as a short-term mitigation measure, it is recommended that sealing of pavement cracks and patching of roadway be undertaken in the slide impacted area. The differential drops along the backscarps should be milled to improve driving conditions. The site should continue to be monitored to provide a history and trend of potential slide activity.</p>		Maintenance (currently about \$100,000 every year)
<p>Consideration should be given to install guard-rails (+/-150 m) along the northbound lane to eliminate the potential hazard of the sharp shoulder as a result of successive overlay patches. In addition, the inlet and outlet areas of the existing 500 mm centreline culvert should be cleared of vegetation and debris to improve its performance. The erosion gully should be monitored for retrogression. The possible tension crack and scour should be backfilled with clay material to minimize the surface water infiltration.</p>		\$70,000

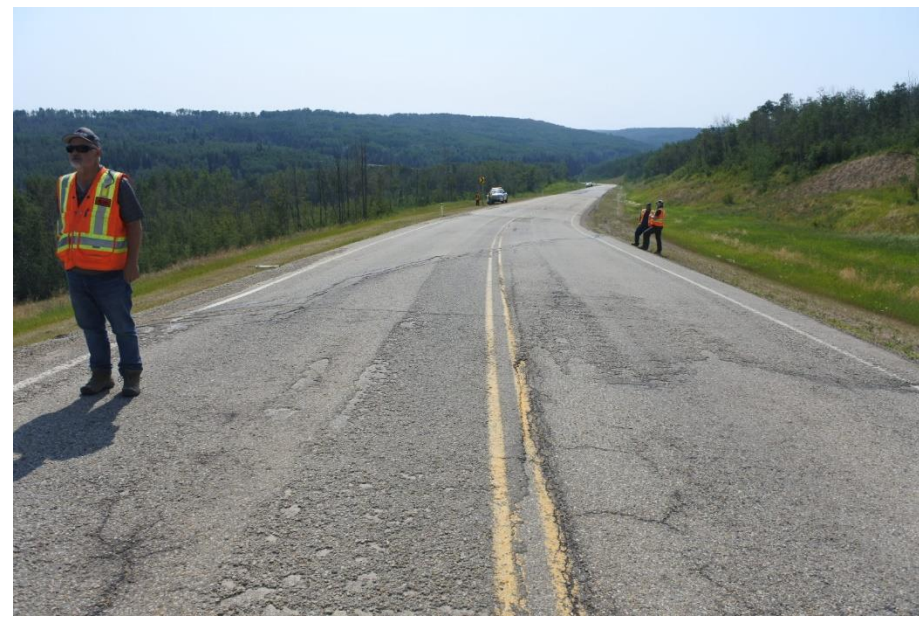
Photo 1.
Looking southwest
along Hwy (former
north slide)

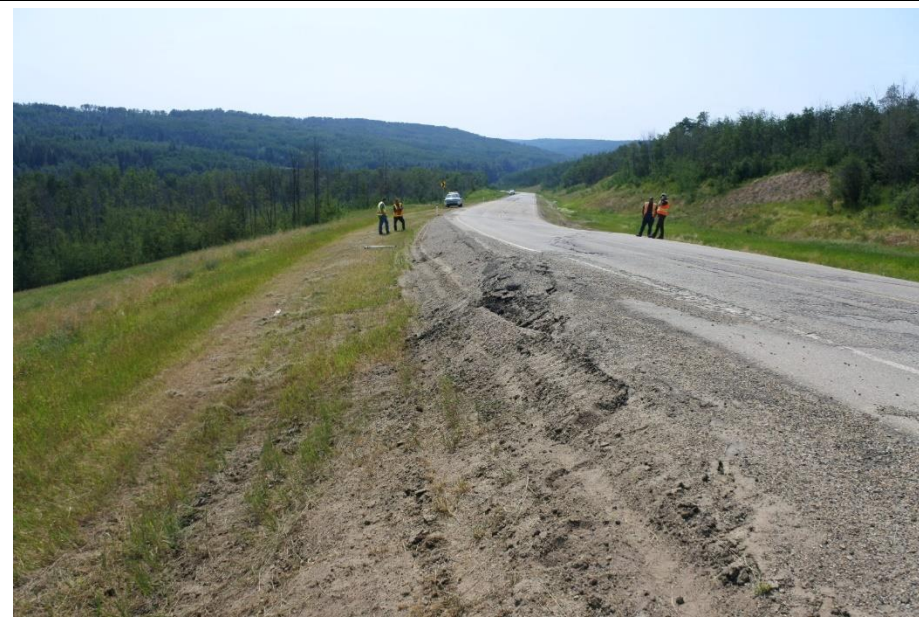
Photo 2.
Looking southwest
along Hwy 733 at
sharp shoulder
from successive
overlays (former
north slide).

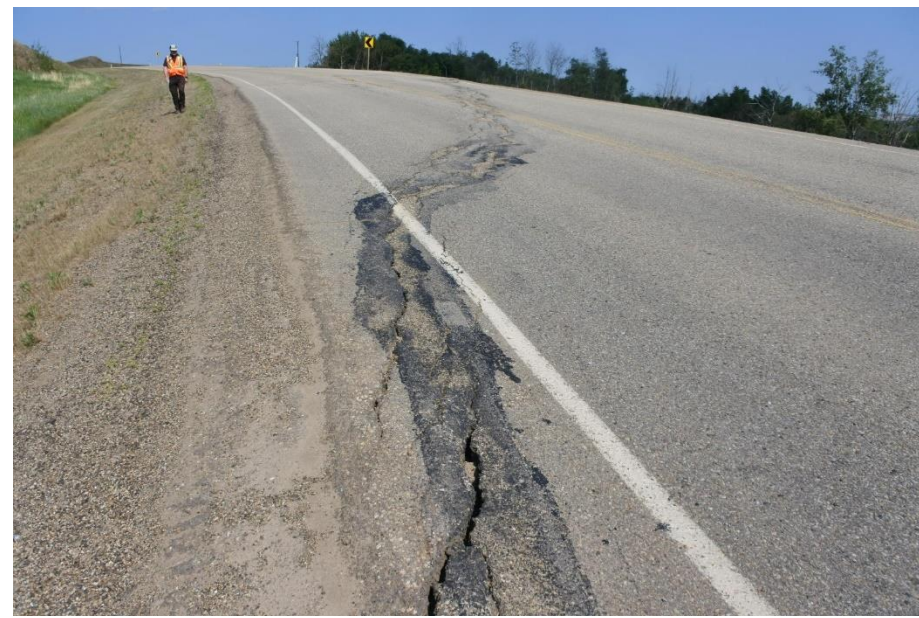
Photo 3.
Looking northeast
along Hwy 733 at
scarp crack which
extends into
shoulder and
embankment
(former north slide)

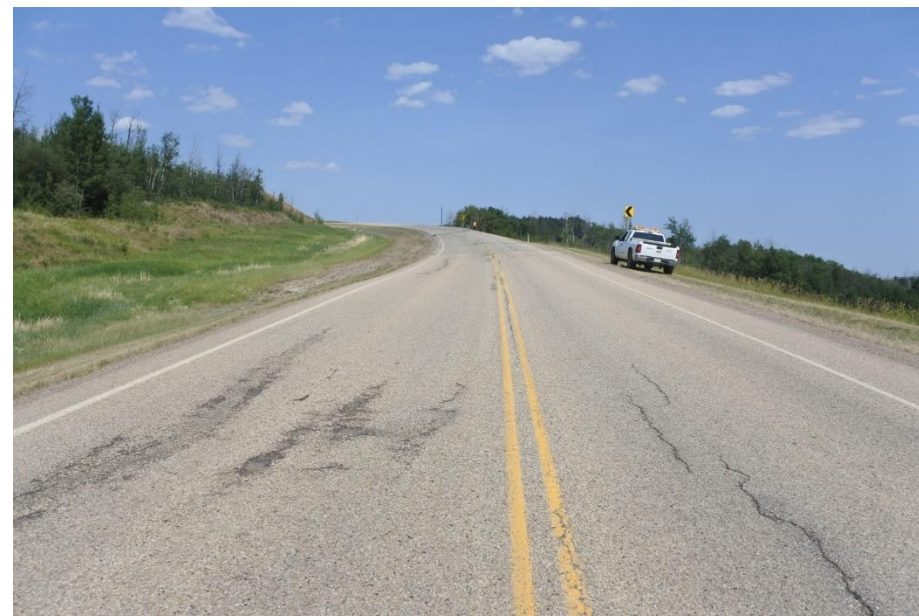
Photo 4.
Looking northeast
along Hwy 733
(former north slide).

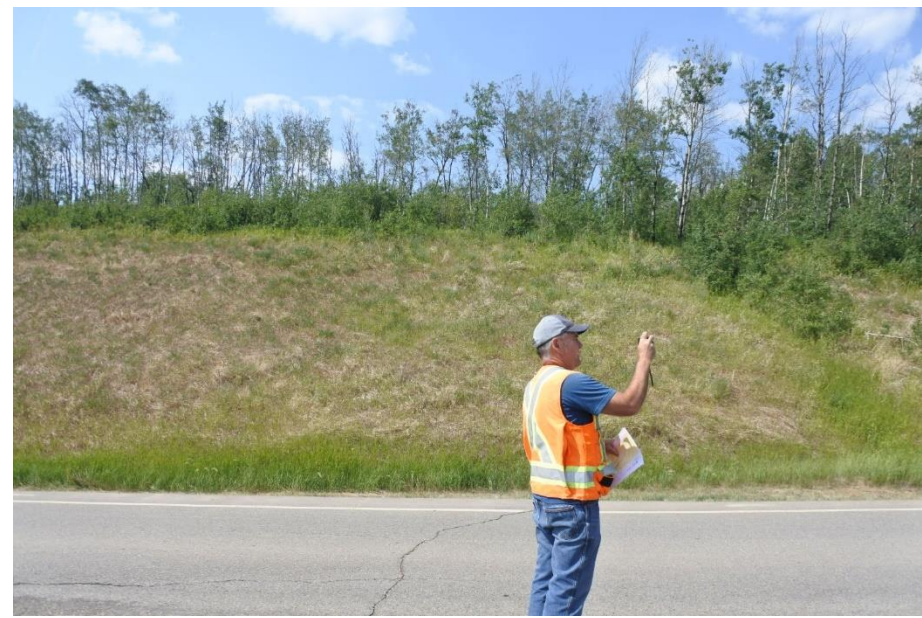
Photo 5.
Looking northwest
at backslope slump

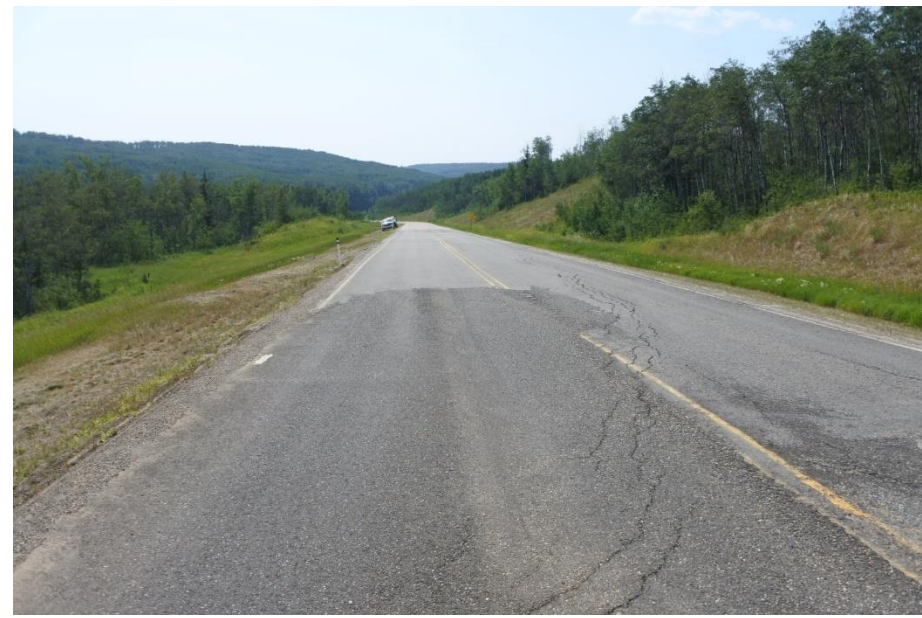
Photo 6.
Looking southwest
(former south
slide).

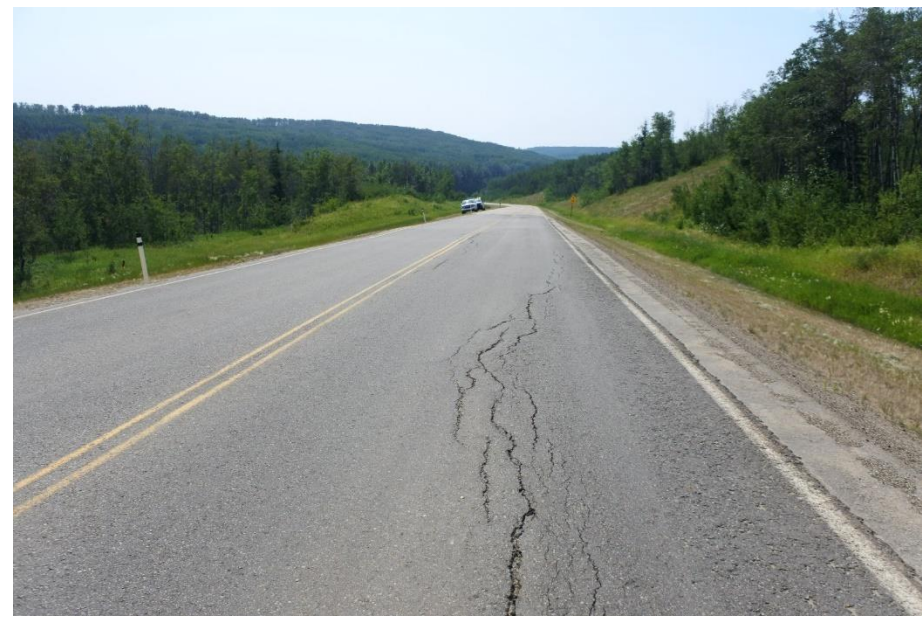
Photo 7.
Looking southwest
(end of the former
south slide).

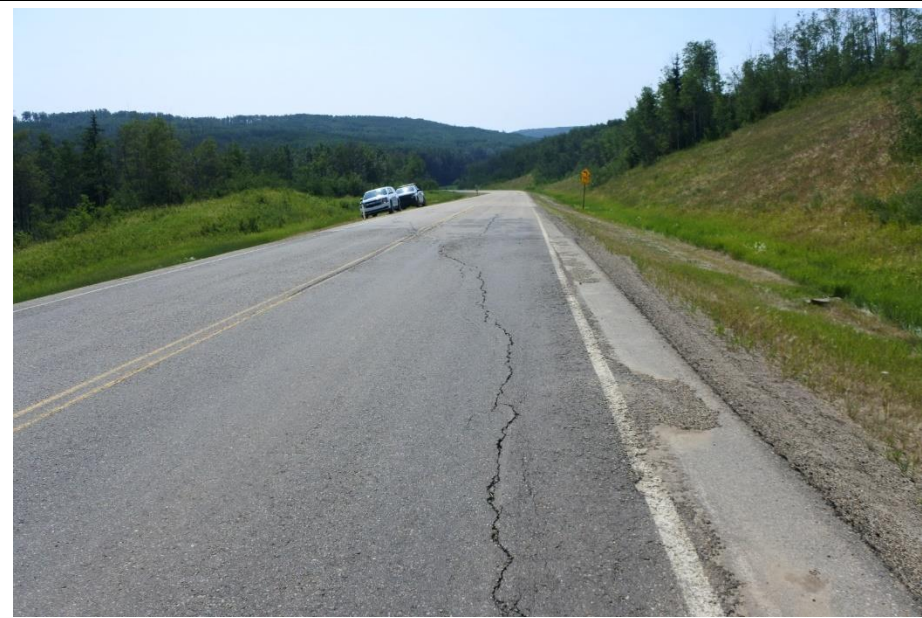
Photo 8.
Looking southwest
(end of the former
south slide).

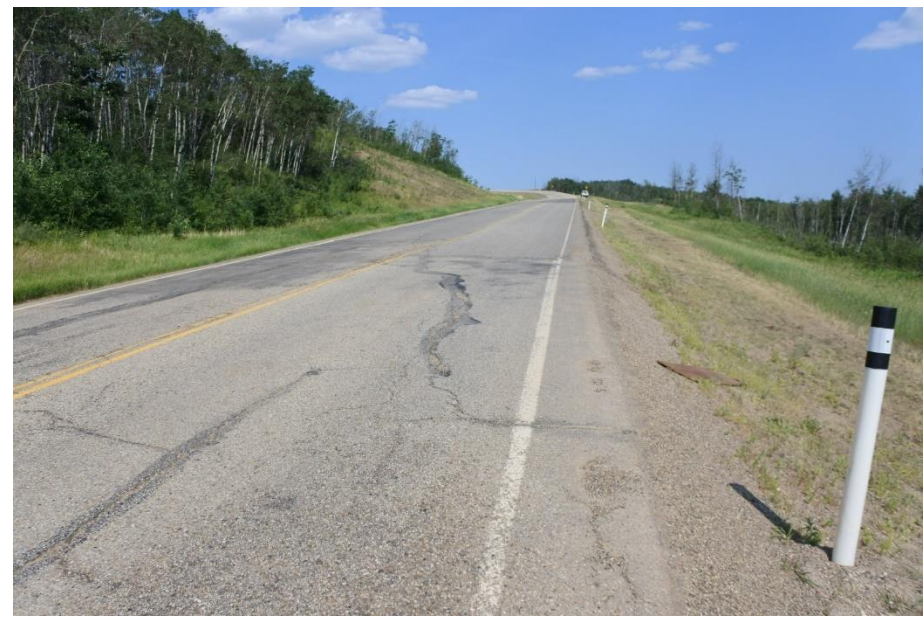
Photo 9.
Looking northeast
near the south end
of the former south
slide.

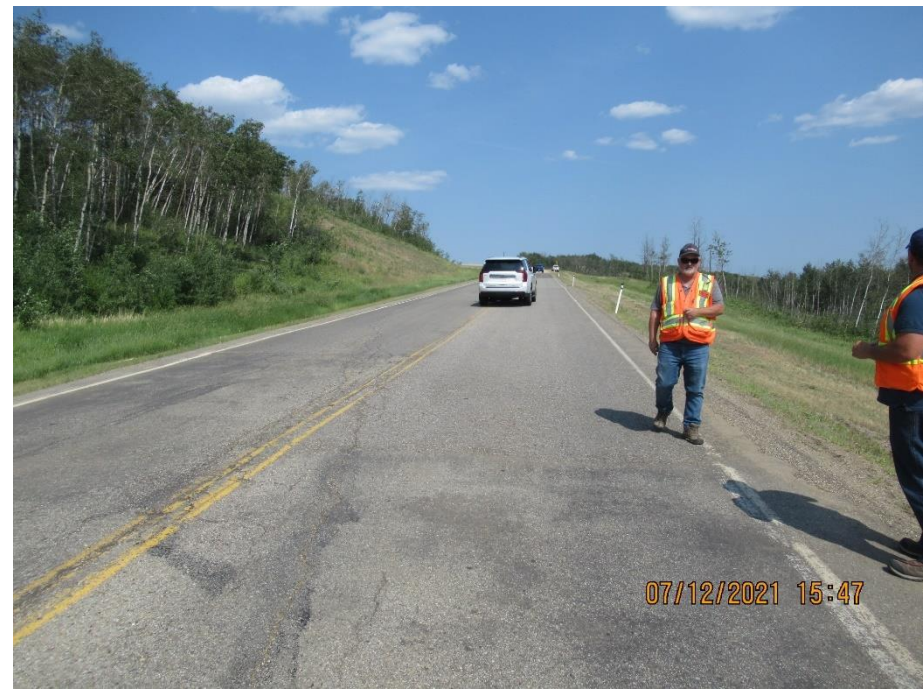
Photo 10.
Looking northeast
near the middle of
the former south
slide.

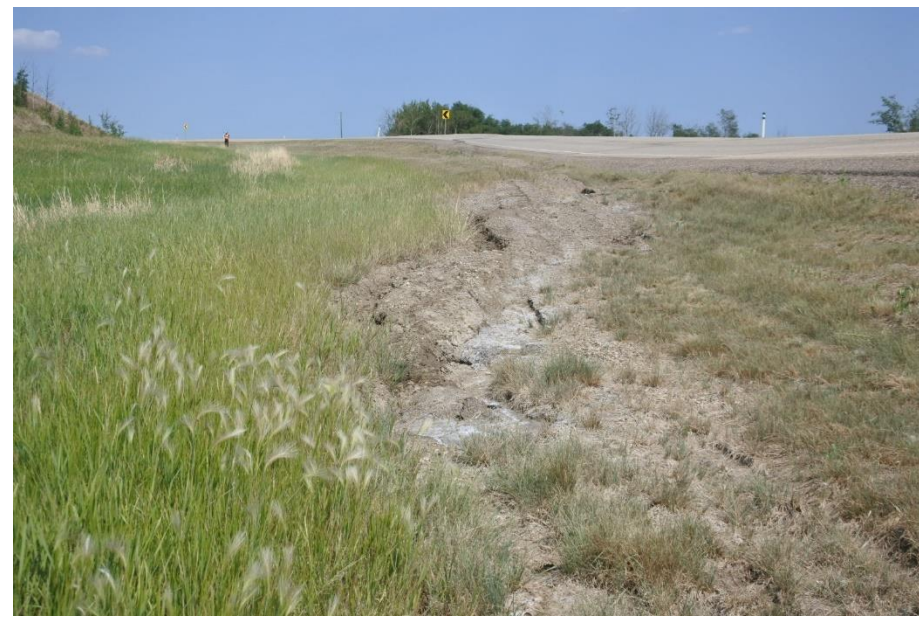
Photo 11.
Looking east at what appears to be the scarp meandering off on the northwest side of the highway

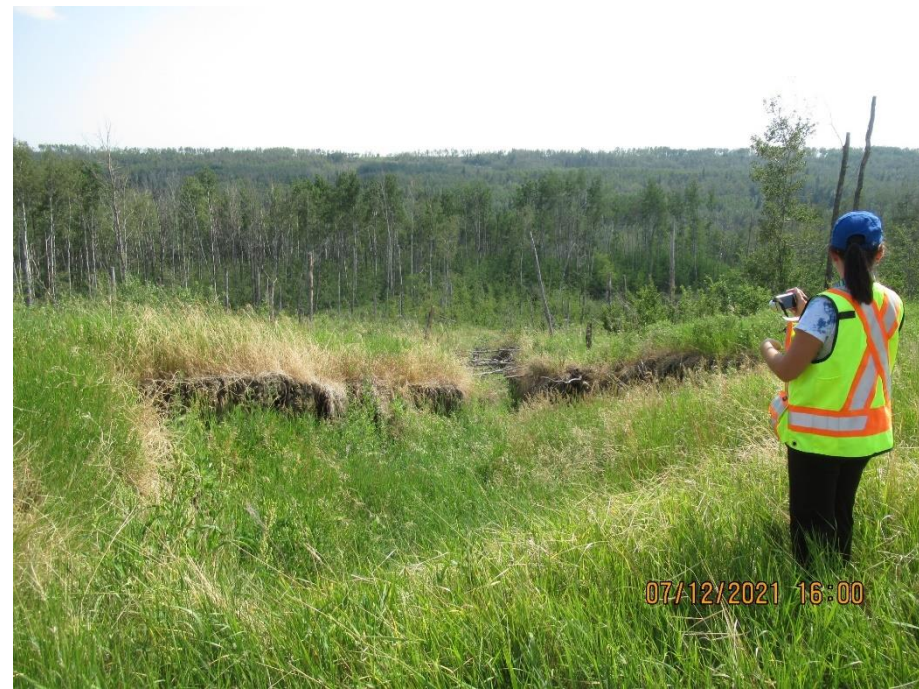
had worsened into an erosion gully in 2020. The gully appeared in similar condition in 2021 and remains 6 m from the culvert outlet.	
<input checked="" type="checkbox"/> Seepage	A gully which channels runoff flow from the farmland to the north to the slide area exists approximately 50 northeast of site. Some ponded water was observed at the base of the gully and seepage was previously observed along the west ditch and in a tension crack in the shoulder; seepage was not present in 2021.	<input checked="" type="checkbox"/>
<input checked="" type="checkbox"/> Bridge/Culvert Distress	The existing centerline culvert (about 500 mm in diameter) appeared to be functioning well at the time of inspection; however, the culvert was partially obstructed by overgrown vegetation at inlet and outlet locations.	<input checked="" type="checkbox"/>
<input type="checkbox"/> Other		<input type="checkbox"/>
Instrumentation:

Photo 12.
Looking south at erosion gully.
