**ALBERTA TRANSPORTATION AND
ECONOMIC CORRIDORS
GEOHAZARD ASSESSMENT PROGRAM
PEACE REGION –GRANDE PRAIRIE DISTRICT - NORTH
2025 INSPECTION REPORT**

Site Number	Location	Name	Hwy	km
GP35	Hwy 733:04	Bad Heart River North	733:04	8.938
Legal Description		UTM Coordinates (NAD 83)		
LSD-1-33-75-3 W6M		E 412,161	N 6,155,446

2025 SITE INSPECTION

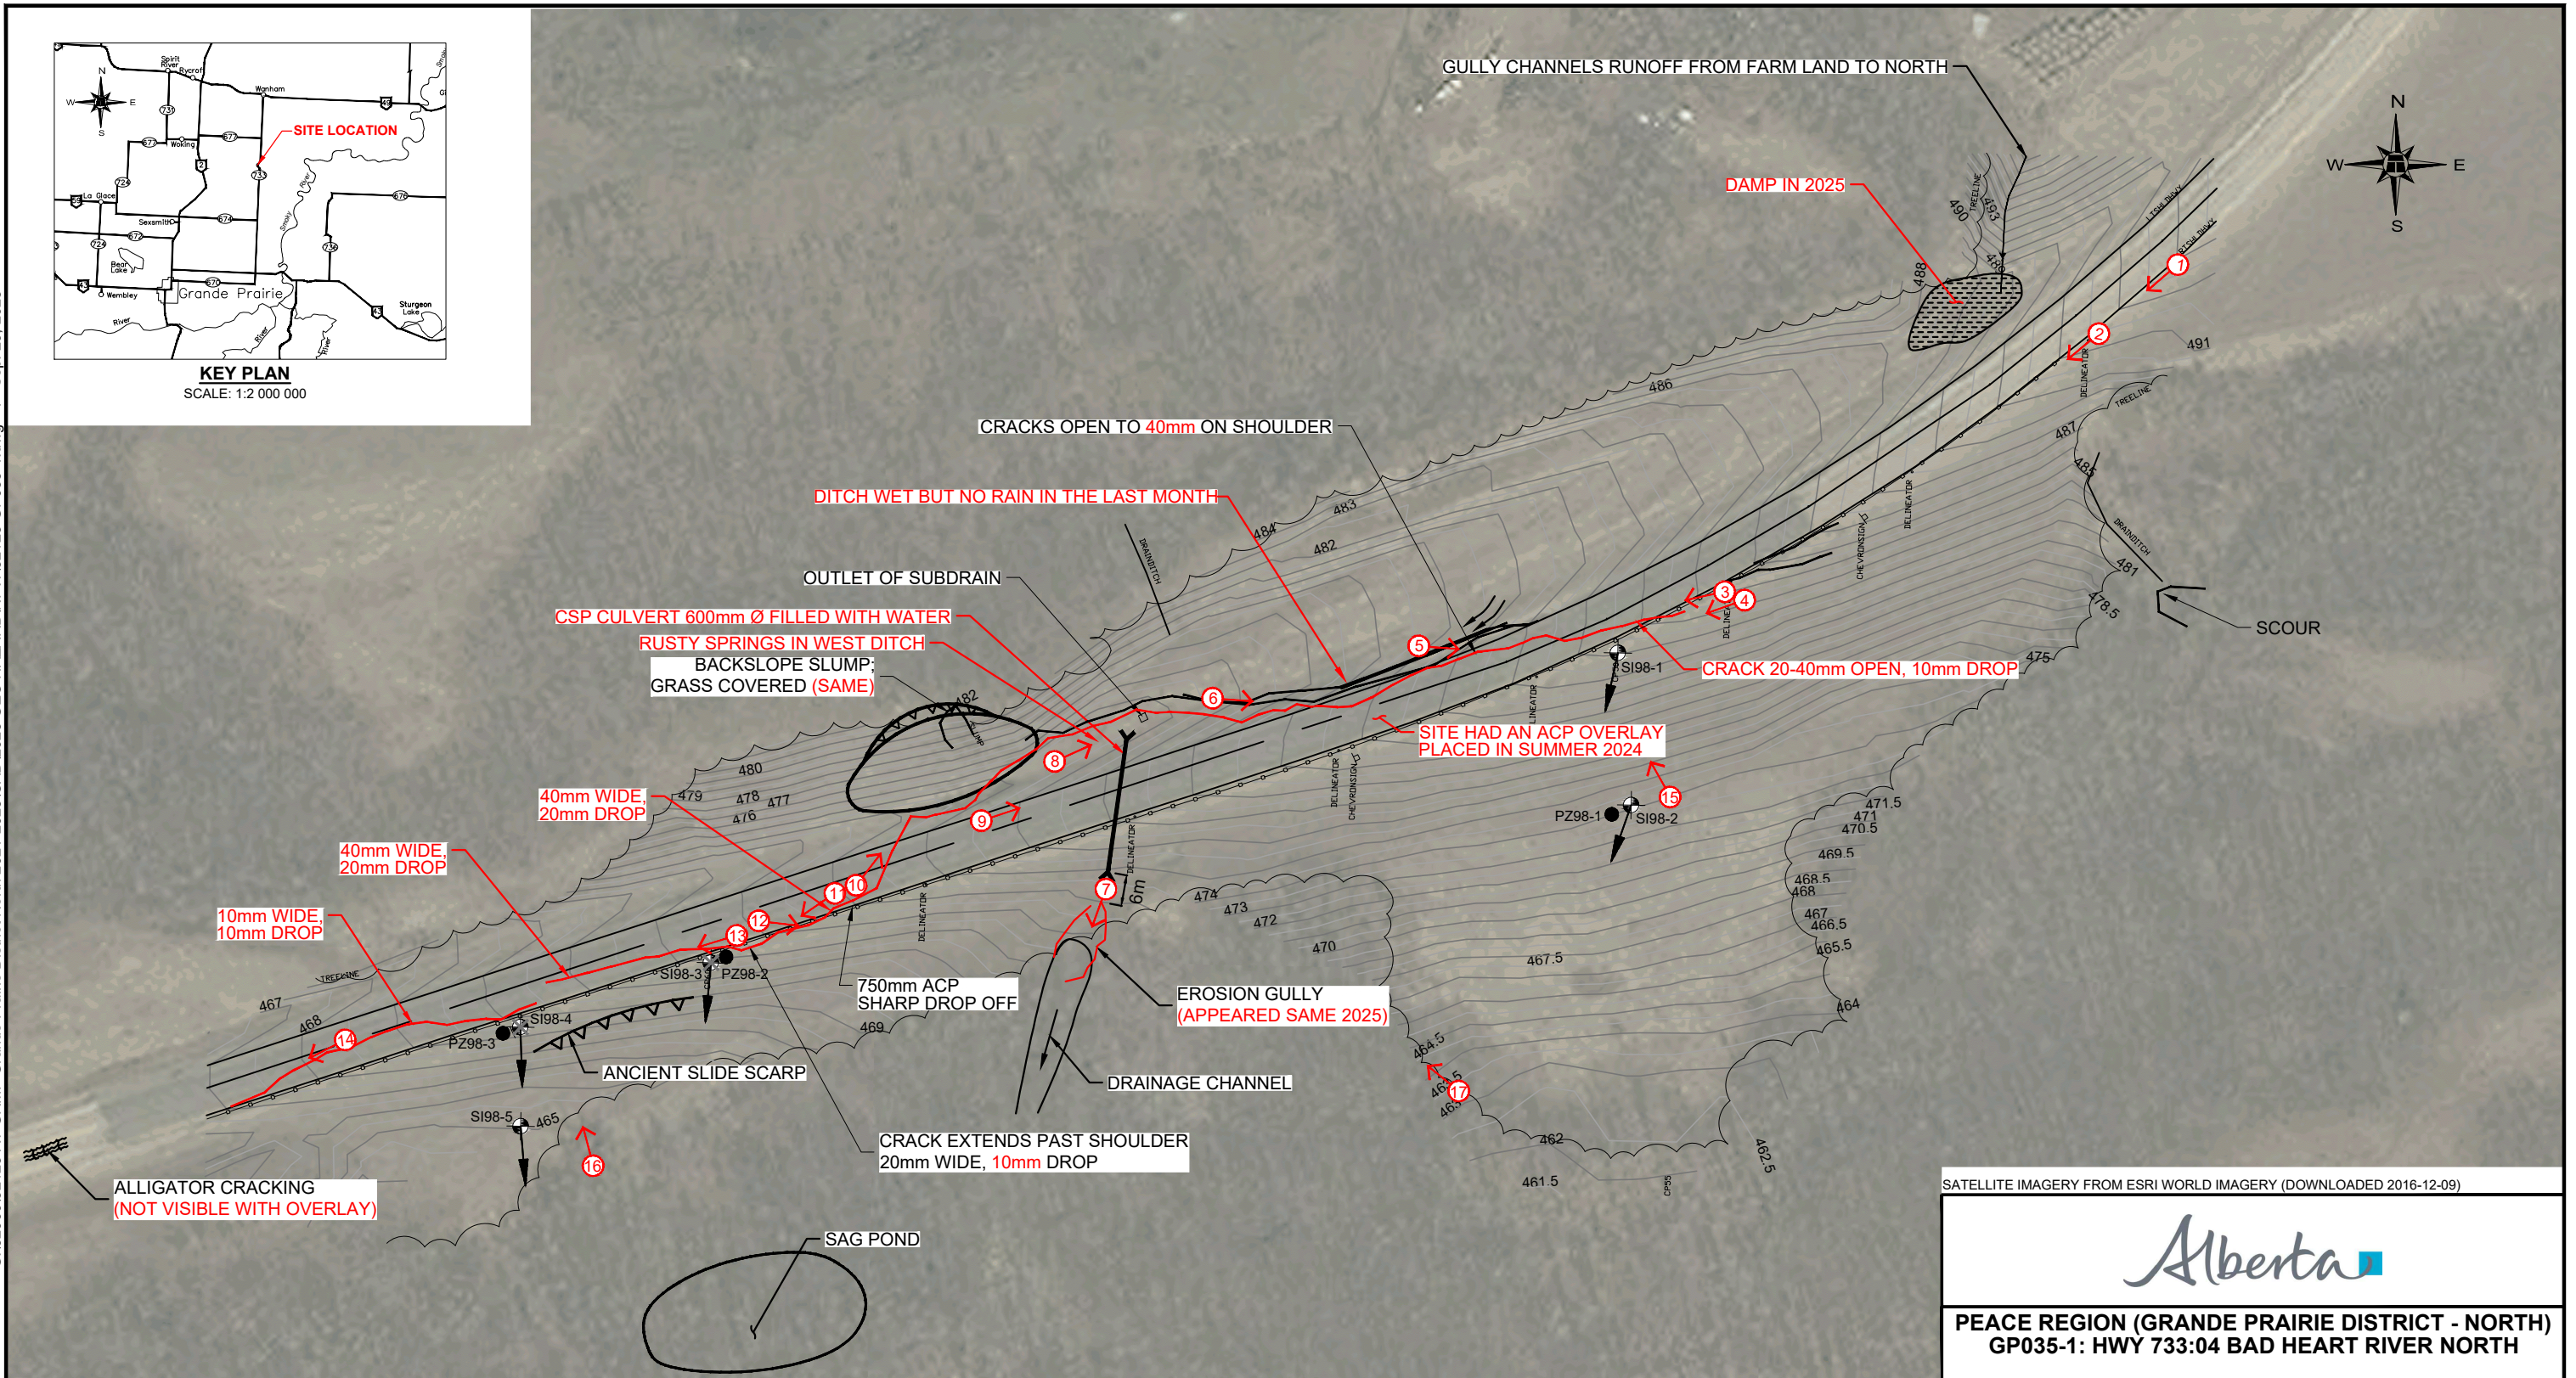
DWG No. 32123-GP035-1

Primary Site Issue:	<p>Sliding movements of Hwy 733:04 along the north valley slope of Bad Heart River Valley. The roadway is located within an active landslide area and previously the site was identified by having an upper slide area and a lower slide area which were active since the early 1980's.</p> <p>Based on the recent observations of ground subsidence and head scarp cracking over the period between 2010 and 2025, it appears that the upper and lower slides have gradually coalesced into one major slide.</p> <p>Slide can be classified as slow movement based on the rate of movement.</p>		
Dimensions:	<p>The upper slide was initially estimated to be about 80 m long and the lower slide was estimated to be about 150 m long along the roadway alignment. The extents along the valley slope for both could not be defined and require further investigation.</p> <p>The upper and lower slides appear to have merged and developed into a large slide about 380 m in length along roadway alignment. There is currently approximately 300 m of roadway showing cracks through the recent overlay.</p>

<p>Recommendations:</p> <p>Short Term : As TEC has been doing over the years, as a short-term mitigation measure, it is recommended that sealing of pavement cracks and patching of roadway be undertaken in the slide impacted area. The differential drops along the backscarp should be milled to improve driving conditions. The site should continue to be monitored to provide a history and trend of potential slide activity.</p> <p>The inlet and outlet areas of the existing 600 mm centreline culvert should be cleared of vegetation and debris to improve its performance. The erosion gully should be monitored for retrogression. The possible tension crack and scour should be backfilled with clay material to minimize the surface water infiltration.</p> <p>The north ditch was wet, with a spring present and may be ponding due to the backscarp pinching the ditch. A subdrain could be installed below the ditch and the ditch re-graded to allow for better subsurface drainage and unimpeded ditch water flow.</p> <p>Longer Term: A mid to long term remediation measure could consist of realigning the highway into the backslope to move it away from the active landslide. Some sideslope flattening could also be completed at that time to unload the active landslide area.</p>		<p>Ballpark Cost</p> <p>Maintenance (currently about \$100,000 every year)</p> <p>\$70,000</p> <p>\$100,000</p>

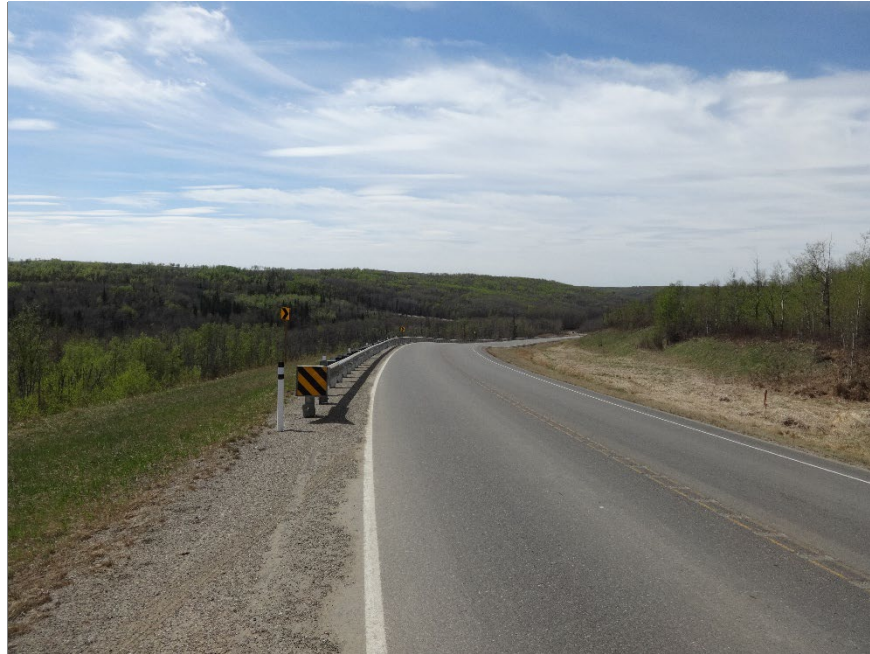
Photo 1. Looking southwest at the east end of the site near the end of the guardrail.

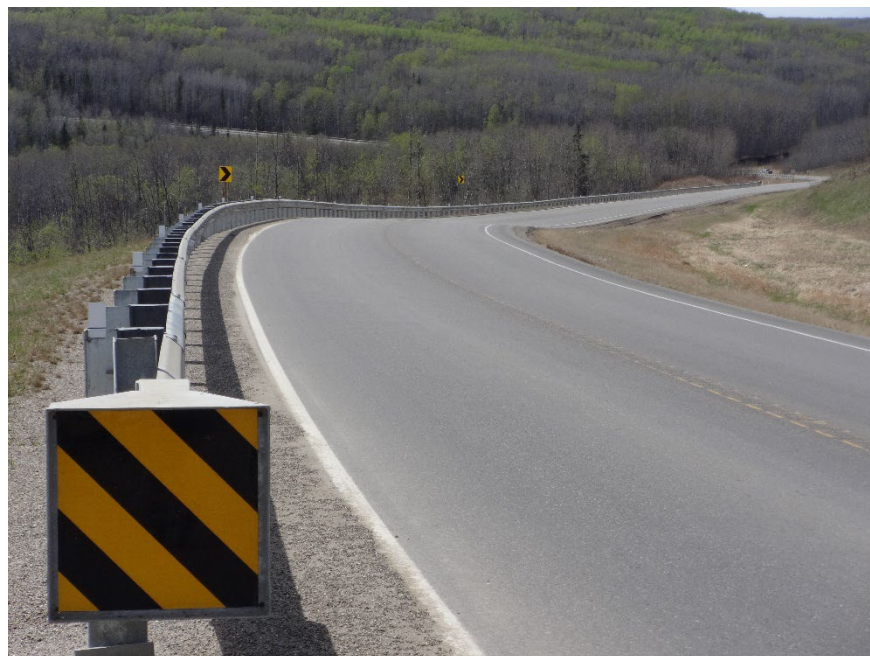
Photo 2. Looking southwest at the end of the guardrail and the undulating road.

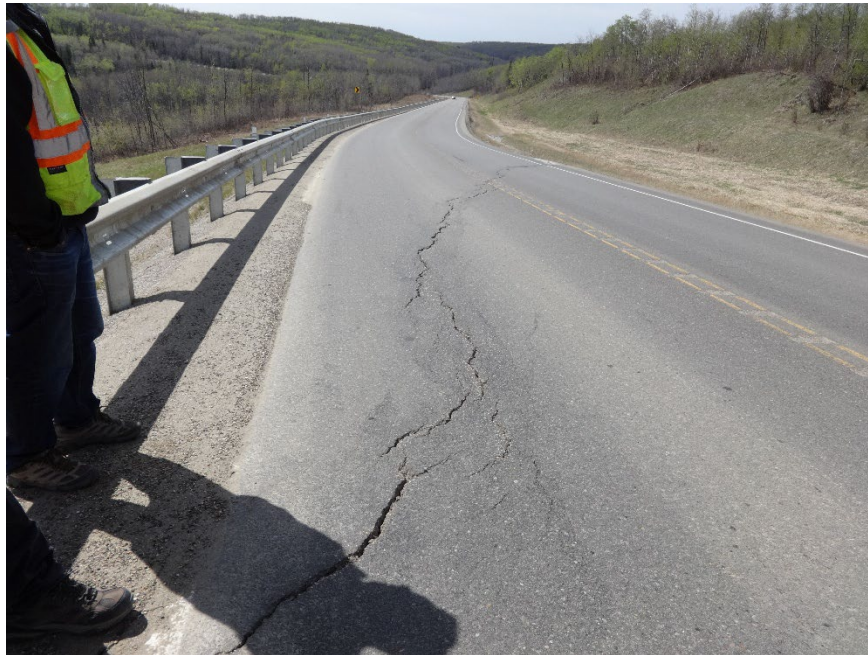
Photo 3. Looking southwest at northmost scarp crack showing through overlay.

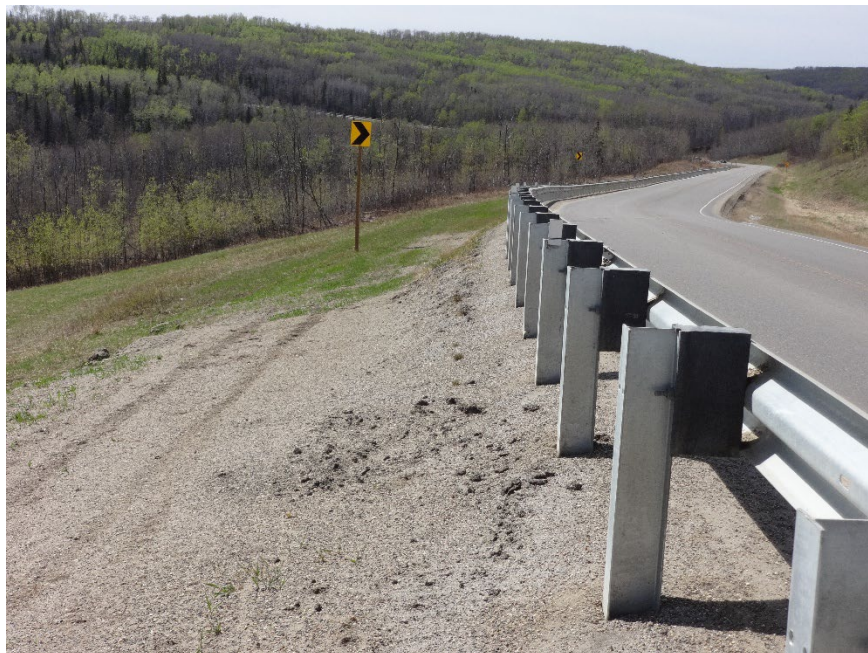
Photo 4. Looking southwest at where gravel had been placed to flatten steep drop off.

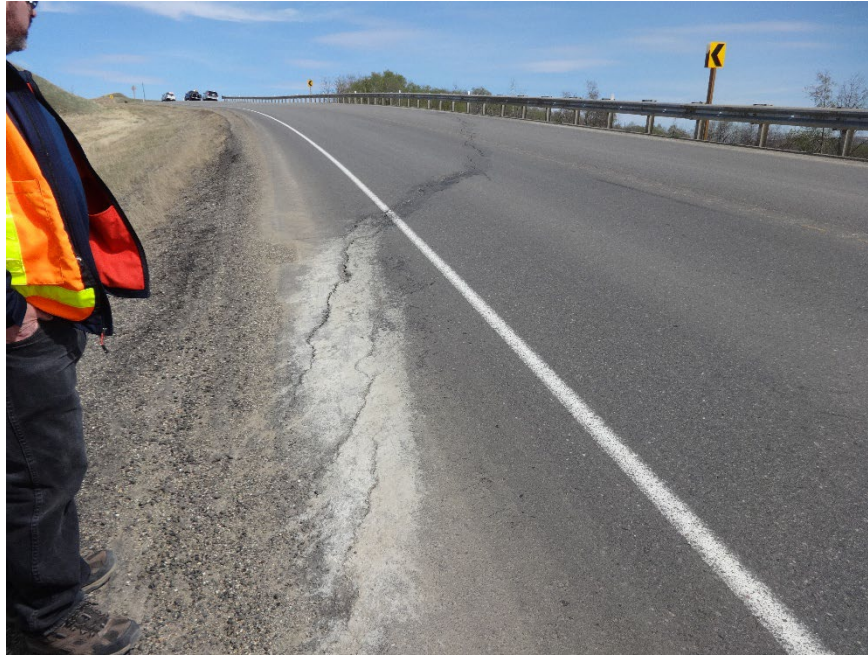
Photo 5. Looking northeast along Hwy 733 at scarp crack

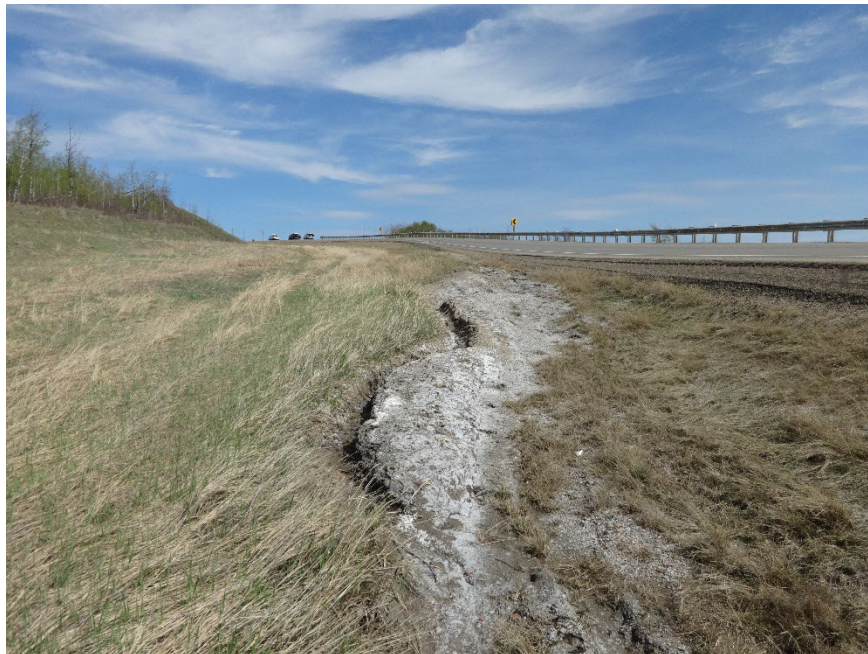
Photo 6. Looking east at scarp crack in the highway ditch with white residue.

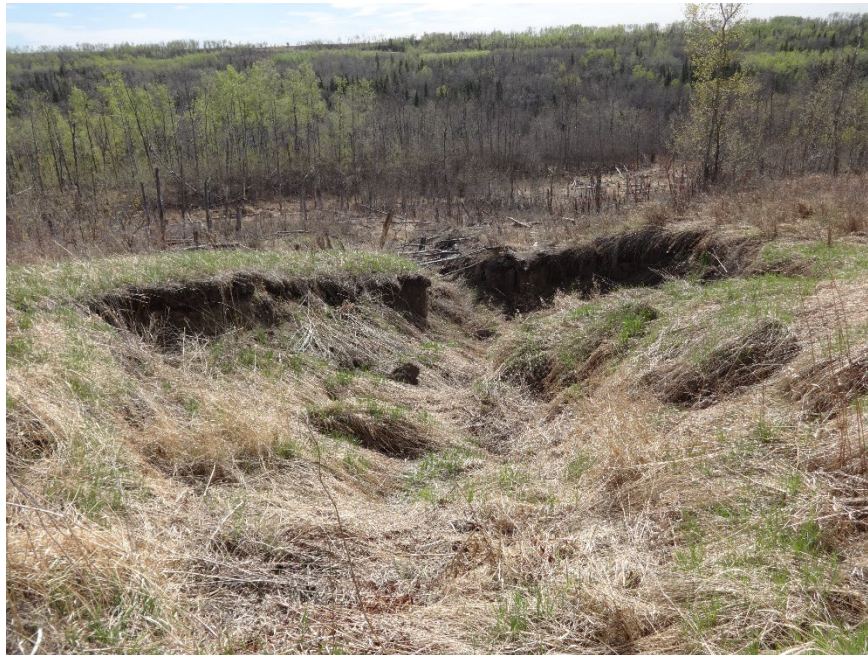
<input checked="" type="checkbox"/> Erosion	A drainage gully was observed just south of the 500 mm diameter CSP culvert during previous inspections and had worsened into an erosion gully in 2020. The gully appeared in similar condition in 2025 and remains 6 m from the culvert outlet.	<input type="checkbox"/>
<input checked="" type="checkbox"/> Seepage	A gully which channels runoff flow from the farmland in the north to the slide area exists approximately 50 northeast of site. Some ponded water was observed at the base of this gully. A spring with rusty water emitting from it was observed in the northwest ditch.	<input checked="" type="checkbox"/>
<input checked="" type="checkbox"/> Bridge/Culvert Distress	The existing centerline culvert (about 600 mm in diameter) appeared to be filled with water at the time of inspection and the culvert was partially obstructed by overgrown vegetation at inlet and outlet locations.	<input checked="" type="checkbox"/>

Photo 7. Looking south at erosion gully.

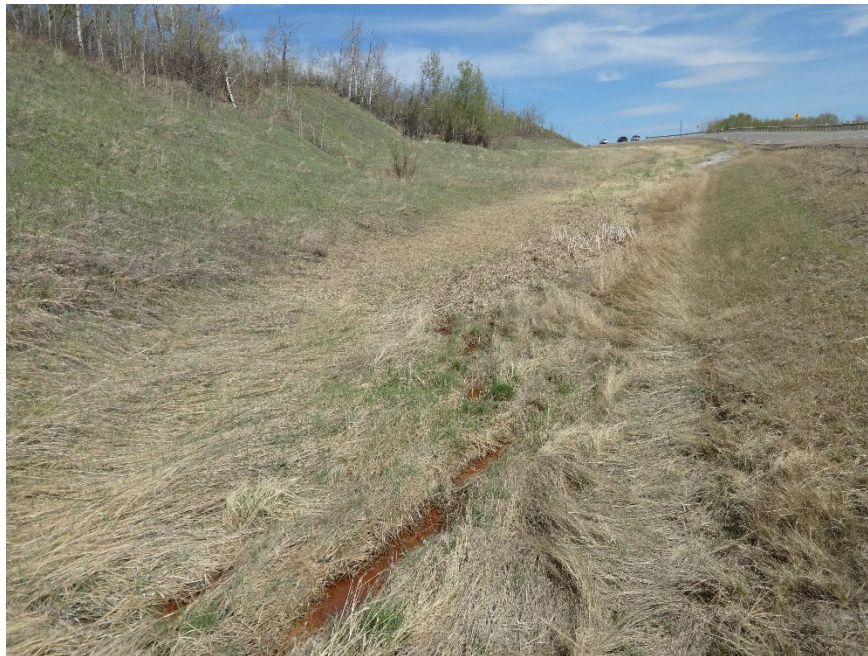
Photo 8. Looking east at rusty coloured water in ditch

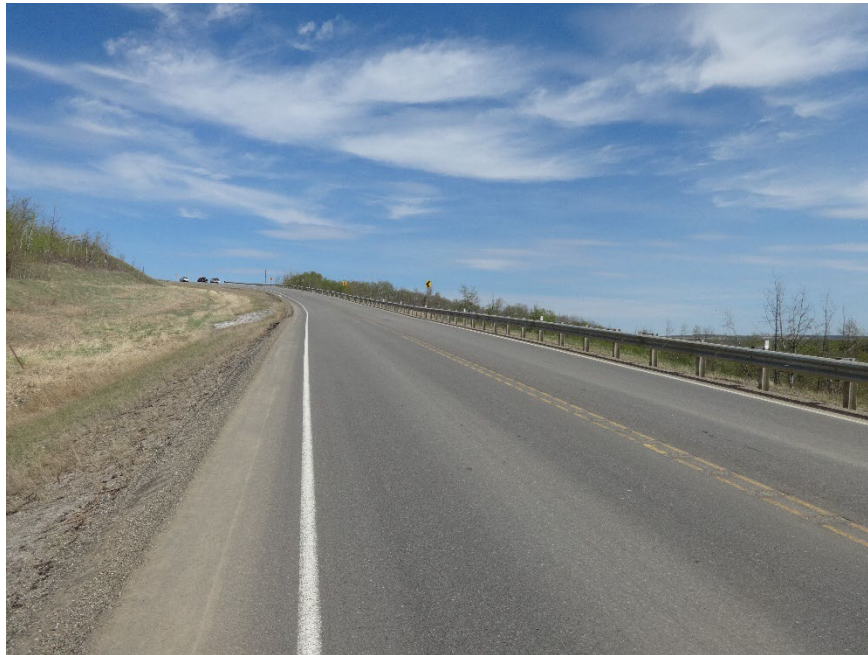
Photo 9. Looking northeast near the middle of the landslide

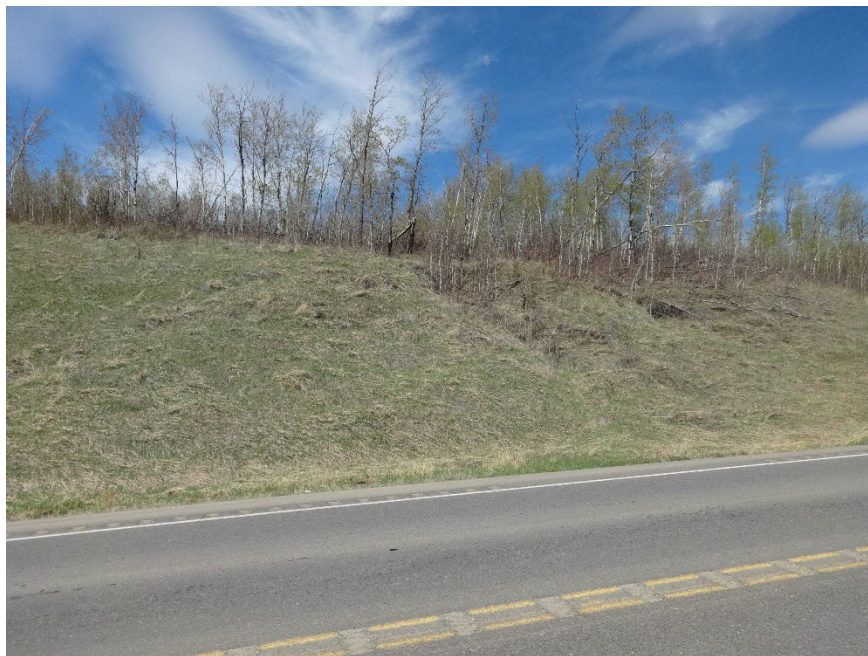
Photo 10. Looking north at old backslope slump

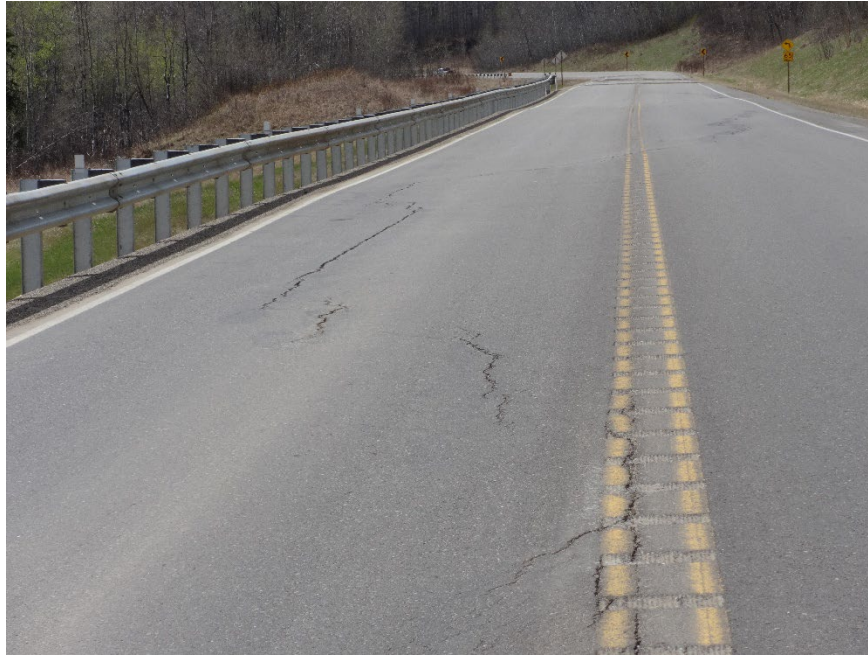
Photo 11. Looking southwest at scarp crack showing through overlay

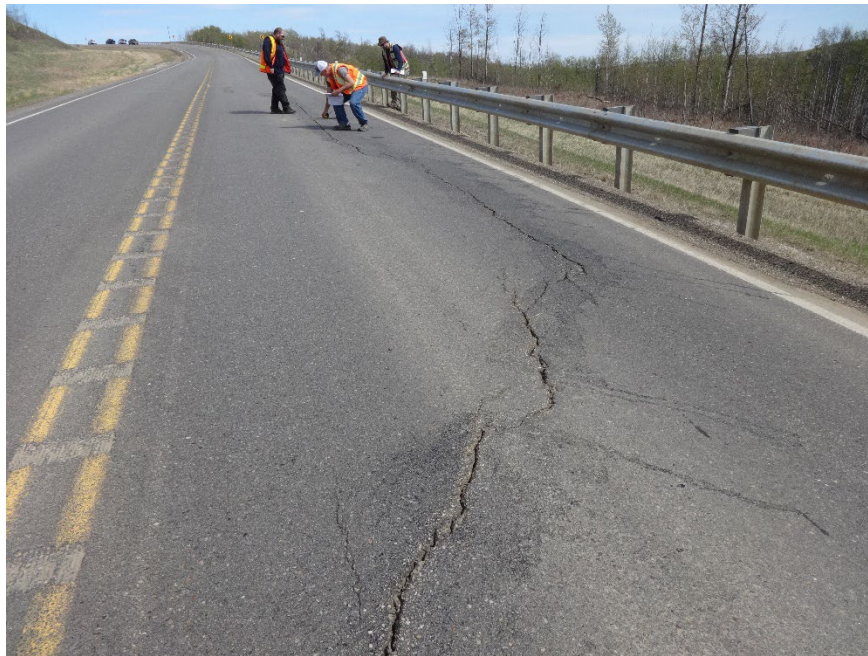
Photo 12. Looking east at scarp crack that was 40 mm wide and had a 20 mm drop.

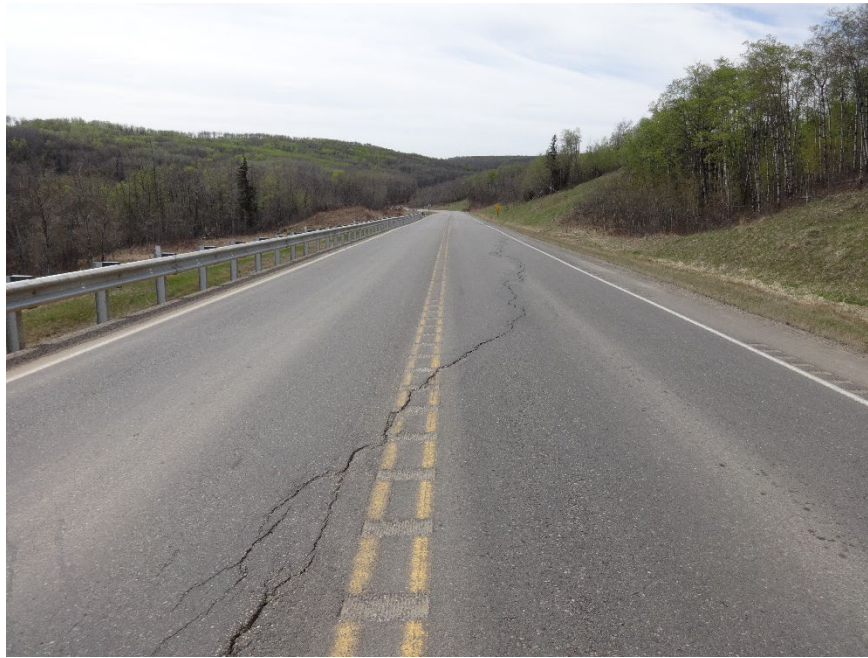
Photo 13. Looking southwest at scarp crack near the westmost part of the site.

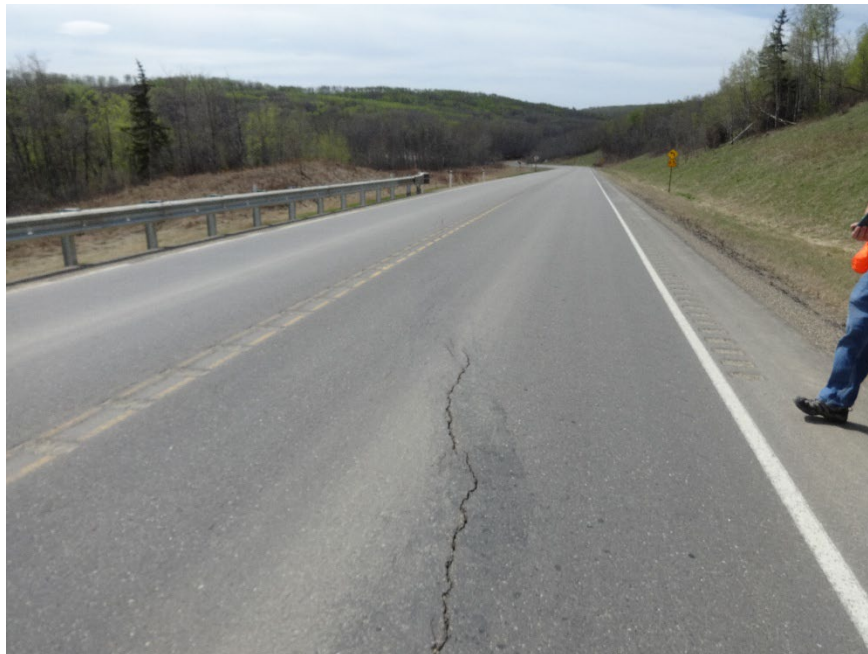
Photo 14. Looking southwest at scarp at the west extent of the site.

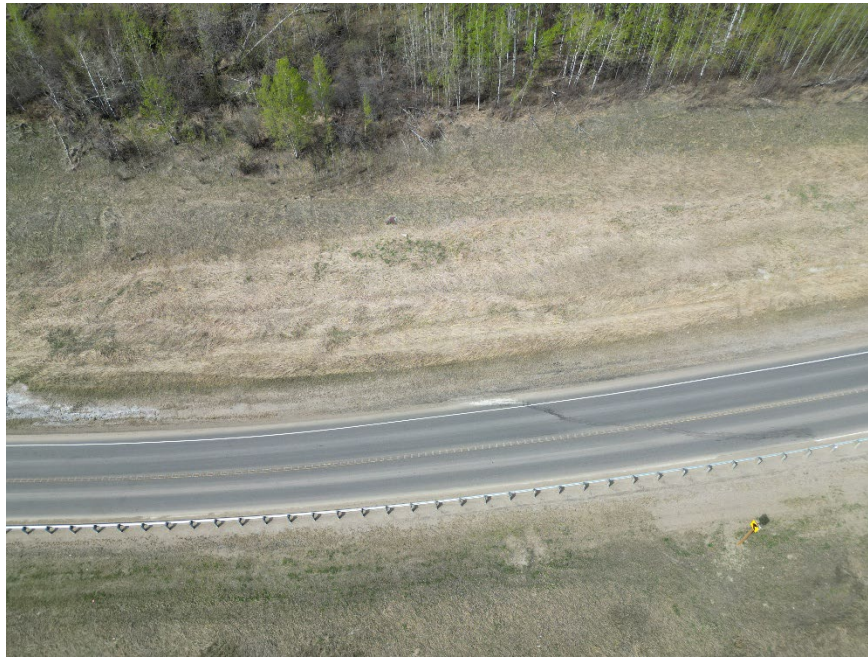
Photo 15. Drone looking northwest at the scarp crack at the northeast extent.

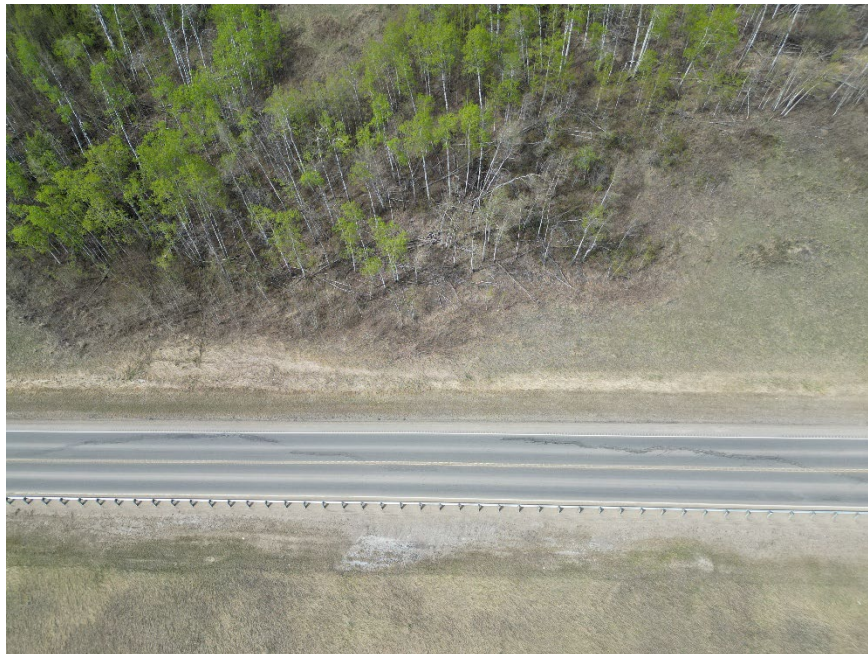
Photo 16. Drone looking north at the scarp crack near the west part of the site.

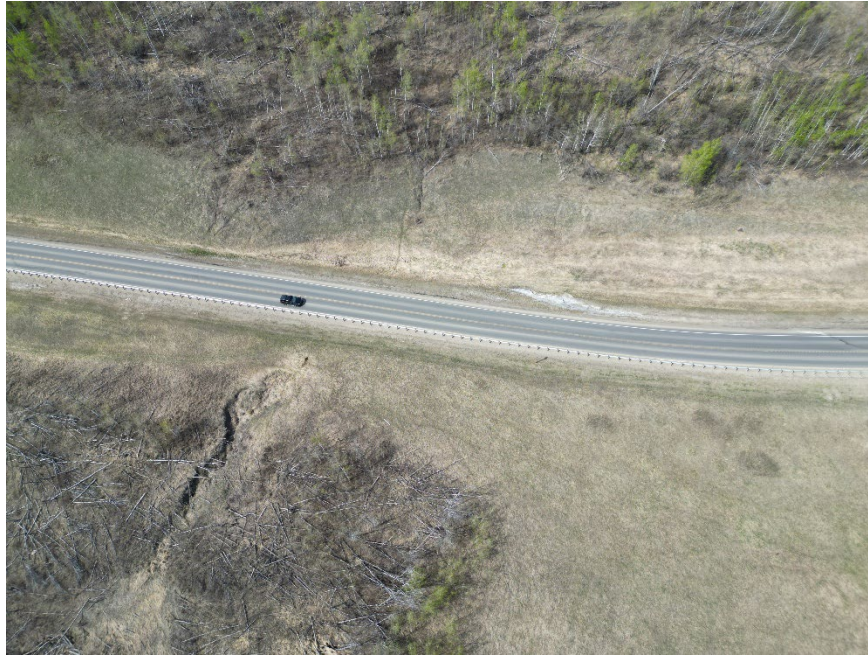
Photo 17. Drone looking northwest at the site and the erosion gully.
