**PEACE REGION (GRANDE PRAIRIE)
 GP031 HWY 740:02 SHAFTESBURY SLIDE**

2020 INSPECTION PLAN

**ALBERTA TRANSPORTATION
GEOHAZARD ASSESSMENT PROGRAM
PEACE REGION – GRANDE PRAIRIE DISTRICT
2020 INSPECTION**

Site Number	Location	Name	Hwy	km
GP031	South slope of the Peace River Valley near the Shaftesbury ferry crossing	Shaftesbury Slide, South Site	740:02	49.3
Legal Description		UTM Co-ordinates (NAD 83)		
LSD 4-9-82-23-W5M		11U N 6 216 300	E 466 120

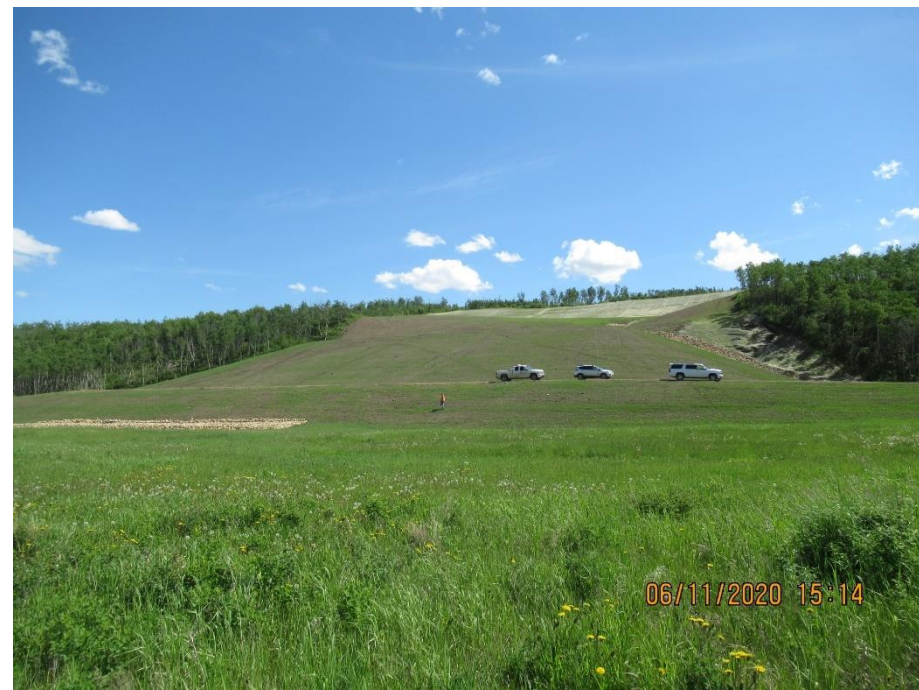
Photo 1.
Looking south at the repaired landslide area from the terrace level.

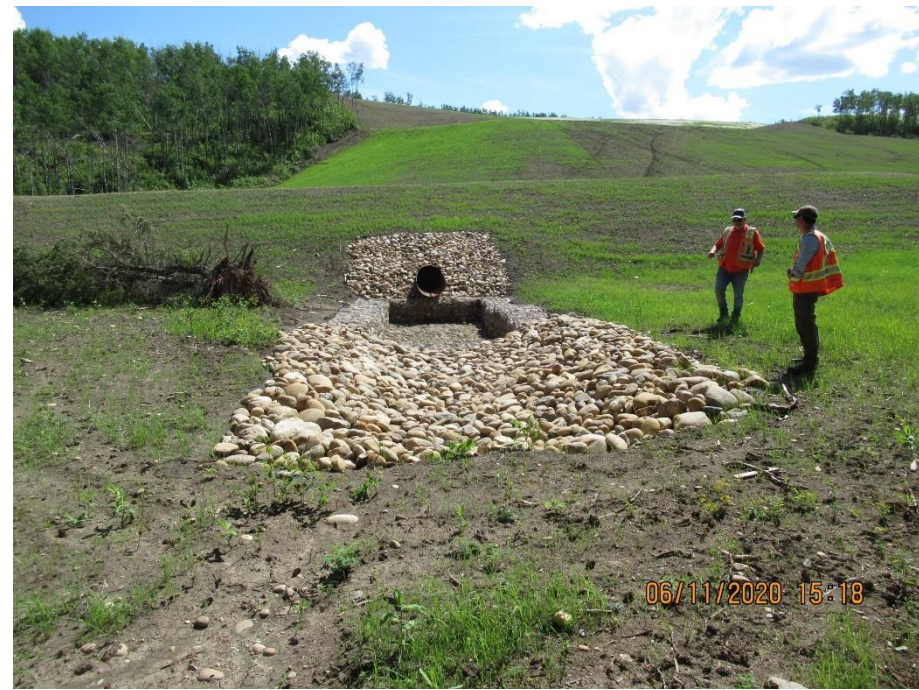
Photo 2.
Outfall for SWSP drop pipe performing well to date.

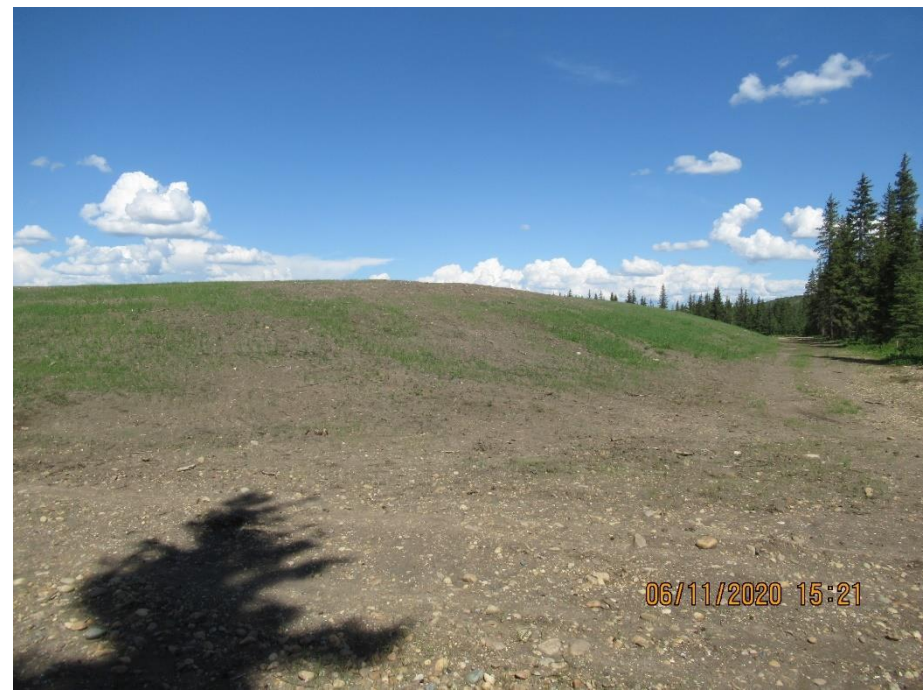
Photo 3.
Grass starting to catch on excess soil stockpile area.

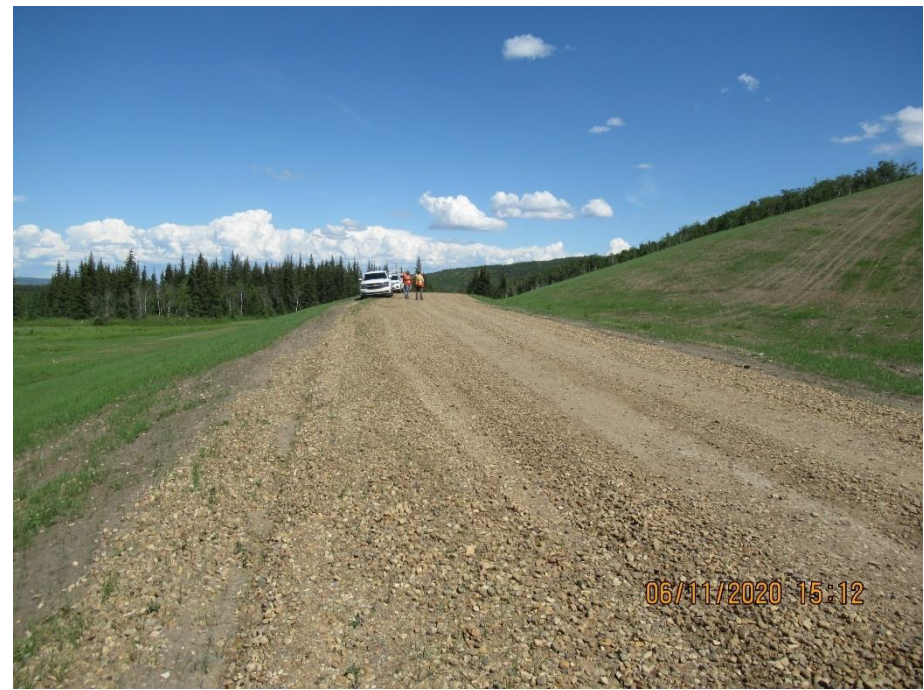
Photo 4.
County road aligned over top of berm and finished with gravel surfacing.

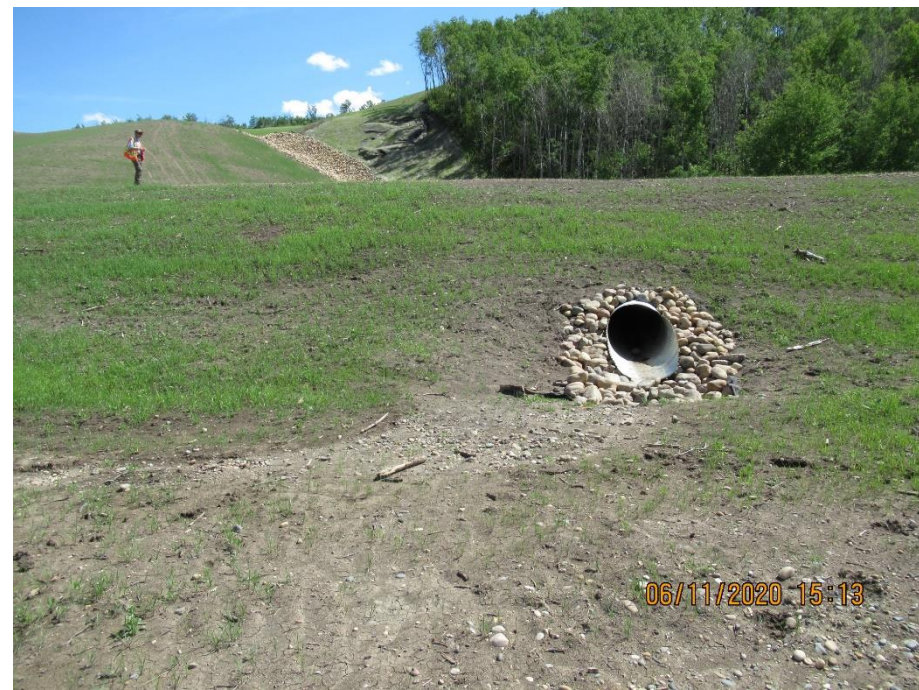
Photo 5.
Outlet of culvert
draining end of West
Riprap Channel.

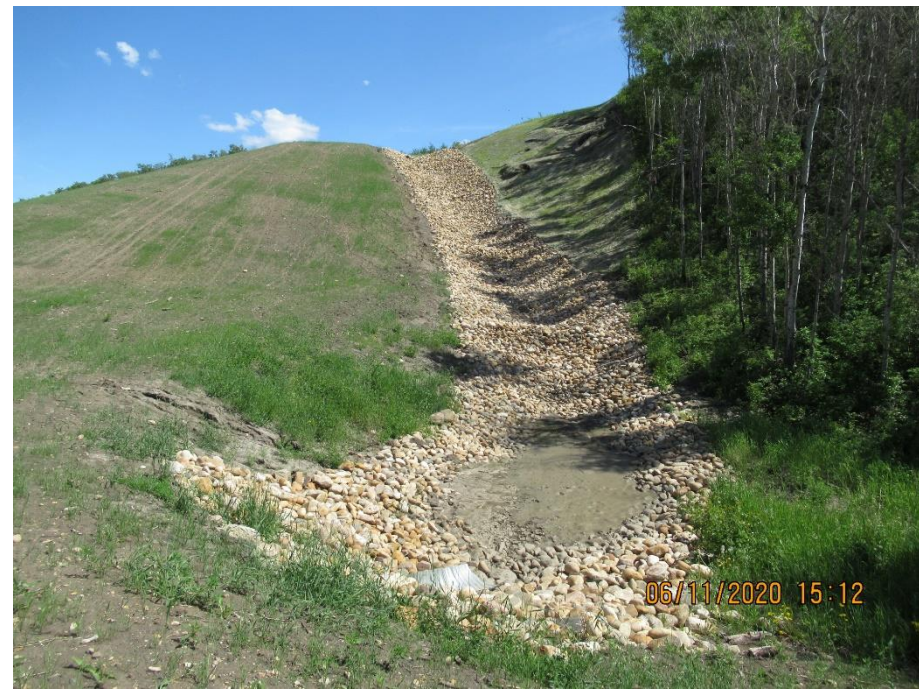
The slump located above the west riprap channel is likely located in weak native material that had been pre-sheared during landslide events prior to construction. This should be repaired soon before it grows in size.

Photo 6.
West Riprap
Channel. A small
slump has formed in
the cut slope above
the curve of the
channel

The local slump above the west riprap channel should be excavated and replaced with free draining gravel.

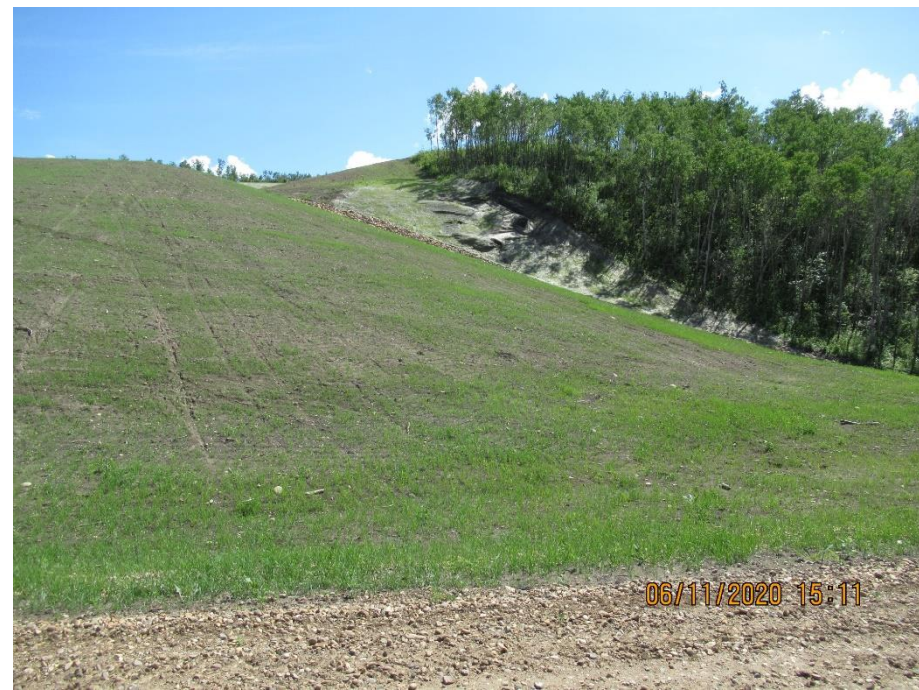
Photo 7.
View of slump above channel.

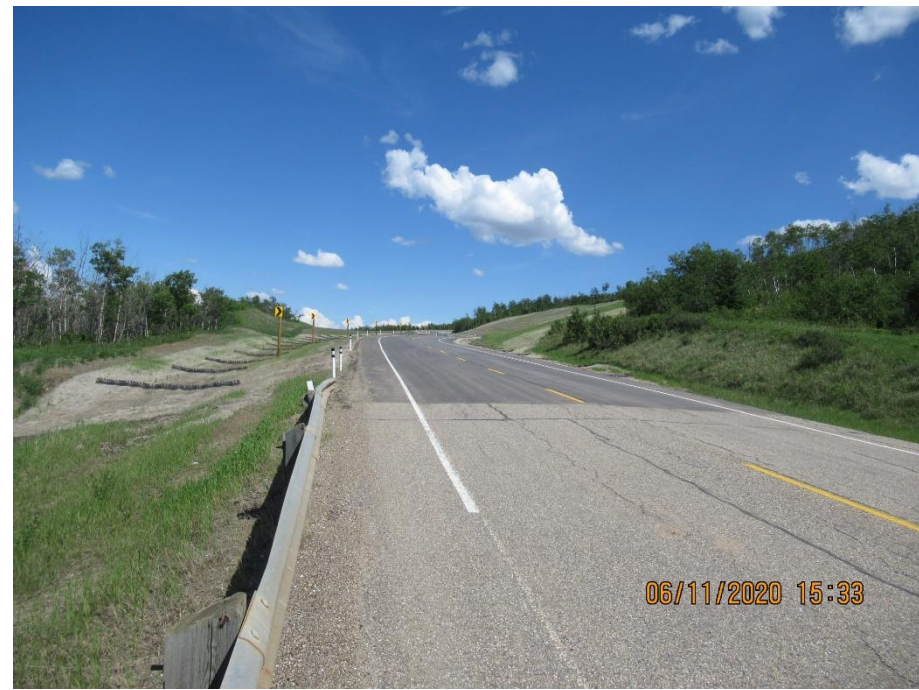
Photo 8.
Looking east along Hwy 740 at repaired slide site.

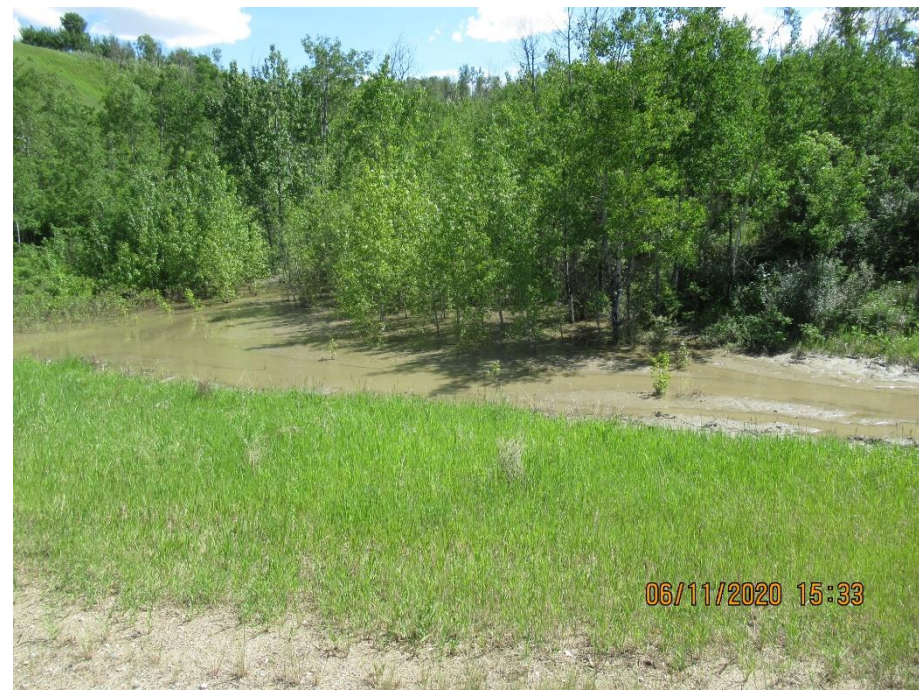
Photo 9.
Silty runoff
accumulating in low
area south of
highway. Not related
to the landslide
repairs.

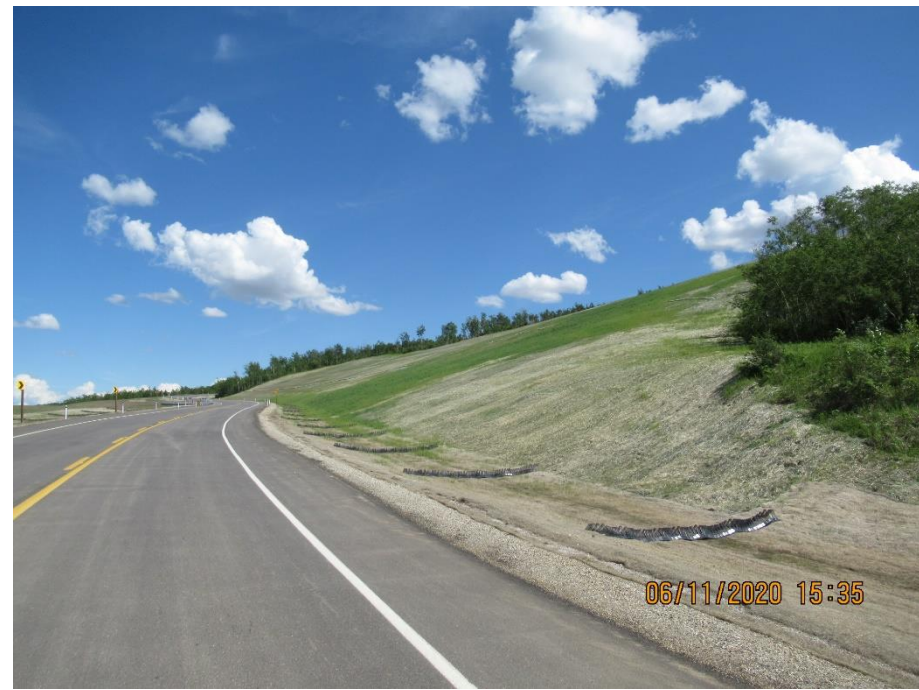
Photo 10.
Looking east at new
highway realignment.

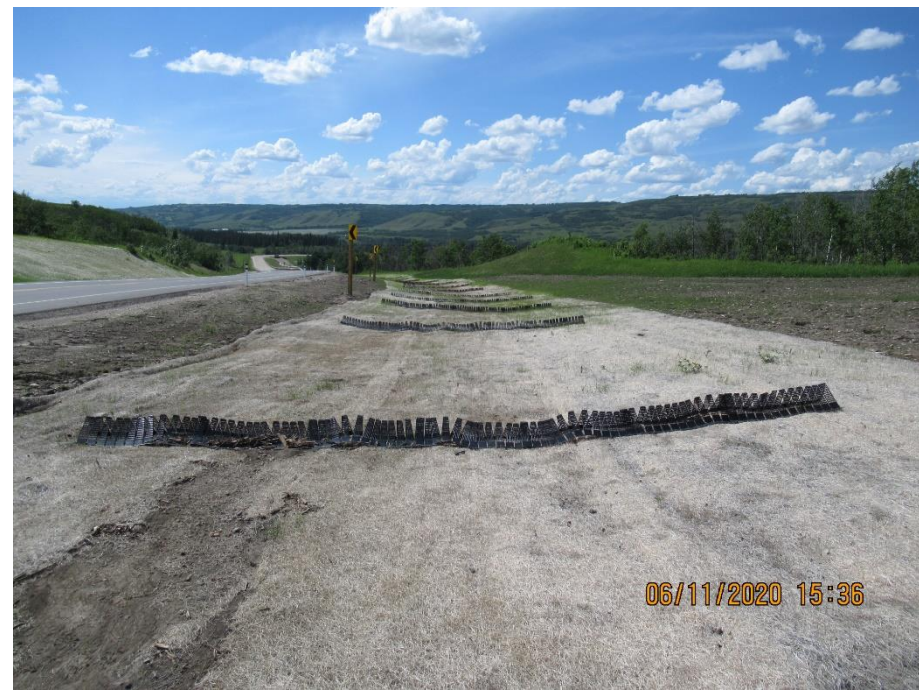
Photo 11.
Southwest ditch,
looking west.

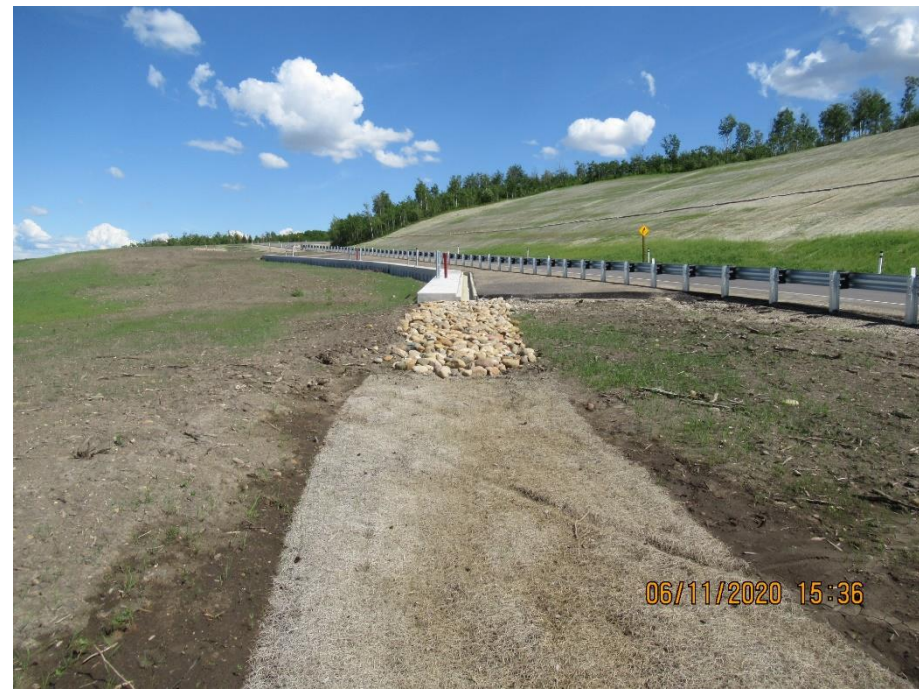
Photo 12.
Looking east at pile
wall.

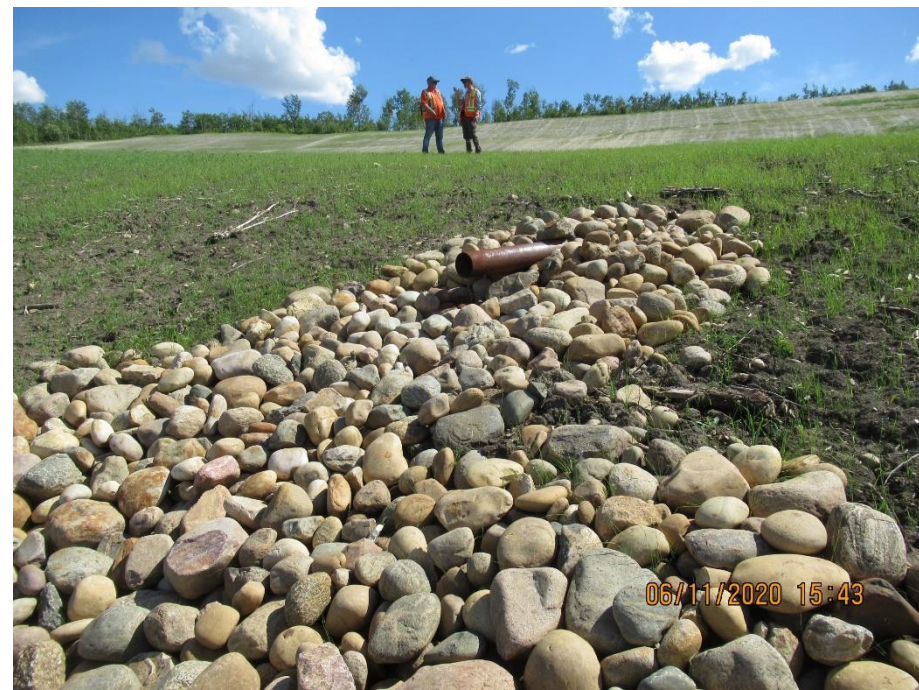
Photo 13.
Drain outlet dripping water.

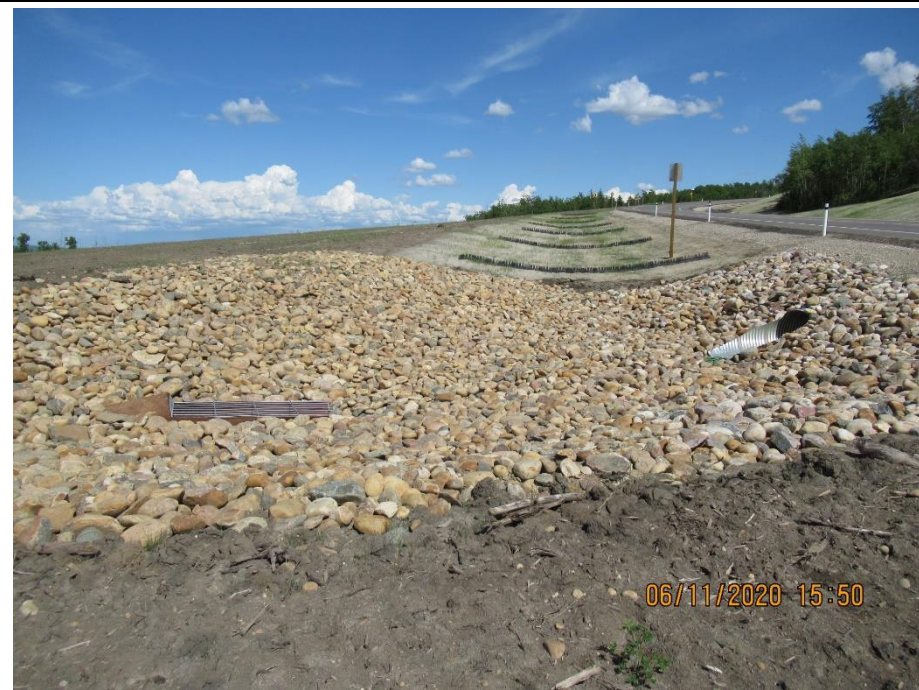
Photo 14.
Looking east toward inlet of drop pipe and outlet of centreline pipe.

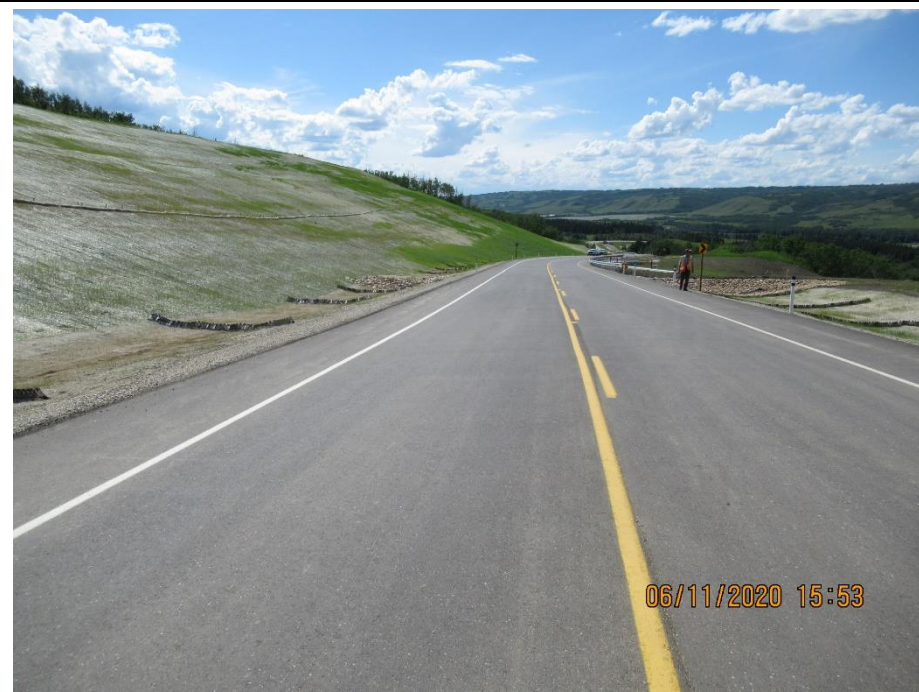
Photo 15.
Looking west at
realigned highway and
backslope.

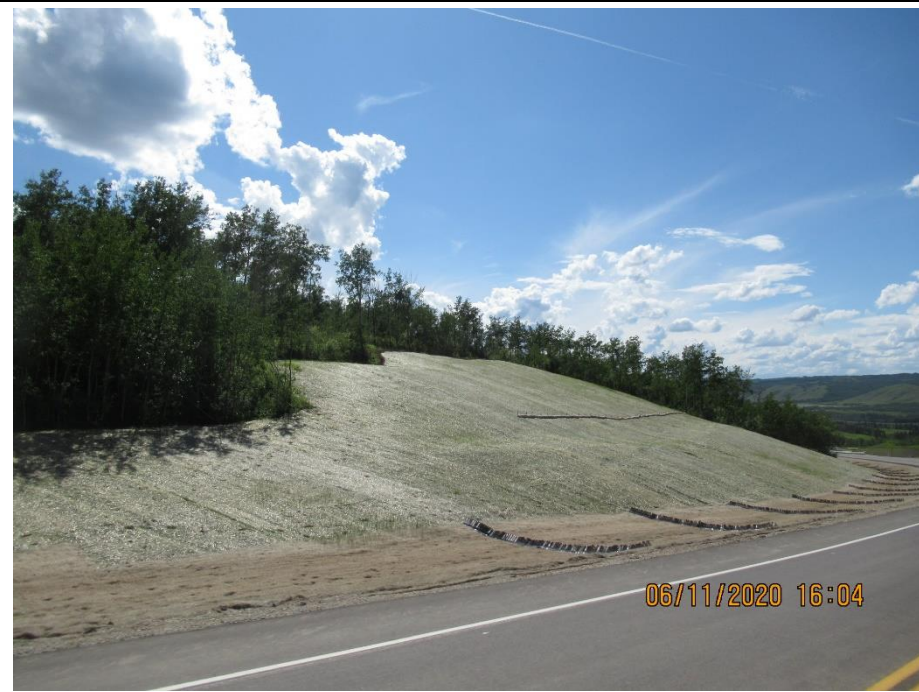
Photo 16.
Looking southwest at
realigned backslope.
