**ALBERTA TRANSPORTATION
GEOHAZARD ASSESSMENT PROGRAM
PEACE REGION – GRANDE PRAIRIE DISTRICT-NORTH
2021 INSPECTION**

Site Number	Location	Name	Hwy	km
GP031	South slope of the Peace River Valley near the Shaftesbury ferry crossing	Shaftesbury Slide, South Site	740:02	49.3
Legal Description		UTM Co-ordinates (NAD 83)		
LSD 4-9-82-23-W5M		11U N 6 216 300	E 466 120

**PEACE REGION (GRANDE PRAIRIE DISTRICT - NORTH)
GP031 HWY 740:02 SHAFTESBURY SLIDE**

2021 INSPECTION PLAN

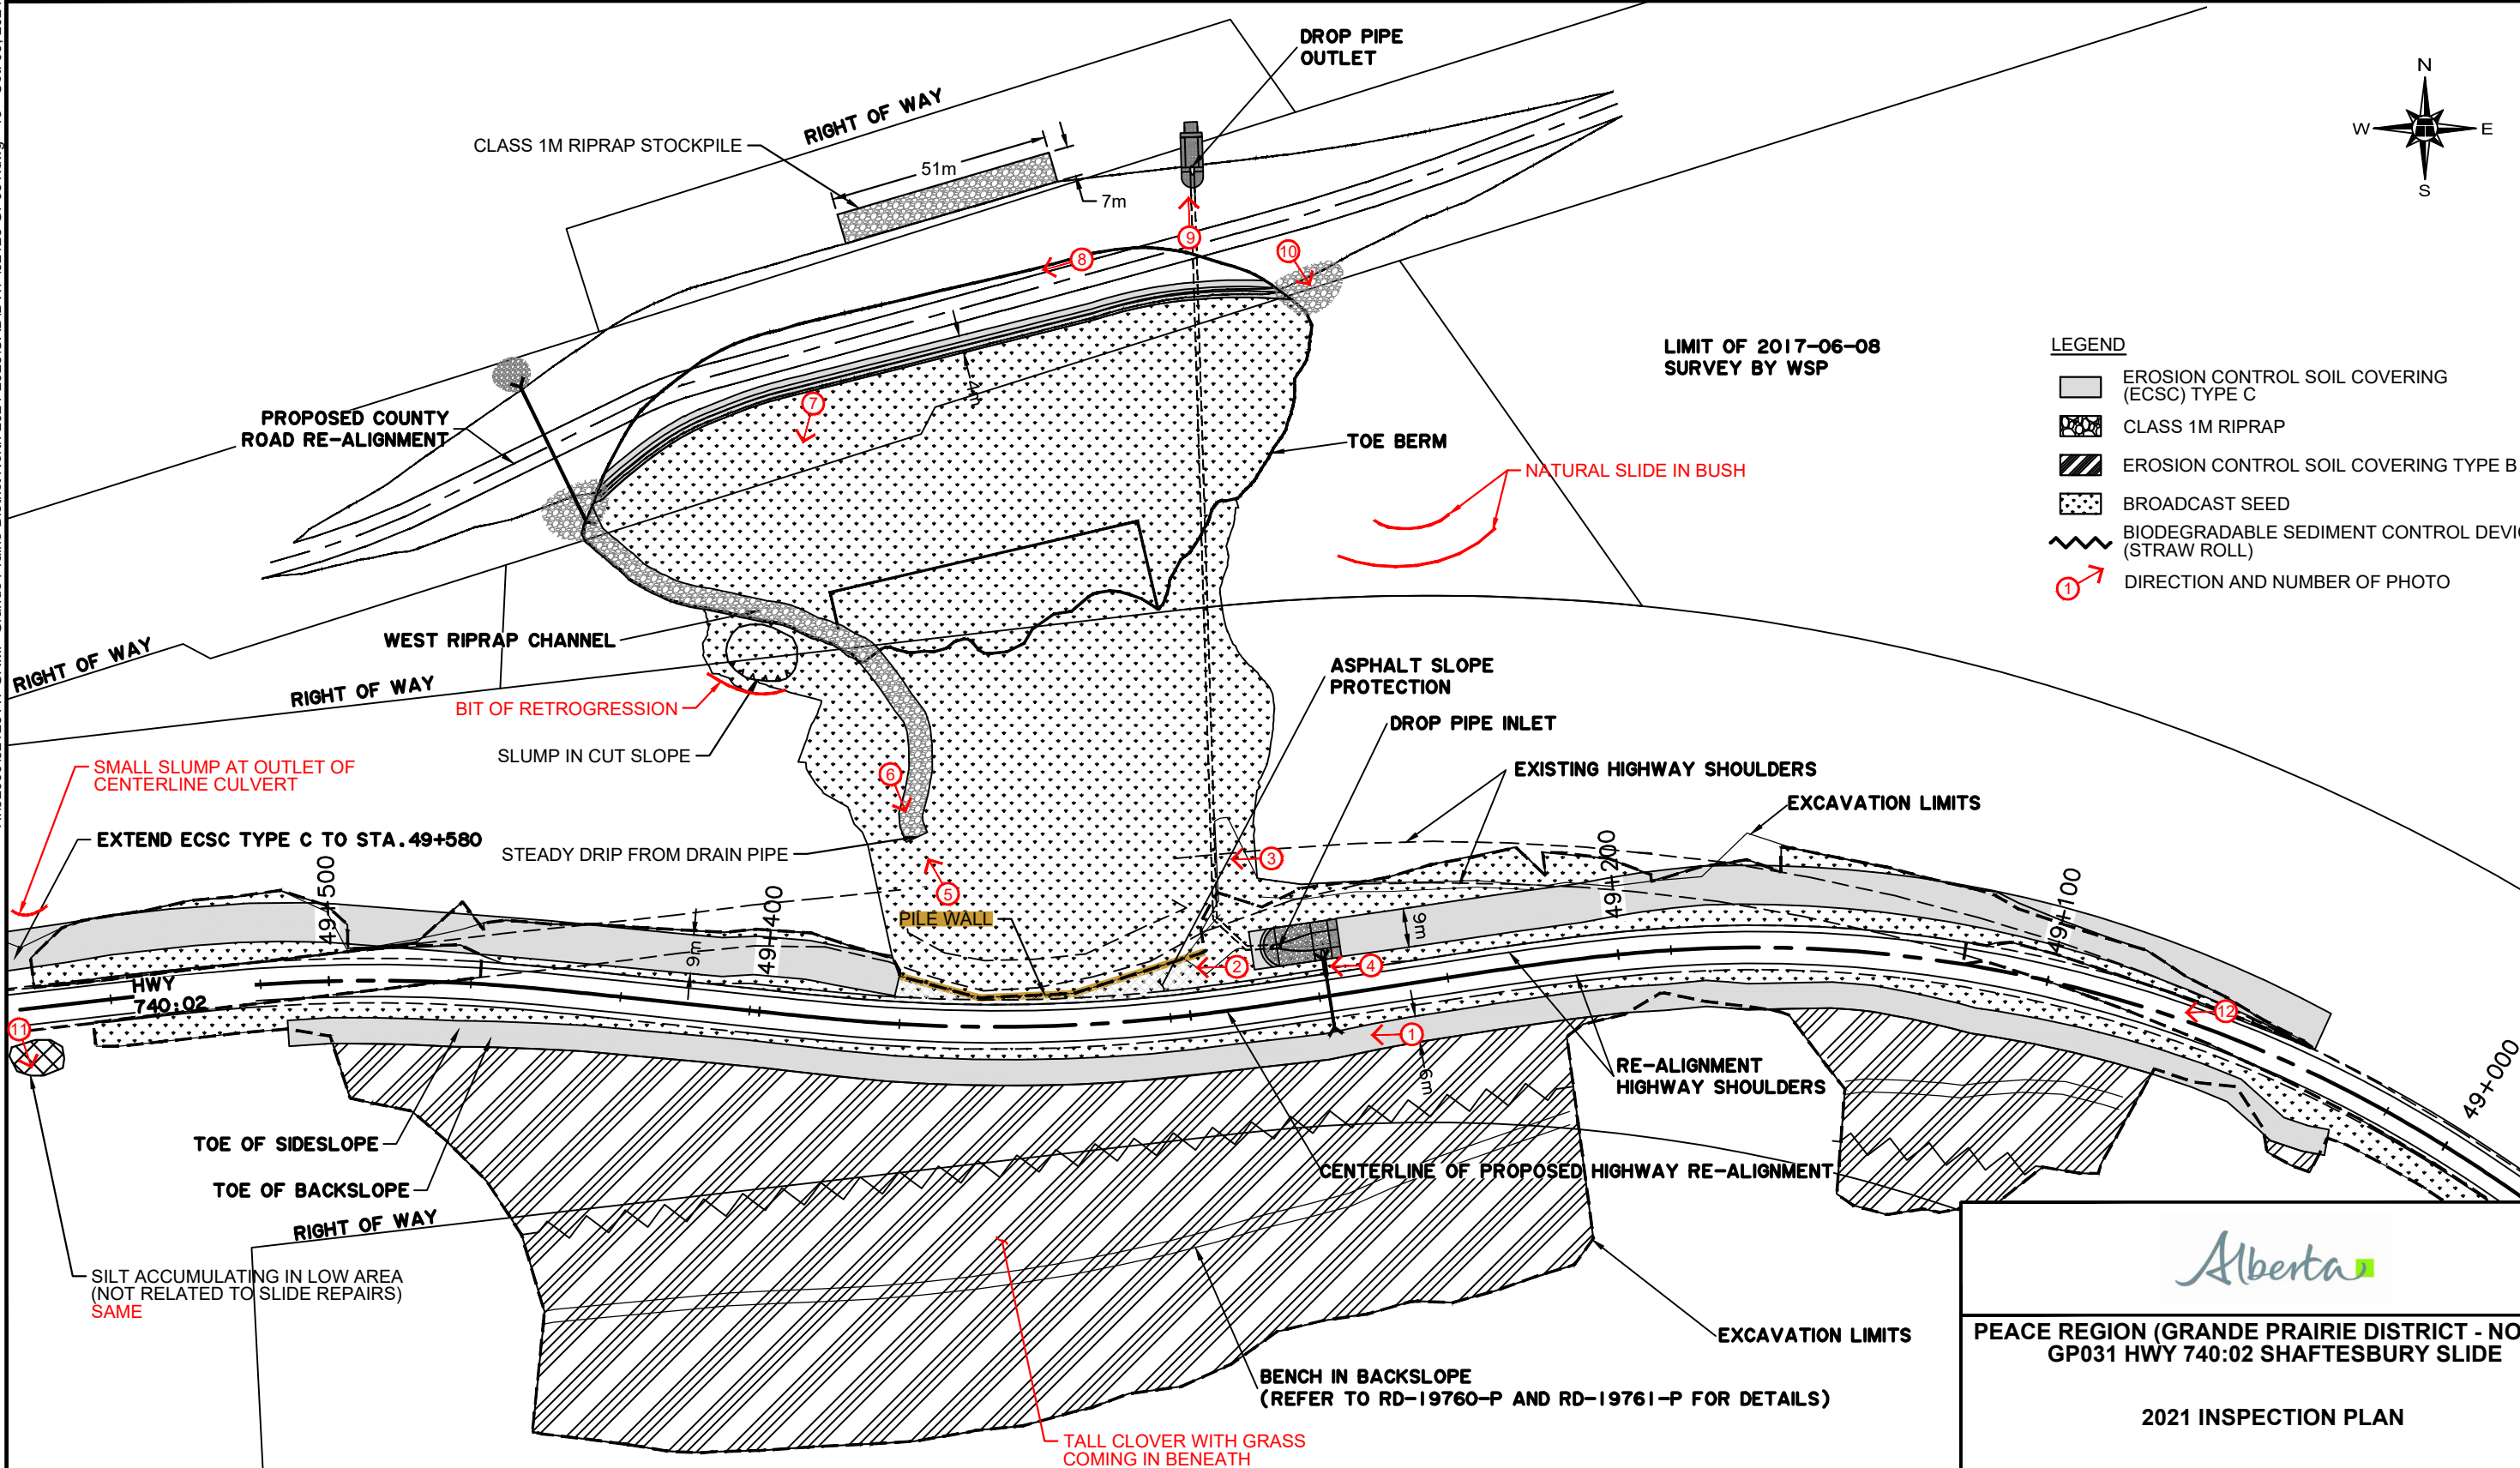
DWG No. 32123-GP031-1

1. JULY 8, 2021 FEATURES SHOWN IN RED

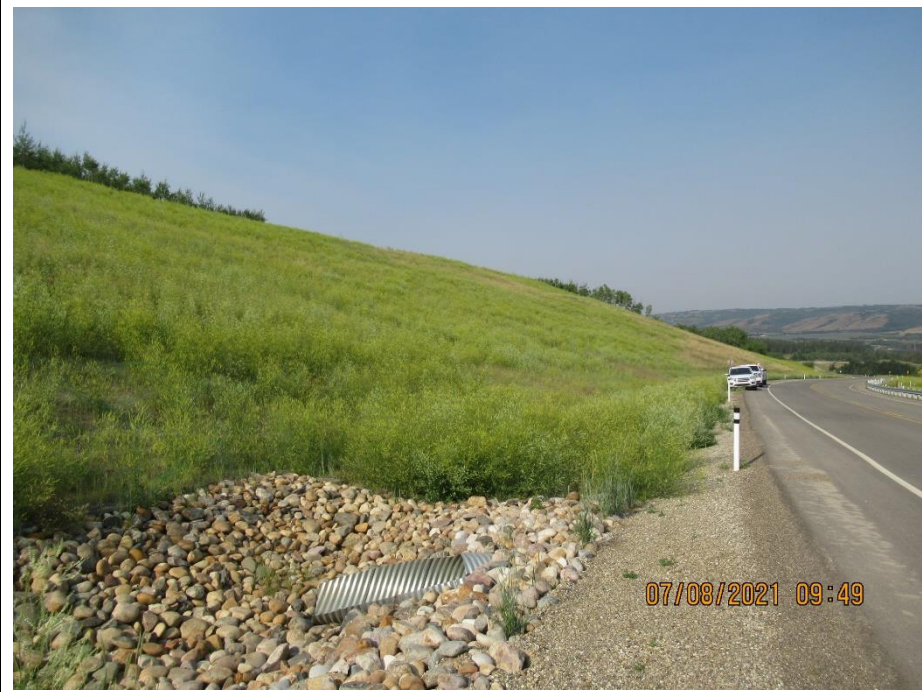
Photo 1.
Looking west at the
backslope of the
repaired landslide
area.

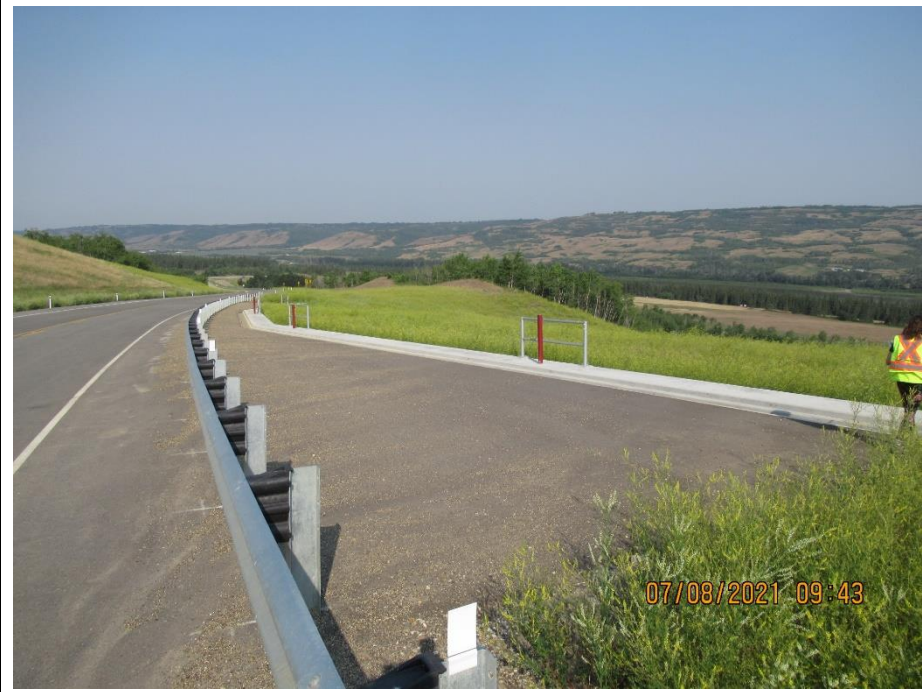
4 slope inclinometers were installed in the pile wall and have measured deflections as follows:

- SI18-P10 = 3.2 mm of pile head deflection
- SI18-P30 = 2.5 mm of pile head deflection
- SI18-P50 = 2.1 mm of pile head deflection
- SI18-P70 = 3.3 mm of pile head deflection

Photo 2.
Looking west at the
pile wall.

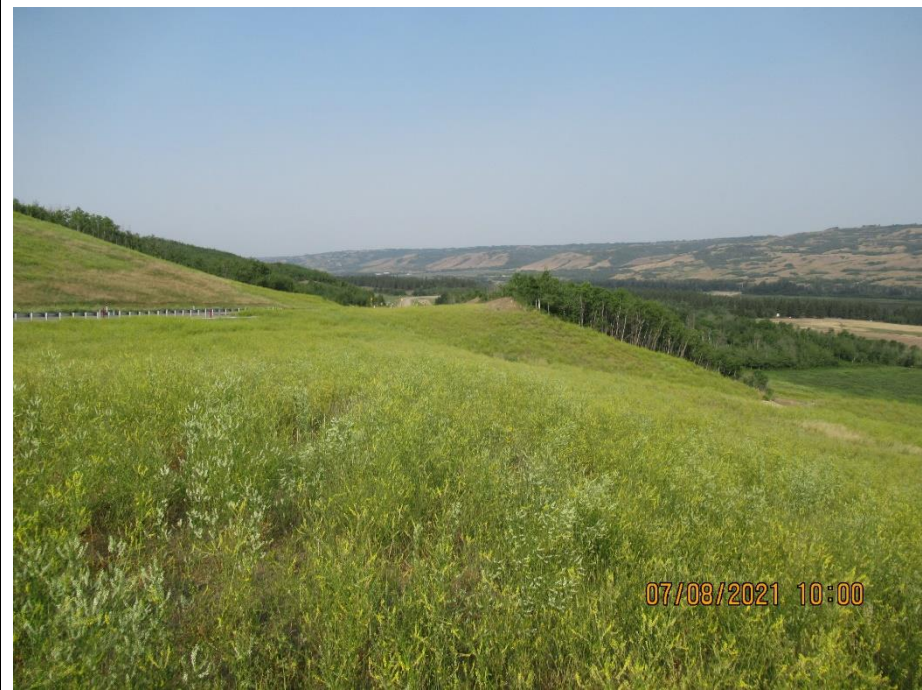
Photo 3.
Looking west at the grass covered slope below the pile wall.

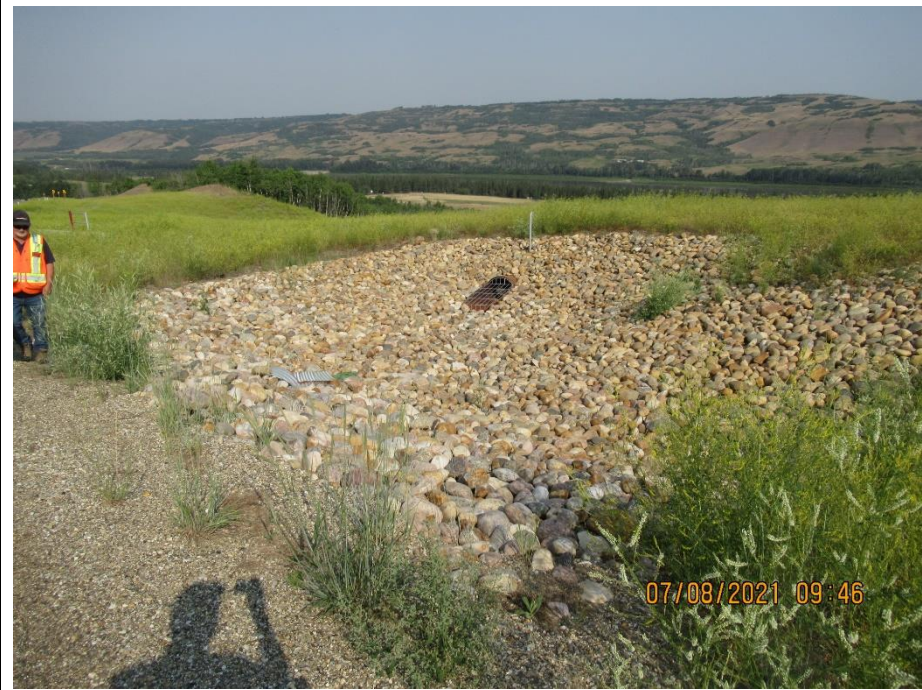
Photo 4.
Riprap area at culverts.

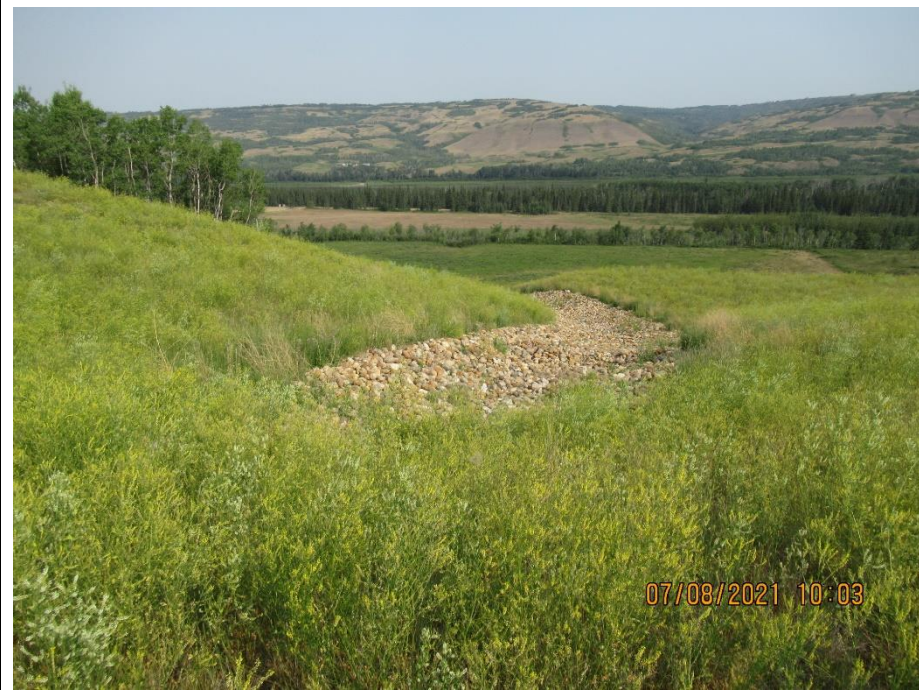
Photo 5.
Looking north at
West Riprap
Channel.

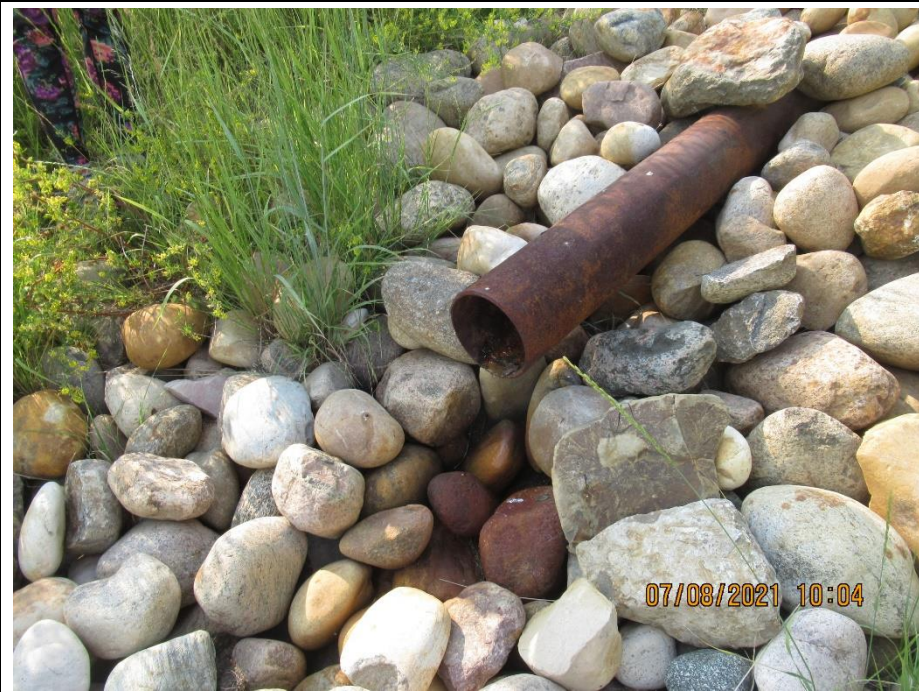
Photo 6.
Seepage from
drainpipe into West
Riprap Channel.

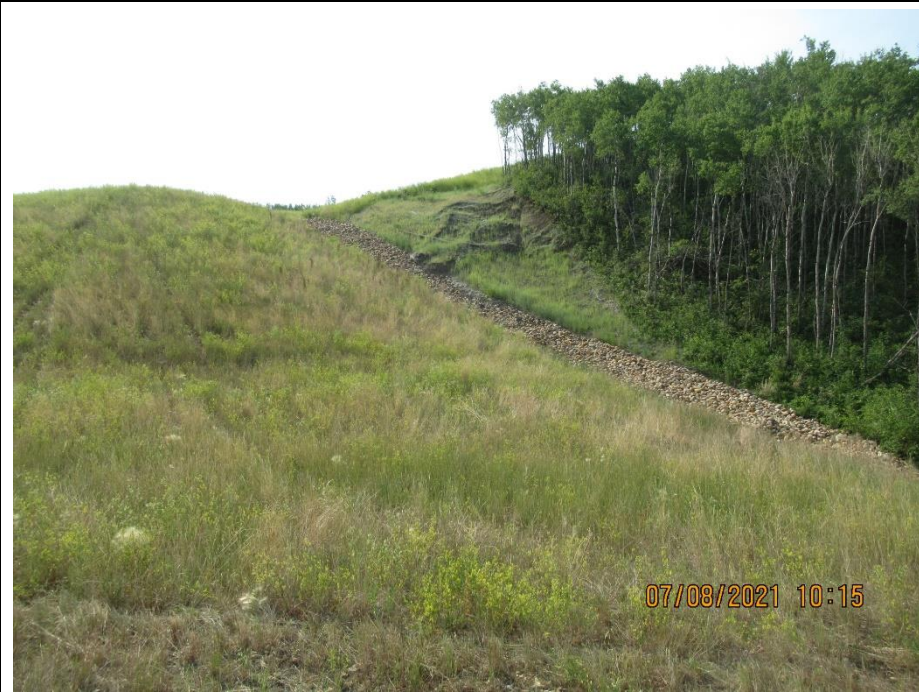
<input checked="" type="checkbox"/> Slope Movement	A small slump has formed in the cut slope above the west riprap channel	<input checked="" type="checkbox"/>
<input checked="" type="checkbox"/> Erosion	There is evidence of erosion outside the project limits resulting in silt accumulating in a low spot in the southwest highway ditch	<input type="checkbox"/>
<input checked="" type="checkbox"/> Seepage	There was a steady drip coming from the drainpipe indicating the presence of groundwater	<input type="checkbox"/>
<input type="checkbox"/> Bridge/Culvert Distress		<input type="checkbox"/>
<input checked="" type="checkbox"/> Other	Some excess Class 1M riprap was stockpiled along the toe of the toe berm and is available for future repairs when needed	<input type="checkbox"/>

The slump located above the west riprap channel is likely located in weak native material that had been pre-sheared during landslide events prior to construction. This should be repaired before it grows.

Photo 7.
View of slump above
West Riprap
Channel, looking
south.

The local slump above the west riprap channel should be excavated and replaced with free draining gravel.

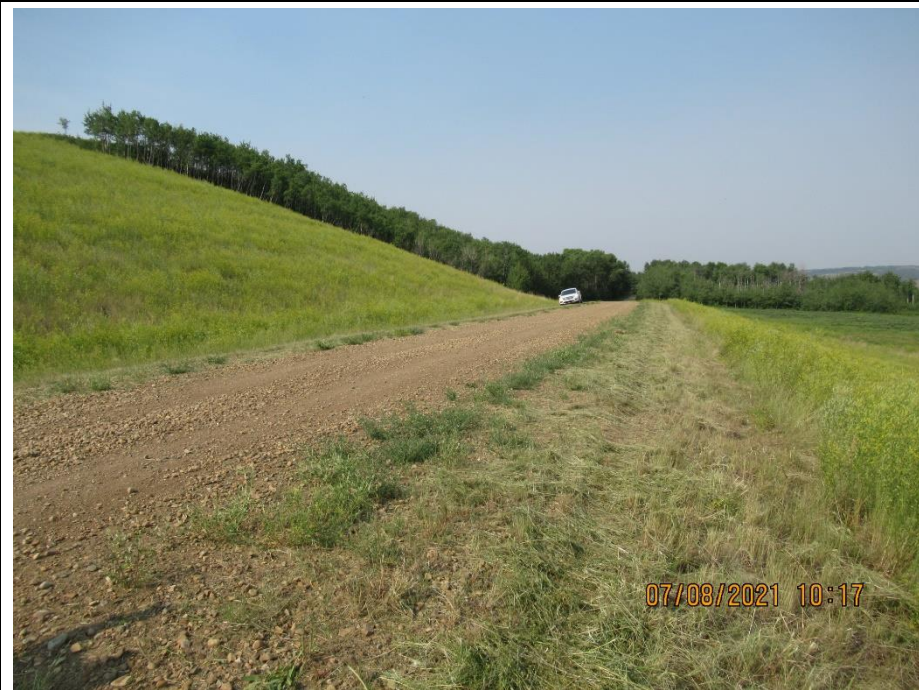
Photo 8.
Looking west along
County road over toe
berm.

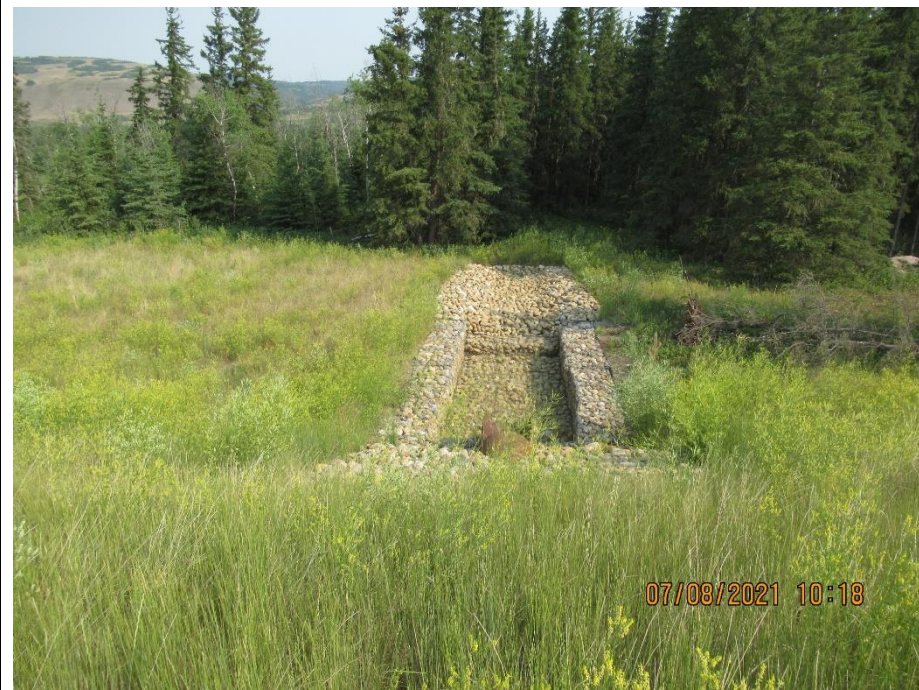
Photo 9.
Looking north at
gabion dissipation
bowl at outlet of drop
pipe.

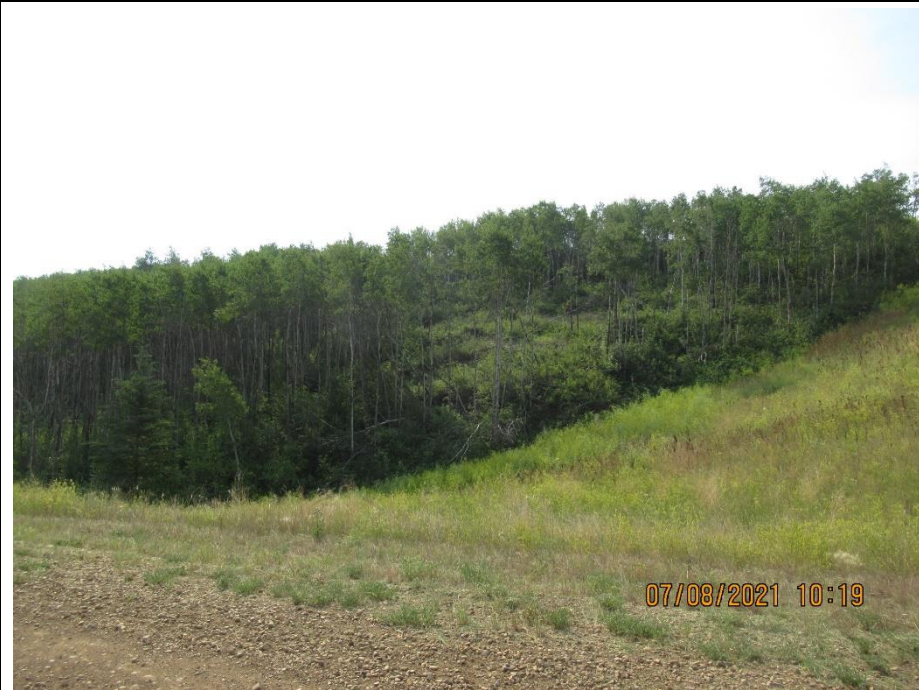
Photo 10.
Looking southeast at
landslide in natural
forested slope.

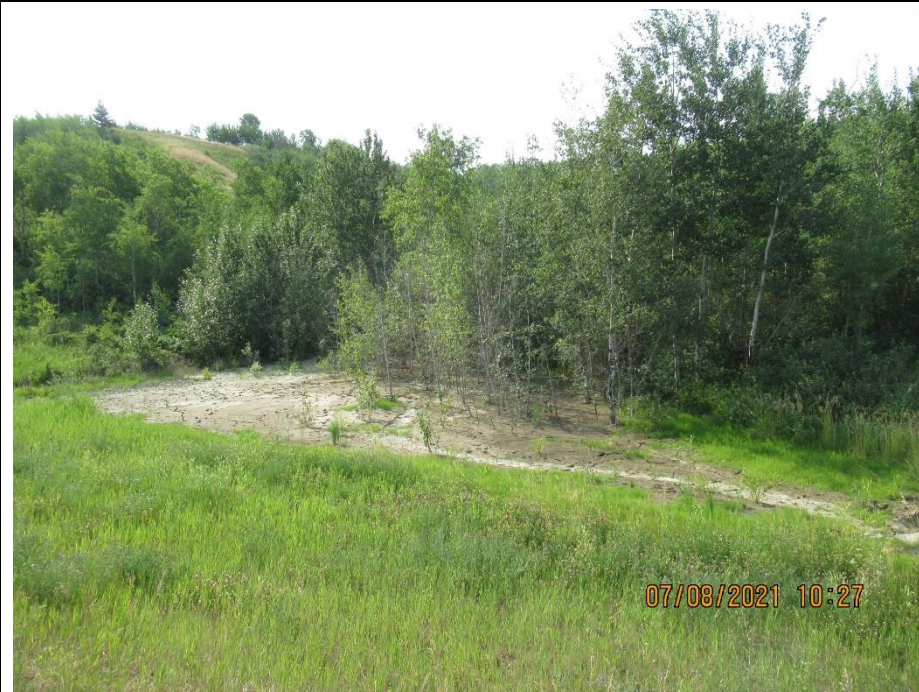
Photo 11.
Silty runoff
accumulating in low
area south of
highway. Not related
to the landslide
repairs

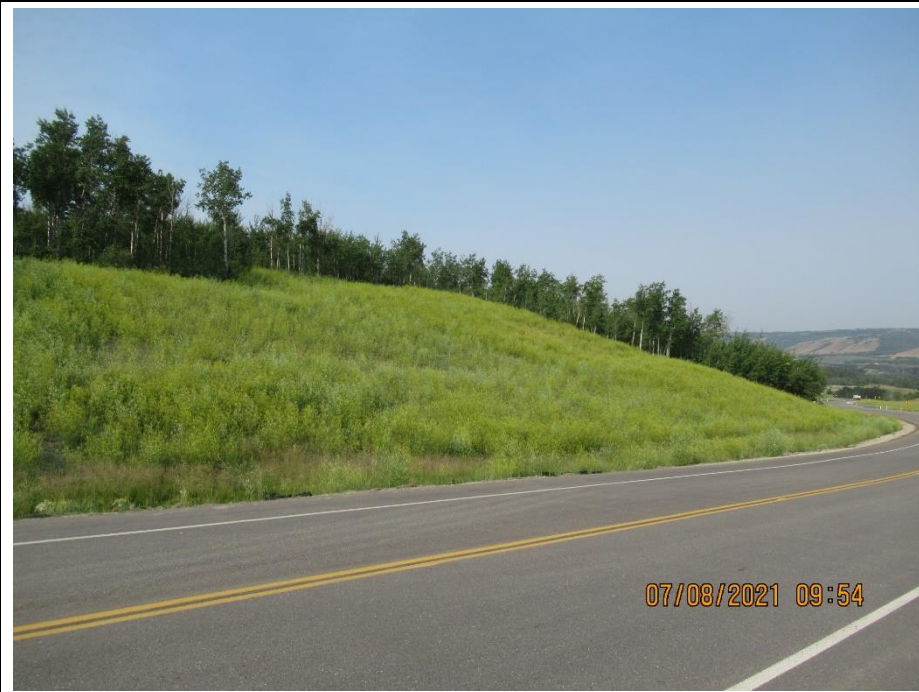
Photo 12.
Looking southwest at
realigned backslope.
