ALBERTA TRANSPORTATION GRMP (CON0022165) PEACE REGION (GRANDE PRAIRIE DISTRICT – NORTH) INSTRUMENTATION MONITORING RESULTS – SPRING 2022

SITE GP031: HWY 740:02, SHAFTESBURY SLIDE

APPENDIX A DATA PRESENTATION

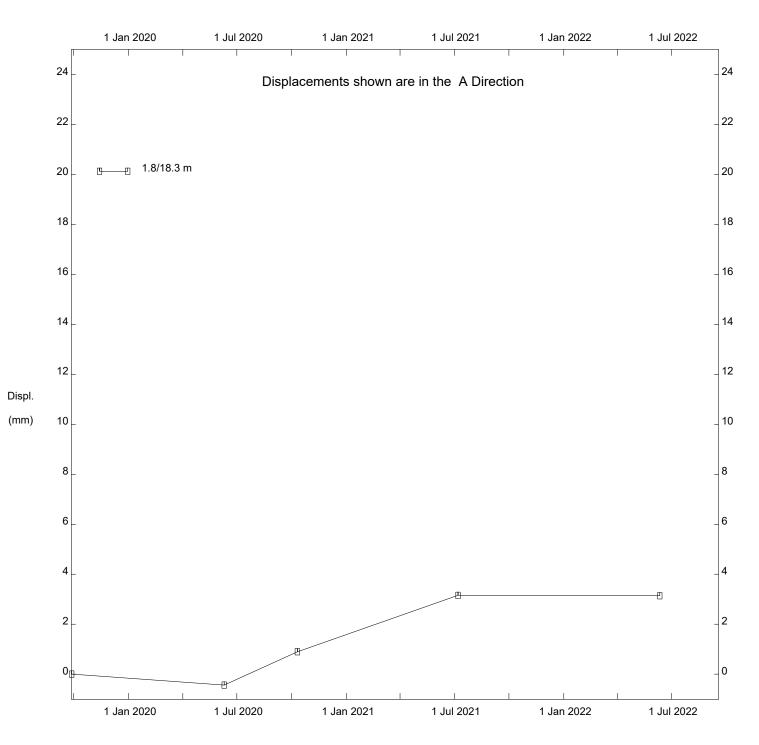
Hwy 740:02 Shaftesbury Trail, Inclinometer SI18-P10

SI18-P10 showed no discernible movement over the length of the pile since the spring of 2021 readings. SI18-P10 has shown a cumulative pile head movement of 3.1 mm to date. SI18-P30 showed a rate of movement of 0.8 mm/yr over the length of the pile and a rate of movement of 0.3 mm/yr over the combined length of the pile and waler since the spring of 2021 readings. SI18-P30 has shown a cumulative pile head movement of 3.2 mm to date. SI18-P50 showed a rate of movement of 0.6 mm/yr over the length of the pile and a rate of movement of 0.3 mm/yr over the combined length of the pile and waler since the spring of 2021 readings. SI18-P30 has shown a total cumulative pile head movement of 2.7 mm to date. SI18-P70 showed a rate of movement of 1.6 mm/yr over the length of the pile and a rate of movement of 2.6 mm/yr over the combined length of the pile and waler since the spring of 2021 readings. SI18-P70 has shown a total cumulative pile head movement of 2.6 mm/yr over the combined length of the pile and waler since the spring of 2021 readings. SI18-P70 has shown a total cumulative pile head movement of 2.6 mm/yr over the combined length of the pile and waler since the spring of 2021 readings. SI18-P70 has shown a total cumulative pile head movement of 4.8 mm to date.

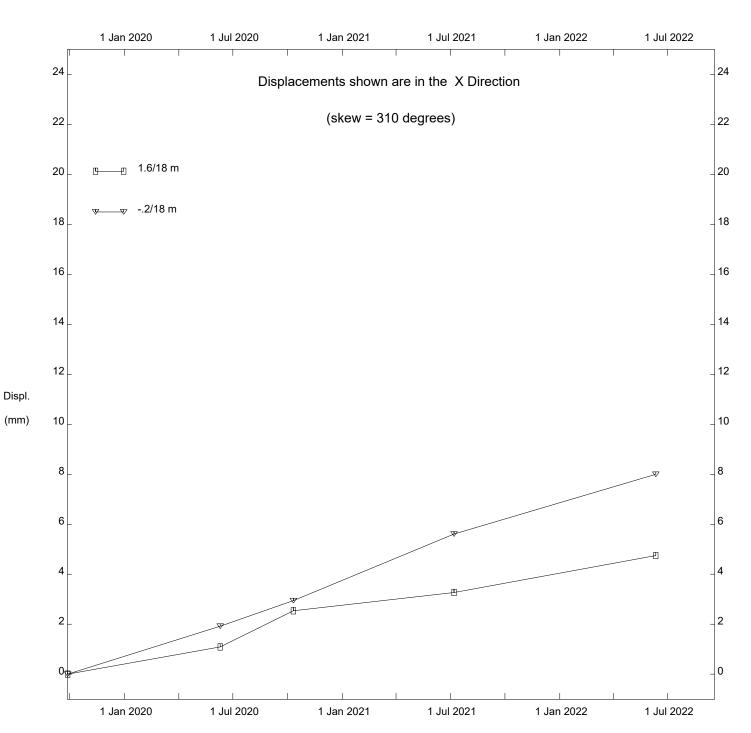
Hwy 740:02 Shaftesbury Trail, Inclinometer SI18-P70

SI18-P70	September 27,	4.8 mm over 1.6 m to 18.0 m depth in 351° direction	4.3 mm/yr in October 2020	Operational	luk 7, 2024	1.5	1.6	0.6
5118-P70	2019	8.0 mm over 0 m to 18.0 m depth in 351° direction	3.6 mm/yr in July 2021	- Operational	July 7, 2021	2.4	2.6	-1.0
