ALBERTA TRANSPORTATION AND
ECONOMIC CORRIDORS
GEOHAZARD ASSESSMENT PROGRAM
PEACE REGION GRANDE PRAIRIE DISTRICT - NORTH
2025 INSPECTION

Site Number	Location	Name	Hwy	km
GP031	South slope of the Peace River Valley near the Shaftesbury ferry crossing	Shaftesbury Slide, South Site	740:02	49.3
Legal Description		UTM Co-ordinates (NAD 83)		
LSD 4-9-82-23-W5M		11U N 6 216 300	E 466 120

Date	PF	CF	Total
Previous Inspection:	May 6, 2024	11	3	33
Current Inspection:	May 16, 2025	11	3	33
Road AADT:	80		Year:	2024
Inspected By:	Don Proudfoot, (Thurber) Rocky Wang (TEC)			
Report Attachments:	<input checked="" type="checkbox"/> Photographs <input checked="" type="checkbox"/> Plans		<input checked="" type="checkbox"/> Maintenance Items

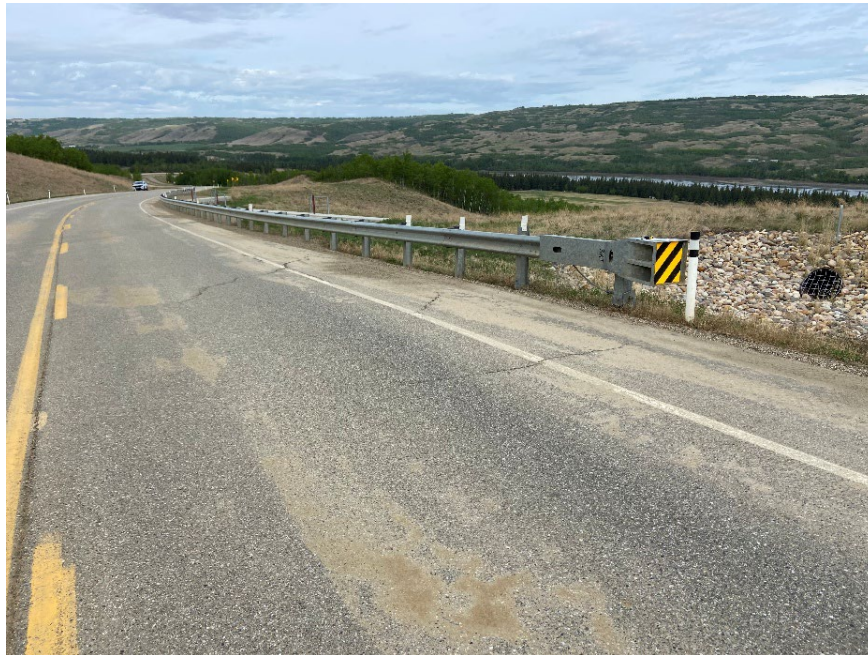
Observations:	Description	Worse?
<input checked="" type="checkbox"/> Pavement Distress	Some diagonal cracks have developed in the pavement surface near the east end of the wall and a dip is present in the road surface further to the east. These cracks had grown and opened up a bit more since last year. Several arc shaped hairline cracks were observed in the westbound lane shoulder possibly due to settlement along a poorly packed shoulder, a transverse crack just west of the culvert was also observed. The extents of the cracks were similar to last year.	<input checked="" type="checkbox"/>
<input checked="" type="checkbox"/> Slope Movement	A small slump is present in the cut slope above the west riprap channel but has not changed for several years. A slide crack was noted in the valley slope downslope of the pile wall, which appears to be the backscarp of the original landslide. It now has a maximum differential of 0.25 m. There is an active landslide with a backscarp varying from 0.8 m to 1.4 m in height in the bush east of the toe berm which appeared to be very active and is potentially associated with cracking of the road surface above this area.	<input checked="" type="checkbox"/>

There is an active landslide within the bush area to the east of the repair. The cracks in the highway at the east end of the wall and the dip in the road at Station 49+170 are located above this active slide and might indicate that the slope above the slide is straining due to the loss of support in the slope, which might ultimately lead to the slope failure extending to the road level at this location in the future. For this reason, the risk level for the site was increased previously.

Photo 3. Looking west at cracks in road beyond east end of pile wall.

If the active landslide in the bush to the east of the repair continues to affect the road some future remedial measures will be required and might involve extending the width of the toe to the east and potentially shifting the highway into the backslope at this location. Excess material from the previous repair was stockpiled over the former gravel pit north of Range Road No. 234 and could be used for the toe berm extension.

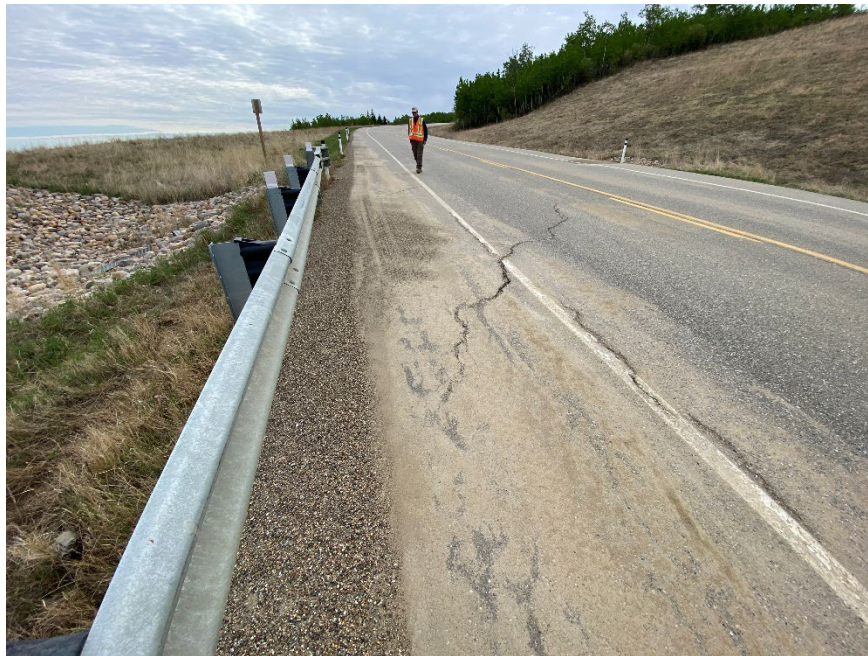
Photo 4. Looking east at cracks in pavement beyond east end of pile wall.

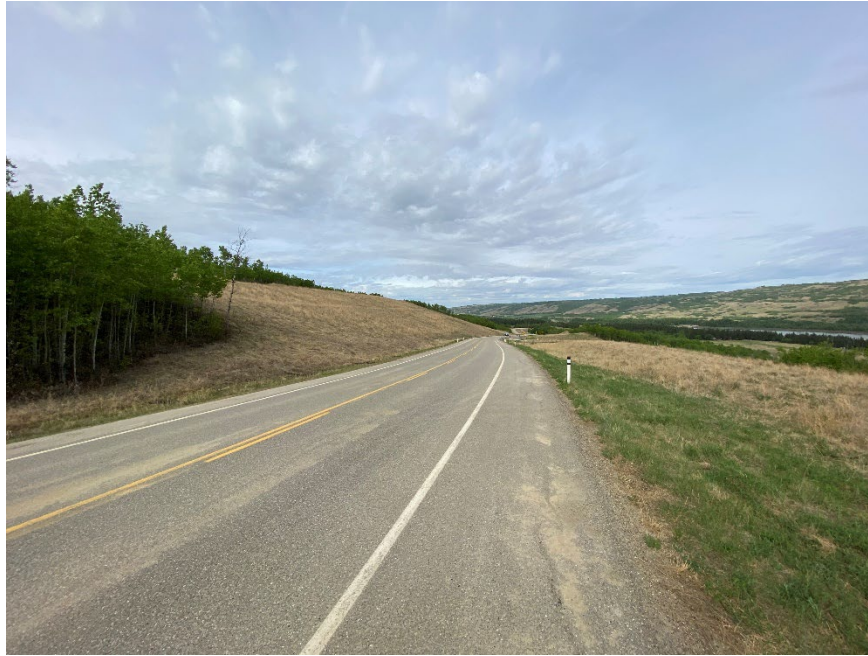
Photo 5. Looking west at the site. Note cracks in north shoulder of pavement.

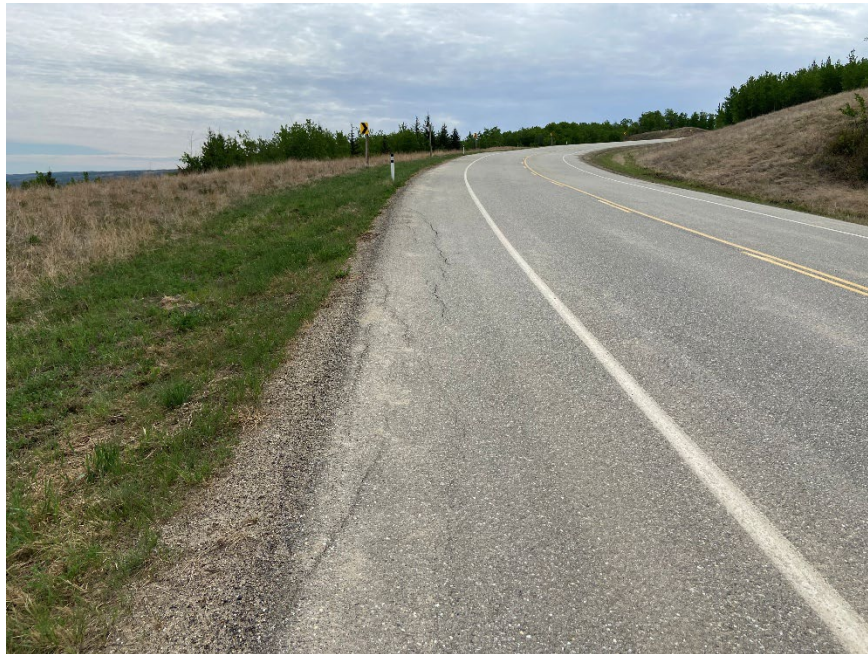
Photo 6. Looking east at the cracks in the north shoulder of the road pavement.

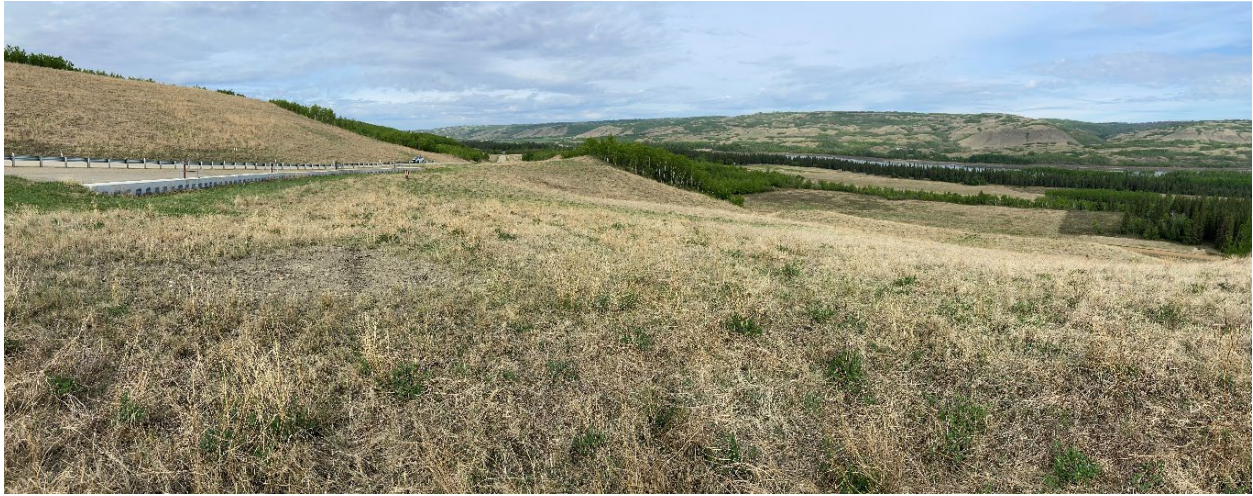
The remedial measures appear to be performing well to date. Pile deflections are all within expected ranges and the global stability of the toe berm and backslope appeared to be in good condition. Grass growth is well established on the site and the erosion prevention measures appear to be working.

Photo 7. Looking west at the remediated slide area.

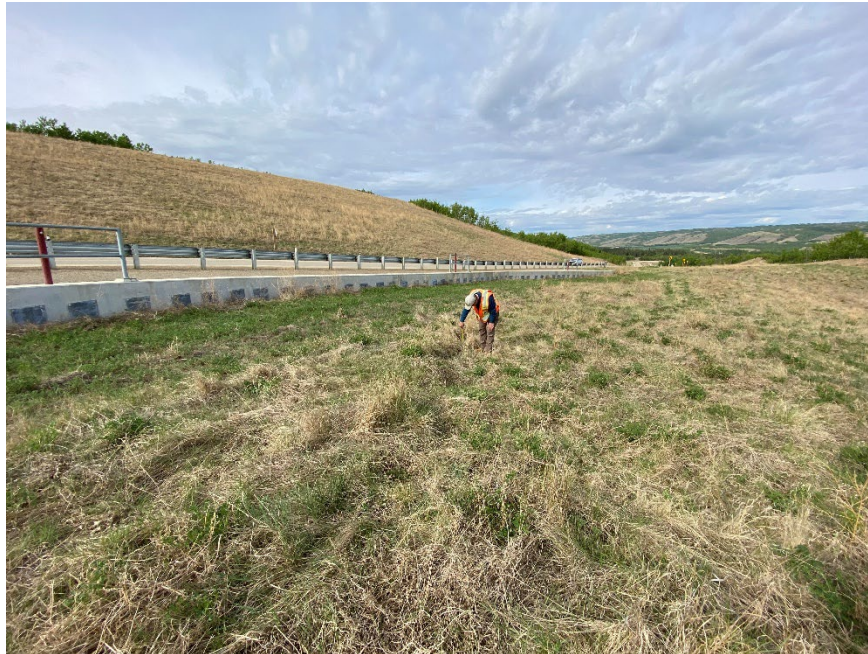
The slide crack downslope of the wall appears to be near the same location as the backscarp of the original slide. In its failed state the slide mass was broken and loose and it is believed that the slide mass has crept downslope as it tightens and consolidates against the toe berm. The piles were designed to protect the road from this creep movement if a significant gap and differential across the crack do not occur. The design assumed a maximum unsupported cantilever of 4m from the top of waler to the slip surface of the slide. However, the wall was designed to accommodate tie-backs, in case the cantilever height is more than 4m.

Photo 8. Looking southwest at backscarp crack located downslope of the pile wall.

Given the appearance of the new slide cracks downslope of the pile wall and the new cracks and dip in the pavement east of the previous repair, it is recommended that the inspection frequency for this site be annually. It is also recommended to install two new slope inclinometers at the site to help monitor these areas, with one downslope of the scarp crack below the middle of the wall and another on the north side of the north highway ditch at about Sta. 49+220.

If further deformation of the slope below the wall occurs it would be beneficial to do some grooming of the area to avoid ponding of surface water and to fill the scarp crack with some clay or topsoil to limit seepage of precipitation runoff into the slip surface of the slide.

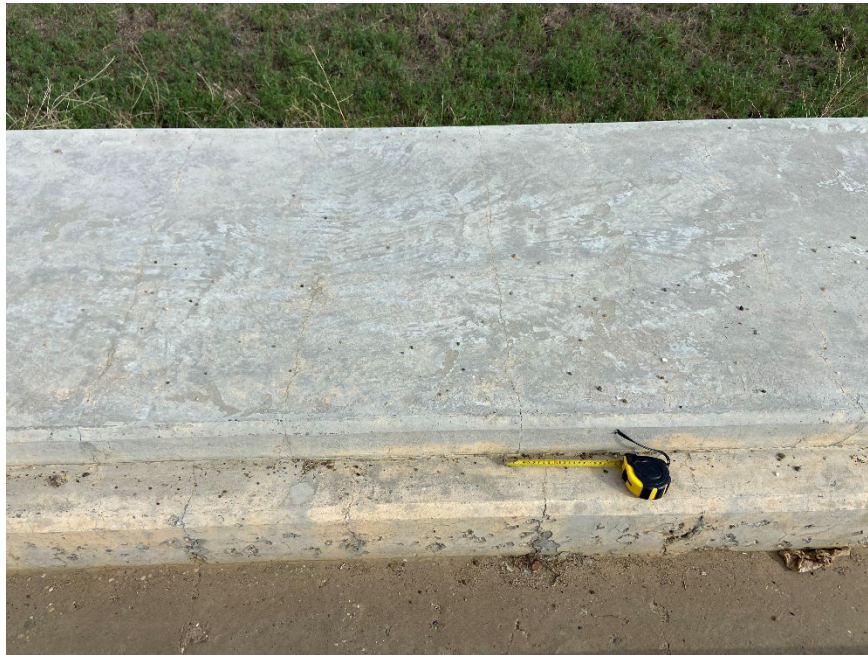
Photo 9. Thermal cracks in the top of the concrete waler of the pile wall.

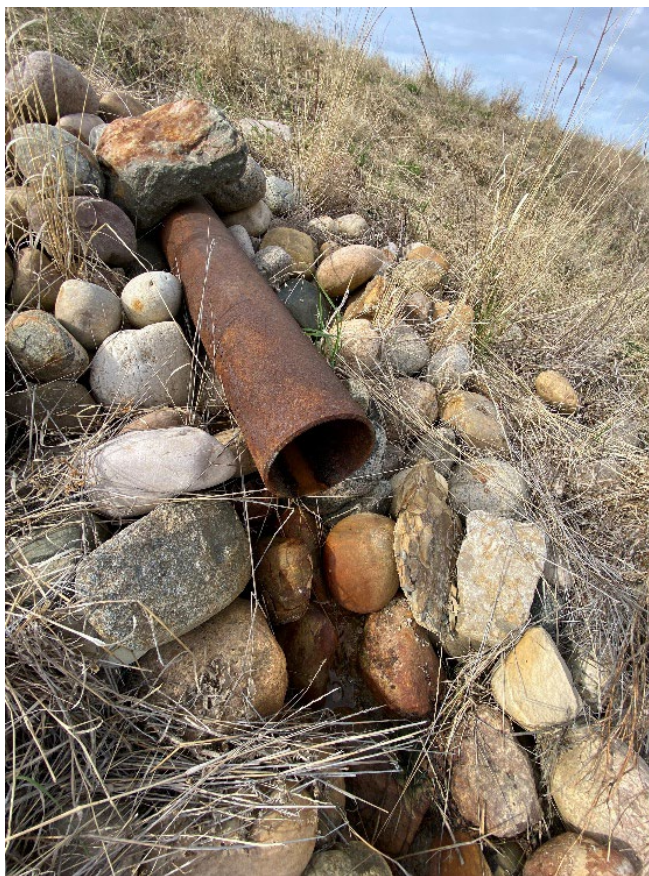
Photo 10. Drain pipe is dripping.

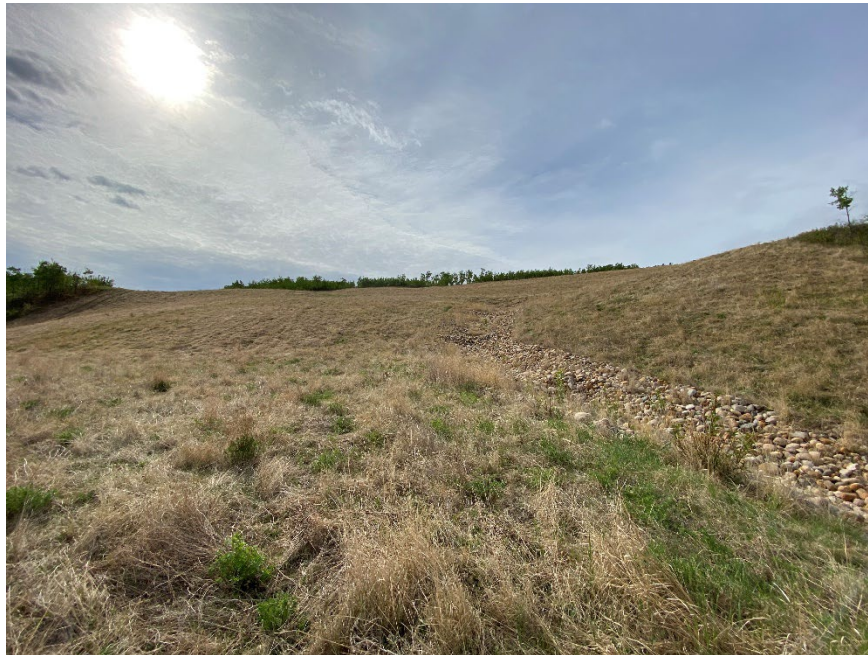
The slump located above the west riprap channel has not changed since 2023 and appears to have reached a stable grassed condition.

Photo 11. Looking south at upper slope and west riprap channel. No change in the shallow slump condition. It is grassed over.

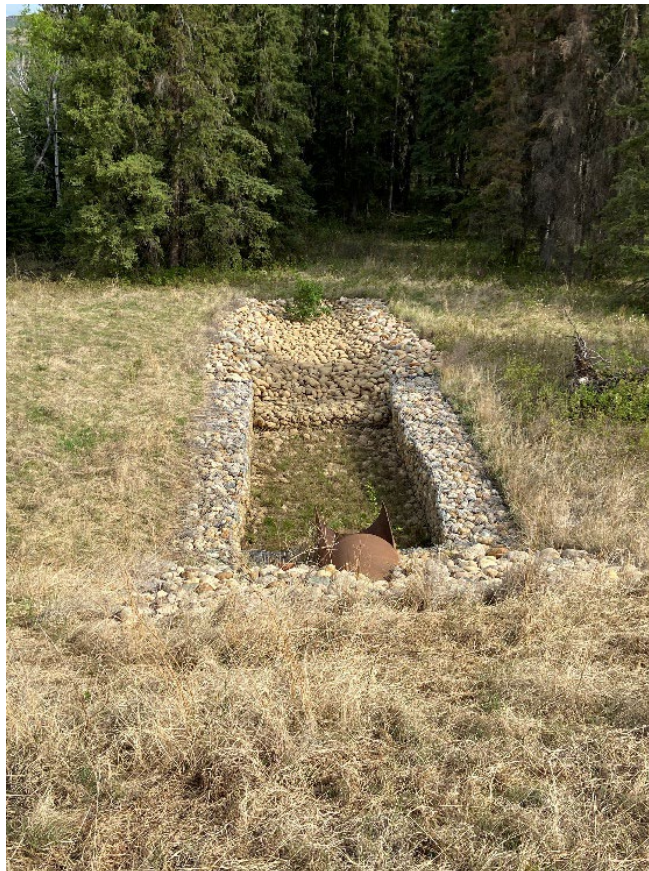
Photo 12. Looking north at drop pipe outlet – in good condition.

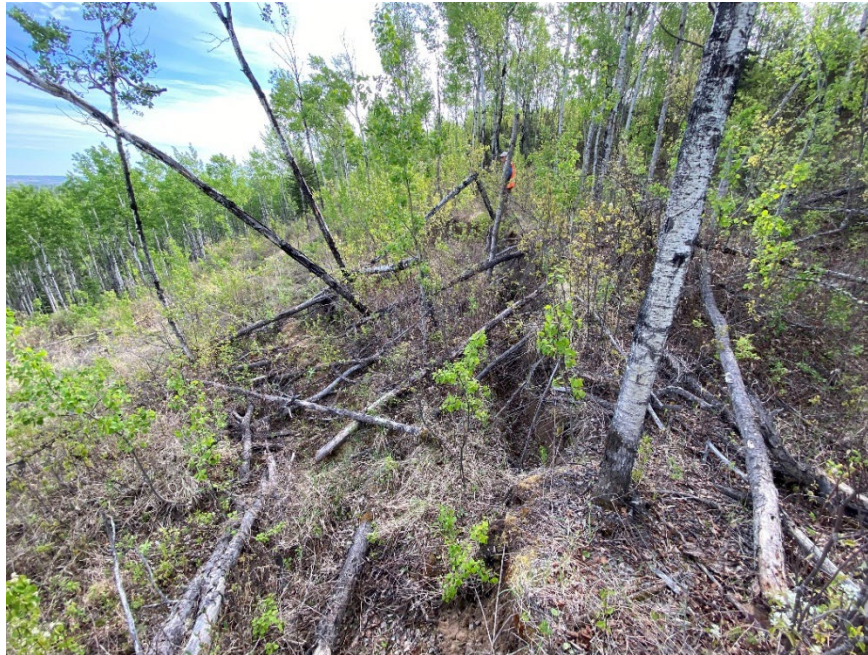
Photo 14. Looking east at landslide backscarp in bush area.

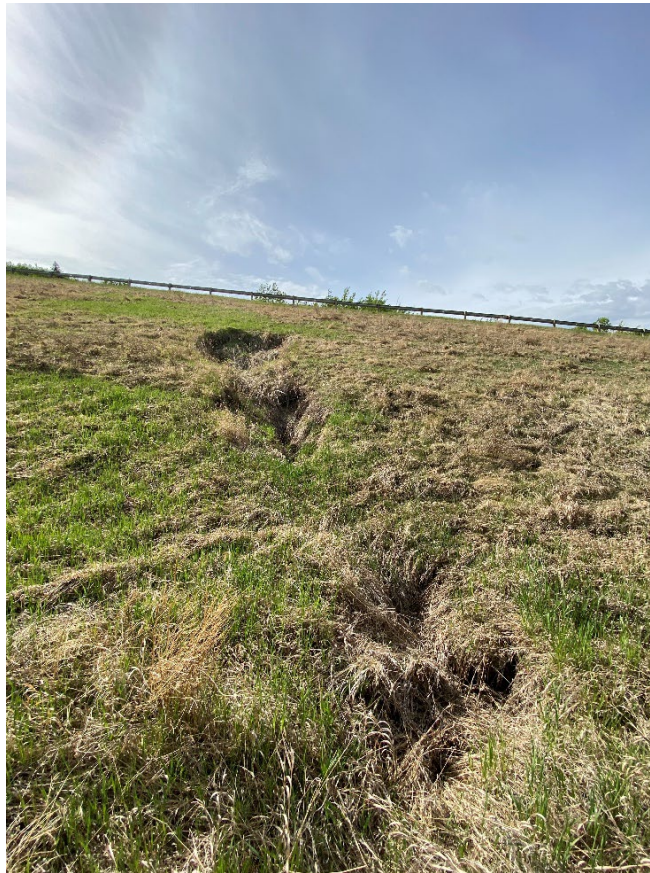
<input checked="" type="checkbox"/> Erosion	There is evidence of erosion outside the project limits resulting in silt accumulating in a low spot in the southwest highway ditch which now has vegetation growing on top of the silt. There is an erosion gully at the outlet of a centreline culvert at the same location. This gully is up to 3 m wide x 15 m long in the downslope direction.	<input checked="" type="checkbox"/>
<input checked="" type="checkbox"/> Seepage	There was a steady drip coming from the drainpipe indicating the presence of groundwater, indicating that the drainpipe is performing as per design.	<input type="checkbox"/>
<input checked="" type="checkbox"/> Bridge/Culvert	The inlet and outlet of a centreline culvert are blocked by silt and erosion /slumping, respectively	<input checked="" type="checkbox"/>
<input type="checkbox"/> Other		<input type="checkbox"/>

Photo 15. Looking south at the erosion gully downslope of the culvert outlet.
