ALBERTA TRANSPORTATION AND ECONOMIC CORRIDORS GRMP GRANDE PRAIRIE REGION – (GRANDE PRAIRIE DISTRICT - NORTH) INSTRUMENTATION MONITORING - SPRING 2025

Site Number	Location	Name	Hwy	km
GP031	HWY 740:02 km 49.332	Shaftesbury Trail South	740:02	Km 49.3
Legal Description	n: 4-9-82-23 W5	UTM Co-ordinates		
		11U E 466039	N 62	16272

Current Monitoring:	nt Monitoring: 07-June-2025 Previous Monitoring		18-May-2024		
Instruments Read By: Mr. Niraj Regmi, G.I.T and Mr. Godfred Entiendem, of Thurber

SITE GP031: HWY 740:02, SHAFTESBURY SLIDE

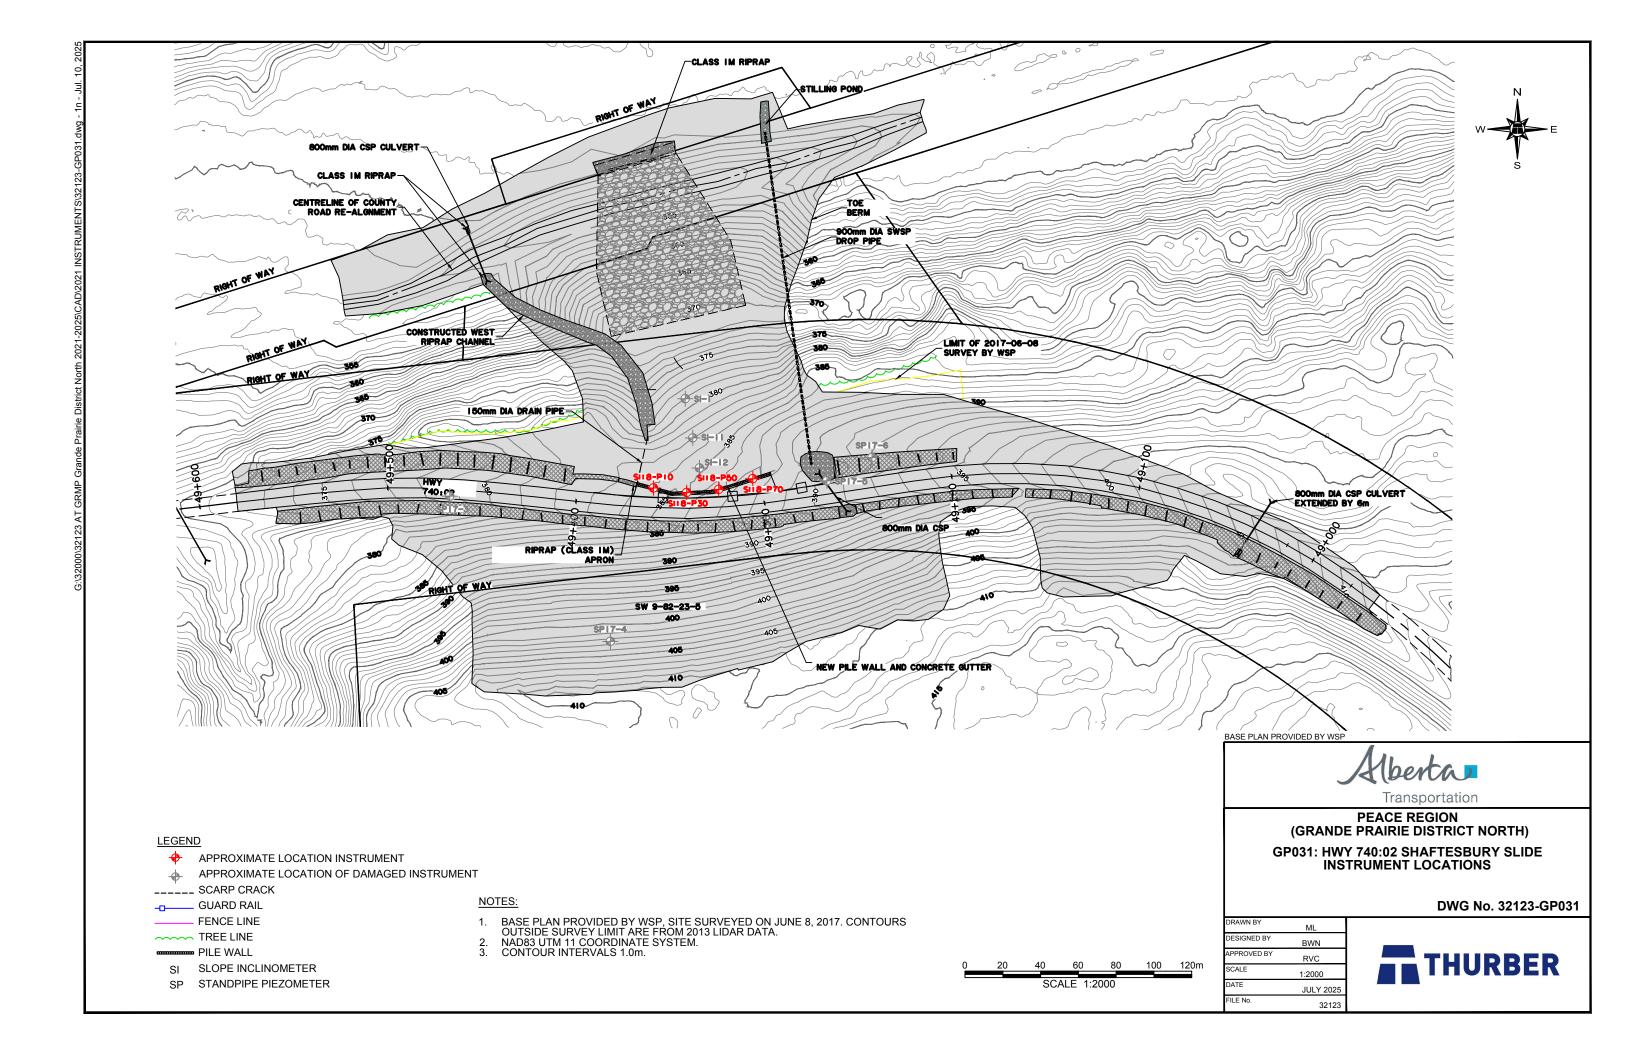
Drawing 32123-PH031 in Appendix A provides a sketch of the approximate locations of the monitoring instrumentation for this site.

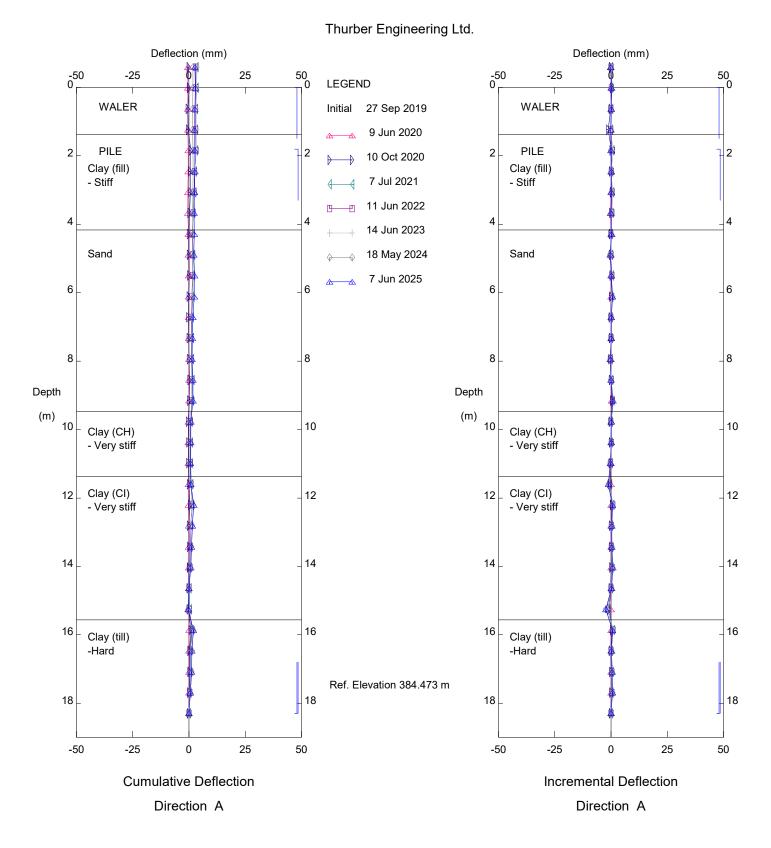
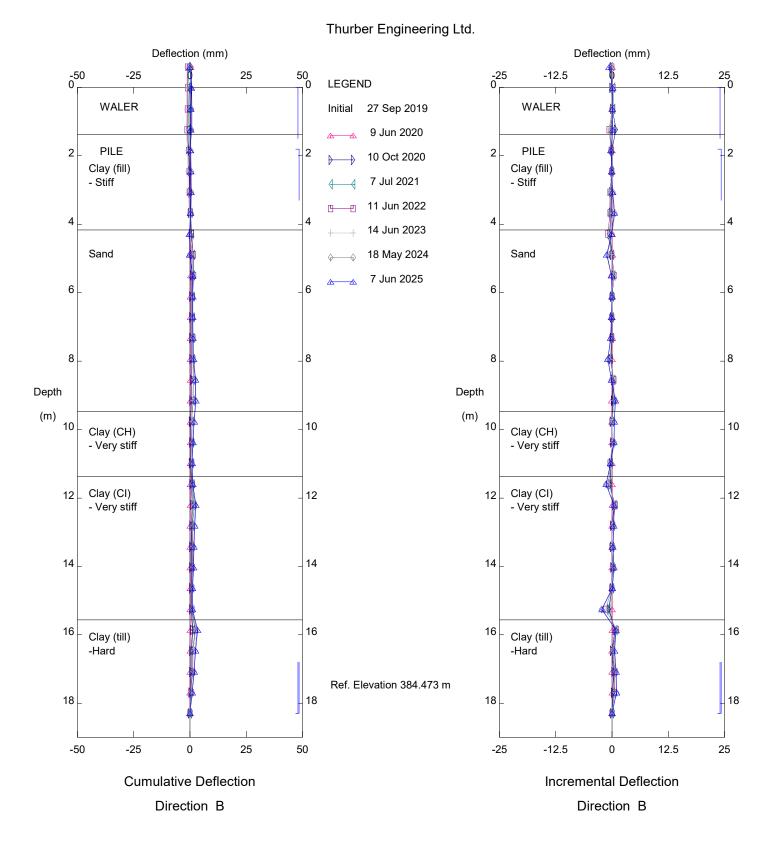
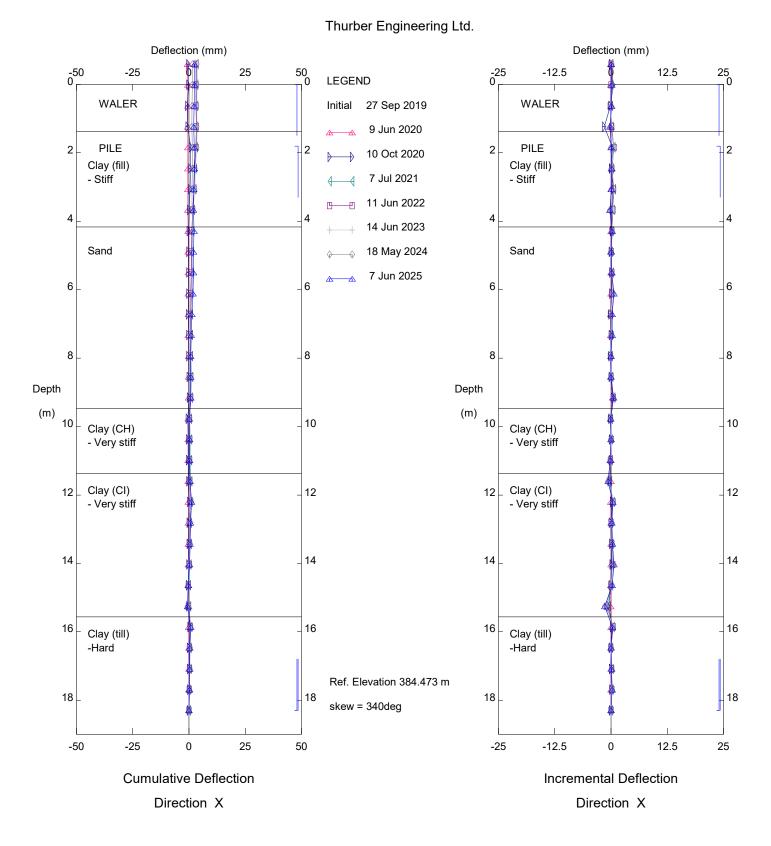
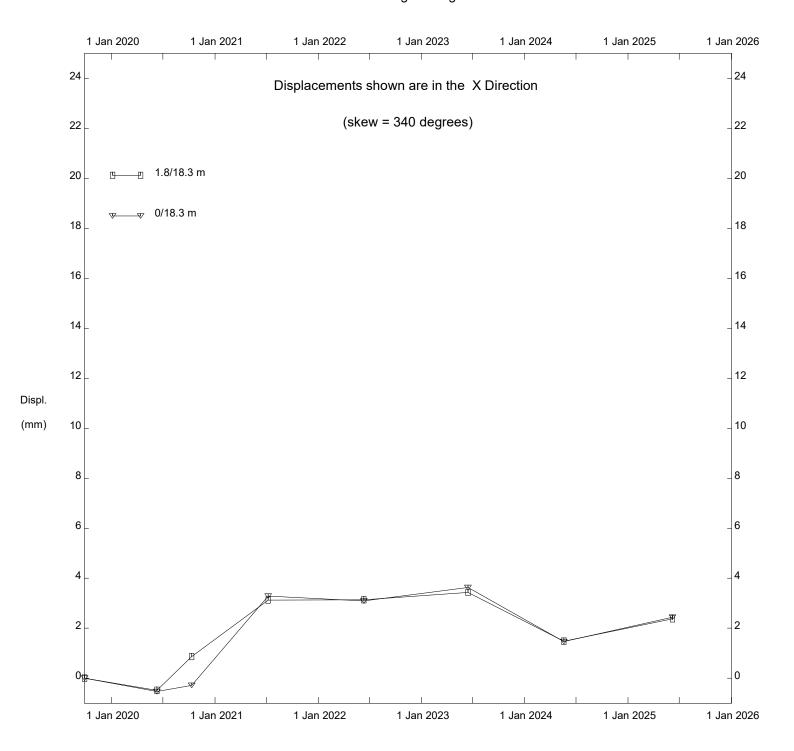
Hwy 740:02 Shaftesbury Trail, Inclinometer SI18-P10

Discussion						
Zones of New Movement:	None						
	SI18-P10 showed a rate of movement of 0.8 mm/yr over the length of the pile and a rate of movement of 0.9 mm/yr over the combined length of the pile and waler since the spring of 2024 readings. SI18-P10 has shown a cumulative pile head movement of 2.4 mm to date.						
	SI18 P30 showed a rate of movement of 0.5 mm/yr over the length of the pile and a rate of movement of 0.7 mm/yr over the combined length of the pile and waler since the spring of 2024 readings. SI18 P30 has shown a cumulative pile head movement of 5.0 mm to date.						
Interpretation of Monitoring Results:	SI18-P50 showed rate of movement of 0.5 mm/yr over the length of the pile and a rate of movement of 0.3 mm/yr over the combined length of the pile and waler since the spring of 2024 readings. SI18-P50 has shown a total cumulative pile head movement of 3.1 mm to date.

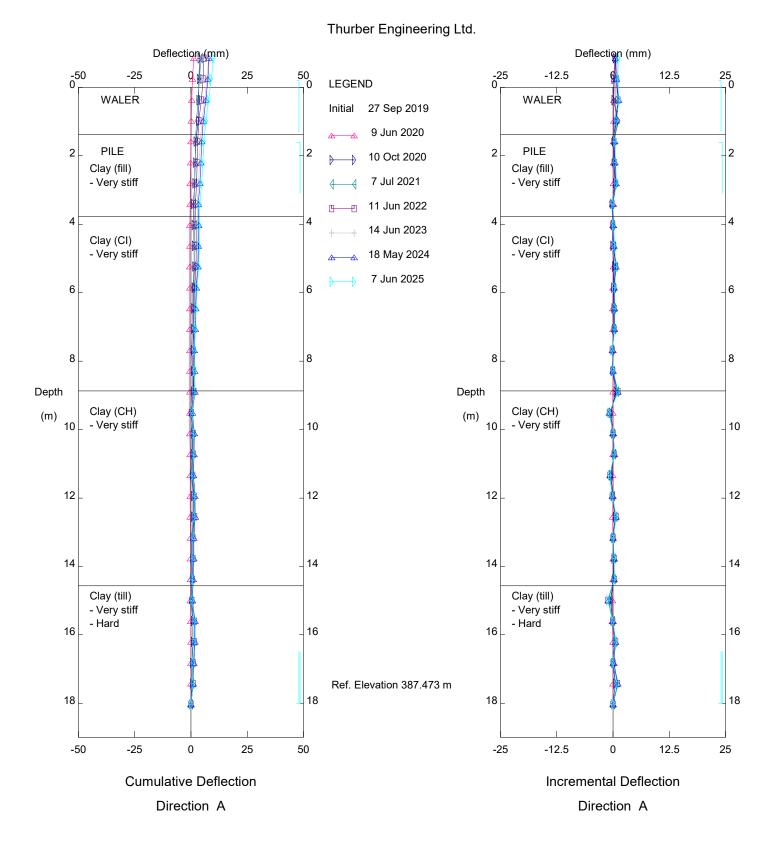
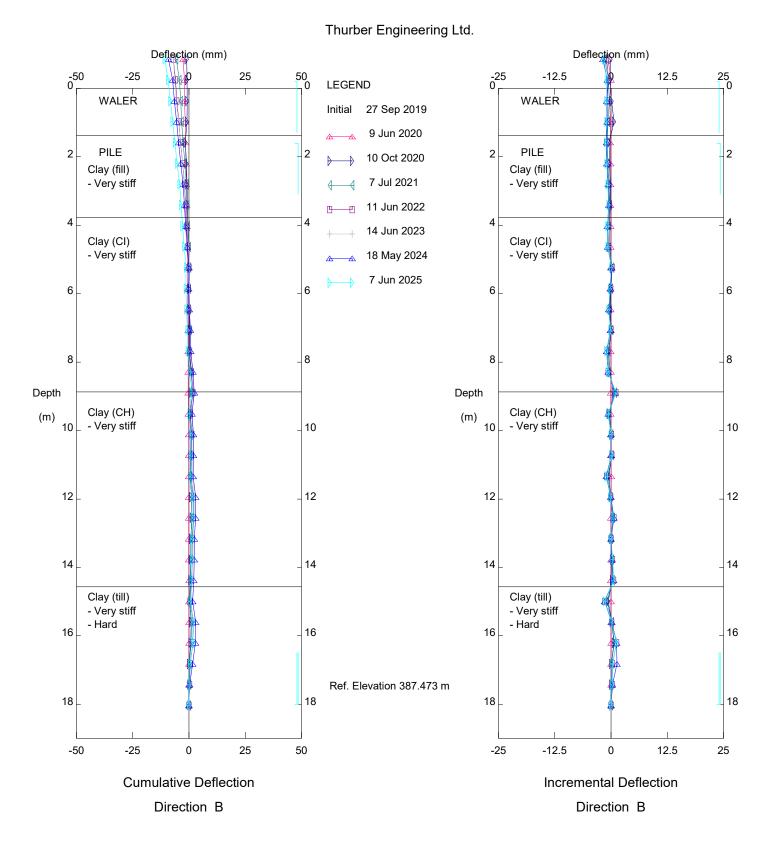
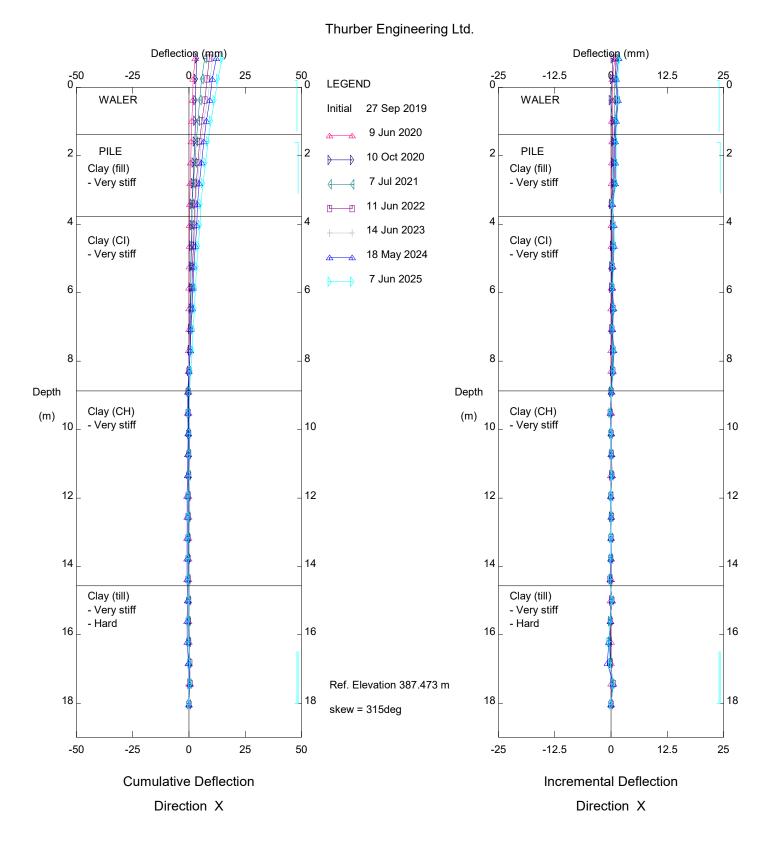
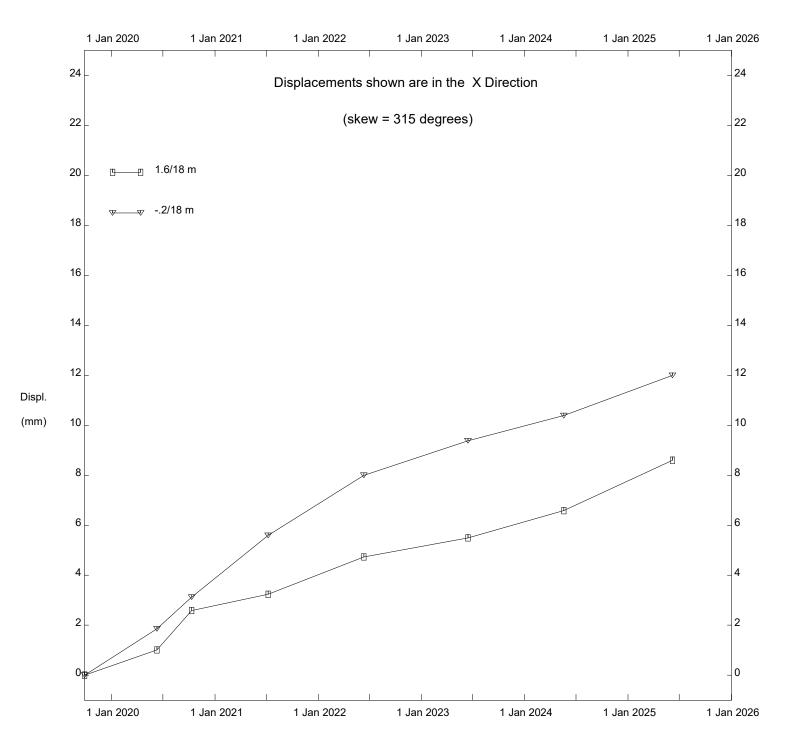
Hwy 740:02 Shaftesbury Trail, Inclinometer SI18-P70

SI18 P70 showed a rate of movement of 1.9 mm/yr over the length of the pile and a rate of movement of 1.5 mm/yr over the combined length of the pile and waler since the spring of 2024 readings. SI18 P70 has shown a total cumulative pile head movement of 8.6 mm to date.						
	Overall, the SI readings show that the remediation measures have been effective in mitigating the landslide at this site.

Negligible or minimal movement was observed on the three SIs (SI18-P10, SI18-P30 and SI18-P50) located further west of the wall; however, some movement is being recorded on SI18-70, the one that is located at the east end of the retaining wall. The site inspection performed at this site over the last few years has recorded tension cracks on the pavement near the east end of the wall; thus, it is possible that the distress observed on the pavement may be adding some load to the east end of the retaining wall reflecting on some movement recorded by the SI. Close monitoring of these tension cracks should be performed to allow for an assessment of whether the movement of the	Future Work:	The instruments should be read again during the spring of 2026.				
P10, S118-P30 and S118-P50) located further west of the wall; however, some movement is being recorded on S118-70, the one that is located at the east end of the retaining wall. The site inspection performed at this site over the last few years has recorded tension cracks on the pavement near the east end of the wall; thus, it is possible that the distress observed on the pavement may be adding some load to the east end of the retaining wall reflecting on some movement recorded by the SI. Close monitoring of these tension cracks should be performed to allow for an assessment of whether the movement of the	Instrumentation Repairs:	No instrument repairs are required at this time.

Additional Comments:	P10, S118-P30 and S118-P50) located further west of the wall; however, some movement is being recorded on S118-70, the one that is located at the east end of the retaining wall. The site inspection performed at this site over the last few years has recorded tension cracks on the pavement near the east end of the wall; thus, it is possible that the distress observed on the pavement may be adding some load to the east end of the retaining wall reflecting on some movement recorded by the SI. Close monitoring of these tension cracks should be performed to allow for an assessment of whether the movement of the
