**PEACE REGION – GRANDE PRAIRIE
GEOHAZARD RISK ASSESSMENT
SITE INSPECTION FORM**

SITE NUMBER GP-24	SITE NAME Hamelin Creek Slide BF-76987	HIGHWAY & KM Hwy 725:02	PREVIOUS INSPECTION DATE July 11, 2012	INSPECTION DATE May 22, 2013
LEGAL DESCRIPTION LSD 11-5-81-8-W6M	NAD 83 COORDINATES N 6,207,569 E 361,702	Previous Risk Assessment PF: 2 CF: 4 TOTAL: 8		
		CURRENT 2012 RISK ASSESSMENT PF: 2 CF: 4 TOTAL: 8

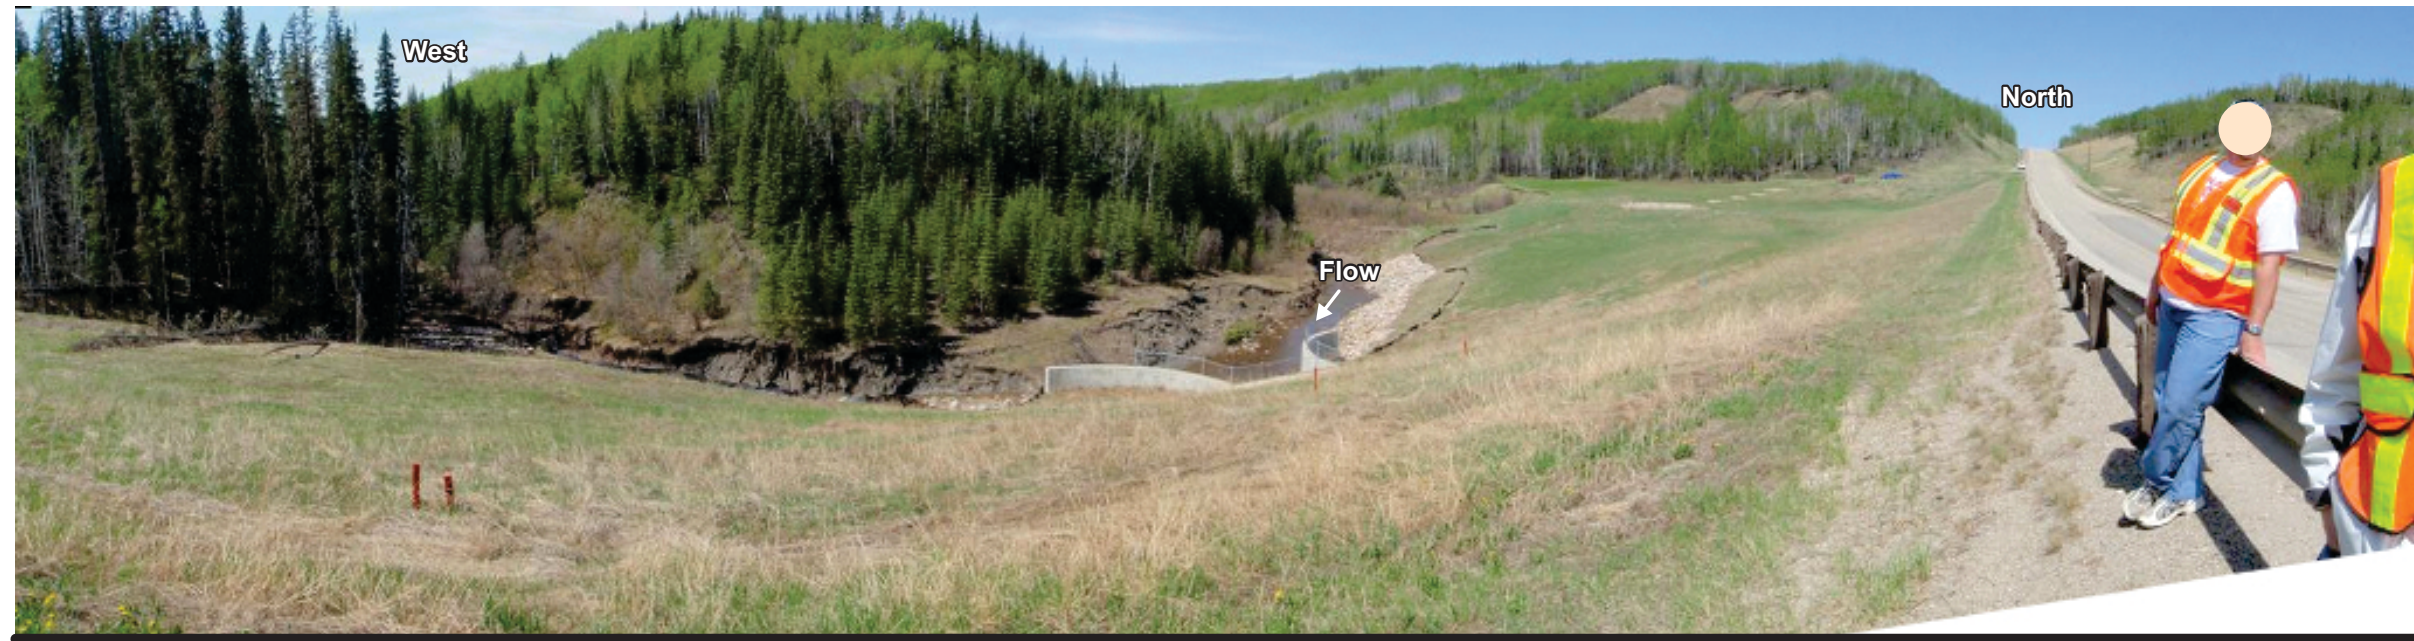
Photo 1

Looking west (toward upstream) and north (away from Hwy 49) from roadway edge guardrail (panorama view)

- Previous (2010) repair work on upstream side of road embankment still in good condition

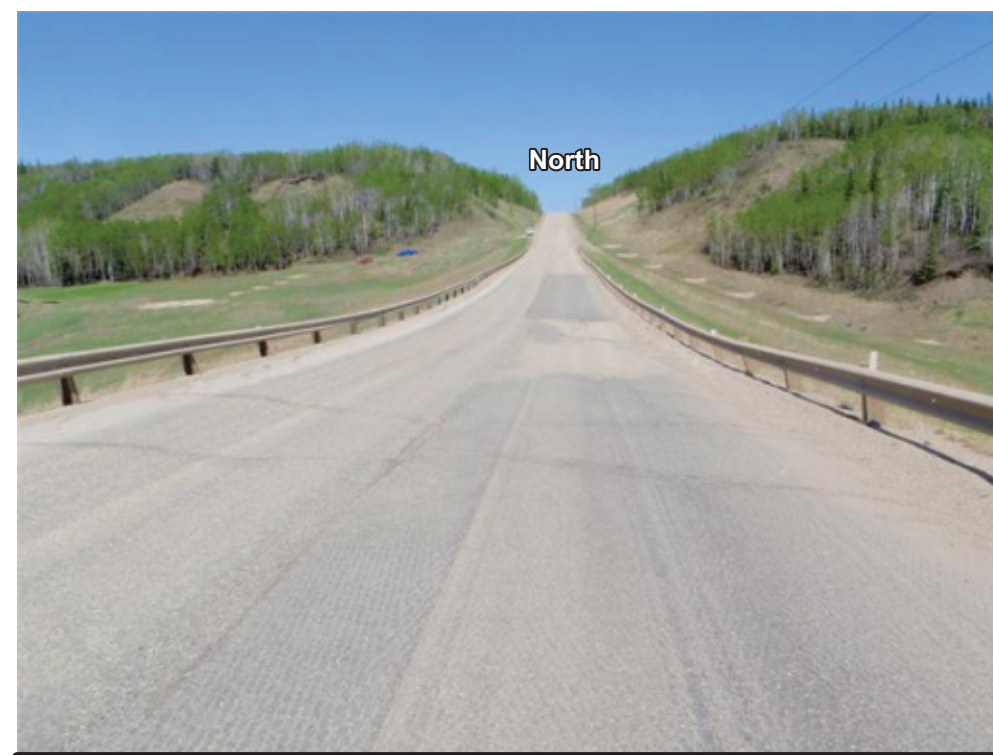
Photo 1a

Road pavement conditions on top of fill embankment – Looking north

- It seems apparent that previous fill settlement and pavement cracking has quiet down
- But some uneven sagging of fill needs to be leveling and smoothing for roadway serviceability

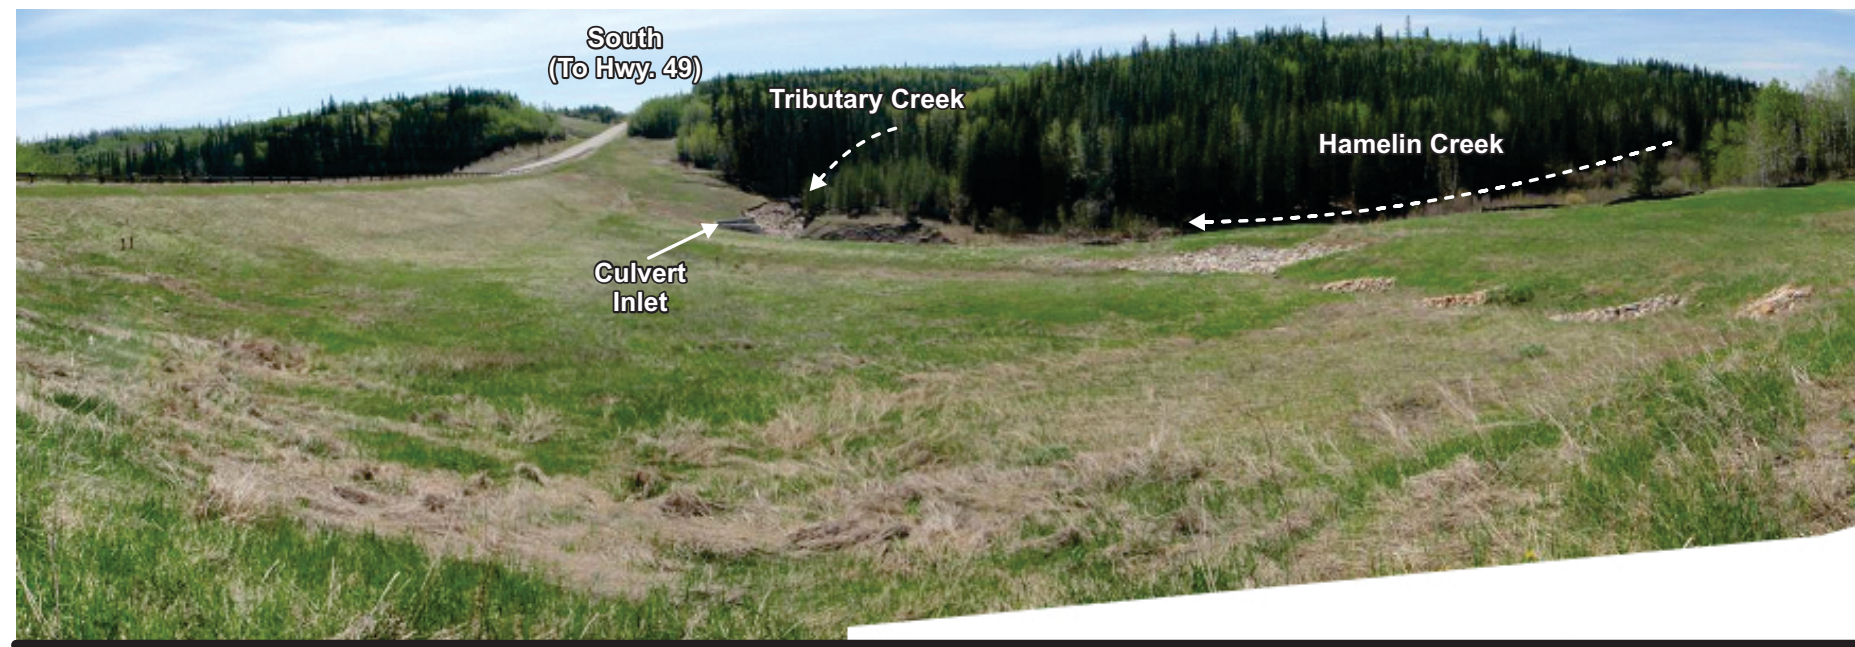
Photo 2

Looking west (toward upstream) and south (towards Hwy 49) showing Culvert Inlet

- Another Panorama view
- Previous (2010) repair work on upstream side of site still in good condition

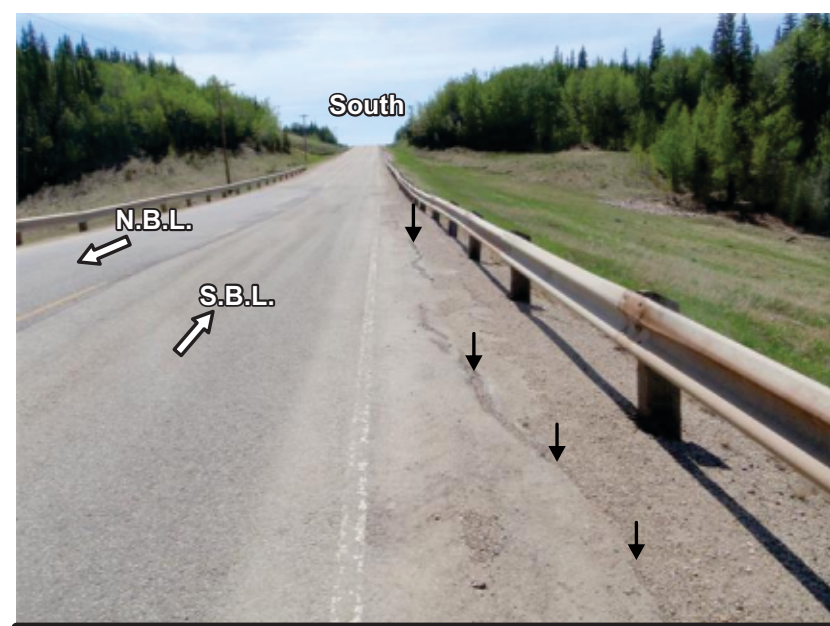
Photo 2a

Looking South

- Some relic tension crack along road edge at top of fill still visible
- Majority of lateral spreading and settlement of fill has quiet down in recent years
- A sag of pavement (settlement of fill) still evident on east side (north bound lane) and needs to be filled in and levelled to smooth over

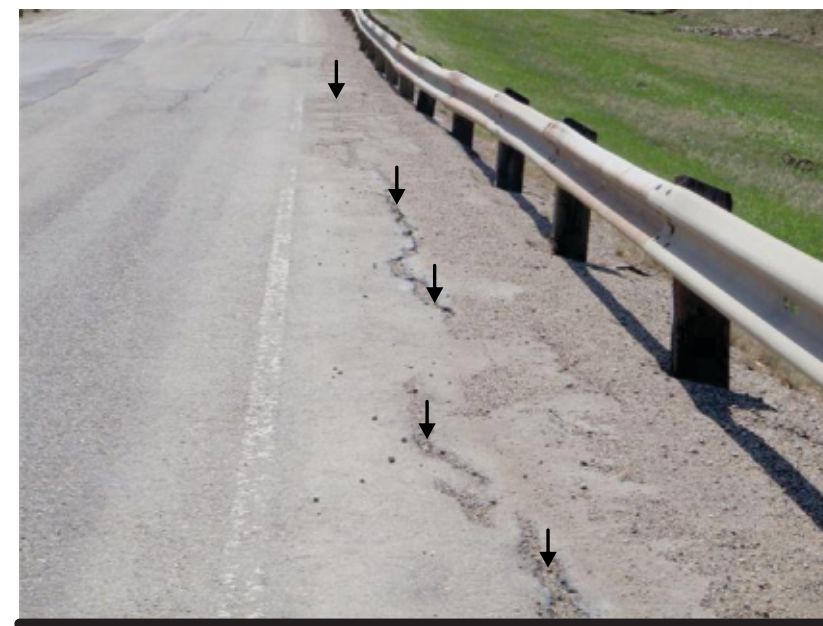
Photo 2b

Looking South

- Some relic tension crack along road edge at top of fill still visible
- Majority of lateral spreading and settlement of fill has quiet down in recent years
- A sag of pavement (settlement of fill) still evident on east side (north bound lane) and needs to be filled in and levelled to smooth over

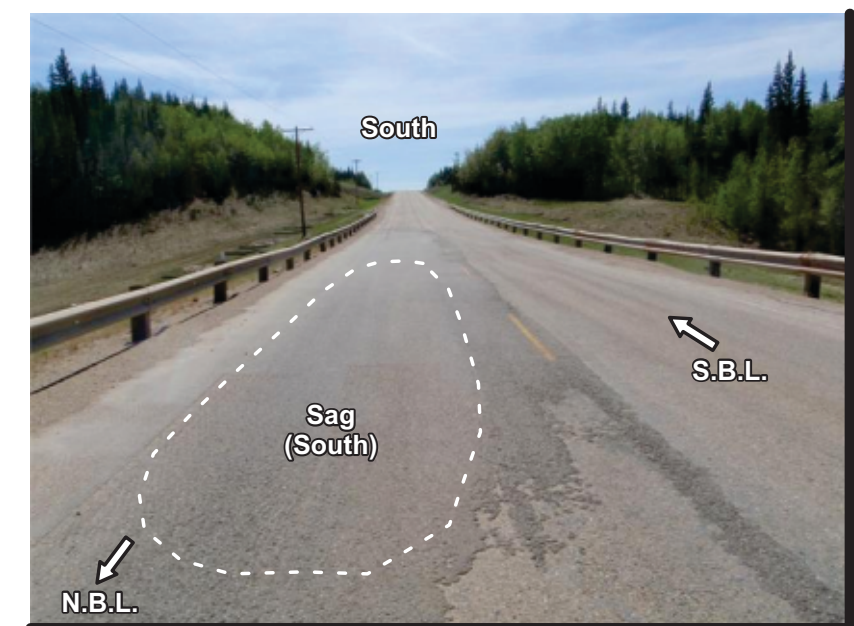
Photo 2c

Looking South

- Some relic tension crack along road edge at top of fill still visible
- Majority of lateral spreading and settlement of fill has quiet down in recent years
- A sag of pavement (settlement of fill) still evident on east side (north bound lane) and needs to be filled in and levelled to smooth over

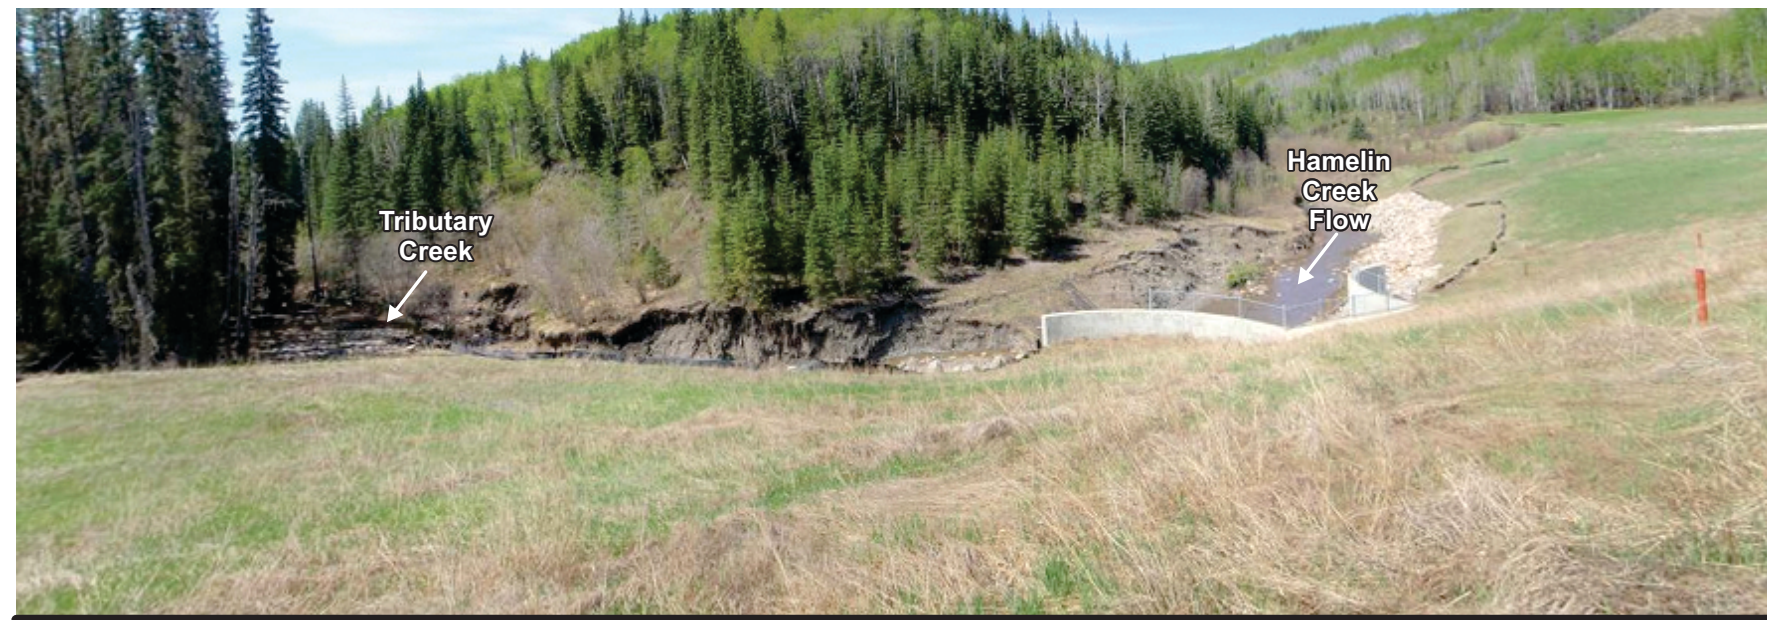
Photo 3
Looking upstream at Hamelin Creek and at Tributary Creek

- Opposite bank and valley slope of Hamelin Creek was eroded steeply
- Bank on highway side well protected by recent (2010) bank armouring
- Previous (2010) repair work on upstream side of site still in good condition
- Culvert Inlet and channel thorough-way looked unblocked

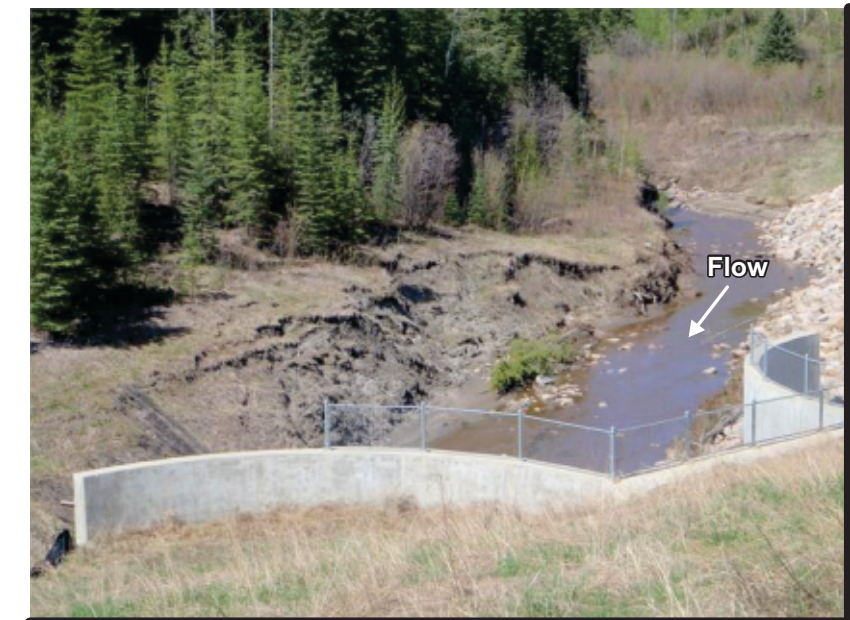
Photo 3a
Looking upstream at Hamelin Creek and at Tributary Creek

- Opposite bank and valley slope of Hamelin Creek was eroded steeply
- Bank on highway side well protected by recent (2010) bank armouring
- Previous (2010) repair work on upstream side of site still in good condition
- Culvert Inlet and channel thorough-way looked unblocked

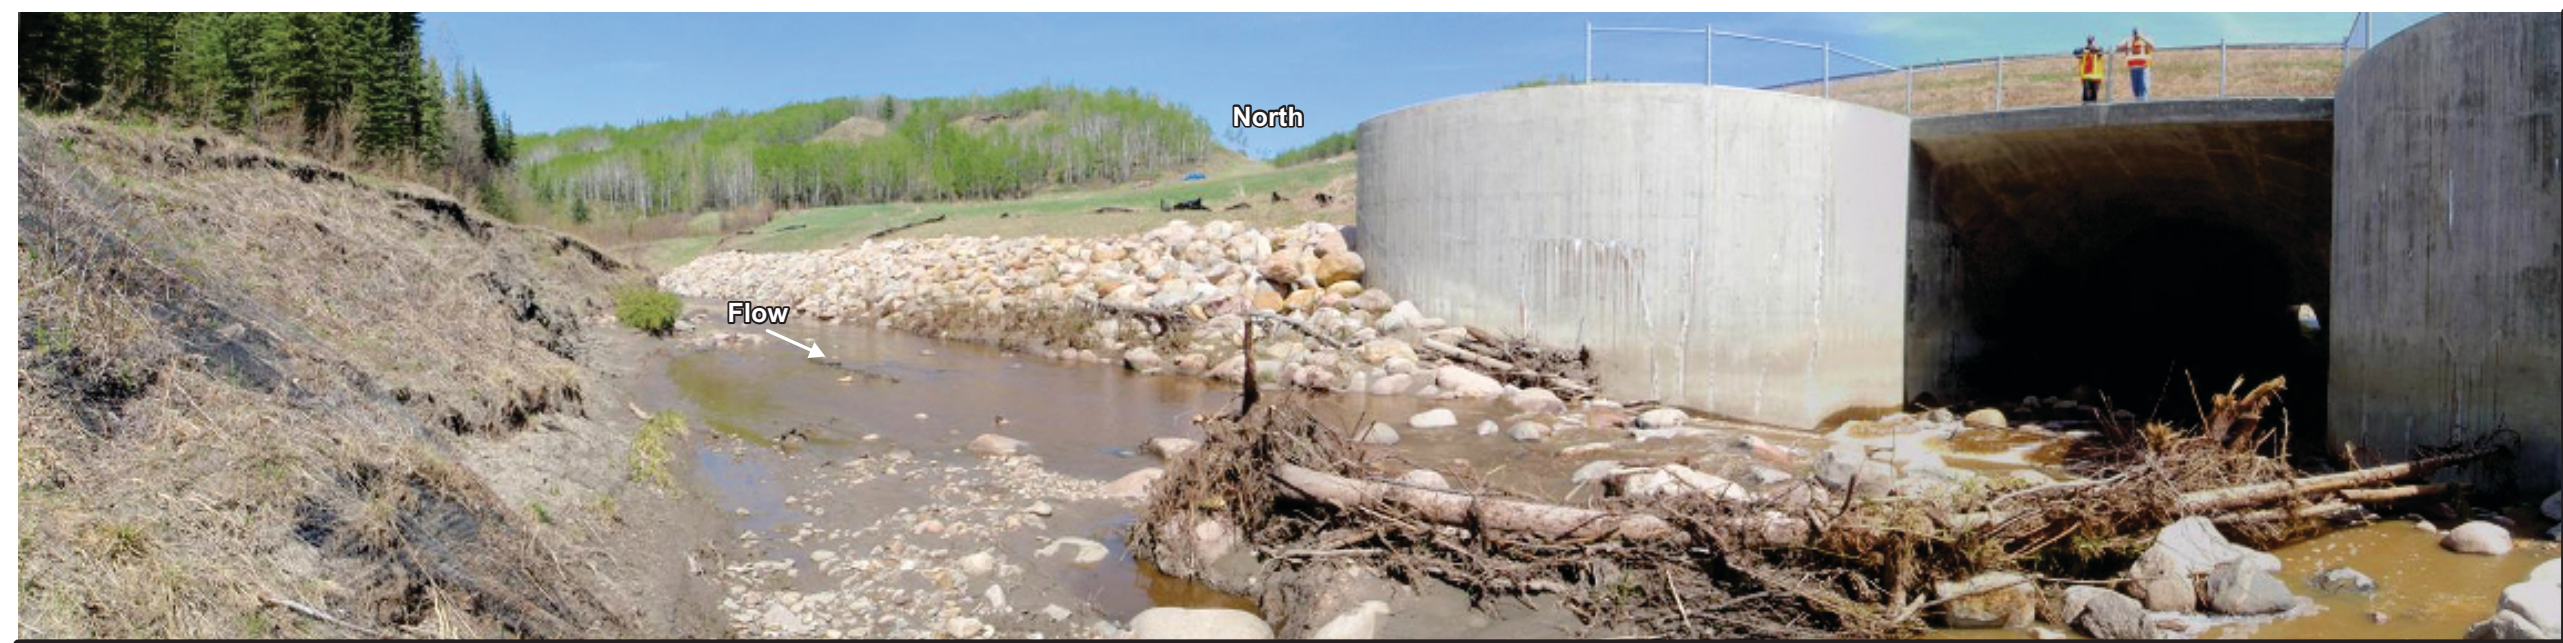
Photo 3b
Looking upstream at Hamelin Creek and at Tributary Creek

- Opposite bank and valley slope of Hamelin Creek was eroded steeply
- Bank on highway side well protected by recent (2010) bank armouring
- Previous (2010) repair work on upstream side of site still in good condition (right of photo)
- Culvert Inlet and channel thorough-way looked unblocked

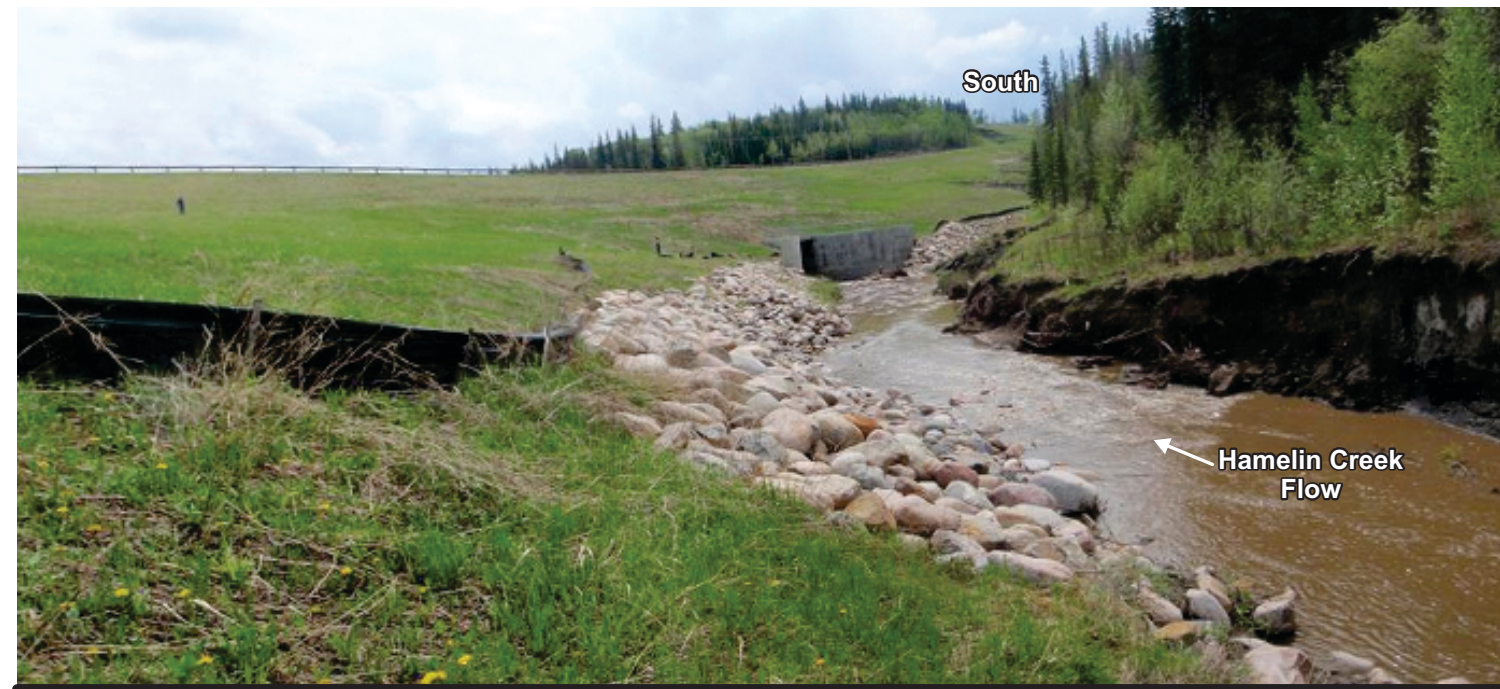
Photo 4

Another view with Culvert Inlet and upstream of Hamelin Creek - Looking downstream

- Recent (2010) bank armour riprap performing well

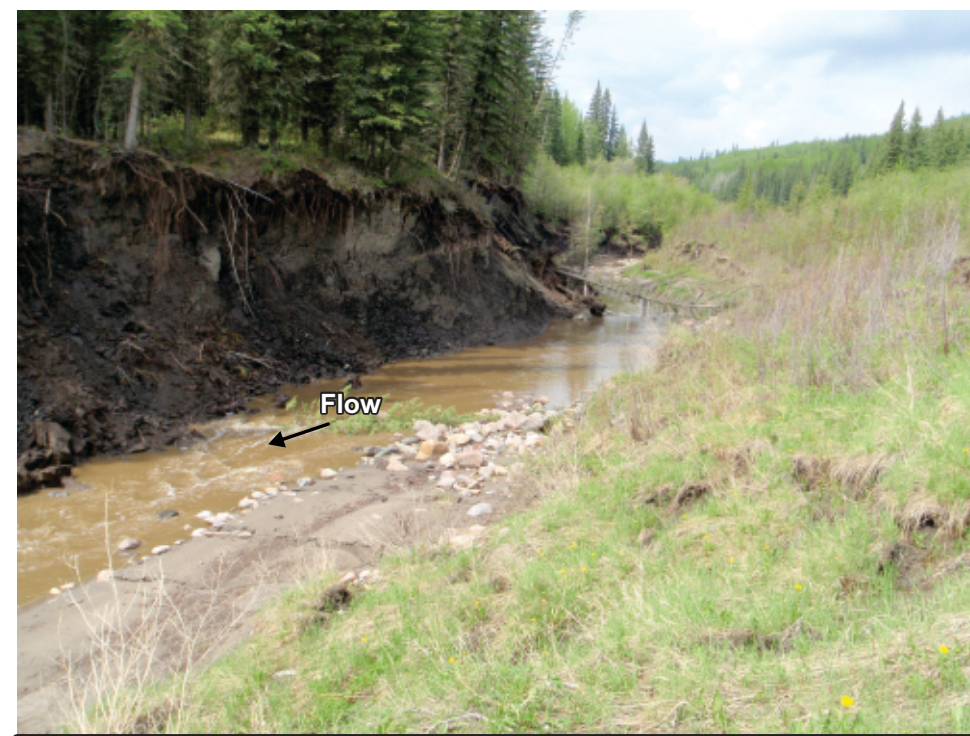
Photo 4a

Upstream of Hamelin Creek - Looking upstream

- No drastic of channel downcut towards upstream apparent

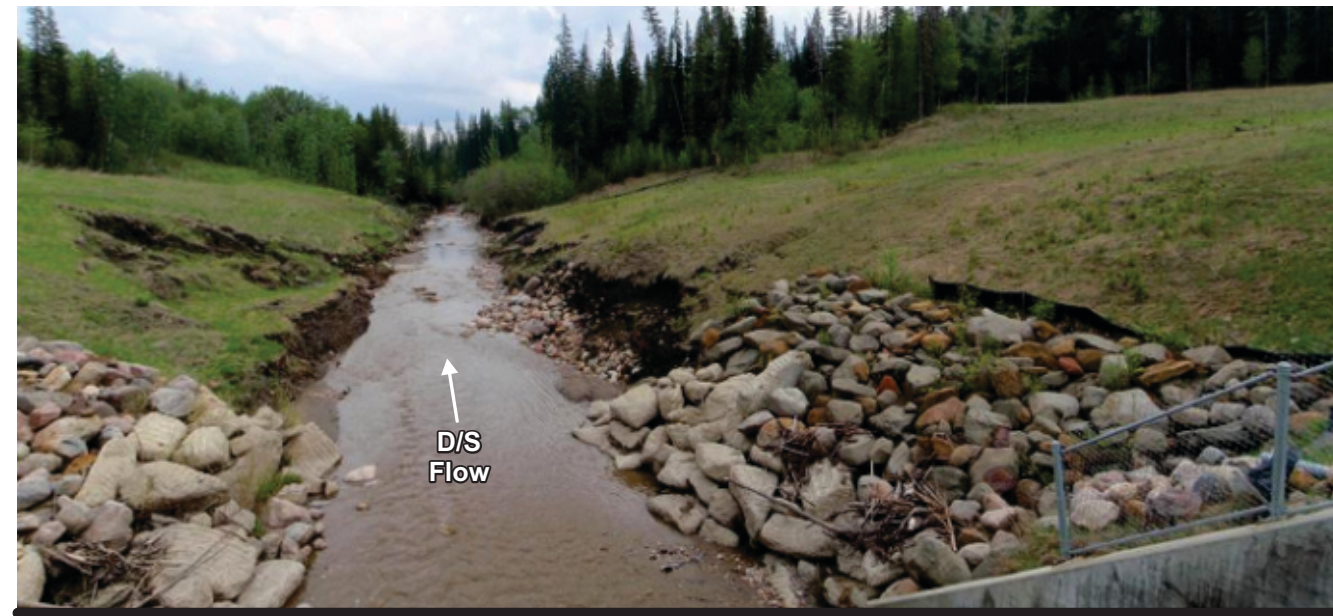
Photo 5

- A view of downstream straight channel (from top of concrete box culvert outlet at toe of fill)**
- Severe bank slumping sliding along north (left) side of channel bank
 - Steepening of bank eroded along both left and right (both north and south) sides of channel bank

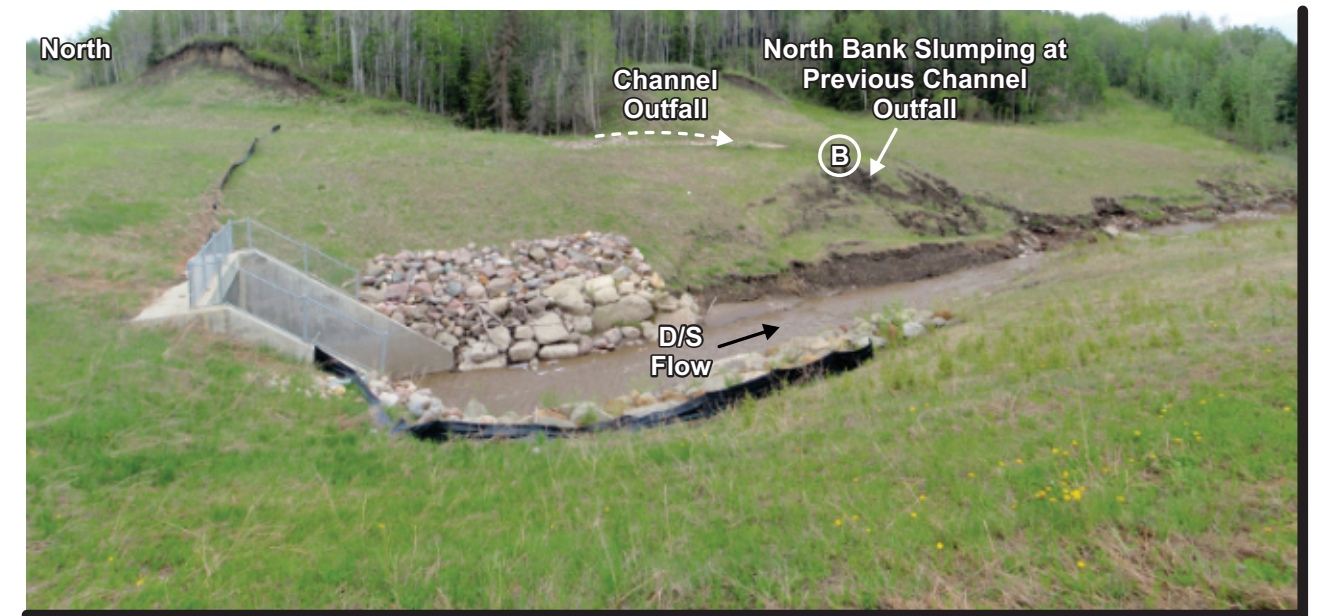
Photo 5a

- A view of north bank of downstream channel from opposite side of channel**
- Riprap bank immediately to culvert outlet in good condition
 - But, adjacent bank slump sliding of channel bank occurring at a previous ditch channel outfall location (B) along north side
 - Previous channel outfall riprap pad (B) and its concrete housing was eroded

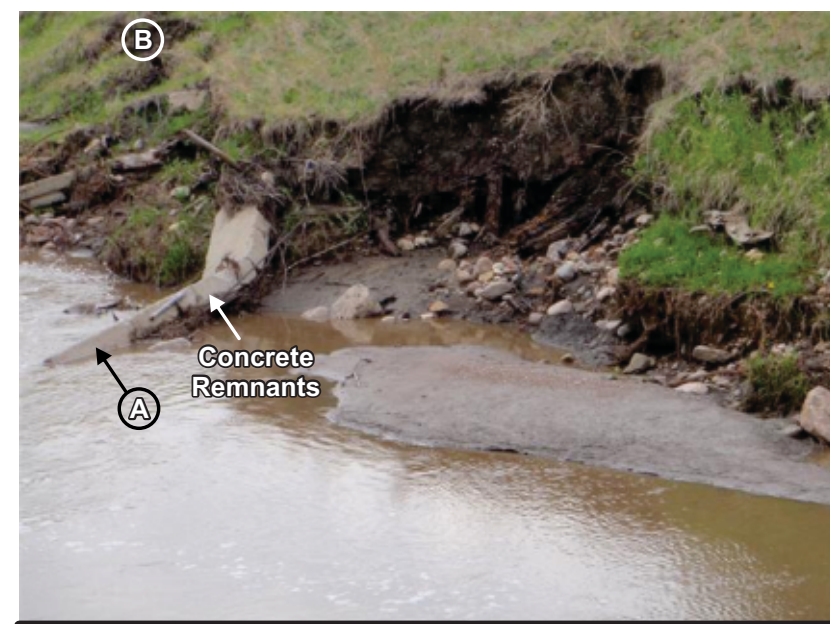
Photo 5b

- North bank slumping failure**
- Close up of bank area of eroded riprap pad and concrete housing

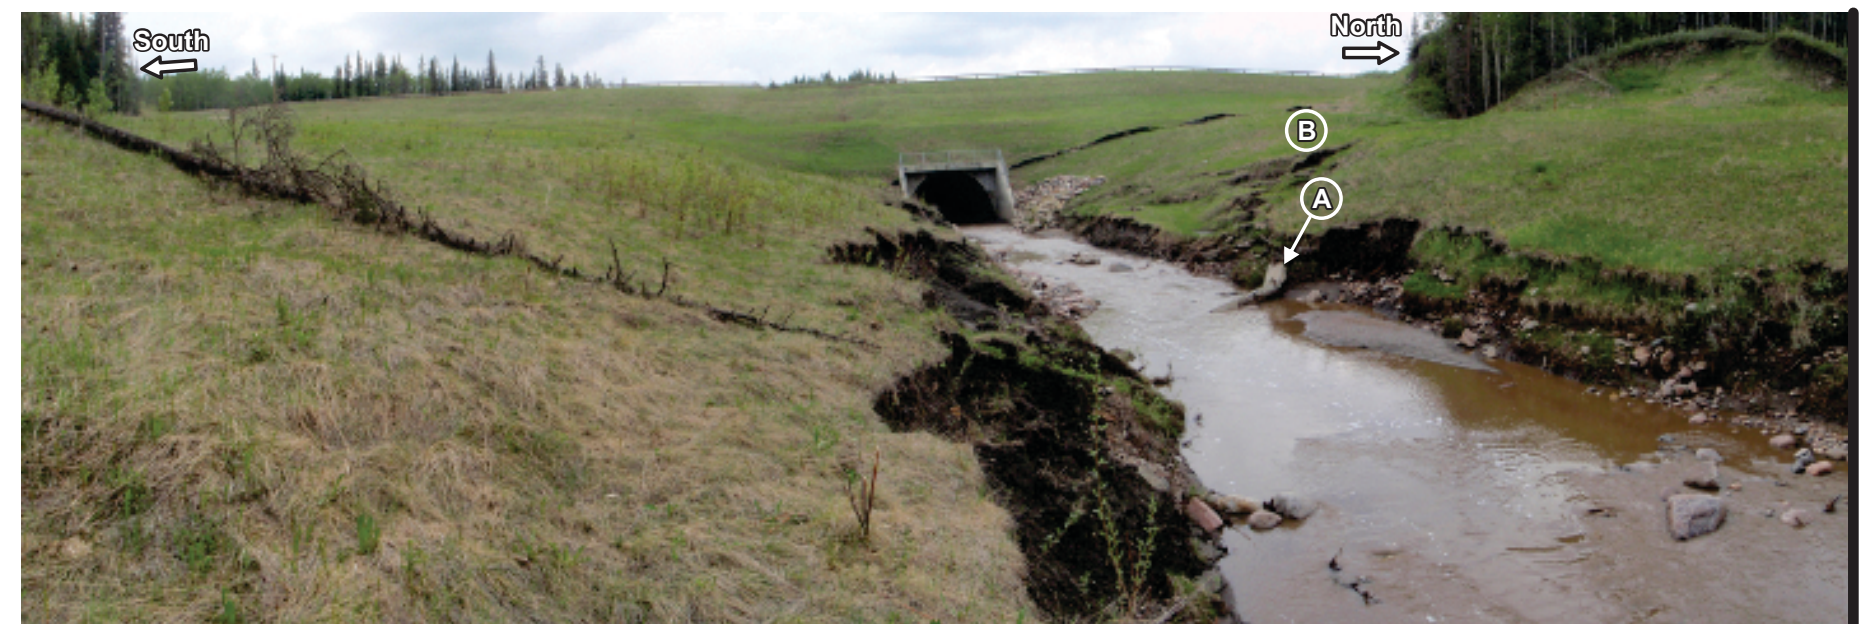
Photo 5c

- Looking upstream at culvert outlet (box culvert)**
- A steepening of both banks along this straight reconstructed downstream channel
