**PEACE REGION – GRANDE PRAIRIE  
GEOHAZARD RISK ASSESSMENT  
SITE INSPECTION FORM**

SITE NUMBER GP-24	SITE NAME Hamelin Creek Slide BF-76987	HIGHWAY & KM Hwy 725:02	PREVIOUS INSPECTION DATE May 22, 2013	INSPECTION DATE May 28, 2014
LEGAL DESCRIPTION LSD 11-5-81-8-W6M	NAD 83 COORDINATES N 6,207,569 E 361,702	Previous Risk Assessment PF: 2                      CF: 4                      TOTAL: 8		
		<b>CURRENT 2012 RISK ASSESSMENT</b> <b>PF: 2                      CF: 4                      TOTAL: 8</b>

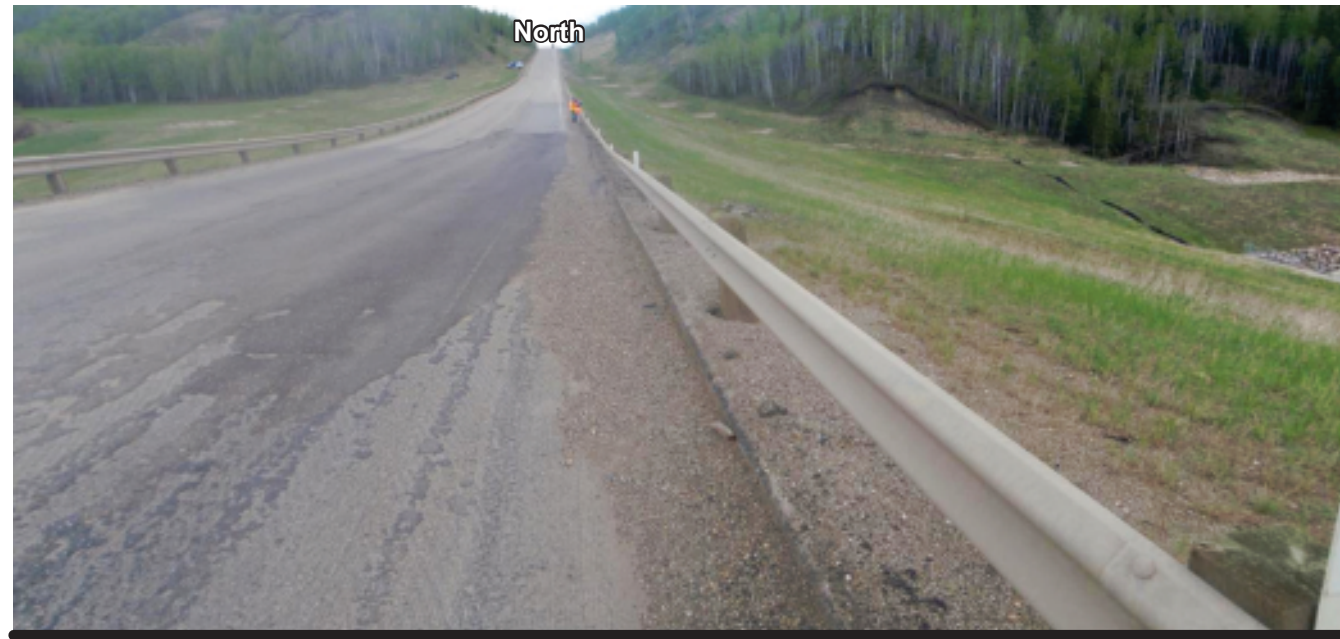
**Photo 1**

**Looking north (away from Hwy 49) and east shoulder**

- Fill embankment in good condition
- Pavement is rough and undulating due to previous settlement which seemed stabilised

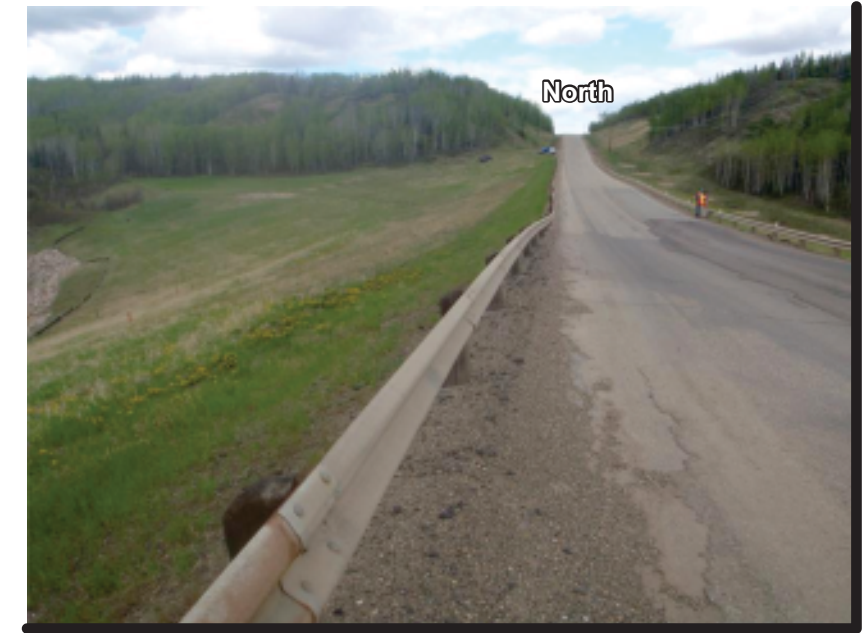
**Photo 1a**

**Another view of pavement along west shoulder**

- Another view of fill embankment and pavement

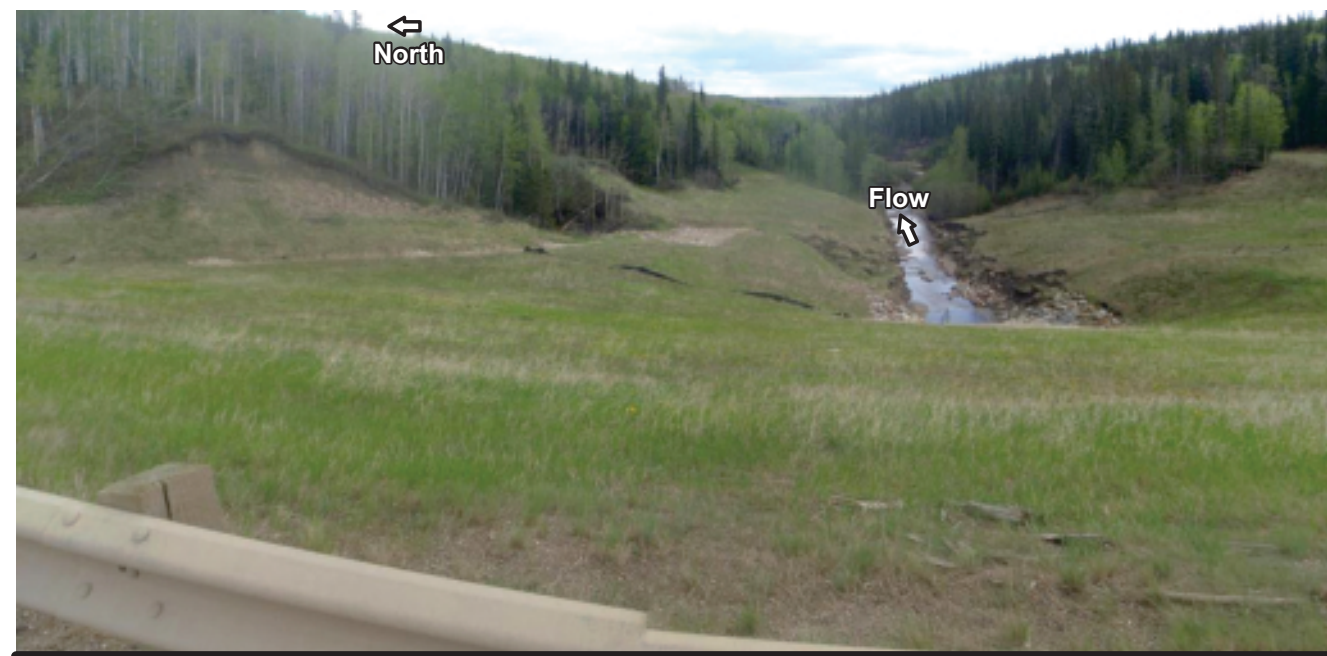
**Photo 1b**

**Looking east at downstream of Hamelin Creek**

- Fill embankment looked OK
