ALBERTA TRANSPORTATION AND ECONOMIC CORRIDORS GRMP PEACE RIVER REGION – (GRANDE PRAIRIE DISTRICT - NORTH) INSTRUMENTATION MONITORING - SPRING 2025

Site Number	Location	Name	Hwy	km
GP024	HWY 725:02 C1 17.41	Hamelin Creek	725:02	Km 17.4
Legal Description	n: 11-5-81-8 W6	UTM Co-ordinates		
		11U E 361702.73	N 62	07568.73

Current Monitoring:	13-June-2025	Previous Monitoring	29-May-2024
Instruments Read By:	Mr. Niraj Regmi, G.	I.T and Mr. Godfred Etiendem, of Thur	ber

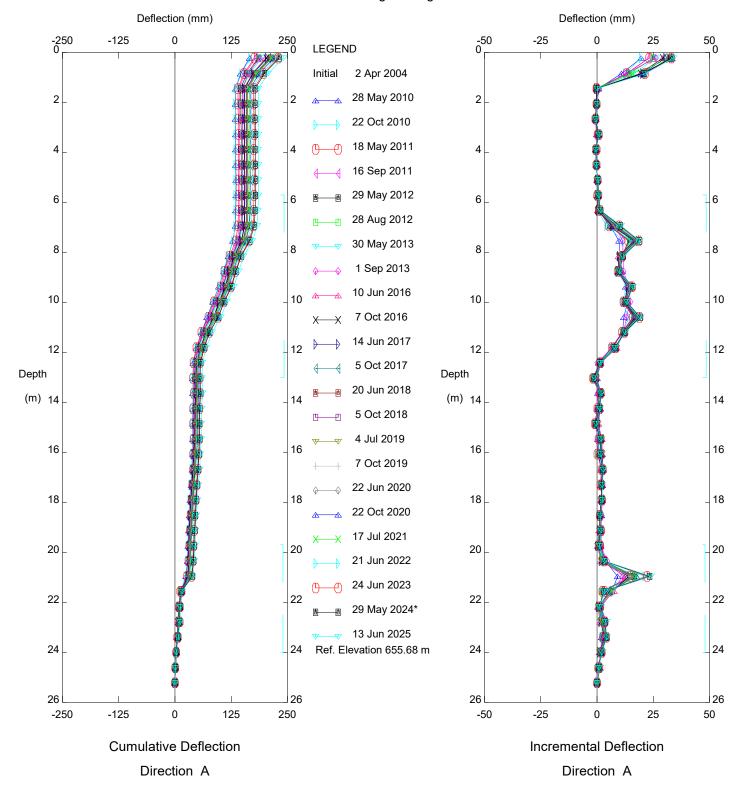
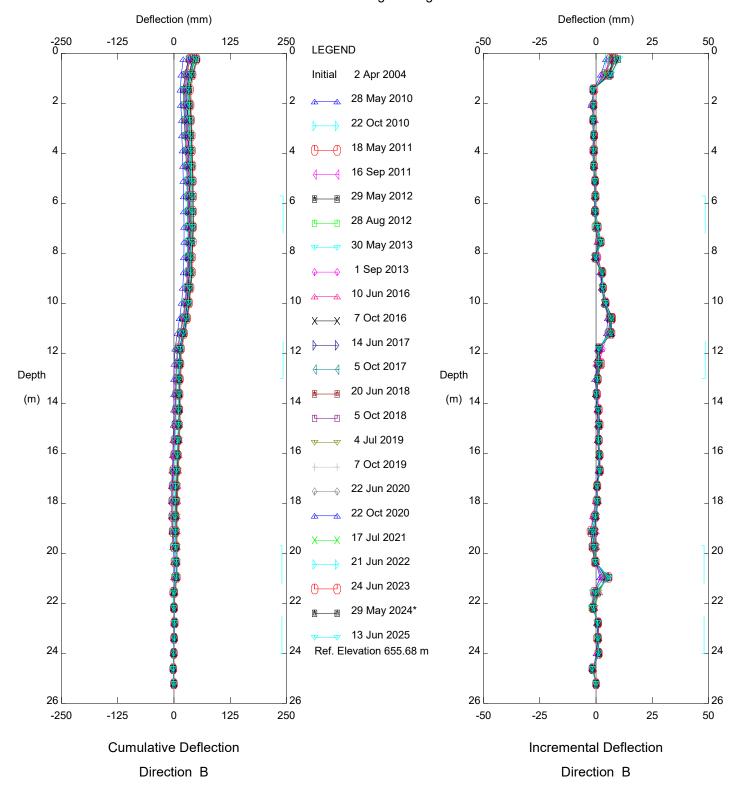
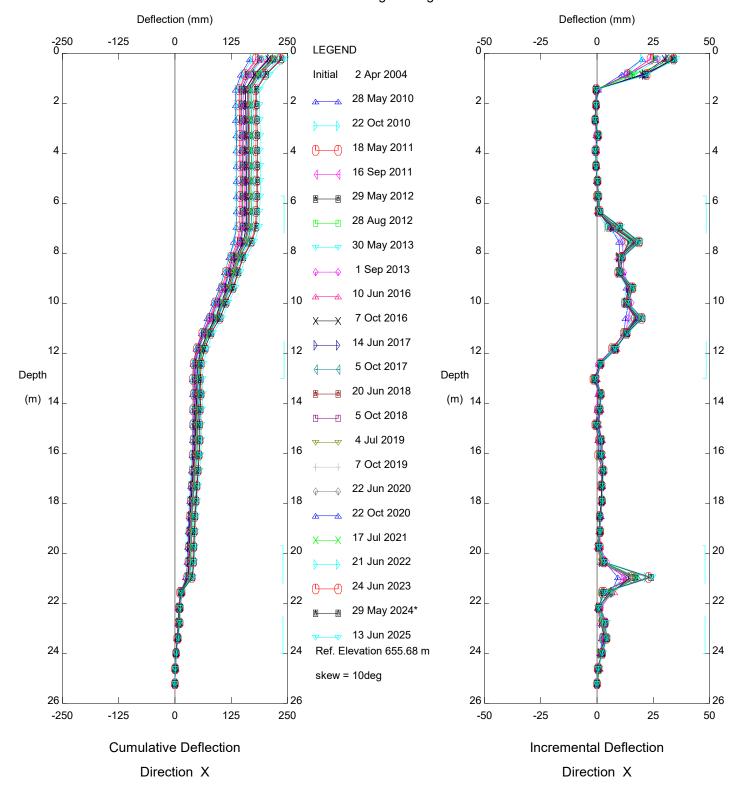
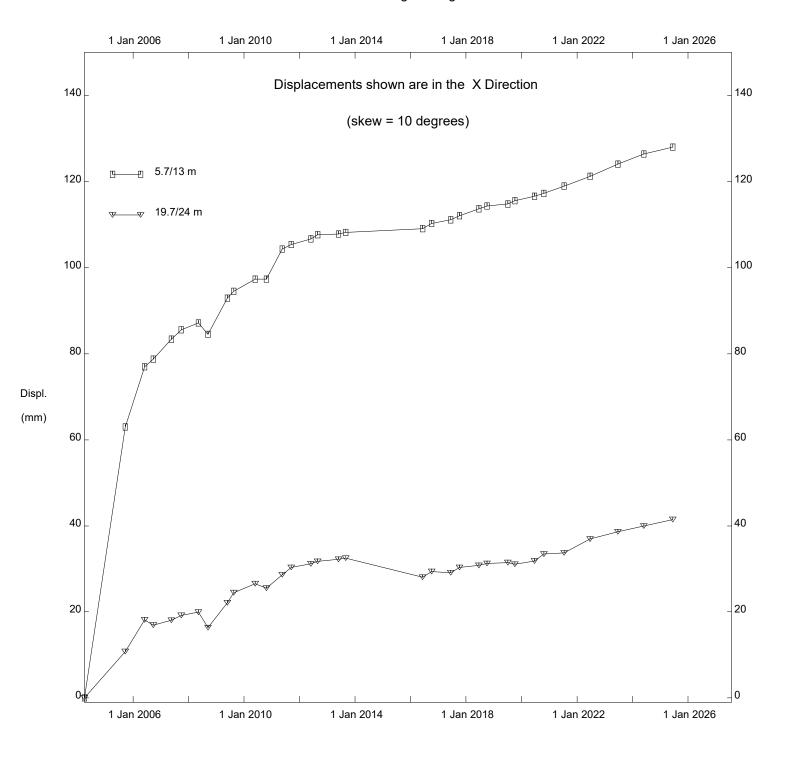
GP024 Hamelin Creek, Inclinometer HC04-3

Discussion
Zones of New Movement:	None
	Slope inclinometer HC04-3, located on the west embankment slope, showed rates of movement less than 0.1 mm/yr over 5.7 m to 13.0 m depth and 19.7 m to 24.0 m depth, since the spring of 2024 readings.
	SI06-08, located on the east embankment slope, showed a rate of movement of 0.6 mm/yr over 2.8 m to 5.2 m depth since the spring of 2024 readings. Both remaining SIs at this site have shown an overall consistent trend of movement for the past several years.
Interpretation of Monitoring Results:	Pneumatic piezometer PN03-06A and PN06-05 showed decreases in groundwater level of 0.03 m and 0.11 m, respectively since the spring of 2024 readings. Pneumatic piezometers PN06-2 and PN06-04 showed increases in groundwater level of 0.02 m and 0.13 m, respectively, since the spring of 2024 readings. Pneumatic piezometer PN06-08 showed no change in groundwater level since the spring of 2024.

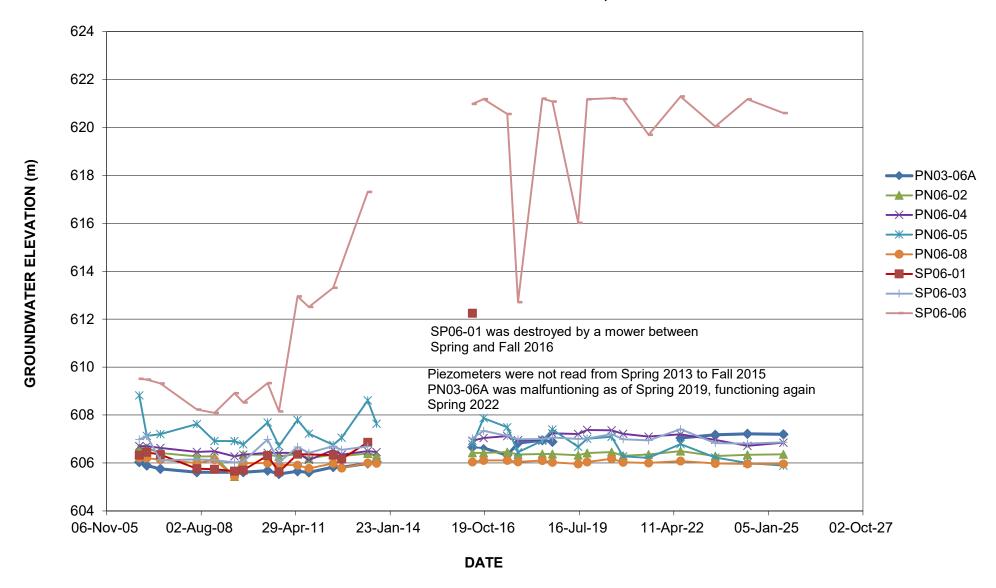
FIGURE GP024-1
PIEZOMETRIC ELEVATIONS FOR HWY 725:02, HAMELIN CREEK

Standpipe piezometer SP06-03 showed an increase in groundwater levels of 0.02 m since the spring of 2024 readings. Standpipe piezometer SP06-06 showed a decrease in groundwater level of 0.57 m since the spring of 2024 readings.
