Slide Name: (GP 26) Ditch Erosion South of Grande Cache
(GP 27) Ditch Erosion North of Grande Cache
Inspection Date: May 6, 2005
Inspection by: Alberta Infrastructure & Transportation and EBA staff listed on Page 1

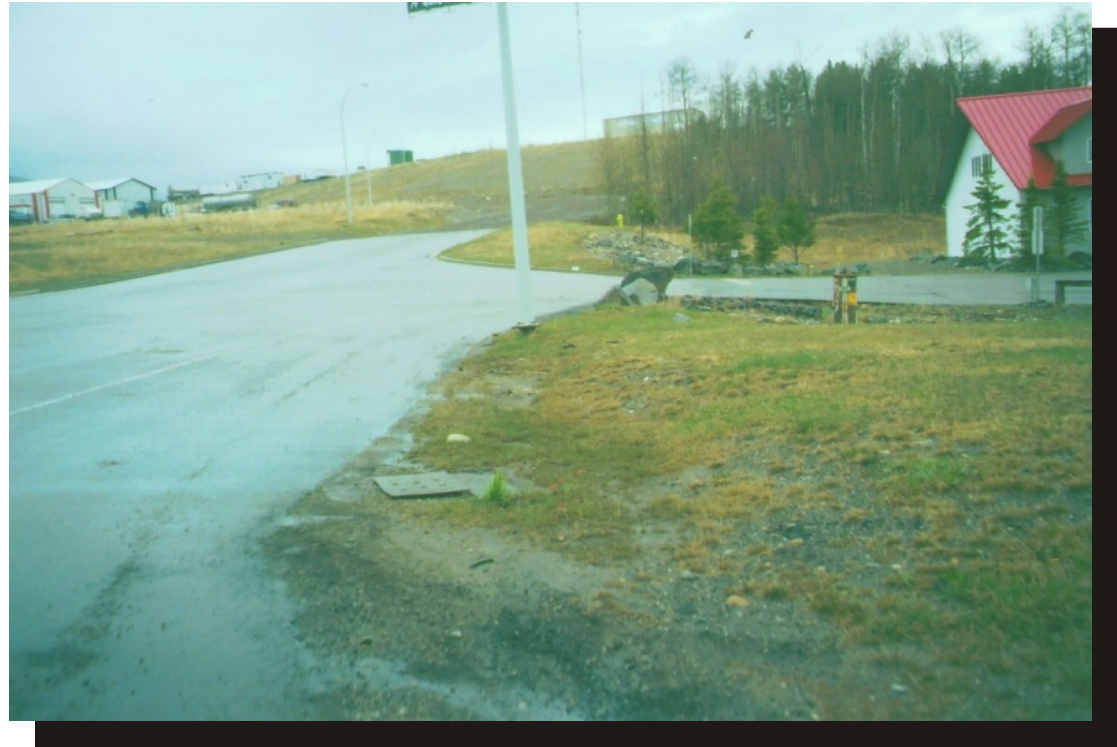
Photo 1

Looking North Towards Town - Top End of South Ditch - Ditch flows south (downgrade) at Tourist Information Centre at south edge of town.

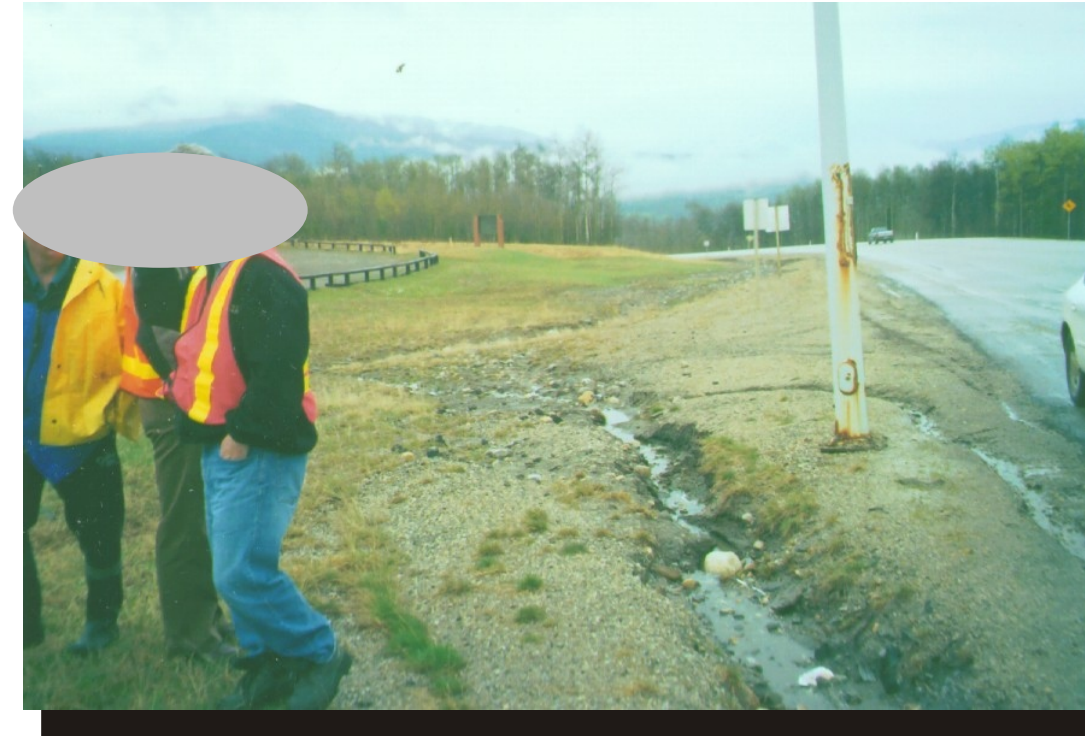
Photo 3

Looking Downgrade South - Minor erosion along roadside. Water flow to a catch basin into a culvert across road to outfall at side slope on right side of photo.

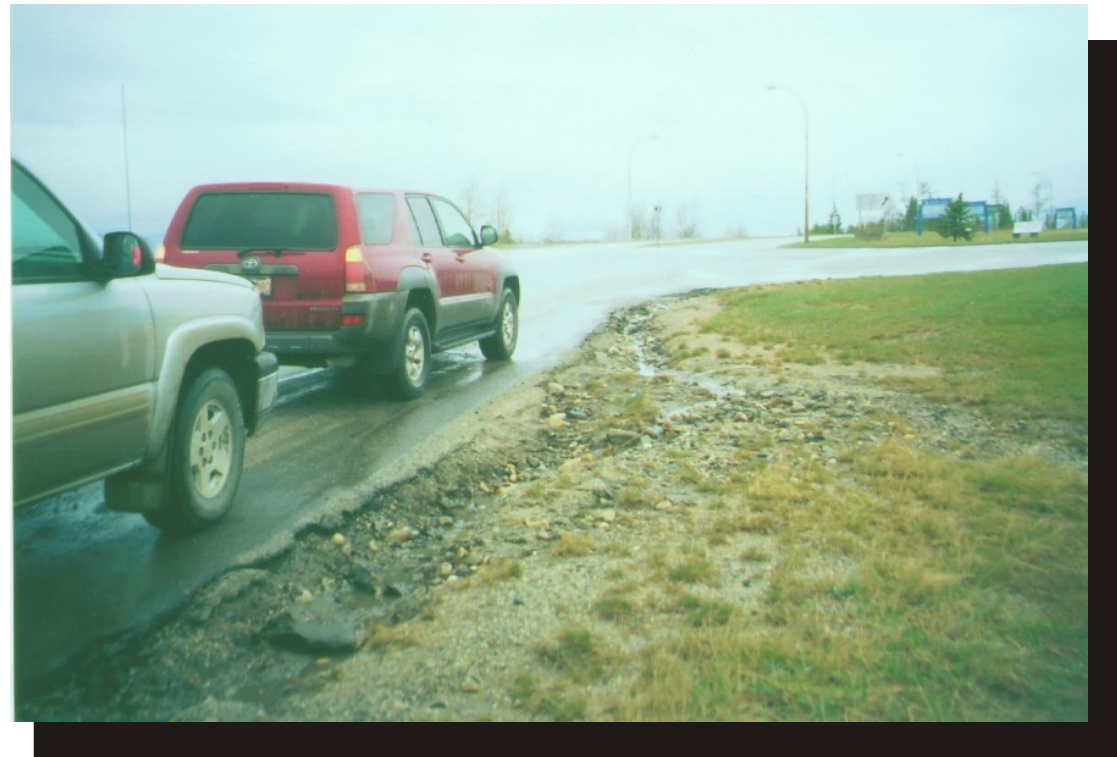
Photo 2

Looking North - Roadside erosion along side slope at south edge of town just before approach to Tourist Information Centre. Surface water flows to a catch basin (at right bottom of photo) to connect to a culvert across highway to outfall to right (west) side of road.

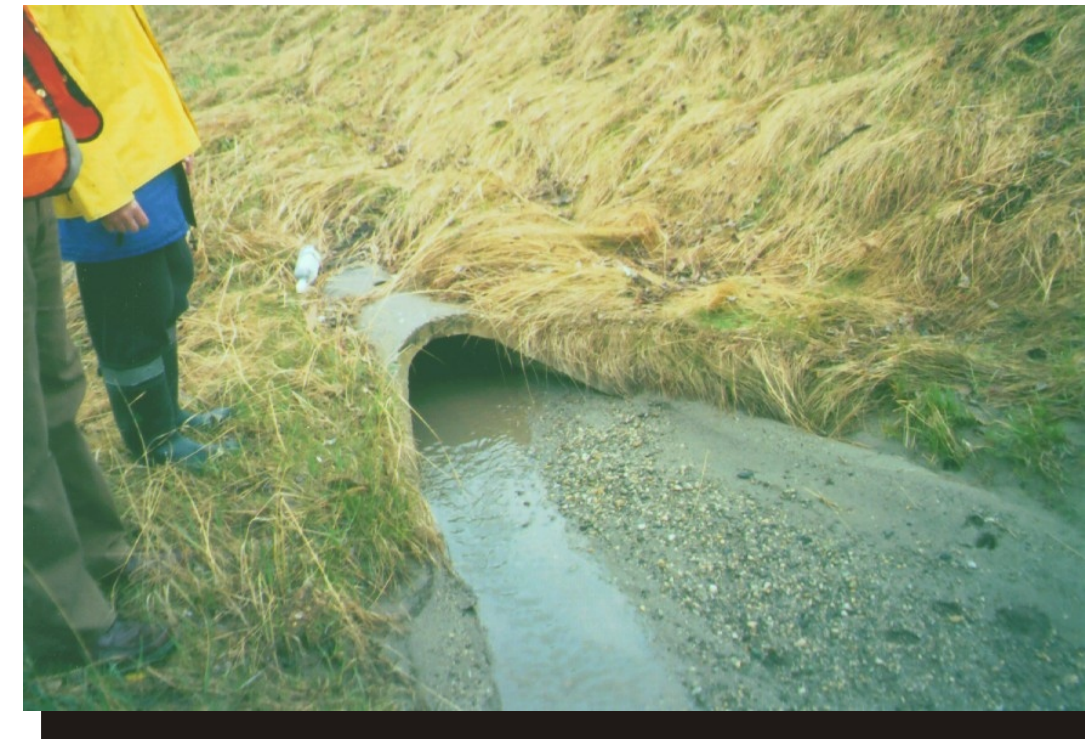
Photo 4

Outlet of culvert at side slope at right (west) side of road. Siltation requires maintenance clearance.

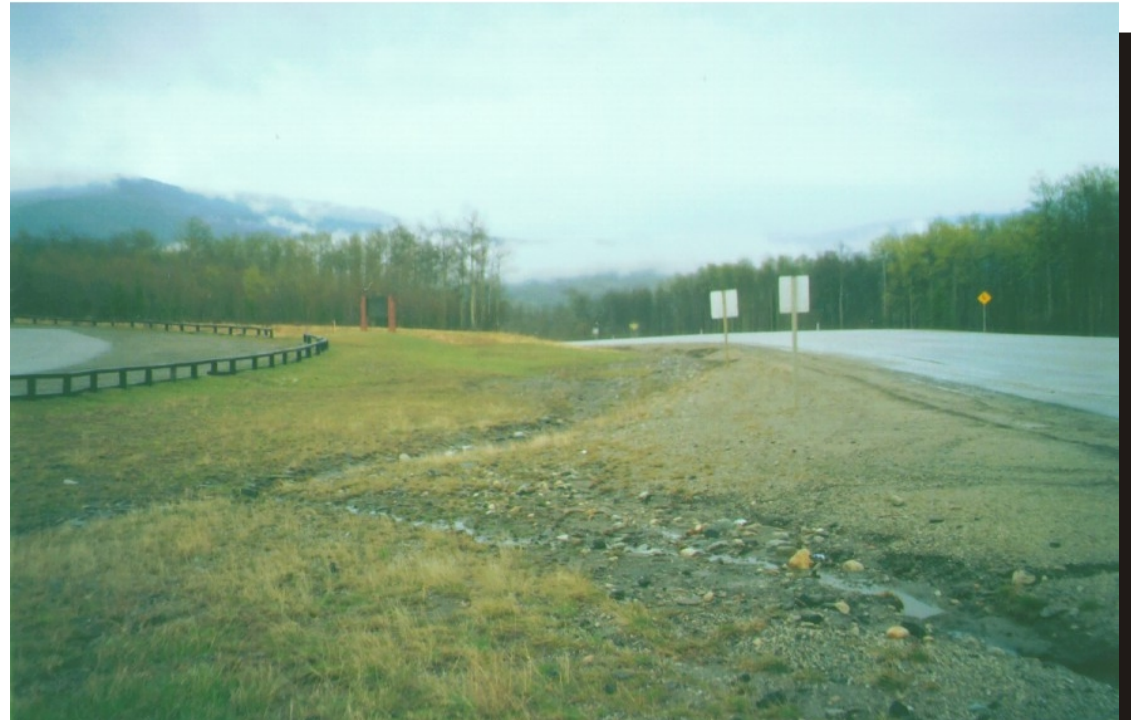
Photo 5

Looking downgrade south along east (backslope) ditch. Some surface water continues to flow from south edge of town down east (backslope) ditch along a curve.

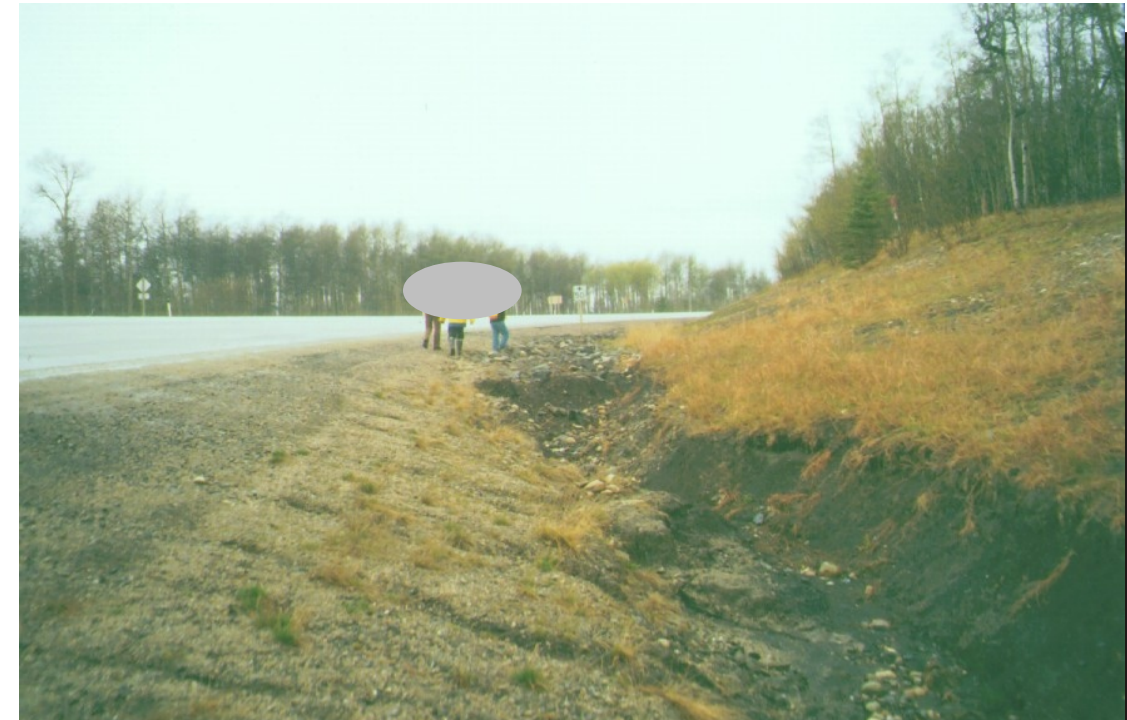
Photo 7

Looking upgrade north. Ditch erosion along 2nd 100 - 200m stretch downgrade (from 50km/hr signage). Steep erosion is severe and vertical scarp along highway subgrade is a safety

- A new ditch design should be considered. The possible design of drop structures to step down the steepness of the ditch grade and a new ditch cross-section design may be required. The use of hard armouring may be appropriate for this site.

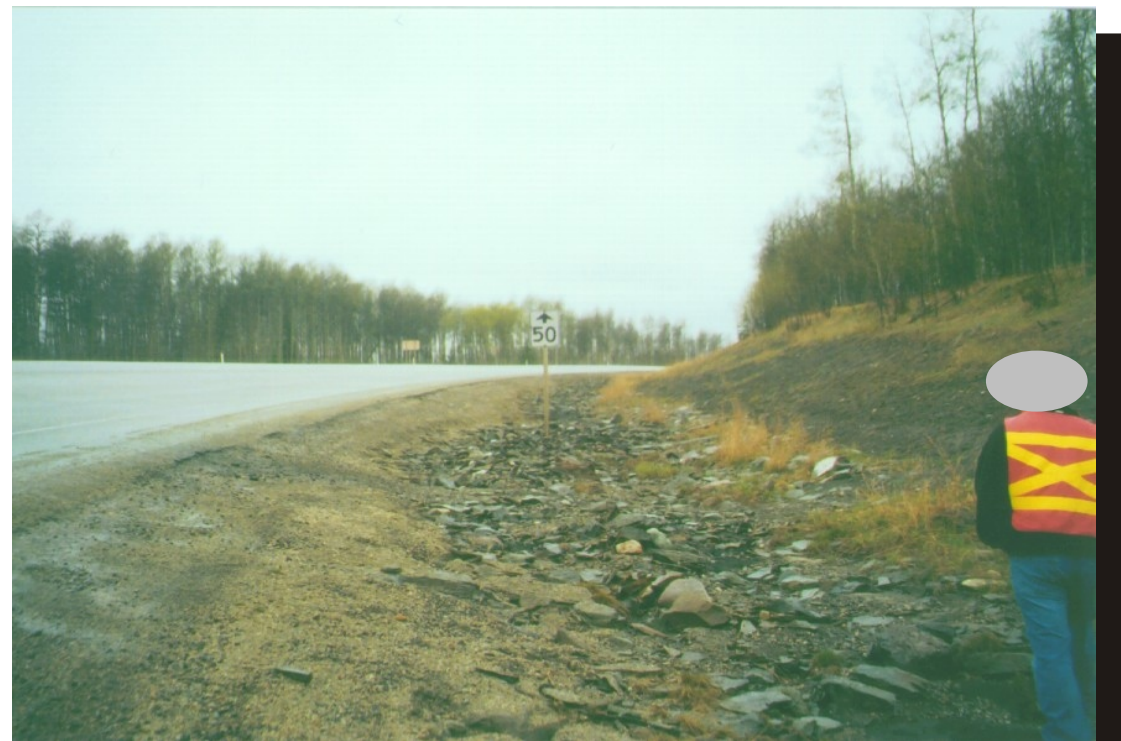
Photo 6

Looking upgrade north. Surface water flows down a curve along a ditch lined with random rock and geotextile underlay. Ditch is in workable condition along 1st 300m stretch downgrade (to the 50km/hr signage) from south edge of town.

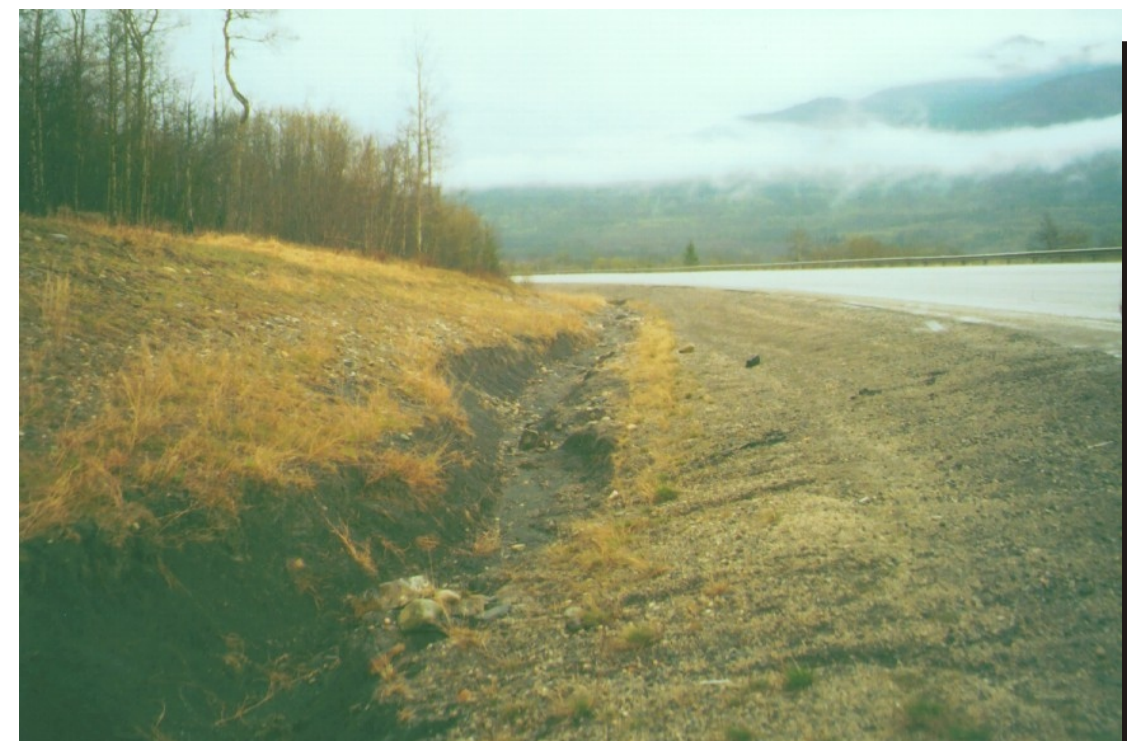
Photo 8

Looking downgrade south. Ditch erosion along 2nd 100 - 200m stretch downgrade. Steep erosion scarp along highway subgrade is a safety concern.

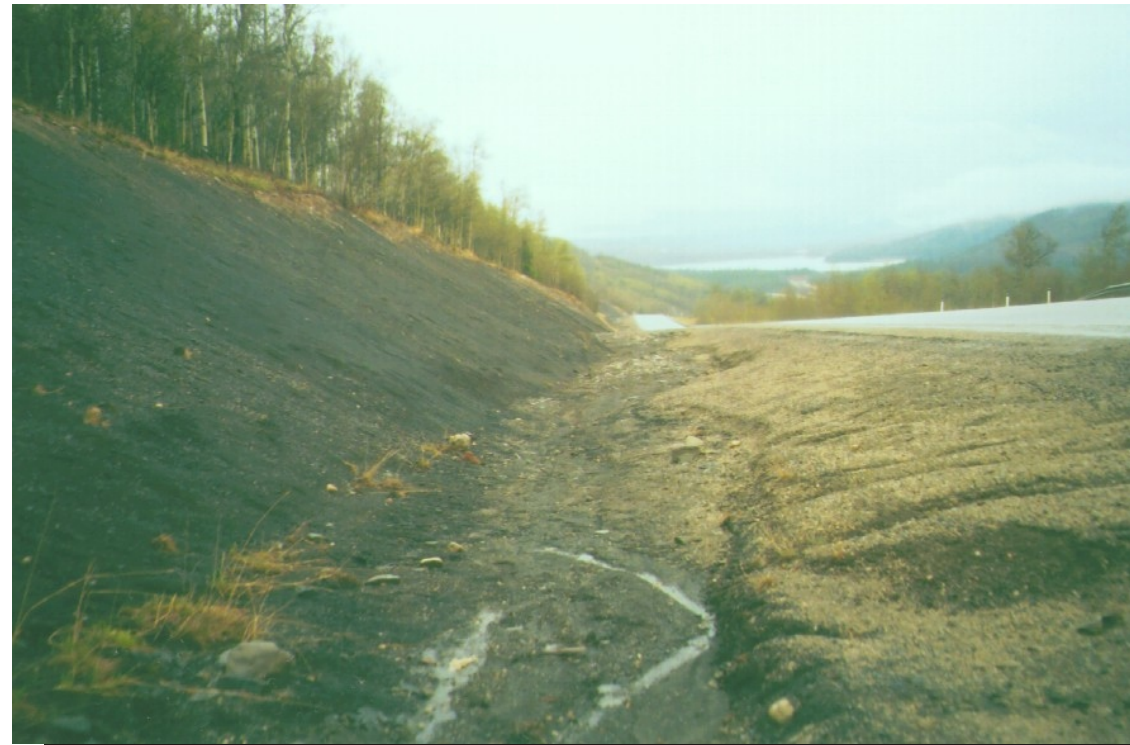
Photo 9
Looking downgrade south ditch erosion mildly severe along 3rd stretch
of 100m downgrade.

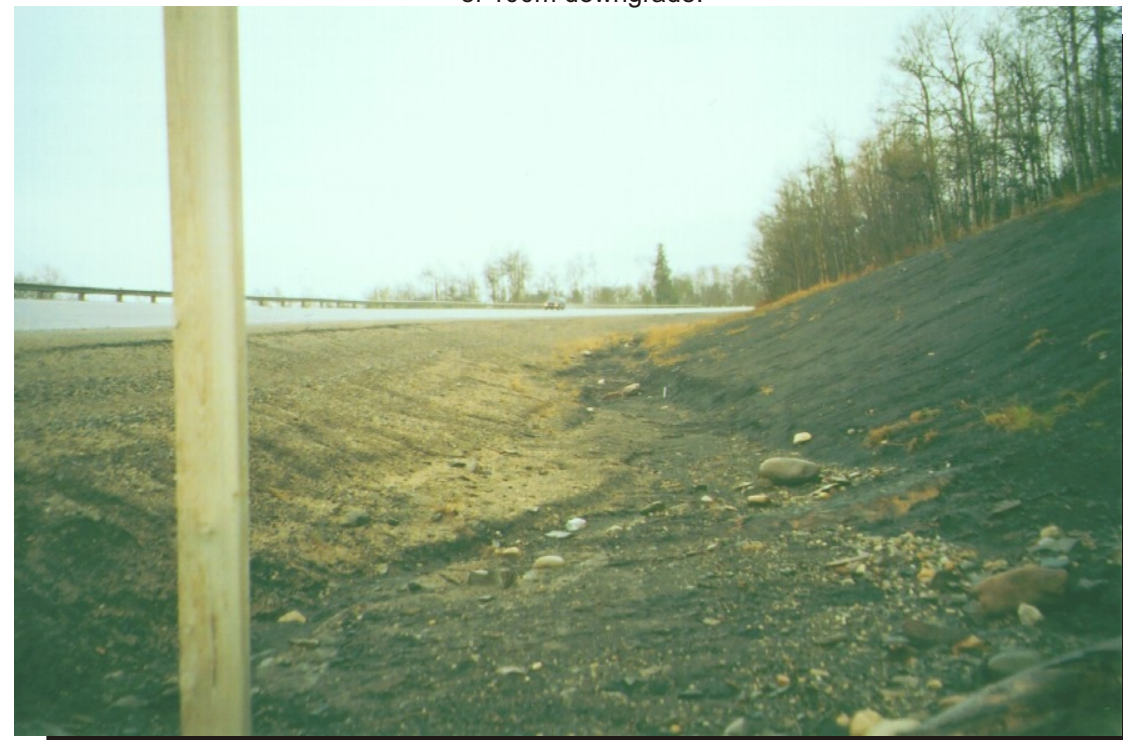
Photo 10
Looking upgrade north ditch erosion mildly severe along 3rd stretch
