<b>SITE NUMBER AND NAME:</b> GP026 Ditch Erosion South of Grande Cache		<b>HIGHWAY &amp; KM:</b> 40:34, 30.254	<b>PREVIOUS INSPECTION DATE:</b> June 13, 2023	<b>INSPECTION DATE:</b> <b>June 2, 2025</b>
<b>LEGAL DESCRIPTION:</b> NW/NE 34-56-08-W6M	<b>NAD 83 COORDINATES:</b> UTM    Northing    Easting 11       5973019    362260		<b>RISK ASSESSMENT:</b>  PF: 10    CF: 2    TOTAL: 20	
<b>AVERAGE ANNUAL DAILY TRAFFIC (AADT):</b> 1,660 (west) & 1,520 (east) (Reference No. 70000983, 2024)			<b>CONTRACT MAINTENANCE AREA (CMA):</b> 504

PROJECT  
PEACE REGION (GRANDE PRAIRIE DISTRICT-SOUTH)  
GEOHAZARD RISK MANAGEMENT PROGRAM

TITLE  
Site Plan  
GP026 - Ditch Erosion South of Grande Cache  
Hwy 40:34, km 30.254

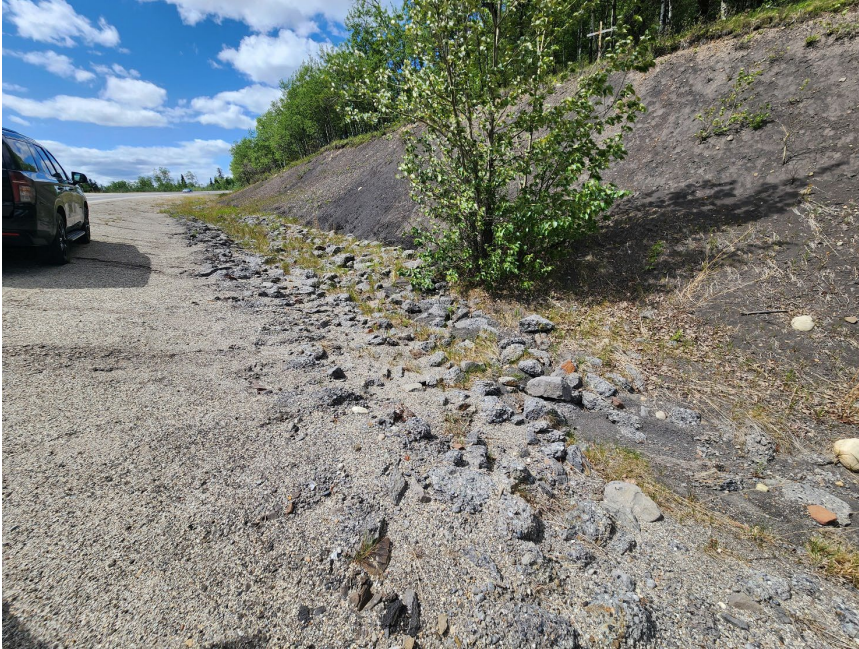
- An erosion feature in the north highway ditch was repaired in 2006 by placing riprap on a woven geotextile separating medium. The riprap was conglomerate from a nearby quarry and has since experienced various degrees of breakdown due to the matrix material for the conglomerate being sandstone with variable resistance to freeze-thaw particle breakdown. Sometime afterwards limestone or greywacke riprap from a nearby quarry was placed on the 2006 repair to augment the riprap armoring where conglomerate riprap had deteriorated due to freeze-thaw action. The eastern extent of the 2006 repair was approximately at WP032 (Photo 1).

- Within the 2006 repair area (upslope/west of WP032), the conglomerate riprap has experienced some breakdown, but has also become vegetated (Photo 1).

**Photo 1** Ditch on north side of Hwy 40:34, upstream of WP032. Note deterioration of riprap placed in ditch channel during 2006 repairs. Photo taken June 2, 2025, facing southwest.

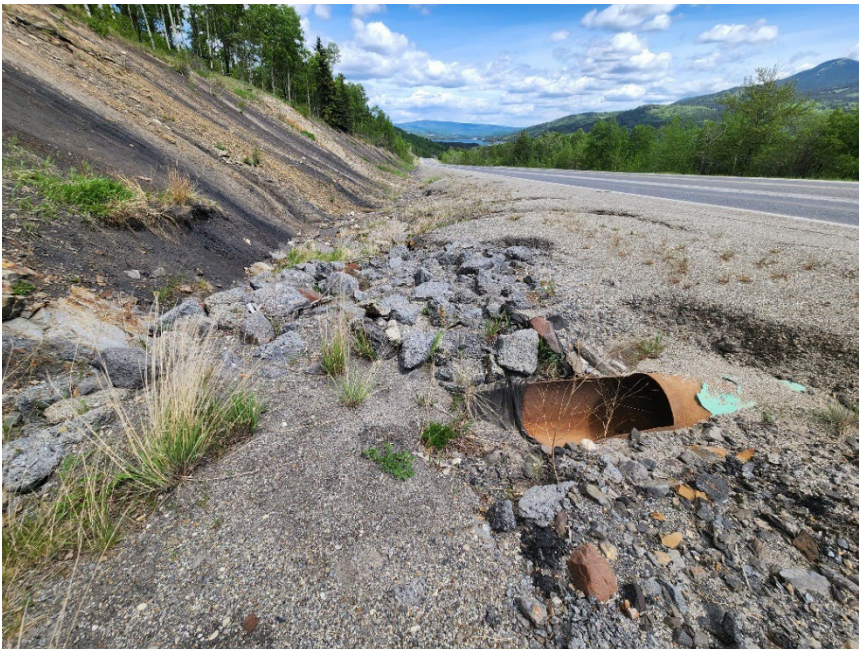
- Erosion is ongoing in the north highway ditch, extending south of the section repaired in 2006 and on either side of the section repaired in 2024 (approximately between WP032 and WP028, Photos 2, 6, and 8). Erosion is exacerbated by surface water flow over edge of pavement onto gravel shoulder.

- A single 600-mm diameter SWSP culvert crosses the highway at WP030 (Photo 2). Flows appear to bypass the culvert inlet on the north side of the highway due to erosion in the ditch channel. An erosion channel has developed downstream of the culvert outlet on the south side of the highway (Photos 3 and 4), extending at least 150 m into the forested slope (WP031). At some locations, the erosion channel is approximately 2.0 m wide and 1.5 m deep, and cuts near vertically into bedrock. Just downstream of the culvert inlets, a small-diameter black cable is exposed in the erosion channel.

**Photo 2** Ditch on north side of Hwy 40:34. Note deterioration of riprap in ditch channel, and erosion / material in ditch channel that appears to divert flow around single culvert inlet (WP030). Photo taken June 2, 2025, facing northeast.

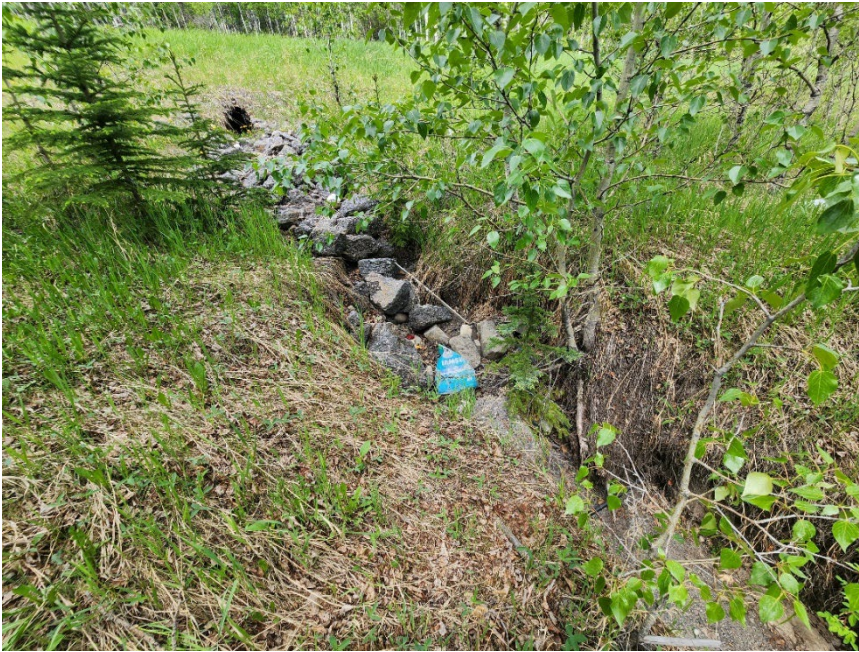
**Photo 3** Erosion channel downstream of single culvert outlet on south side of Hwy 40:34.  
Photo taken June 2, 2025, facing north.

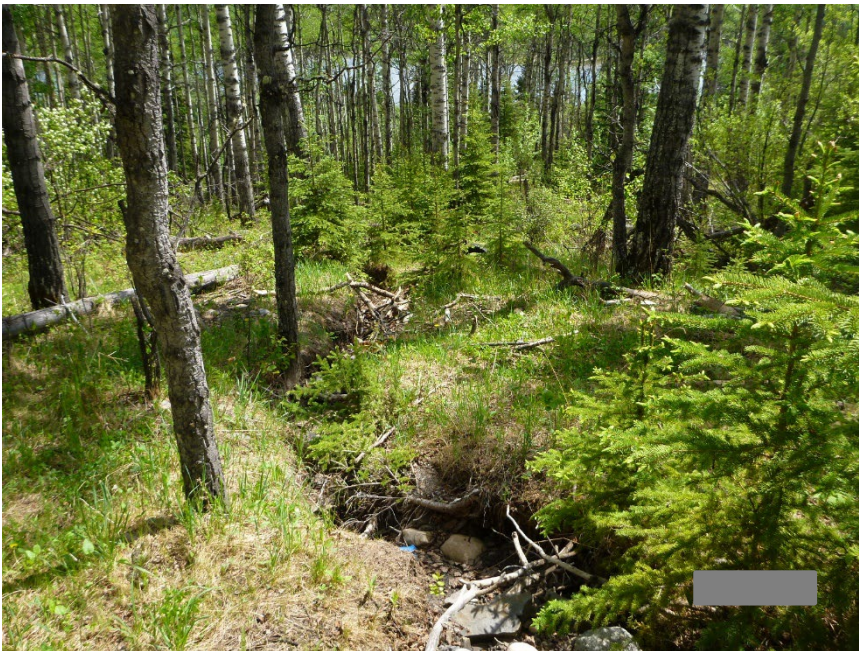
**Photo 4** Erosion channel downstream of single culvert outlet on south side of Hwy 40:34.  
Photo taken June 2, 2025, facing southeast near WP031.

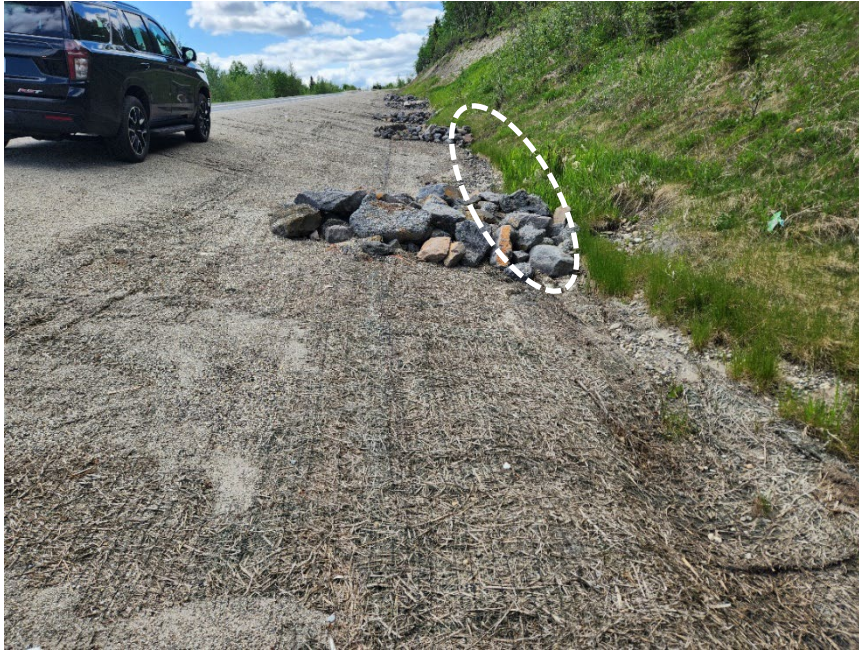
- TEC's Highway Maintenance Contractor (HMC), graded the north highway ditch, installed a turf reinforcement mat (TRM), and installed approximately 13 above-grade riprap check dams in spring 2024 (Photo 5). The repair extent was approximately 200 m, roughly between WP029 and WP030. Within this repaired area, bedrock outcrops were previously observed in the ditch channel near the west end, gravelly soils near the middle, and soils near the east end. The check dams include some particles of conglomerate that will likely experience breakdown similar to the riprap placed during 2006 repairs.

- Within the 2024 repair area (approximately between WP029 and WP030), an erosion feature has begun to form at the bottom of the V-shaped ditch between the highway embankment slope and backslope (Photo 5), at the edge of the TRM. Also, the above-grade riprap check dams are a potential roadside hazard, and sediment is beginning to build up behind some of them.

**Photo 5** Ditch on north side of Hwy 40:34. Note turf reinforcement mat (TRM) and check dams installed during repair completed in 2024, and where erosion and water is beginning to bypass the repair in bottom of ditch (circled in white). Photo taken June 2, 2025, facing southwest.

- In the spring of 2025, KCB completed an environmental evaluation (EE) and preliminary engineering for ditch repairs at the site, including the section previously repaired in 2024. At TEC's request, KCB will complete detailed design and prepare a tender for the selected design option: removing the existing above-grade check dams, regrading the ditch, installing below-grade check dams, and armouring the ditch with riprap. Estimated cost: approximately \$1,400,000 to \$1,650,000 based on a repair length of 1,150 m (approximately between WP028 and WP032), and the price of hard, durable limestone that is not likely to be locally available. The final repair length will be determined during detailed design. The cost for riprap could be considerably lower if TEC considers the use of locally available greywacke for this repair. The use of greywacke and concerns about variability in particle durability could potentially be addressed through special provisions within the tender which could include inspection and testing quality control / quality assurance (QA/QC) during production and placement, and an extended warranty period. Repair of the eroded culvert outlets on the south side of the highway will be also included in the project scope. The repair may be tendered together with GP041 highway ditch erosion repairs.

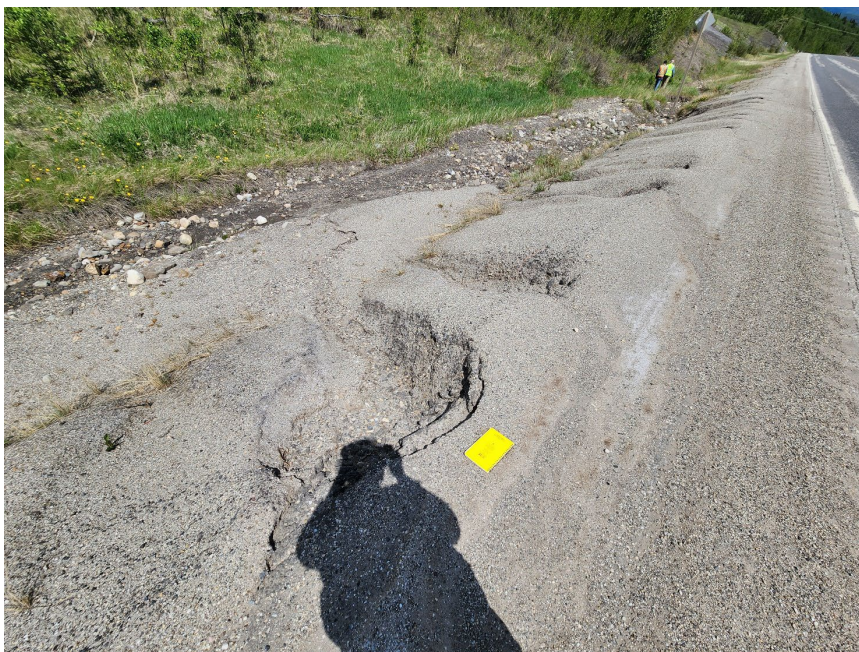
- Erosion features on the north highway shoulder continue to retrogress towards edge of pavement (some are already at edge of pavement, approximately 1 m from the nearest lane) despite previously being filled in at some locations (Photos 6 and 7).

**Photo 6** Ditch on north side of Hwy 40:34. Note erosion in ditch channel and erosion features along north highway shoulder at edge of pavement. Photo taken June 2, 2025, facing northeast.

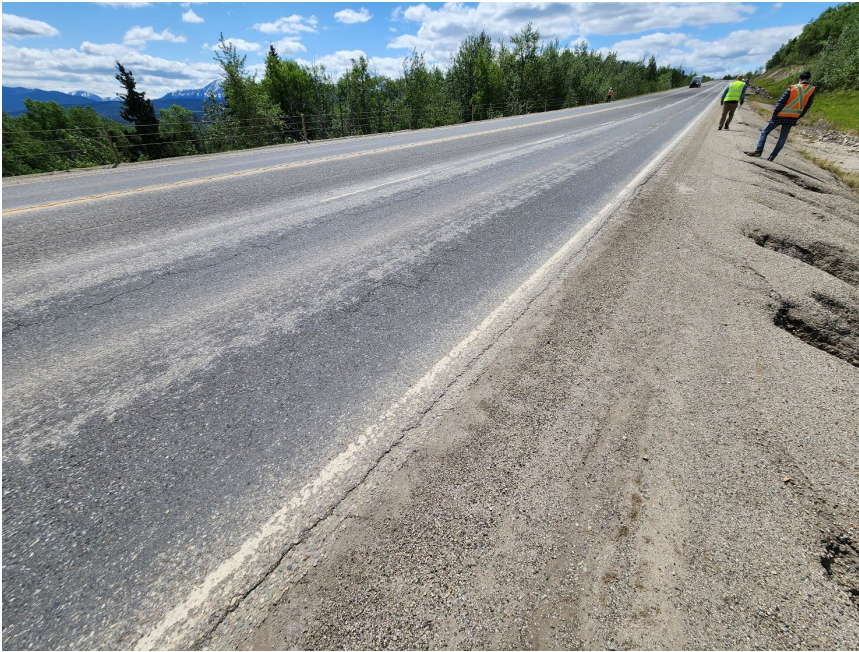
**Photo 7**      **Surface of Hwy 40:34. Note erosion features along north highway shoulder progressing towards edge of pavement. Photo taken June 2, 2025, facing southwest.**

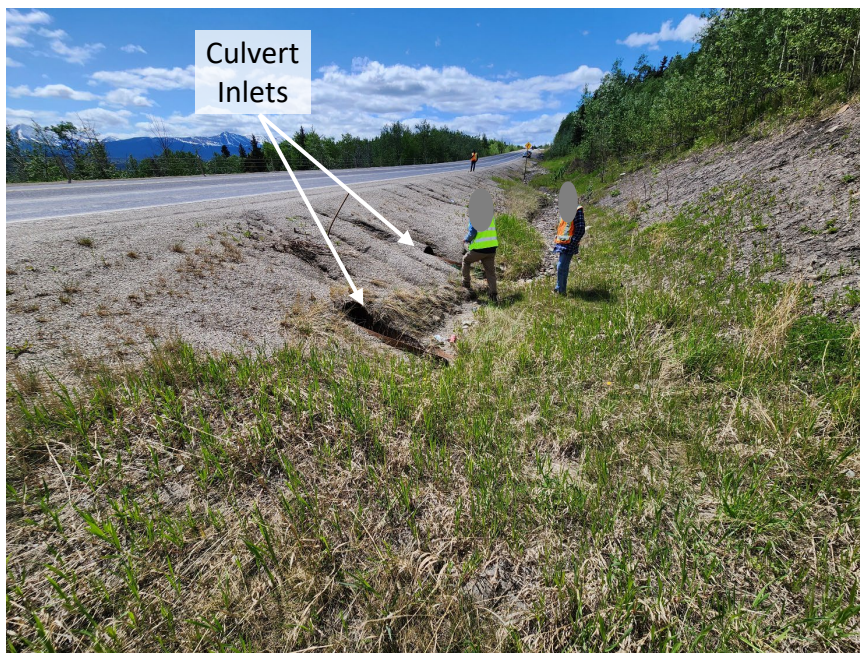
- Twinned 1,040-mm diameter culverts cross the highway at WP028 (Photo 8). Beneath the highway, the culverts transition from smooth-walled steel pipe (SWSP) at the inlets to corrugated steel pipe (CSP) at the outlets. Based on visual inspection, the culvert grade increases substantially after the transition from SWTP to CSP. The culvert outlets on the south side of the highway are hanging above an approximately 5-m deep erosion gully that has developed below the culvert outlets (Photo 9). An erosion channel had also developed downstream of the culvert outlets (Photo 10), extending at least 50 m into the forested slope.

**Photo 8**      **Ditch on north side of Hwy 40:34. Note erosion in ditch channel and twinned culvert inlets (WP028). Photo taken June 2, 2025, facing southwest.**

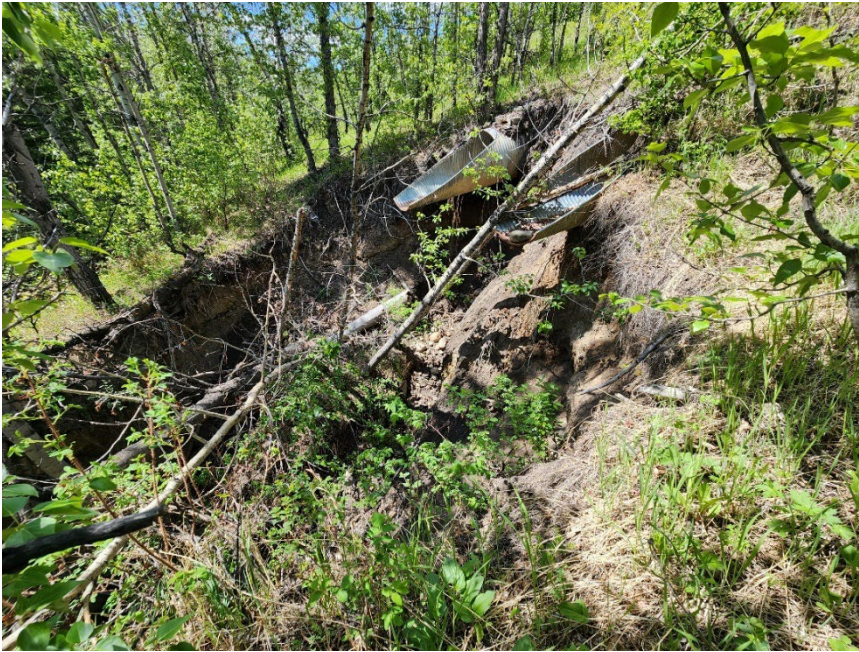
**Photo 9**      **Erosion gully at twinned culverts outlets on south side of Hwy 40:34. Photo taken June 2, 2025, facing southwest.**

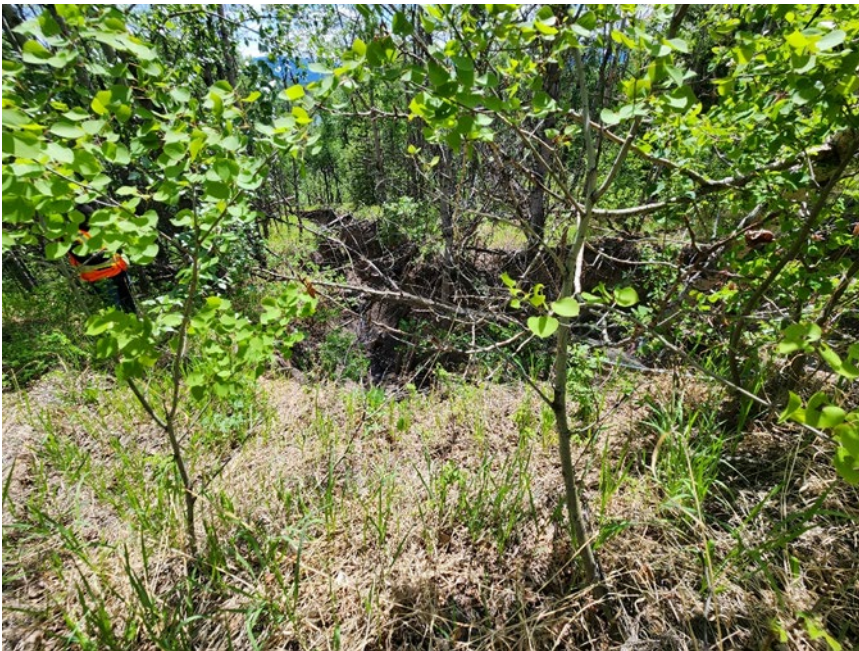
**Photo 10**      **Erosion channel downstream of twinned culvert outlets on south side of Hwy 40:34. Photo taken June 2, 2025, facing southwest.**
