Slide Name: (GP 26) Ditch Erosion South of Grande Cache
(GP 27) Ditch Erosion North of Grande Cache
Inspection Date: May 6, 2005
Inspection by: Alberta Infrastructure & Transportation and EBA staff listed on Page 1

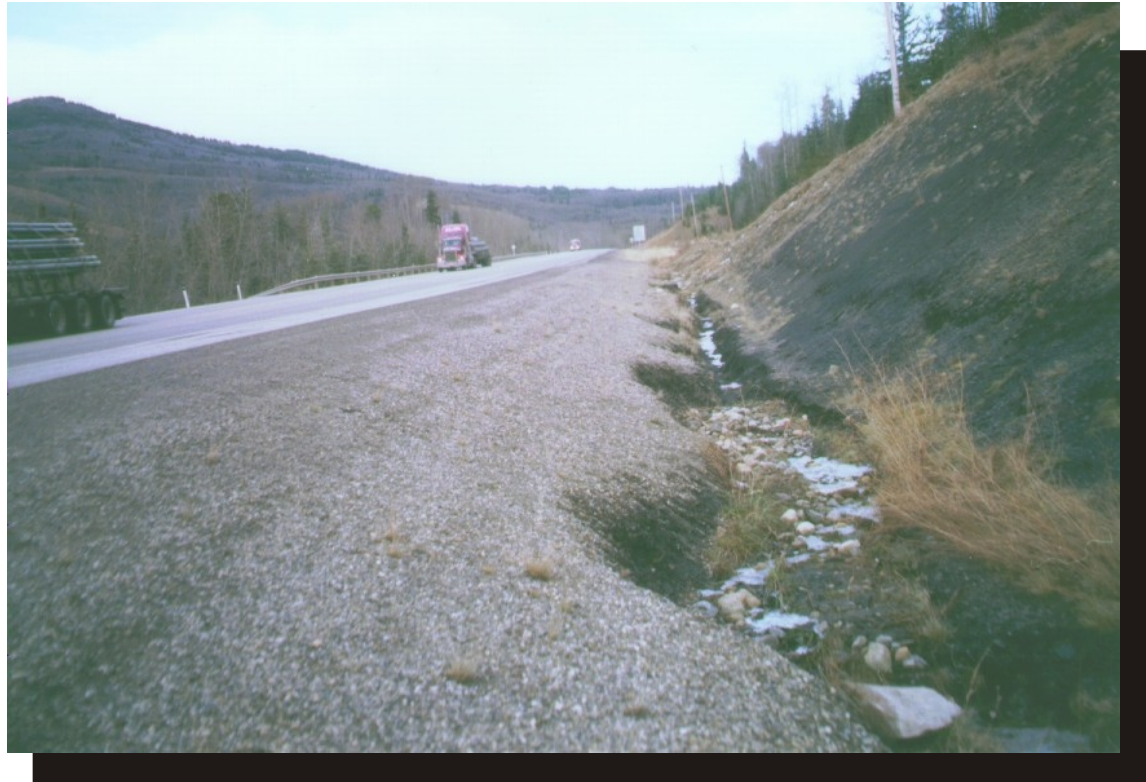
Photo 11

Looking upgrade south towards town along backslope ditch. Erosion vertical scarp (1.5m deep) along road ditch subgrade is a safety concern. Affected stretch is 100m to 150m in length.

- A new ditch design should be considered. The possible design of drop structures to step down the steepness of the ditch grade and a new ditch cross-section design may be required. The use of hard armouring may be appropriate for this site.

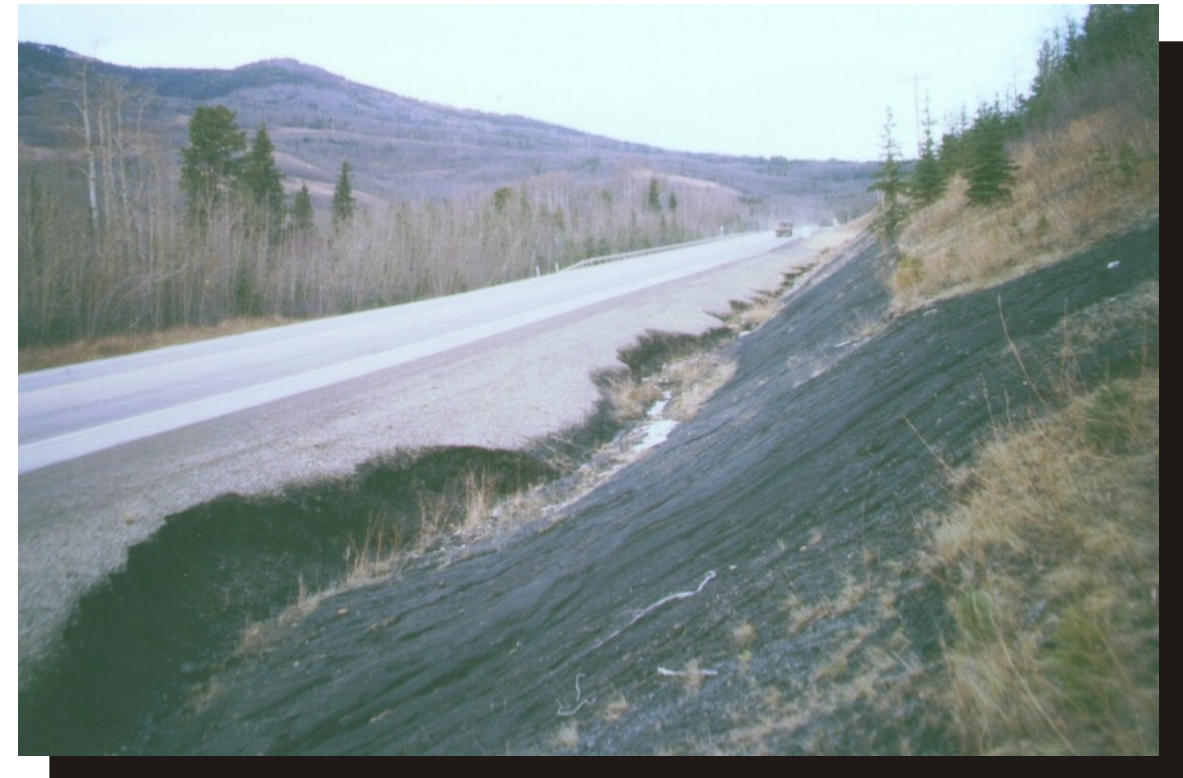
Photo 12

Looking upgrade south - another view of vertical erosion scarp (1.5m deep) along road ditch subgrade.

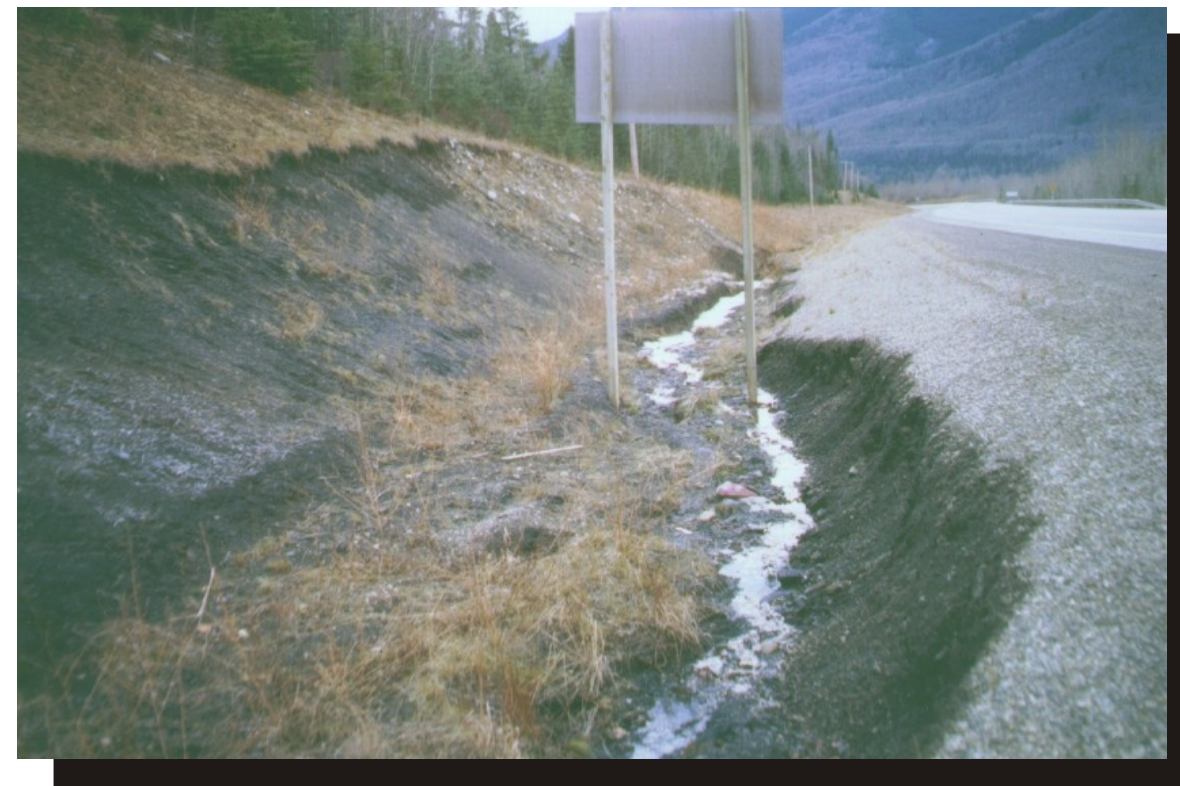
Photo 13

Looking downgrade north - another view of erosion vertical scarp along road ditch subgrade.

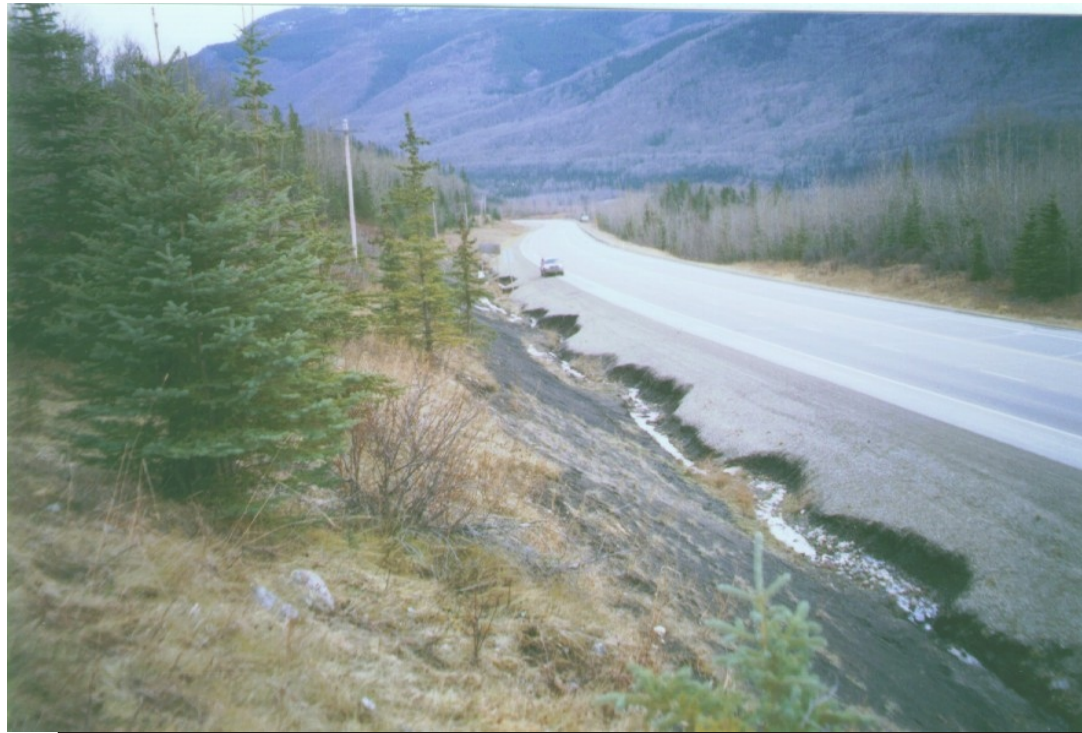
Photo 14
Looking north - another view.

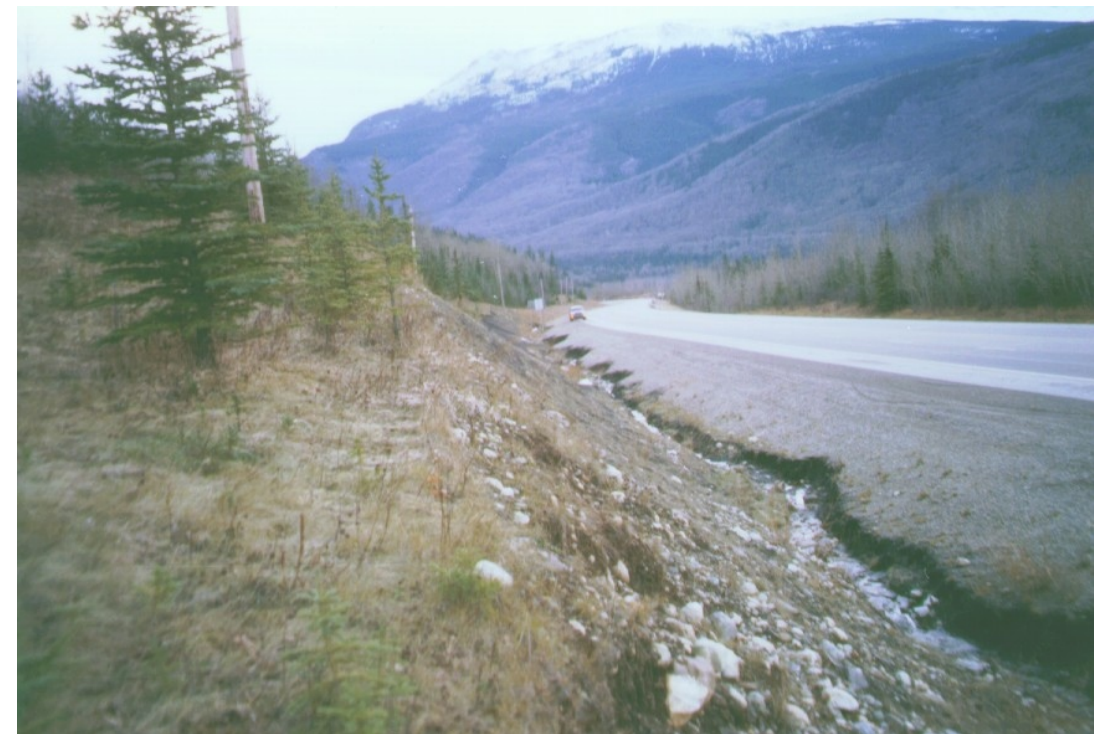
Photo 16
Looking north - steep erosion scarp of highway ditch subgrade will be a safety concern.

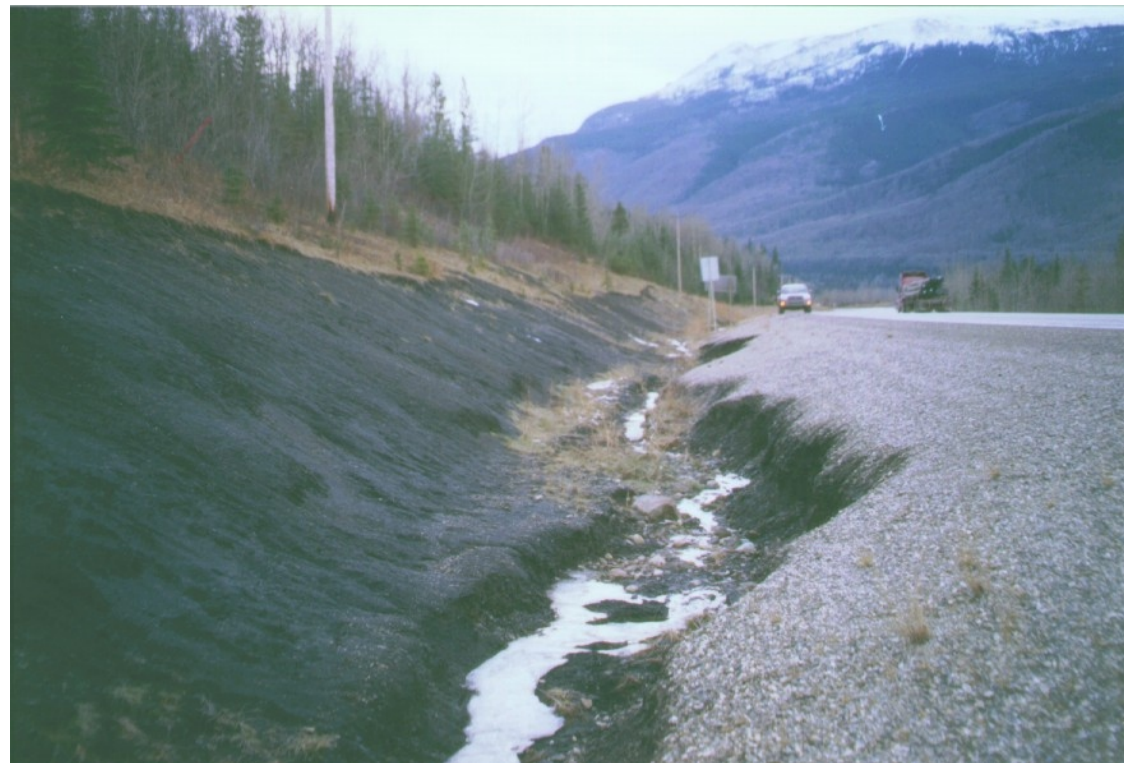
Photo 15
Looking north - another view.

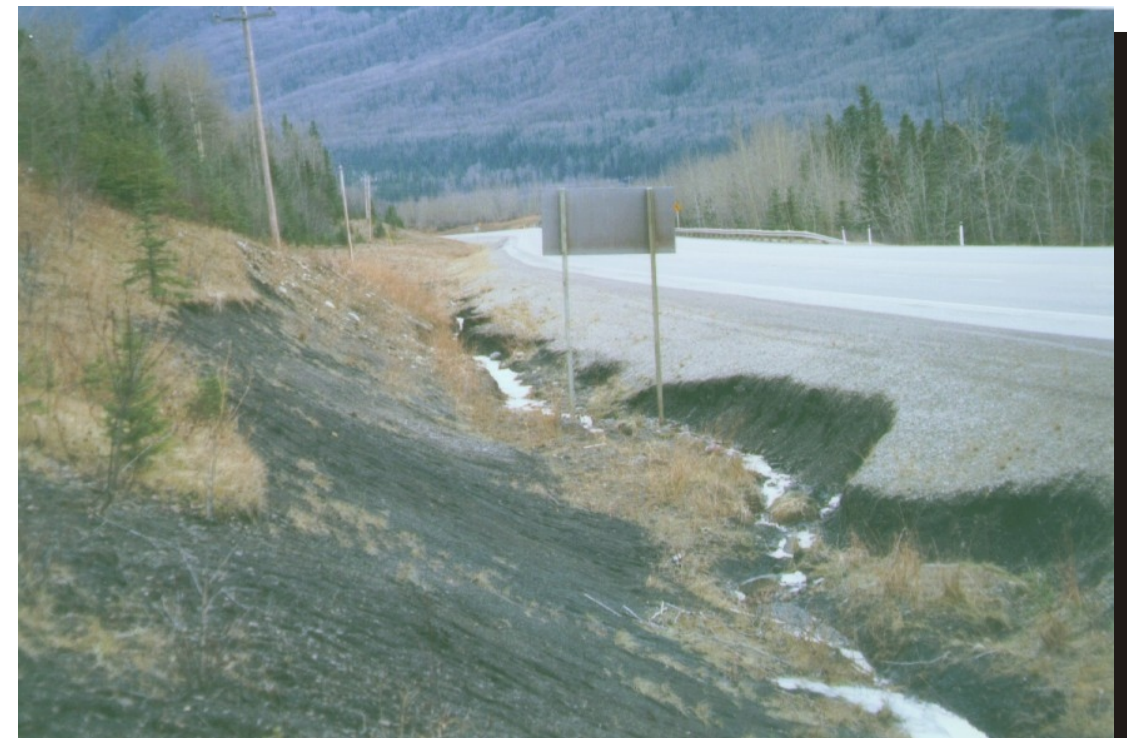
Photo 17
Looking north - another view.
