**PEACE REGION – GRANDE PRAIRIE
GEOHAZARD RISK ASSESSMENT
SITE INSPECTION FORM**

SITE NUMBER GP-25	SITE NAME (i)New Haul Road to Mine Extension (ii)*Mudslide (previous) at McIntyre Mine Access	HIGHWAY & KM Hwy 40:36	PREVIOUS INSPECTION DATE: June 3, 2011	INSPECTION DATE: July 13, 2012
LEGAL DESCRIPTION	NAD 83 COORDINATES	Previous RISK ASSESSMENT PF: 5 CF: 2 TOTAL: 10 (*2007) <i>Risk (post 2012)remains to be assessed after Haul Road completion</i>

**GP-25 (Previous Mud Slide Site)
Mine Haul Road Extension
Page 1 of 1**

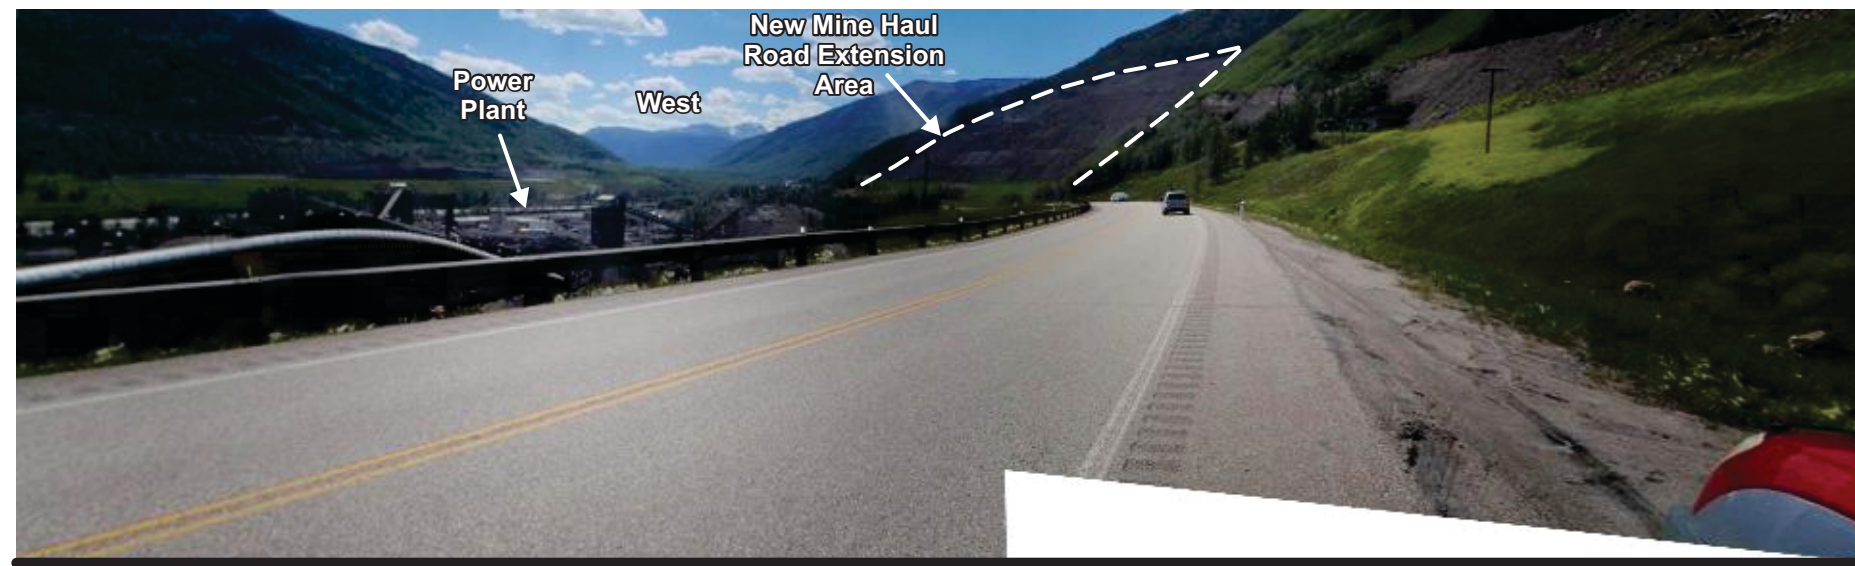
Photo 1

**Looking South (towards Grande Cache) - Panorama of River Valley
A view Hwy 40 adjacent to New Haul road constructed for Mine Extension**

- A new haul road being constructed at upper-mid valley slope (above highway backslope)
- A massive earthwork program and change of surface drainage pattern of mining scale to form part of haul road works
- Work entail sidehill embankment (dump) earthwork, drainage works (ditches, rock drains, settlement ponds and dykes), and rock debris traps, etc.

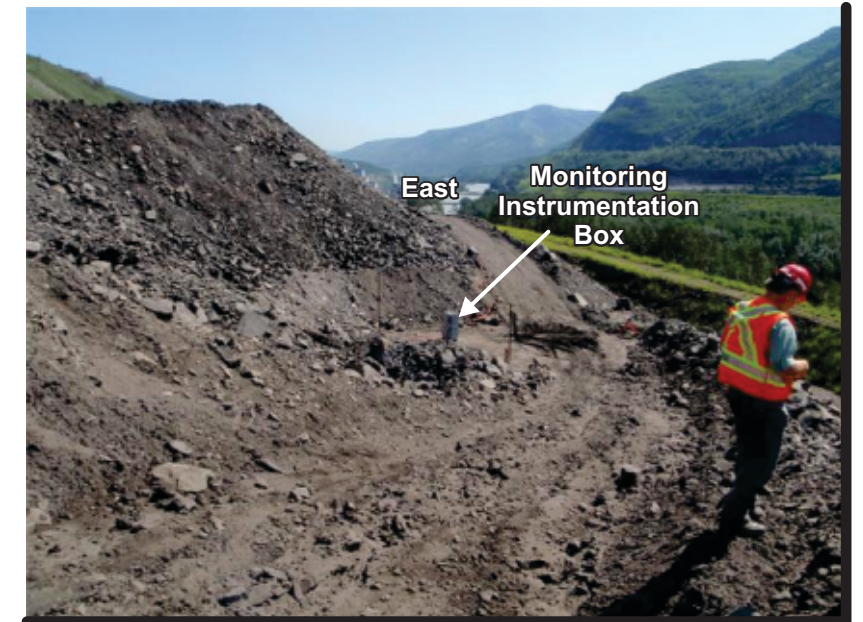
Photo 1a

Looking toward Smoky River –

- Instrumentation box for monitoring of stability and movement of the slopes

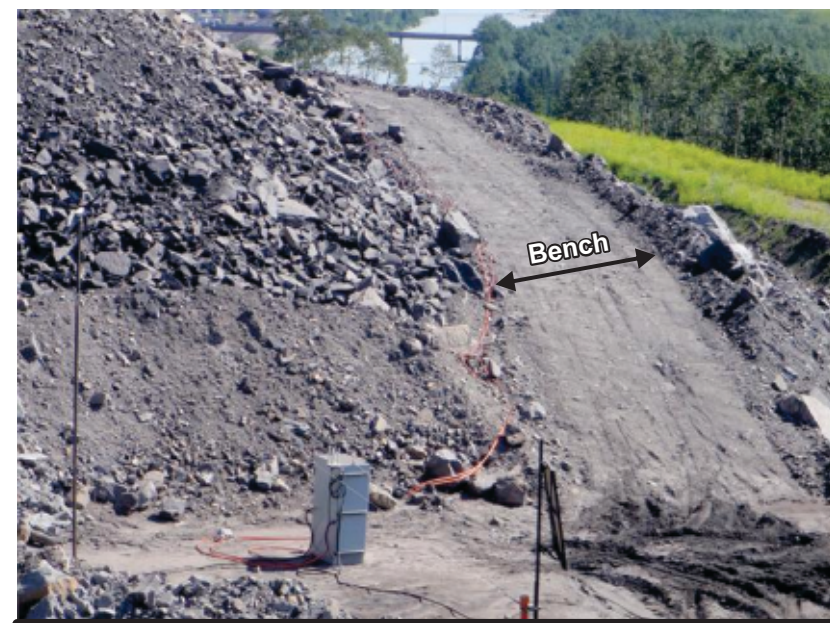
Photo 1b

Instrumentation box for monitoring

- Close up

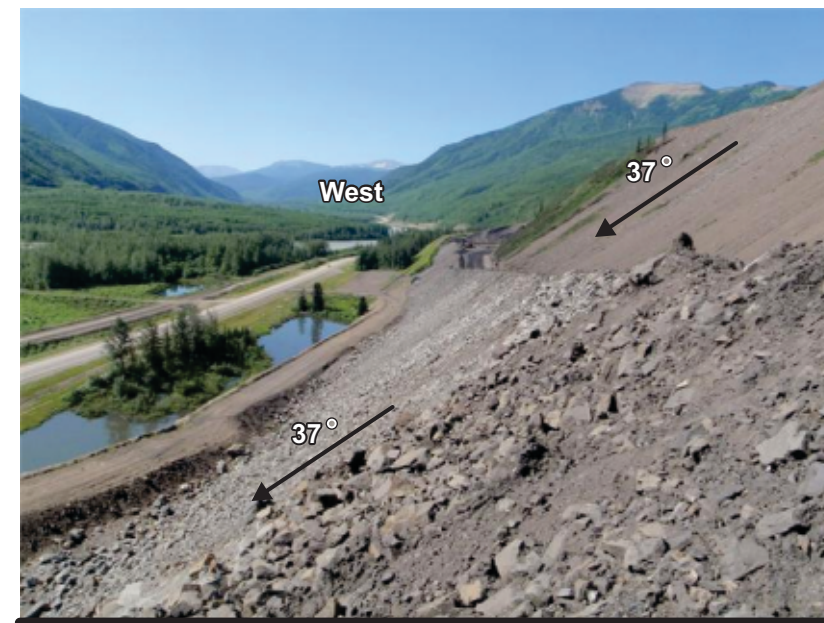
Photo 1c

Intermediate rock dump slopes

- It is understood that rock fill was placed at 37 degree with horizontal and with mid slope bench

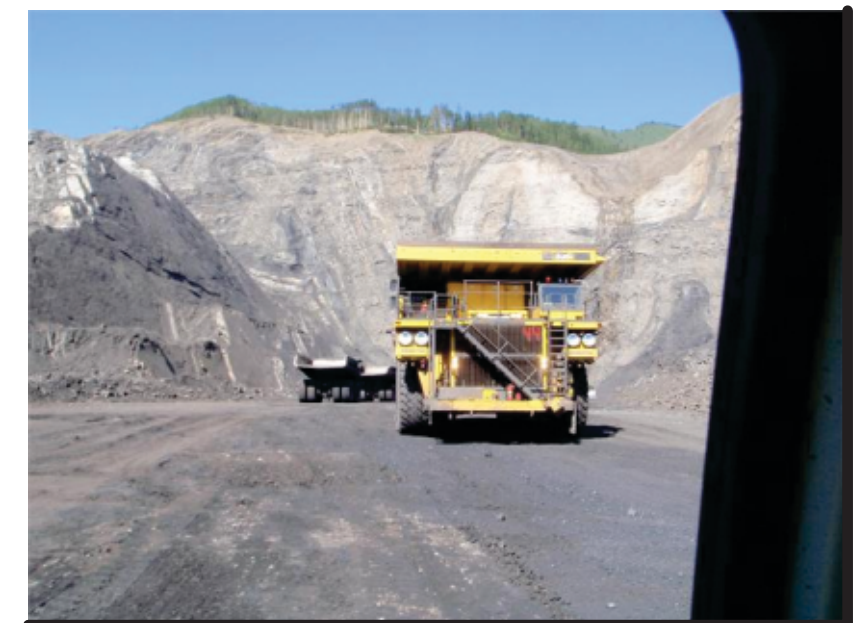
Photo 2

A view of a dump truck (240 ton) operating
