**PEACE REGION – GRANDE PRAIRIE  
GEOHAZARD RISK ASSESSMENT  
SITE INSPECTION FORM**

<b>SITE NUMBER</b> GP-25	<b>SITE NAME</b> (i) New Haul Road to Mine Extension (ii) *Mudslide (previous) at McIntyre Mine Access	<b>HIGHWAY &amp; KM</b> Hwy 40:36	<b>PREVIOUS INSPECTION DATE:</b> July 13, 2012	<b>INSPECTION DATE:</b> May 24, 2013
<b>LEGAL DESCRIPTION</b>	<b>NAD 83 COORDINATES</b>	<b>Previous RISK ASSESSMENT</b> PF: 5      CF: 2      TOTAL: 10 (*2007) <i>Risk (post 2012) remains to be assessed after Haul Road completion</i>

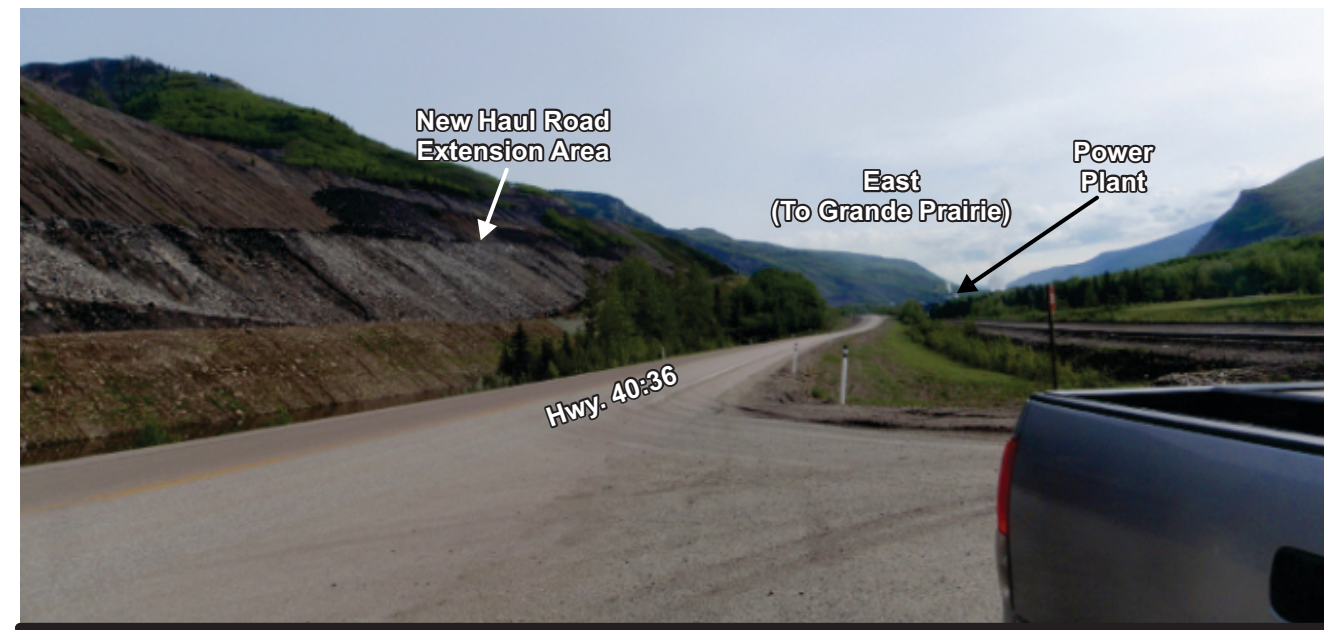
**Photo 1**

**Looking north (towards Grande Prairie) - Panorama of River Valley**

- Smoky River to right of photo
- Milner Power Plant at centre and depth of photo
- New Haul Road Construction at left of photo (reshaping of mountain and construction access road for mining)

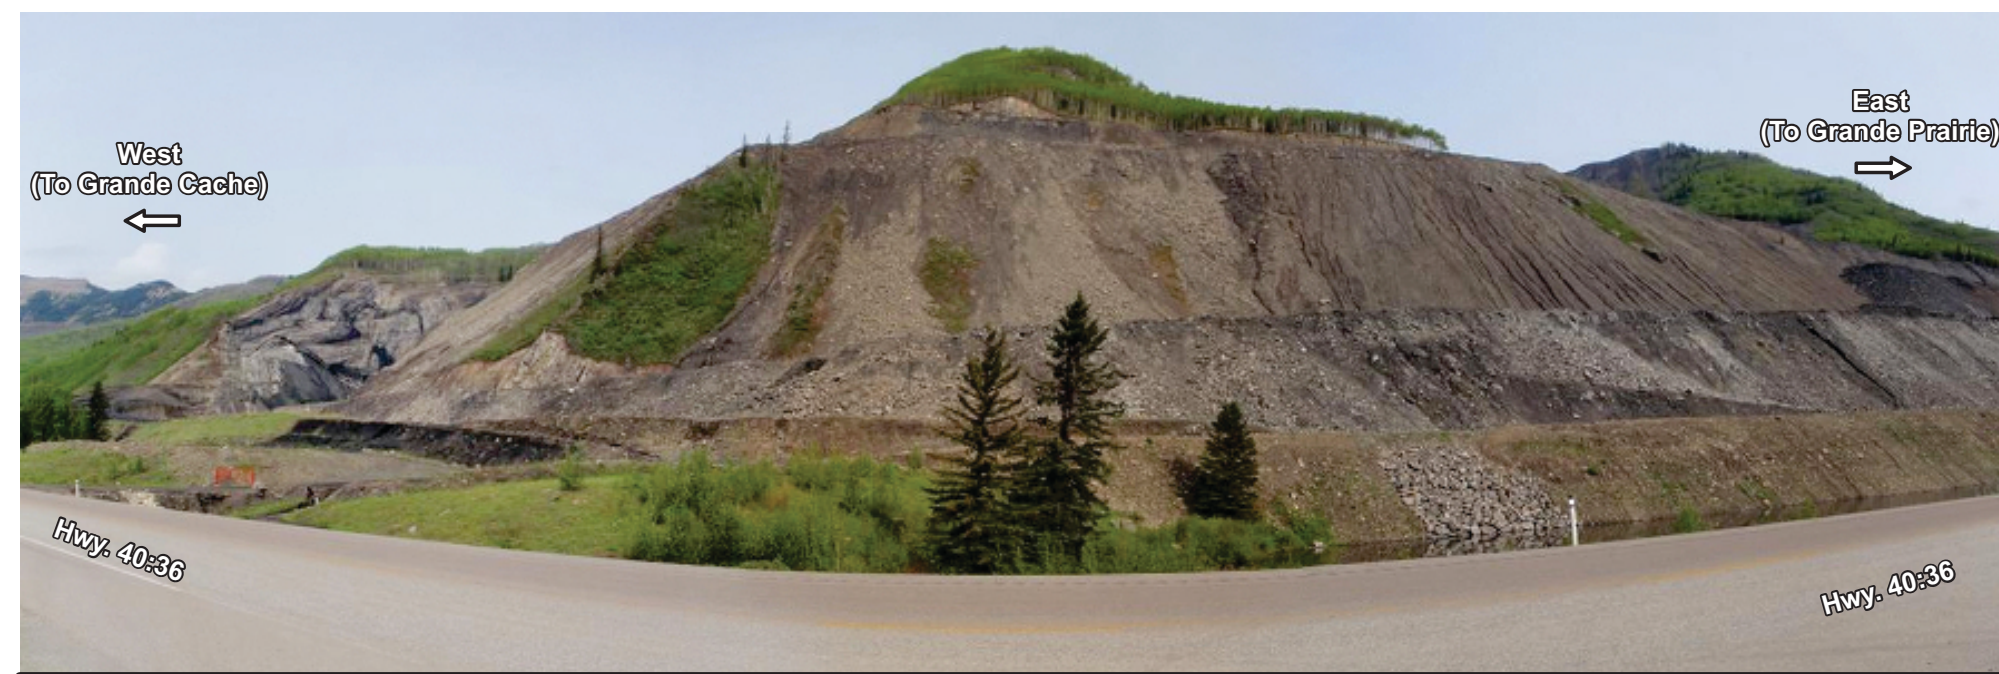
**Photo 1a**

- ii) Immediately above and adjacent the highway, the work completed will include
  - the planned haul road
  - the rock dump (i.e. highway dump) alongside above Hwy 40 . It is understood that the dump slopes were constructed at 37 degrees, and with intermittent benches (i.e. switch back roads), the final slopes will be likely finished off at 26 degrees (after reactivation of intermittent benches) as the long term slope angle.
- ii) The current rock dump (i.e. highway dump) was being monitored by "real time" instrumentations including (a) radar prism(s) and (b) conventional slope indicator+piezometers.

**Looking west at mountain upland area being reshaped by mining equipments**

- Cutting of benches to construct switch back zipzap haul road
- Rock fill dump constructed along roadway to form steep new backslopes (replacement of native mountain slopes)

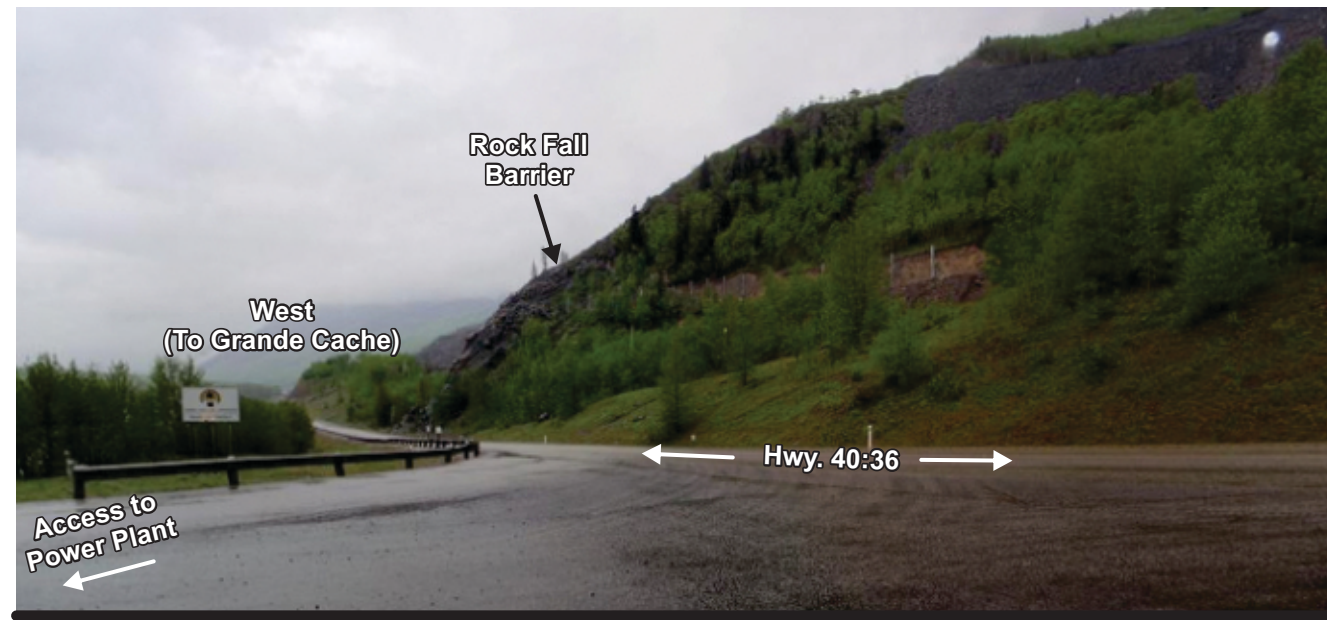
iii) It was observed a line of rock check "wire trap" barrier was constructed.

**Photo 2**  
Looking towards west (Grand Cache) from Power Plant access  
• Rock trap fence construction along backslope above highway

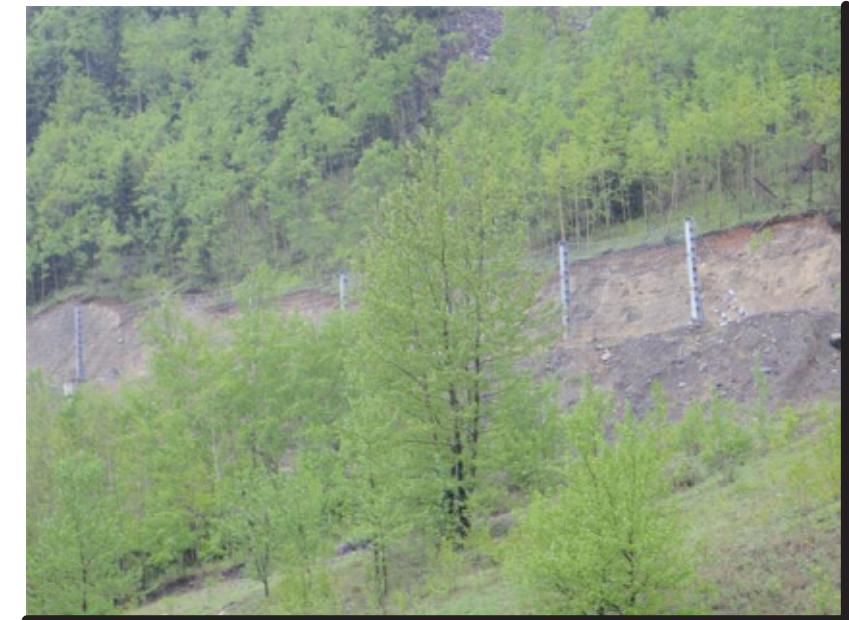
**Photo 2a**  
Close up of rock trap fence

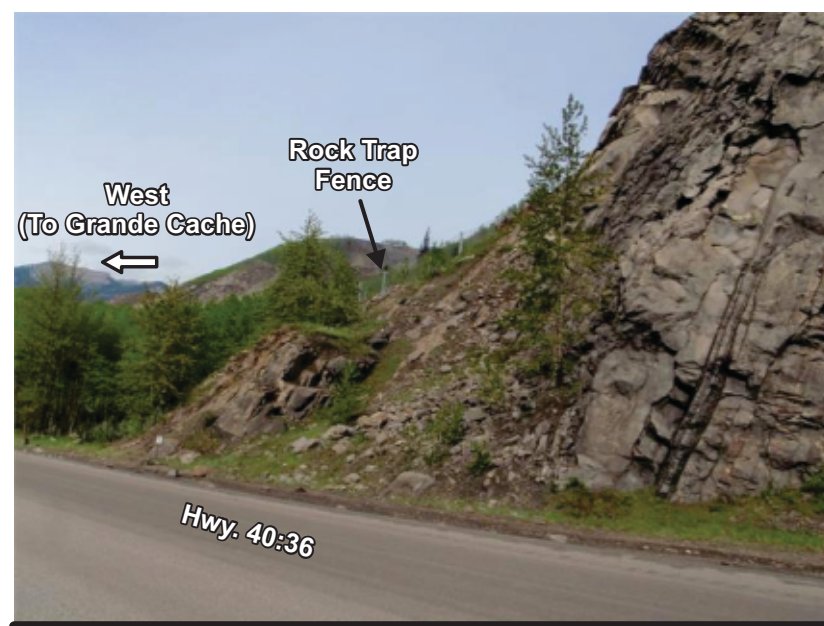
**Photo 2b**  
Close up of rock trap fence

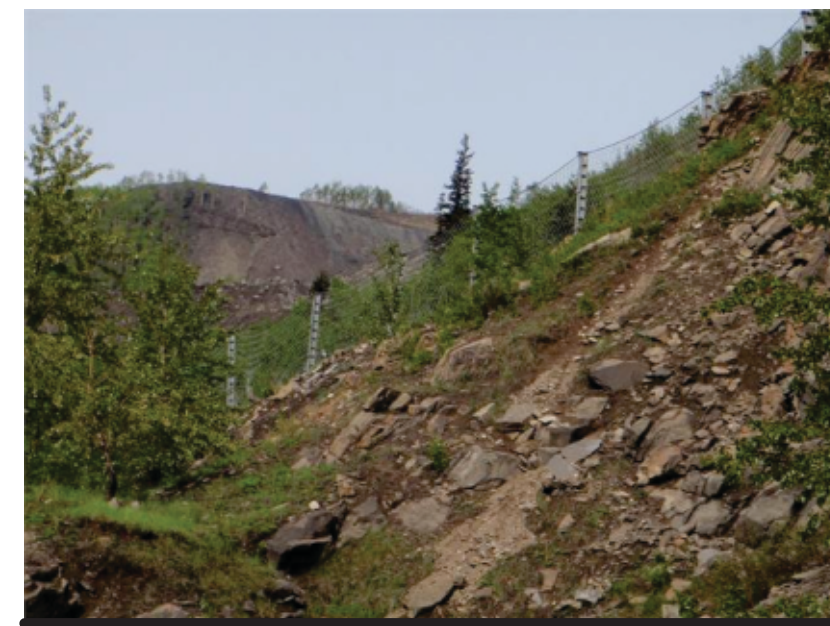
**Photo 2c**  
Close up of rock trap fence

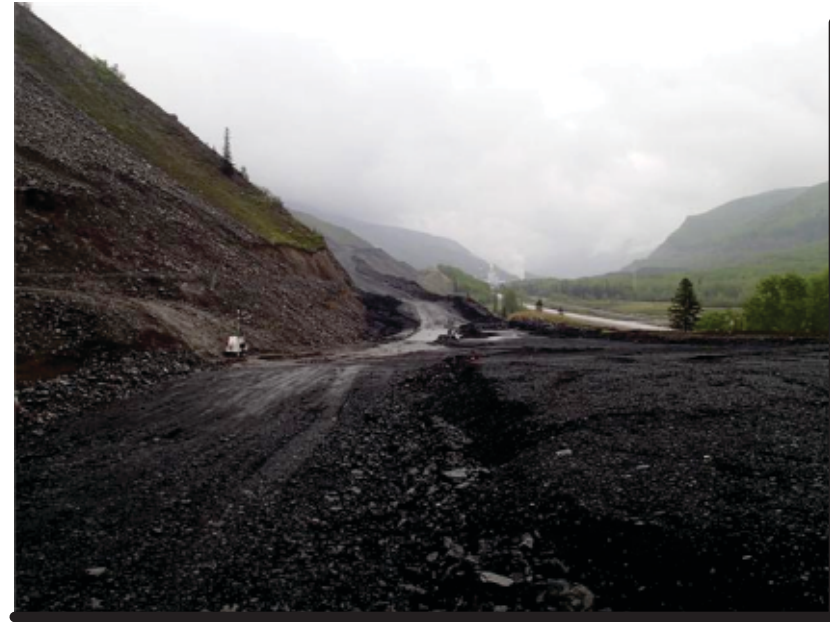
**Photo 3**  
A view of a portion of mine operation area

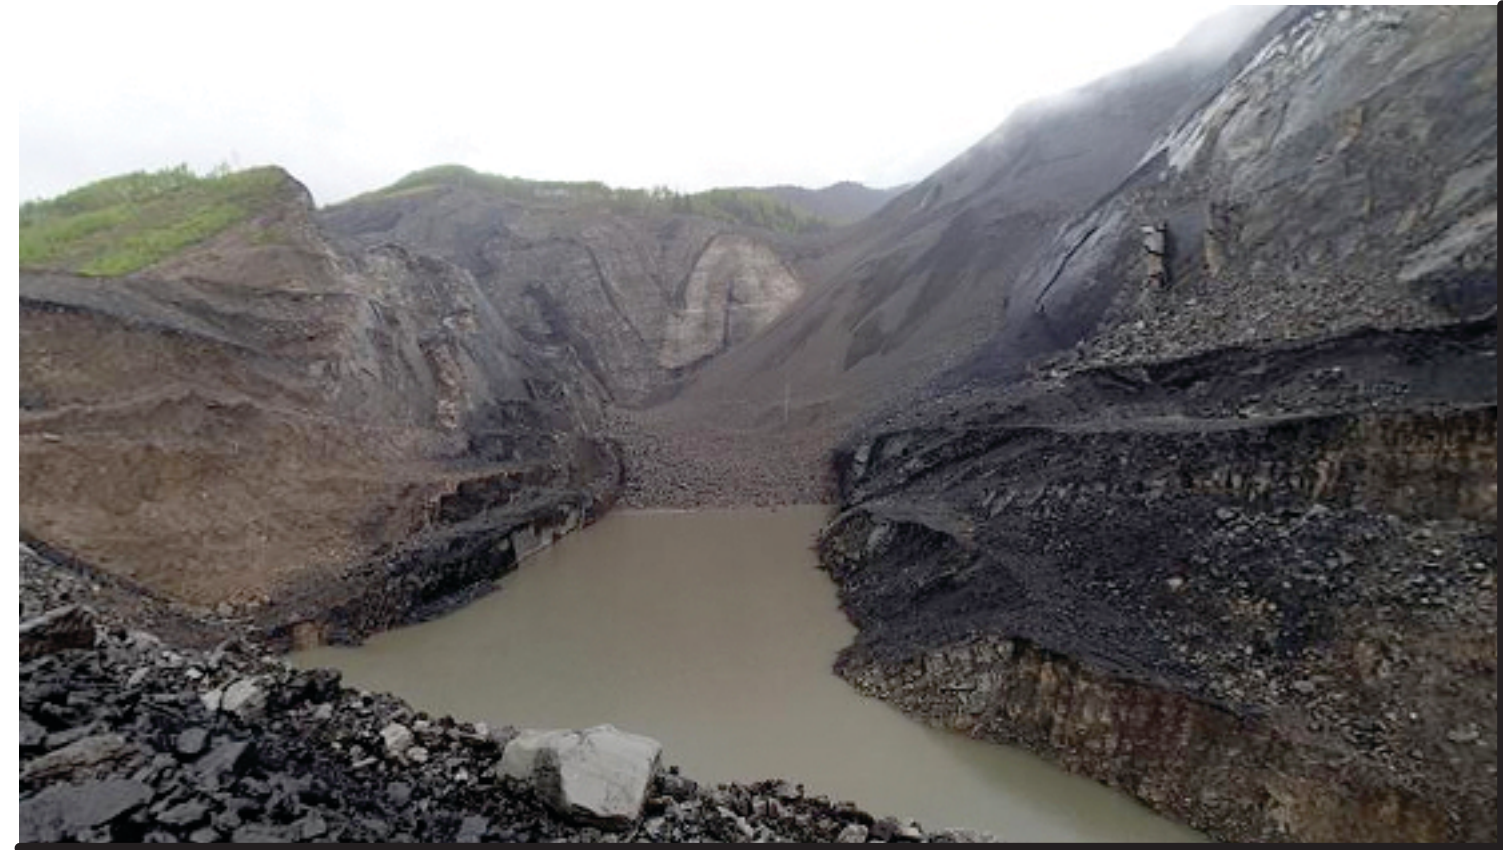
**Photo 3a**  
A settling pond inside the mine
