December 19, 2008

**Re: Peace Region (Grande Prairie) GeoHazard Assessment  
(GP 33) HWY 40:36 South View Slide @Km 39.4 (culvert)  
(43 km south of Kakwa River Bridge)  
Sta. 43+600 to Sta. 43+850 (Culvert at Sta. 43+580)  
AT Regional Geotechnical Contract 106/08  
- Part B – Annual Site Inspection (Slide Tour) Report**

In compliance with requirements of the captioned Contract, an annual site inspection of the site was carried out and a report (for 2008 year) is provided with this letter.

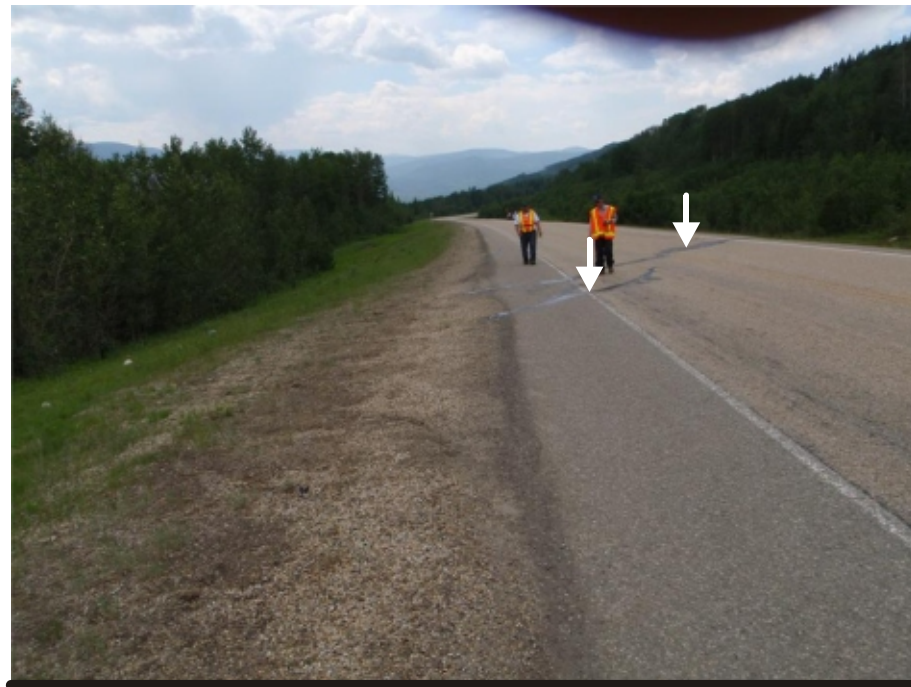
**Photo 1**

**Looking south (towards Grande Cache direction)**

- Headscarp crack crossed centreline toward backslope ditch. Crack infill with tar.
- Slide occurs at minor sidehill fill at upper verge of the Smoky River valley slope.
- There is a centreline culvert at south flank of slide
- Stream flow from backslope side to inflow into centreline culvert

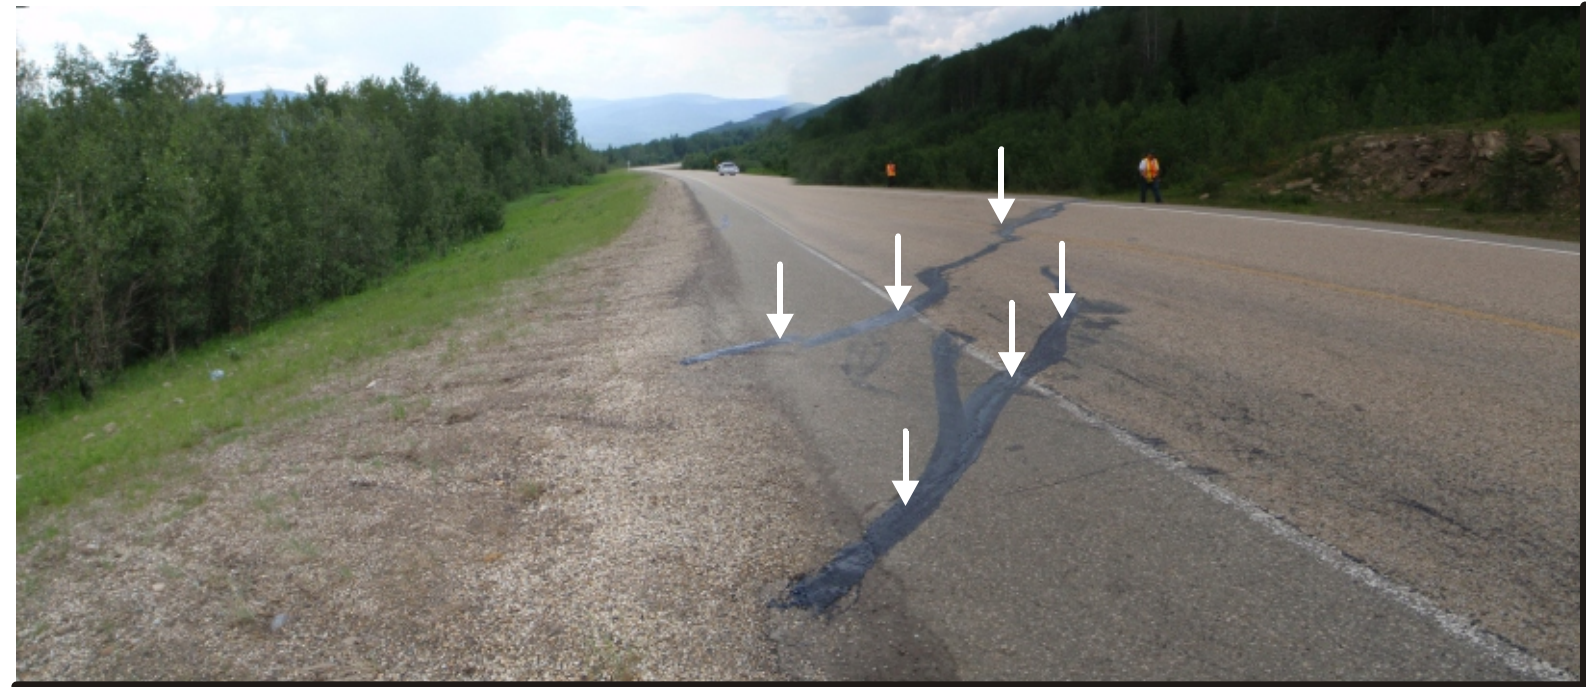
**Photo 2**

**Headscarp crack**

- Close-up

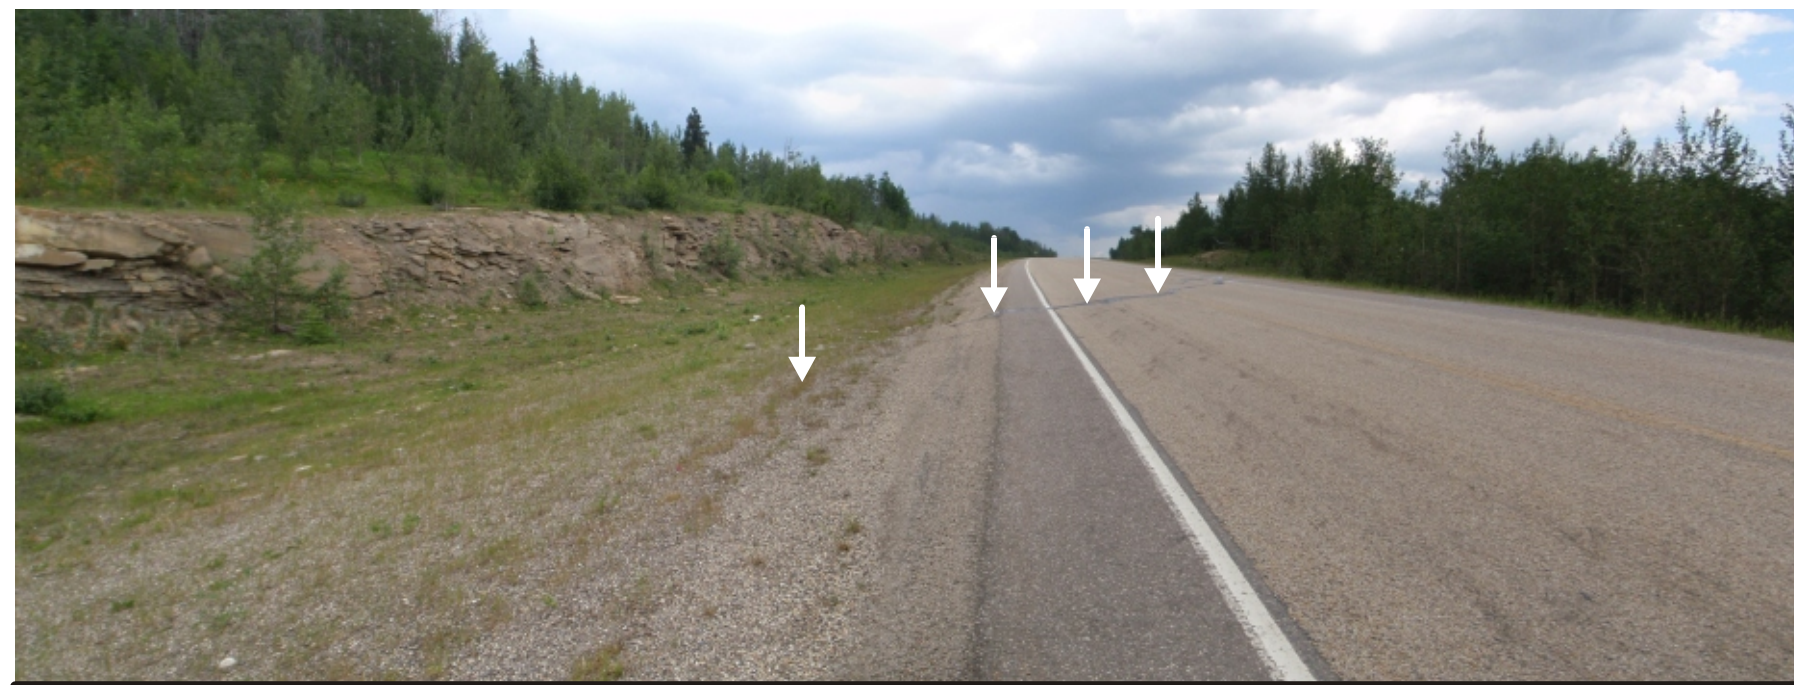
**Photo 3**

**Looking north (towards Grande Prairie direction) at north flank of slide**

- The slide area is just after transition from cut (rock cut at backslope)

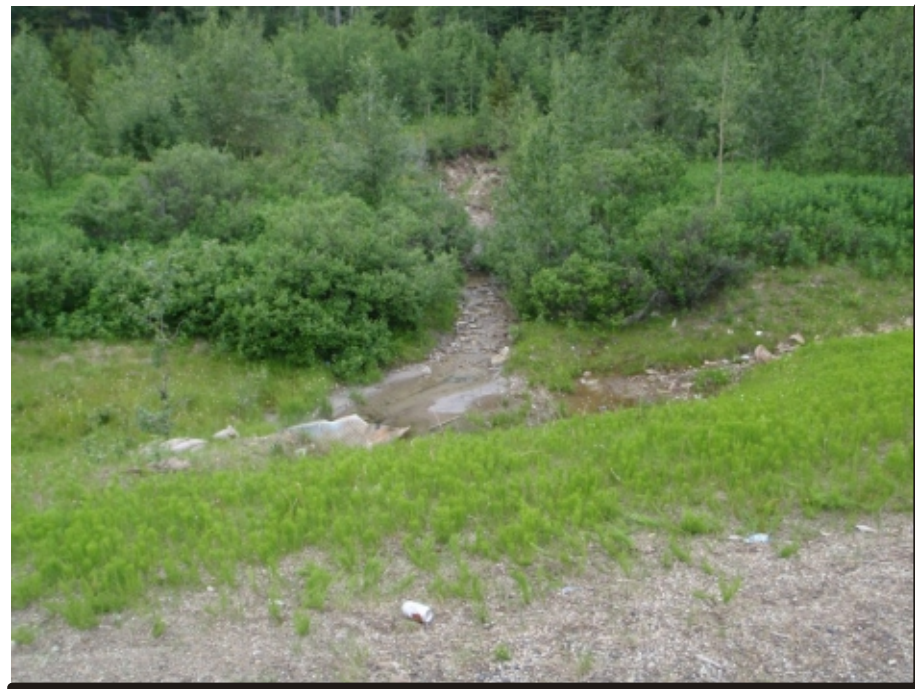
**Photo 4**  
**Centreline culvert inlet at south flank of slide**  
- Steady water inflow from stream

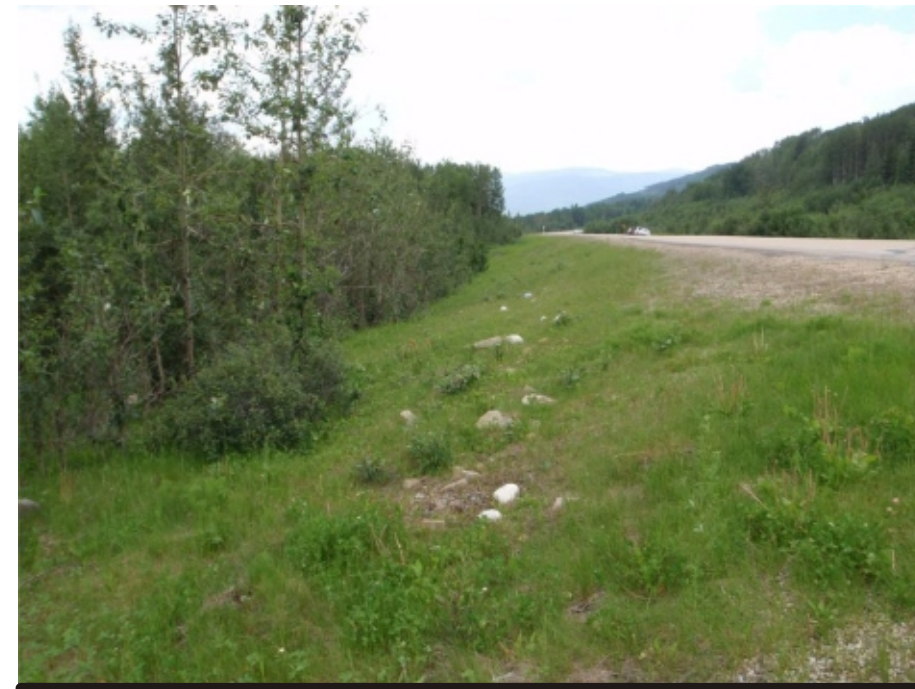
**Photo 5**  
**Looking south along sideslope (towards Grande Cache direction)**  
- 1.5m high sidehill embankment fill along verge of Smoky River Valley slope

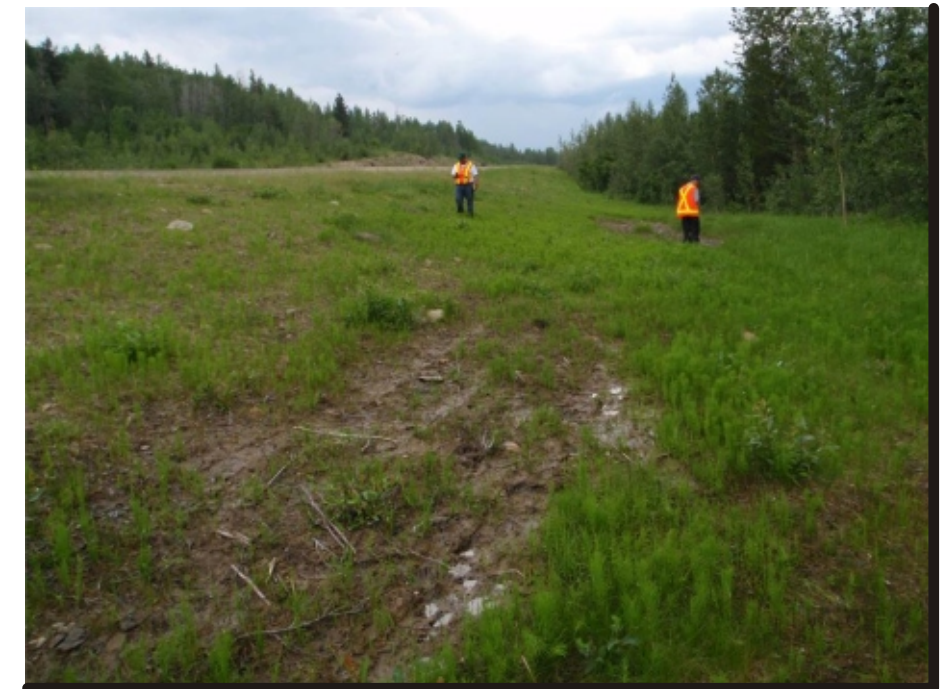
- the inlet end of the culvert might has been severed to have possibly caused a wetting and seepage along the footprint of the highway fills. The wet ground conditions were observed at the adjacent areas of sideslope at downstream side beside the culvert outlet

**Photo 6**  
- Wet patches of sideslope fill adjacent to culvert outlet area can be observed. It can be indicative of seepage along base of fill  
- Need to check if potential severing or breakage of culvert maybe cause of seepage

area. (toward Grande Prairie direction). It is advisable to have local MCI and maintenance forces perform a detailed inspection of the culvert integrity conditions.

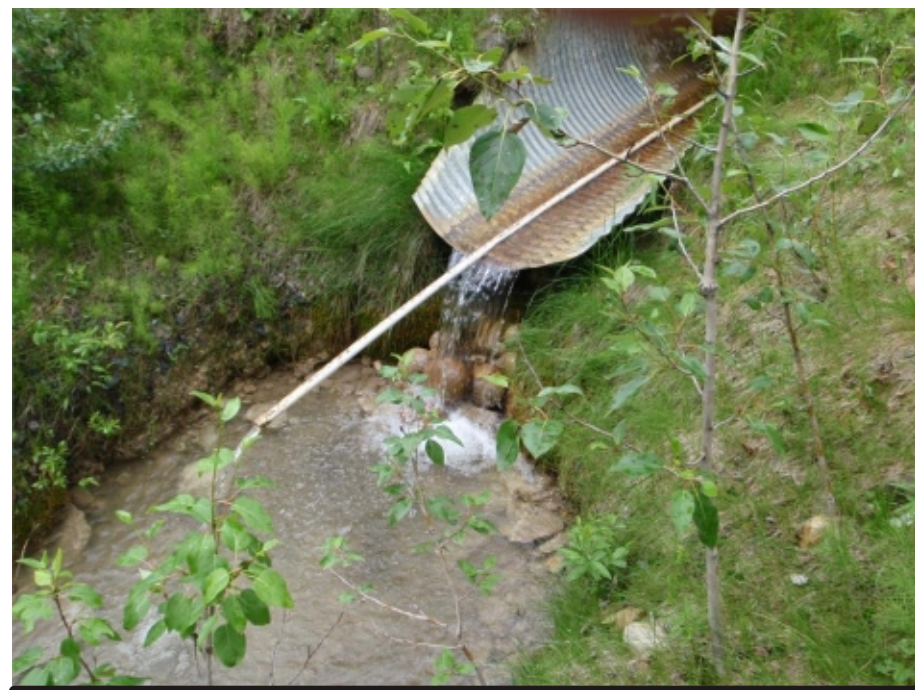
**Photo 7**  
**Culvert outlet**  
- A drop of ground at culvert outlet will cause vertical erosion at outlet. Need to be infilled with adequate size granular fill to provide a smooth outflow apron.  
- De-icing pipe presnt

- There is a small scour drop hole at outfall channel area of the culvert outlet. It is advisable to in fill the scour drop hole with resistant rocky fill material to deter further downcut erosion of channel.

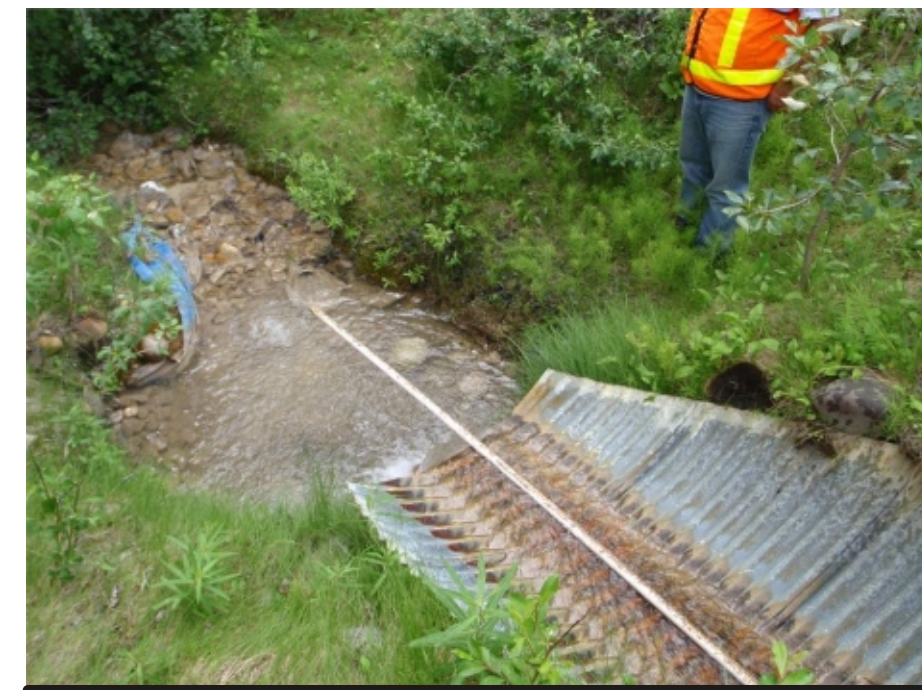
**Photo 8**  
**Culvert outlet**  
- A drop of ground at culvert outlet will cause vertical erosion at outlet. Need to be infilled with adequate size granular fill to provide a smooth outflow apron.  
- De-icing pipe presnt
