**PEACE REGION – GRANDE PRAIRIE  
GEOHAZARD RISK ASSESSMENT  
SITE INSPECTION FORM**

SITE NUMBER GP-33	SITE NAME Southview (Km 39.4) culvert slide	HIGHWAY & KM Hwy 40:36 @Km39.4	PREVIOUS INSPECTION DATE: July 4, 2008	INSPECTION DATE: July 12, 2012
LEGAL DESCRIPTION LSD -NE21-59-6-W6M	NAD 83 COORDINATES N5,999,312 E381,218	PREVIOUS RISK ASSESSMENT PF: 8      CF: 3      TOTAL: 24		
		<b>CURRENT 2012 RISK ASSESSMENT</b> PF: 8      CF: 3      TOTAL: 24

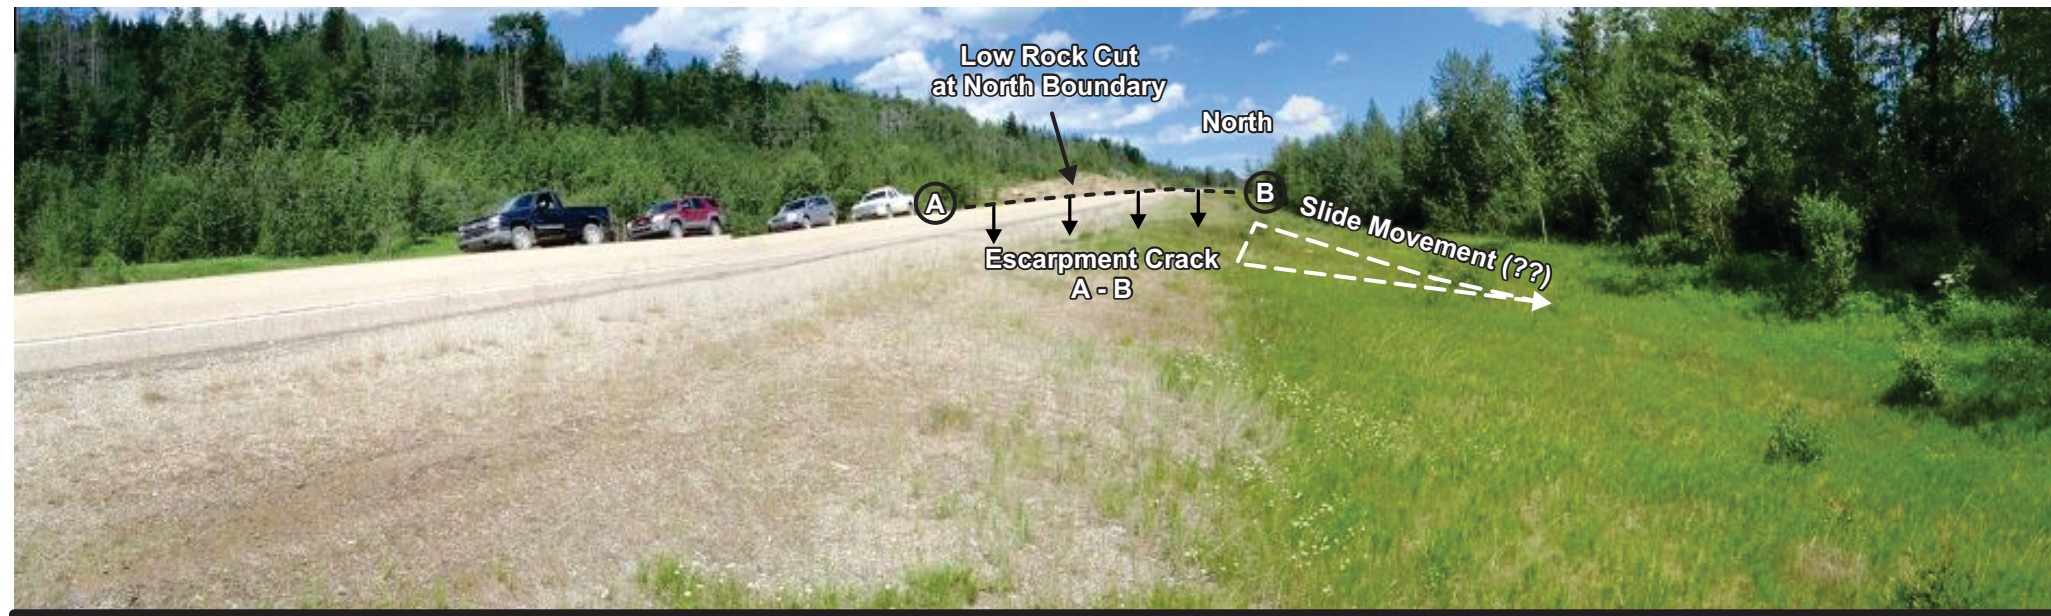
**Photo 1**

**Looking north (towards Kakwa River)**

- Slide movement (??) may be under development from left to right (?) downvalley
- An escarpment crack has persisted at its north frank crossing (from sideslope @B to backslope ditch @A)
- Site is bordered to the north with a low rock cut slope
- Site is bordered to the south (Grande Cache direction) by a culvert

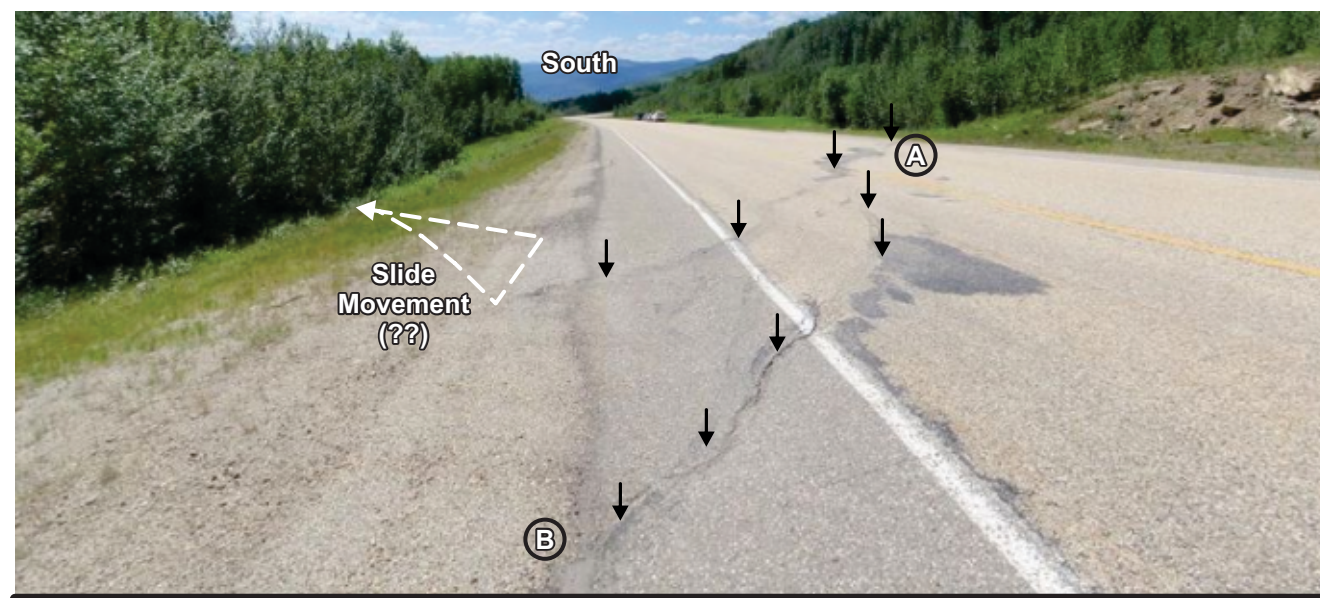
**Photo 1a**

**Looking south along sideslope**

- Escarpment crack across roadway (from sideslope @B to backslope @A)
- Close up

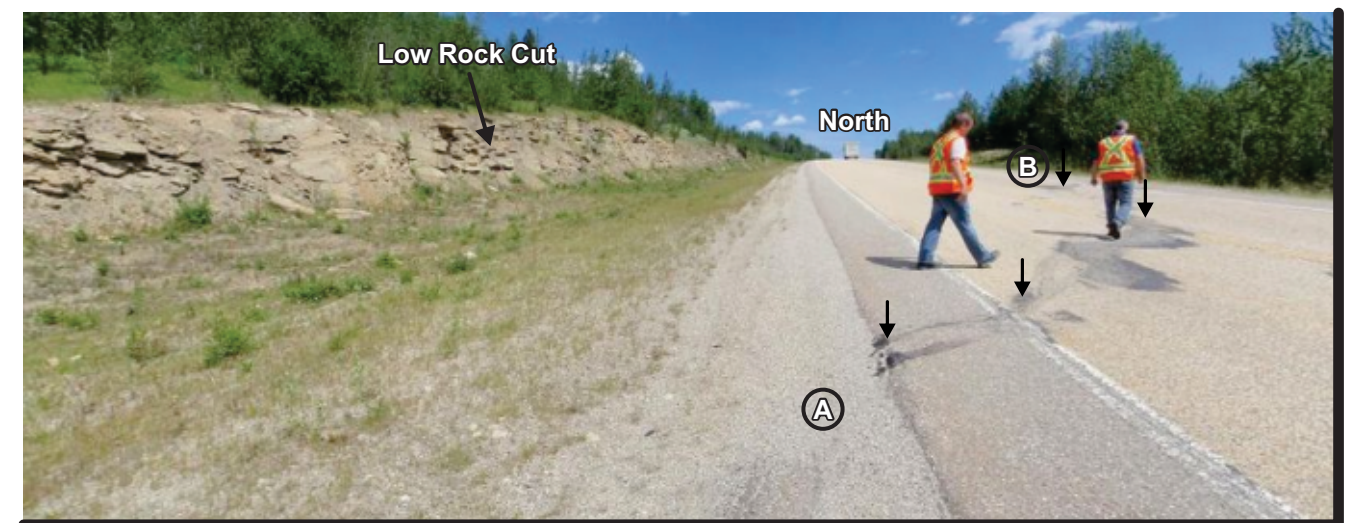
**Photo 1b**

**Looking north along backslope**

- Another perspective of same crack A-B
- Close up

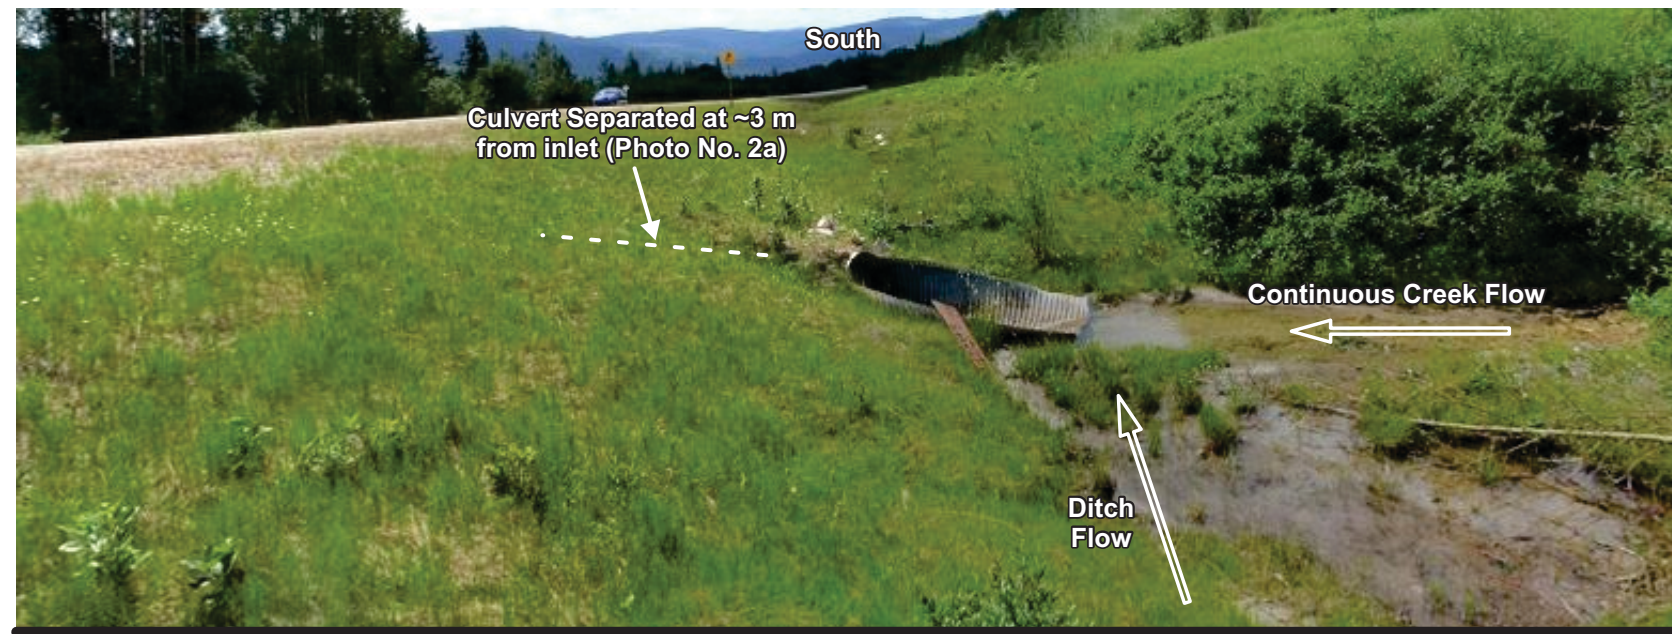
**Photo 2**  
**Looking south (towards Grand Cache)**  
 • A culvert a south border  
 • Broken at inlet area

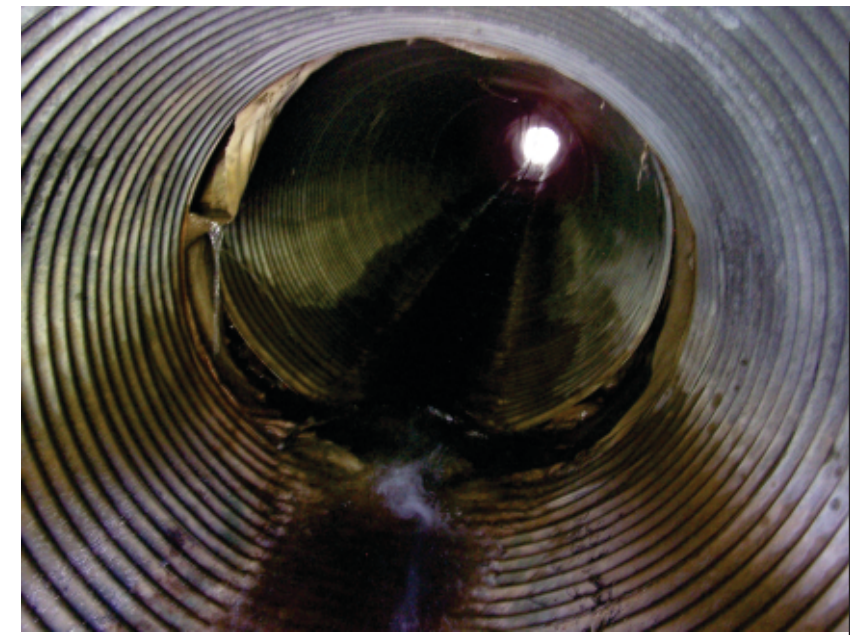
pavement at east (north)end.		
SLOPE MOVEMENT	x		Likely slippage of embankment under influence of seepage groundwater regime		x
EROSION		x	n/a		
SEEPAGE	x		Probable seepage flow beneath embankment		
CULVERT DISTRESS	x		900mm dia culvert separated (July 2012)at 3m distance from inlet. Need to repair as a priority.		
<p>COMMENTS:</p> <p>In current 2012 site visit, it was reviewed that</p> <ol style="list-style-type: none"> <li>1) Headscarp crack at east (north) end has not deteriorated.</li> <li>2) At the west (south) end, the culvert is separated and has to be repaired as a priority. Active stream flow is entering the broken pipe. Leakage and seepage has been occurring.</li> <li>3) For this distress area, groundwater seepage flow beneath the embankment maybe likely. The continuous spring flow from a stream (skirting from backslope flat area) can be indicator of year-round seepage feed in the area. Thus for the cracking at the east (north) end, it maybe causal by likely seepage influence below embankment. However, this remains to be observed.</li> <li>4) Future deterioration of the site remains to be observed. Site to be inspected next year.</li> </ol> <p>Important Note:</p> <p>This form assessment is an update for current year only. Please refer to the detailed assessment provided as in the 2011 Annual Assessment and other earlier Reports for background understanding of this site.</p> <p>END</p>

**Photo 2a**  
**Culvert separated at about 3m from inlet**  
 • Culvert to be repaired

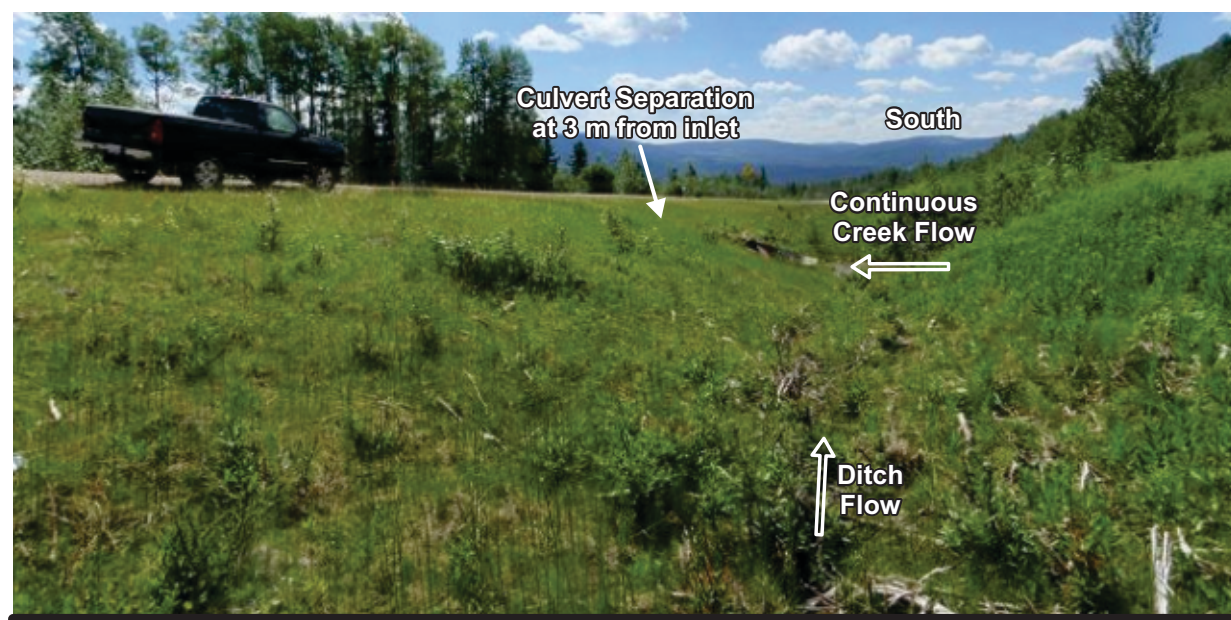
**Photo 2b**  
**Looking south**  
 • Backslope ditch to inflow merging flow from a continuous flowing creek

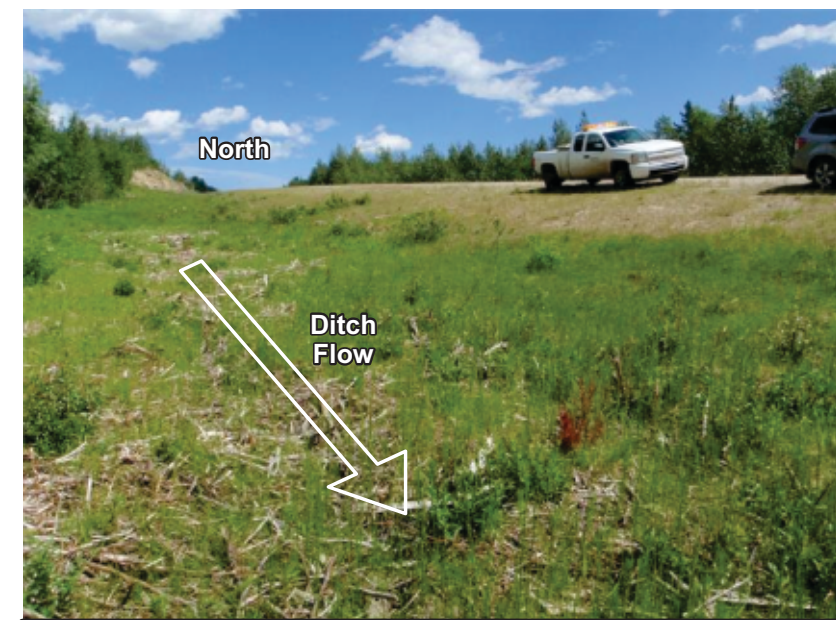
**Photo 2c**  
**Looking north (away from Grande Cache)**  
 • Another view of backslope ditch

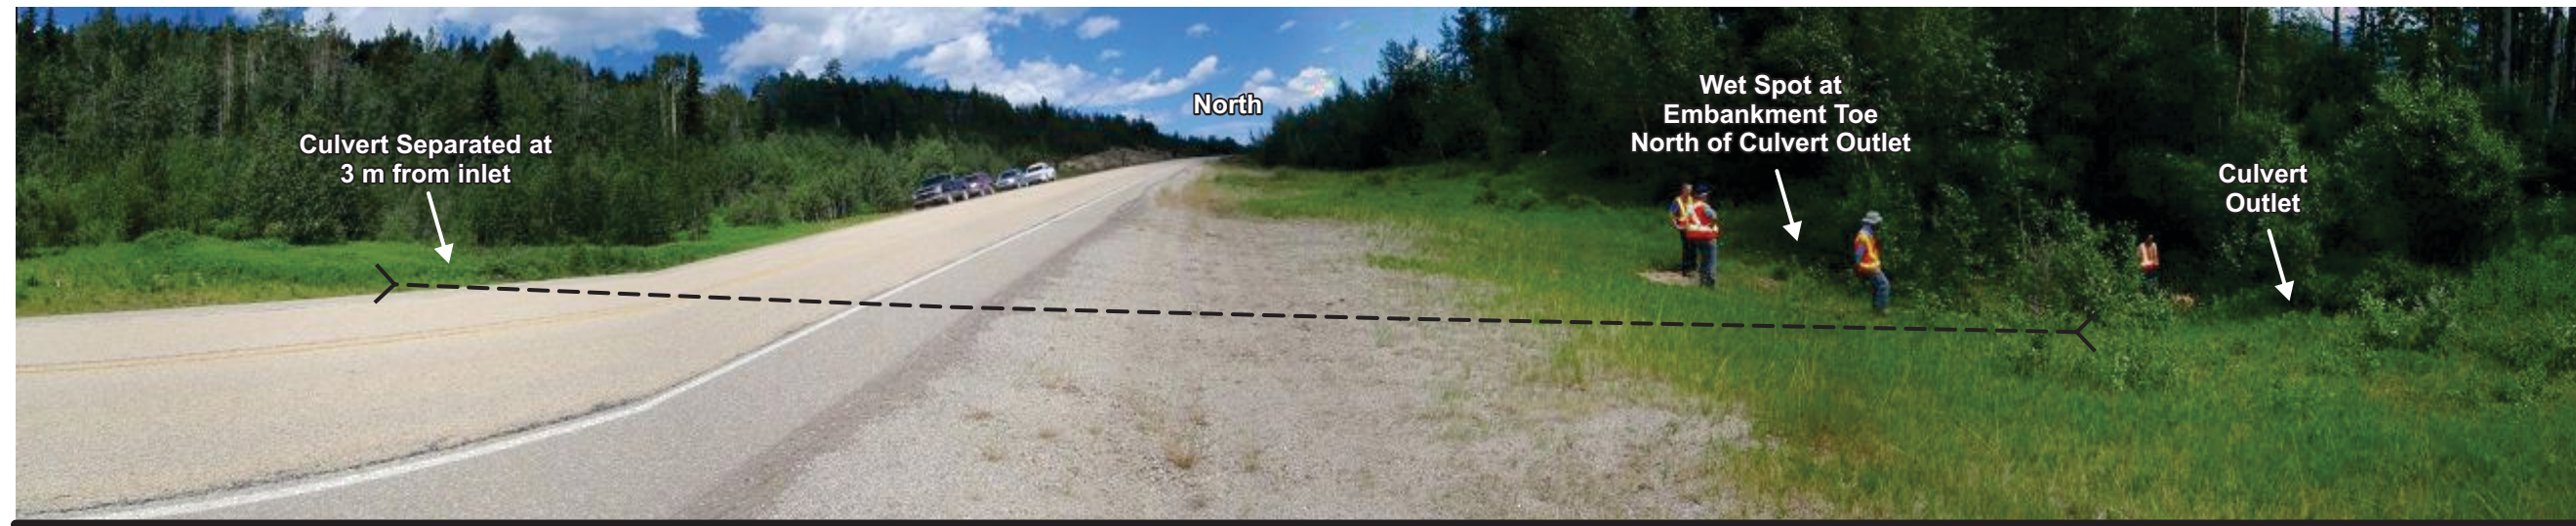
**Photo 3**

**Looking north (away from Grande Cache)**

- A chronic wet spot at toe of road embankment beside the culvert outlet
- May be causal by culvert leakage
- Culvert separated at 3 m from inlet

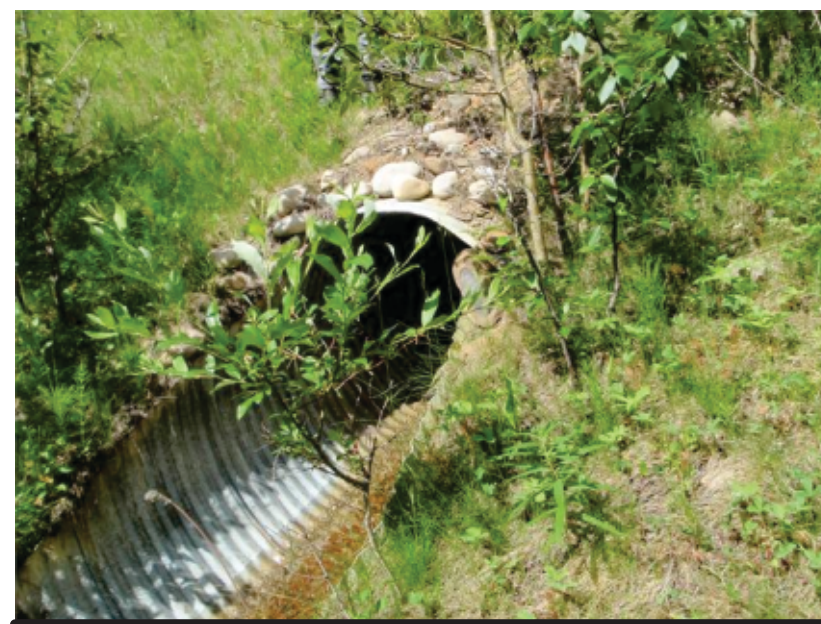
**Photo 3a**

**Culvert outlet with continual flow**
