**ALBERTA TRANSPORTATION
GEOHAZARD ASSESSMENT PROGRAM
PEACE REGION – GRANDE PRAIRIE DISTRICT
2017 INSPECTION**

Site Number	Location	Name	Hwy	km
GP43 Callout	No Name Creek	Undermined Culvert	40:36	38.5
Legal Description		UTM Co-ordinates (NAD 83)		
SE21-59-6-W6		11U N 5,997,793	E 380,279

**2017 GP43 CALLOUT, HWY 40:36, km 38.5
UNDERMINED CULVERT
SE 21-59-6-W6M**

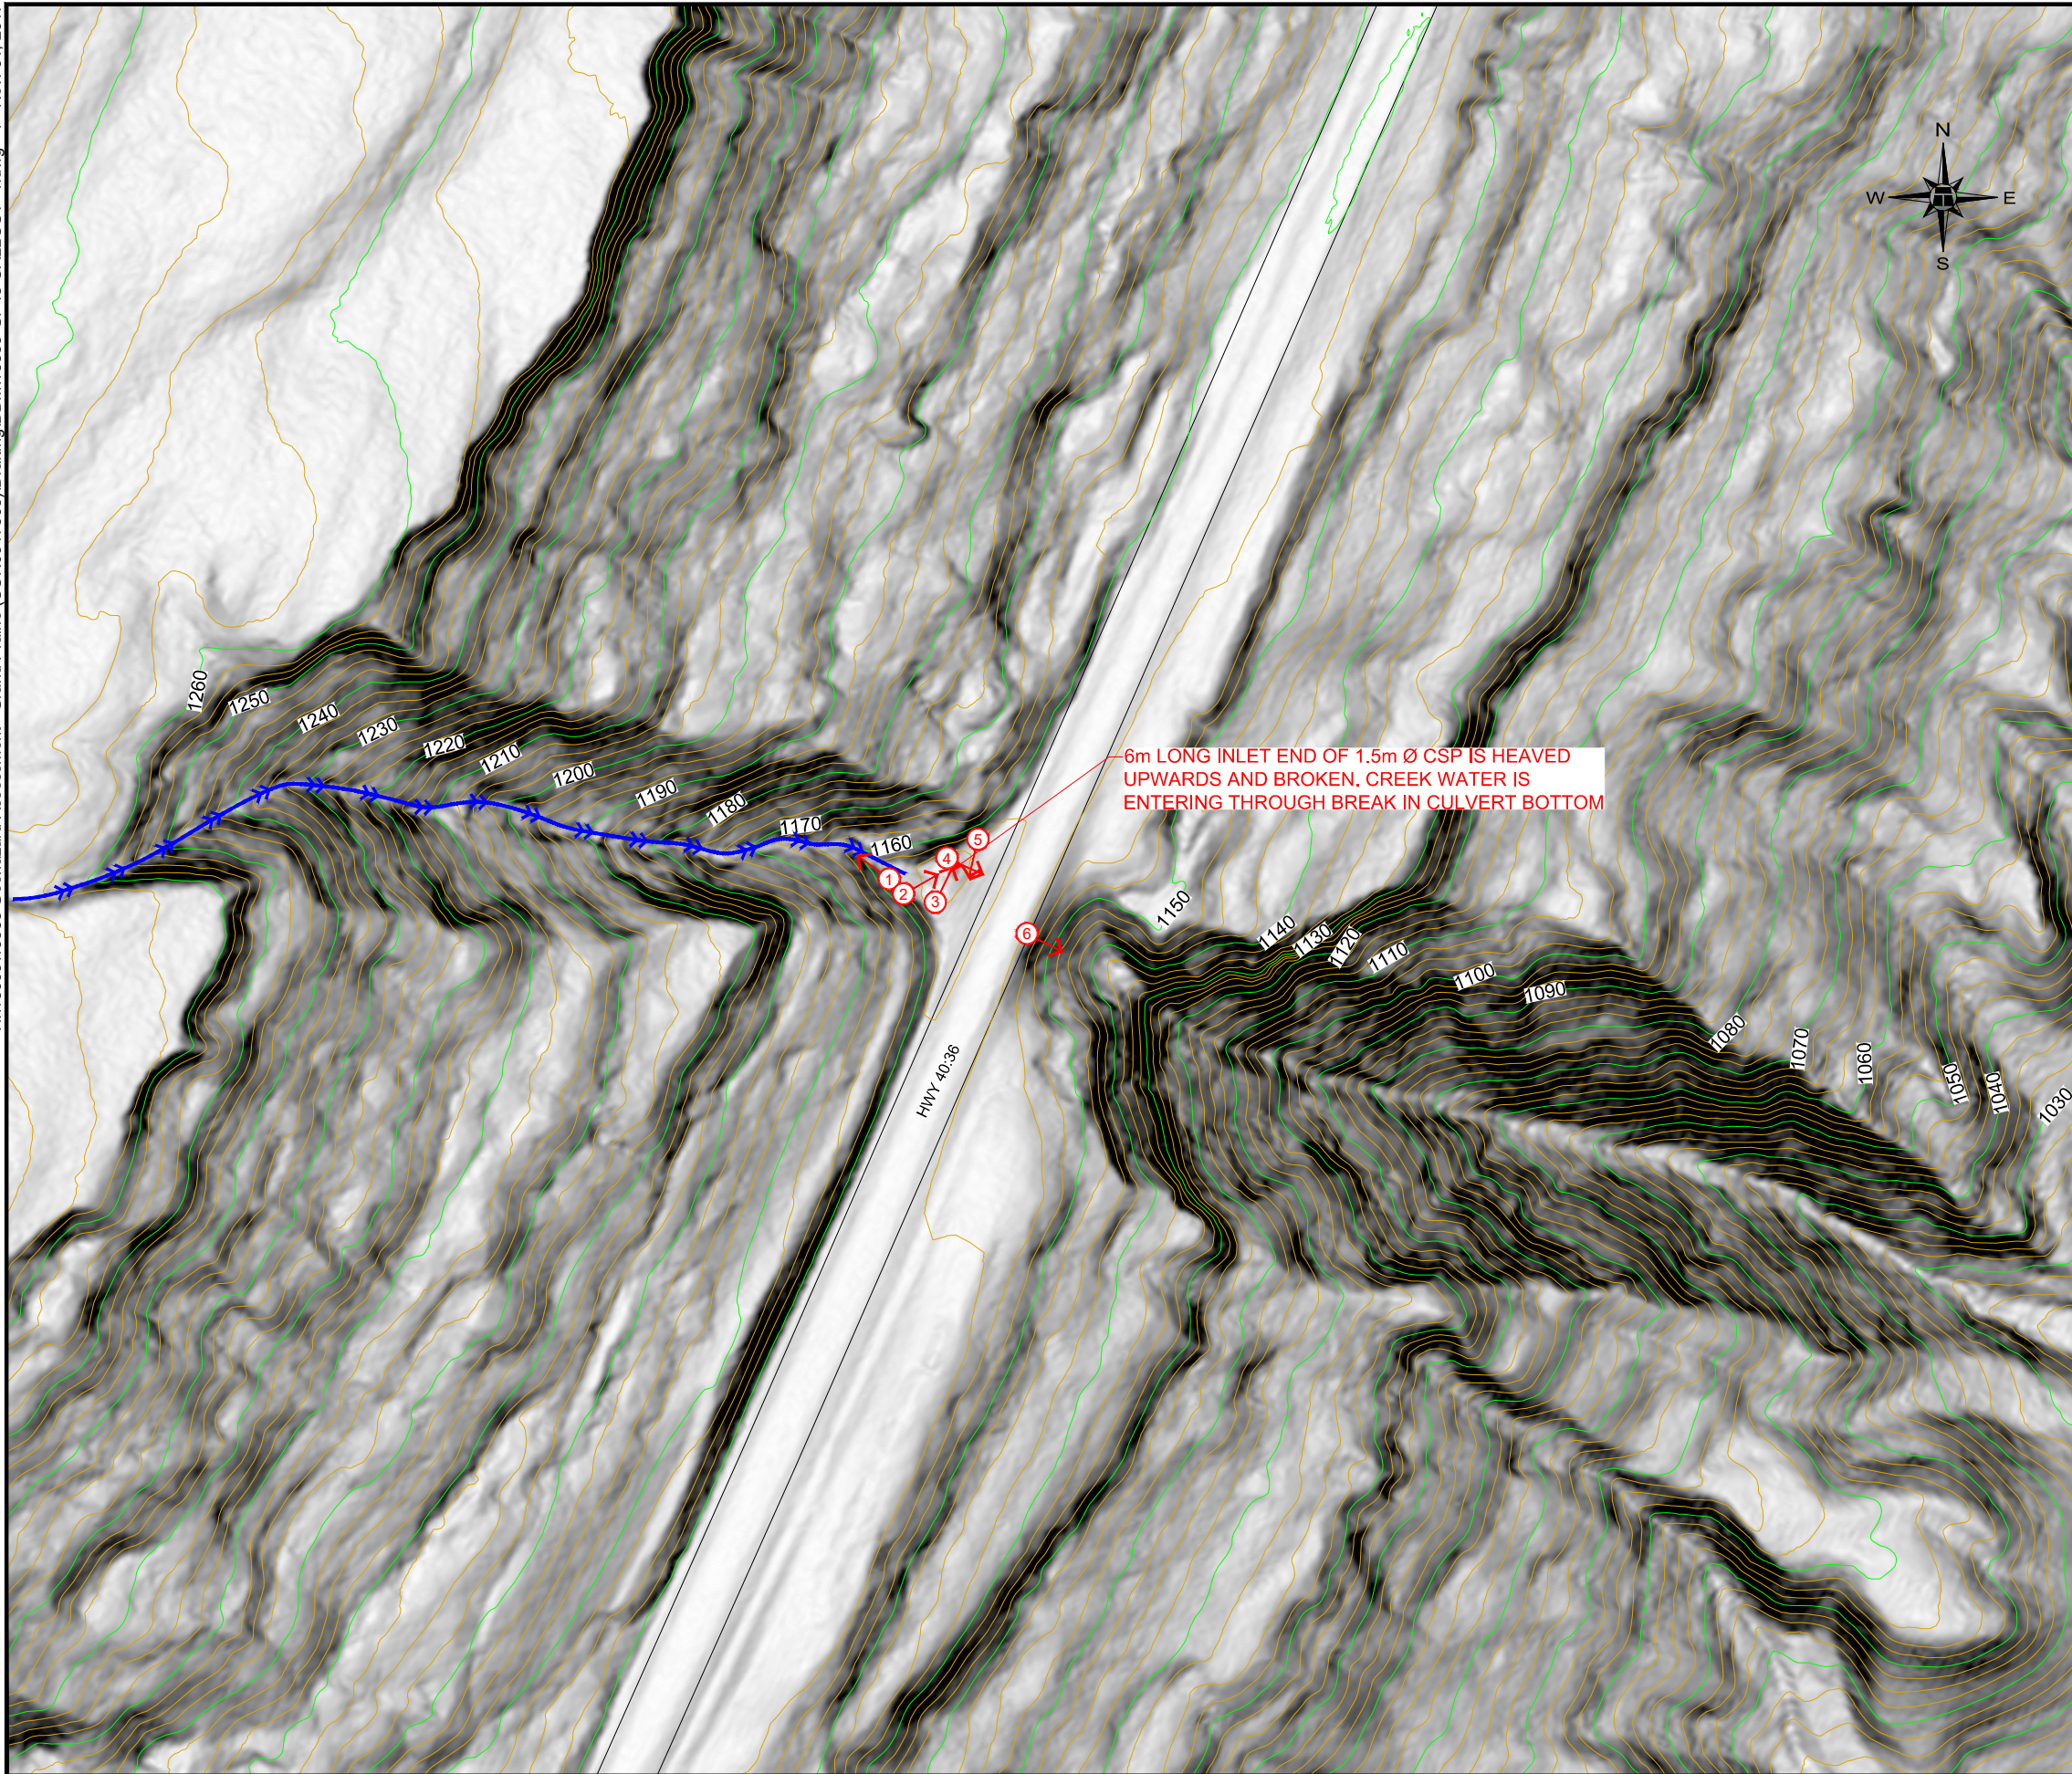
DWG No. 13353-GP43-CALLOUT-1

SITE PLAN

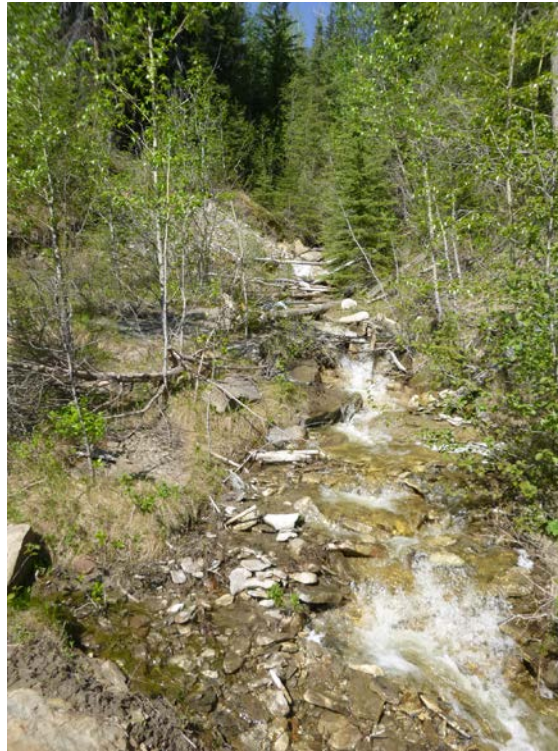
Photo 1 – Looking upstream (west) at the creek flowing into the culvert – no significant erosion.

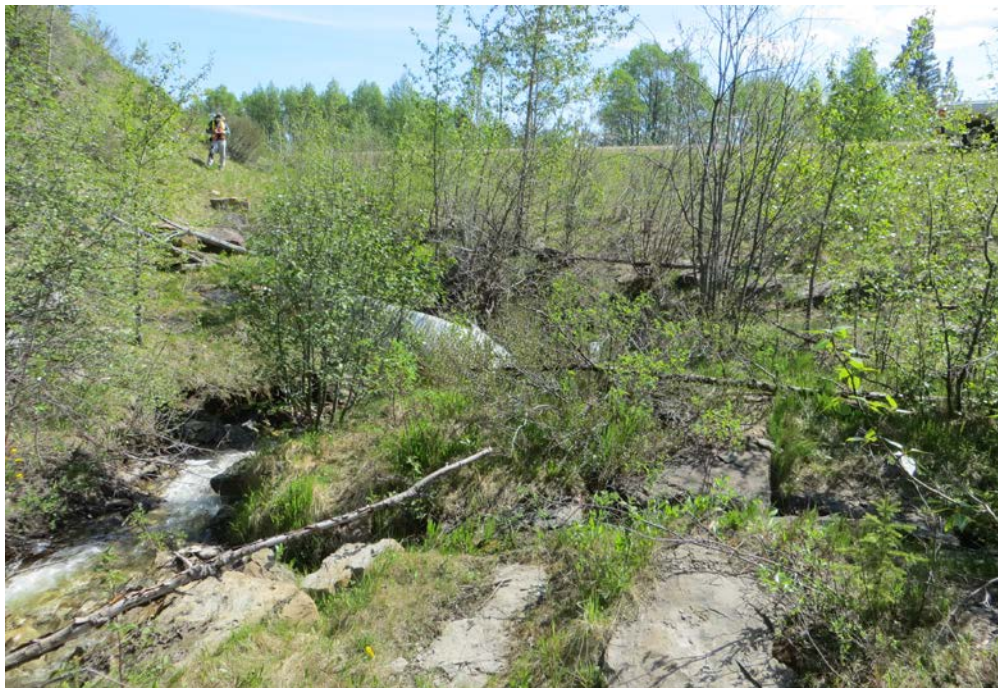
Primary Site Issue:	An approximate 6 m long portion of the 1.5 m diameter CSP culvert inlet on the west side of the highway is protruding upwards, and creek flow is entering the culvert at this broken location.	
Dimensions:	~6 m length of damaged CSP (1.5m diameter) and erosion beneath it.	
Date of any remediation:		
Maintenance:		
Observations:	Description	Worse?
<input type="checkbox"/> Pavement Distress		<input type="checkbox"/>
<input type="checkbox"/> Slope Movement		<input type="checkbox"/>
<input checked="" type="checkbox"/> Erosion	Active erosion activity is occurring beneath the existing damaged culvert inlet that is protruding upwards.	<input type="checkbox"/>
<input type="checkbox"/> Seepage		<input type="checkbox"/>
<input checked="" type="checkbox"/> Bridge/Culvert Distress	The first 6 m length of 1.5 m diameter CSP is damaged, and needs a new inlet piece attached onto the existing undamaged portion.	<input type="checkbox"/>

It is thought that the inlet of the culvert became eroded and that during a high flow event the water got under the pipe and pushed up the inlet section causing it to separate from the rest of the pipe at the first joint.

The highway was not affected by the undermined culvert at the time of our inspection, however with time, continued erosion could eventually affect the highway sideslope if not dealt with. The broken culvert will impede flow during a future high flow event, with the risk of water backing up behind the highway and more severe erosion occurring.

Photo 2 – Looking east at the lifted/undermined culvert inlet and highway embankment.

The repair of the CSP culvert inlet should consist of the following:

- 1) Remove the damaged 6 m long portion of the culvert inlet
- 2) Remove the existing (typical Class 1 sized) riprap, and salvage it for re-use
- 3) Restore the eroded creek channel bed with the salvaged riprap

- 4) Place and securely fasten a new section of 1.5 m diameter CSP culvert onto the existing undamaged pipe portion
- 5) Construct a new concrete headwall around the new inlet location
- 6) Place properly sized riprap along the stream bed leading up to the culvert headwall

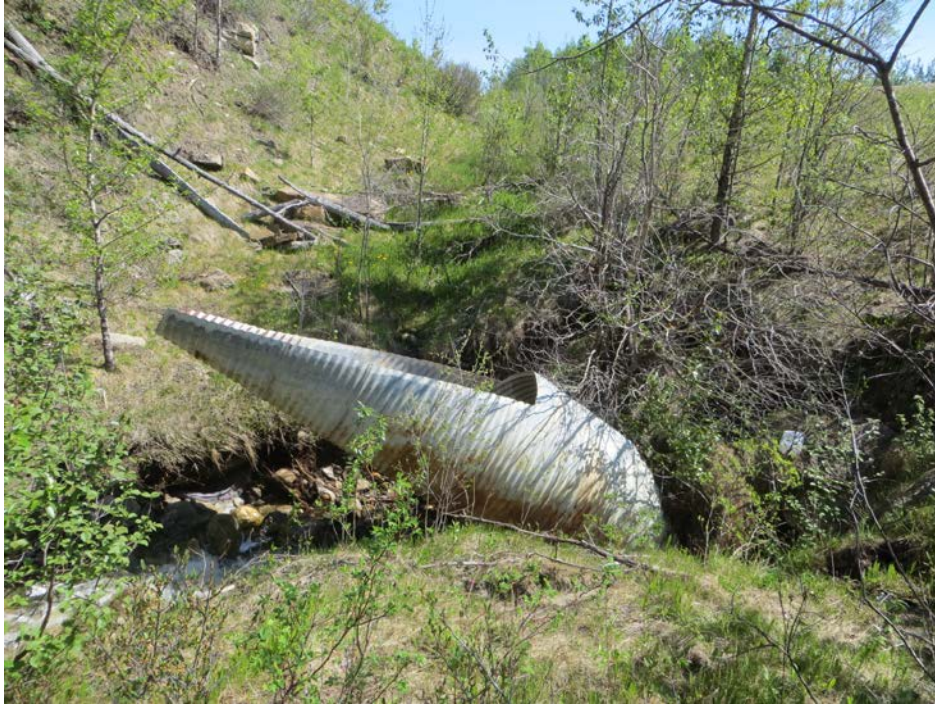
Photo 3 – Looking northeast at the culvert inlet and northwest highway runoff ditch.

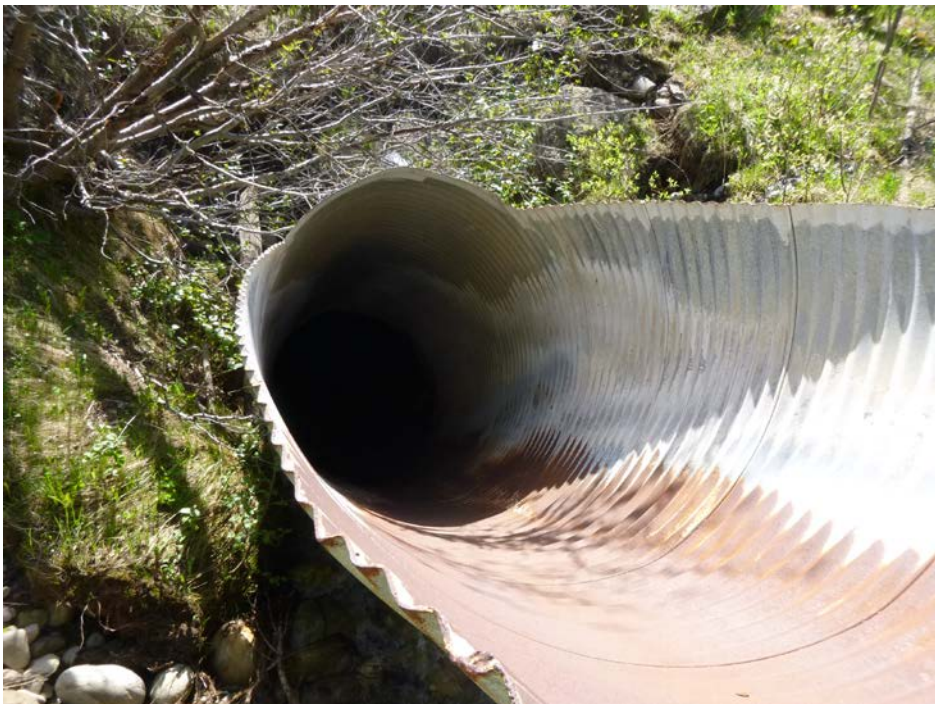
Photo 4 – Close-up view looking down at the culvert inlet.

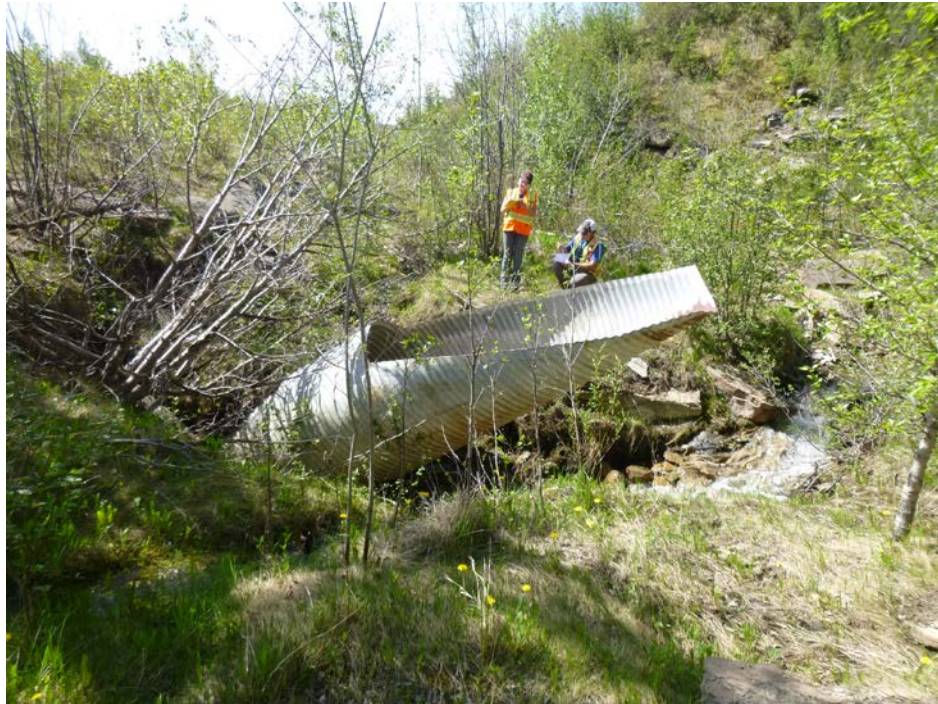
Photo 5 – Looking south at the lifted/undermined culvert inlet.

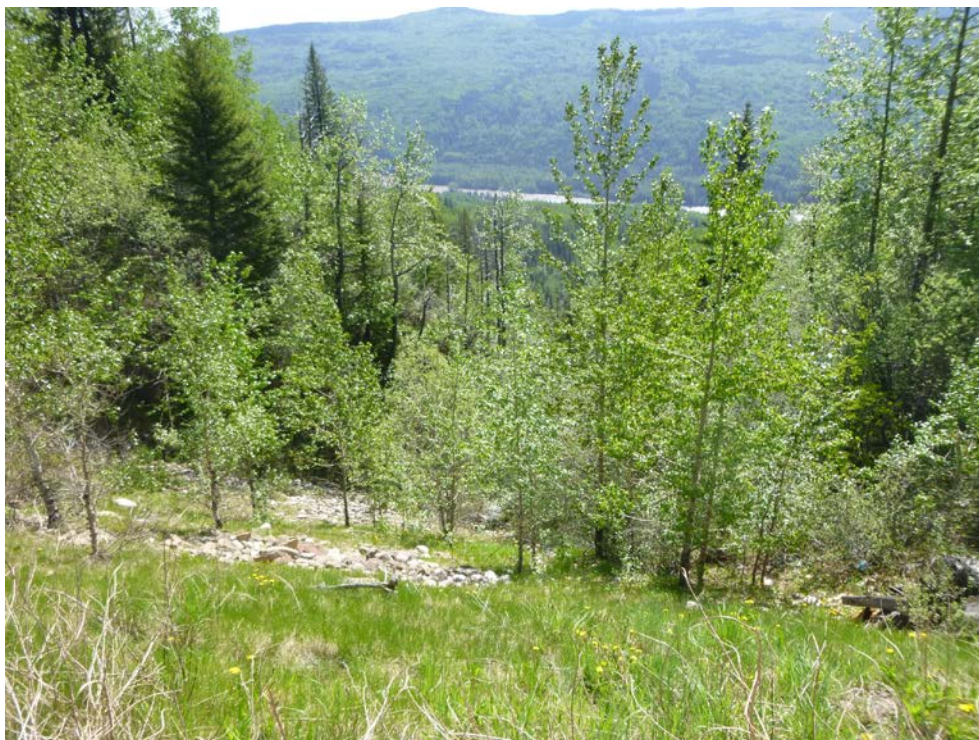
Photo 6 – Looking east at the downstream highway embankment towards the culvert outlet.
