Slide Name: (GP 2) Hwy 40:38 Kakwa River (20 km S. of Kakwa River)
Inspection Date: May 5, 2005
Inspection by: Alberta Infrastructure & Transportation and EBA staff listed on Page 1

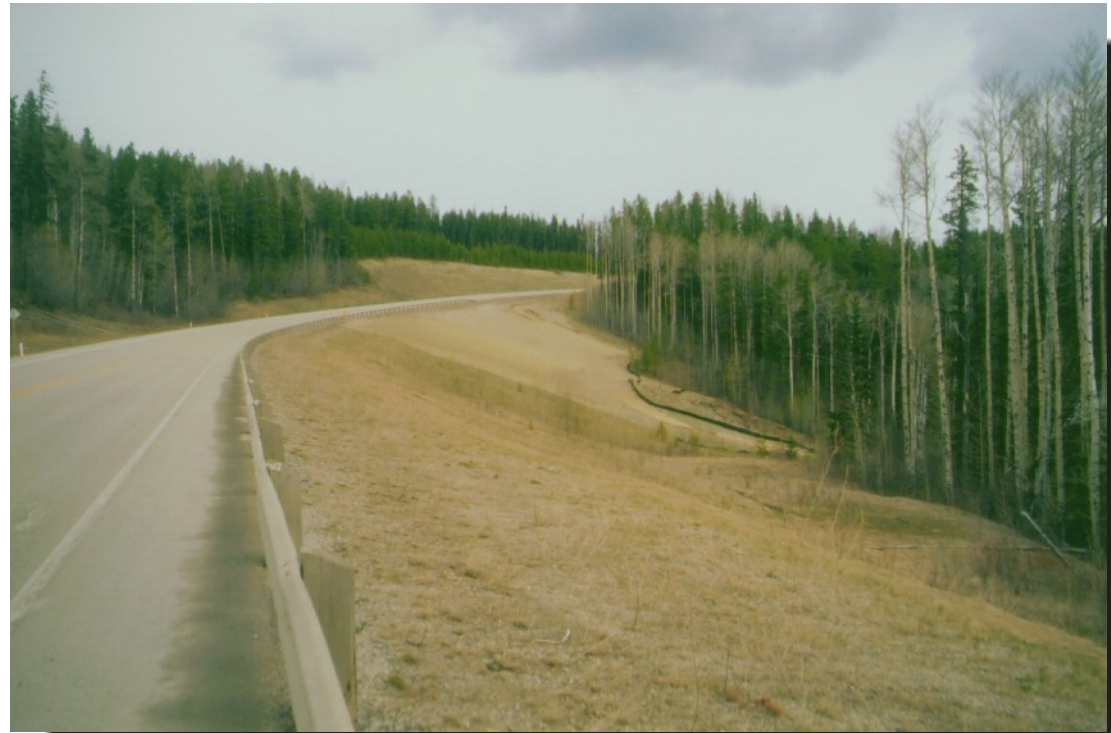
Photo 1

Looking north (toward Grande Prairie)

- Slide remediation (slope reconstruction) area between guardrail and to the left of siltation fence perimeter at toe of slope
- Pitrun material utilized for slope reconstruction and slope face protected with erosion control matting

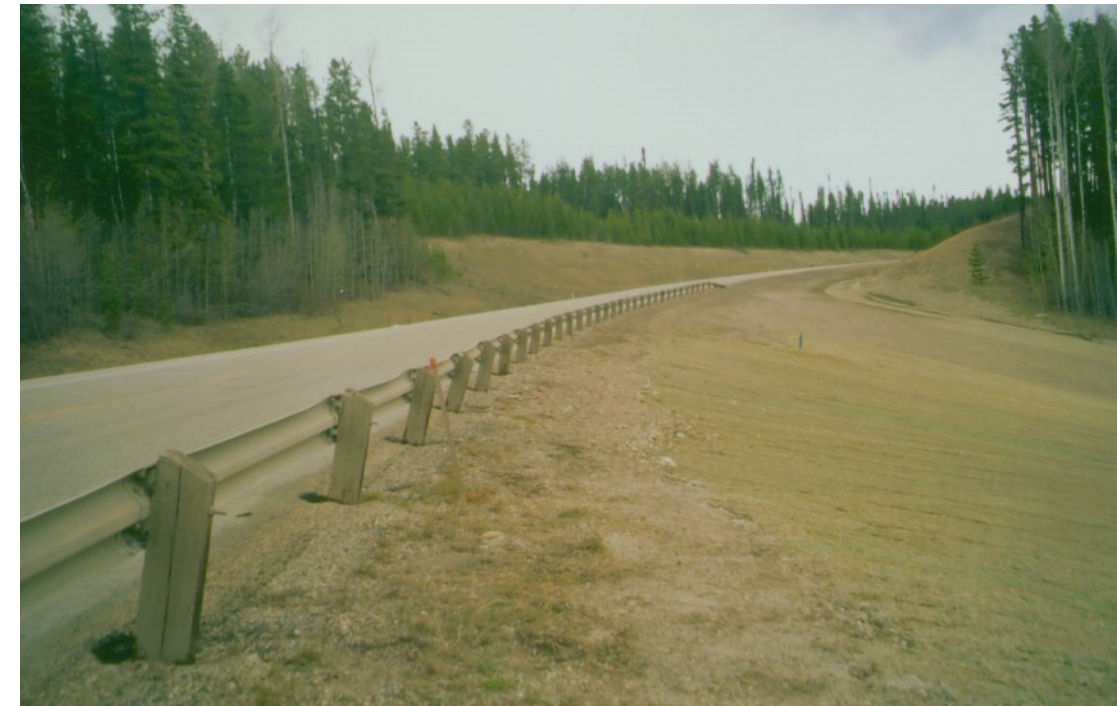
Photo 2

Looking north - another closer view

- Fill placement buttressed onto shoulder edge (previous slide scarp) to right of guardrail edge
- Fill settlement very minor

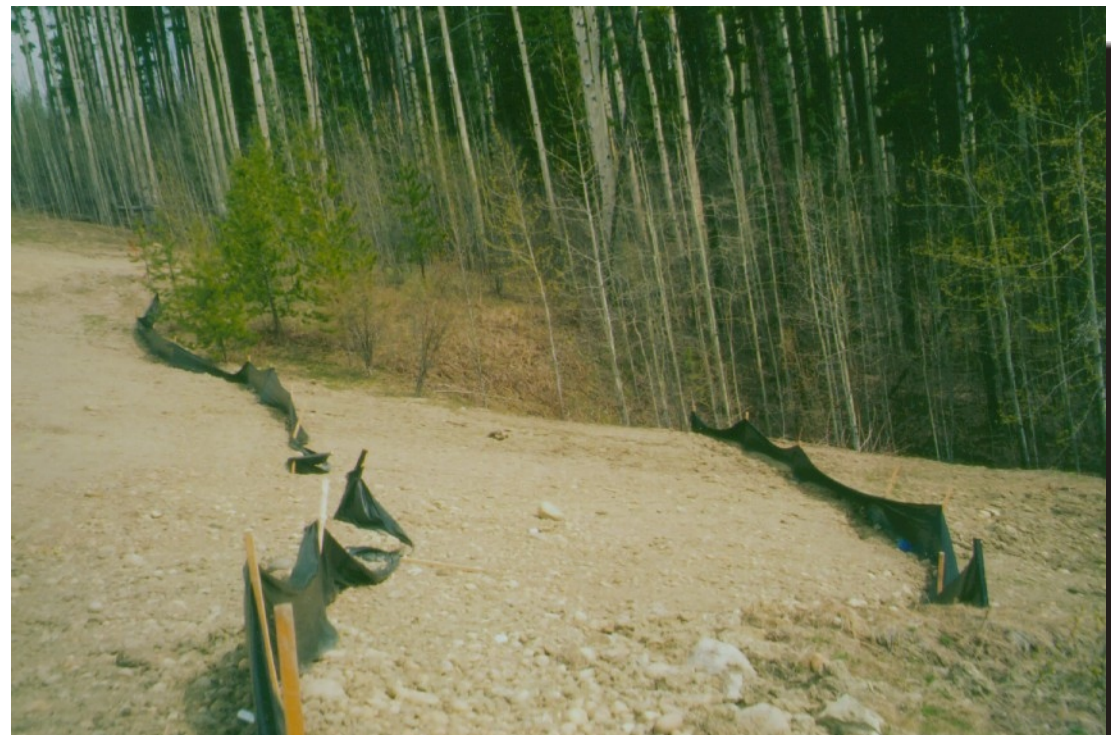
Photo 3

Toe area

- Two rows of silt fence at perimeter locations

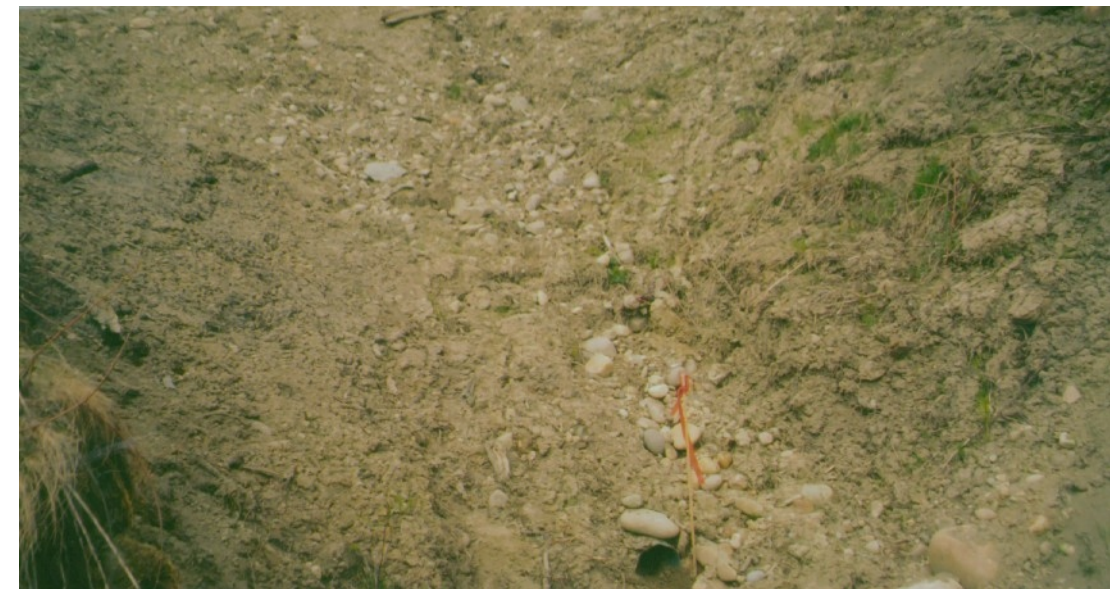
Photo 3a

Toe area of slope reconstruction (Grande Prairie side)

- Second (safety) drainage outlet for tile system at basal granular toe key
- very minimal water outfall as this second outlet is higher than first outlet (on south side)

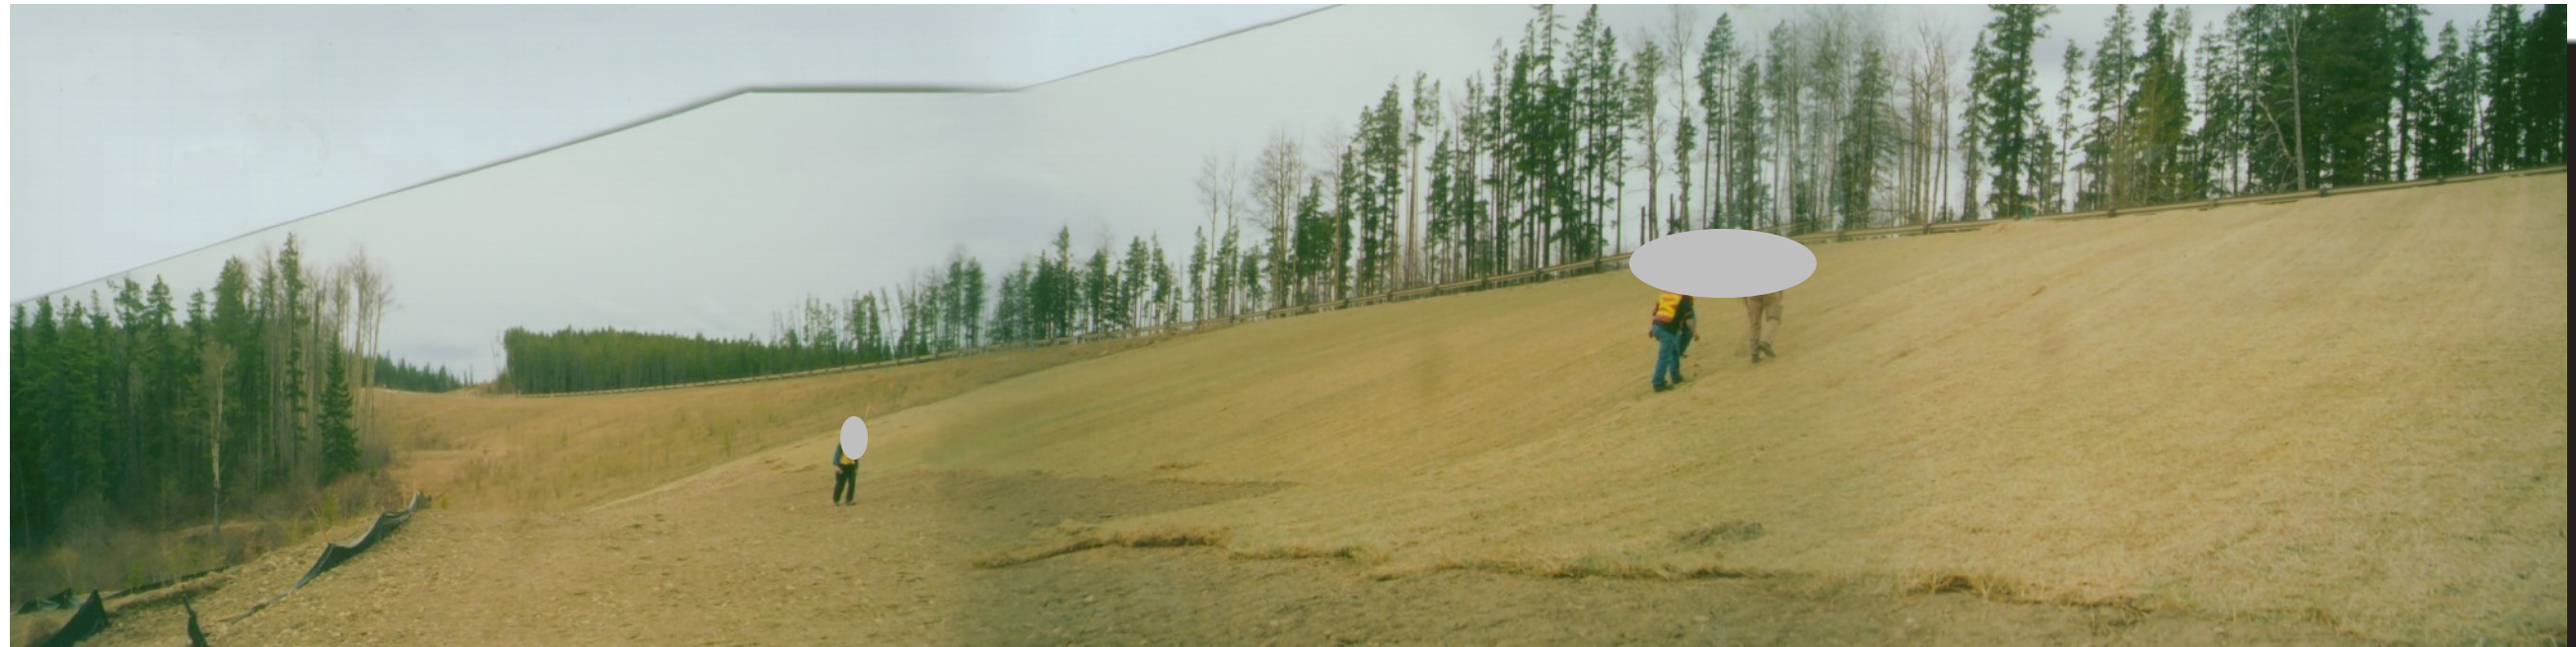
Photo 4
Looking south along toe of slope
- Slope reconstruction to 3H:1V with pitrun material
- Erosion control matting material with high intensity seeding (3 times normal rate)
- toe drainage outlet at left corner of photo (at far end of silt fence)

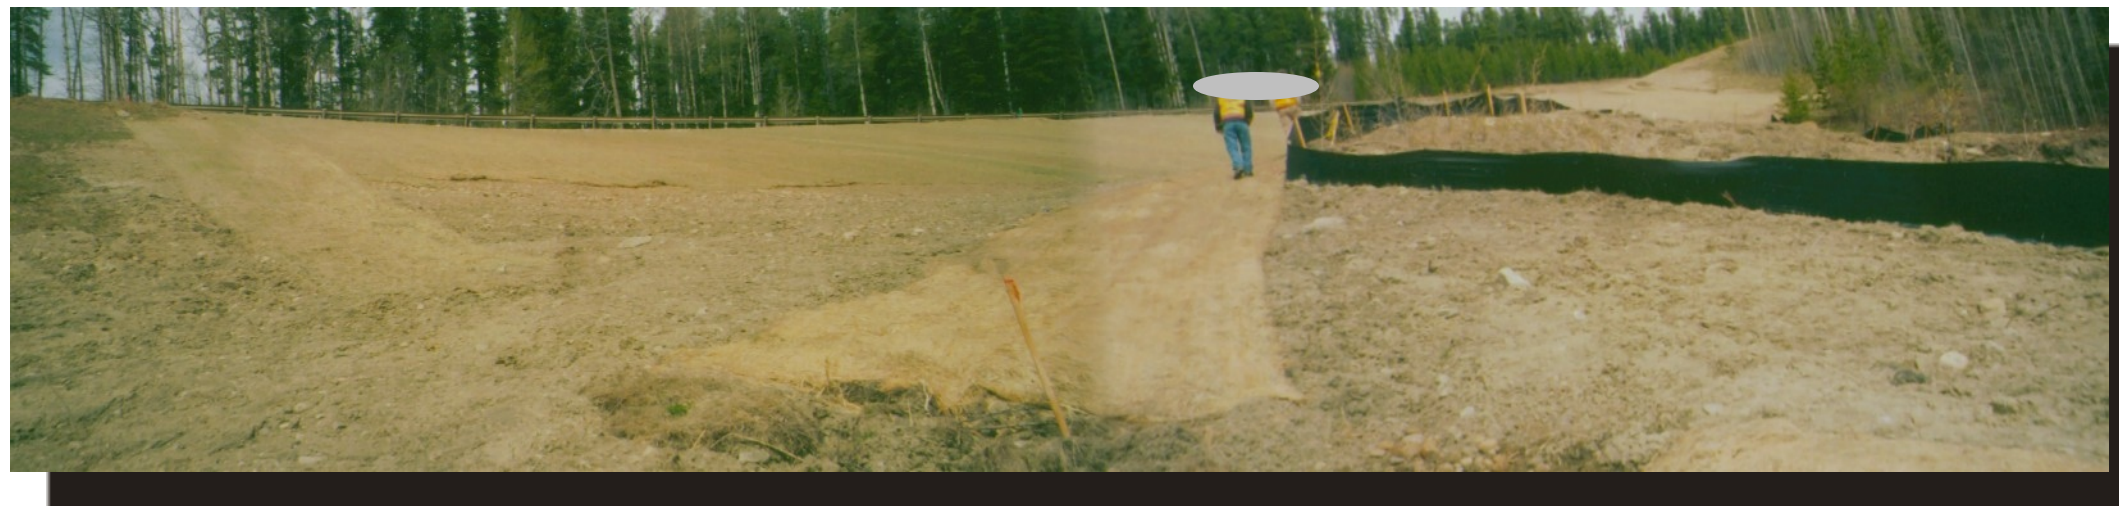
Photo 5
Looking north from south edge of toe area
- First drainage outlet (of tile system at base of toe key at center bottom of photo) yield continuous flow
- silt fence along perimeter at bottom toe edge of slope reconstruction
