Slide Name: (GP 2) Hwy 40:38 Kakwa Slide (20 km S. of Kakwa River)

Inspection Date: June 21, 2006

Inspection by: Alberta Infrastructure & Transportation and KarlEng Staff listed on Page 1

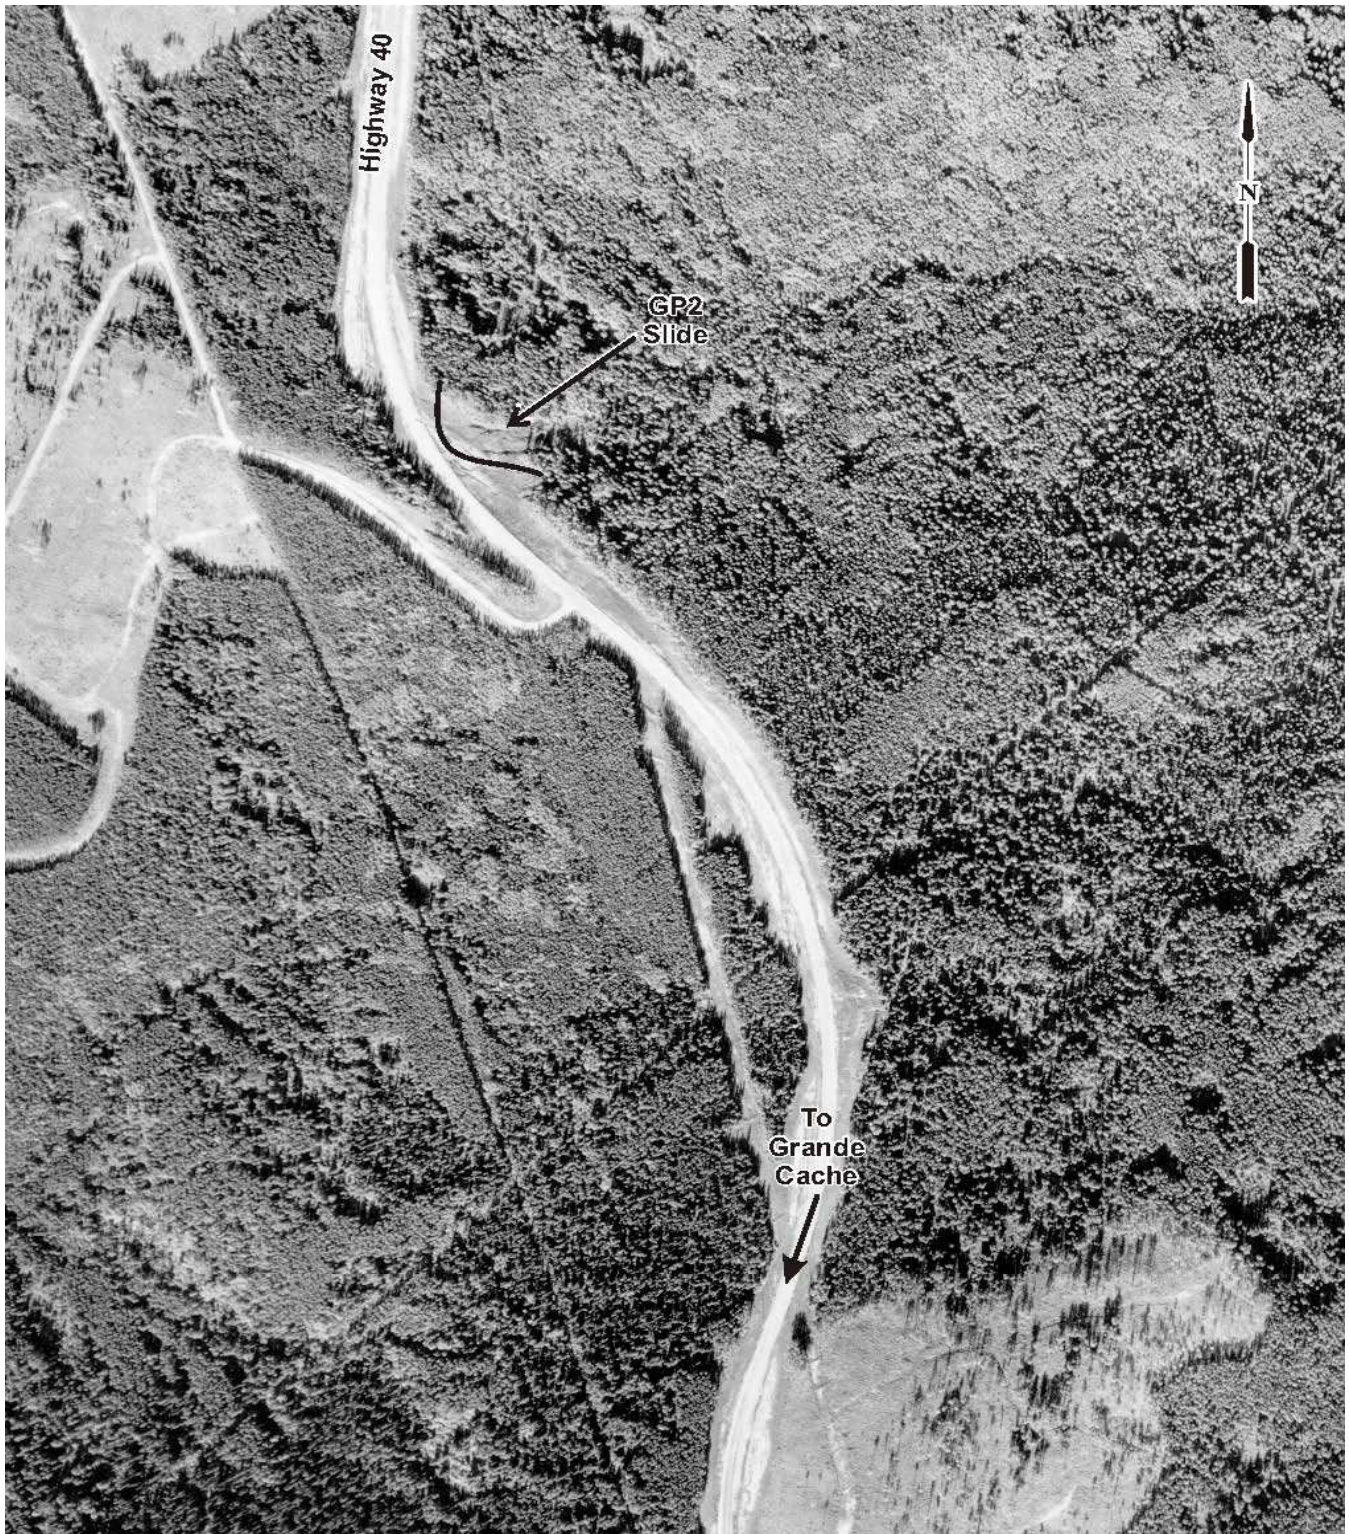
Figure 1

1993 Aerial Photograph

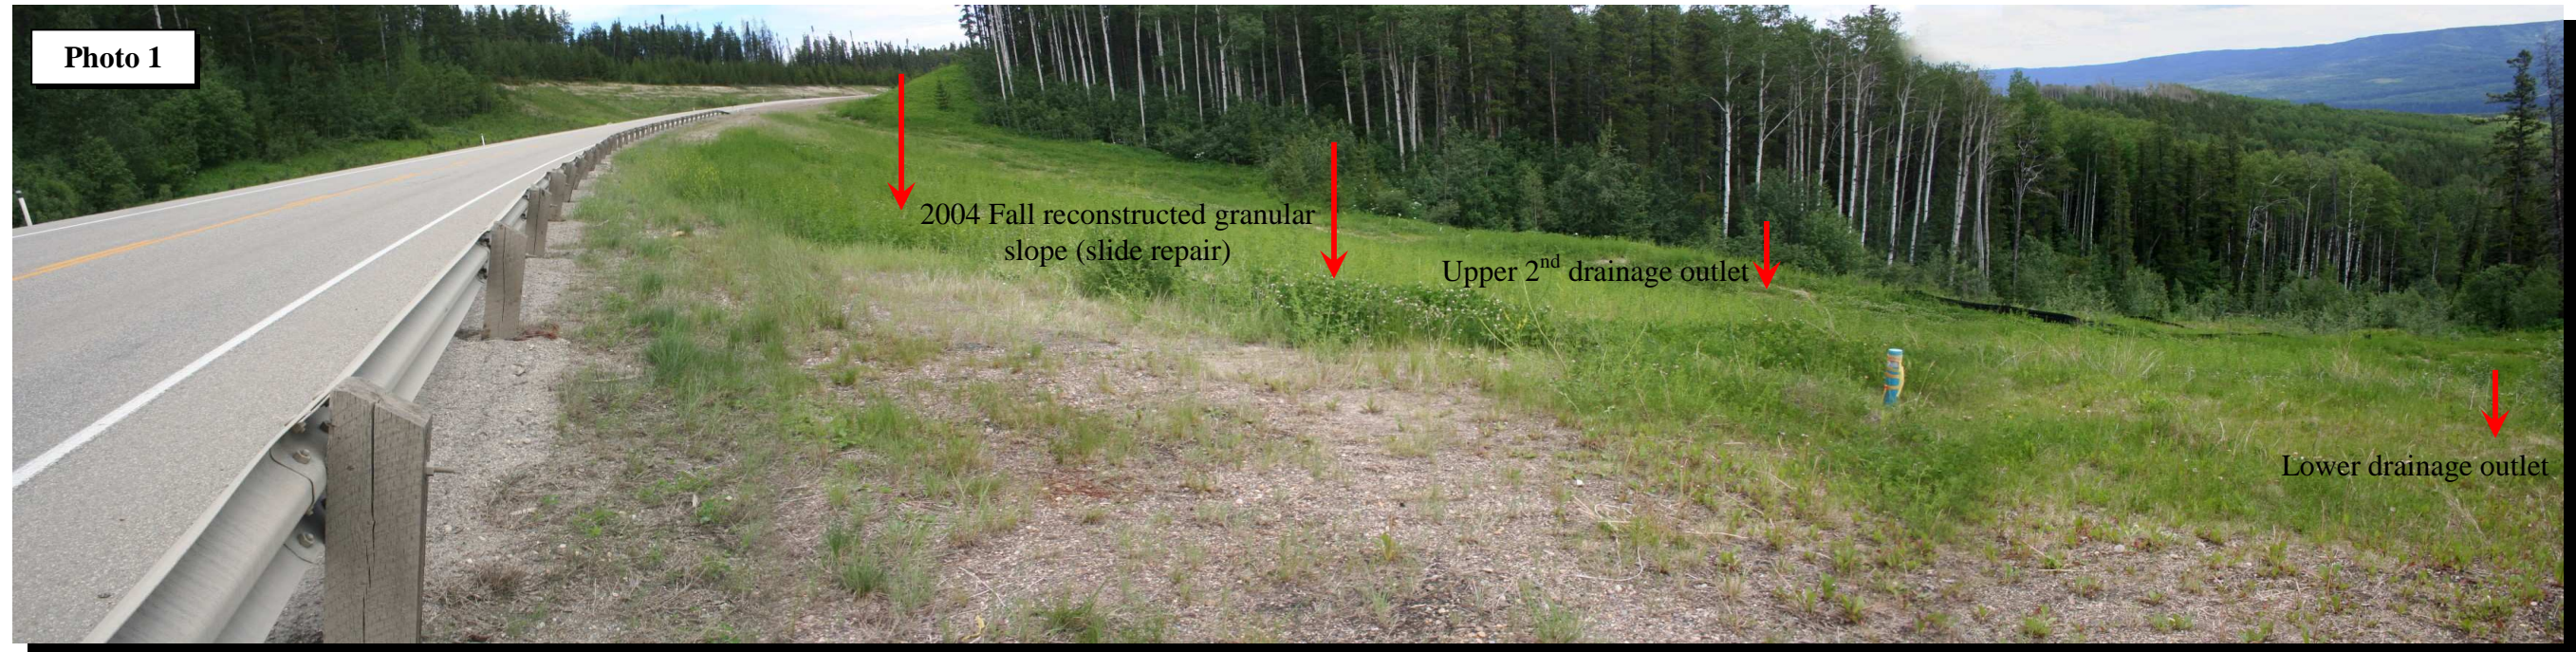
Looking north (towards Grande Prairie)

- Repaired slope well vegetated
- Slope reconstructed with granular material
- 2 drainage outlets at toe of slope (lower outlet and upper outlet)

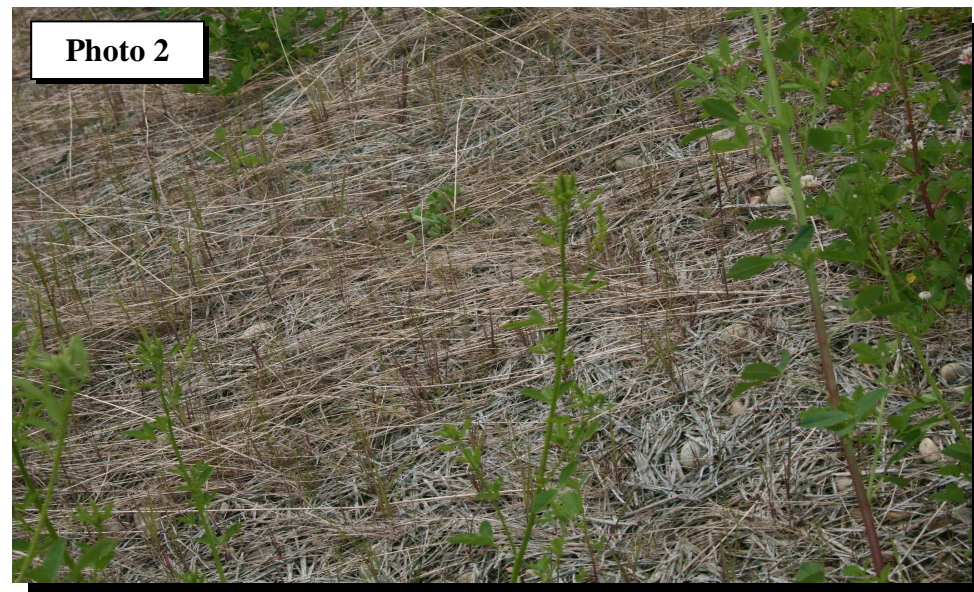
Slope re-vegetation over granular fill

- 3 times seeding density (compared with seeding density for normal top soil subgrade)
- Grass growth started to emerge from straw matting coverings; however the growth of clover (short life) is ahead of grass growth

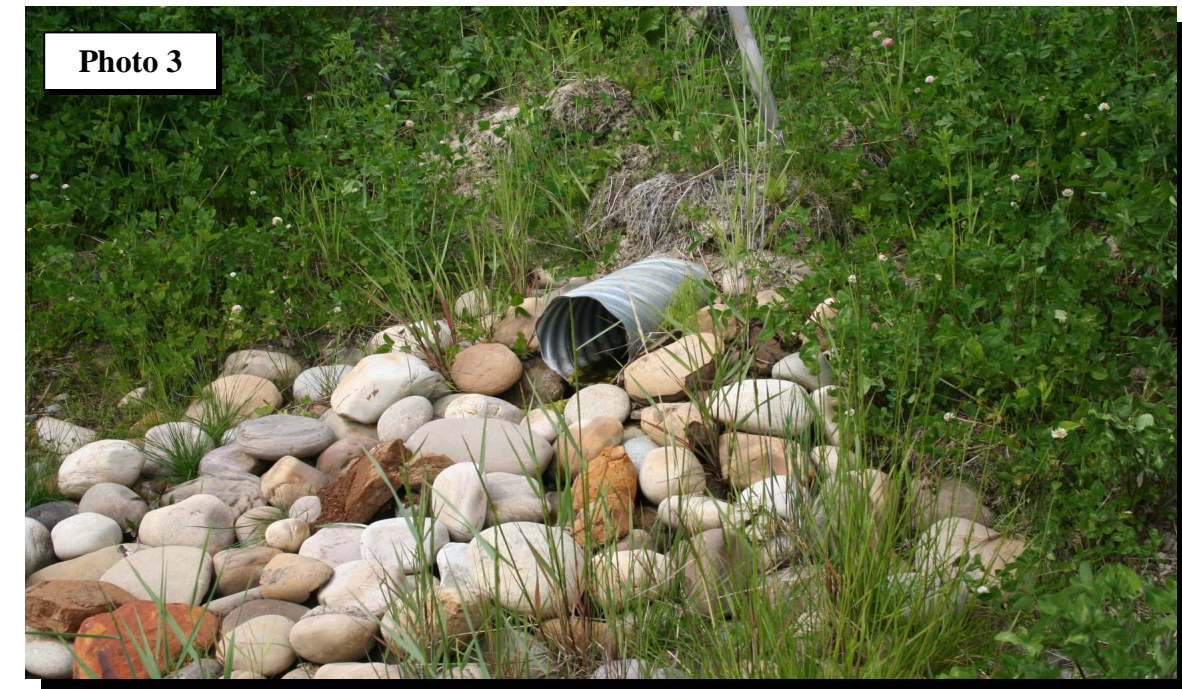
- Steady water outflow from lower drainage normal outlet
- Perforated pipe were incorporated at base of granular slope reconstruction for groundwater drainage
  - Steady water outflow observed over 3 years since slope reconstruction (in winter 2004)

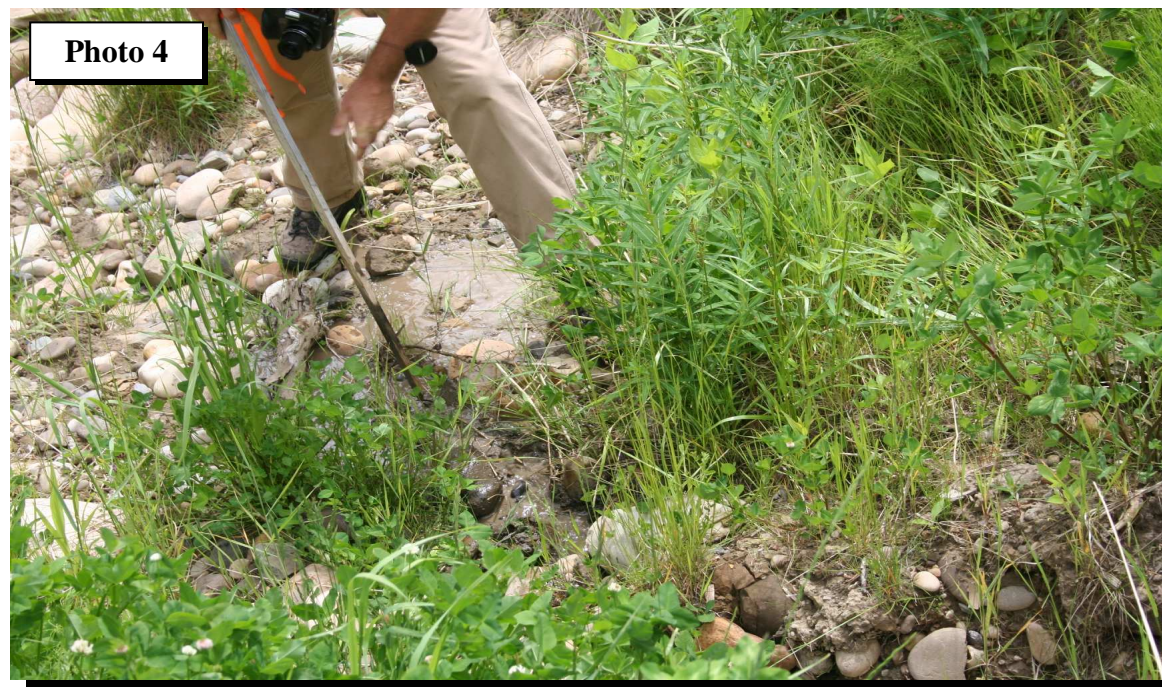
- Entrapped water at upper (2<sup>nd</sup>) drainage safety outlet
- Cleanout of debris (sediment) at 2<sup>nd</sup> outlet yields drainage outflow
  - Constant clean out inspection is required at outlet of subsurface drains to ensure its proper function to prevent buildup of pore water pressure to destabilize the slope
  - This upper outlet was installed as redundancy outlet for high excessive groundwater condition and in the event of any plugging of the lower outlet

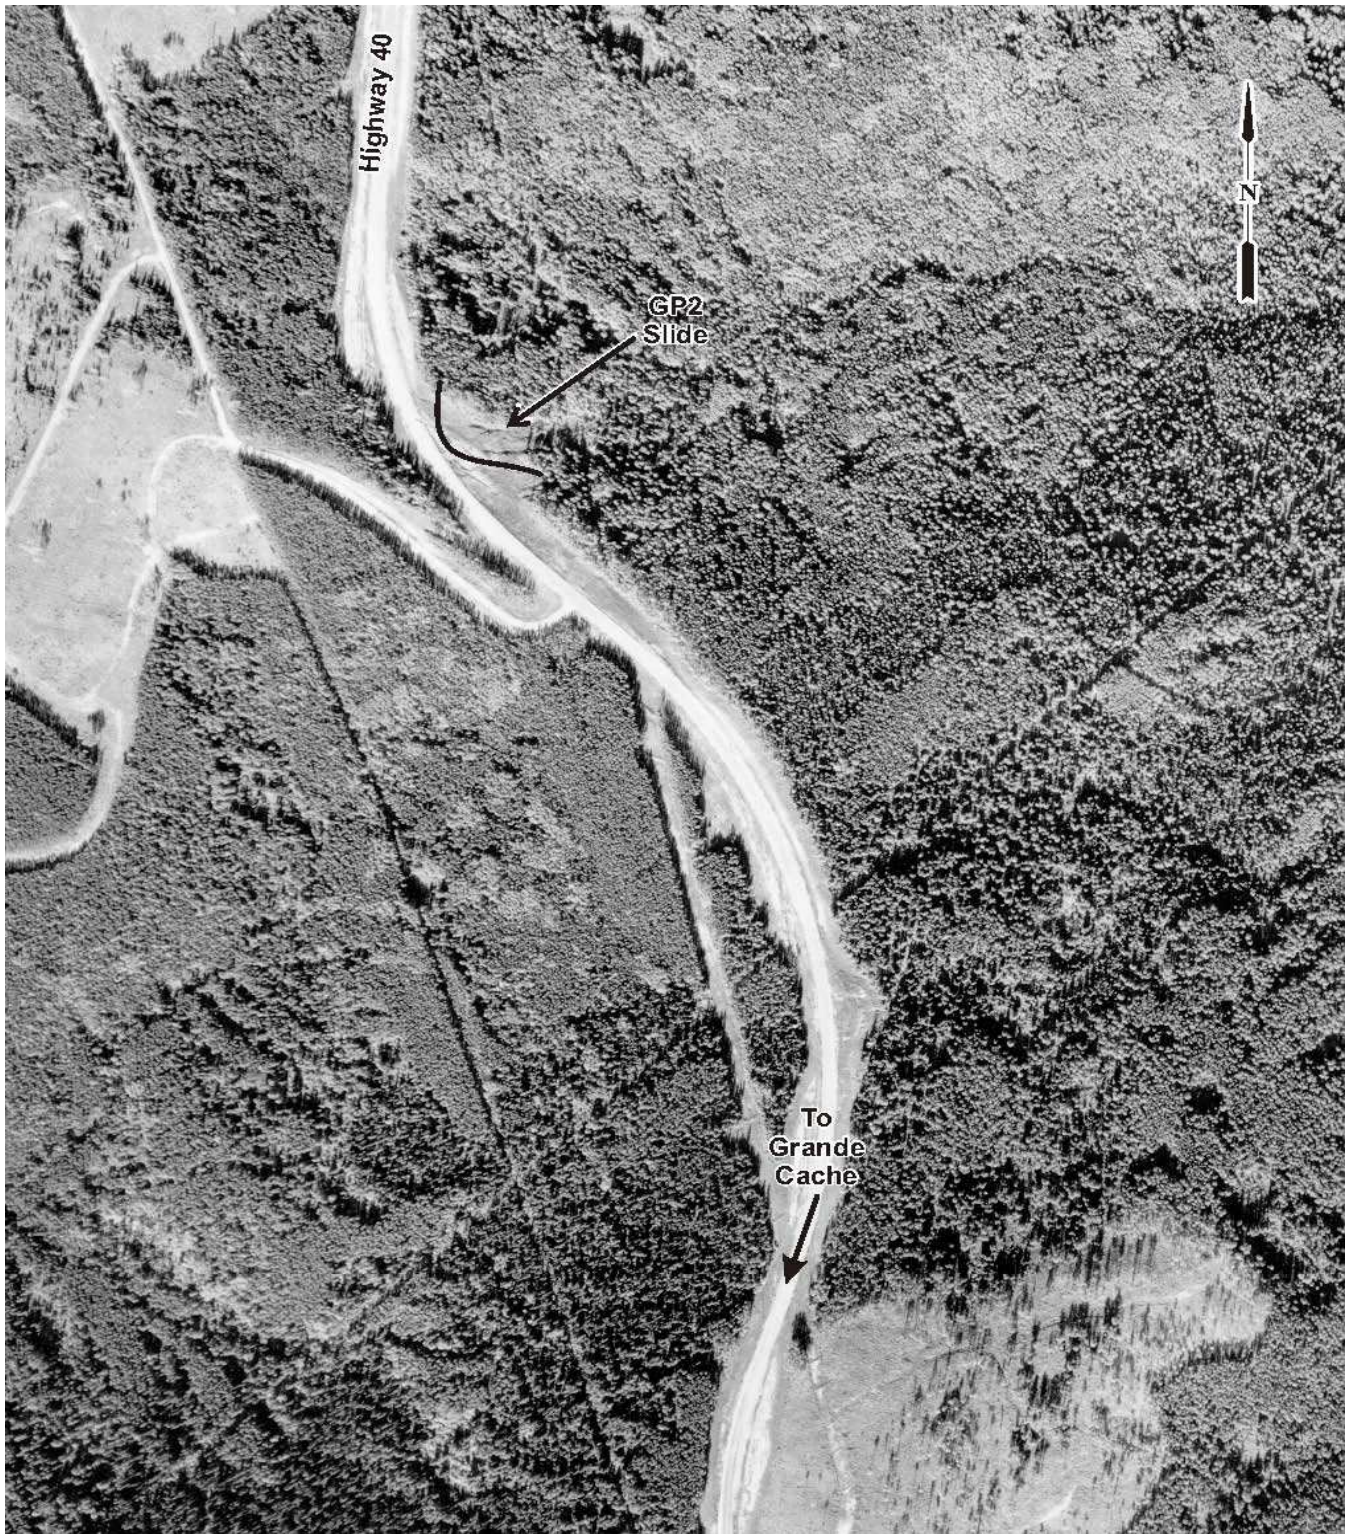
**Figure 1**

1993 Aerial Photograph
