**PEACE REGION – GRANDE PRAIRIE
GEOHAZARD RISK ASSESSMENT
SITE INSPECTION FORM**

SITE NUMBER GP-5	SITE NAME Cutbank North Slide	HIGHWAY & KM Hwy 40:40	PREVIOUS INSPECTION DATE May 20, 2010	INSPECTION DATE June 2, 2011
LEGAL DESCRIPTION LSD 9-21-65-5-W6M	NAD 83 COORDINATES N 6,056,268 E 391,516	PREVIOUS RISK ASSESSMENT PF: 7 CF: 6 TOTAL: 42		
		CURRENT 2011 RISK ASSESSMENT PF: 7 CF: 6 TOTAL: 42

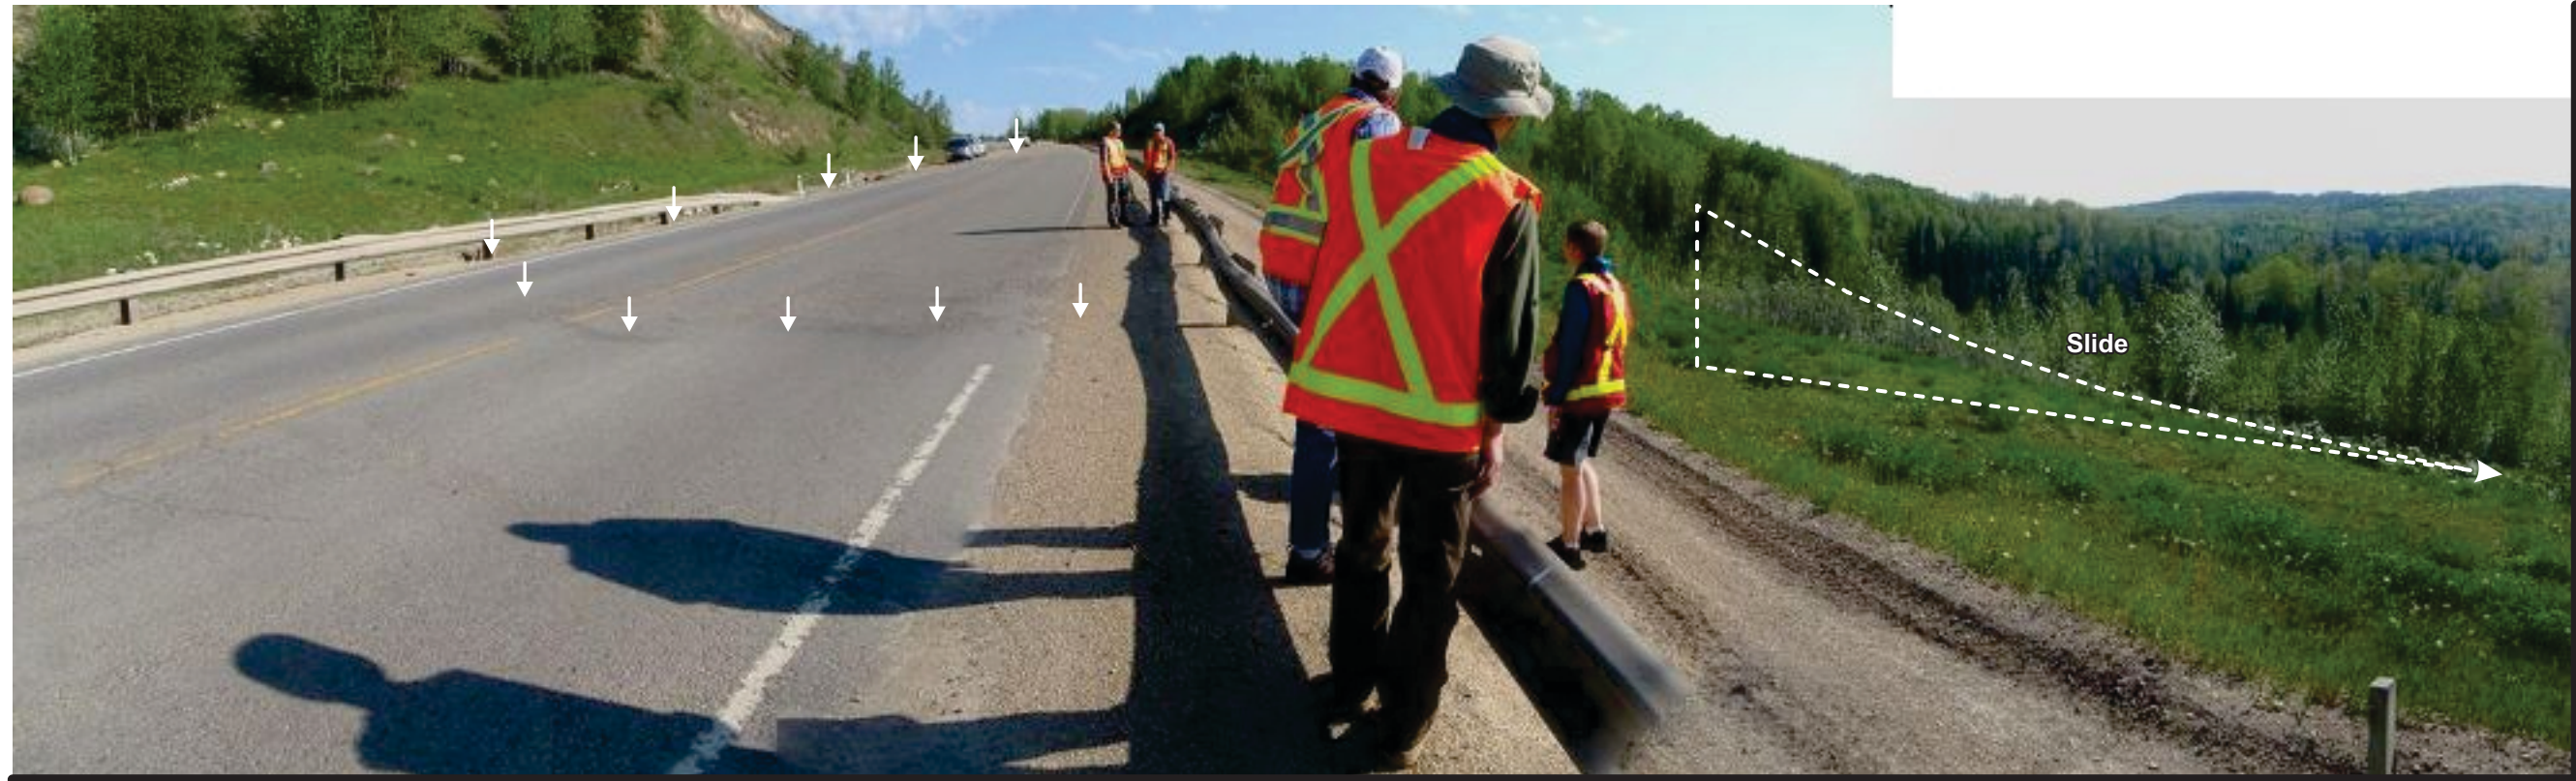
Photo 1

Looking north upgrade (towards Grande Prairie direction) at headscarp crack

- Headscarp cracking has encircled both lanes and backslope ditch
- Shape of headscarp (width of slide) remained same for last 5-10 years
- Slide movement (right to left) down this approach fill

- However, some erosion of backslope ditch has re-started and the ditch should be regraded with additional riprap lining.
- 2) Pavement patching should be carried out as appropriate when subsidence movement and cracking of pavement occurs.

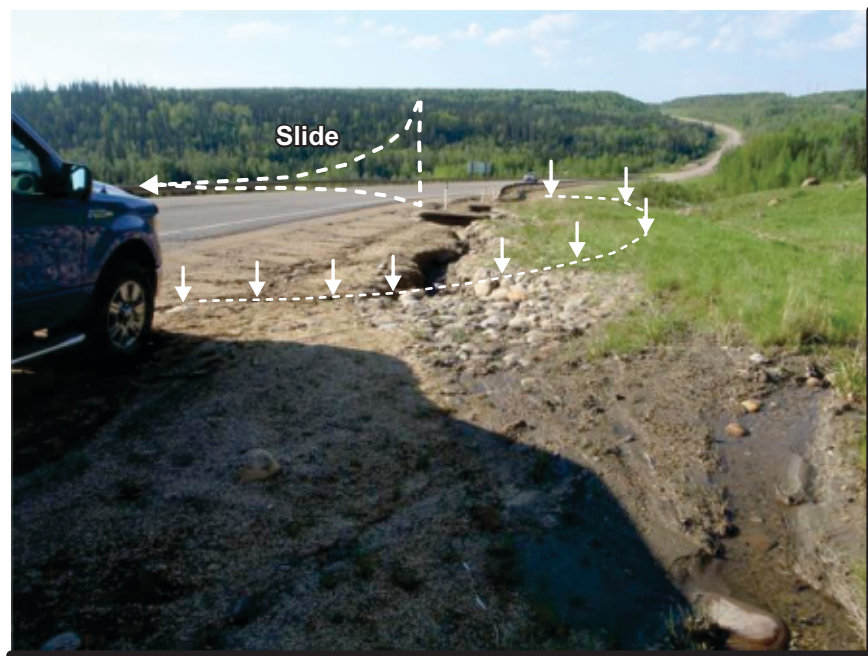
Photo 2

Looking south downgrade (towards Cutbank River and bridge) at headcarp of slide

- Ditch erosion has re-started to continue despite earlier placement of bouldery pitrun lining along ditch
- Ditch water runs into erosion rill towards headscarp circuit slump zone

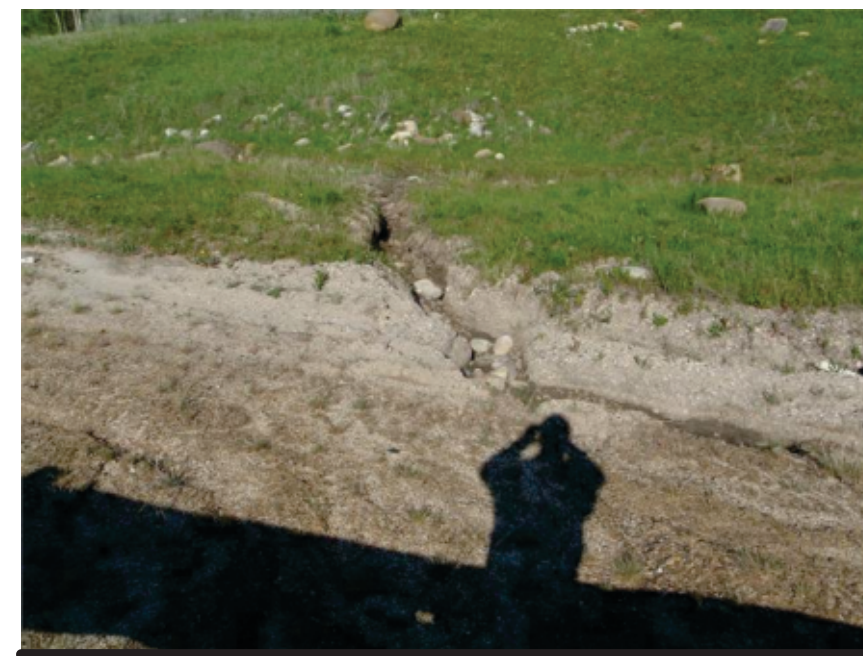
Photo 2a

Rill erosion along headscarp circuit at head of slide

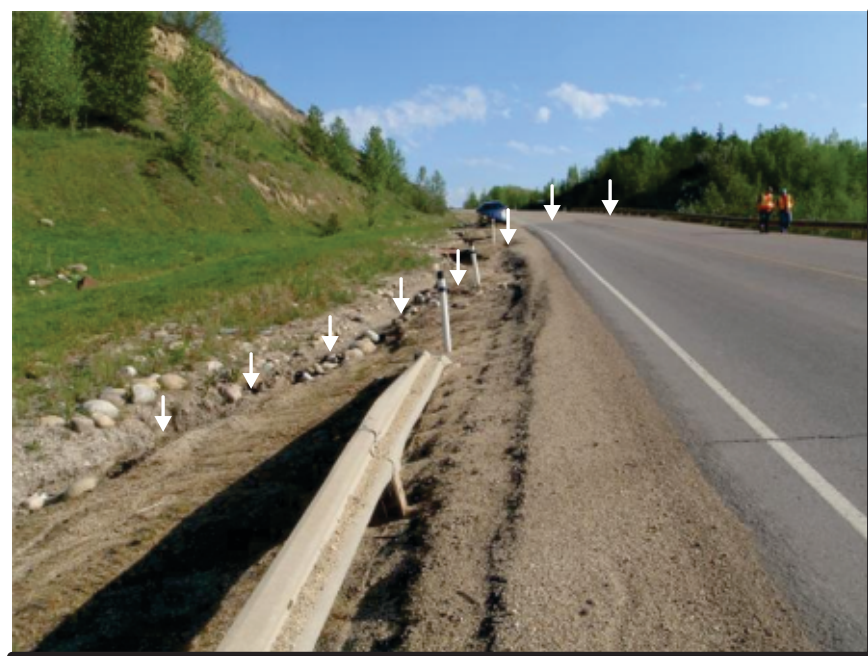
Photo 2b

Looking north upgrade along backslope ditch

- Erosion of ditch continuing

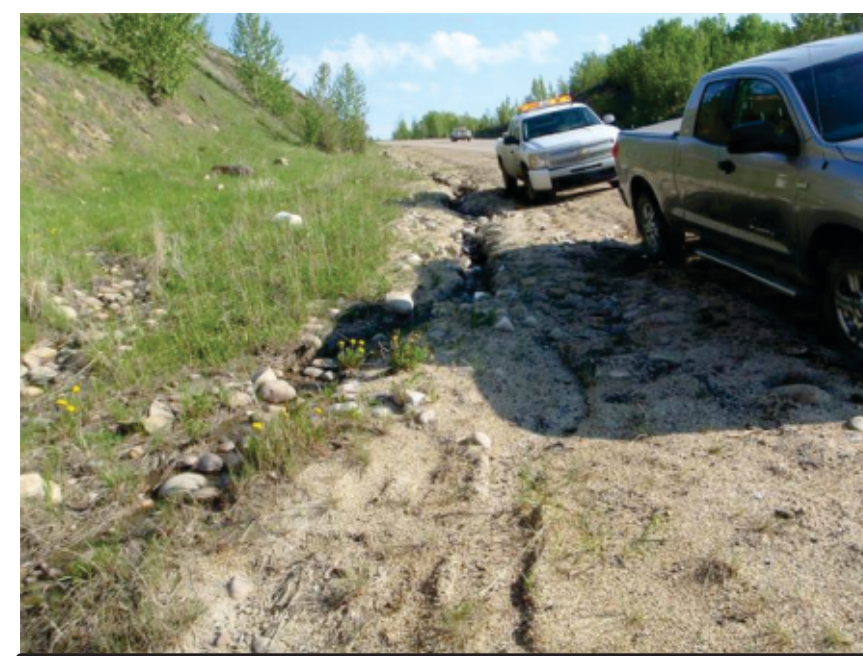
Photo 2c

Looking north upgrade along backslope ditch

- Erosion of ditch continuing
