**PEACE REGION – GRANDE PRAIRIE
GEOHAZARD RISK ASSESSMENT
SITE INSPECTION FORM**

| SITE NUMBER GP-5 | SITE NAME Cutbank North Slide | HIGHWAY & KM Hwy 40:40 | PREVIOUS INSPECTION DATE June 2, 2011 | INSPECTION DATE July 12, 2012 |

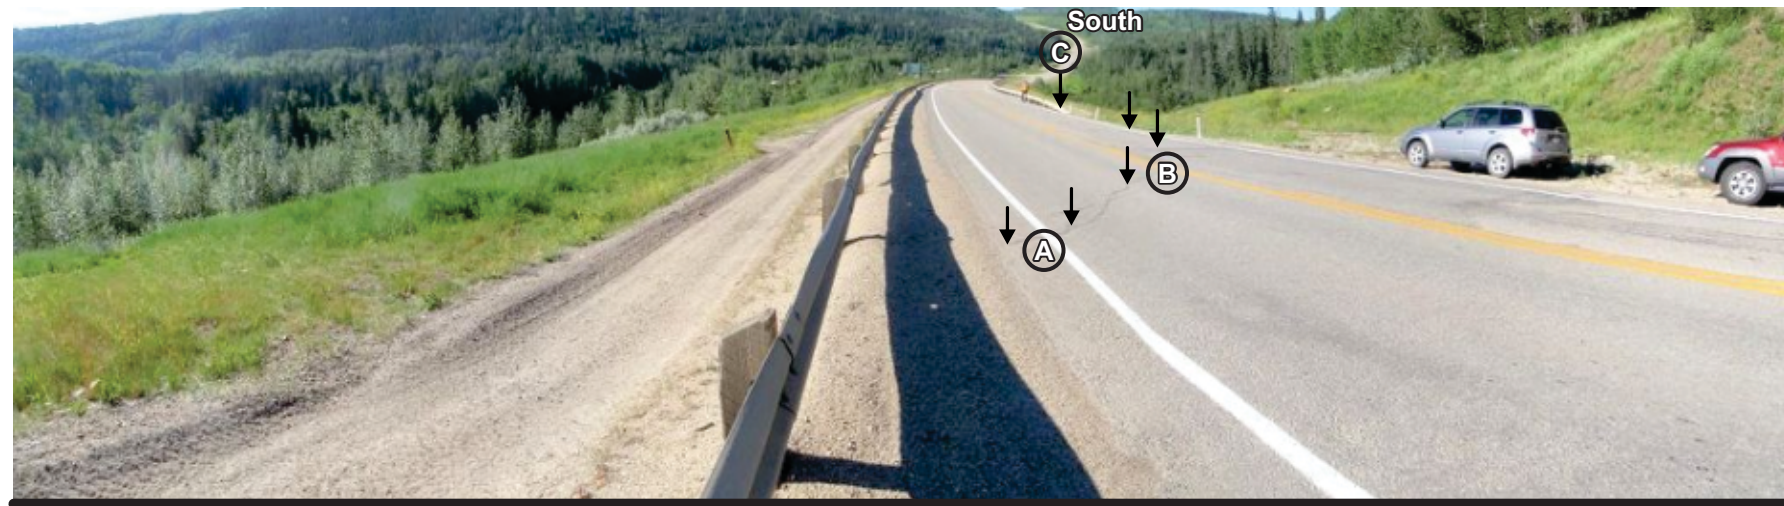
Photo 1

Looking south downgrade (towards Cutbank River and bridge) at headscarp of slide

- Headscarp cracking has encircled both lanes and backslope ditch (see Photo 2 for downgrade side of headscarp crack).
- Shape of headscarp (width of slide)(A-B-C) (to upgrade side) remained same for last 5-10 years
- Scarp subsidence of ditch is evident in recent years (see photo 1d)
- Slide movement (right to left) down this approach fill. Most movement can be attributed to relaxation of toe berm area and consolidation settlement of high approach fill
- Further movement (drop at headscarp) not as significant in recent 3-5 years and after over 30 years since construction (early 1980's)

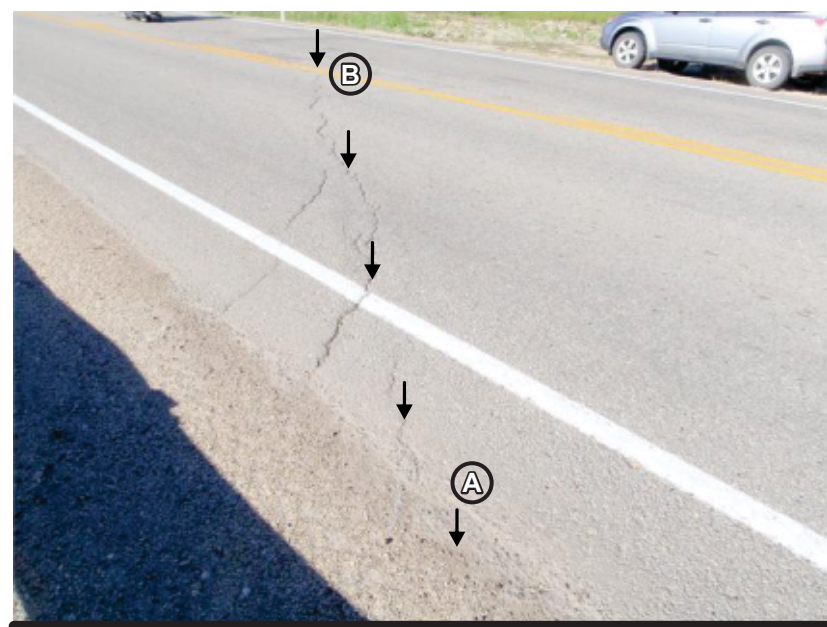
Photo 1a

Propagation of headscarp crack

- Close up of crack propagating from A (sideslope shoulder) to B (centreline) to C (guardrail along backslope ditch).
- Recent workmanship in milling and patching has improved significantly to smooth off the headscarp cracking unevenness. This has improved roadway serviceability.

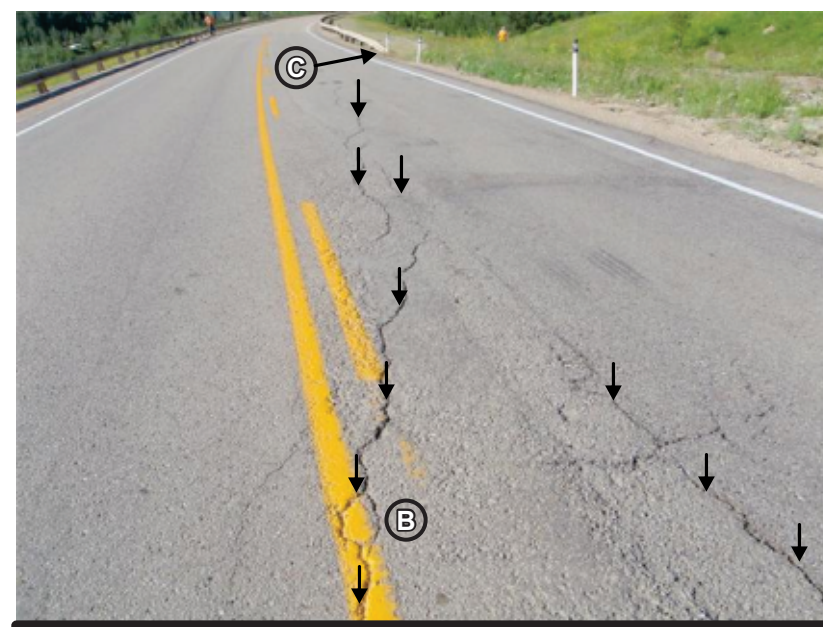
Photo 1b

Propagation of headscarp crack

- Close up of crack propagating from A (sideslope shoulder) to B (centreline) to C (guardrail along backslope ditch).
- Recent workmanship in milling and patching has improved significantly to smooth off the headscarp cracking unevenness. This has improved roadway serviceability.

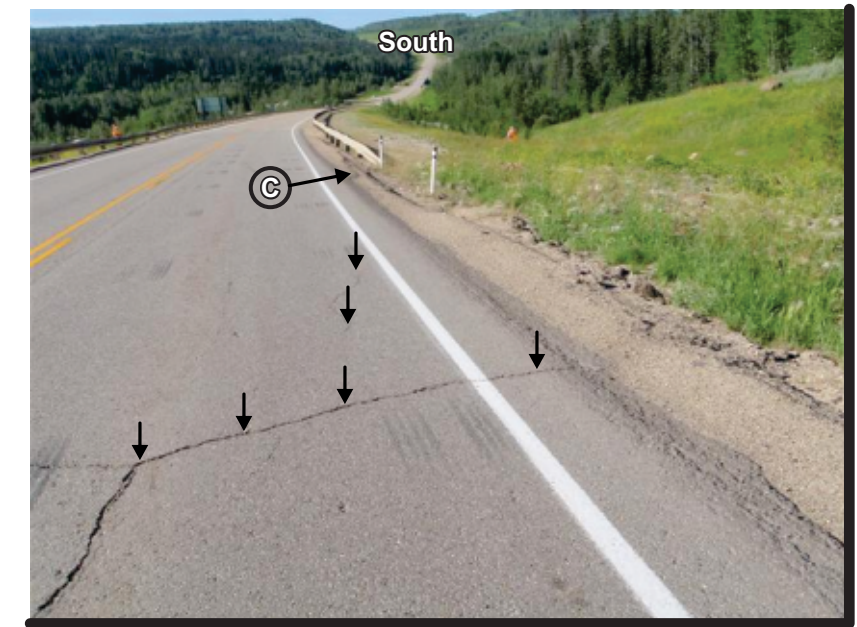
Photo 1c

Propagation of headscarp crack

- Close up of crack propagating from A (sideslope shoulder) to B (centreline) to C (guardrail along backslope ditch).
- Recent workmanship in milling and patching has improved significantly to smooth off the headscarp cracking unevenness. This has improved roadway serviceability.

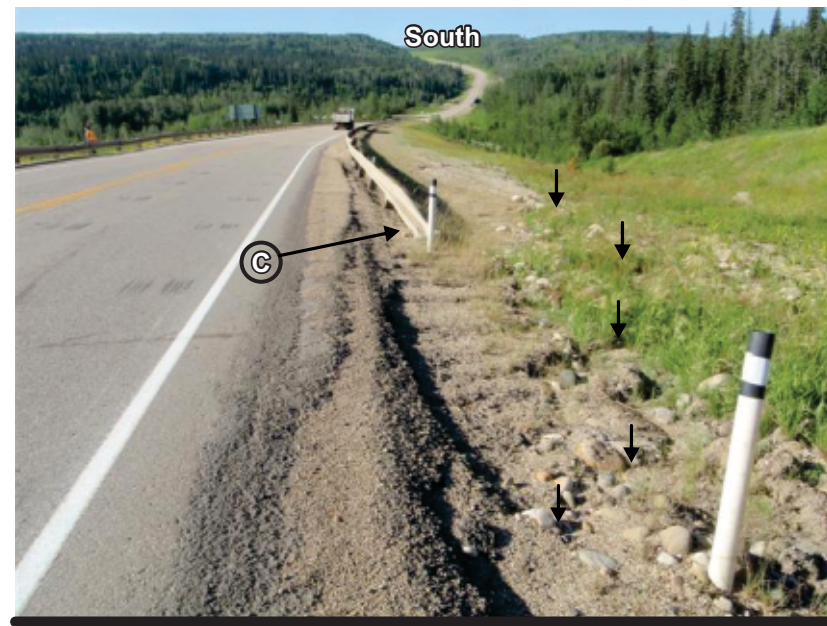
Photo 1d
Propagation of headscarp crack
• Headscarp crack has imprinted onto backslope ditch area

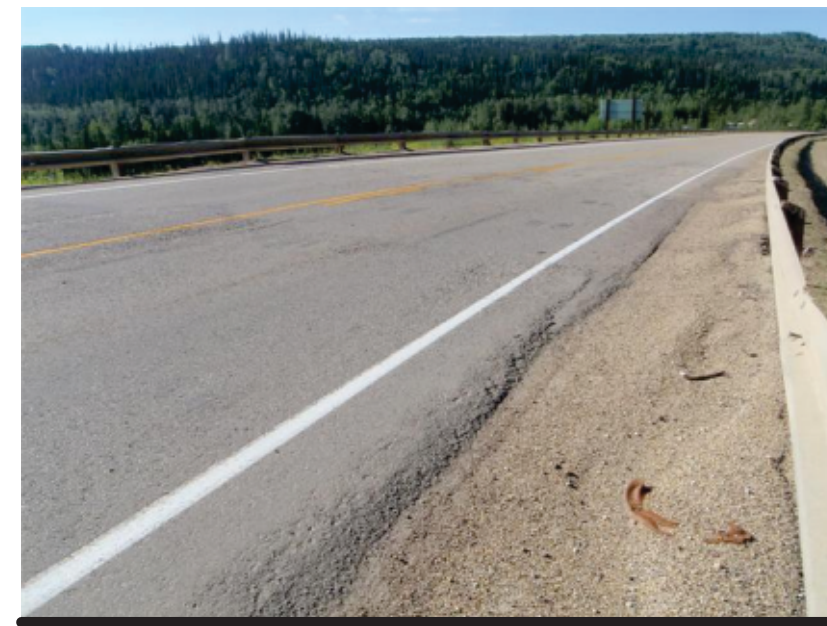
Photo 1e
Patched area of headscarp crack
(Looking south towards Cutbank River and bridge)
• at downgrade side

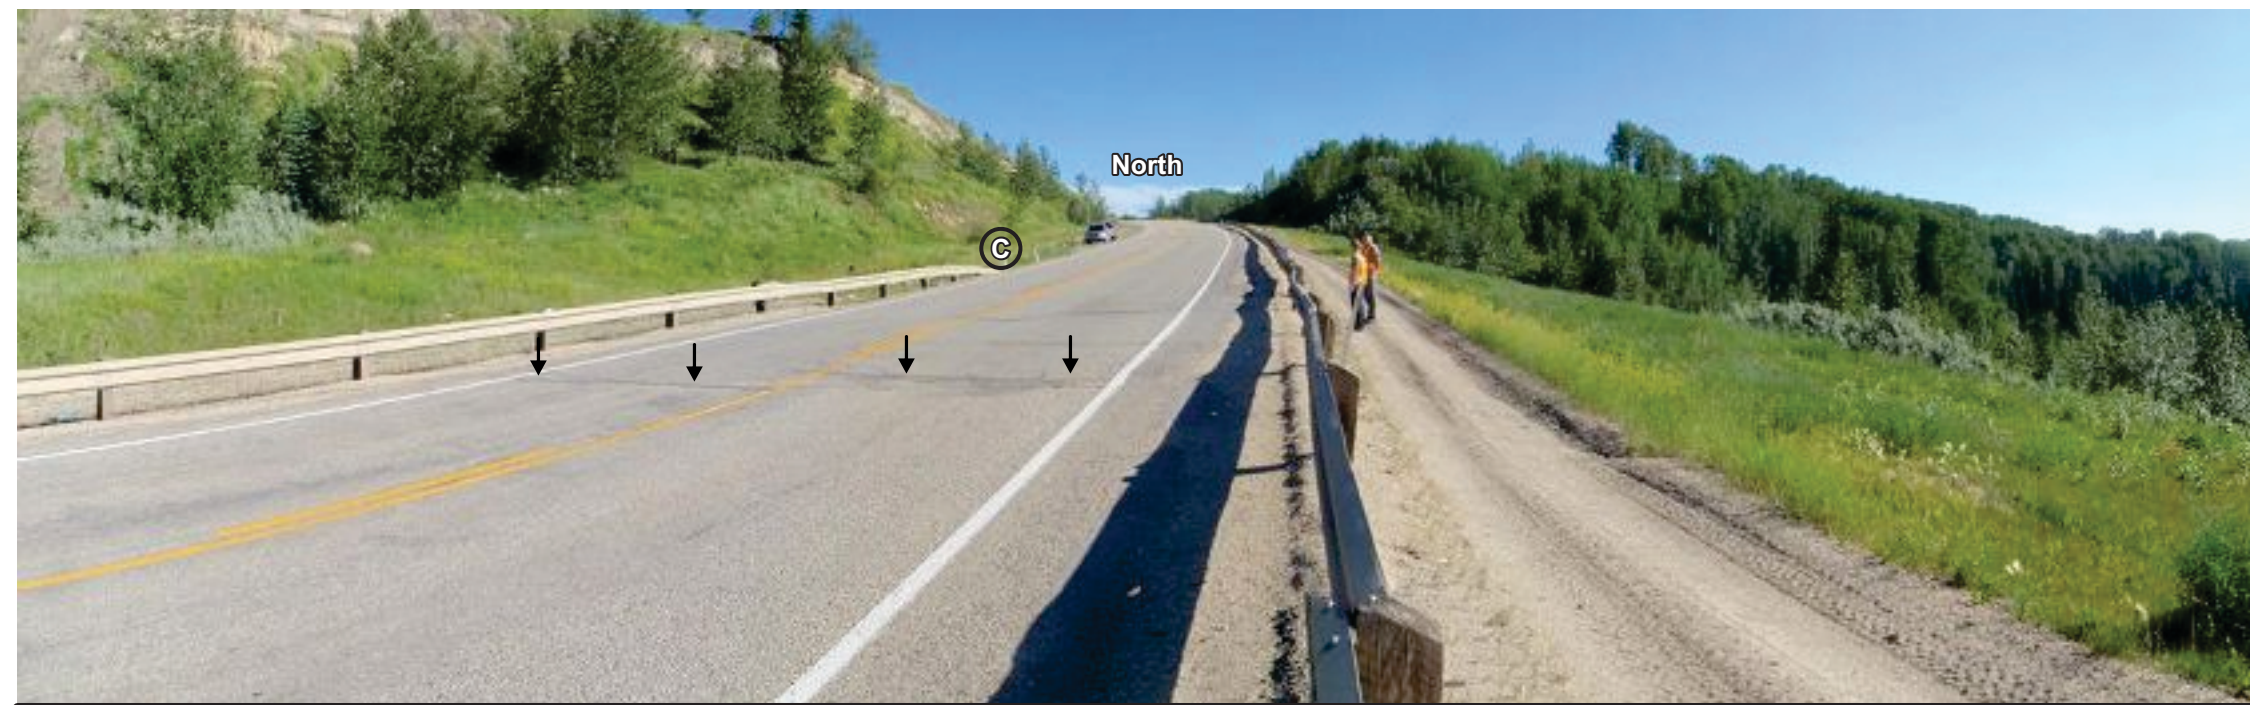
Photo 1f
Closed-up of headscarp crack (Looking north toward Grand Prairie)
• at downgrade side
