File: 2006-1002h

Date July 8, 2007(prelim)

Re: **Call-out Inspection Report**
Hwy 43:00 (1 mile east of B.C. border)
Embankment Slide at Spring Creek Culvert (BF 73565) ISW 8-75-13-6

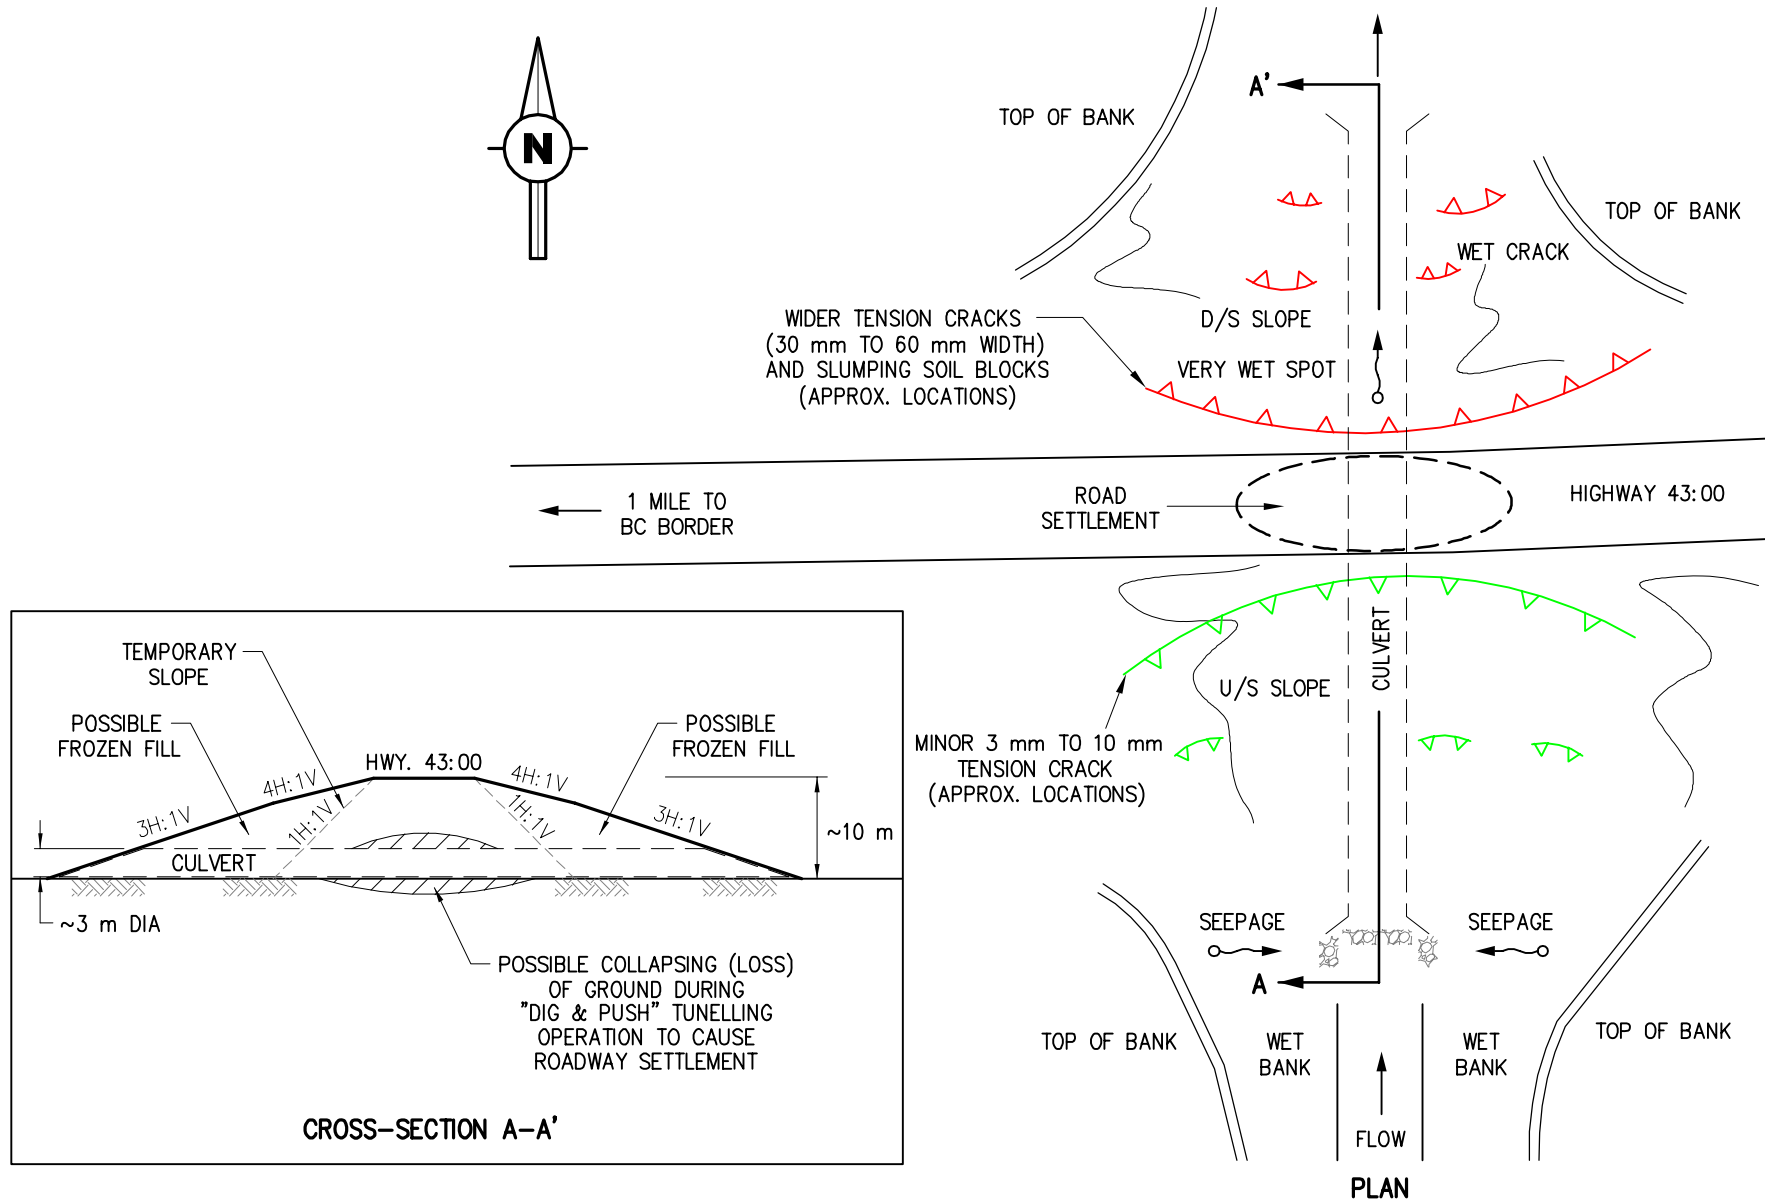
Figure 1
Slide at Embankment Slope u/s & d/s

Along both upstream and downstream slopes of the 10m high fill embankment, headscarp cracks and slumping cracking movements of fill slopes can be observed. The slopes are about 4H:1V along upper half of slope and about 3H:1V along lower half of slope. The breadth of the slide along its headscarp can be estimated at about 50m in length and is offset 1-3m along the roadway shoulder edge. The headscarp crack started at close to road shoulder edge and possibly coincided with the top of temporary cut slopes excavated for "Dig and Push" installation of the culvert.

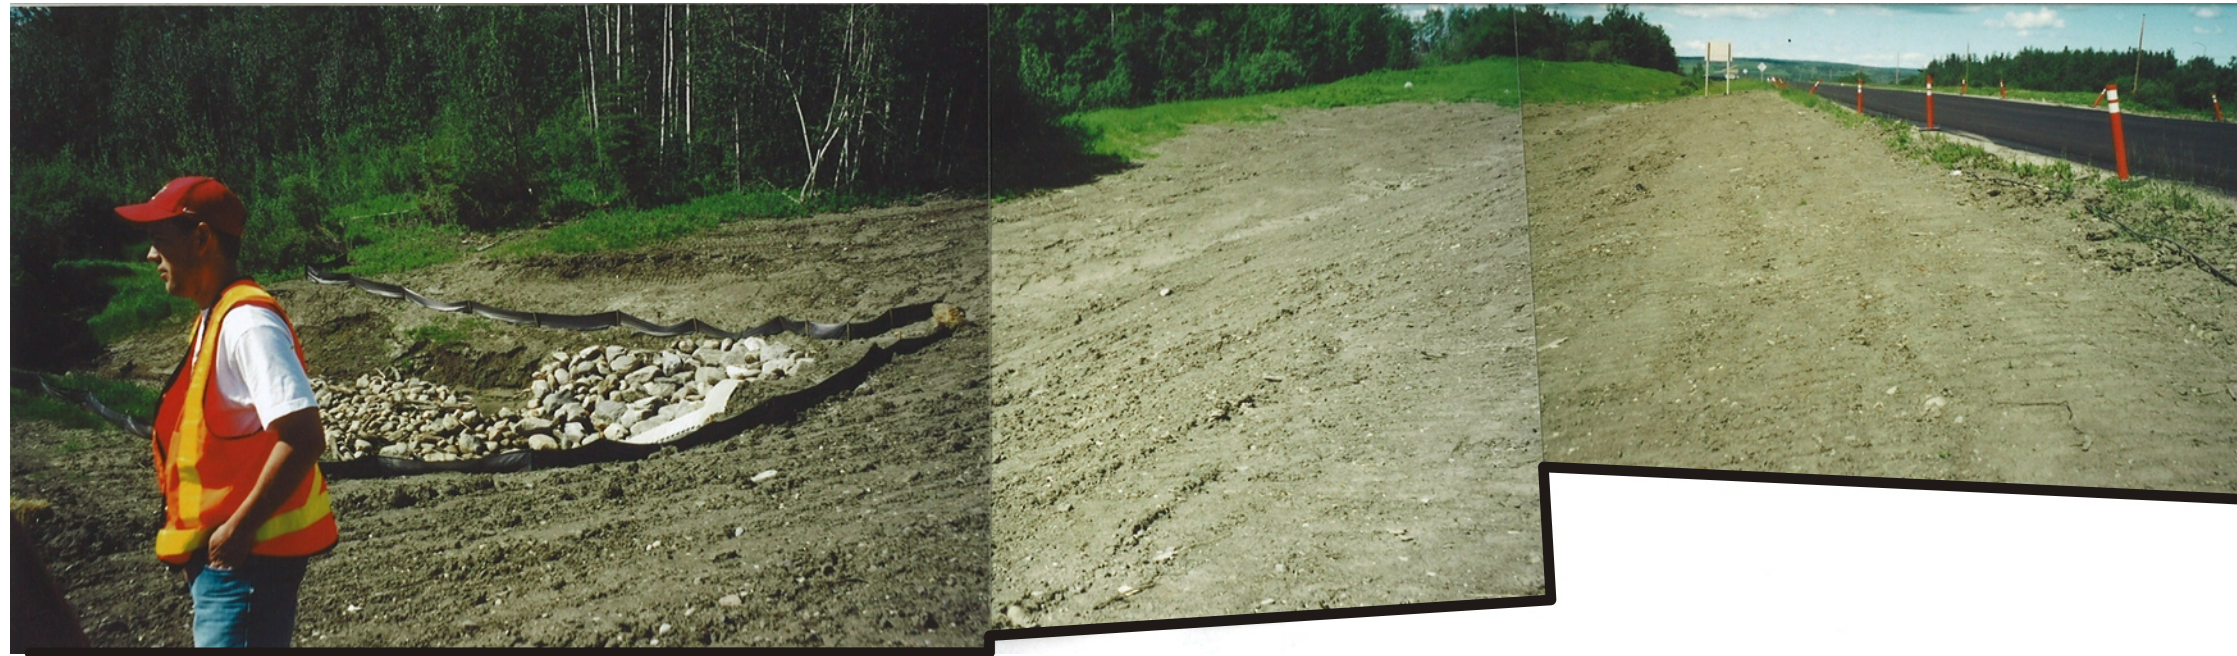
**Photo 1**

- Along the upstream slope, narrow tension cracks can be noted and undulation settlement of fills was obvious. The tension crack extended along the headscarp. It is understood that the contractor attempted to dress and seal the crack but was unsuccessful as cracks of 3-5mm width still persisted. Slide movement of this upstream slope has occurred.

- Along the upstream banks, signs of seepage and wet banks can be noted at an elevation as high as the culvert and top of bank riprap placement. It can be estimated the seepage along the banks can be estimated attempts at 3-5m above creek bank elevation.

Looking west (at B.C. Border) on upstream side of fill embankment

- Cracking and Settlement of fill obvious from the sliding of fills along culvert (centre) alignment
- Contractor attempted to seal off crack; however 3-5mm wide tension crack can be observed along a 50m breadth of slide scarp across the culvert top
- Cracking of fill starting from slope top at 1-2m offset from shoulder edge
- Slumping and undulation settlement of fill extending from shoulder to slope toe despite apparent effort by contractor to dress back the slope
- Apparently, the fill seems fluffy and not in well compacted state. Quality of fill questionable-frozen? Snow? Compaction?
- Seepage and wet banks can be noted at upstream banks (close to top elevations of culvert and riprap) at 3m-4m above creek bed

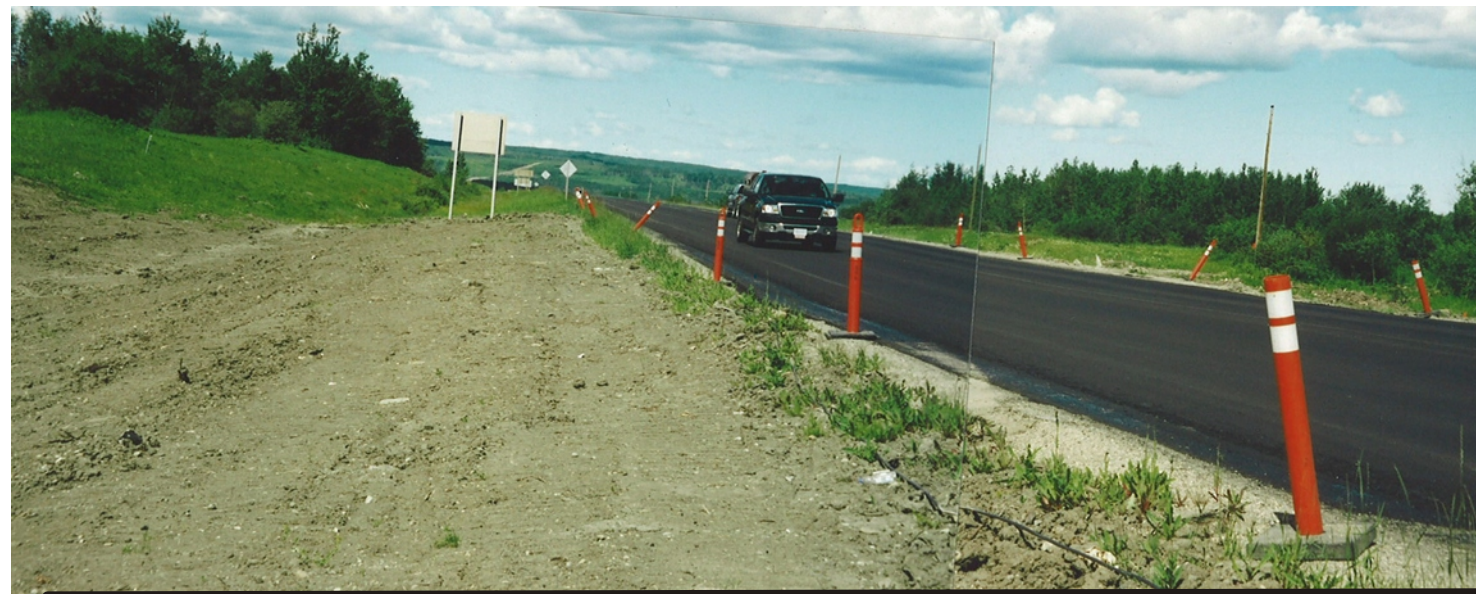
**Photo 2**

- Along the roadway pavement, settlement of fill at centre of culvert seems to persist despite of pavement overlay to patch up the settlement. It maybe possible that a loss of ground might have occurred in the event that excavation advance of the "Dig and Push" operation may have encountered wet seepage soil conditions causing a void out "loss of ground" of a larger annulus area at centre of roadway. It maybe possible that loss of grounds was not completed in filled or grouted back for support of roadway. This possible scenario of presence of seepage and wet ground conditions in conjunction with probable "loss of ground" along the floor of the excavation can invoke settlement of roadway. It will be advantageous to check with the "Dig and Push" contractor if wet ground and seepage conditions and "loss of grounds" were encountered. Future maintenance operation may require more patching to accommodate the settlement before the settlement stabilizes.

Looking west (at B.C. Border) on upstream side

- Settlement of road-pavement still obvious from road undulation
- It maybe possible that the "tunneling" (dig and push) culvert installation operation may have experienced loss of ground to incur settlement at top of fill at top of culvert
- It maybe possible that the "tunneling" excavation might have encountered wet and seepage grounds to cause settlement at roadway centreline area

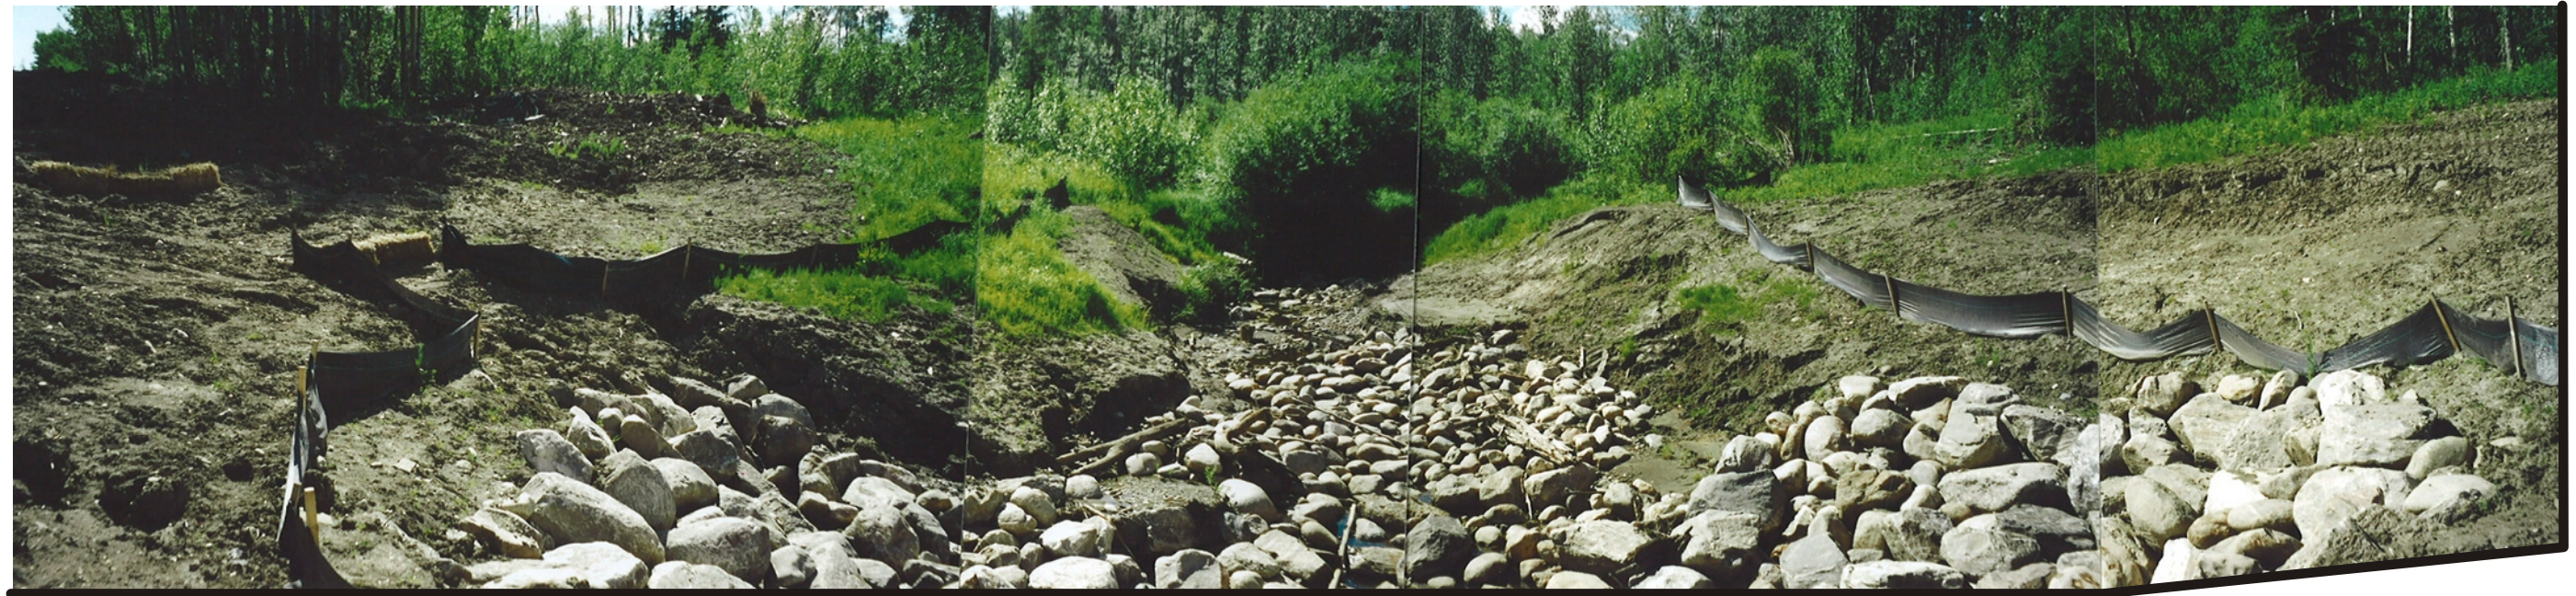
Photo 3

Looking south at upstream of Spring Creek Channel
- Wet soils and seepage exit from both banks obvious

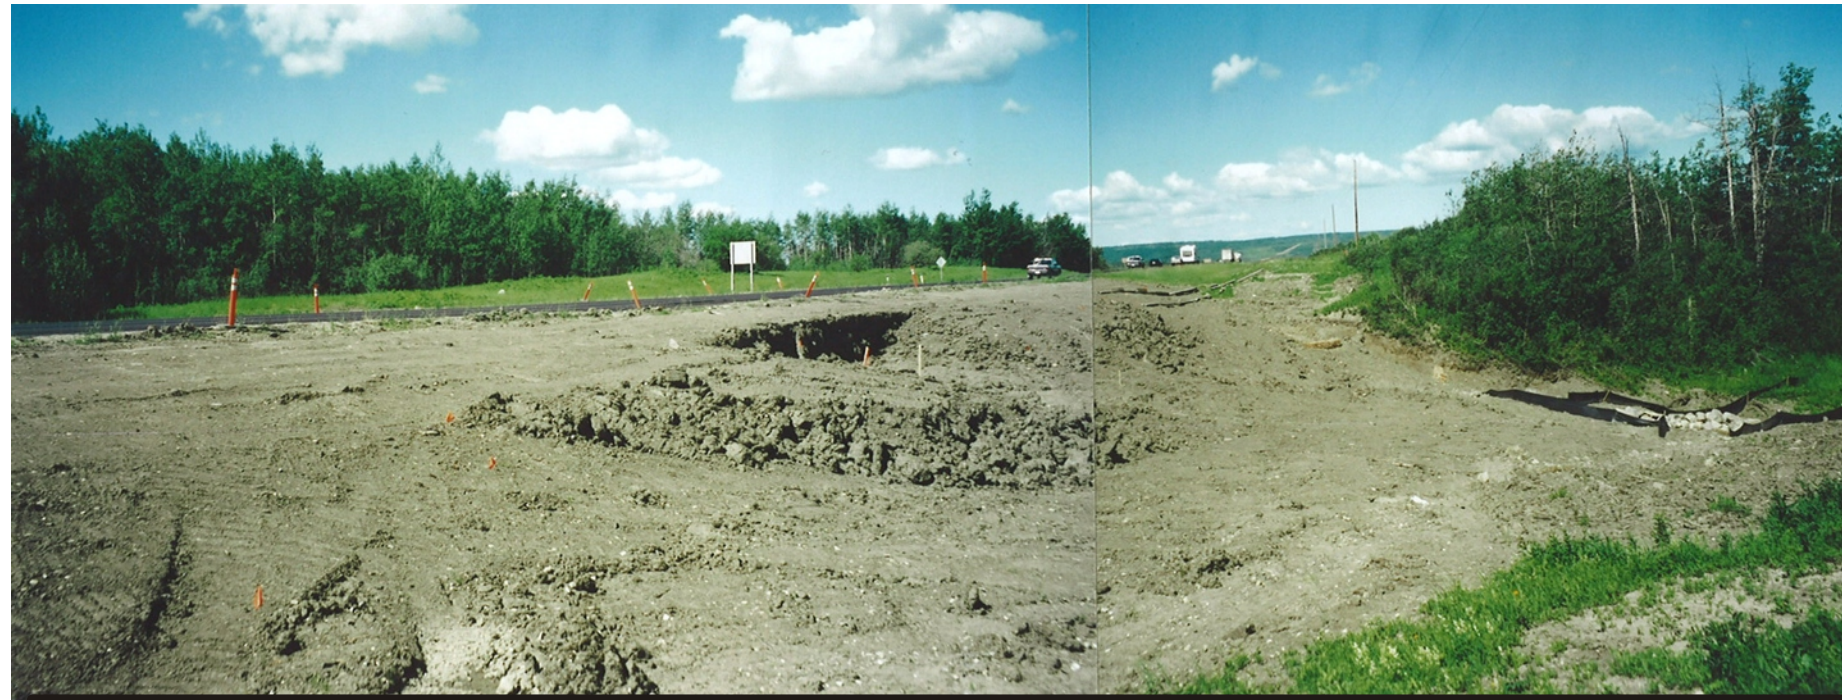
Photo 4

- Along downstream slope, obvious slumping (0.5 to 1m) of soil blocks and the opening of wider cracks (30 to 60mm) can be observed to include several wet soil spots of along the slope face. It is understood that the contractor was unsuccessful in redressing the top part of the slide and a 1.5m high steep headscarp still remained at the time of this inspection. At some crack locations, hand probing beneath the dried surface soil crust revealed very wet soft clay beneath. At the headscarp centre area just beside shoulder edge and on top of the culvert installation, a spot of very soft wet clay with oozing wetness (resembling a seepage outflow) can be observed to indicate possible presence of deeper depth of wet and soft soil. It is uncertain whether frozen fill may be present and undergoing thawing and softening to cause the present settlement/sliding movements. This should be the primary concern as cause of sliding of this fill embankment.

- Looking west (at B.C. Border) on downstream side
- Sliding of fill embankment obvious despite contractor's effort to dress back slide. A drop of headscarp crack (1.5m) at shoulder
 - Progressive downslope slumping blocks and wide tension cracks (40mm to 60mm width) obvious
 - Wet fill at inside of crack and below fill surface can be indication of frozen material being thawed
 - Compaction of fill very questionable, quality of fill very questionable

- In the event that frozen fill be investigated as the cause of sliding of this fill embankment, the slope should be reconstructed using competent fill with proper benching and compaction.

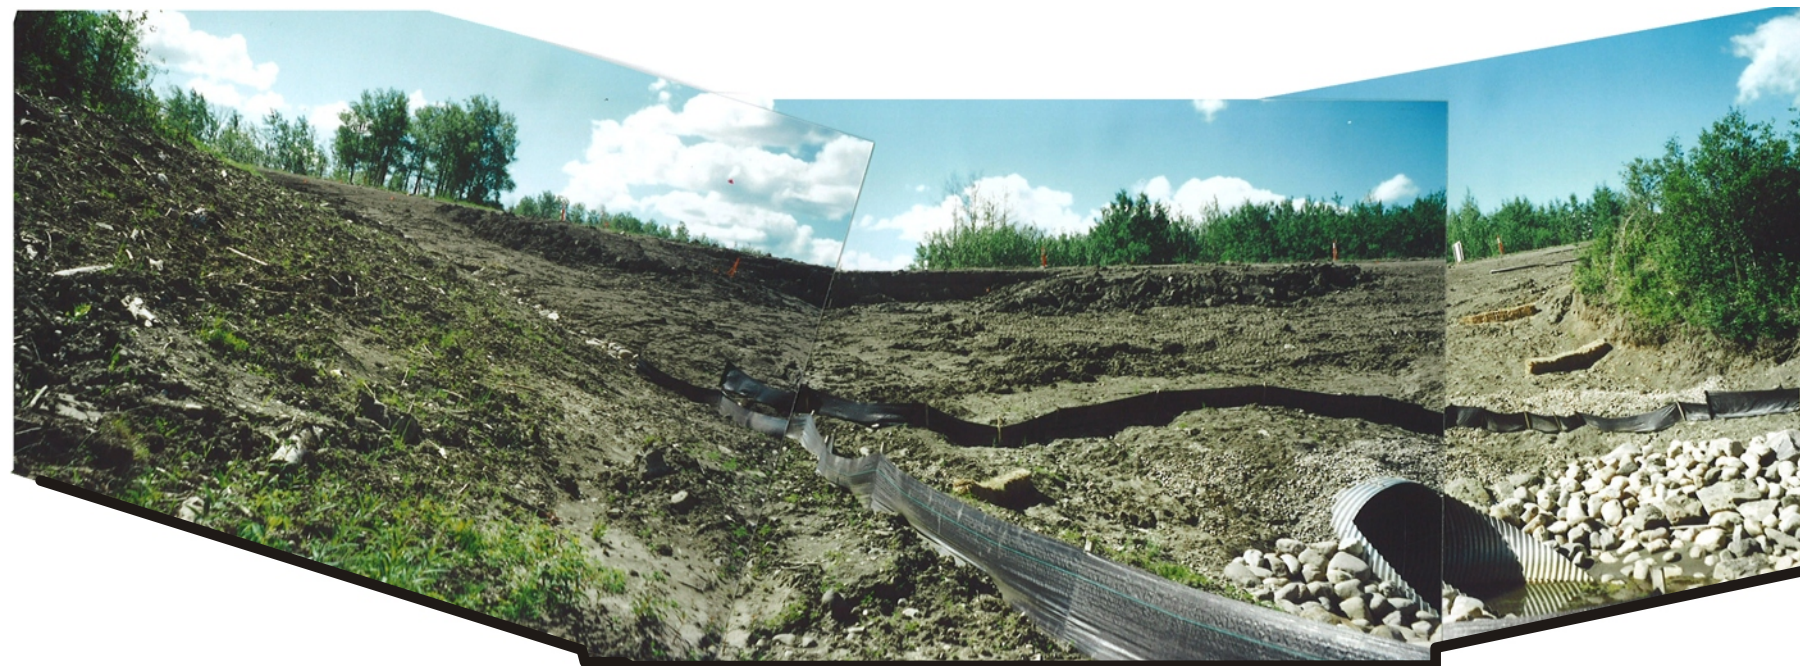
Photo 5

- Looking south (up road) from downstream outlet
- Sliding and settlement of fill obvious

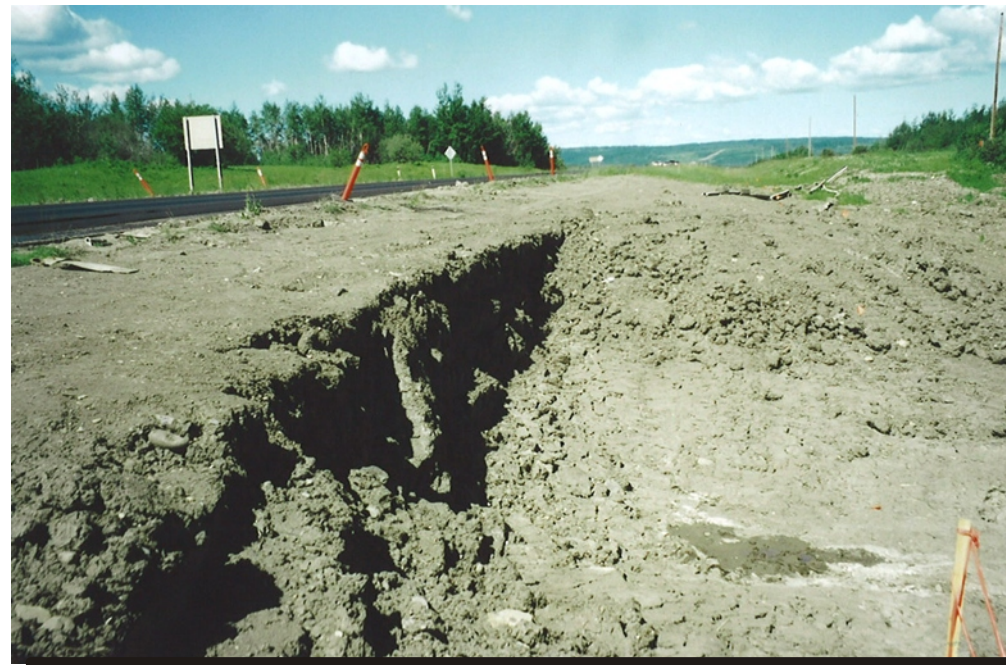
Photo 6

- Looking west (at B.C. Border) along downstream side
- Drop of fill at headscarp of about (1.5m) despite contractor's effort to dig out and dress back
- slide at deeper depth and possible presence of incompetent fill (uncompacted, frozen, snowy) to be located at depth
- Wet seepage spot at surface of fill due to melting if frozen wet fill

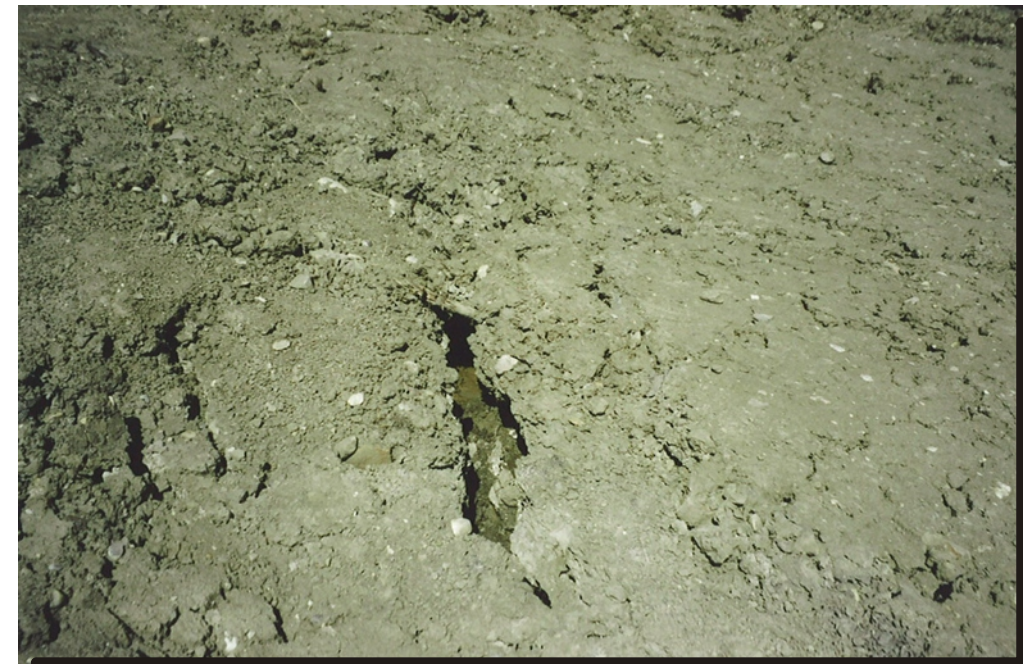
Photo 7

- Another wet fill sign along downstream slope
- Wet soft fill can be located at inside of cracks and beneath dried surface crust of fill

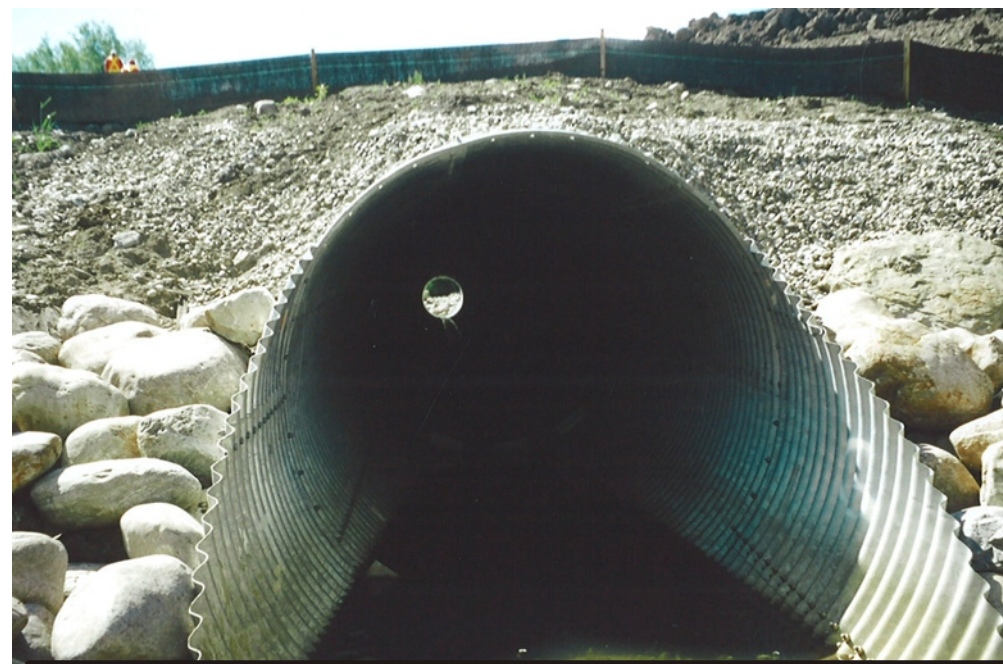
Photo 8

- Looking at culvert from downstream outlet
- Culvert structure looks ok
