Slide Name: (GP 10) Hwy 43:06 S. of Sturgeon Lake

Inspection Date: June 19, 2006

Inspection by: Alberta Infrastructure & Transportation and KarlEng Staff listed on Page 1

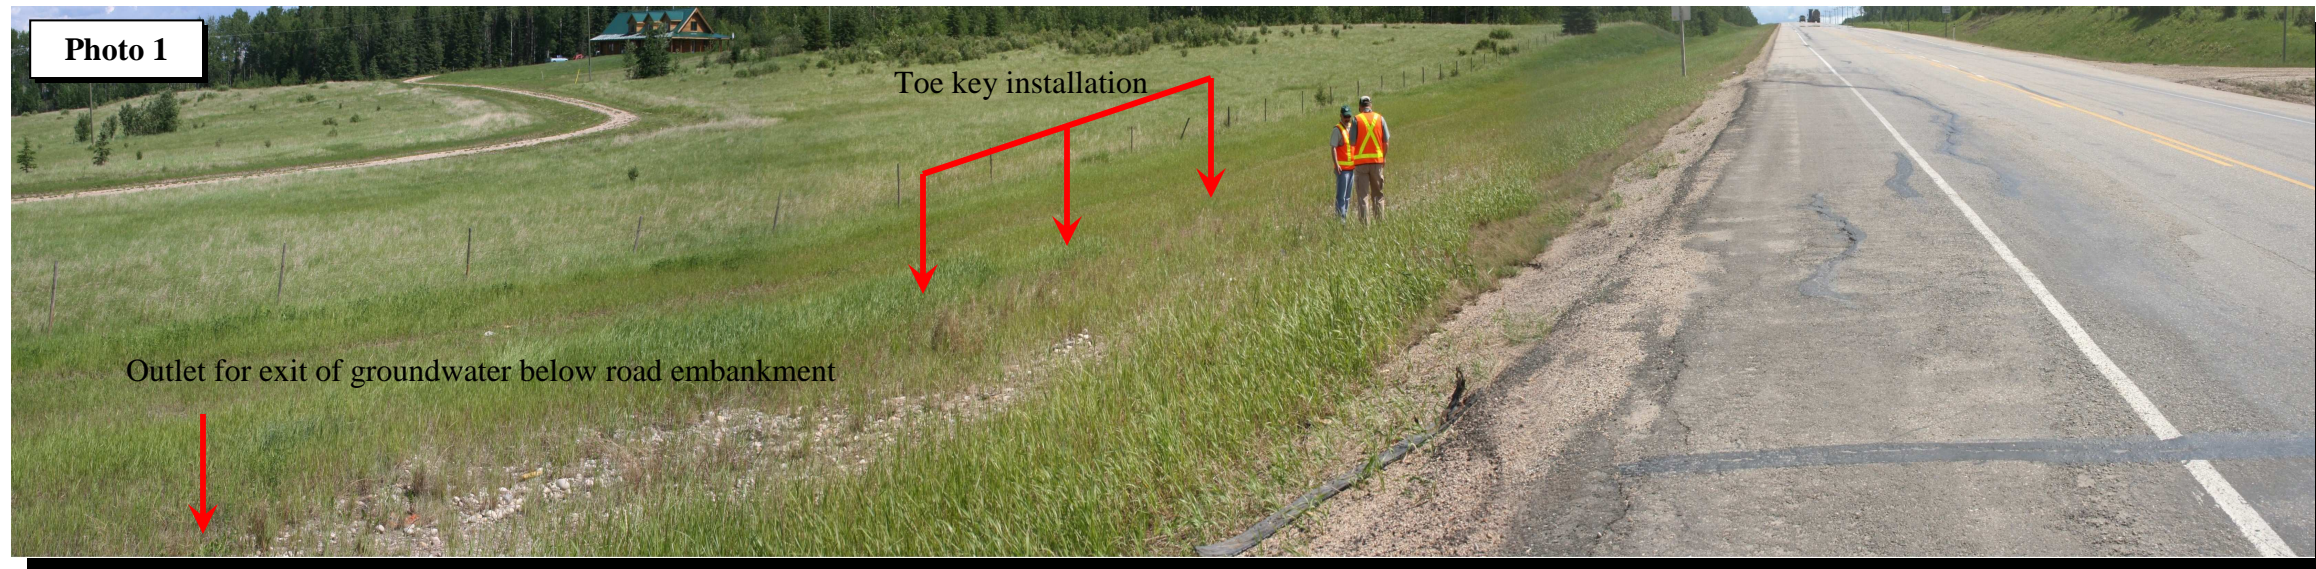
- Looking east (towards valley-view) along north ditch
- Slide previously (~2000) repaired with granular toe berm with geotextile underlay
 - Settlement of repaired slope has greatly slowed down within recent 2 years (2004/06)
 - Slide headscarp crack still reflected through pavement after 5 years (since 2000) due to entrapped groundwater within toe key constructed over low flat terrain of soft, wet lakeshore clay sub-grade and presence of an underground spring
 - Groundwater still actively exiting (since 2000 construction) from toe of slope (at left lower corner of photo) as a result of water entrapped within the granular toe berm

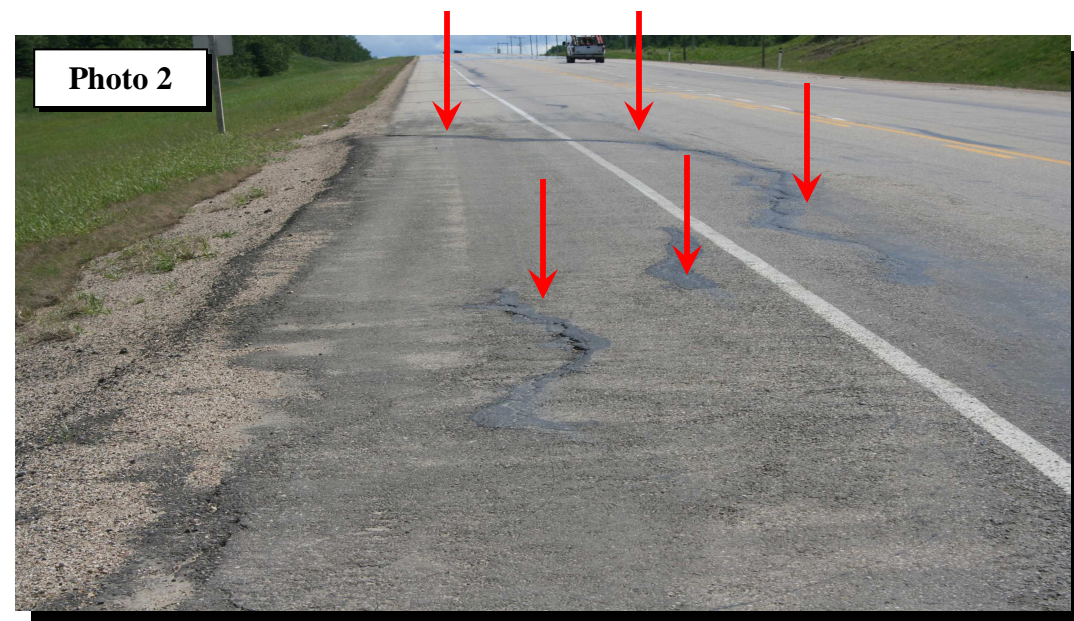
Another view of pavement crack

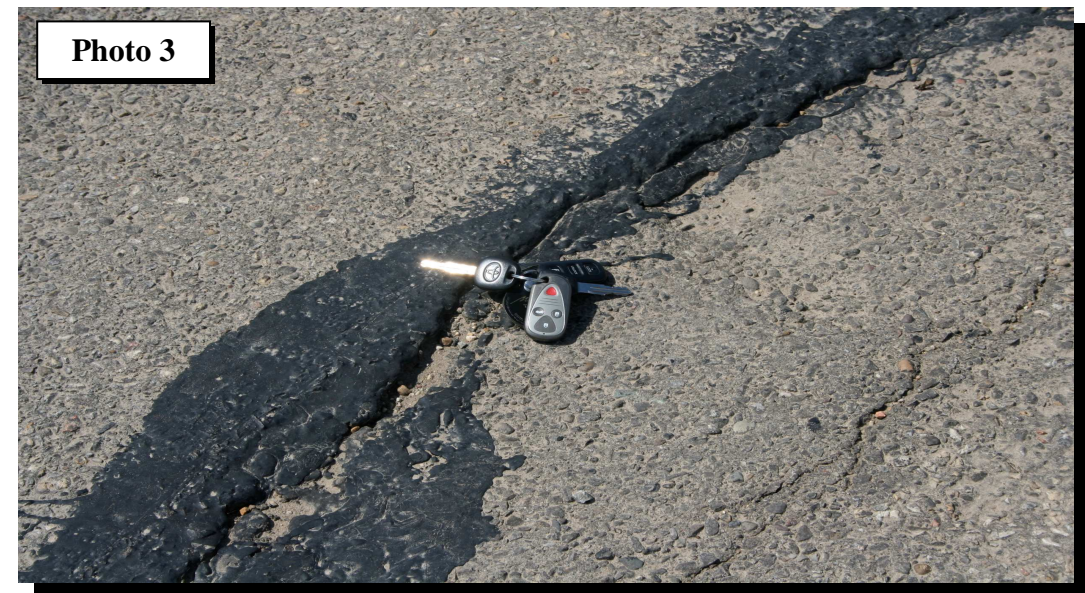
Close up view of crack

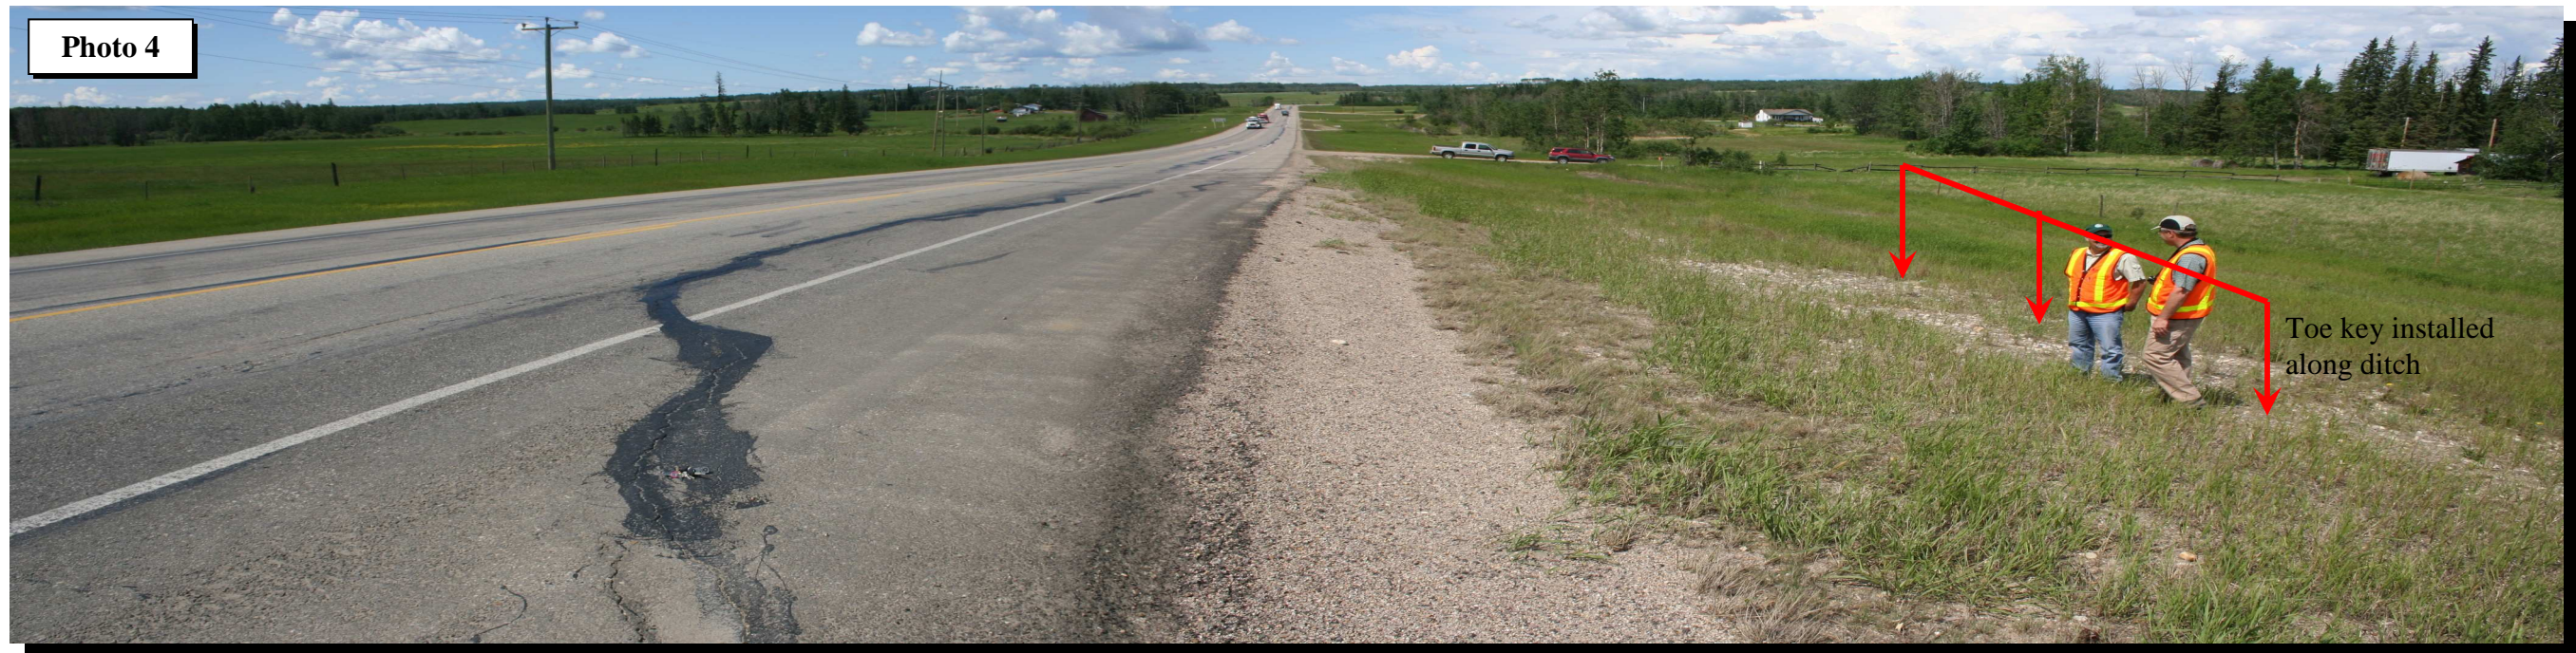
Looking west (away from valley-view)
- Reflective crack of pavement
- Another view

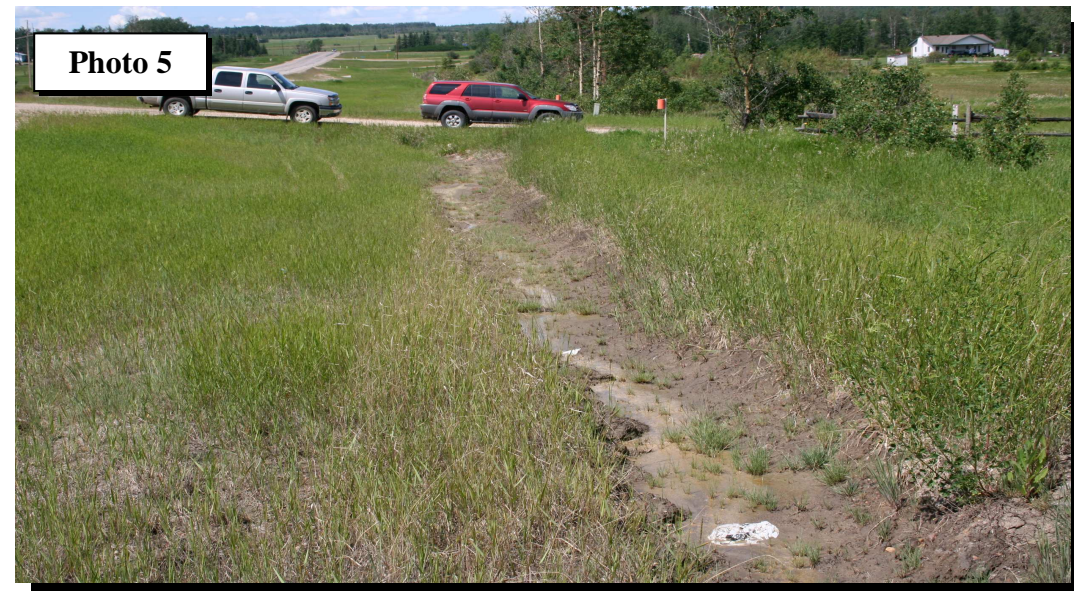
Swale along ditch to drain groundwater to away from slope toe area

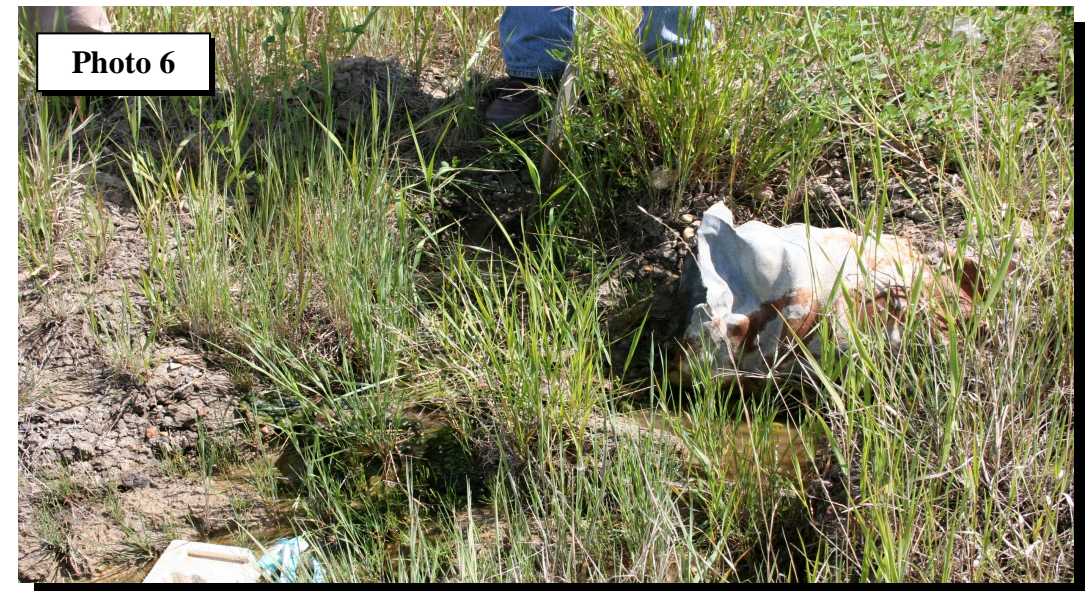
Outlet for exist of groundwater through a culvert spout at edge of toe key berm

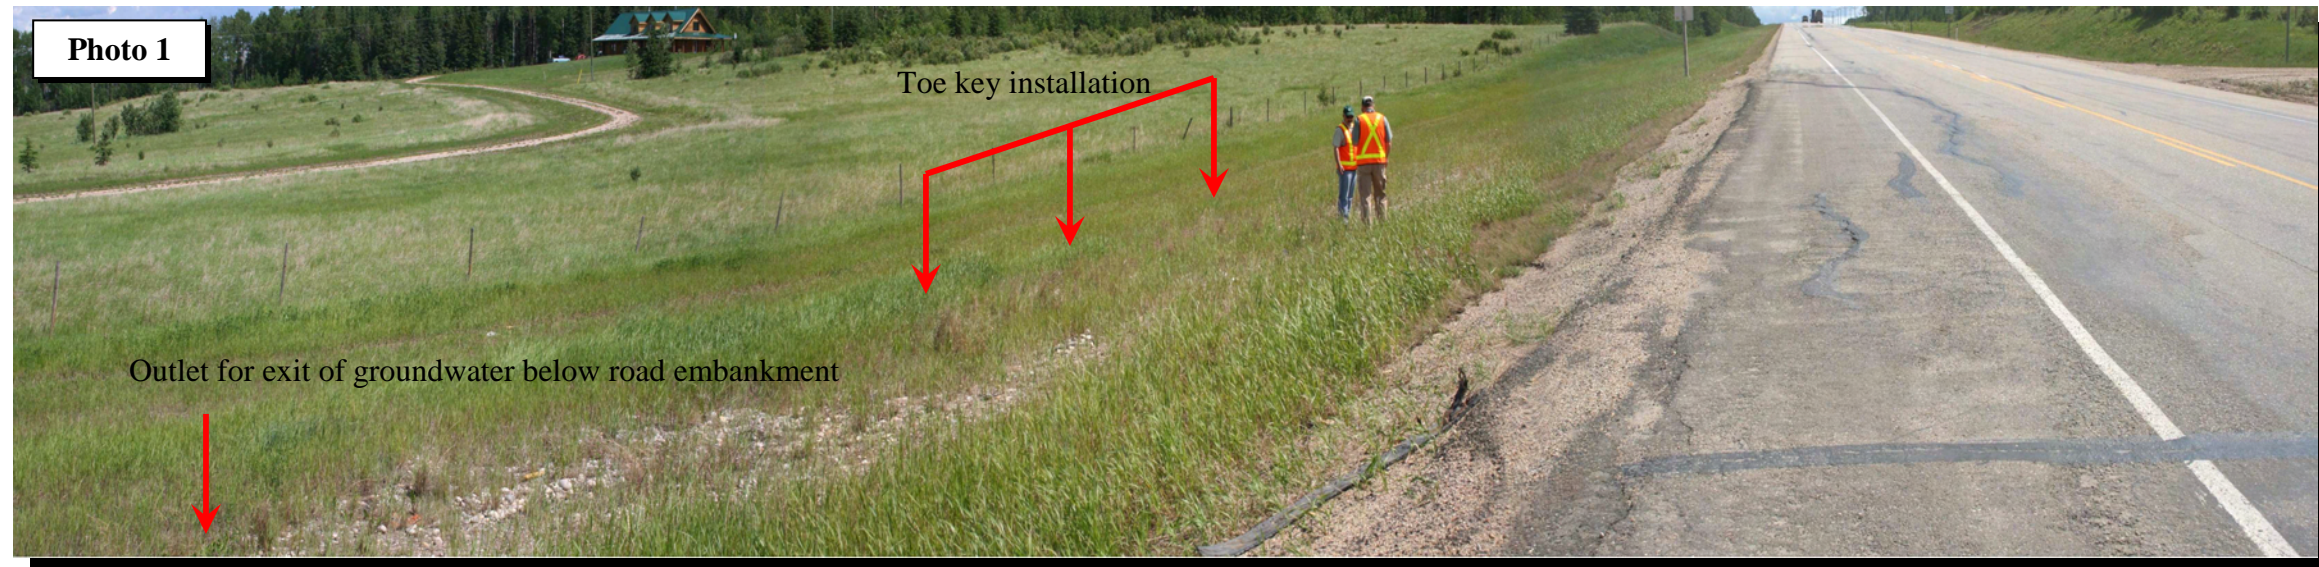
- Looking east (towards valley-view) along north ditch
- Slide previously (~2000) repaired with granular toe berm with geotextile underlay
 - Settlement of repaired slope has greatly slowed down within recent 2 years (2004/06)
 - Slide headscarp crack still reflected through pavement after 5 years (since 2000) due to entrapped groundwater within toe key constructed over low flat terrain of soft, wet lakeshore clay sub-grade and presence of an underground spring
 - Groundwater still actively exiting (since 2000 construction) from toe of slope (at left lower corner of photo) as a result of water entrapped within the granular toe berm

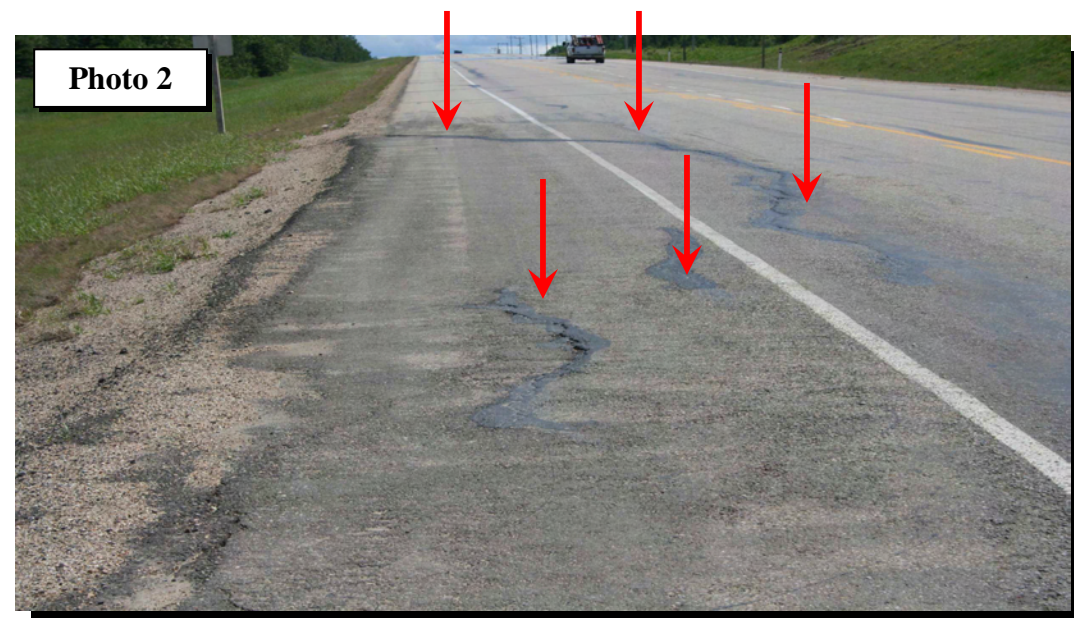
Another view of pavement crack

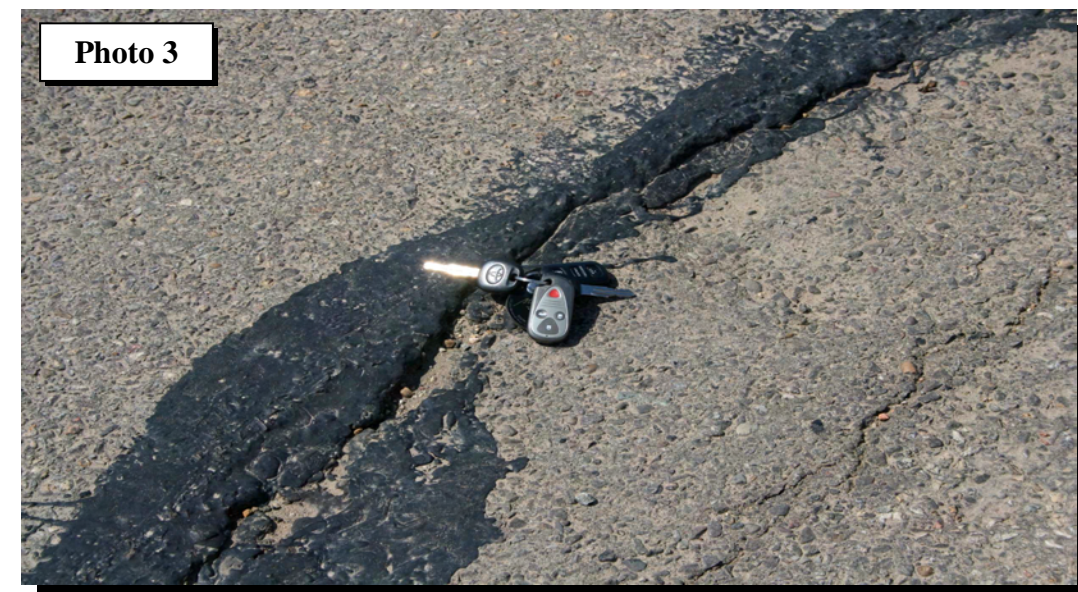
Close up view of crack

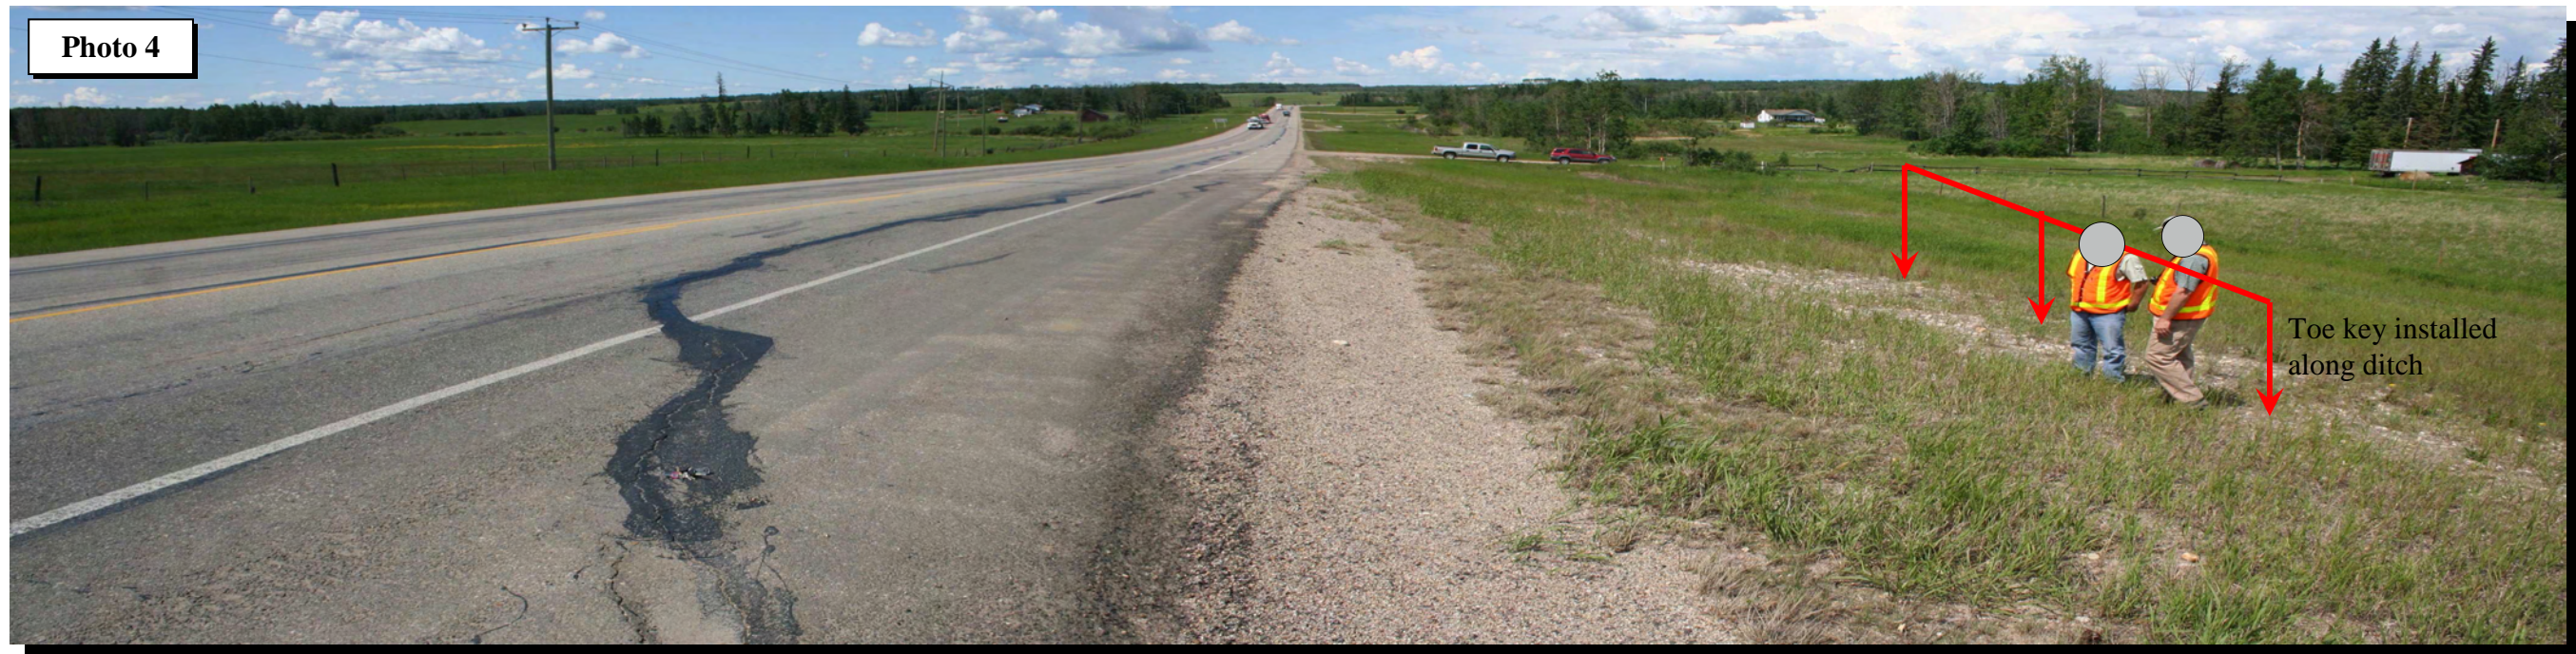
Photo 4

Looking west (away from valley-view)
- Reflective crack of pavement
- Another view

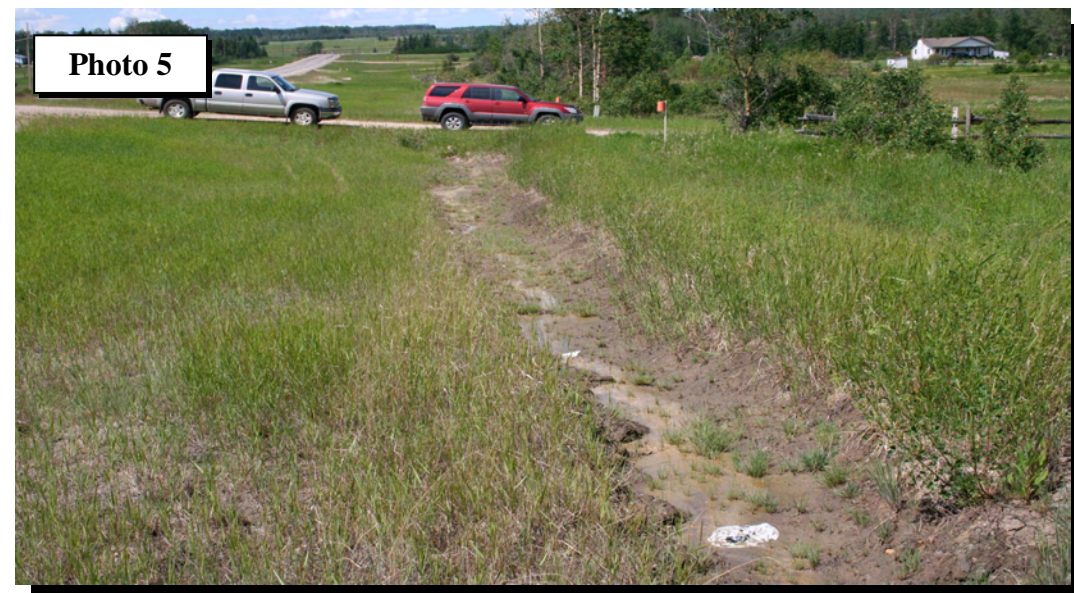
Photo 5

Swale along ditch to drain groundwater to away from slope toe area

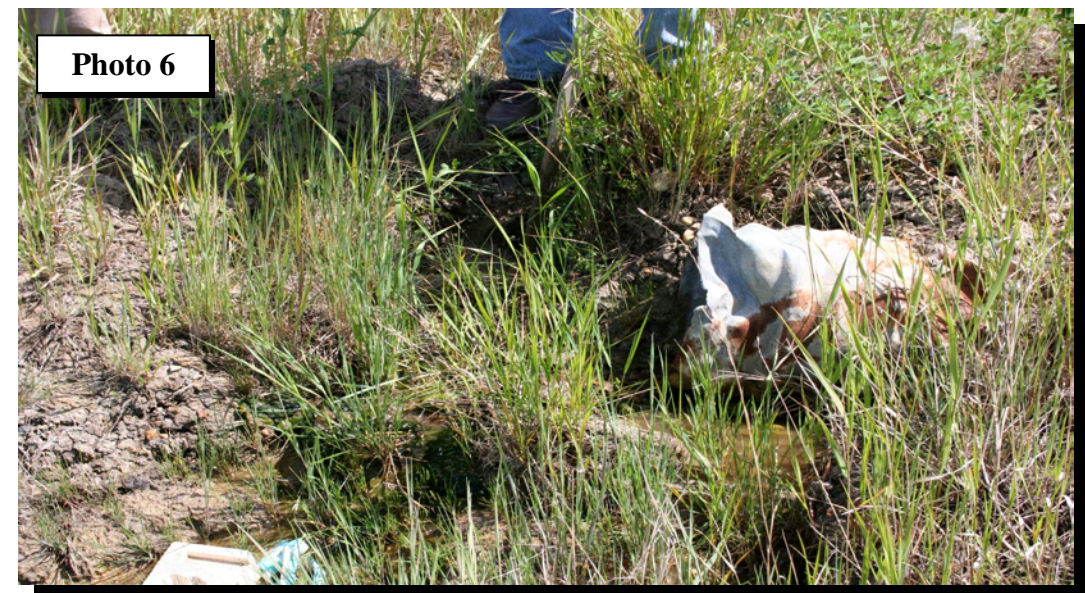
Photo 6

Outlet for exist of groundwater through a culvert spout at edge of toe key berm
