Slide Name: (GP 10) Hwy 43:06 S. of Sturgeon Lake

Inspection Date: June 25, 2007

Inspection by: Alberta Infrastructure & Transportation and KarlEng Staff listed on Page 1

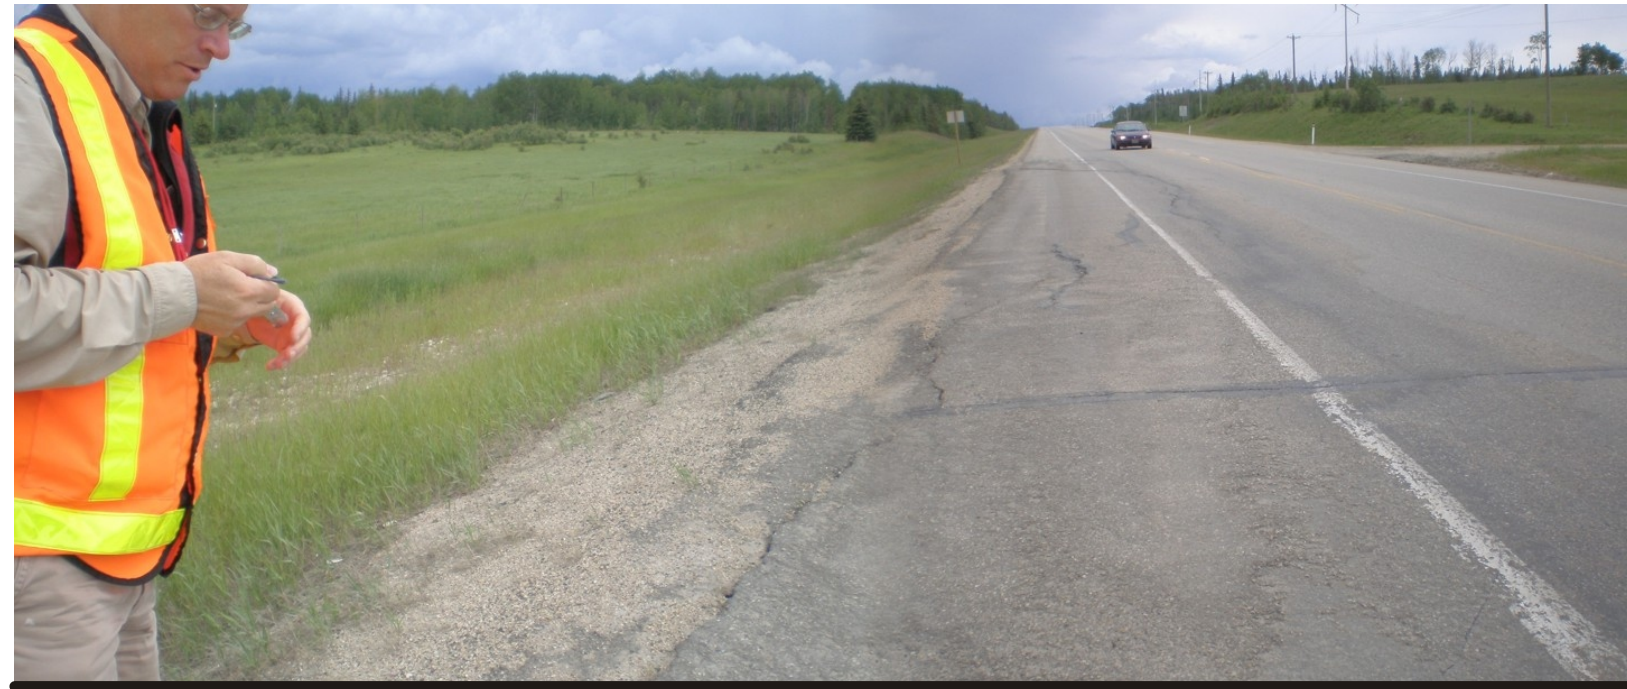
Photo 1
Looking East (towards Valleyview) along westbound lane
 - Pavement crack from headscarp from sliding of low embankment.
 The crack extended about 1m beyond shoulder line
 - Breadth of headscarp crack about 30m in length along roadway
 - Pavement cracking and minor subsidence has progressively stabilized since 2001 (granular toe key with woven geotextile underlay)
 Continual operation of roadway is acceptable to maintenance forces

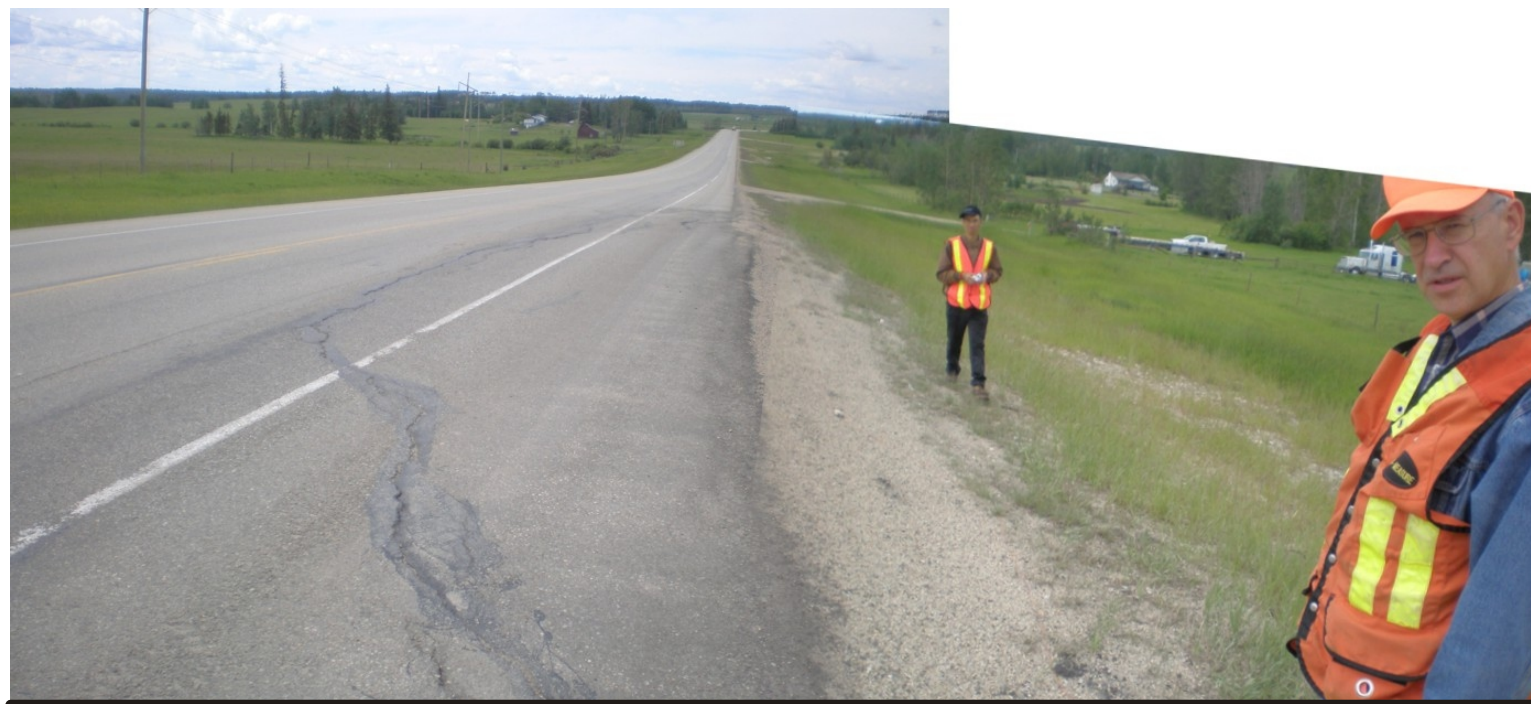
Photo 2
Looking West
 - Another view of pavement crack area that was patched over
 - Serviceability of roadway can be acceptable

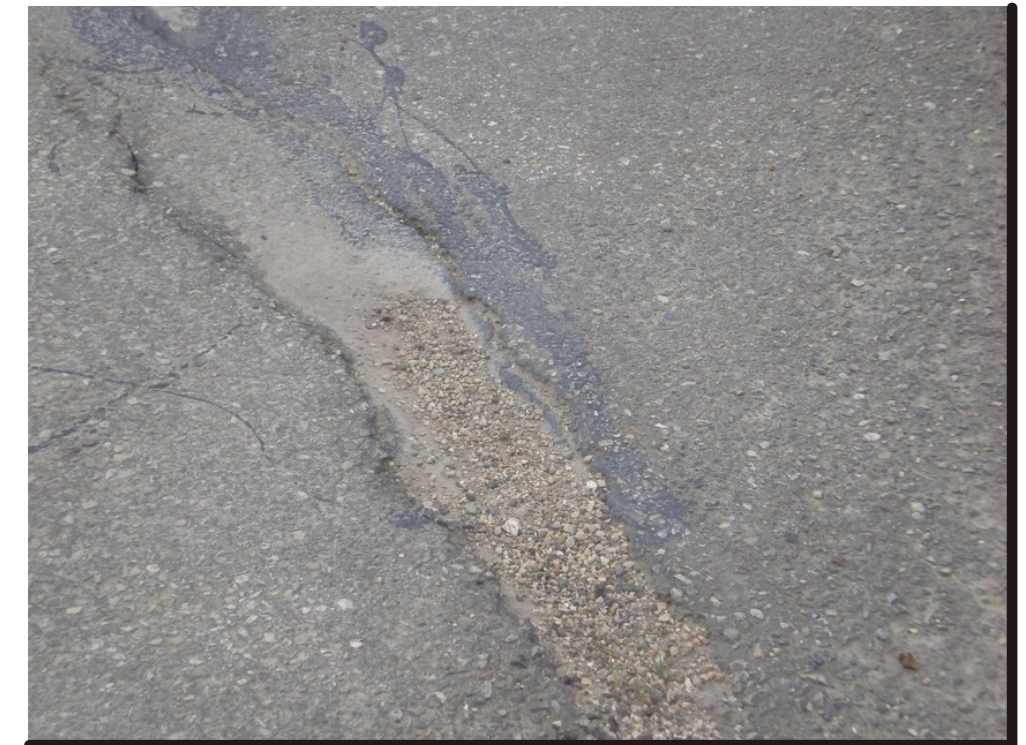
Photo 2a
 Minor reflection of cracks that was patched over and sealed

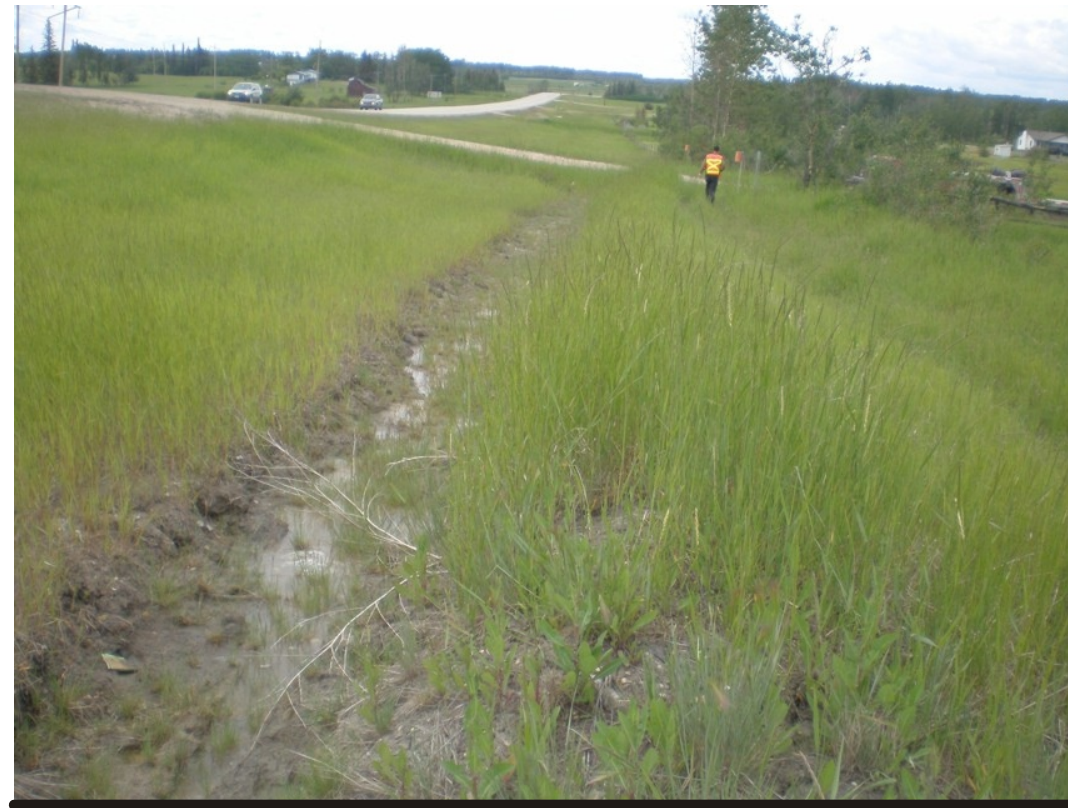
Photo 3

Looking west (away from Valleyview) along south ditch

- Low height fill embankment and low flat terrain (along north lake shore of Sturgeon Lake) with wet subgrade and possible spring exit.
- Low flat terrain very difficult to provide drainage for granular toe key
- A section CSP culvert was installed at edge of granular toe key to connect to dissipate pore pressure from saturated toe key.

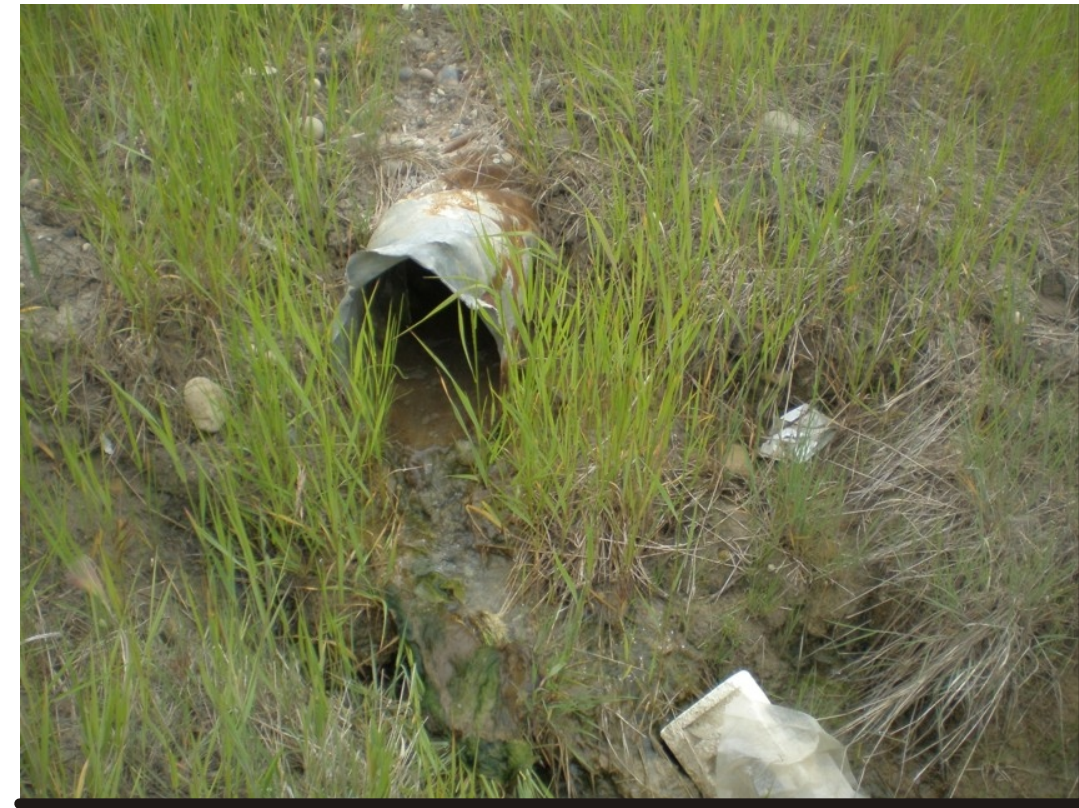
Photo 3a

CSP culvert outlet to connect to edge of granular toe key as drainage outfall to dissipate pore pressure

- A closeup view.
- Continual slow flow was inspected for many years. There is a need to regularly inspect and open up this CSP exit point from time to time.
