Slide Name: (GP 23) Hwy 43:08 Waskahigan River – NBL (Climbing Lane)
Inspection Date: May 3, 2005
Inspection by: Alberta Infrastructure & Transportation and EBA staff listed on Page 1

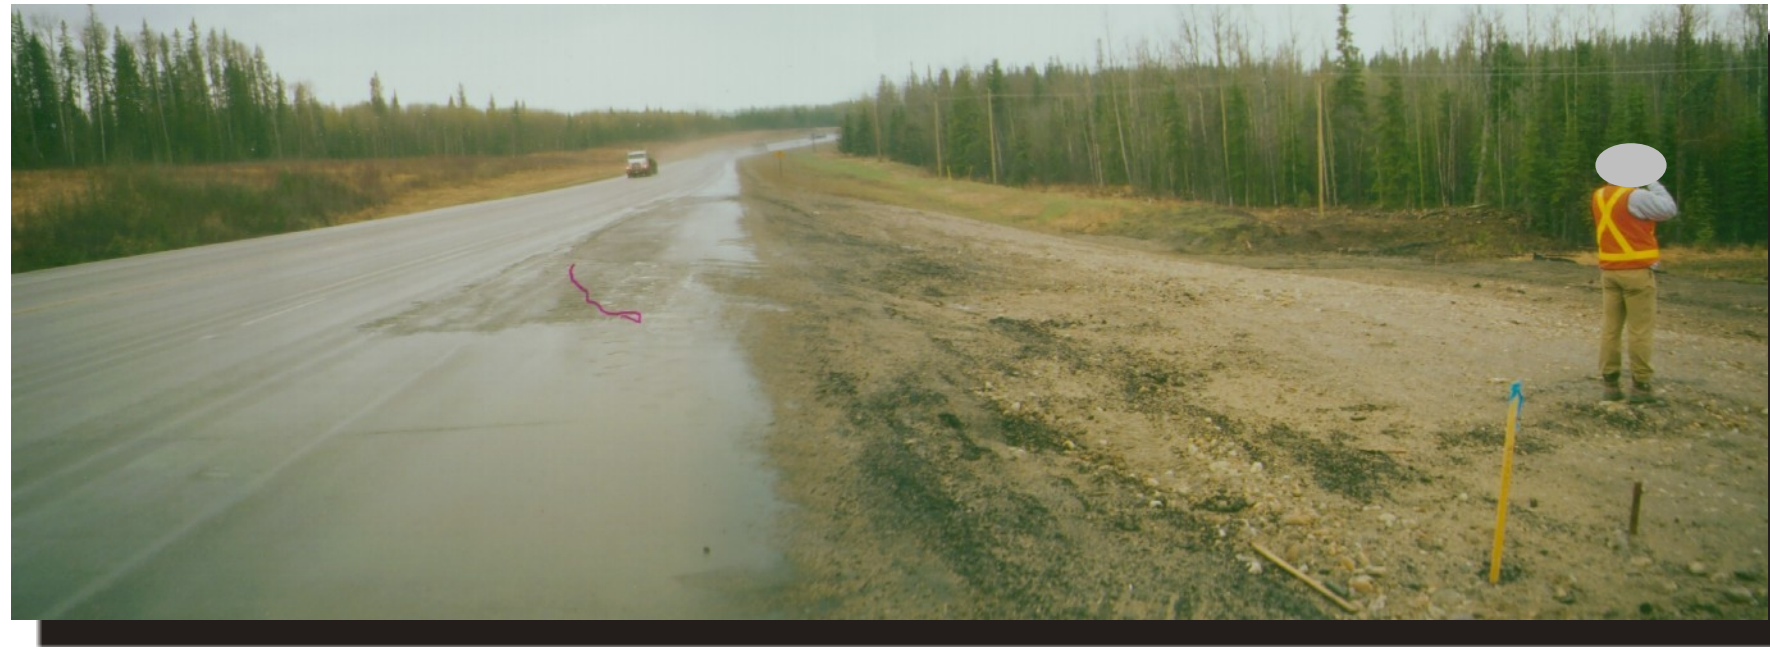
Photo 1

Looking north (towards Valleyview)

- Slide remediated by removal of "snake pit" of buried organic material and the slope reconstructed with pit-run to include toe key and berming
- Reconstruction of slope extended to shoulder edge of Climbing Lane
- A buried utility line runs along toe of slope and required exposing during slope reconstruction

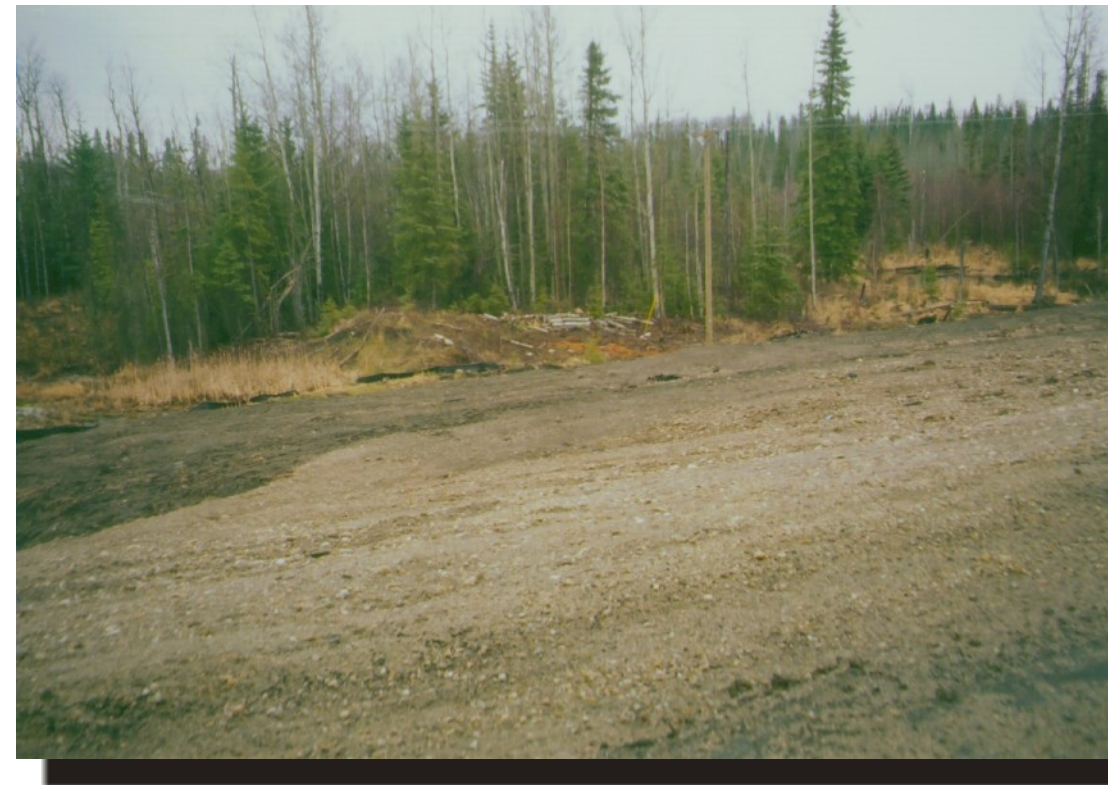
Photo 2

Looking east at toe berm.

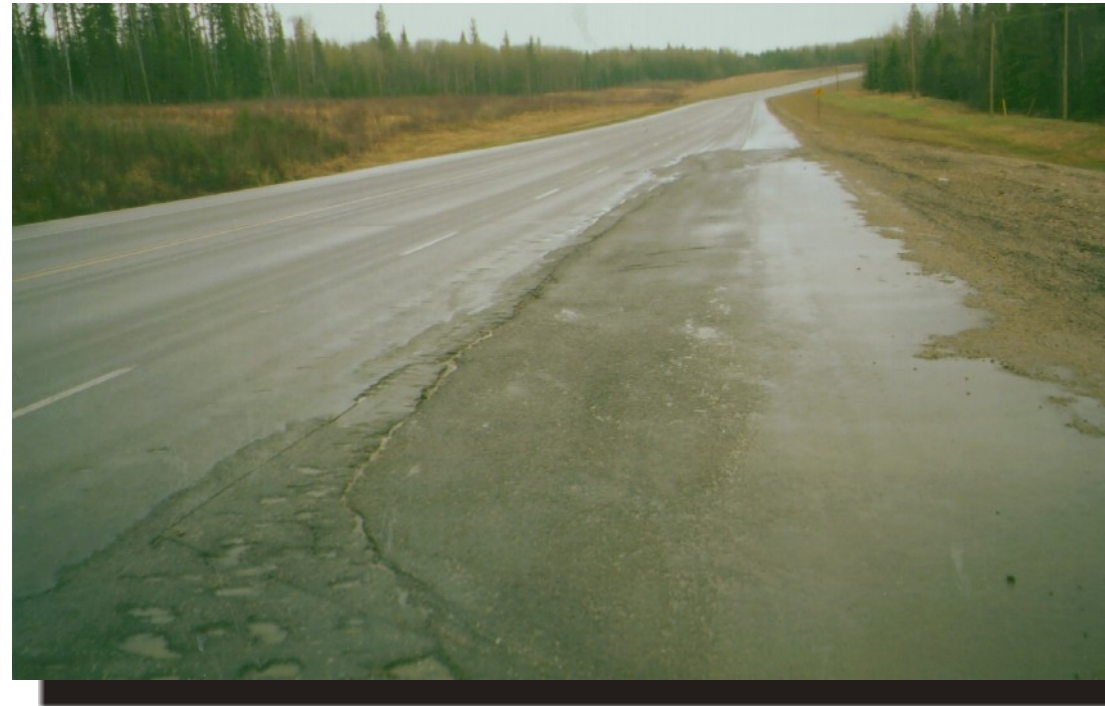
Photo 3

Looking north (towards Valleyview)

- Top portion of slope reconstruction forming $\frac{1}{2}$ of a highway lane
- Pavement structure (temporary pavement) performing well for half year since December 2004 slope reconstruction

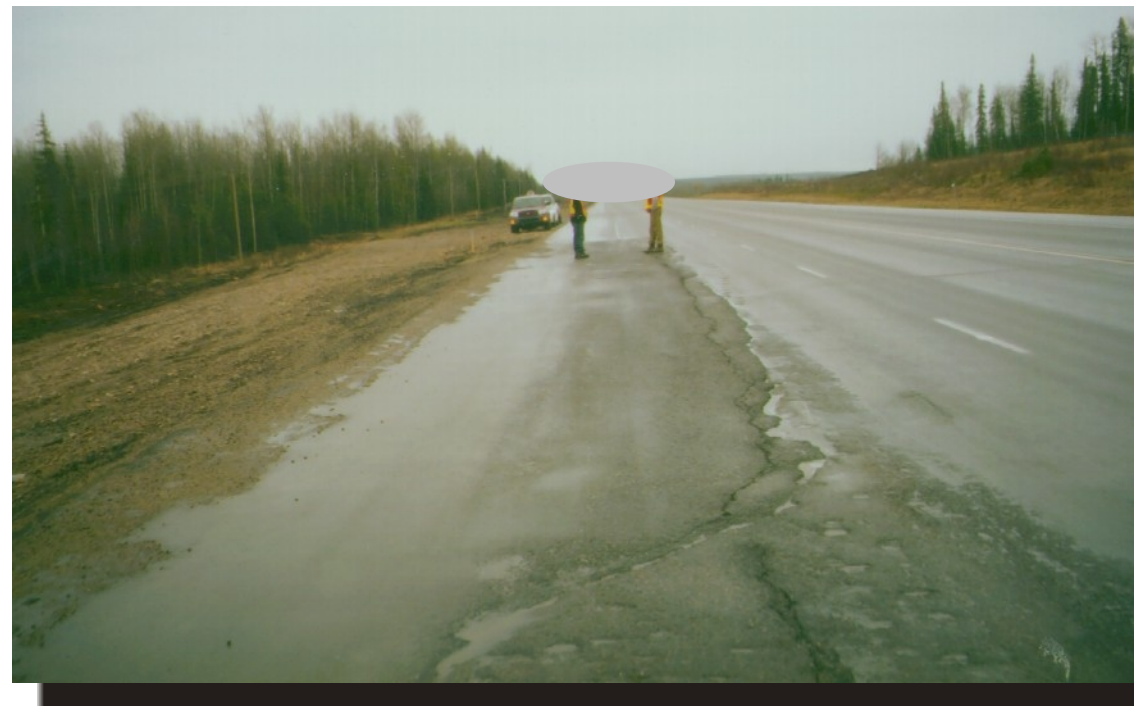
Photo 4

- Looking south (towards Fox Creek)
- Temporary pavement performing well
