Slide Name: (GP 23) Hwy 43:08 Washahigan River – NBL (Climbing Lane)

Inspection Date: June 19, 2006

Inspection by: Alberta Infrastructure & Transportation and KarlEng Staff listed on Page 1

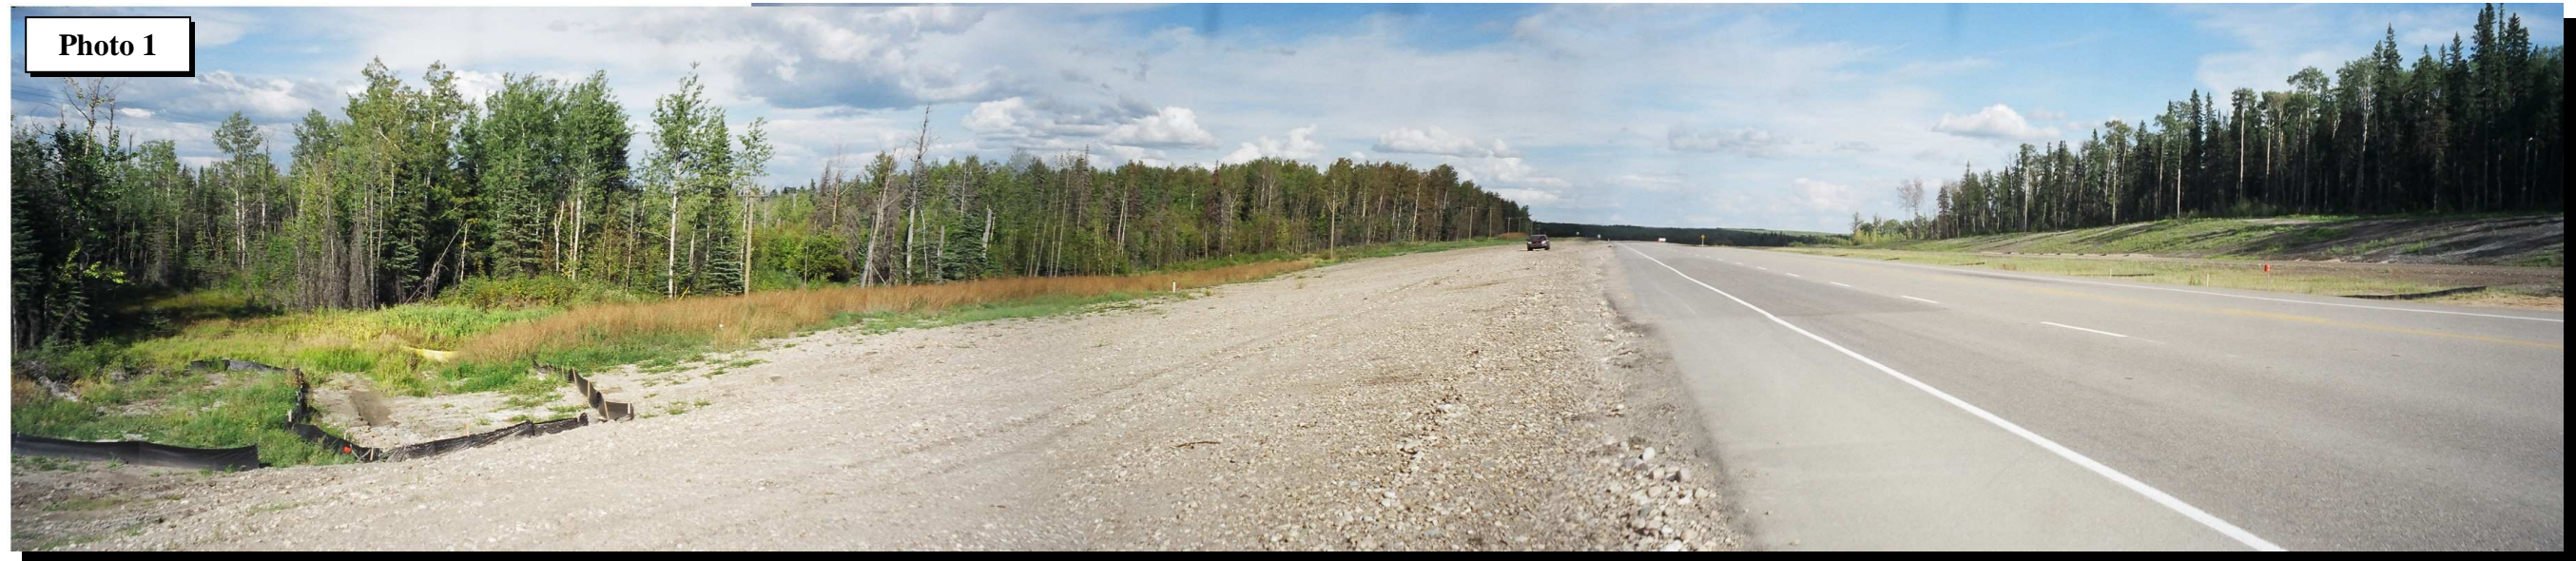
**Photo 1**

Looking east downgrade towards Waskahigan River bridge (at far end of photo)

- Patched area indicates previous slide location of affected pavement
- Previous slide area extended east 60-80m from culvert location (i.e. patched area)
- Slope reconstructed with granular fill
- A buried utility line located along toe of slope
- A new smooth wall steel pipe culvert installed (at left of photo) by push pipe drilling

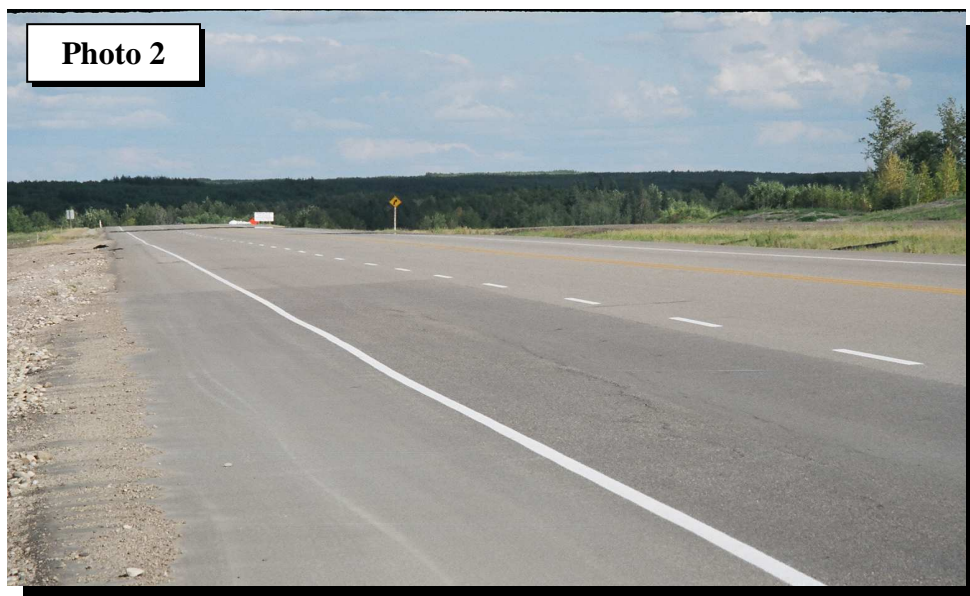
**Photo 2**

Close up of previous slide area

- Minor settlement crack of new granular fill of slope reconstruction

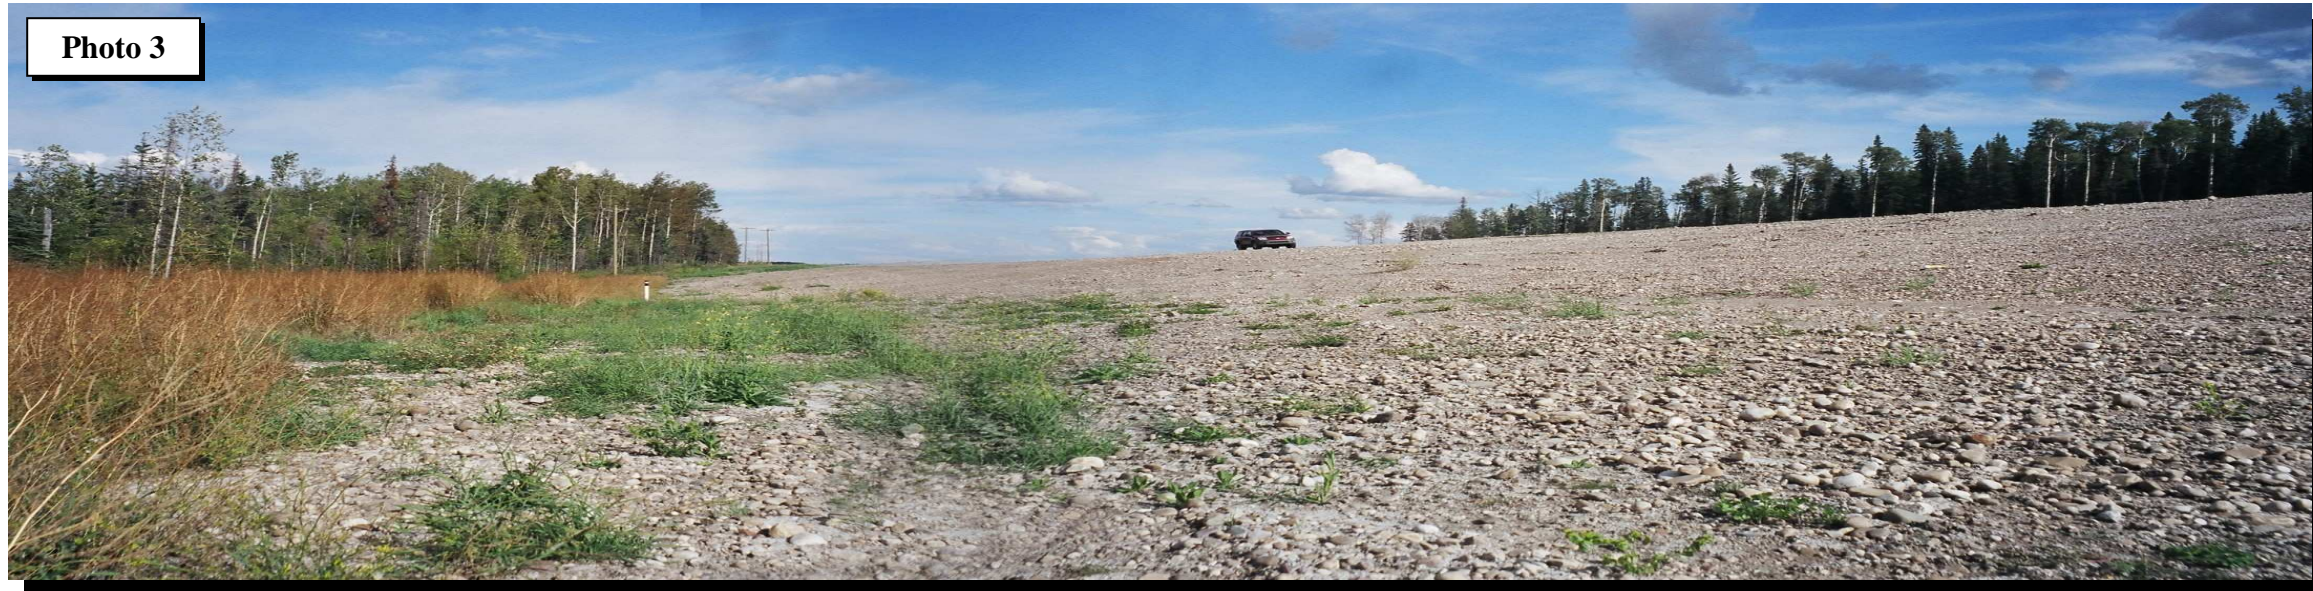
Looking east along toe of reconstructed slope

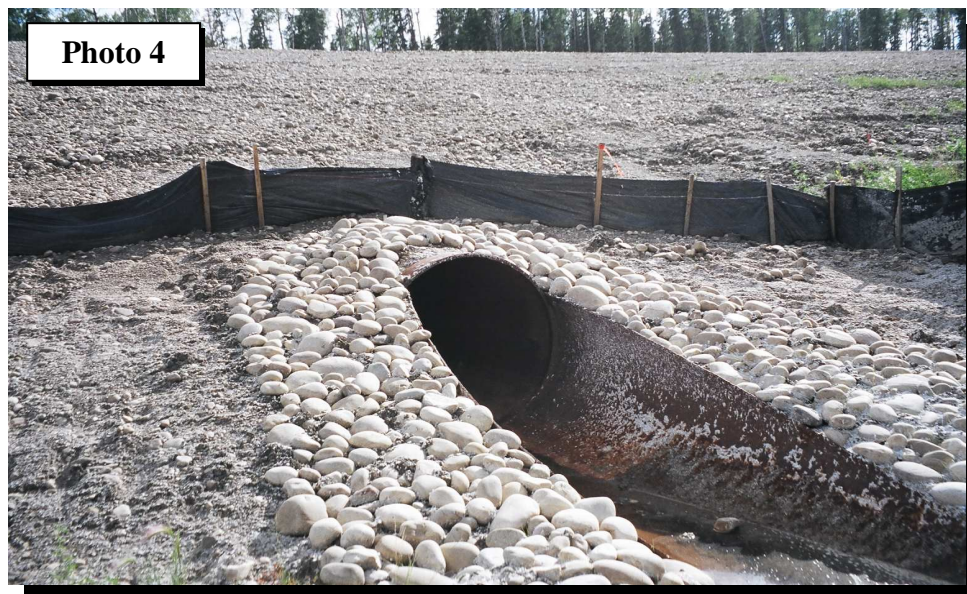
New smooth wall steel culvert at west edge of slide area

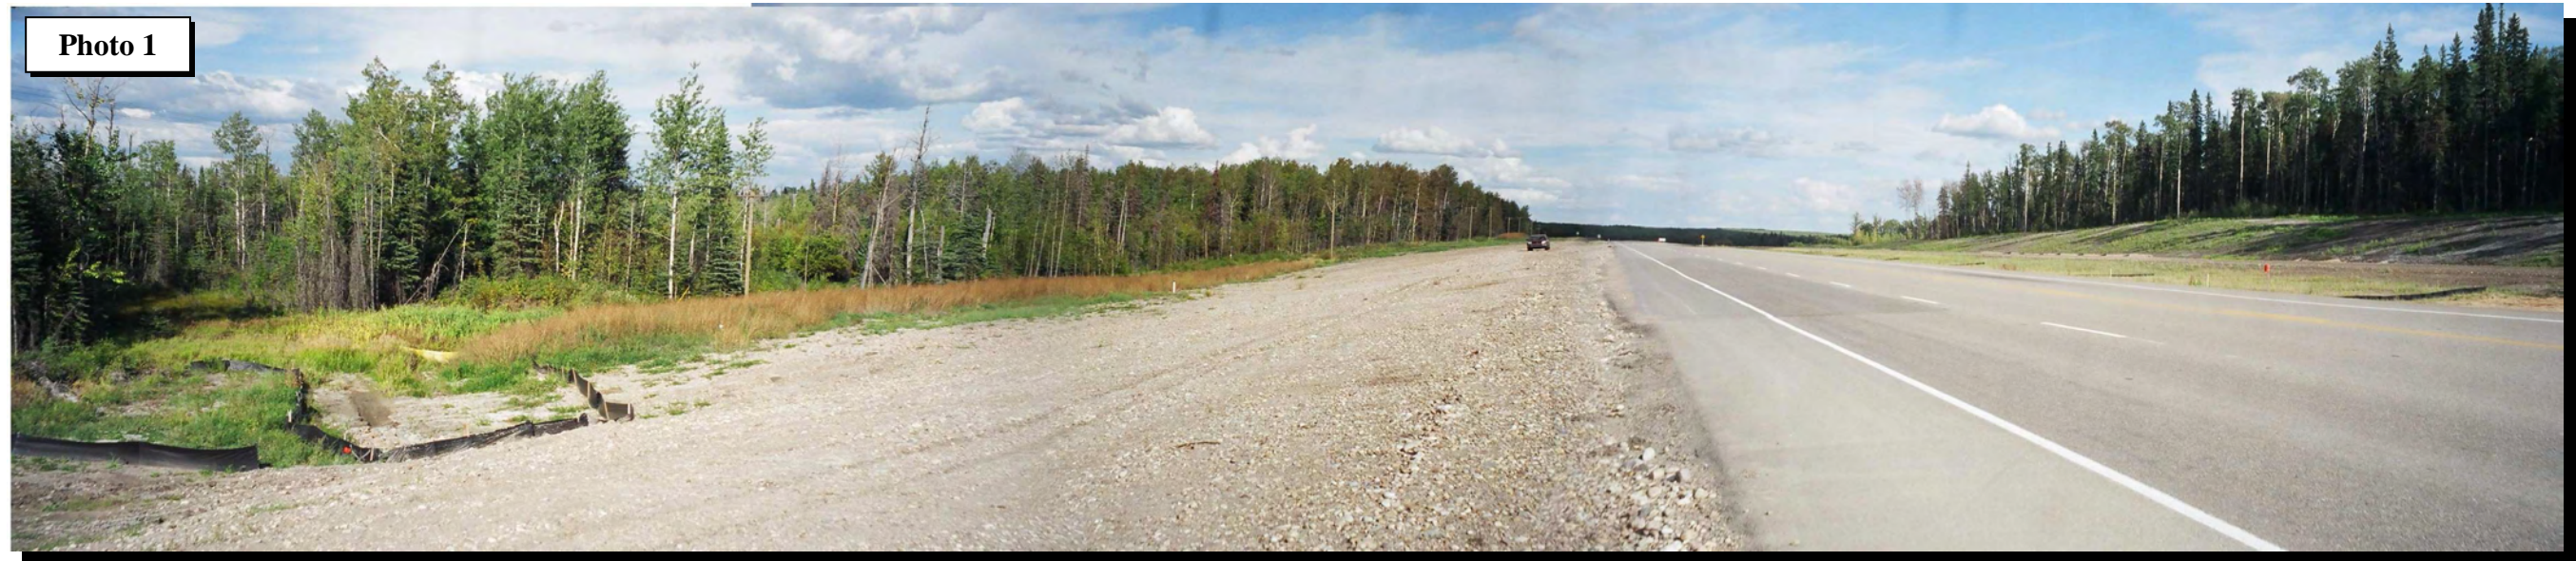
**Photo 1**

Looking east downgrade towards Waskahigan River bridge (at far end of photo)

- Patched area indicates previous slide location of affected pavement
- Previous slide area extended east 60-80m from culvert location (i.e. patched area)
- Slope reconstructed with granular fill
- A buried utility line located along toe of slope
- A new smooth wall steel pipe culvert installed (at left of photo) by push pipe drilling

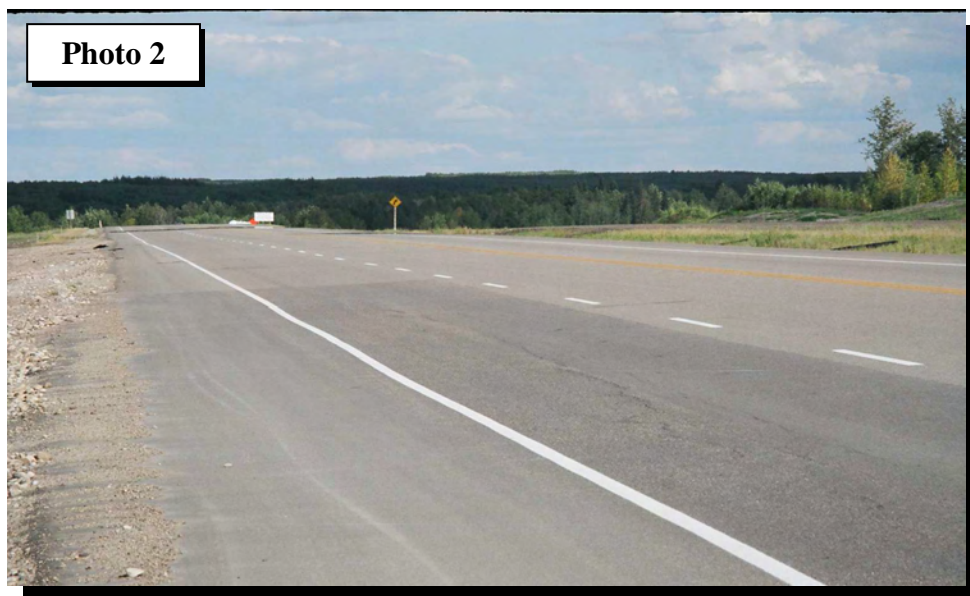
**Photo 2**

Close up of previous slide area

- Minor settlement crack of new granular fill of slope reconstruction

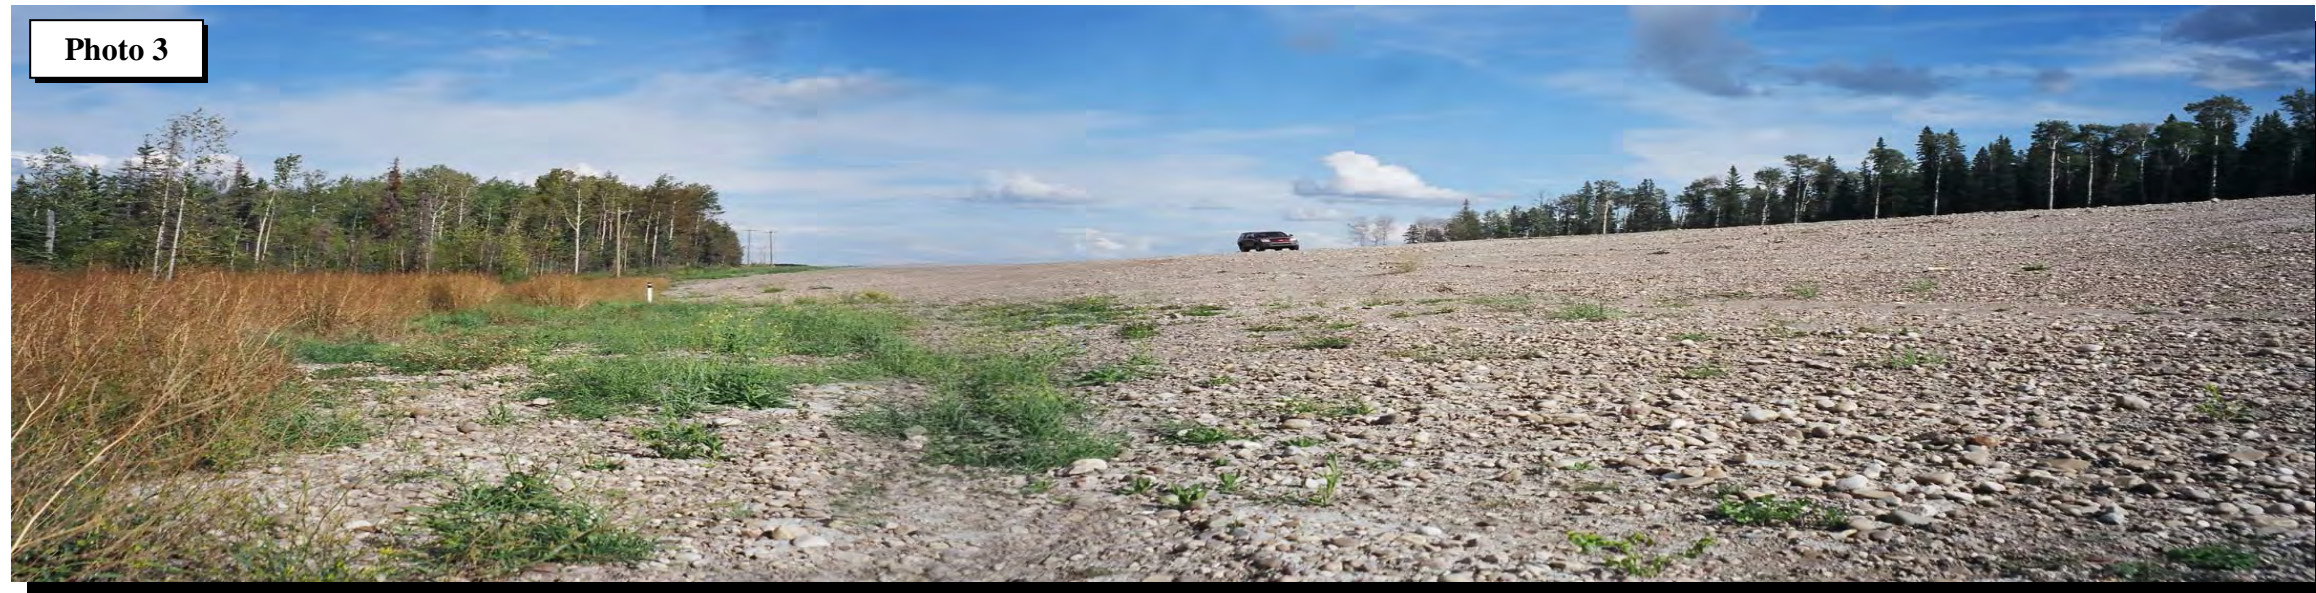
Looking east along toe of reconstructed slope

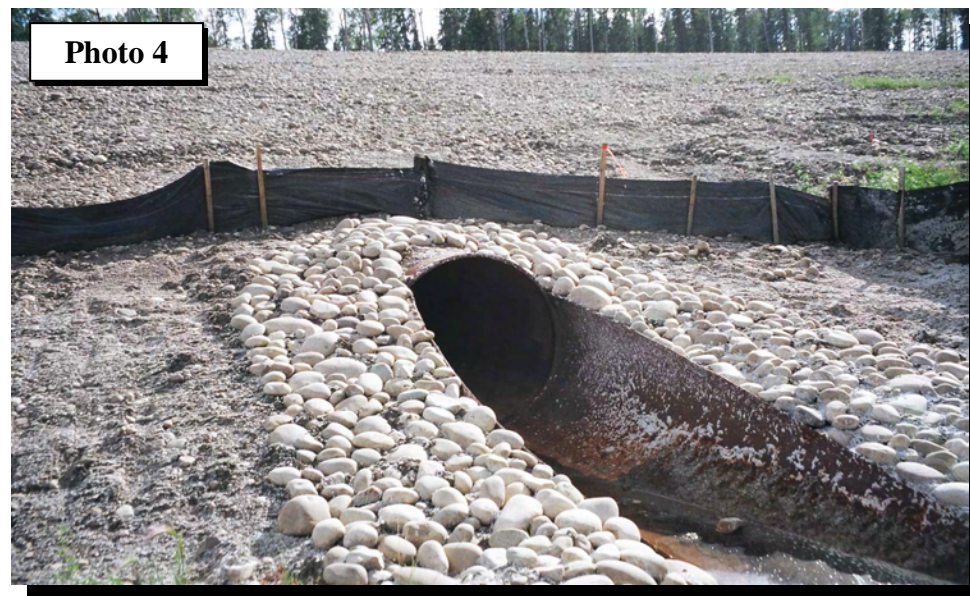
New smooth wall steel culvert at west edge of slide area
