**PEACE REGION – GRANDE PRAIRIE
GEOHAZARD RISK ASSESSMENT
2010 SITE INSPECTION FORM**

SITE NUMBER GP-18	SITE NAME Sturgeon Creek	HIGHWAY & KM Hwy 49:12	PREVIOUS INSPECTION DATE June 9, 2009	INSPECTION DATE May 18, 2010
LEGAL DESCRIPTION LSD 13-35-70-22-W5M	NAD 83 COORDINATES N 6,107,120 E 483,726	RISK ASSESSMENT PF: 2 CF: 1 TOTAL: 2**(after repair 2010) PF: 10 CF: 4 TOTAL: 40 (prior to 2010 repair)

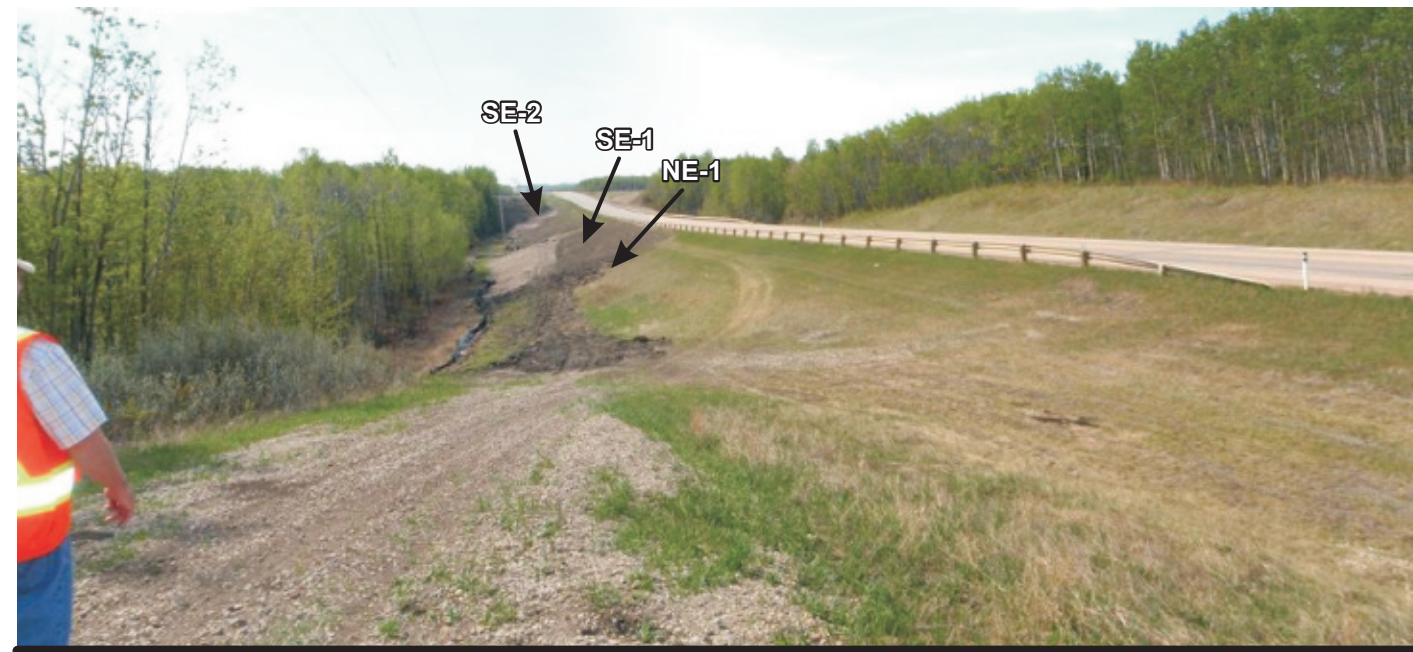
Photo 1
Looking south along east (downstream) sideslope
Repaired Slides NE-1, SE-1 and SE-2. General view along east ditch

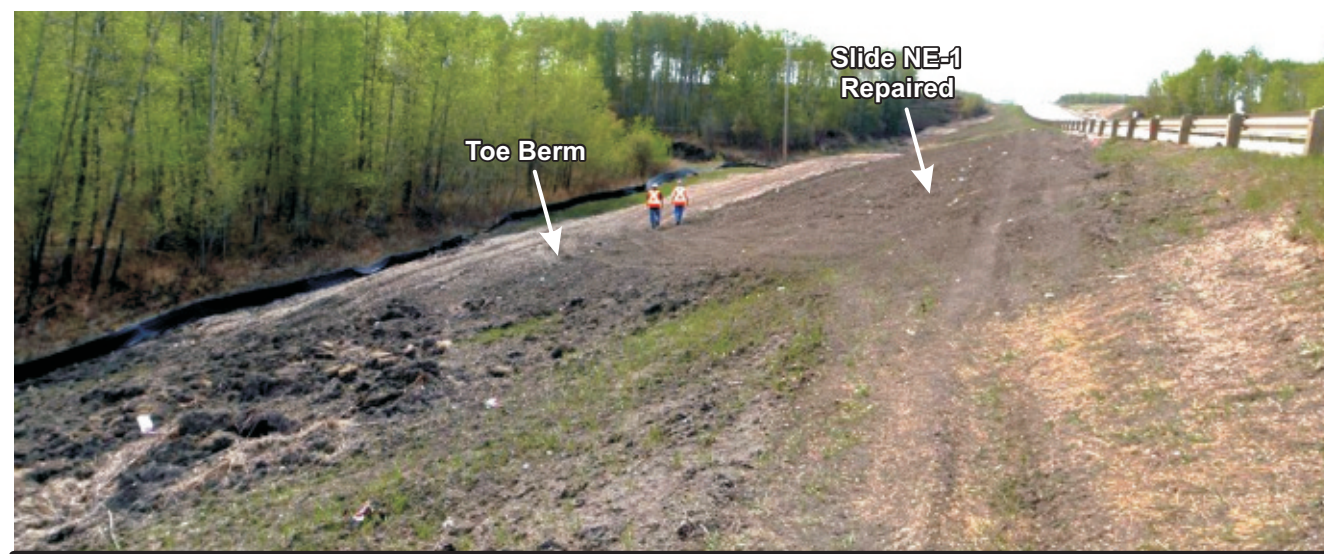
Photo 1a
Closed up view

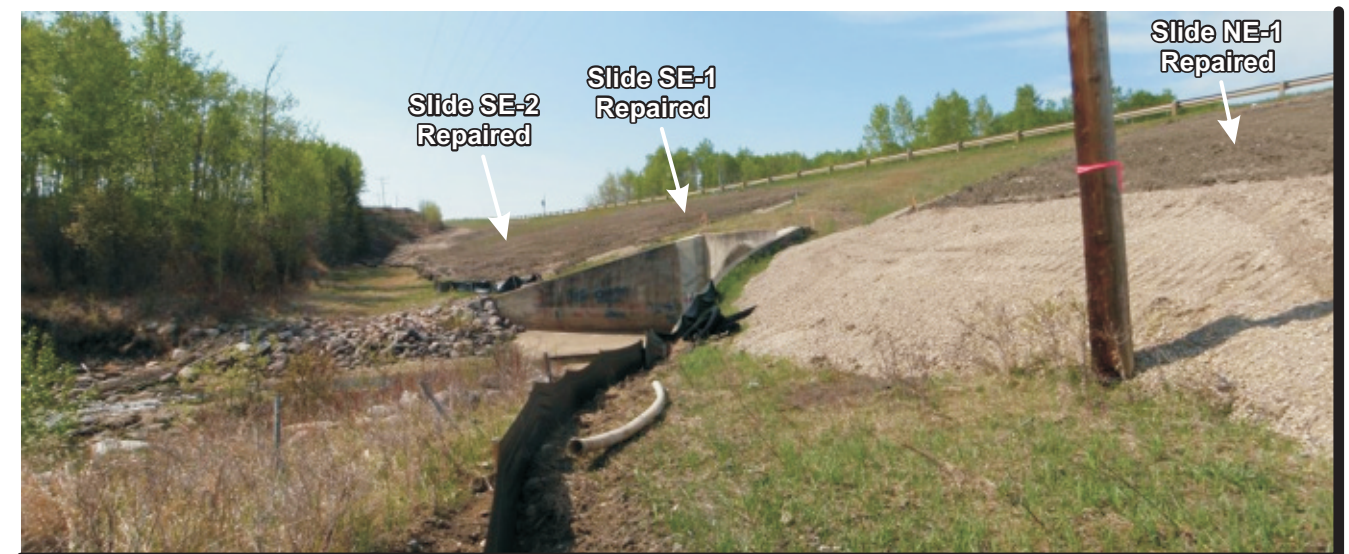
Photo 1b
Closed up view

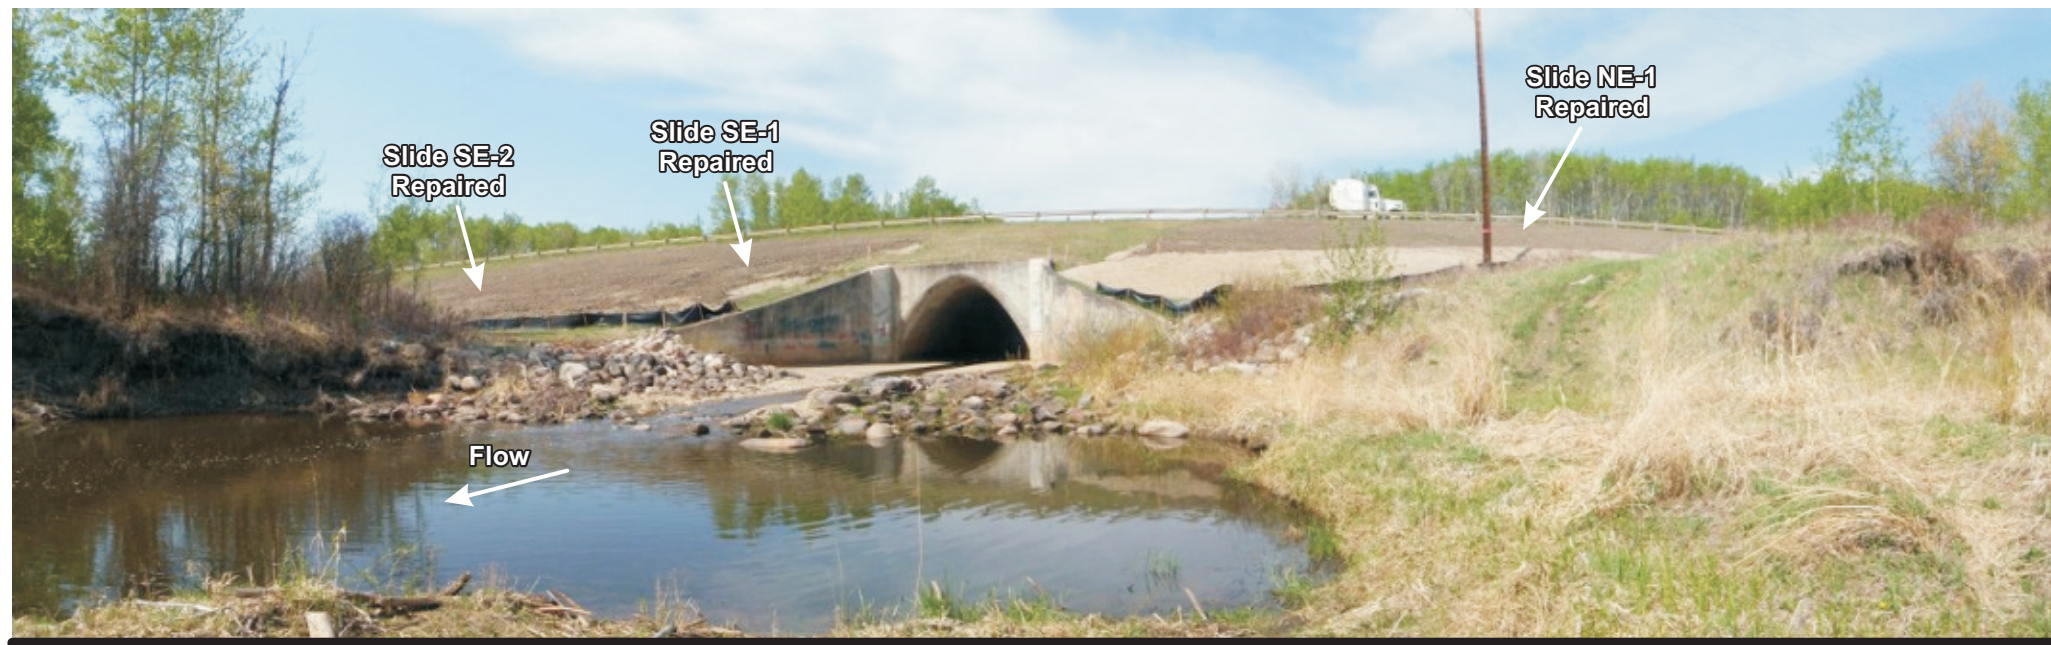
Photo 2
Looking west at outlet of culvert (downstream) and sideslope
Another view of Repaired Slides NE-1, SE-1 and SE-2

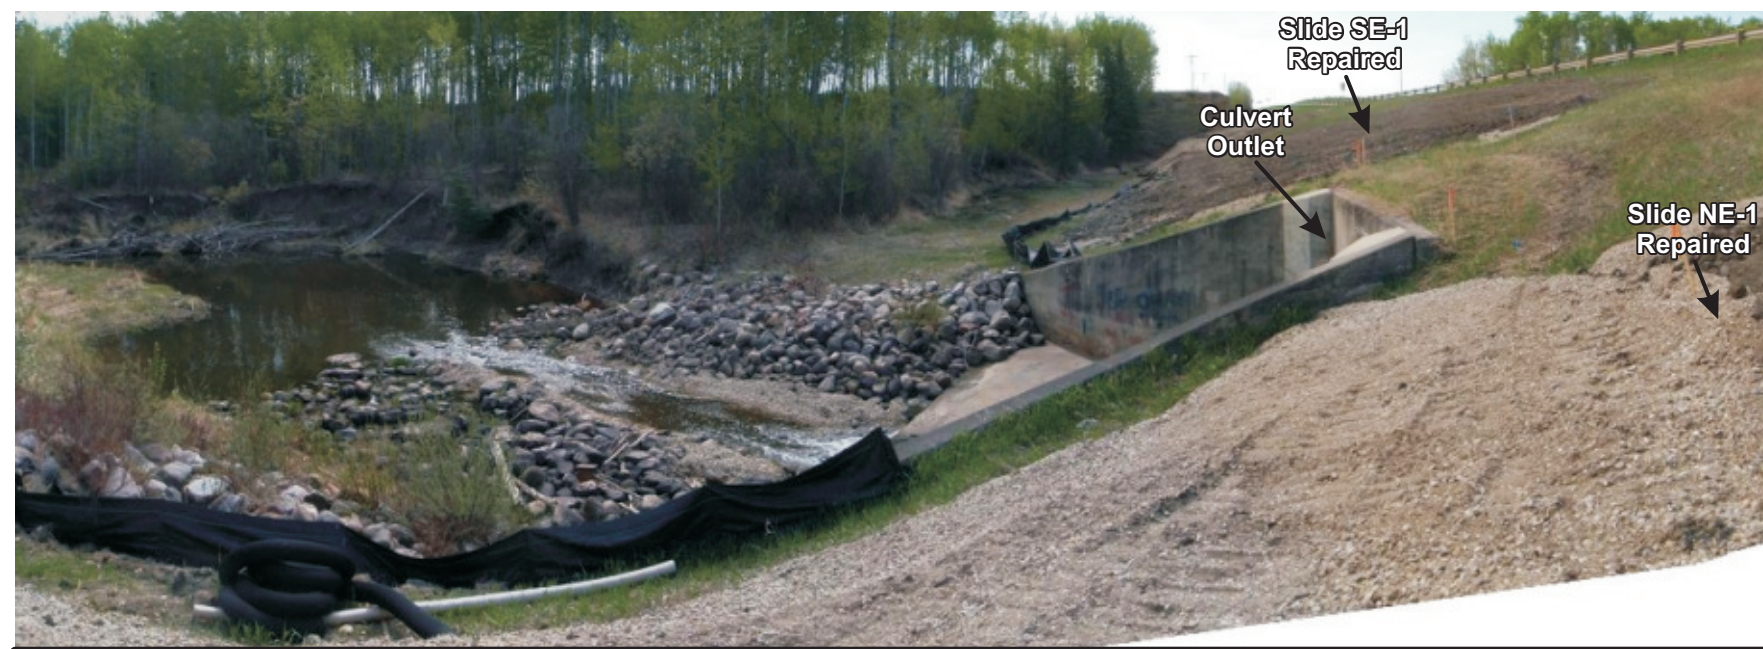
Photo 2a
Another view at top elevation of culvert outlet
Repaired Slides NE-1 & SE-1

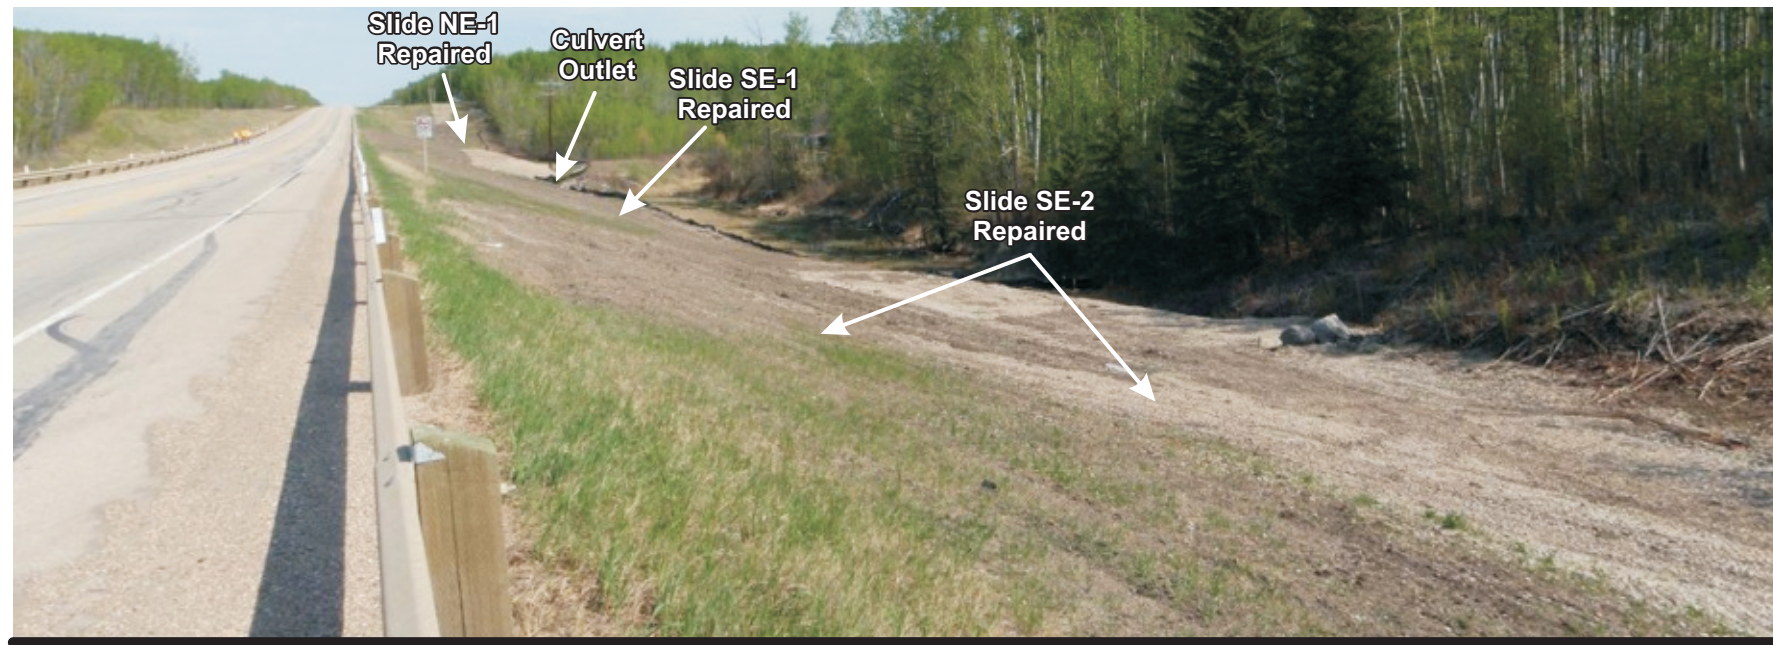
Photo 3
Looking north along east (downstream) sideslope of approach fill embankment
across Sturgeon Creek from south (near upland) edge of this crossing
A series of 3 Repaired Slides (NE-1, SE-1, SE-2) along the east sideslope of fill embankment

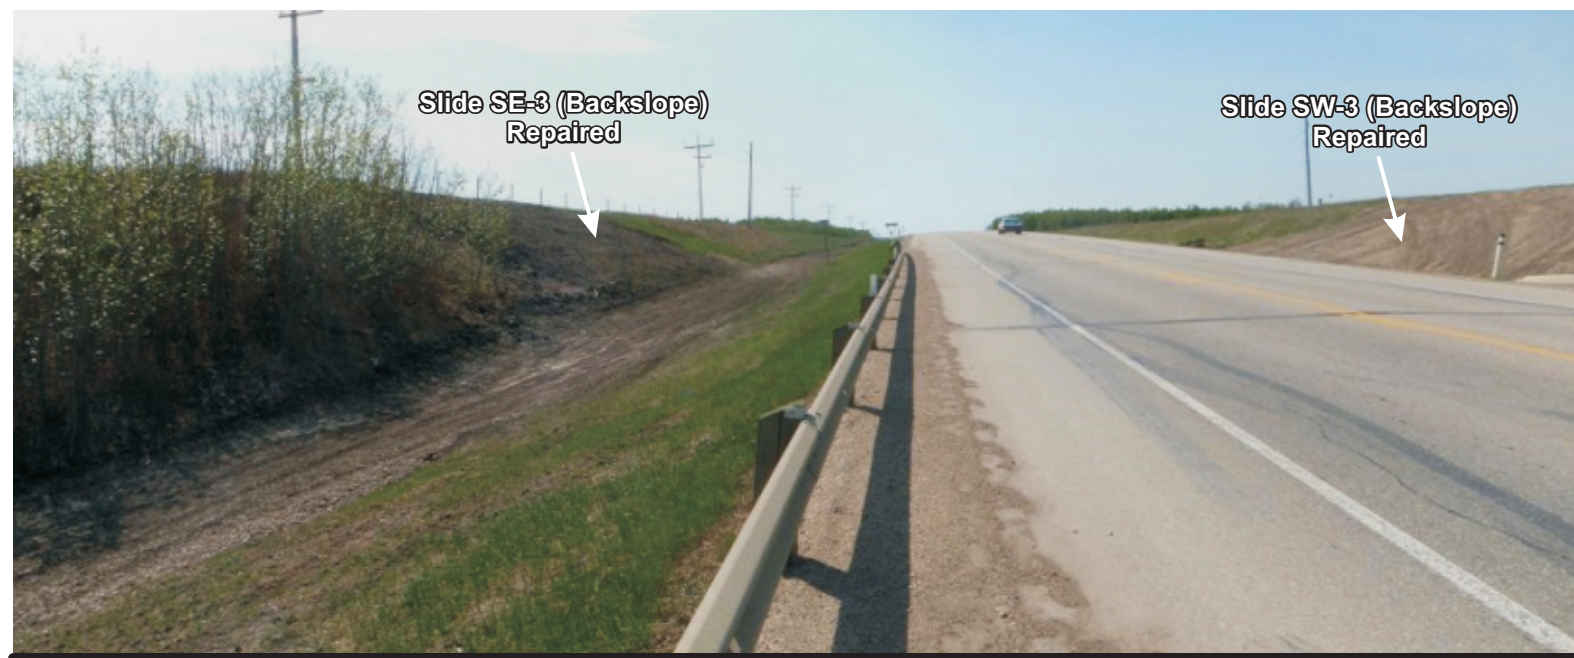
Photo 3a
Looking south (at top of upland) along east ditch
Repaired (SE-3) Slide at upland verge
Repaired (SW-3) Slide at upland verge at opposite ditch

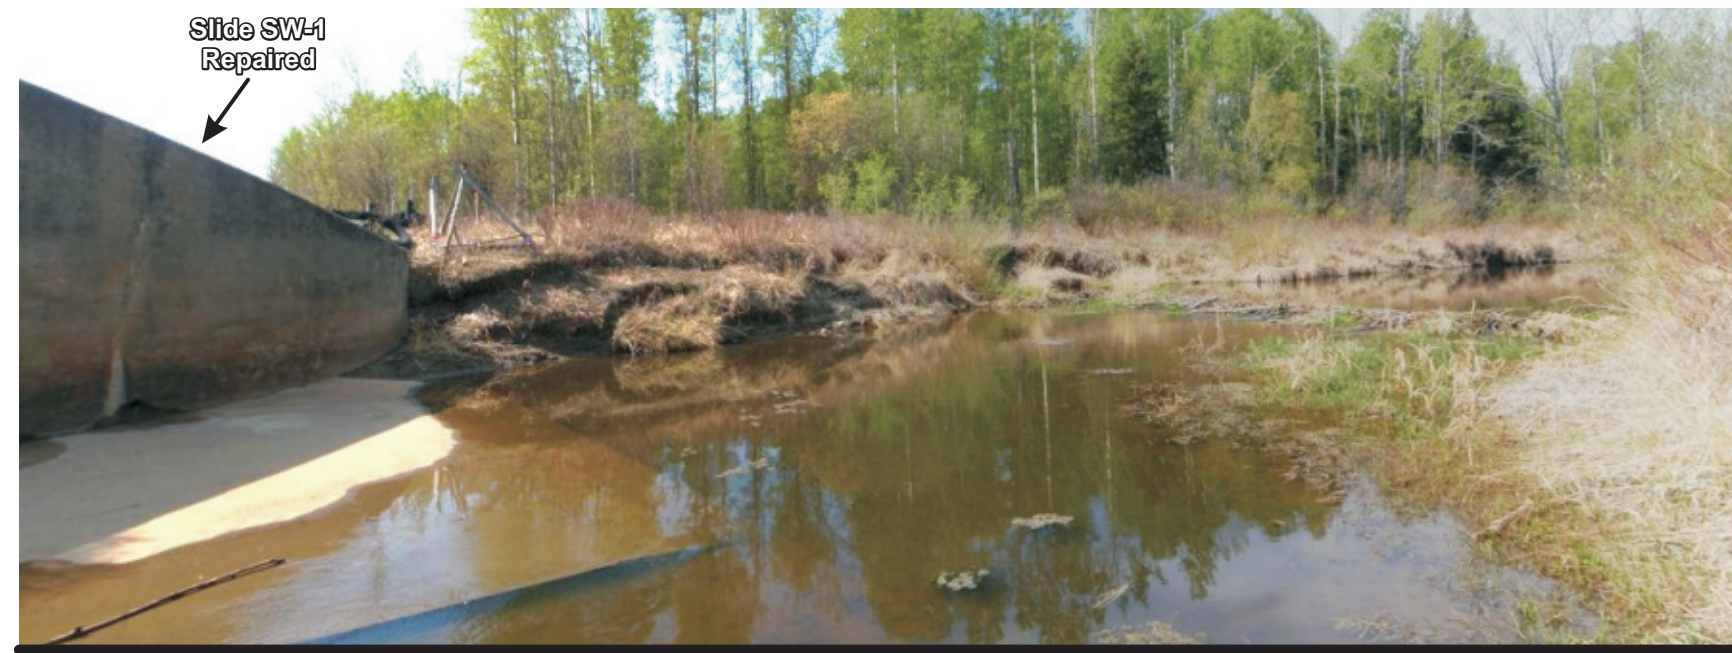
Photo 4
Looking west at upstream (south) bank adjacent to culvert inlet
Repaired Slide (SW-1) just adjacent to bank and above headwall

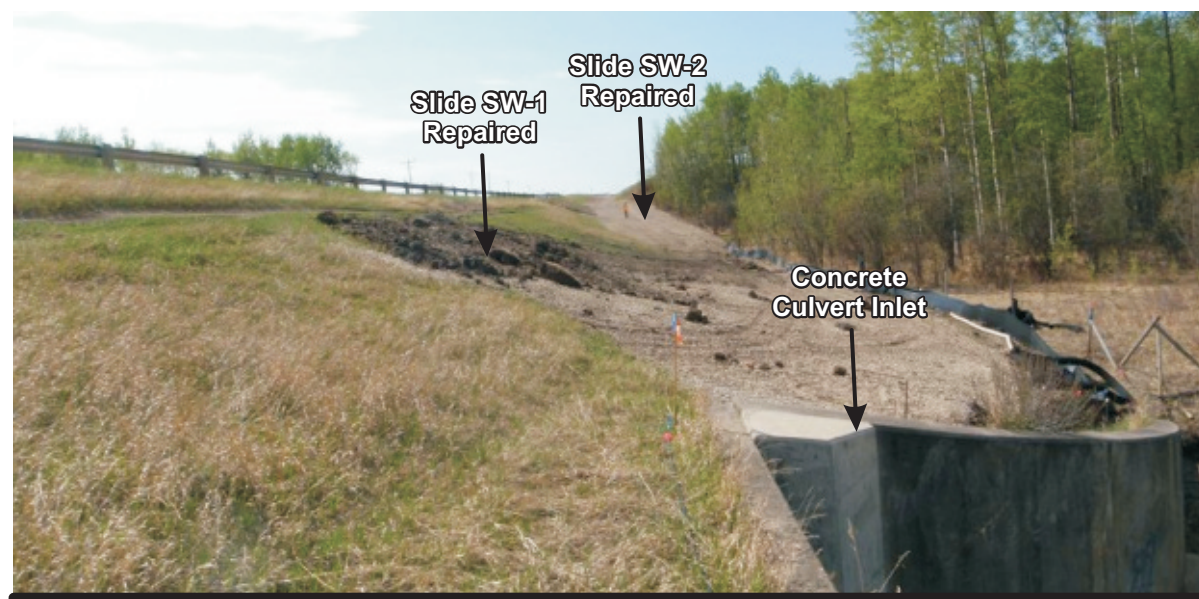
Photo 5
Looking south along west ditch (upstream side of culvert) culvert inlet
A view of SW-1, SW-2 Repaired Slides

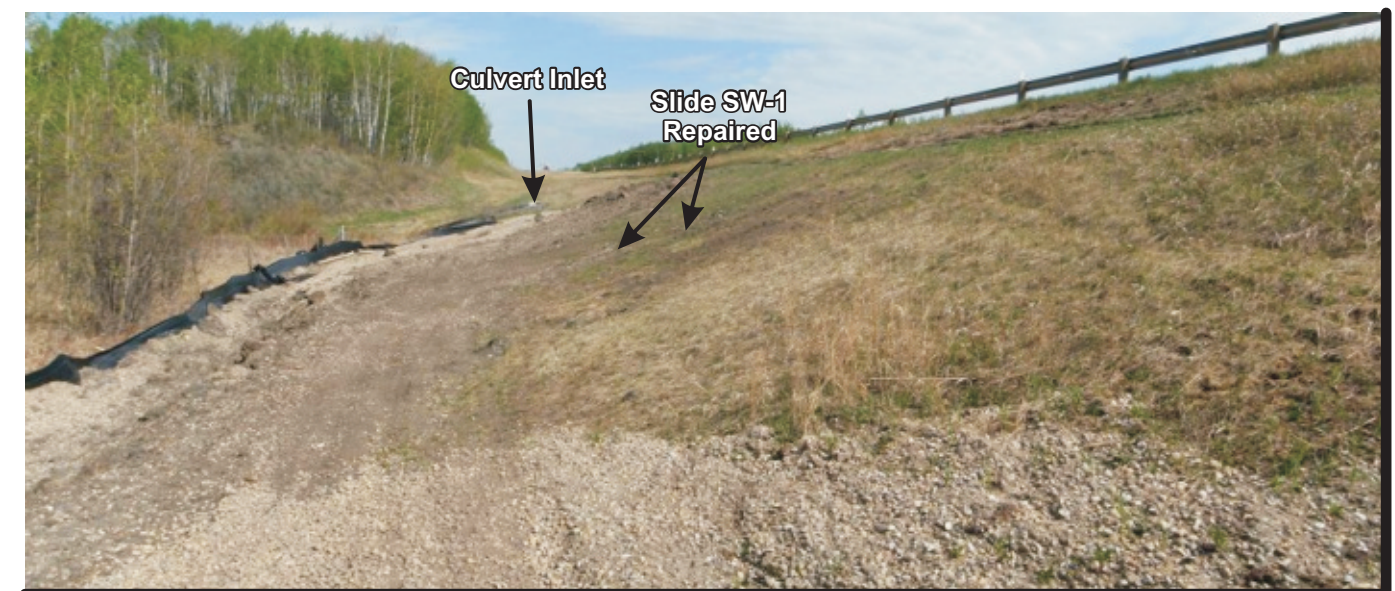
Photo 5a
Looking north along west ditch (upstream side of culvert) culvert inlet
SW-1 just adjacent to Wing-wall of culvert

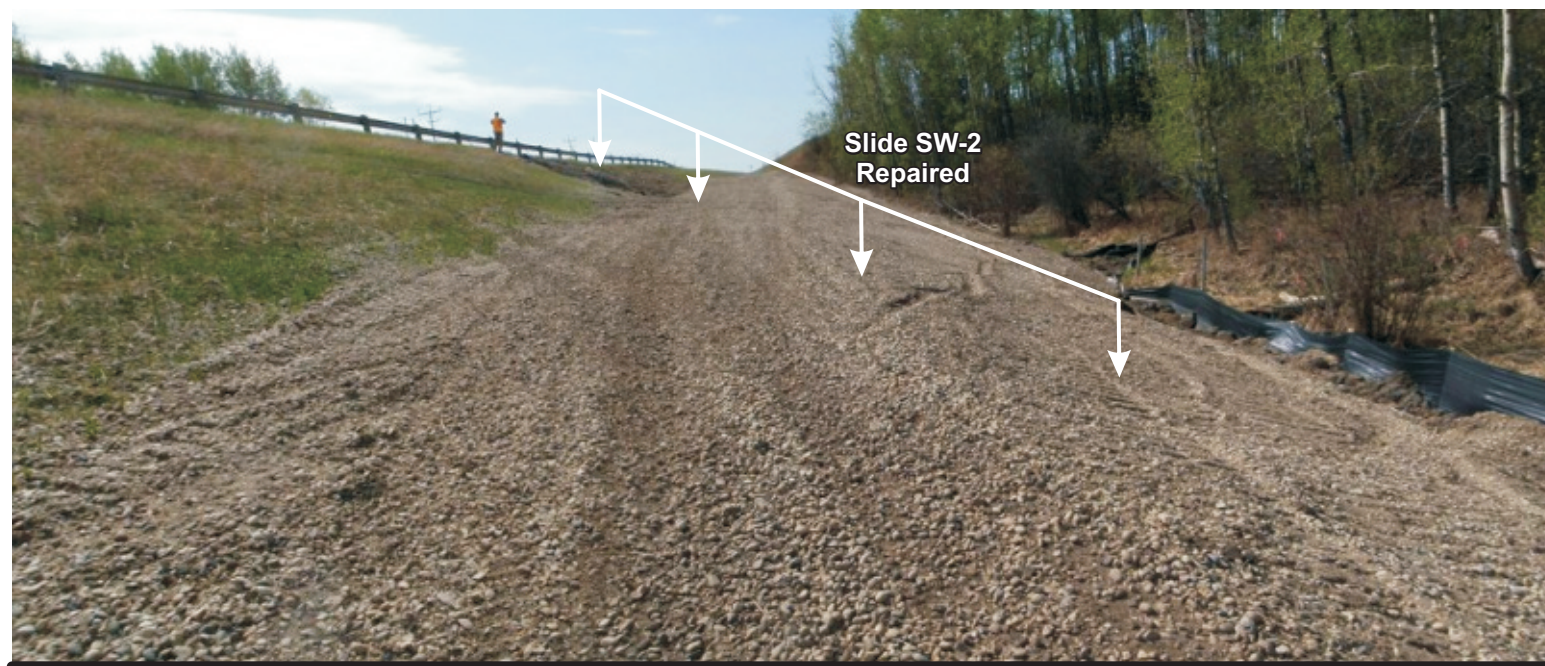
Photo 5b
Looking south along west ditch
SW-2 along sideslope
SW-3 along verge of valley wall

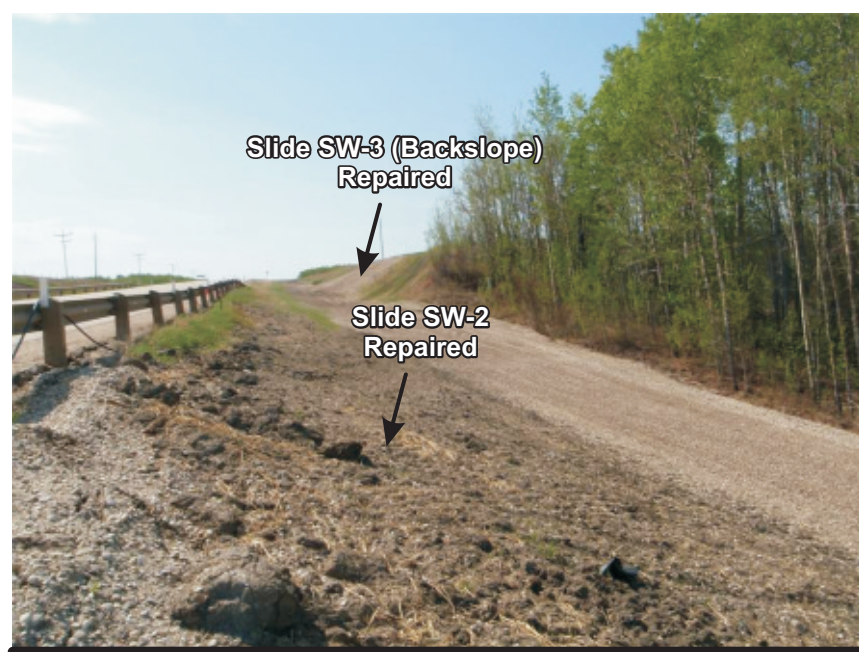
Photo 5c
Looking south along west ditch
SW-2 along sideslope
SW-3 along verge of valley wall

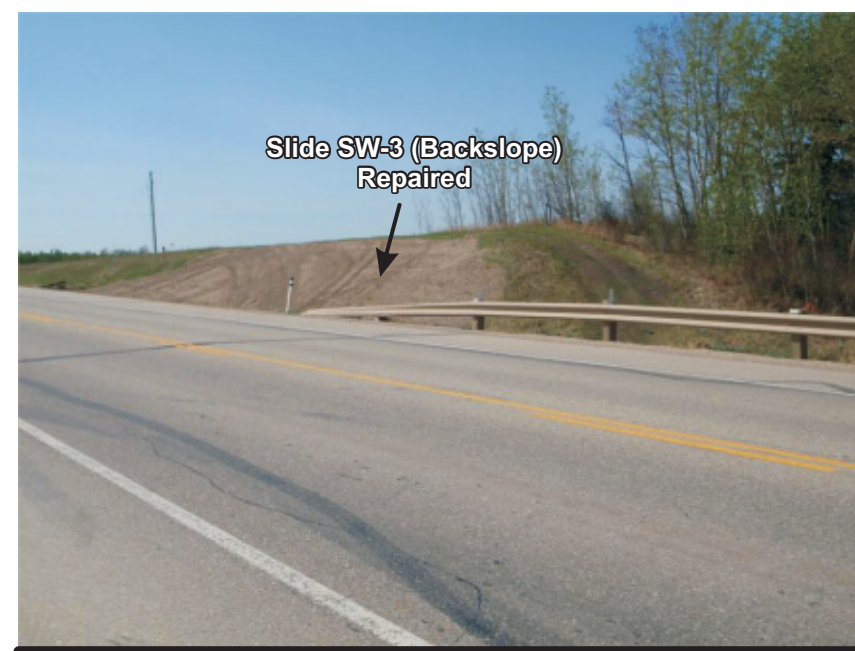
Photo 5d
Looking south along west ditch
SW-2 along sideslope
SW-3 along verge of valley wall
